**ALMA COLLEGE CONDITIONS ASSESSMENT PROJECT**  
Midpeninsula Regional Open Space District  
Santa Clara County, CA

Phase I: Assessment of Existing Conditions

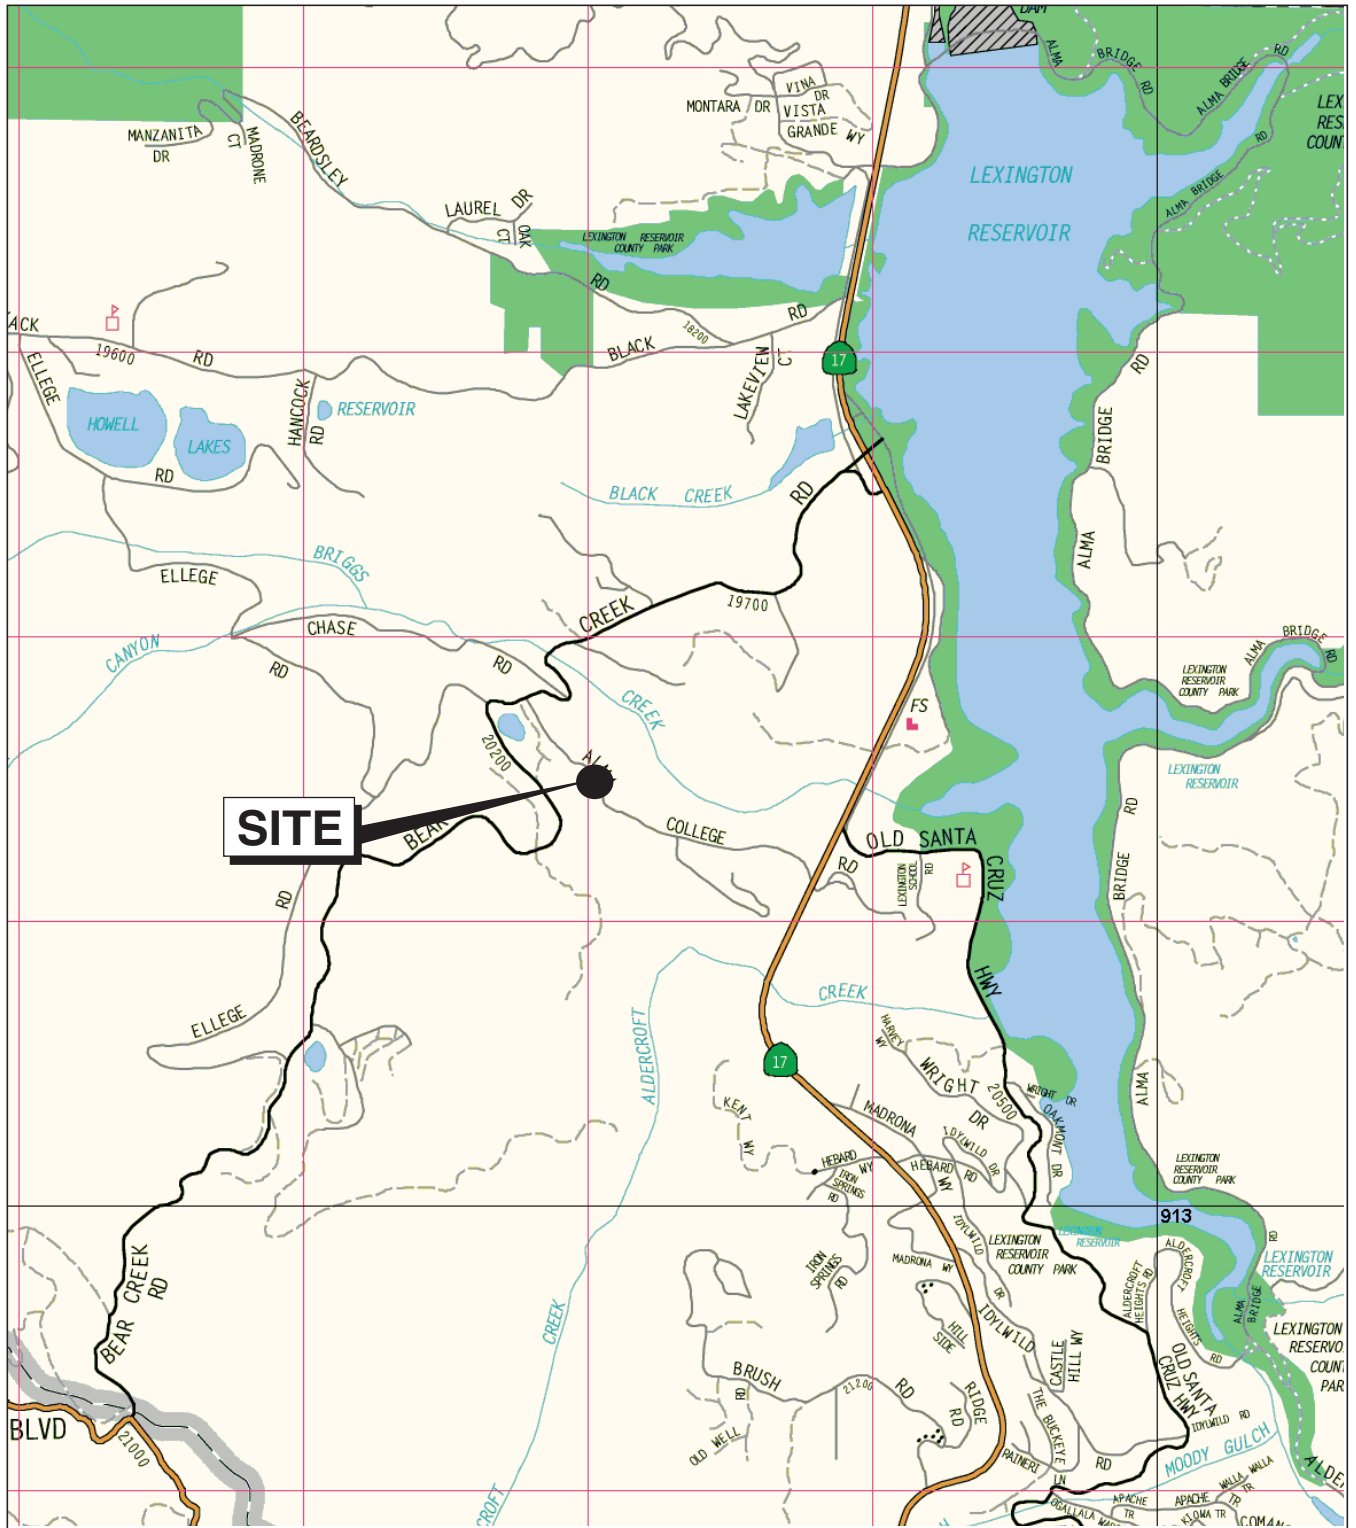
Base map: The Thomas Guide  
 Santa Clara County  
 1999

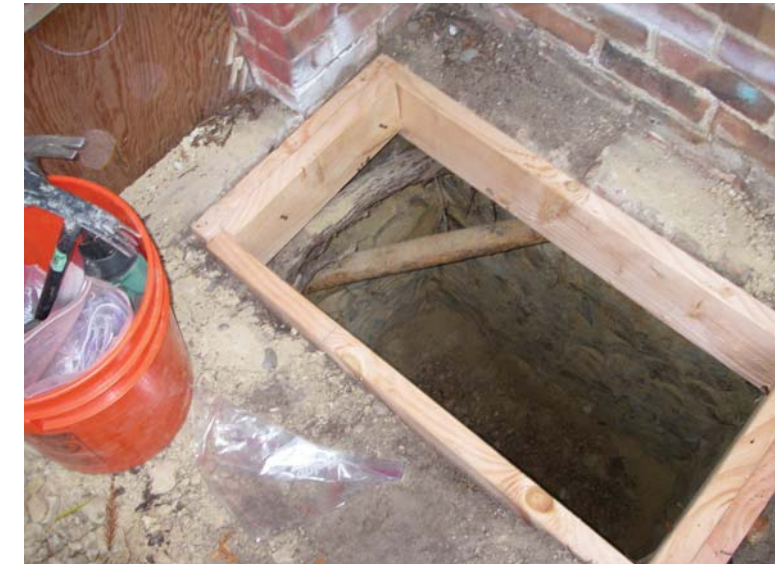
- ① SANDSTONE  
yellowish brown (10YR 5/6) and  
grayish brown (10YR 5/2),  
homogeneous, dense, friable,  
well-sorted, fine- to very fine-  
grained, subrounded, slightly  
moist  
[BEDROCK]

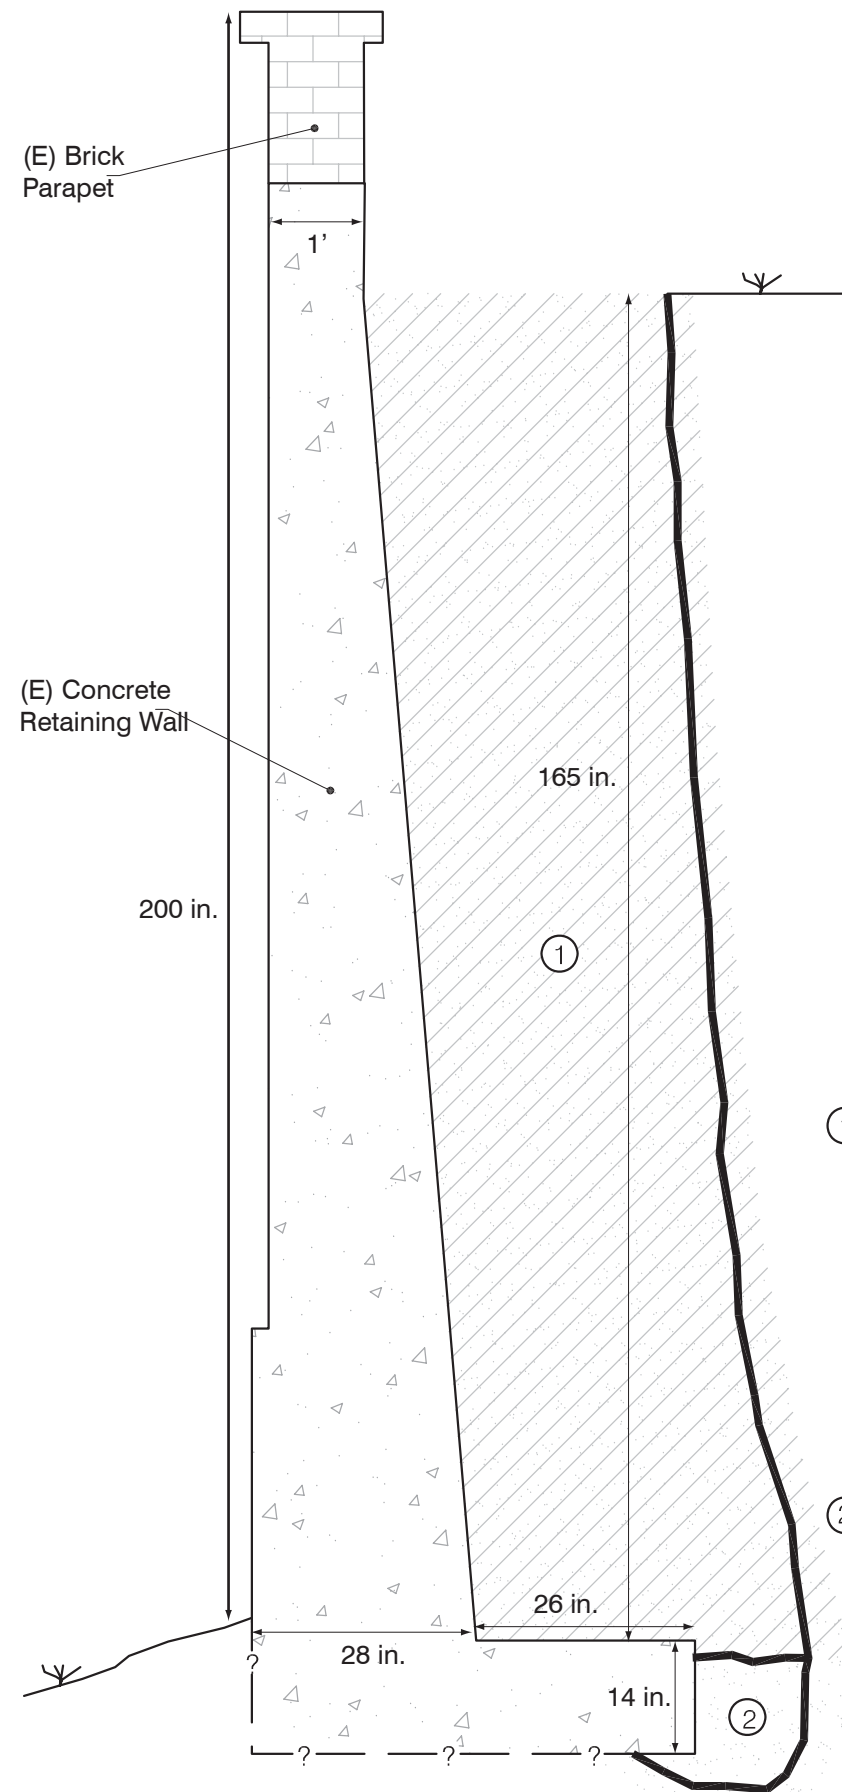
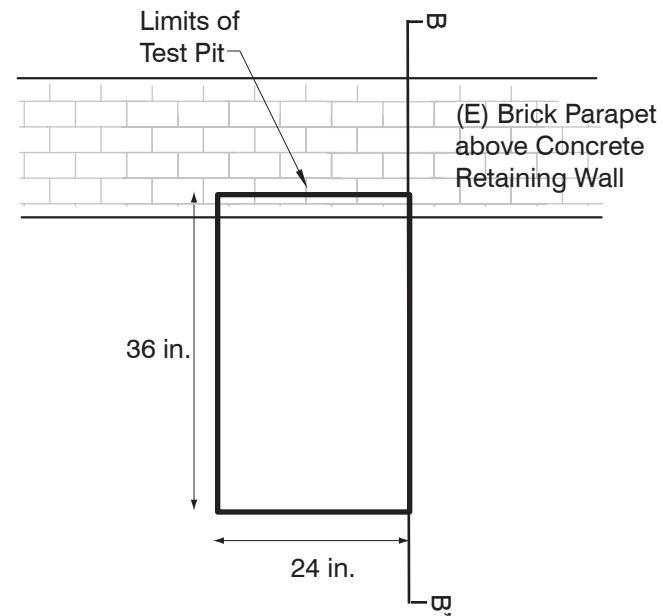
- ① SANDY CLAY (CL)  
brown (10YR 4/3) to dark brown (10YR 3/3), stiff, slightly moist, low to moderately plastic, heterogeneous with brick, concrete, and glass fragments scattered throughout, 10-20% fine- to medium-grained sand and 5-10% gravel [RETAINING WALL BACKFILL]
- ② SANDSTONE  
yellowish brown (10YR 5/6) and grayish brown (10YR 5/2), homogeneous, dense, friable, well-sorted, fine- to very fine-grained, subrounded, slightly moist [BEDROCK]

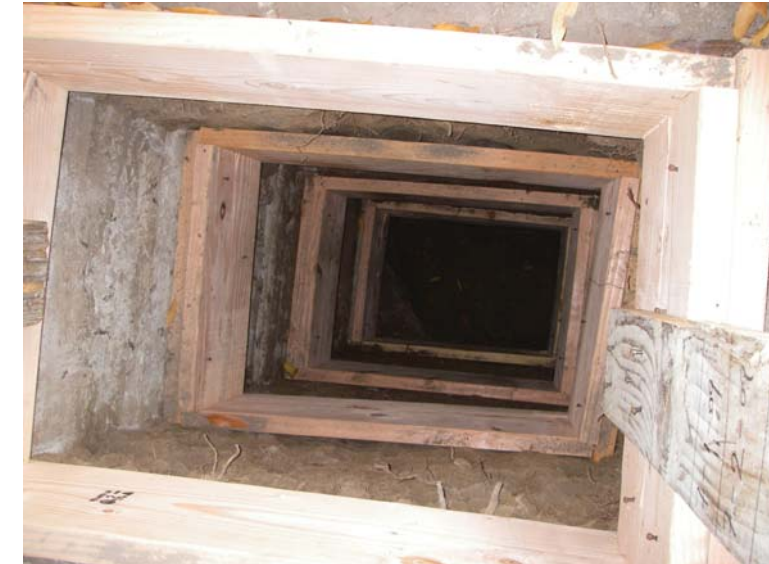
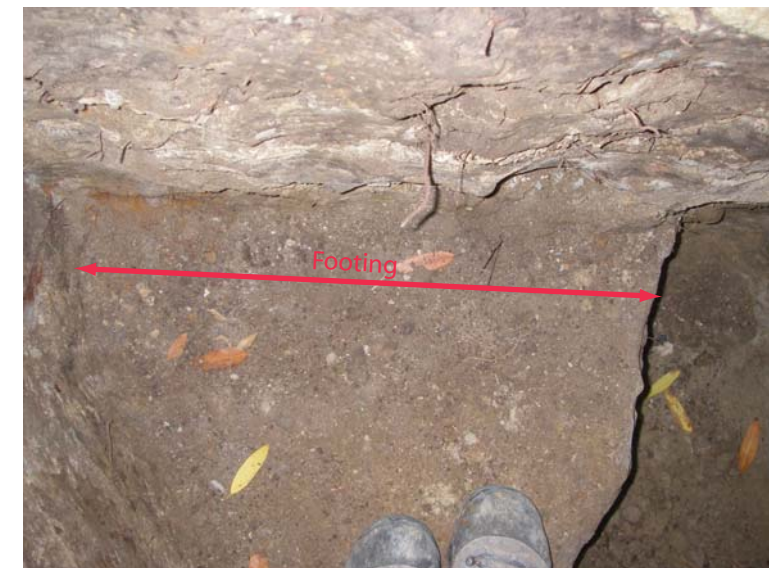
**ALMA COLLEGE CONDITIONS ASSESSMENT**  
Santa Clara County, California

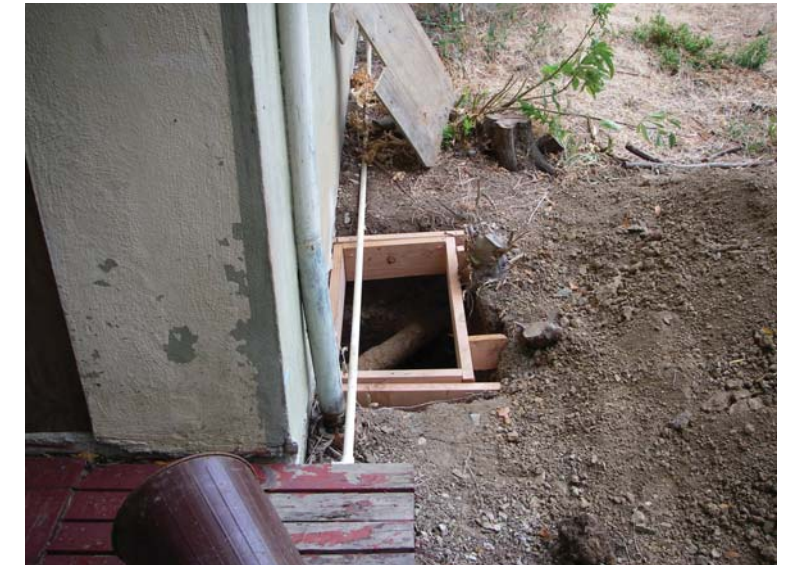
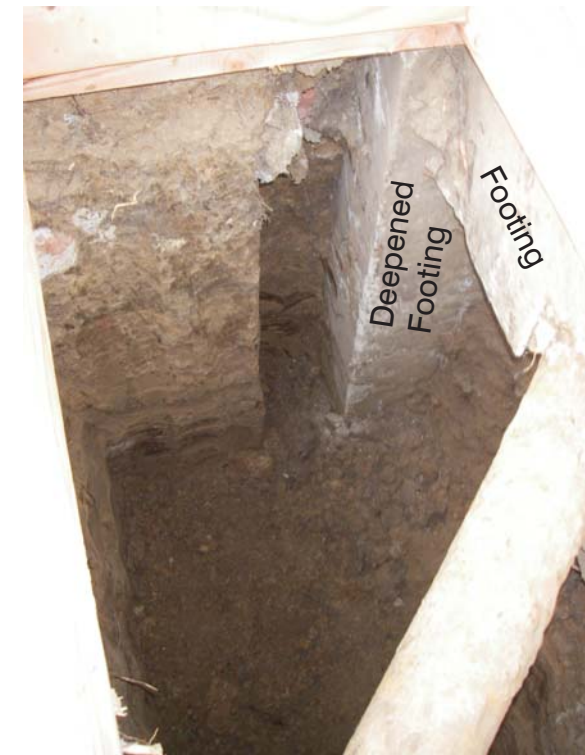
- ① SILTY SAND (SM) to CLAYEY SAND (SC) very dark grayish brown (10YR 3/2) with variegated colored sand and rock fragments, medium dense, poorly sorted, very fine- to coarse-grained, scattered brick and concrete fragments, moist, low plasticity, abundant roots and rootlets  
[FILL]

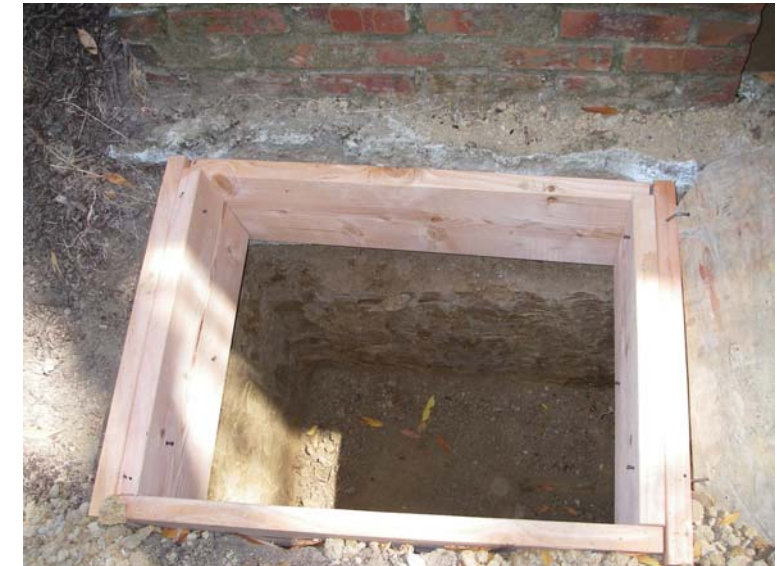
- ① SANDY SILT (ML)  
dark grayish brown (10YR 4/2),  
stiff, homogeneous, dry, poorly  
sorted, fine- to coarse grained,  
dry, abundant roots and organics  
[TOPSOIL]
- ② SANDSTONE  
yellowish brown (10YR 5/6) to  
grayish brown (10YR 5/2),  
very dense, homogeneous, well-  
sorted, very fine- to fine-grained,  
subrounded to subangular,  
slightly moist  
[BEDROCK]

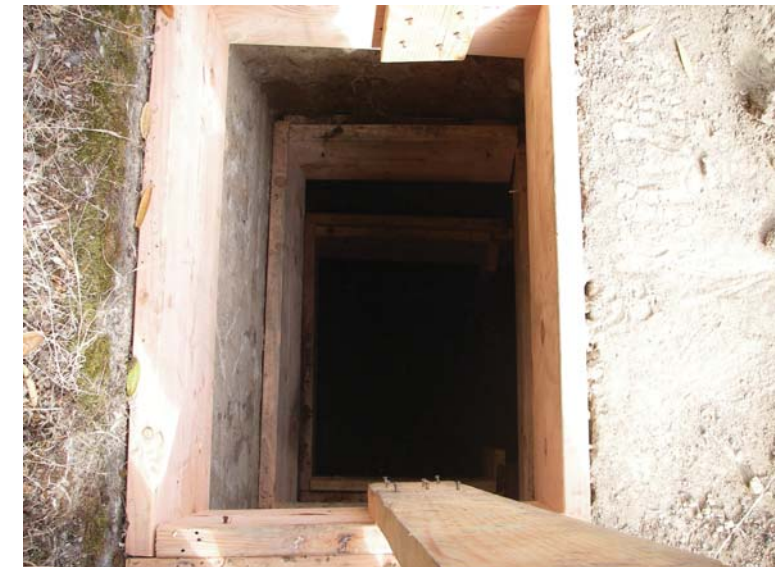
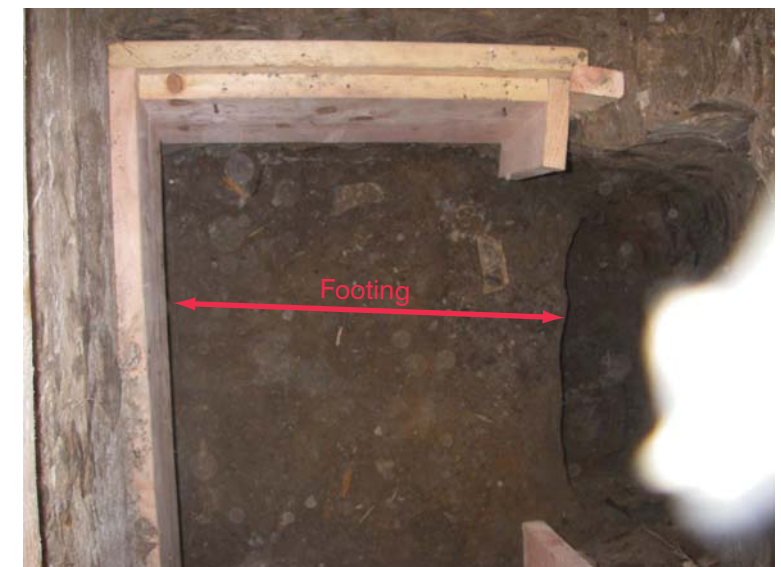
- ① SANDY CLAY (CL)  
brown (10YR 4/3) to dark brown (10YR 3/3), stiff, slightly moist, low to moderately plastic, heterogeneous with brick, concrete, and glass fragments scattered throughout, 10-20% fine- to medium-grained sand and 5-10% gravel [RETAINING WALL BACKFILL]
- ② SANDSTONE  
yellowish brown (10YR 5/6) and grayish brown (10YR 5/2), homogeneous, dense, friable, well-sorted, fine- to very fine-grained, subrounded, slightly moist [BEDROCK]

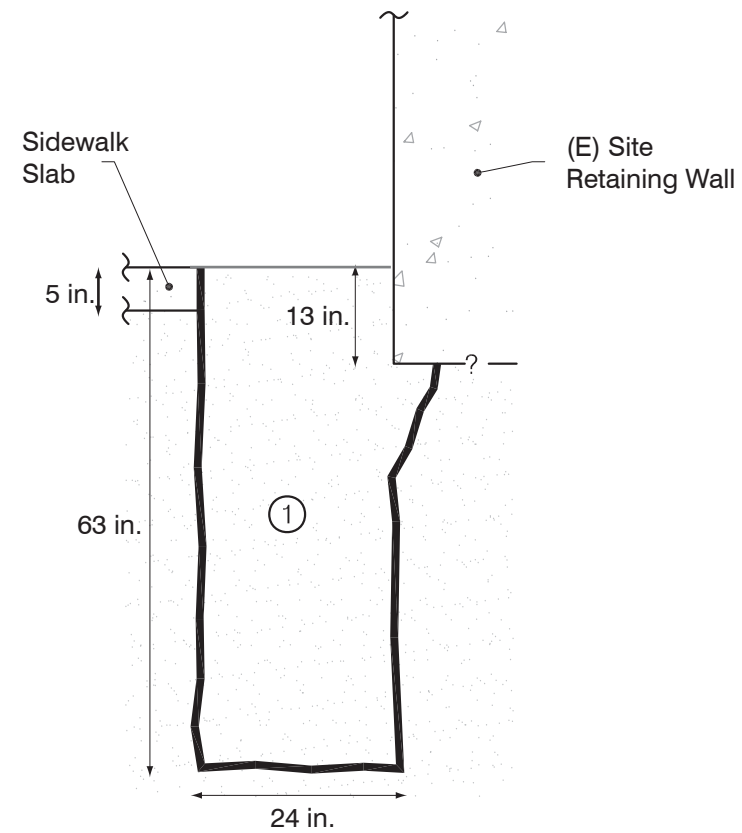
- ① SANDSTONE  
yellowish brown (10YR 5/6) and  
grayish brown (10YR 5/2),  
homogeneous, dense, friable,  
well-sorted, fine- to very fine-  
grained, subrounded, slightly  
moist  
[BEDROCK]

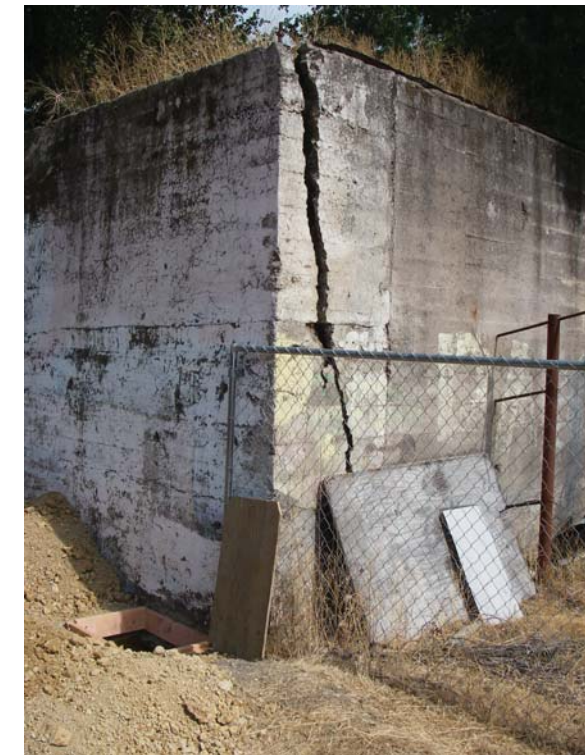
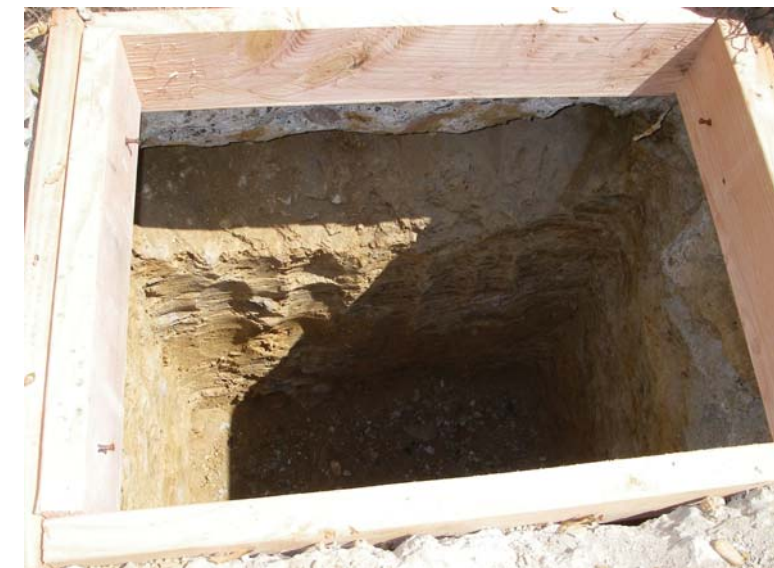
**ALMA COLLEGE CONDITIONS ASSESSMENT**  
Santa Clara County, California

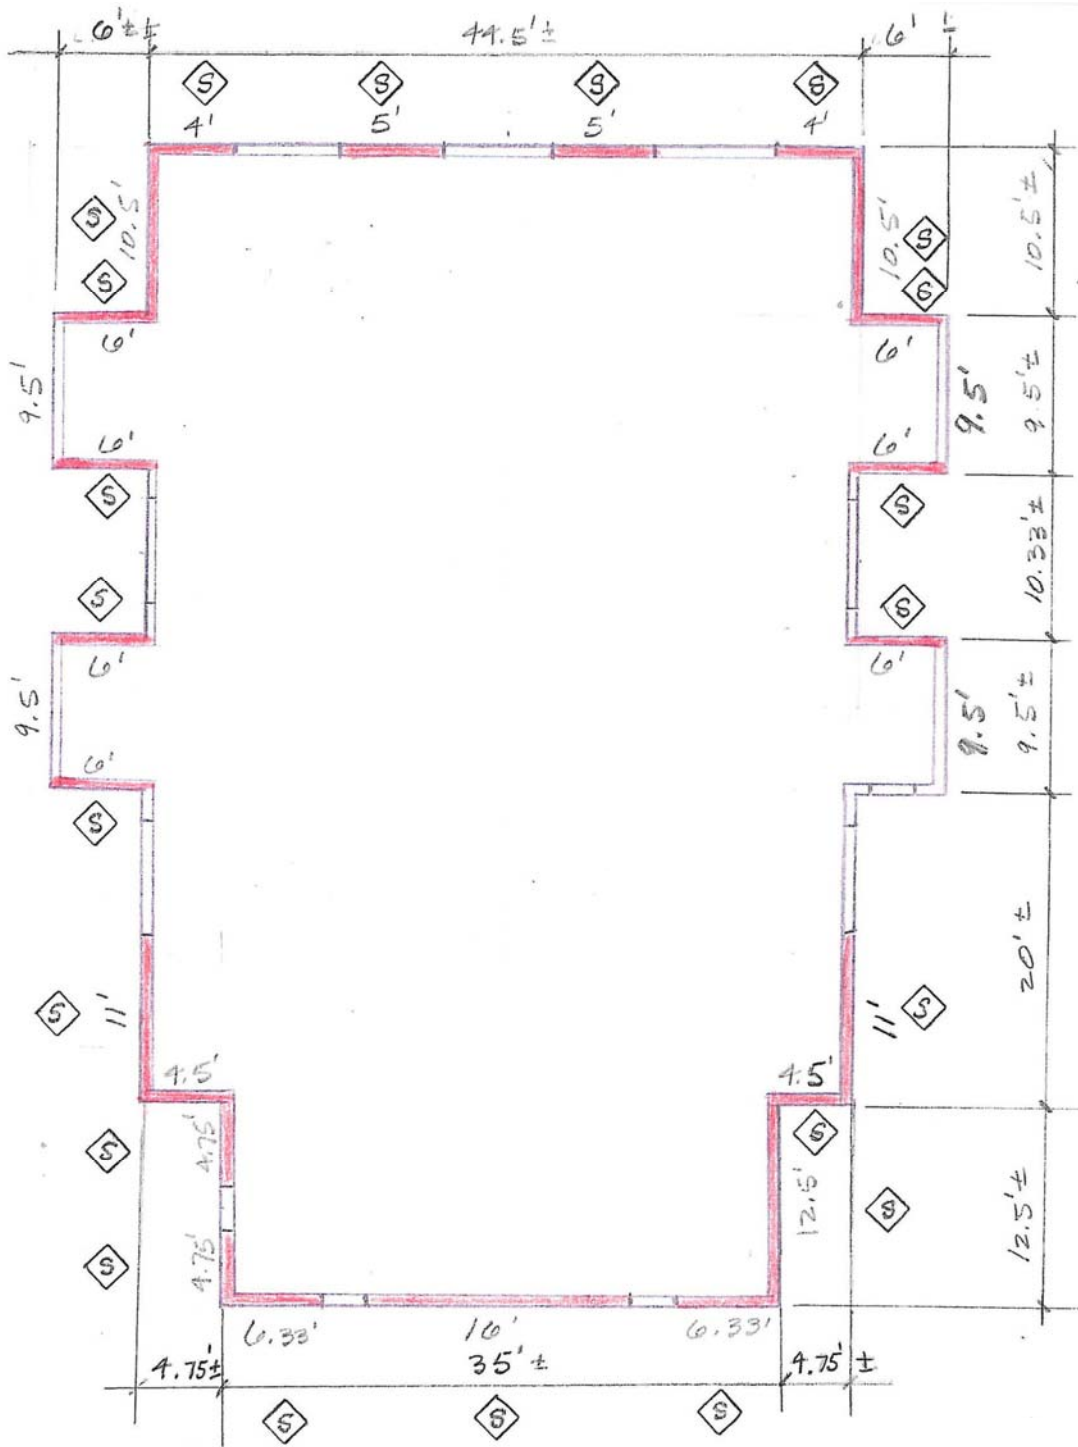
Legend for Shear Strengthening

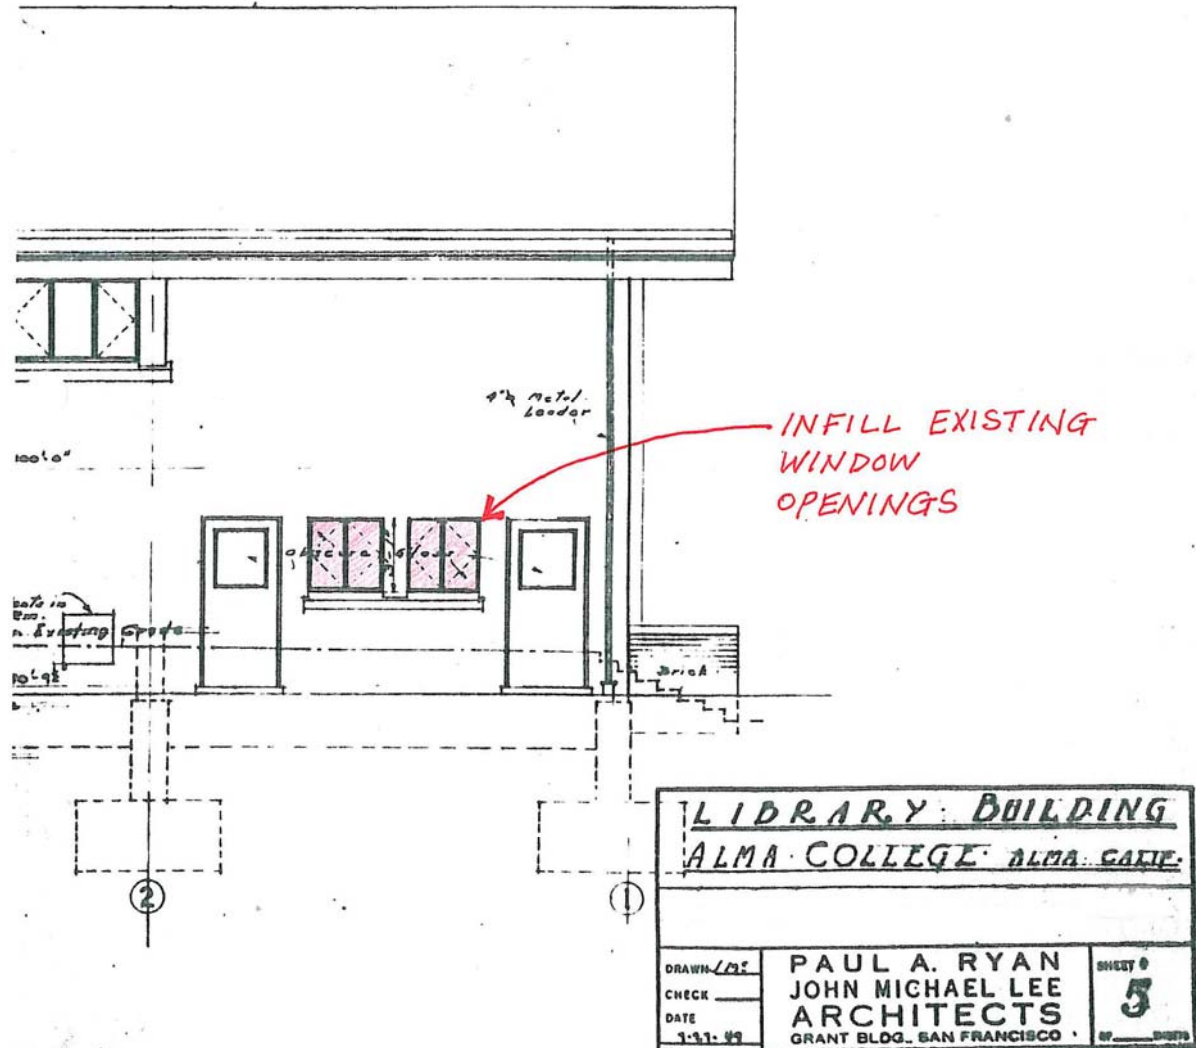
### 1950 Library Structure

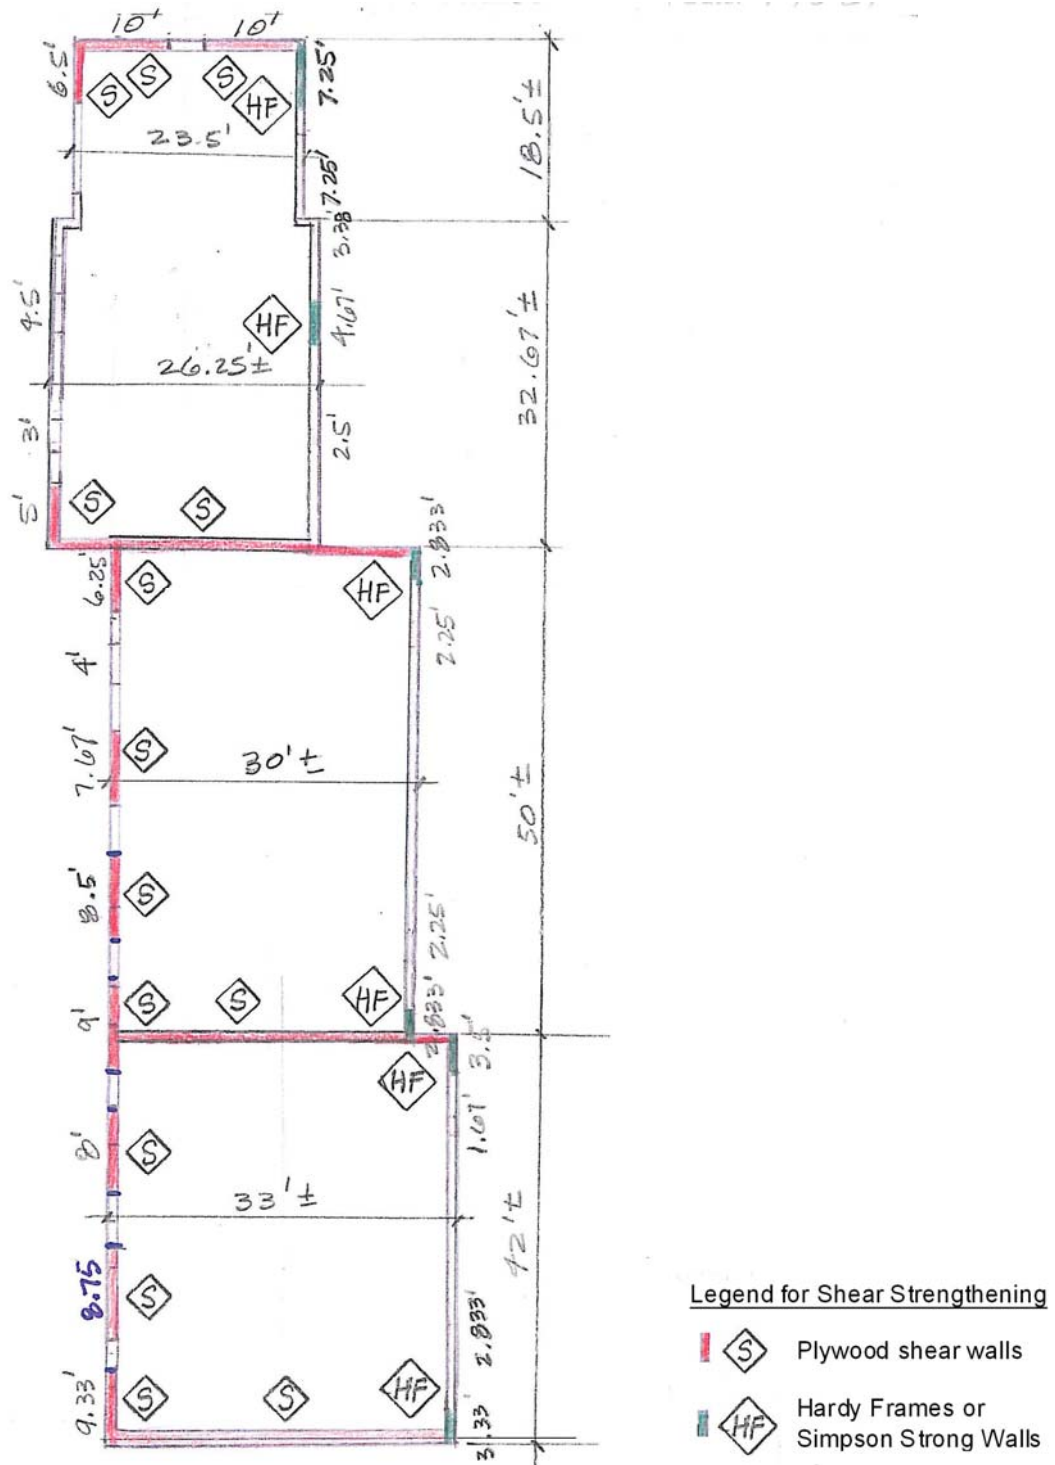
North wall window infill proposed for shear wall strengthening.

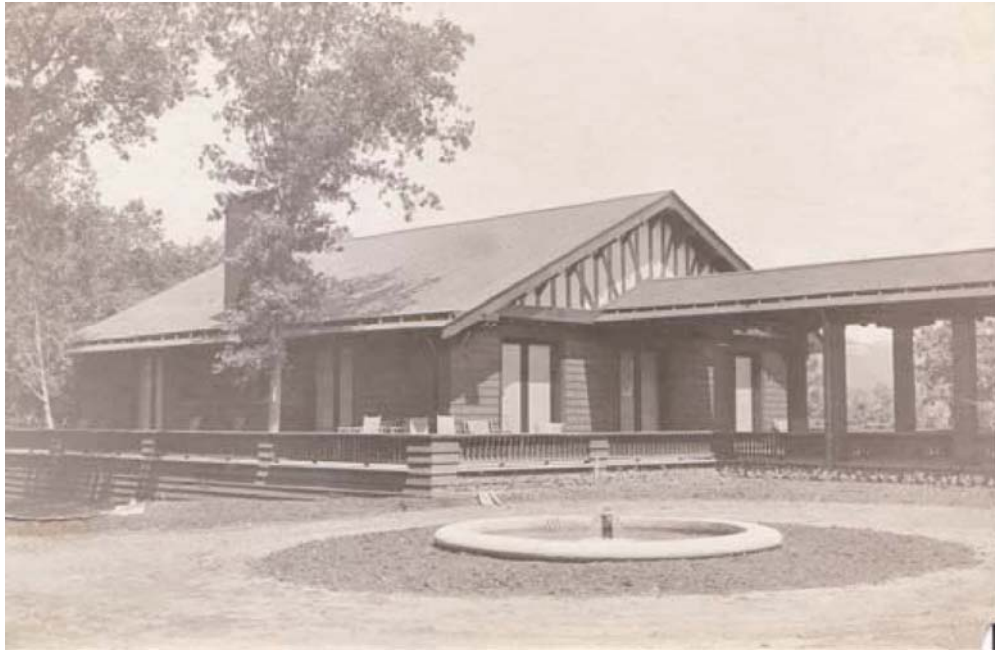
Image 1. Tevis Library, historic exterior view of south and east façades with a wrapping veranda with railing and the original walkway to the Tevis House to the east (not shown). (California Jesuit Archives, Santa Clara. Alma College File.)

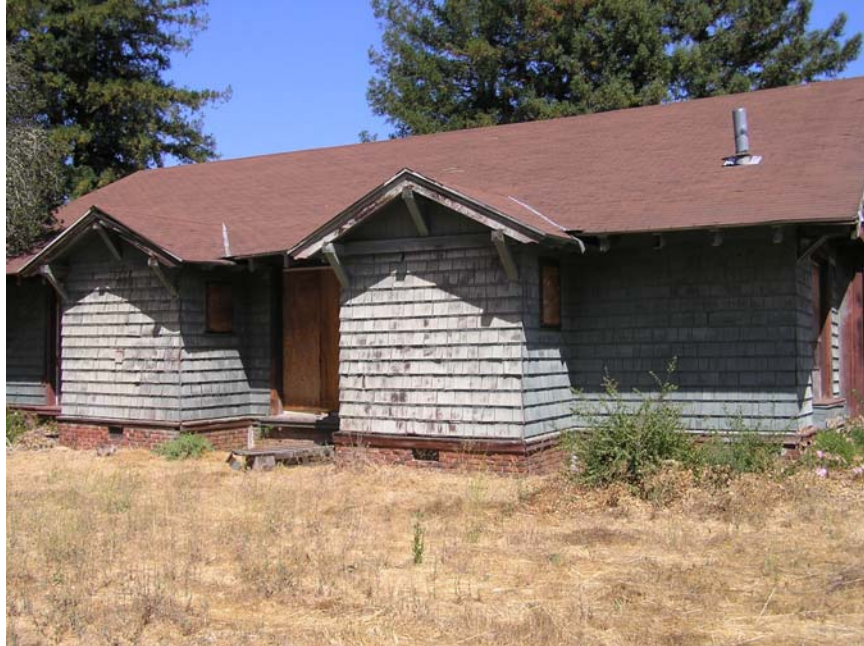
Image 5. Alma College Chapel, existing exterior view of the south facade. As the most exposed side of the building, the wood deterioration is more severe than other sides. (Knapp Architects, digital photograph, 2009)

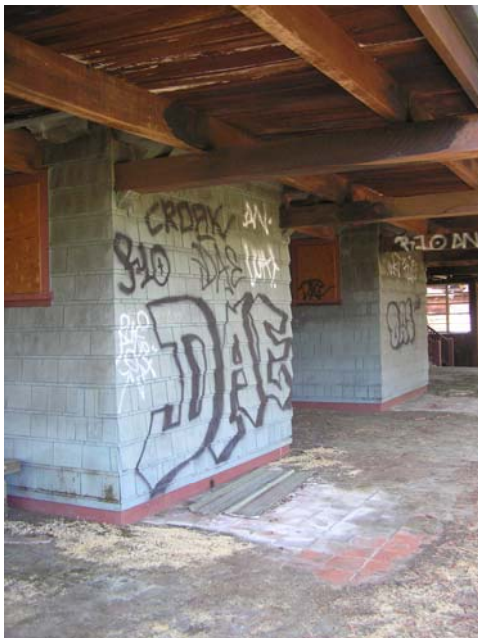
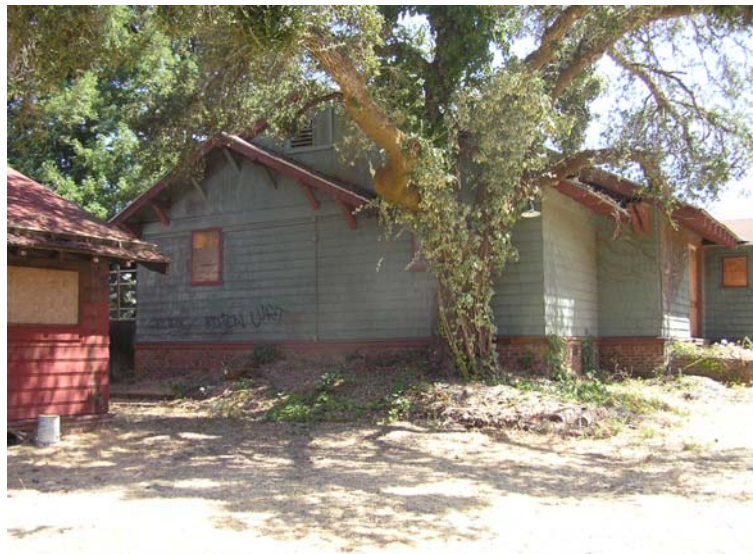
Image 6 & 7. Alma College Chapel, existing exterior view of the north façade (left) and west façade (right). The building has sustained paint vandalism at various locations. The clay tile at the north veranda is worn and has some vegetation growth. The north covered walkway obscures the upper façade and roofline. (Knapp Architects, digital photograph, 2009)

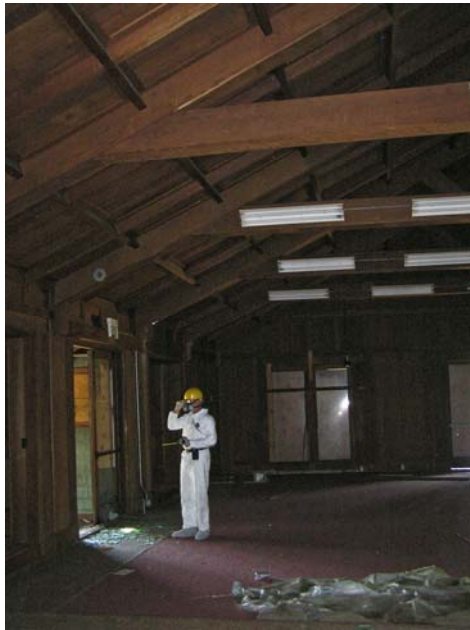
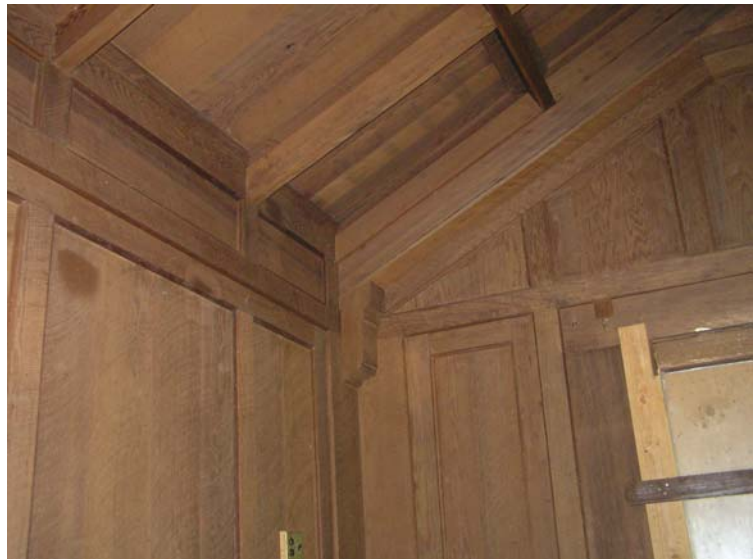
Image 8 & 9. Alma College Chapel, existing interior view to the west (left) and detail of corner with wood paneling (right). An indigenous bat population lives within the building. Carpeting has protected the floor from bat guano collection. The wood wall paneling is intact and appears to be in good condition. (Knapp Architects, digital photograph, 2009)

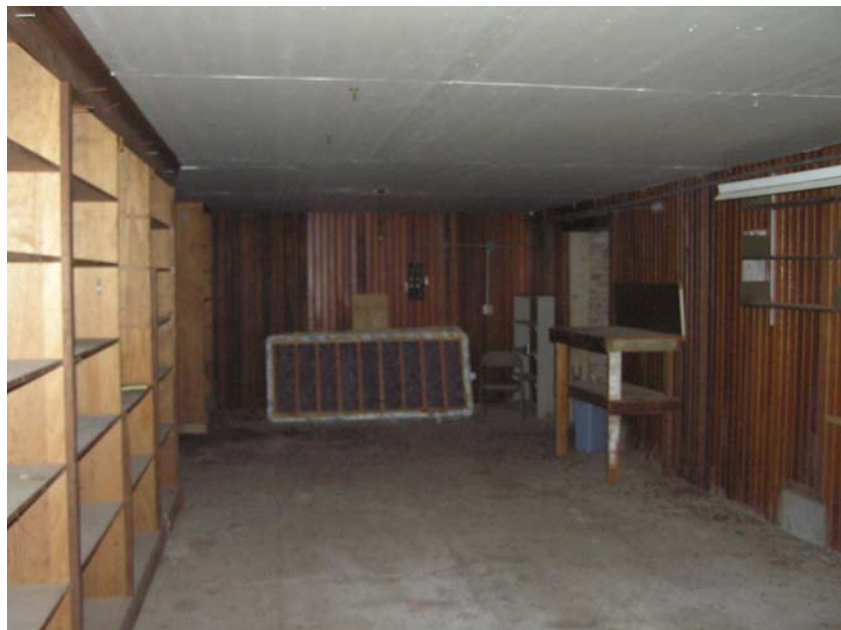
Image 10. Alma College Chapel, existing interior view of a basement space. The basement has limited wood paneling but does not appear to be historically significant. (Knapp Architects, digital photograph, 2009)

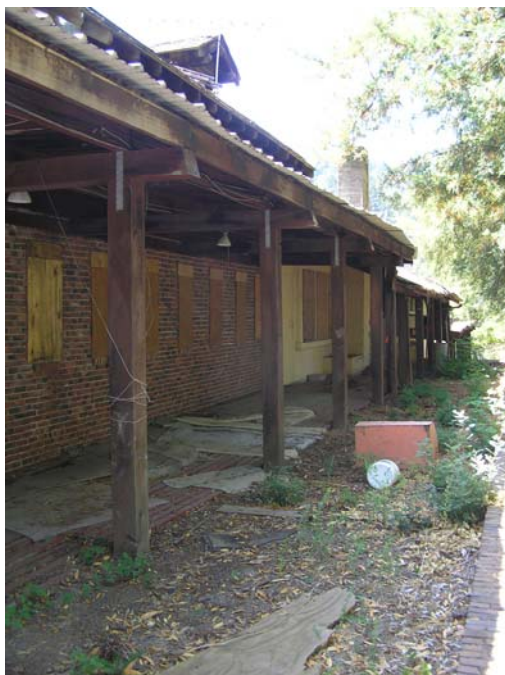
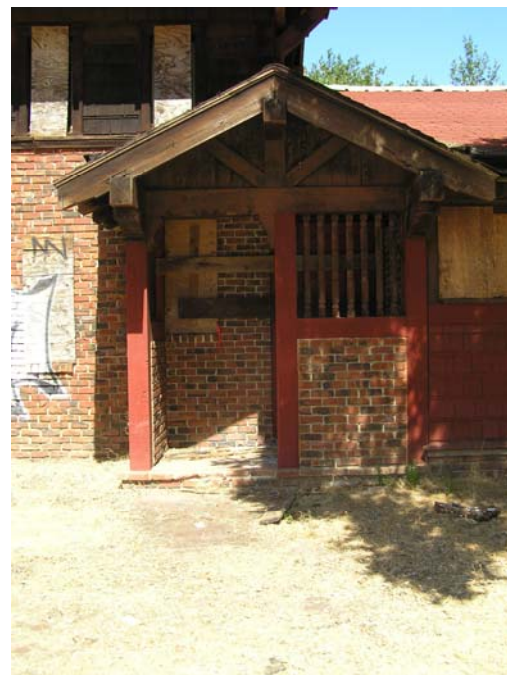
Image 14 & 15. Alma College 1934 Library, existing view of the north façade (left) and south porch (right). The wood floor at north walkway is uneven and damaged and the walkway roof obscures part the lower façade. The entry porch is intact with minor damage at the brick step. (Knapp Architects, digital photograph, 2009)

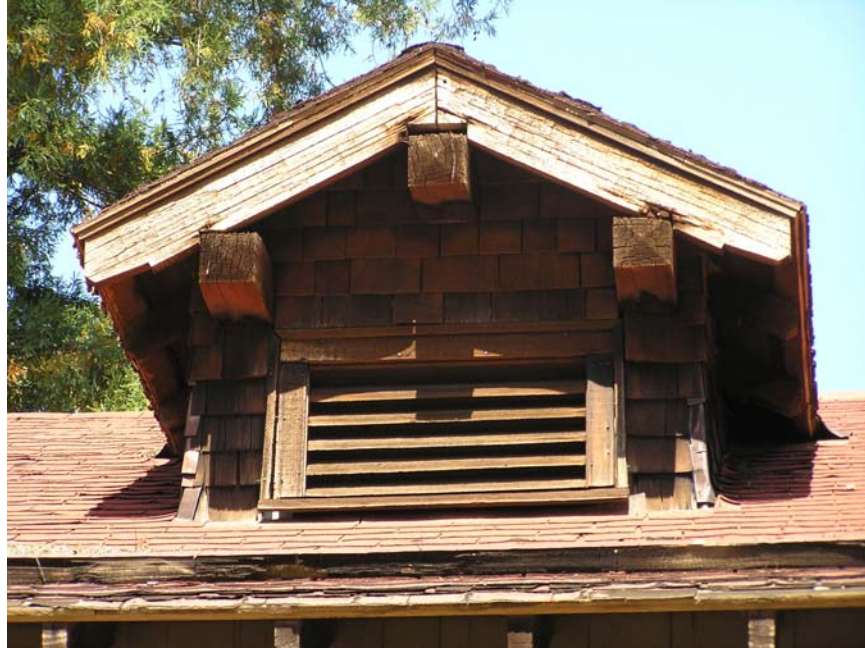
Image 16. Alma College 1934 Library, existing view of south-facing roof dormer. (Knapp Architects, digital photograph, 2009)

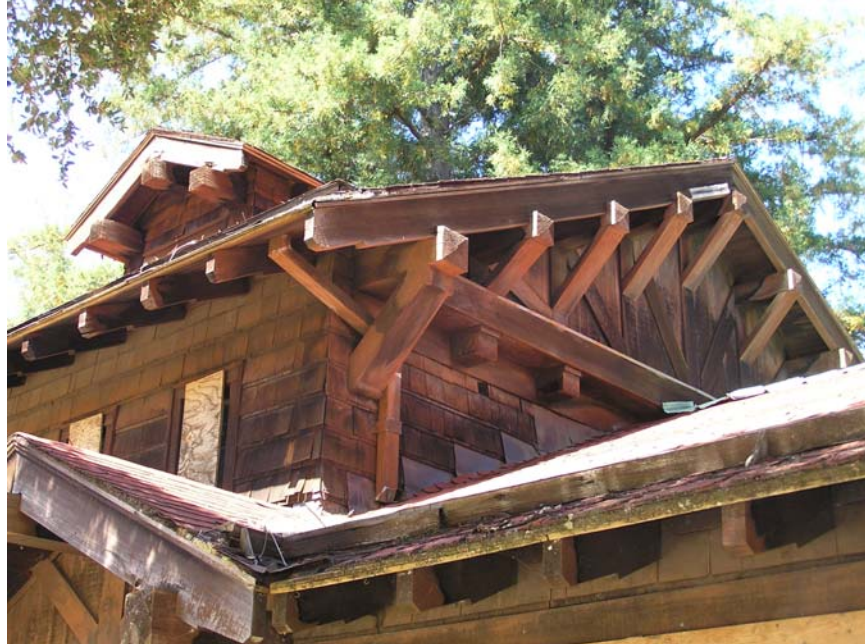
Image 17. Alma College 1934 Library, existing lower east roof, upper roof and roof dormer viewed from the southeast. The woodwork, roof material and sheathing are deteriorated. (Knapp Architects, digital photograph, 2009)

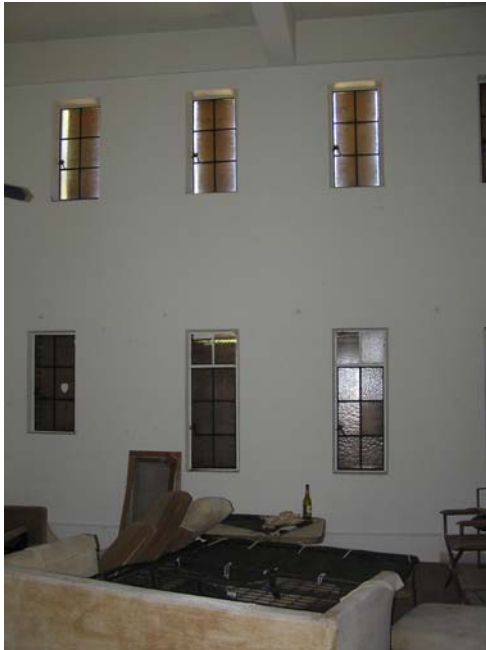
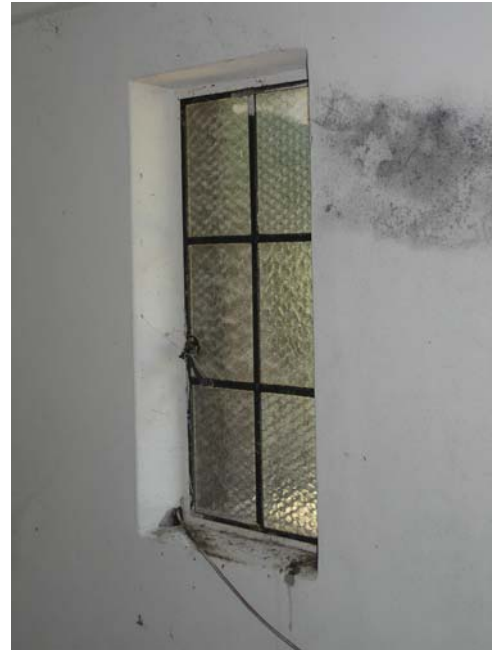
Image 18 & 19. Alma College 1934 Library, existing interior view of north wall (left) and detail of window (right). The character of the space and its industrial steel sash windows is intact. (Knapp Architects, digital photograph, 2009)

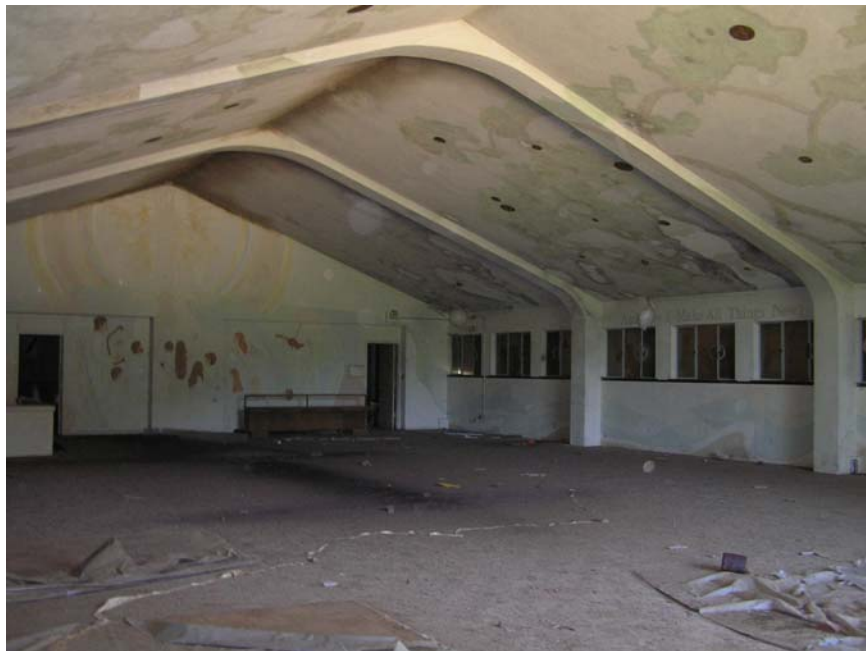
Image 25. Alma College 1949 Library addition, existing interior view looking east. Murals at the ceiling and walls are visible. A band of windows is seen at the right. Brown staining at the peak of the vault implies water infiltration. (Knapp Architects, digital photograph, 2009)

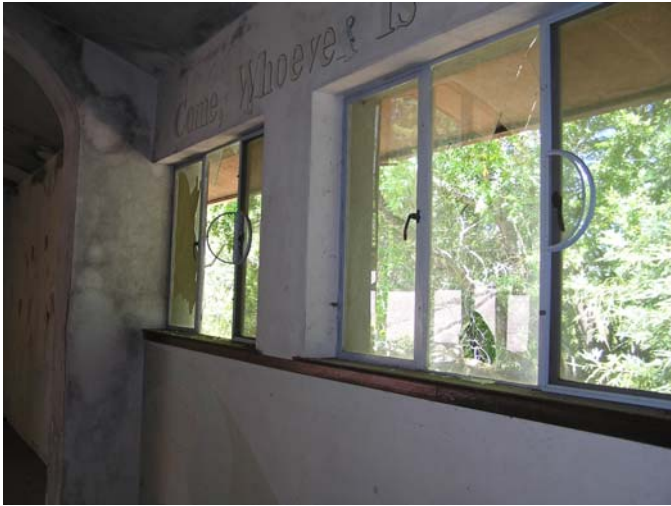
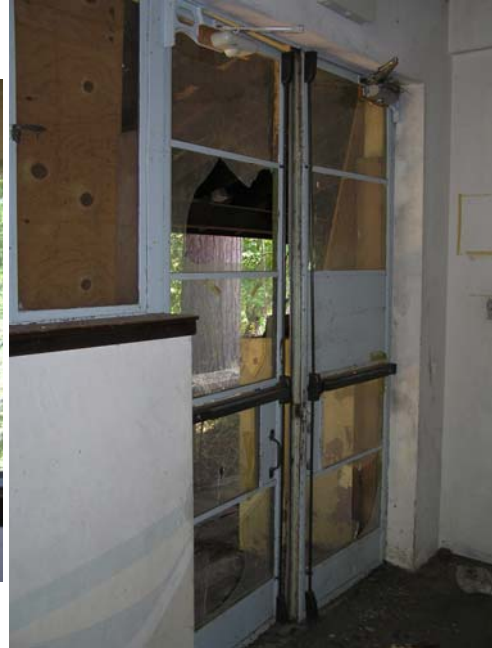
Image 26 & 27. Alma College 1949 Library, existing north windows (left) and doorway (right). Window screens and glazing are damaged. The glazed door operability requires repair. (Knapp Architects, digital photograph, 2009)

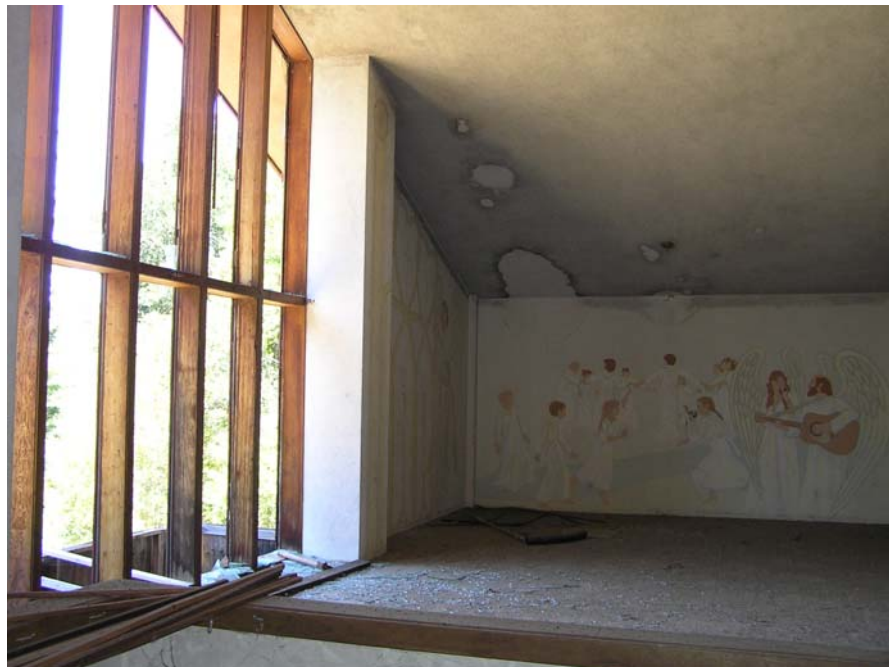
Image 28. Alma College 1949 Library, existing interior view of full-height west window and mural at north wall. The west window framing is substantially intact but the glazing is broken. (Knapp Architects, digital photograph, 2009)

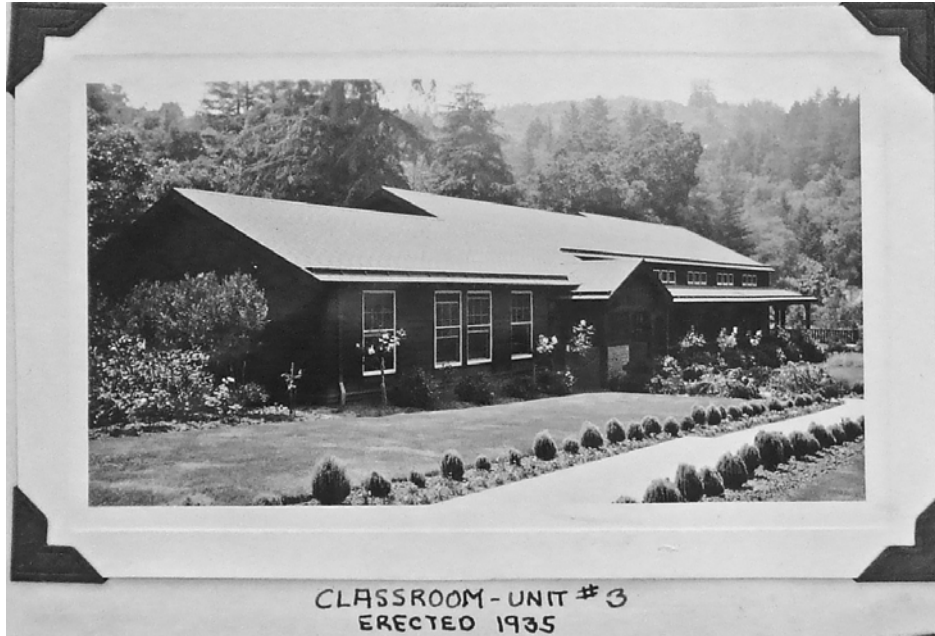
Image 29. Alma College Classroom Building, historic view of north façade from the northeast. (California Jesuit Archives, Santa Clara. Alma College File.)
