**ALMA COLLEGE CONDITIONS ASSESSMENT PROJECT**  
Midpeninsula Regional Open Space District  
Santa Clara County, CA

Phase I: Assessment of Existing Conditions

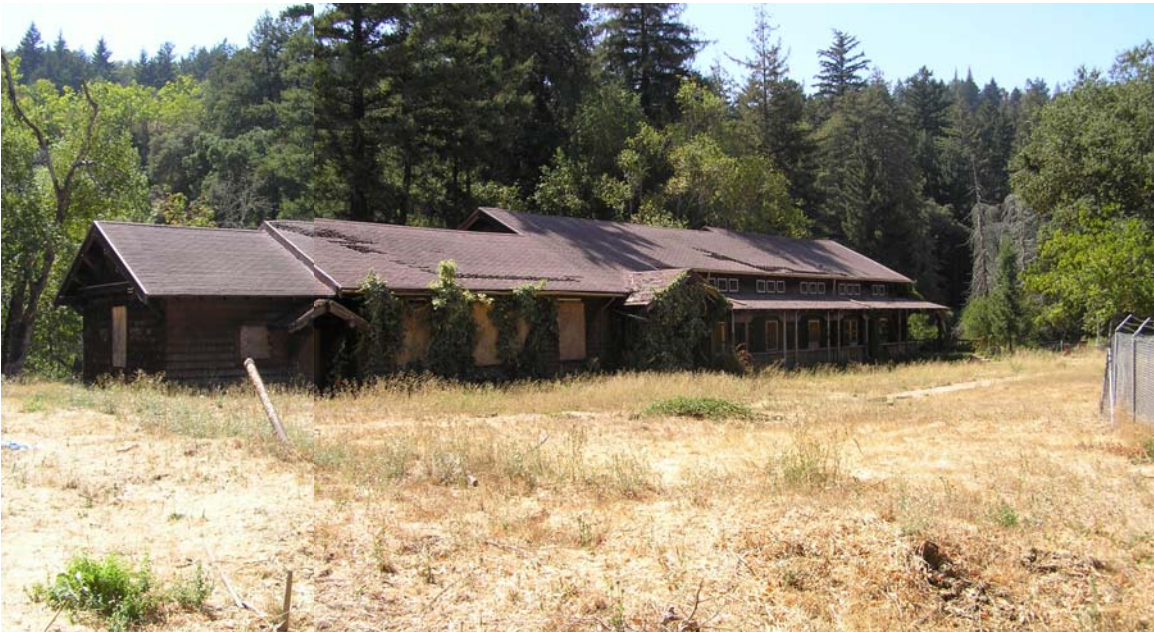
Image 31. Alma College Classroom Building, existing exterior view of north façade. The dark lines at the roof are displacement cracks where the roof form is warped ((Knapp Architects, digital photograph, 2009)

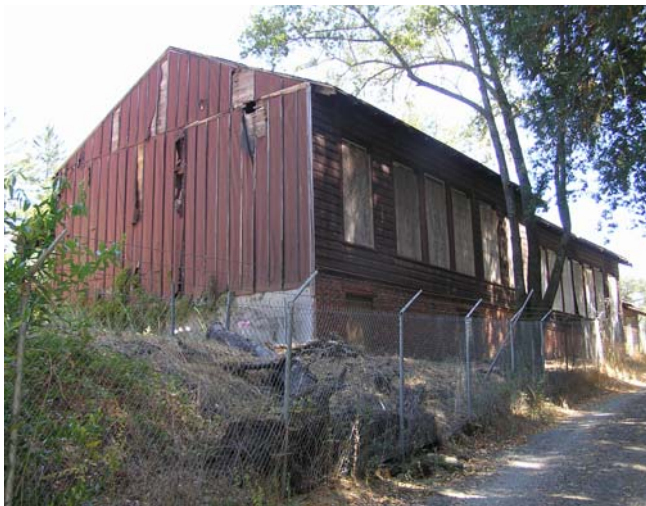
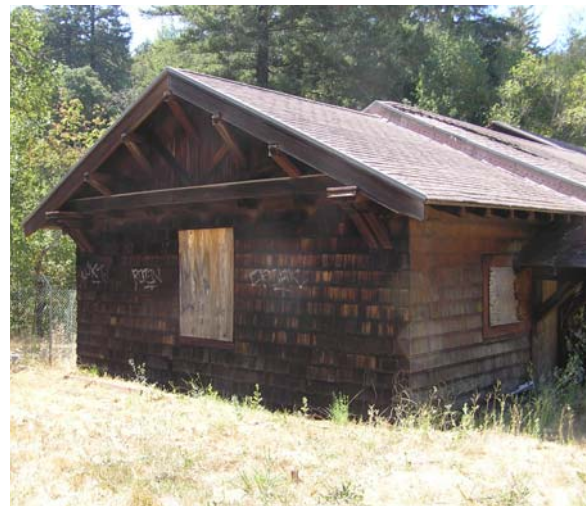
Image 32 & 33. Alma College Classroom Building, existing exterior view of the southwest corner (left) and east façade (right). The west façade finish material is missing. The east façade has incurred some paint vandalism at the shingles. (Knapp Architects, digital photograph, 2009)

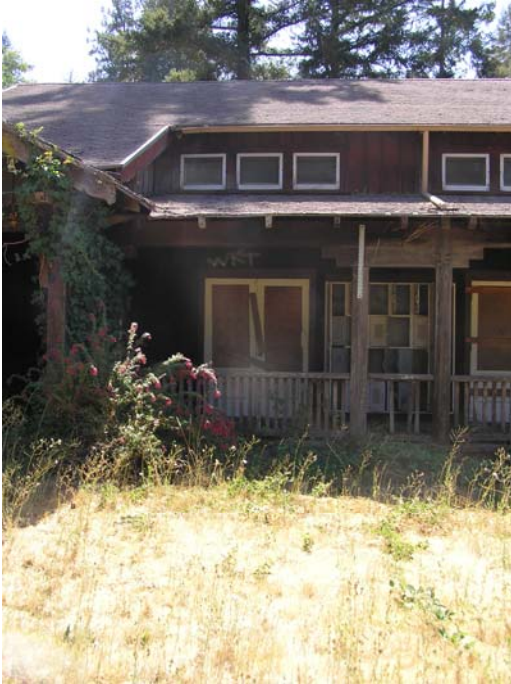
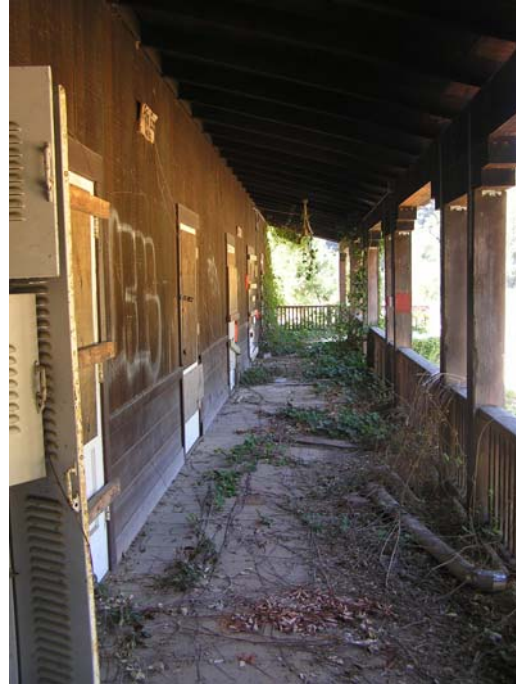
Image 34 & 35. Alma College Classroom Building, existing exterior view of typical bay at the arcade (left) and interior view along the arcade (right). Vegetation has invaded the perimeter of the building, grown onto the building and at the floor of the arcade. (Knapp Architects, digital photograph, 2009)

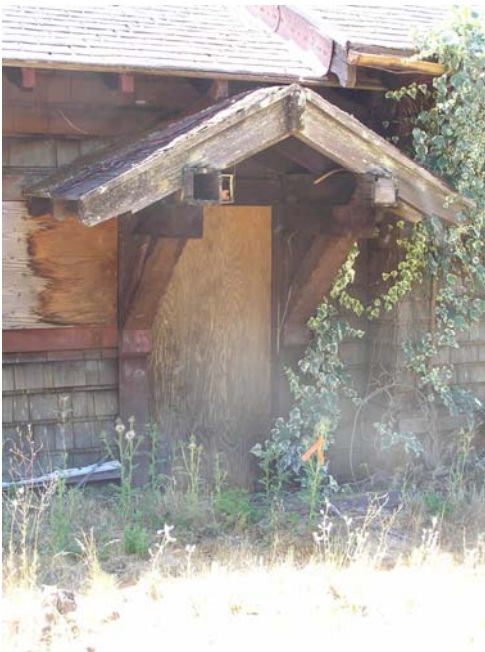
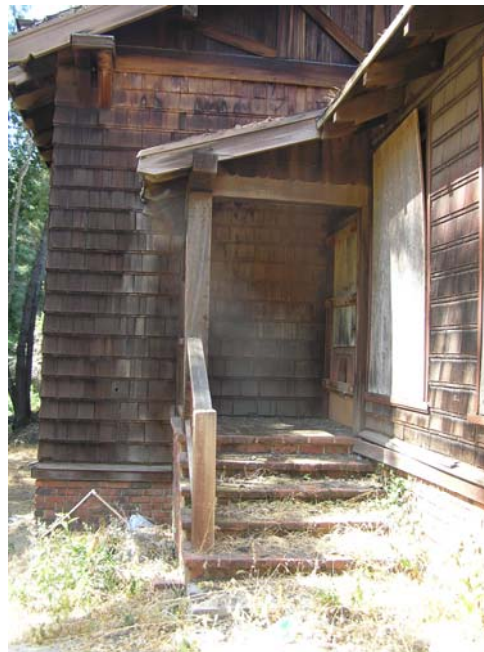
Image 36 & 37. Alma College Classroom Building, existing exterior view of secondary north entryway and south entry porch with stair. Lack of gutters has allowed water to flow from the roof down onto the walls which are water-stained. (Knapp Architects, digital photograph, 2009)

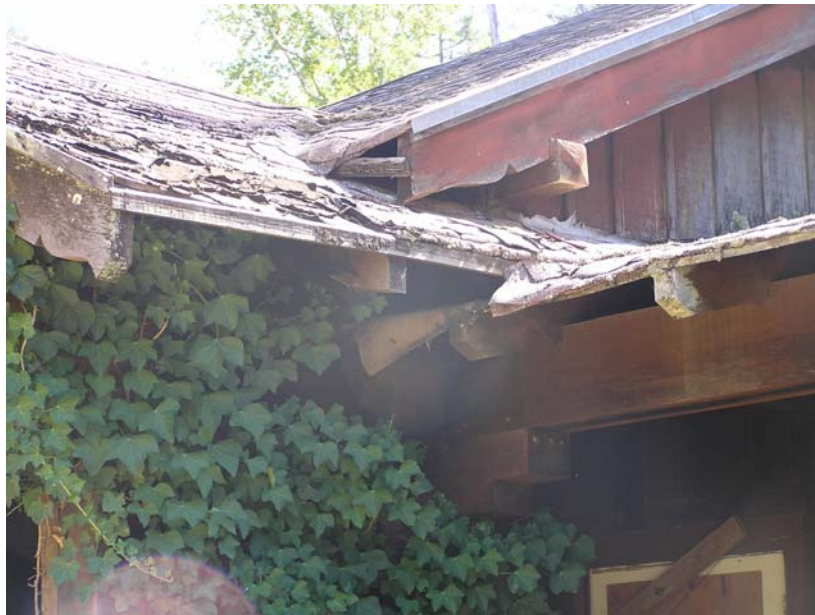
Image 38. Alma College Classroom Building, existing exterior view of roofline at main south entry porch at left. The roofing and wood sheathing are deteriorated. Vegetation growth on the building brings moisture that increases wood deterioration. (Knapp Architects, digital photograph, 2009)

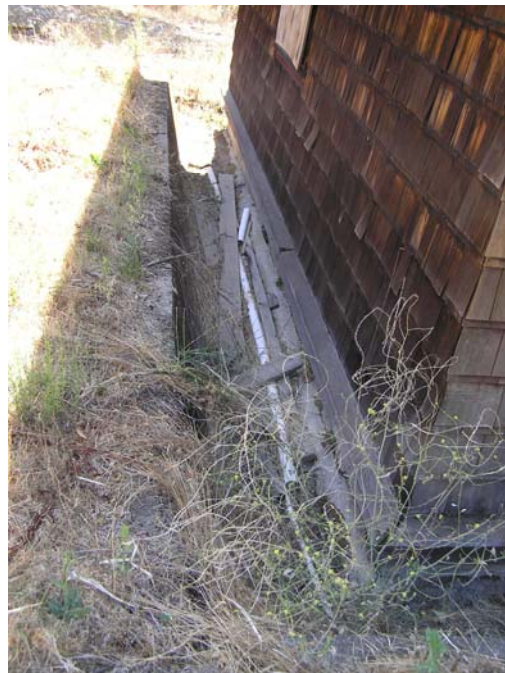
Image 39. Alma College Classroom Building, existing exterior view of retaining wall at east façade which creates a partial moat where vegetation and debris have collected. (Knapp Architects, digital photograph, 2009)

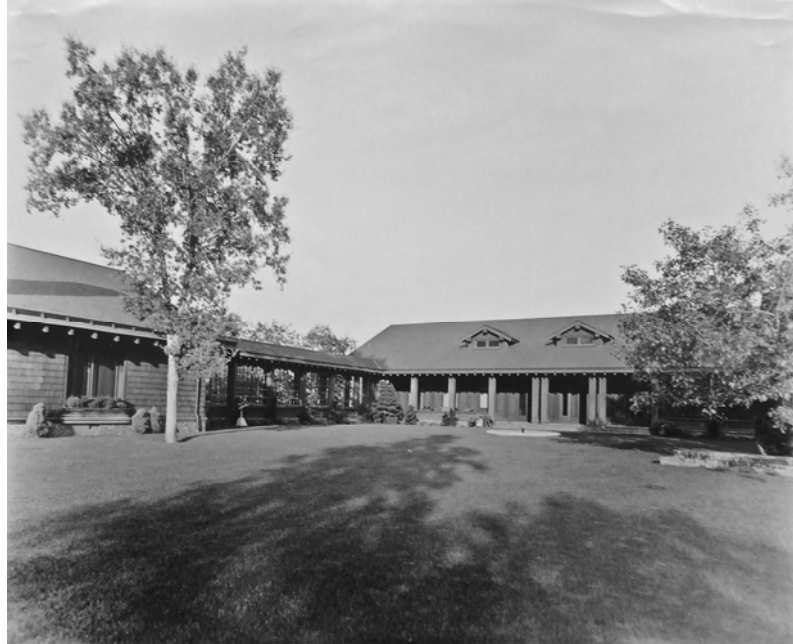
Image 43. Alma College East Walkway, historic exterior view from the southwest. The walkway connected the Chapel (left) to the Faculty Residence (right) but was damaged in the fire that destroyed the Faculty Residence in 1970. (California Jesuit Archives, Santa Clara. Alma College File.)

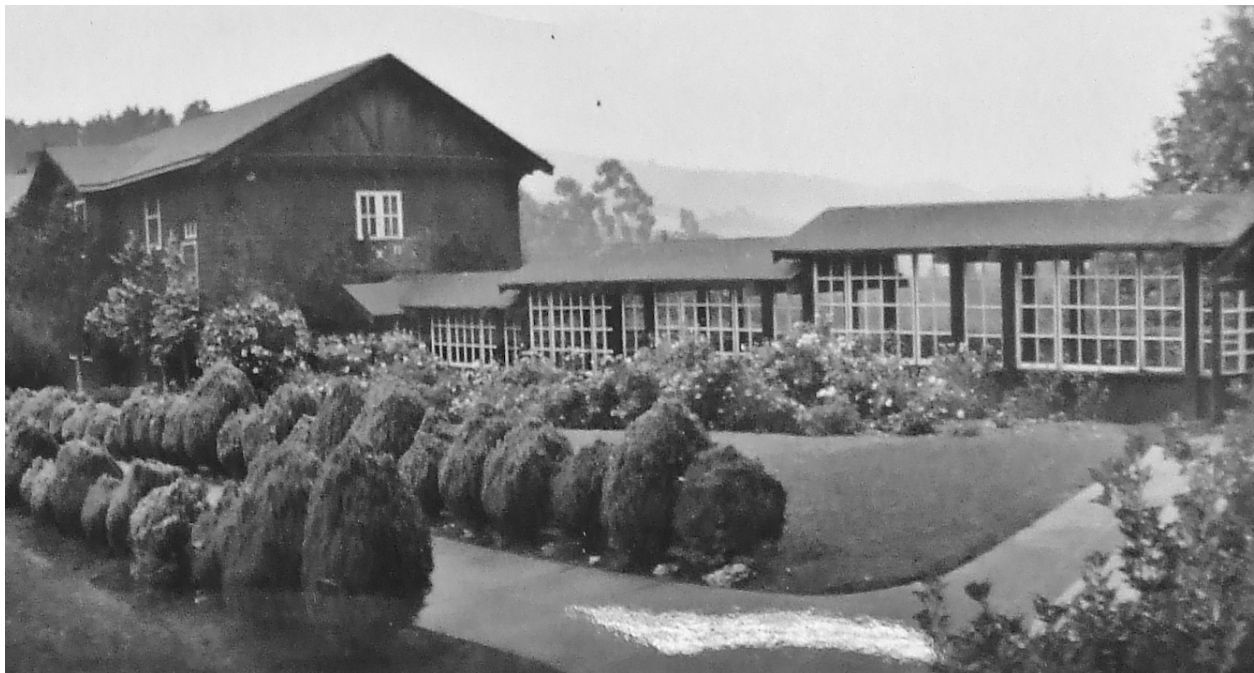
Image 44. Alma College North Walkway, historic exterior view of walkway between the Dormitories (left) and the 1934 Library (not shown to the right). (California Jesuit Archives, Santa Clara. Alma College File.)

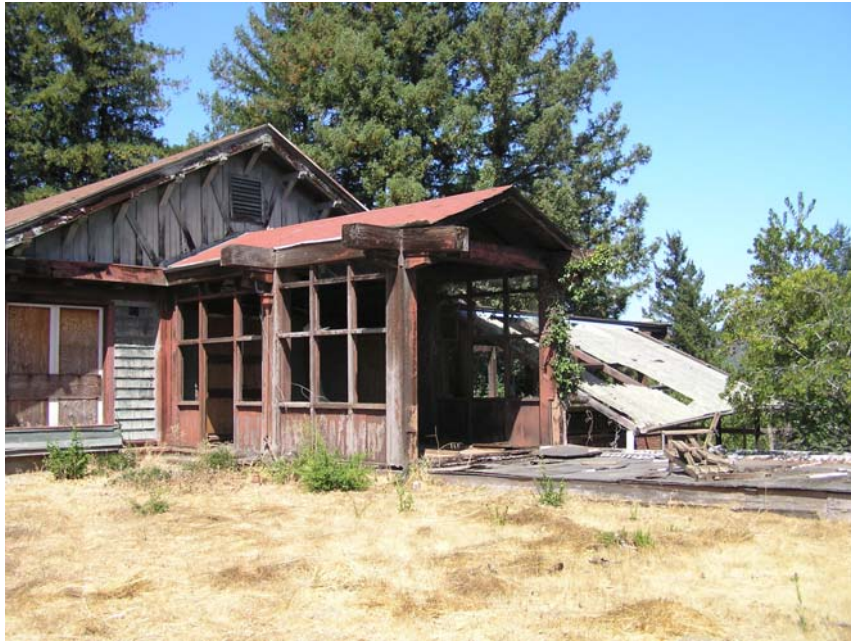
Image 45. Alma College East Walkway, existing exterior view from the southeast attached to the Chapel east façade. The wood floor is damaged and open to subflooring. (Knapp Architects, digital photograph, 2009).

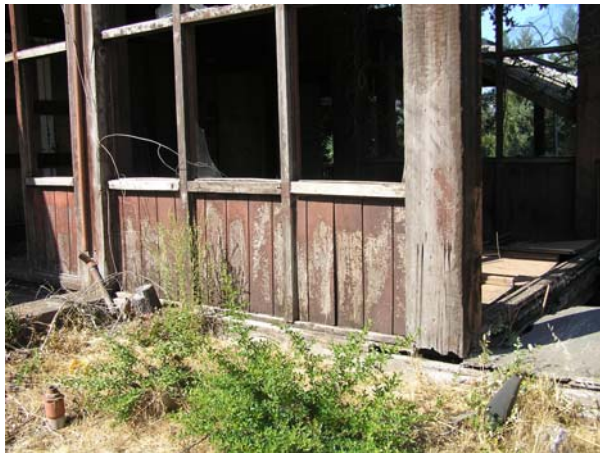
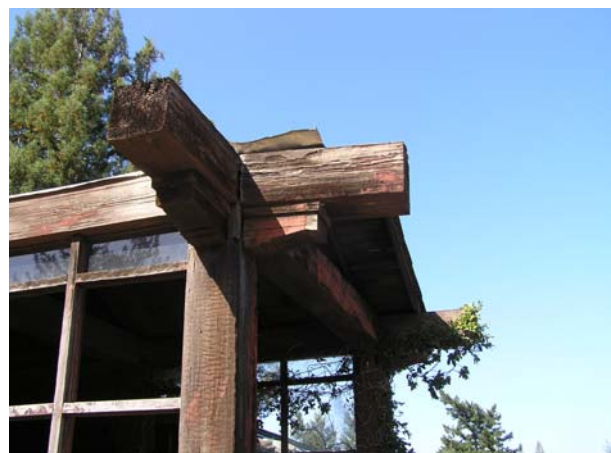
Image 46 & 47. Alma College East Walkway, existing exterior view of lower wood panels and windows (left) and upper wood beam framing. The glazing at windows is missing or broken. The wood at the east end of the remaining portion of the walkway shows evidence of fire damage. (Knapp Architects, digital photograph, 2009)

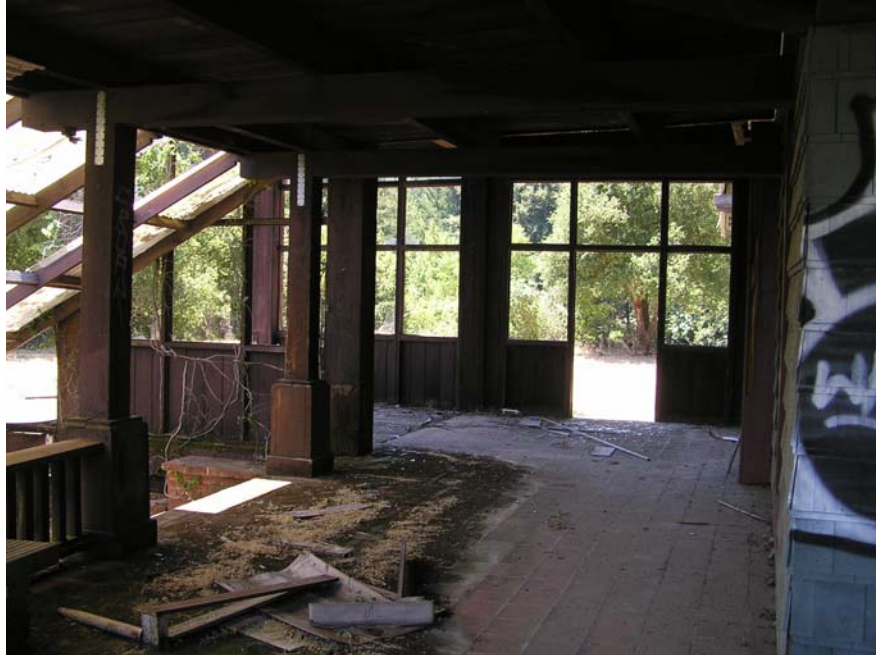
Image 48. Alma College East Walkway beyond, existing view inside the North Walkway from the northeast corner of the Chapel. At the left, a brick stair, covered by a shed roof with corrugated plastic, leads to the Chapel basement entry . Vegetation growth is seen at the veranda clay tile. (Knapp Architects, digital

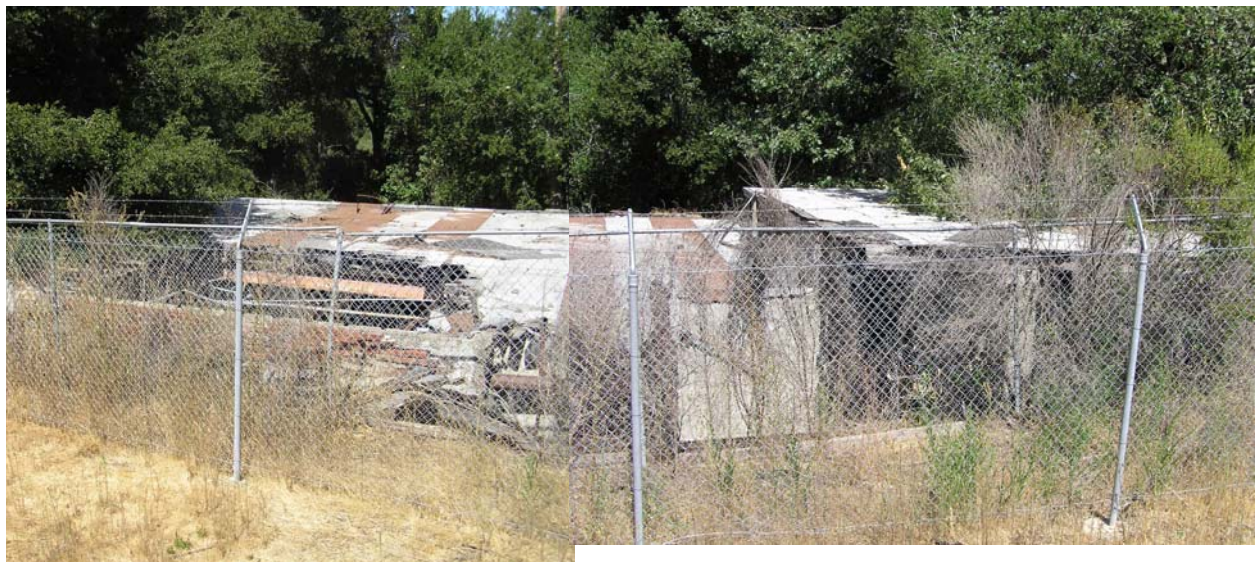
Image 58. Alma College Dormitory ruins, existing exterior view looking north. A portion of the dormitory foundations is visible within which debris has collected. Some metal roofing material covers the ruin. (Knapp Architects, digital photograph, 2009)

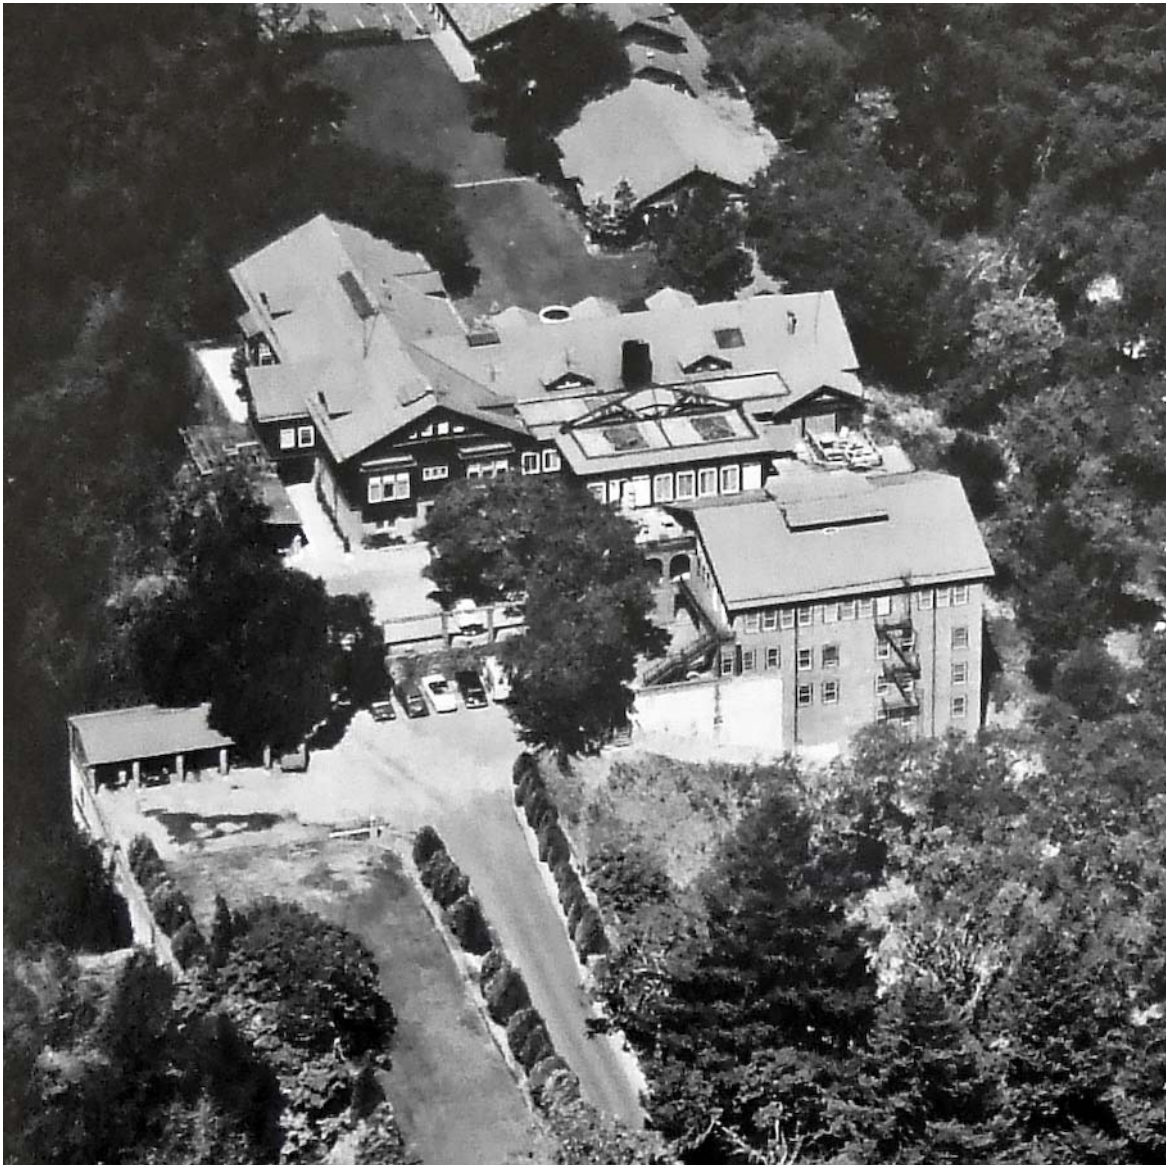
Image 59. Alma College Tevis House/Faculty Residence, historic exterior aerial view from the southeast. The Faculty Residence was large, comprised of additions by Tevis and Alma College. The rear façade arches of Carport A are visible to the right of the dark mass of trees at the building. The four bay openings of the Garage/Residence building are shown at the left. Another parking area exists between Carport A and Garage/ Residence. At some point, a covered structure was placed in this area and is referred to as Carport B in this report. (California

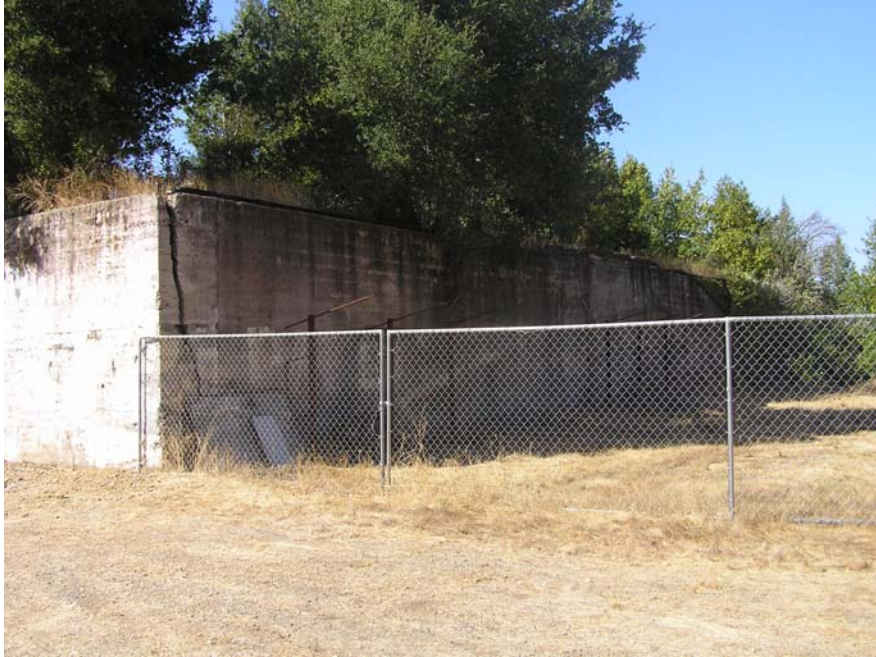
Image 60. Alma College Tevis House / Faculty Residence ruin, exterior view looking northwest at the retaining wall that supported a west portion of the house. A large crack in the concrete retaining wall is seen at the left near the wall corner. (Knapp Architects, digital photograph, 2009)

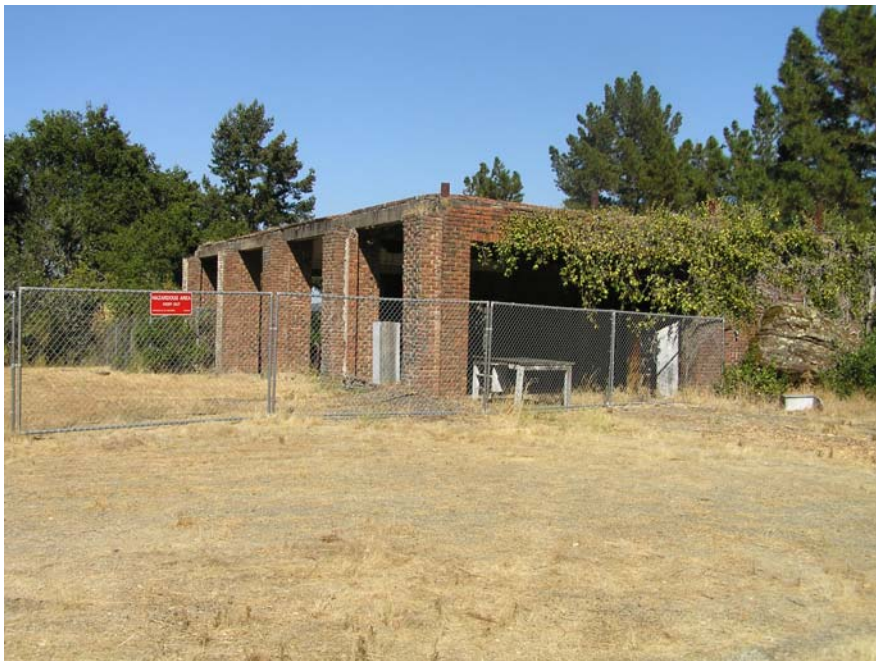
Image 61. Alma College Tevis House / Faculty Residence ruin, Carport A, exterior view looking northeast. A terrace still exists just below and east of the carport. (Knapp Architects, digital photograph, 2009)

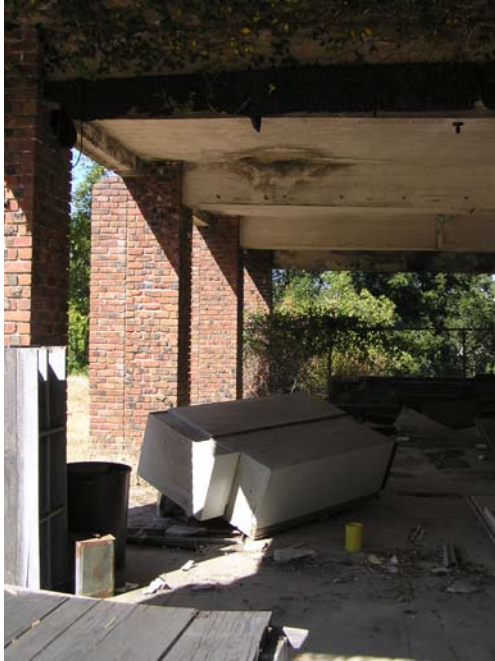
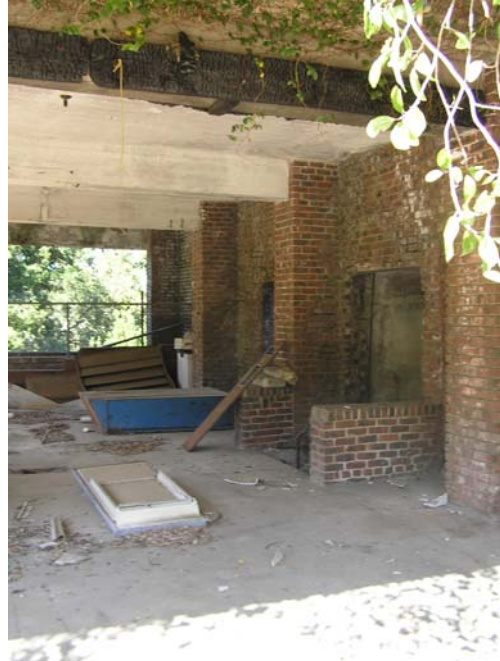
Image 62 & 63. Alma College Tevis House / Faculty Residence ruin, Carport A, existing interior view of looking north. The brick facing and concrete structure remain. Wood cover trim has sustained fire damage. The carport has an interior space and rear archways and a lower terrace to the east, not shown. (Knapp Architects, digital photograph, 2009)

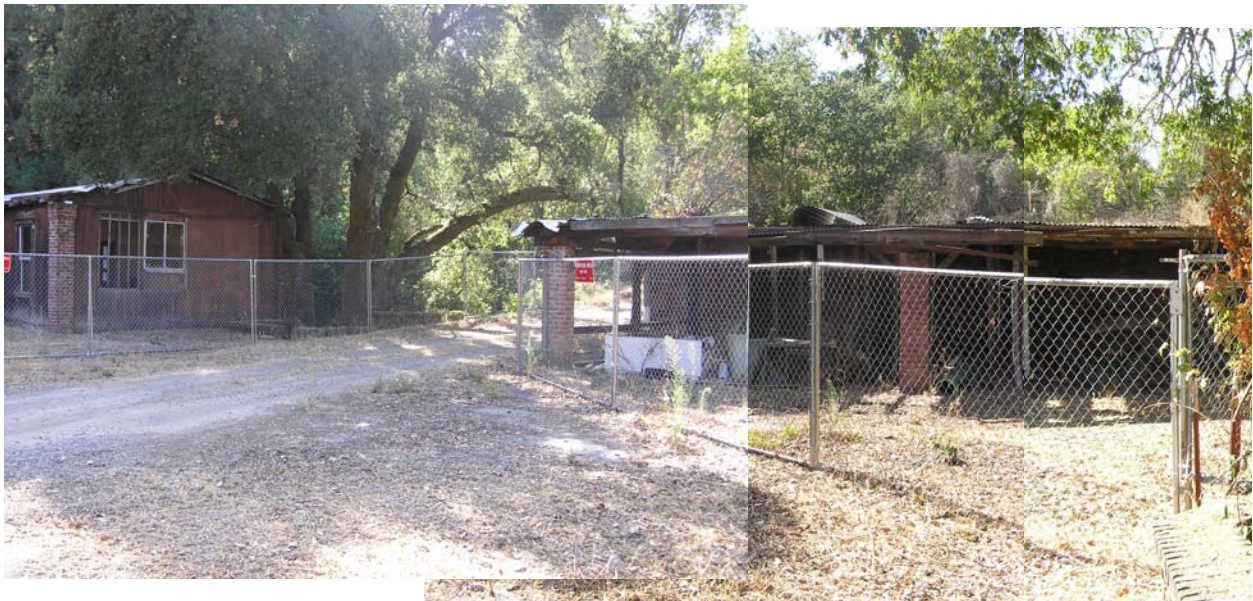
Image 64. Alma College Tevis House / Faculty Residence, Carport B (right), existing exterior view looking west. The secondary carport was a parking area adjacent to the Garage/ Residence shown at left. (Knapp Architects, digital photograph, 2009)

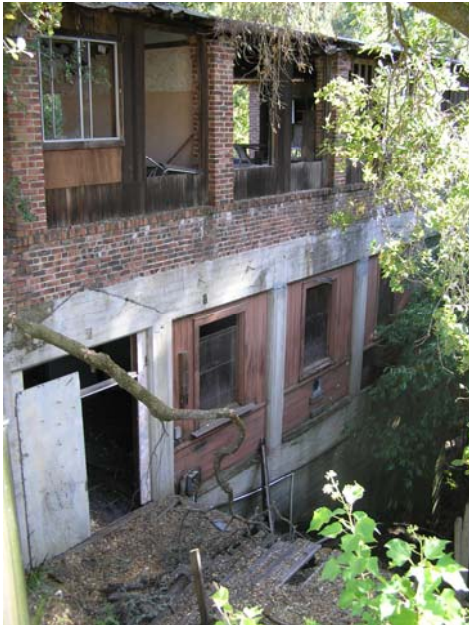
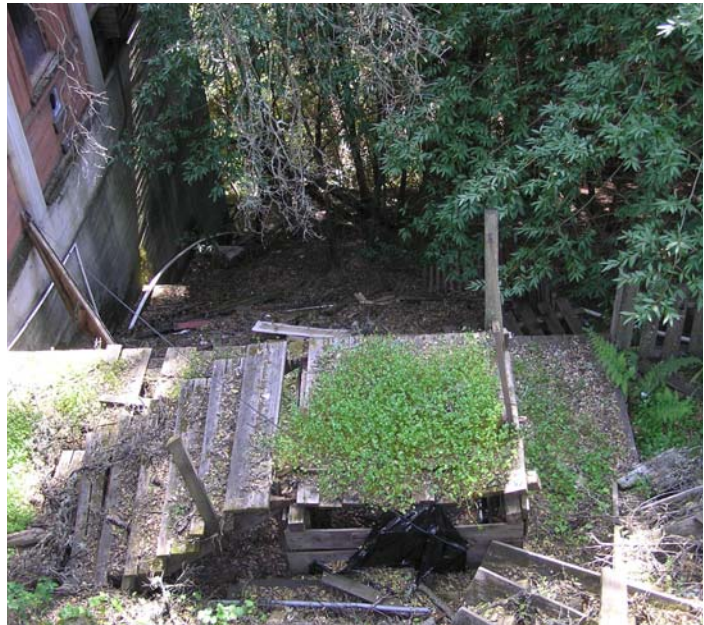
Image 66. Alma College Garage/Residence, existing exterior view from the northwest (left). The multi-story building is composed of concrete and brick. The wood stair to the lower level entry is severely damaged and unusable (right). (Knapp Architects, digital photograph, 2009)

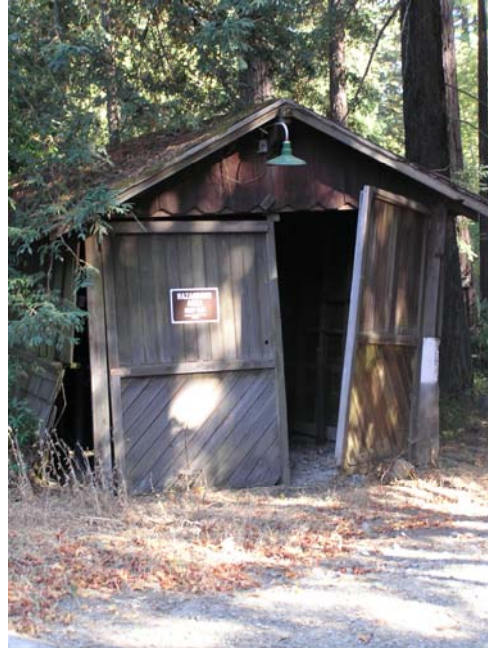
Image 67. Alma College Wood Shed, existing exterior view of west façade with decorative wood shingles and framed barn-like doors. (Knapp Architects, digital photograph, 2009)

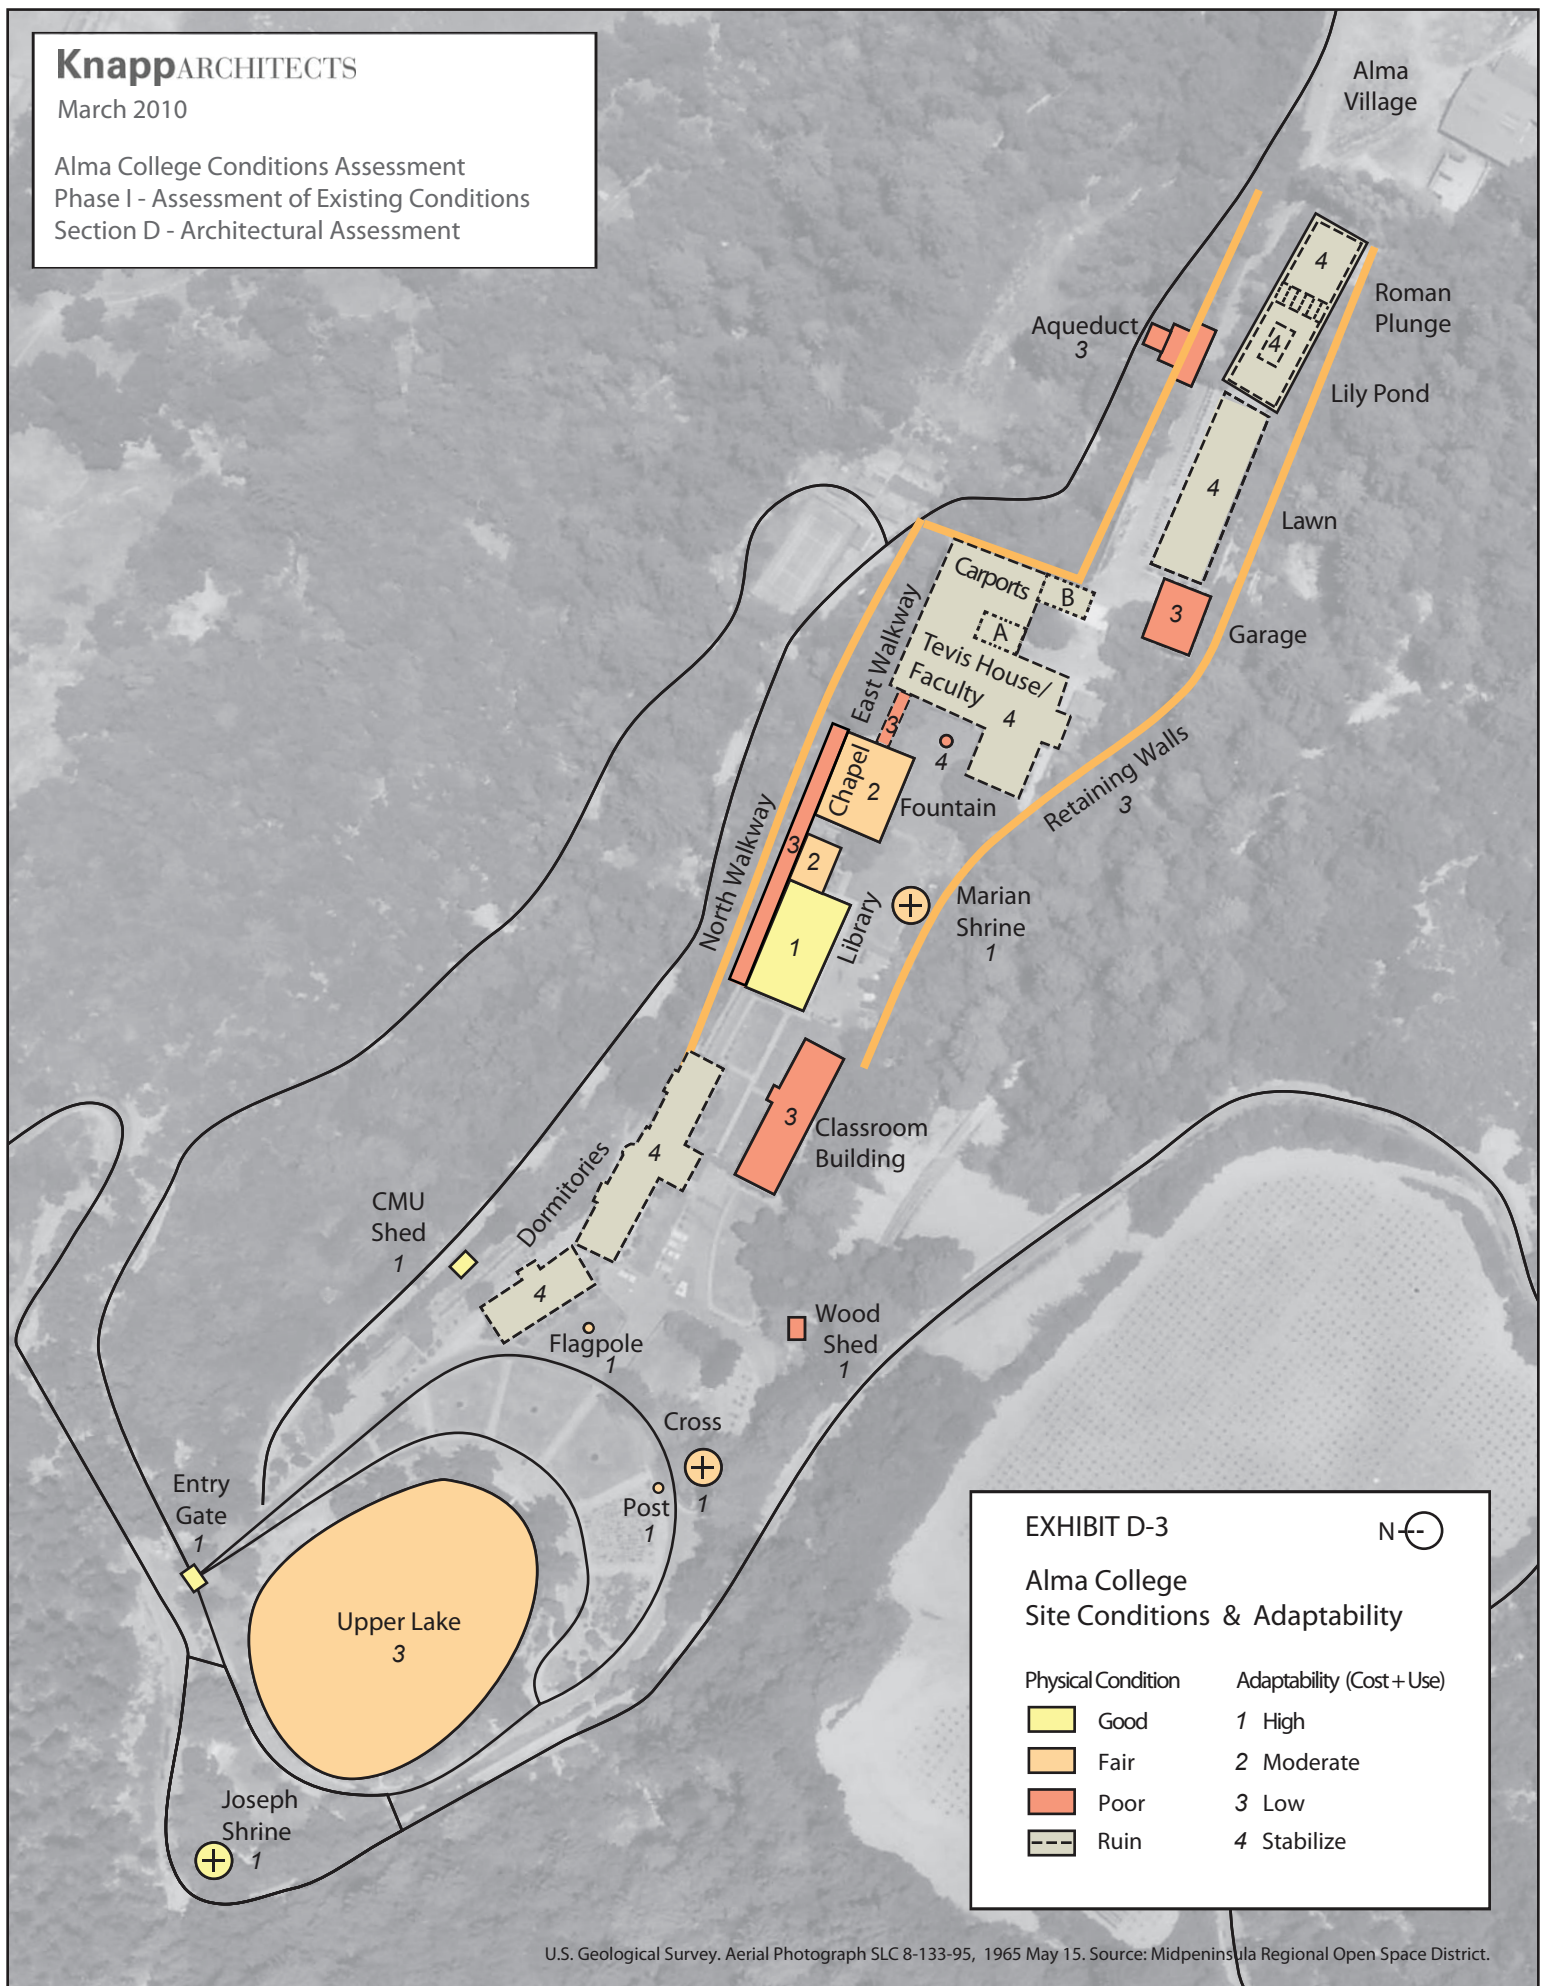
## **II. ASSESSMENTS & ANALYSES**

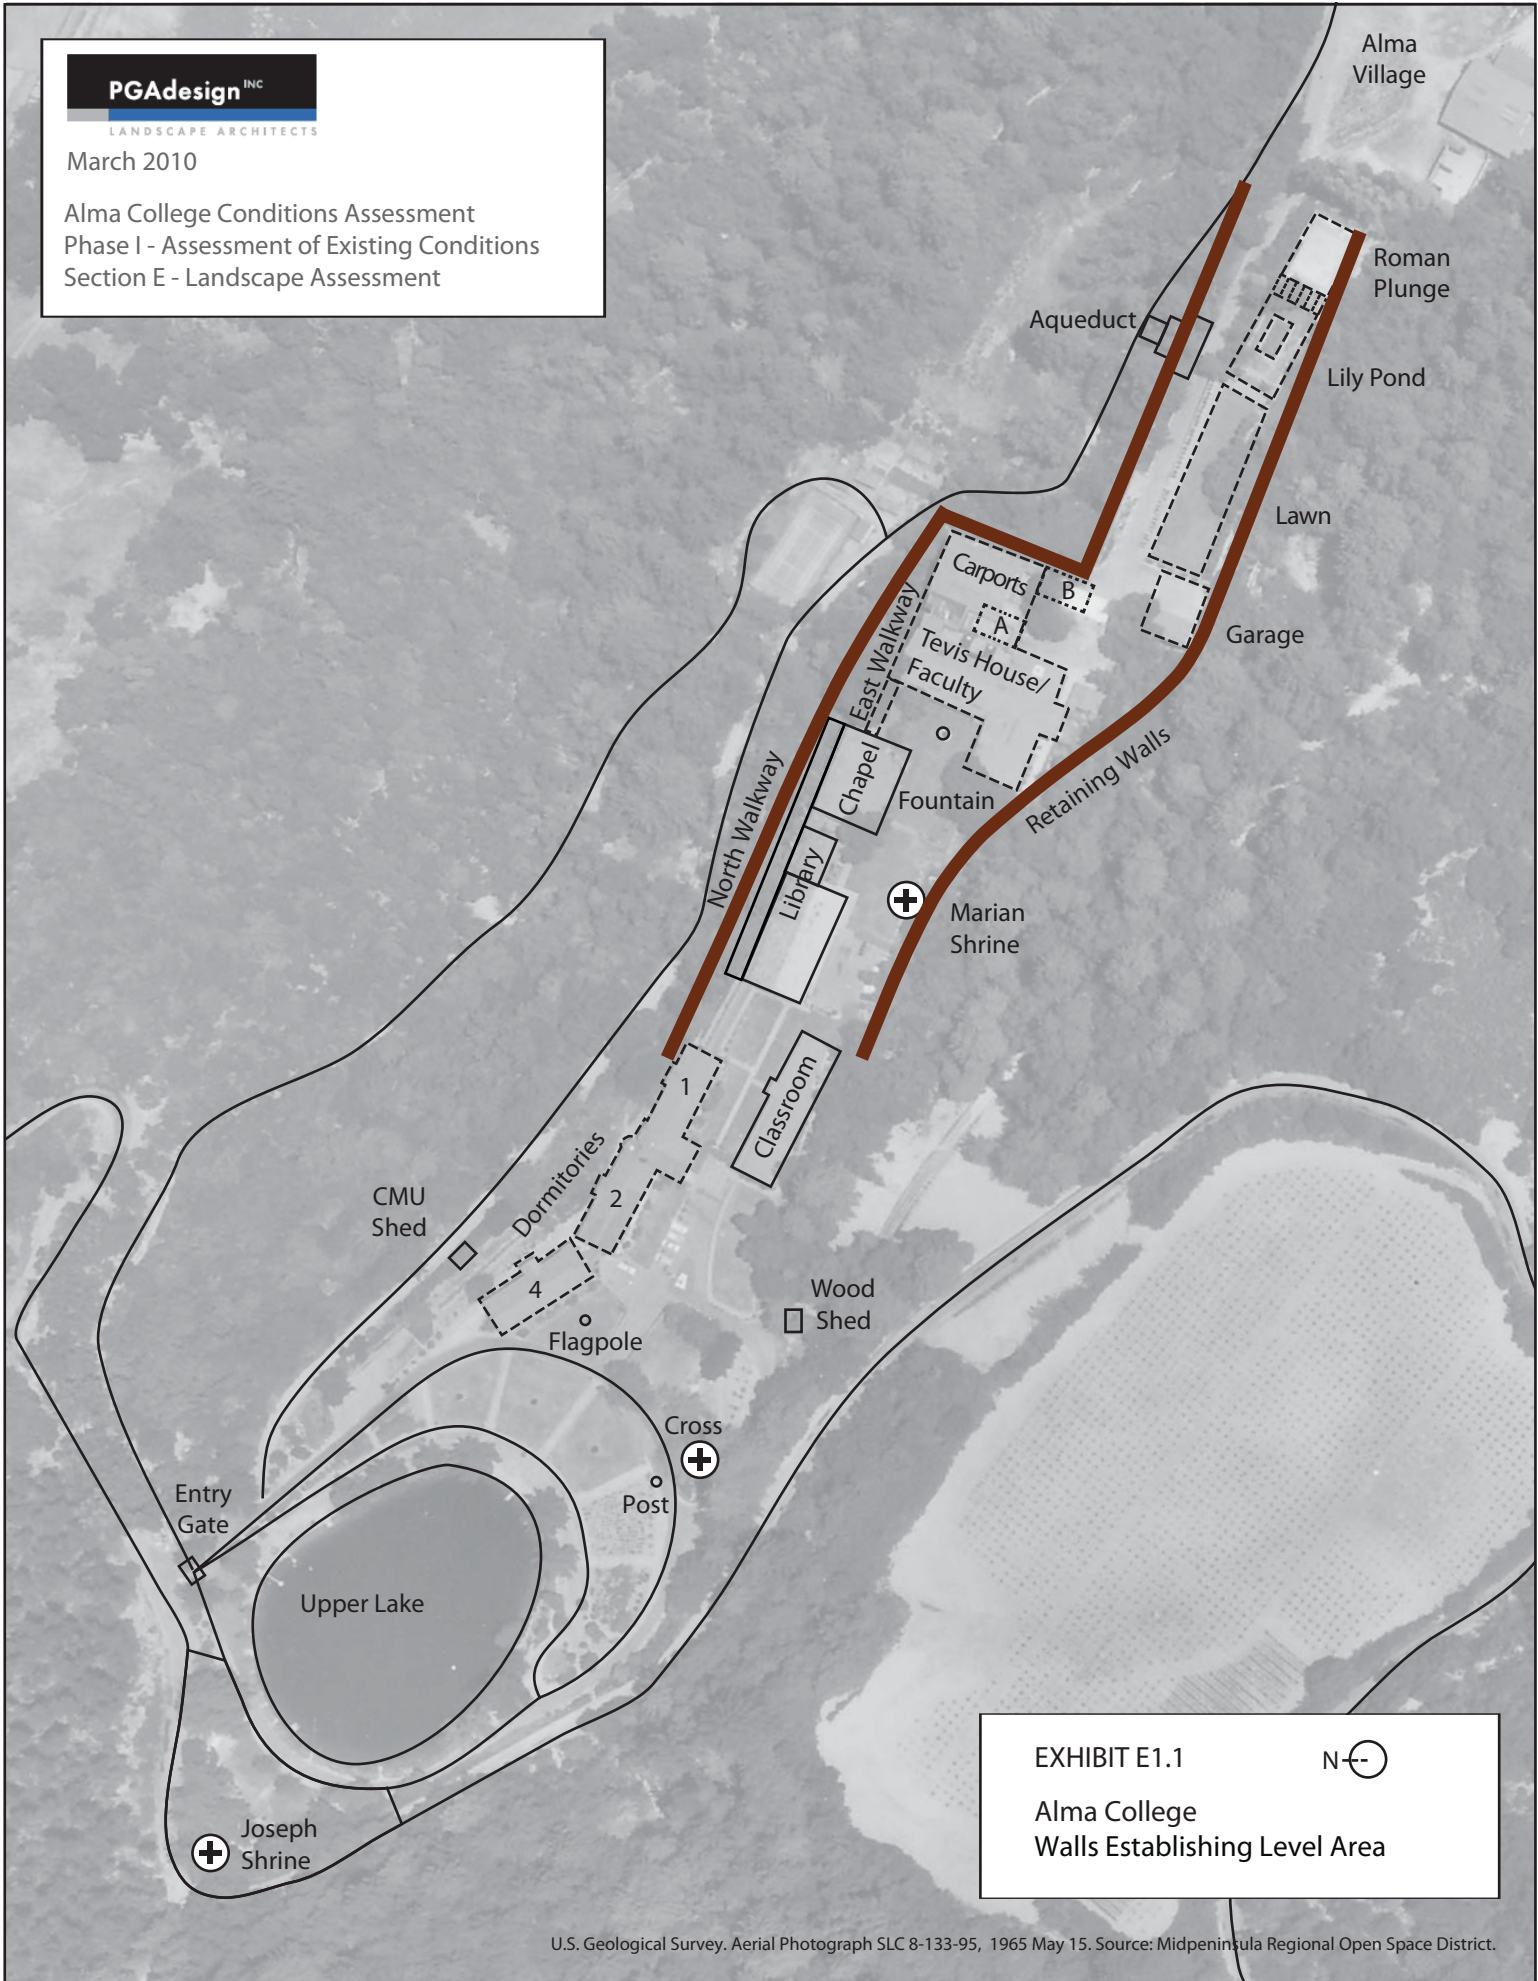
EXHIBIT E1.1      N ↯  
Alma College  
Walls Establishing Level Area

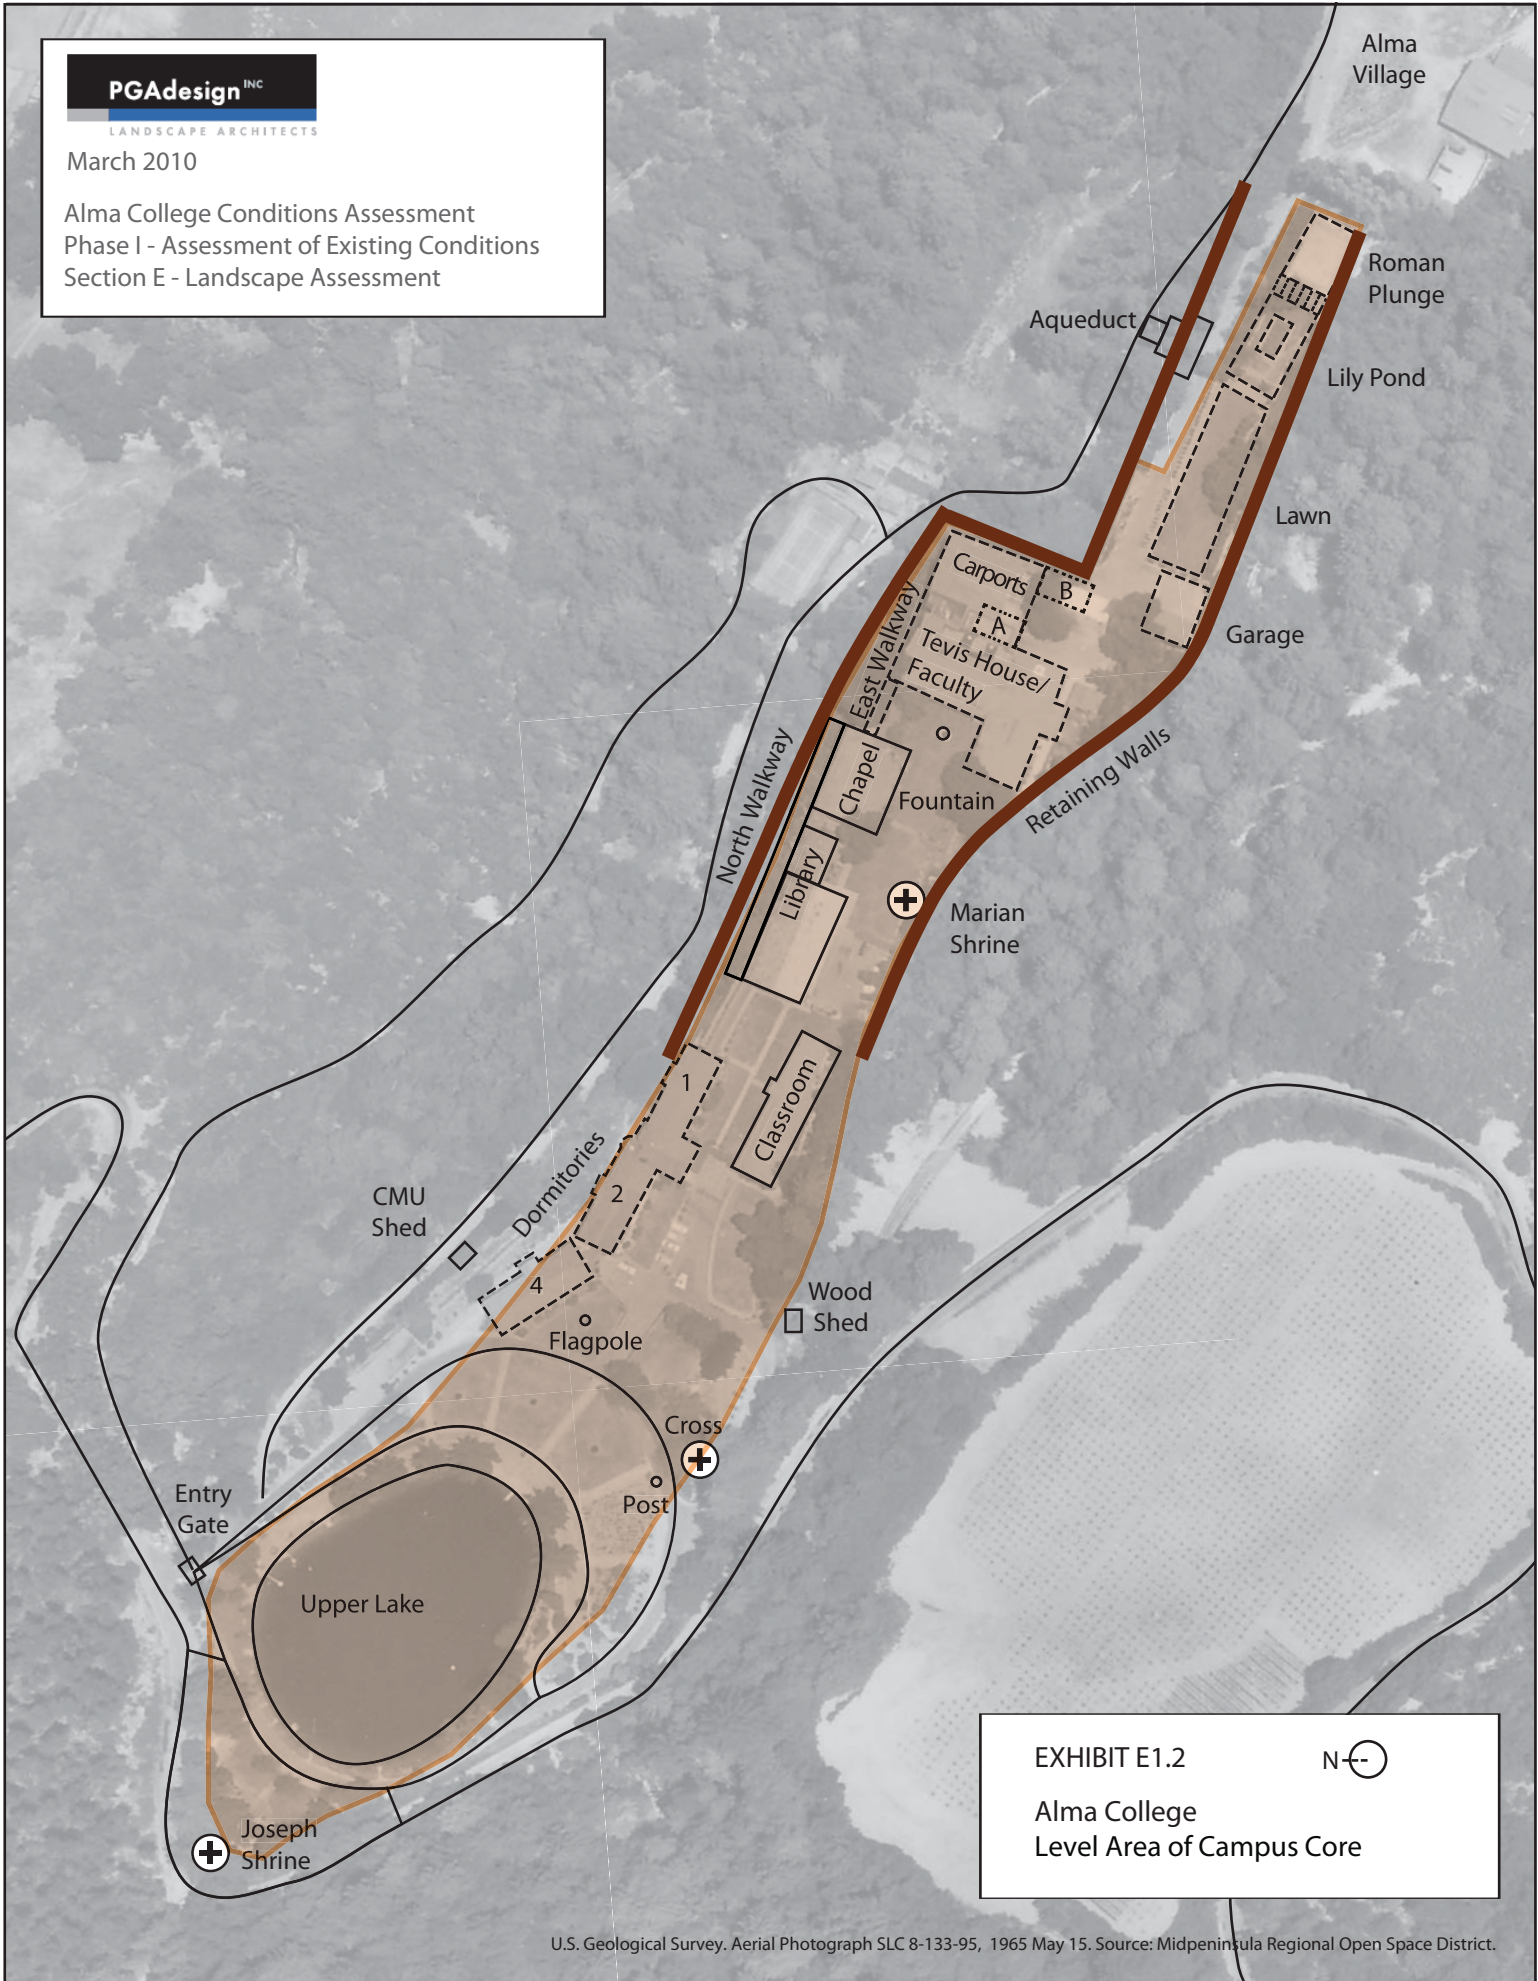
EXHIBIT E1.2      N ⊕  
Alma College  
Level Area of Campus Core
