**ALMA COLLEGE CONDITIONS ASSESSMENT PROJECT**  
Midpeninsula Regional Open Space District  
Santa Clara County, CA

Phase I: Assessment of Existing Conditions

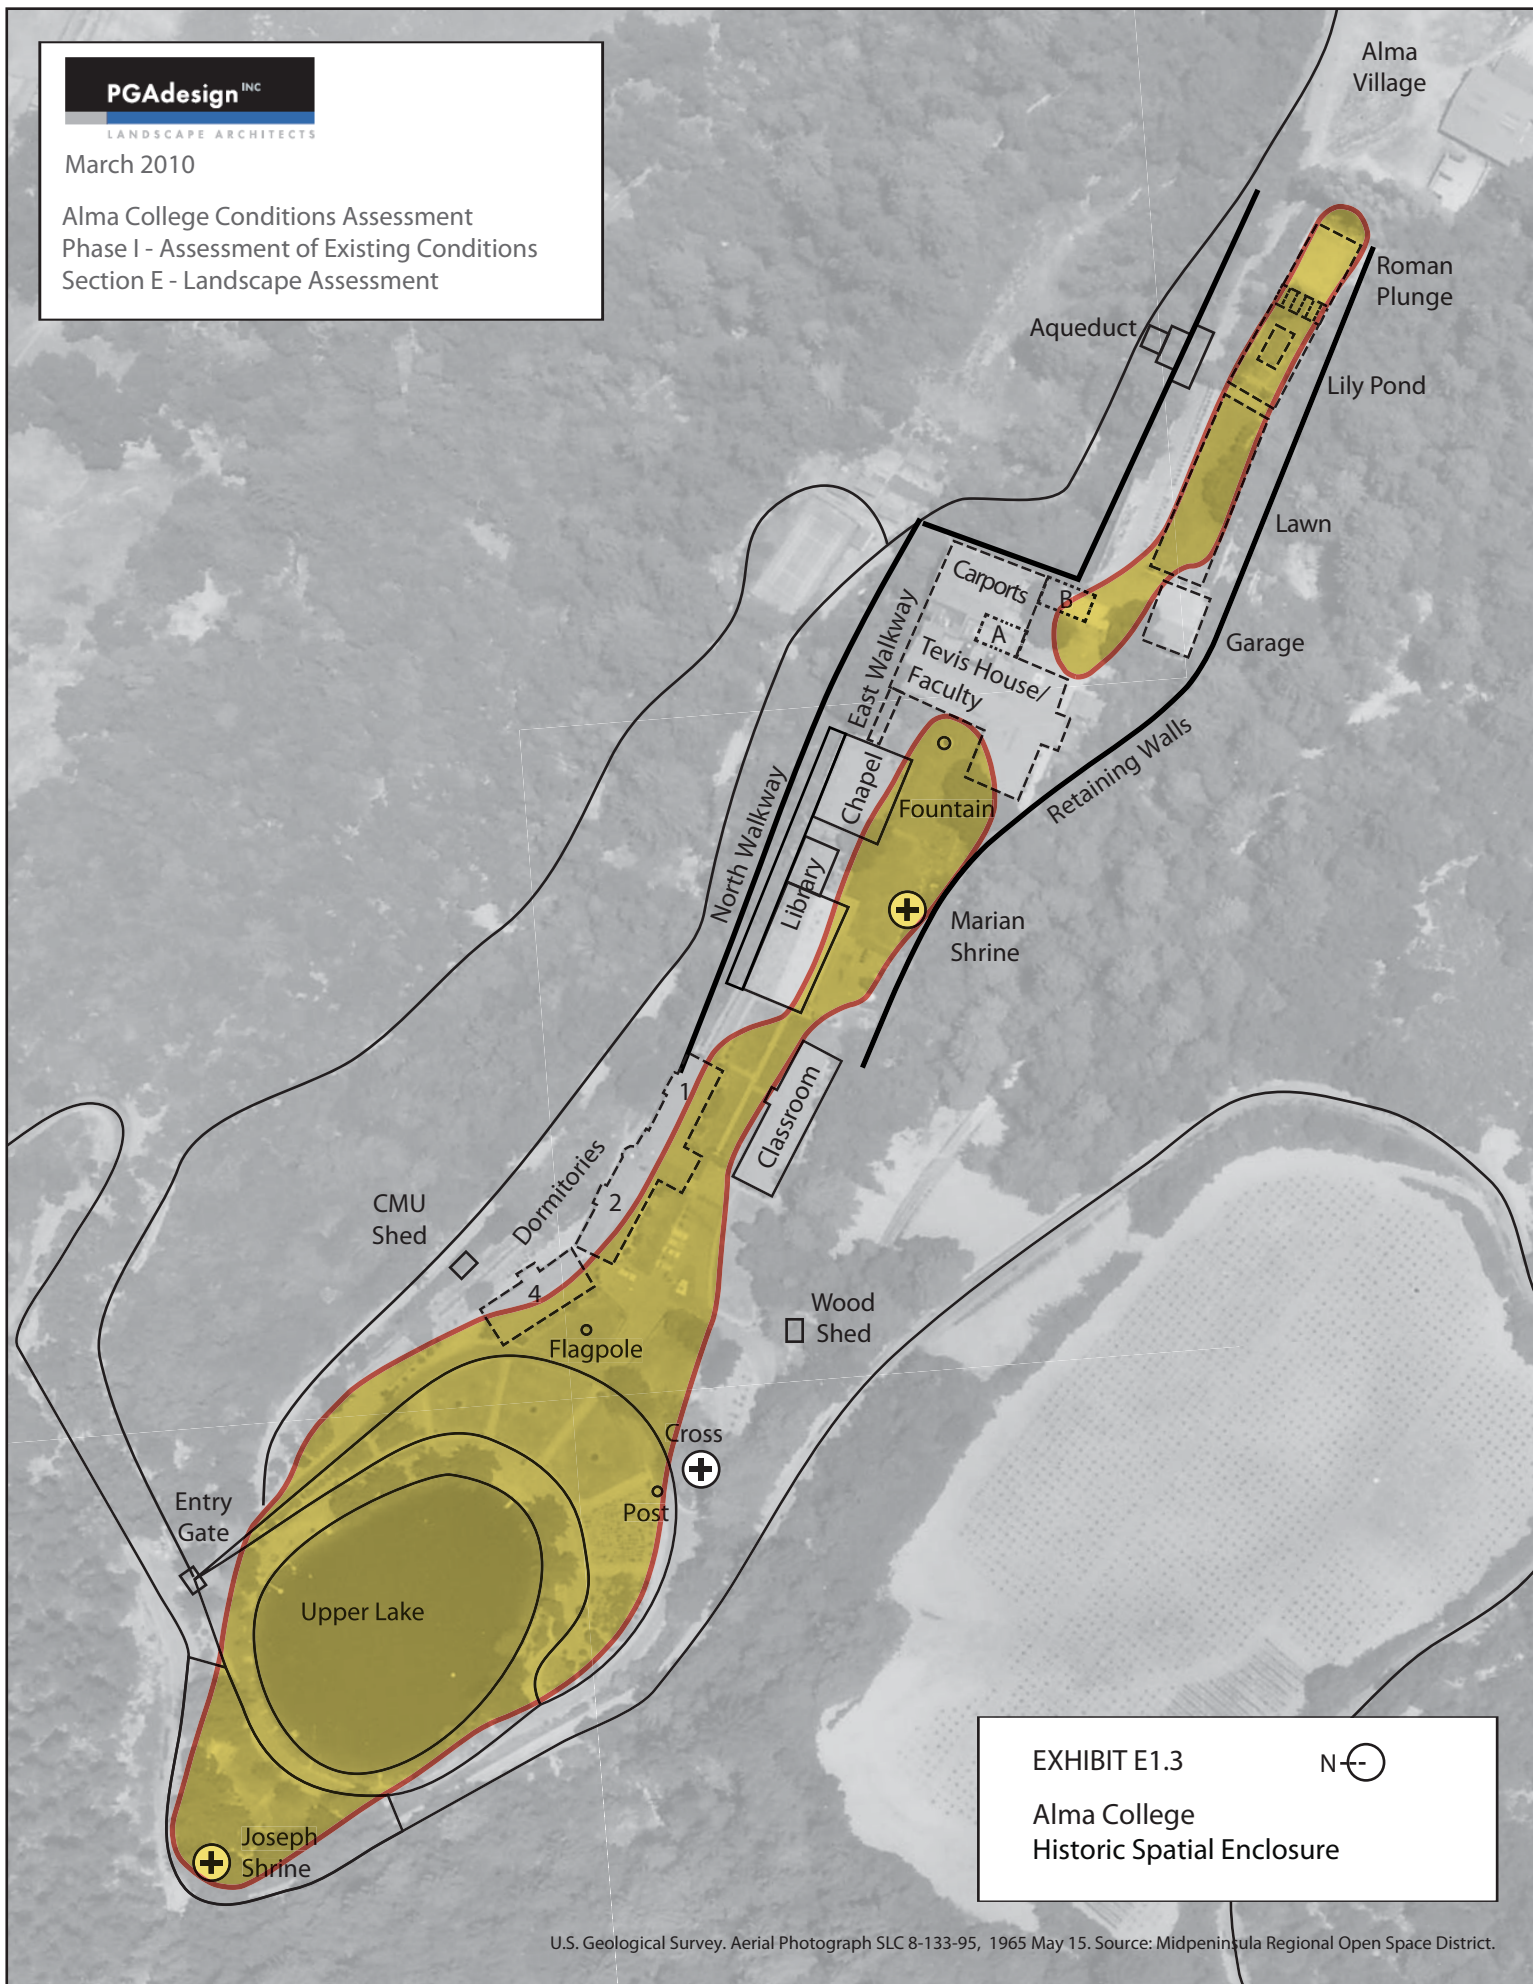
Alma College Conditions Assessment  
Phase I - Assessment of Existing Conditions  
Section E - Landscape Assessment

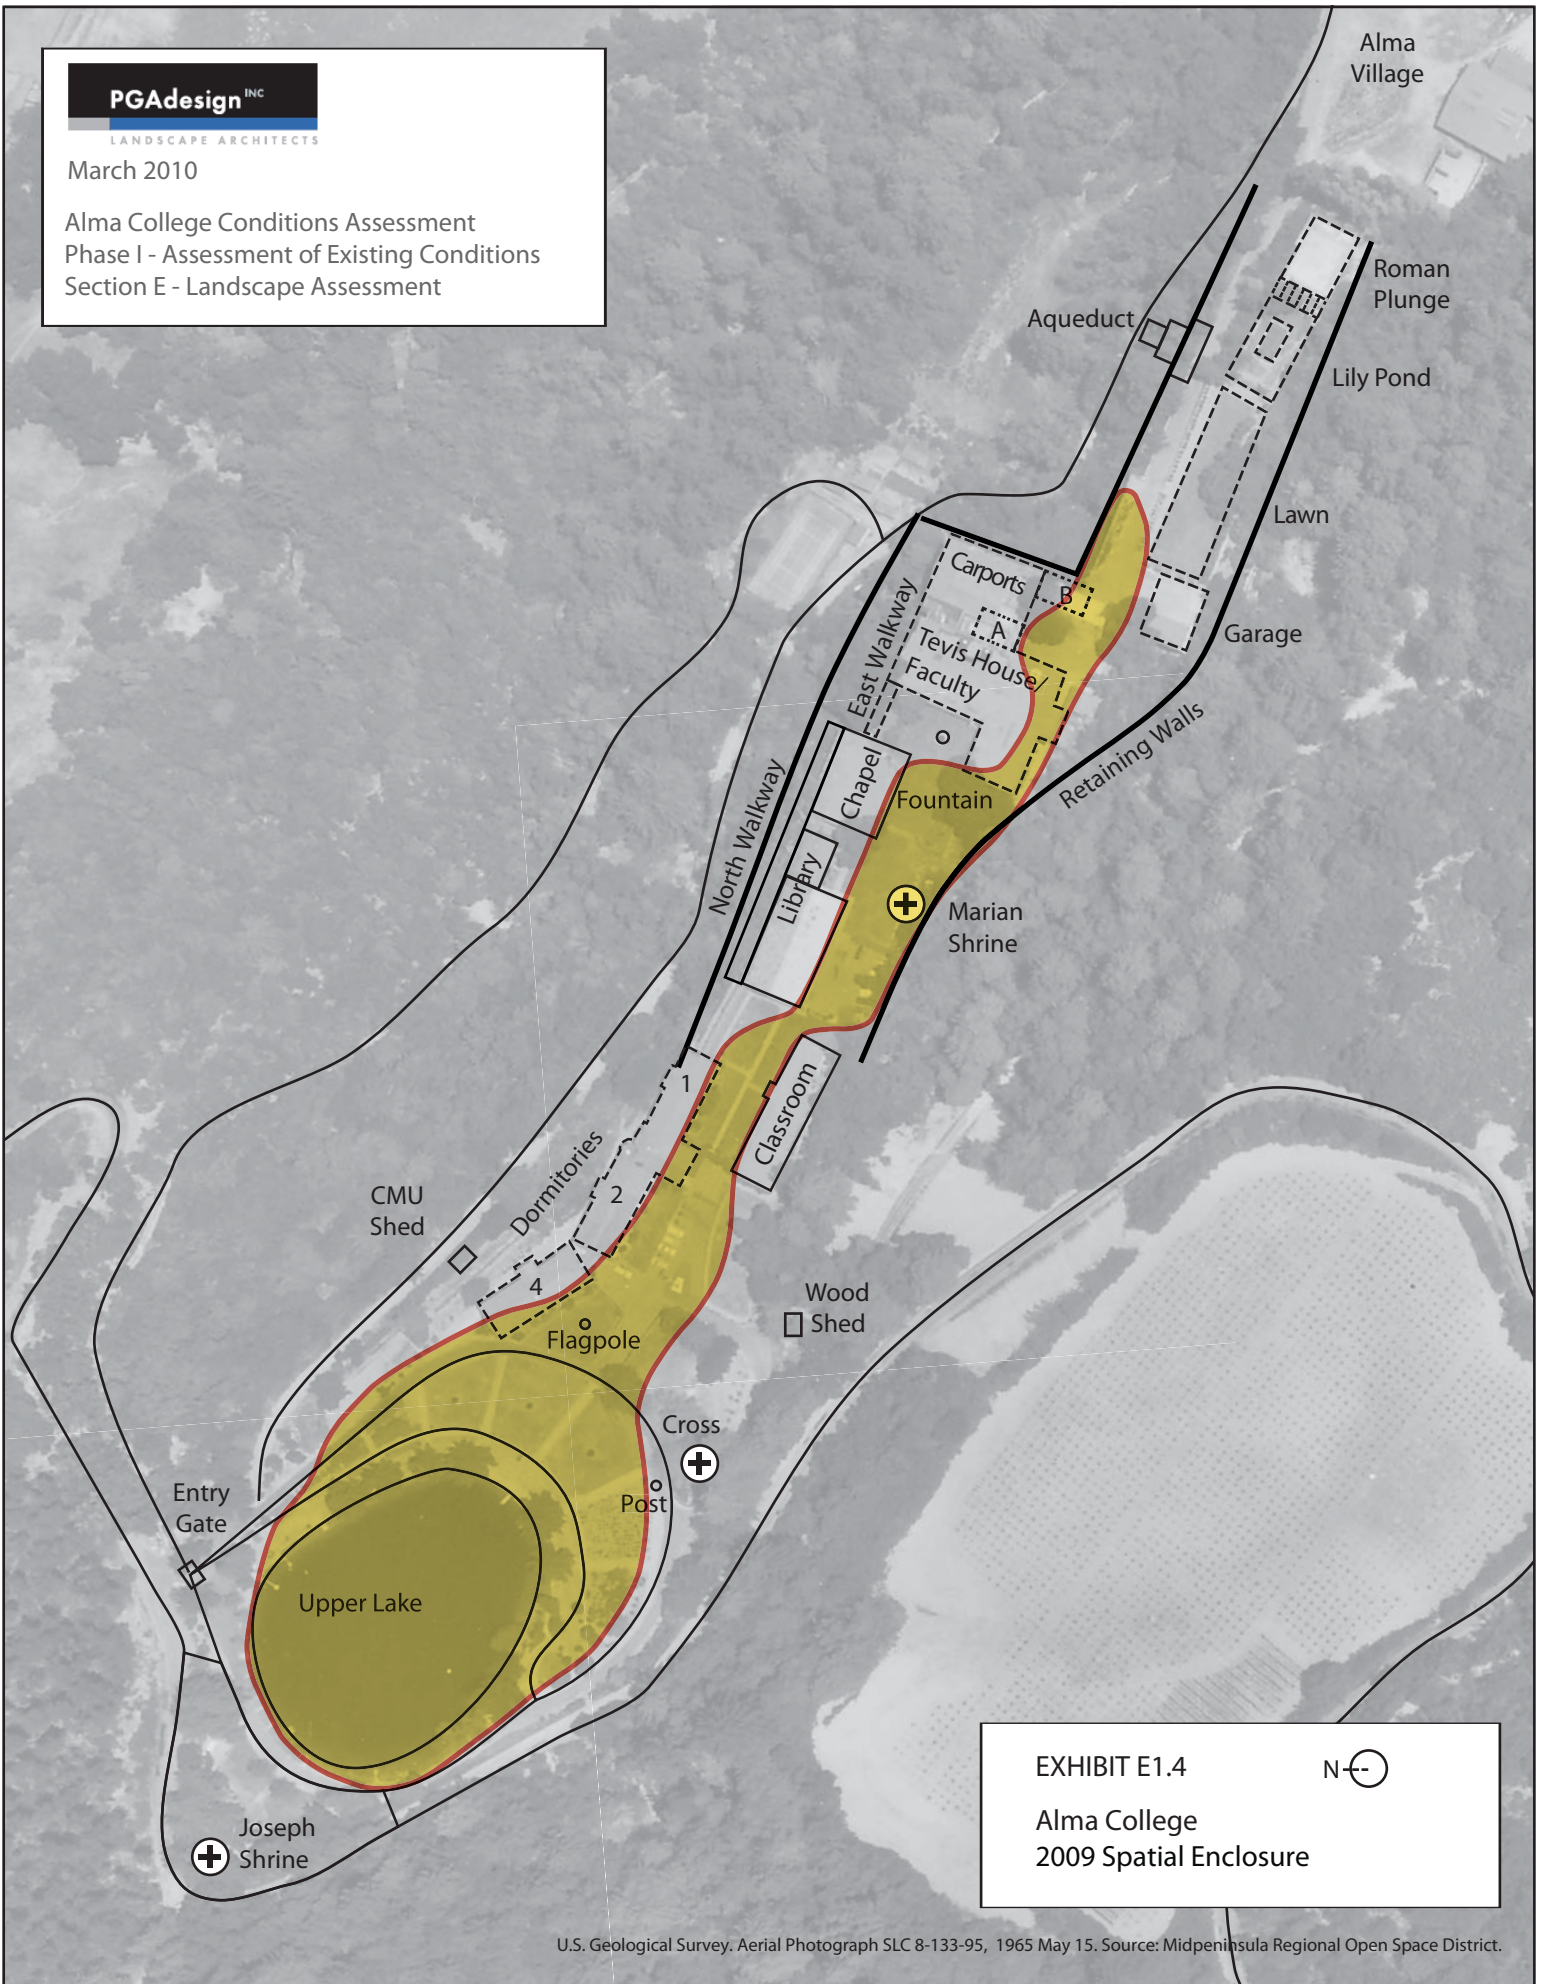
Alma College Conditions Assessment  
Phase I - Assessment of Existing Conditions  
Section E - Landscape Assessment

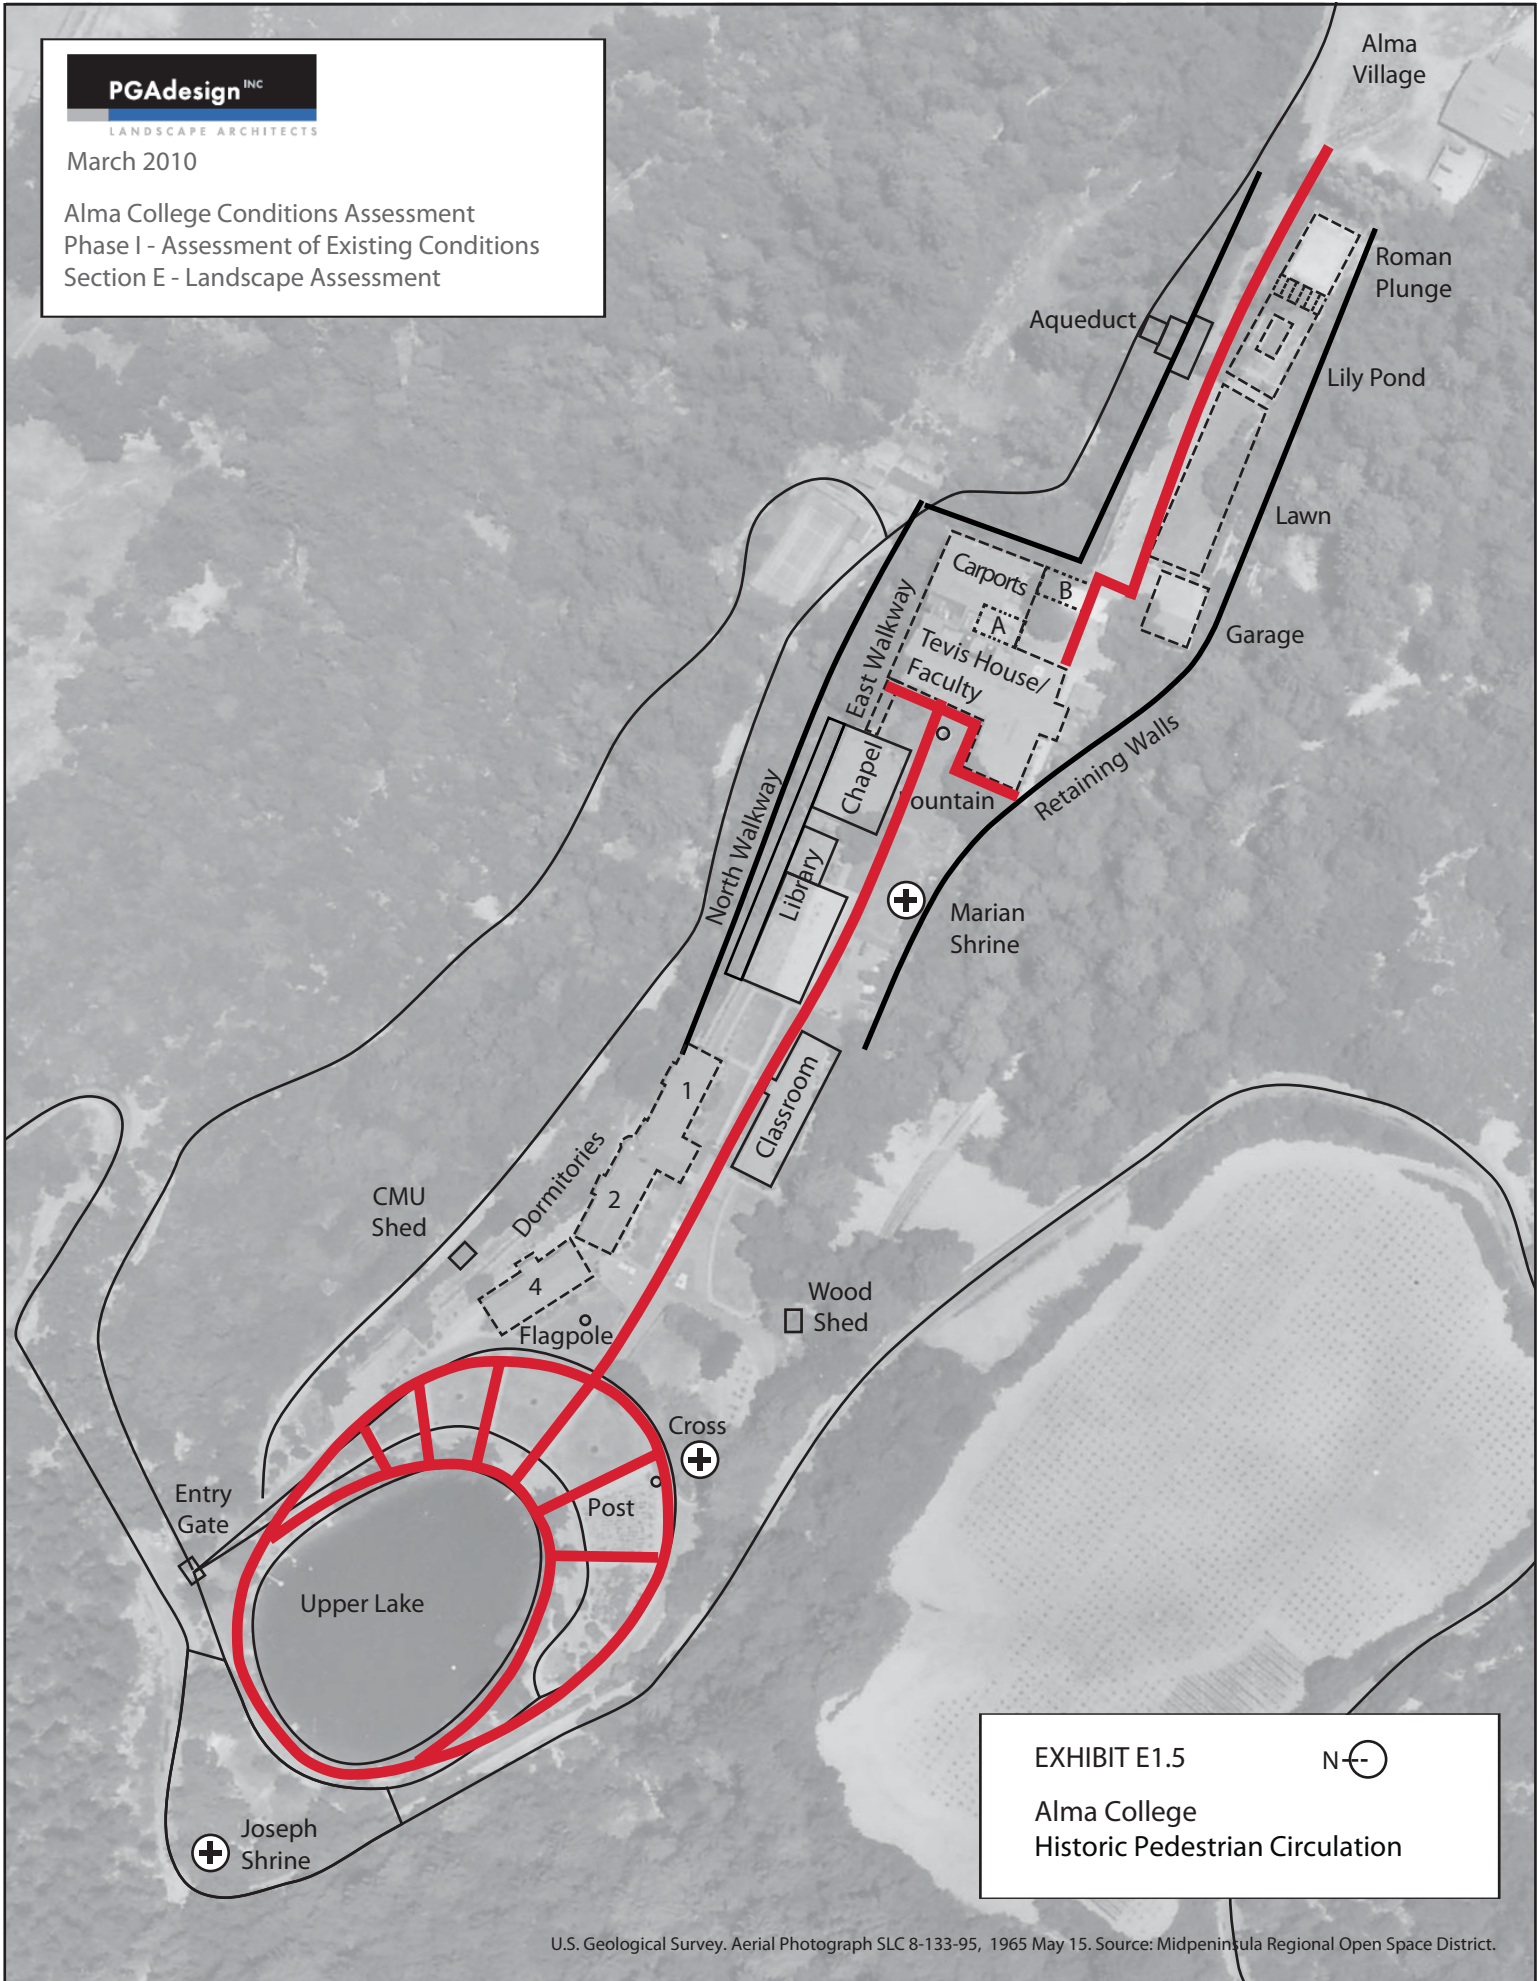
EXHIBIT E1.5      N ↯

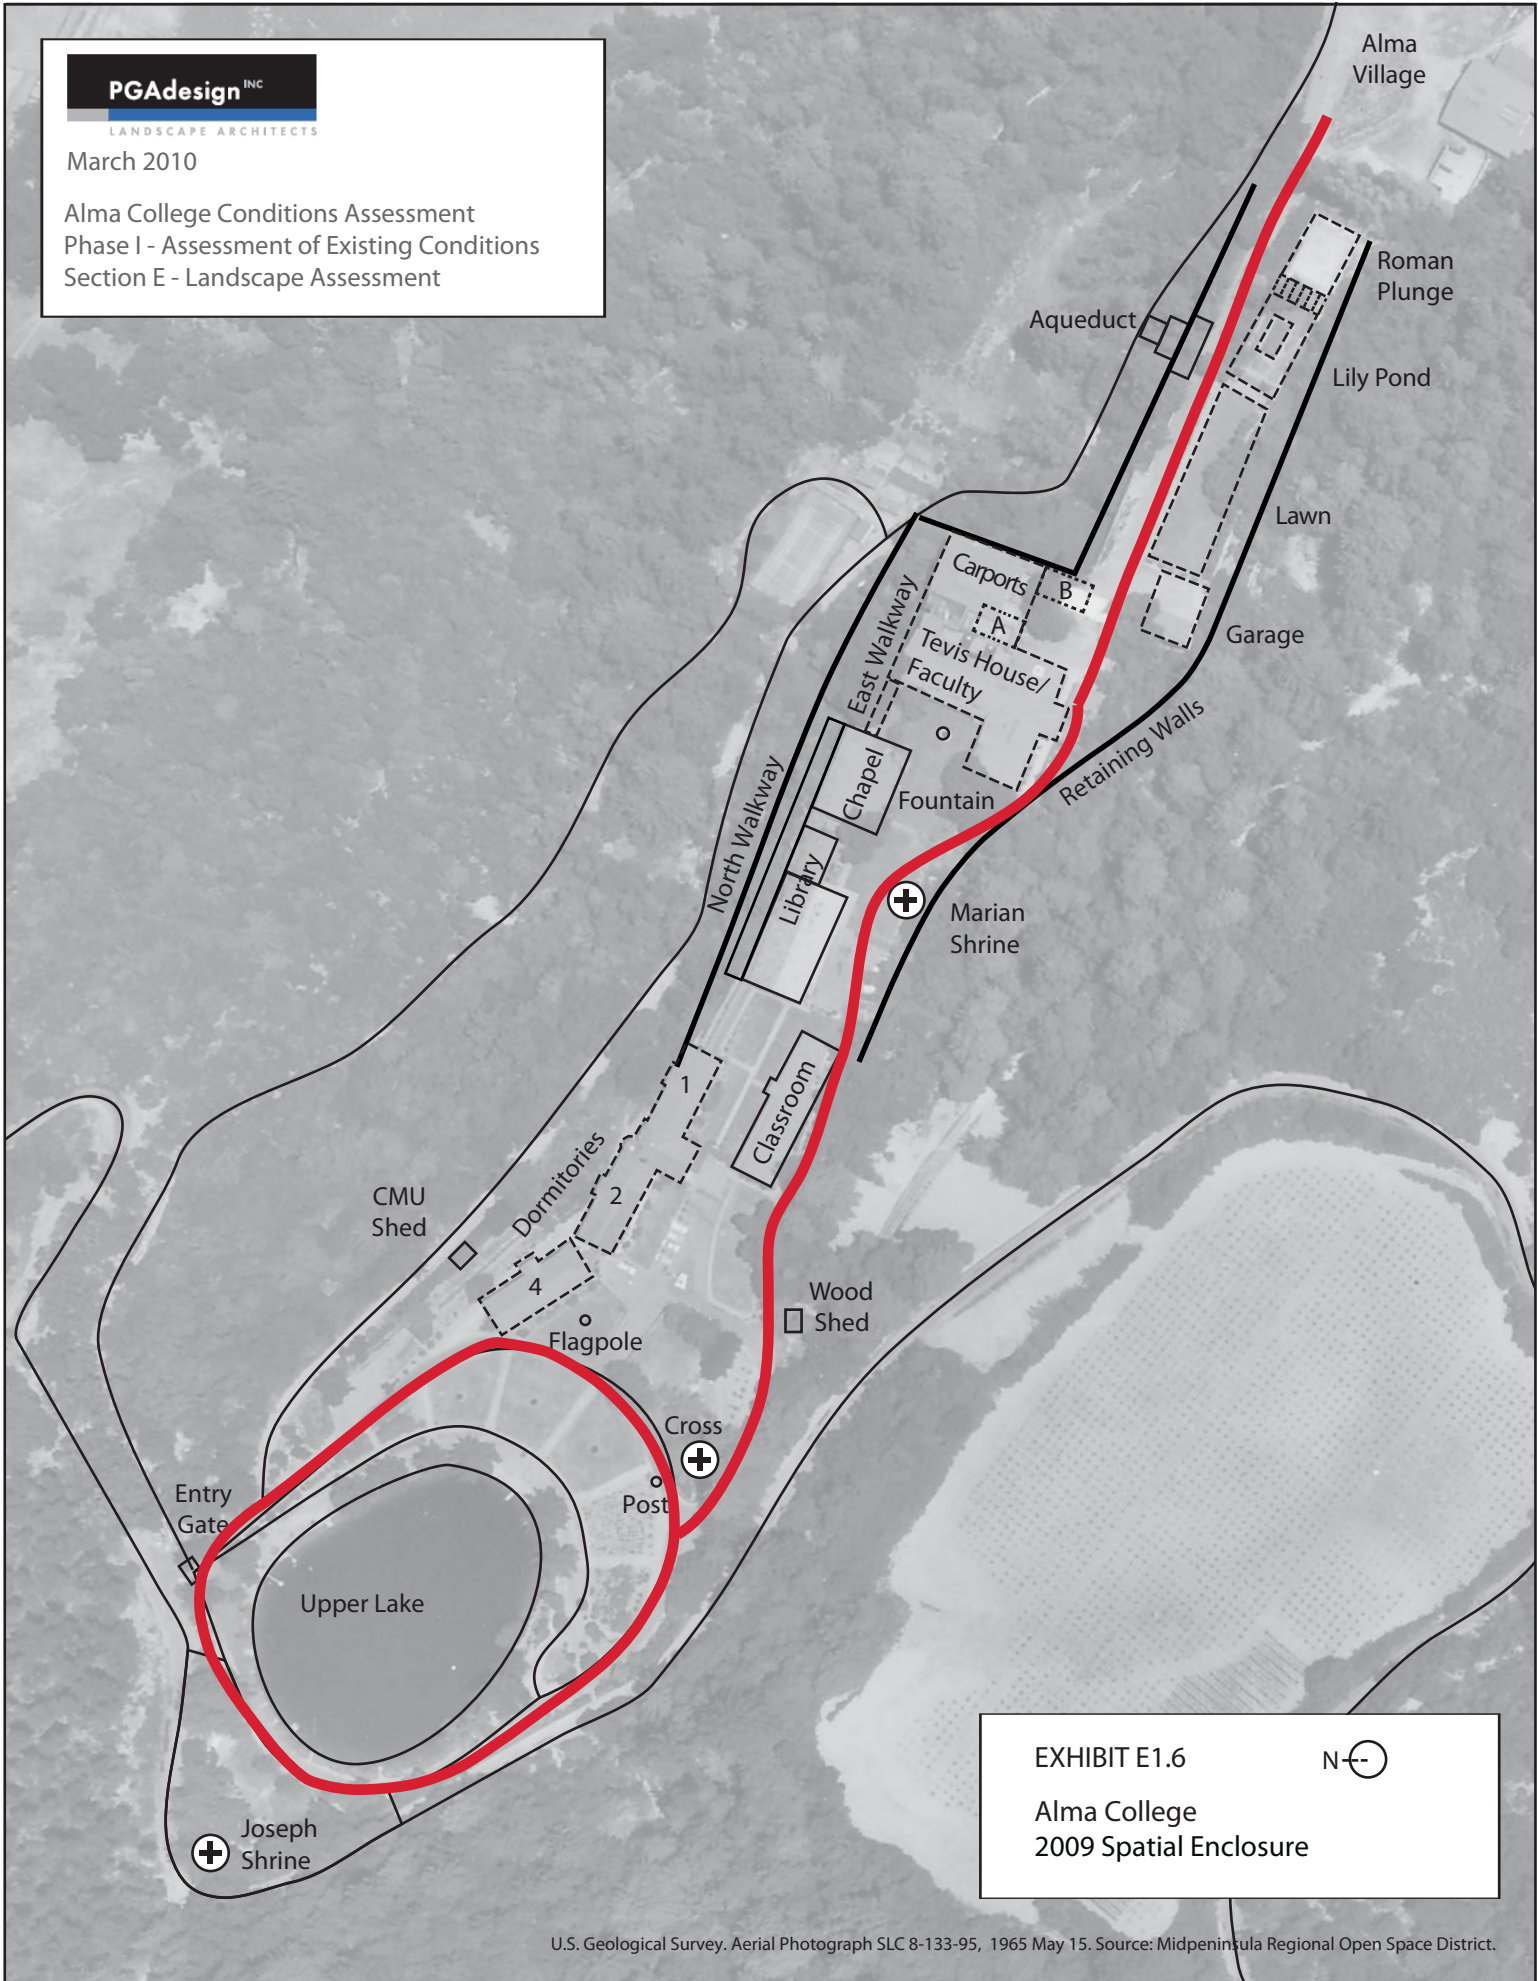
Alma College Conditions Assessment  
Phase I - Assessment of Existing Conditions  
Section E - Landscape Assessment

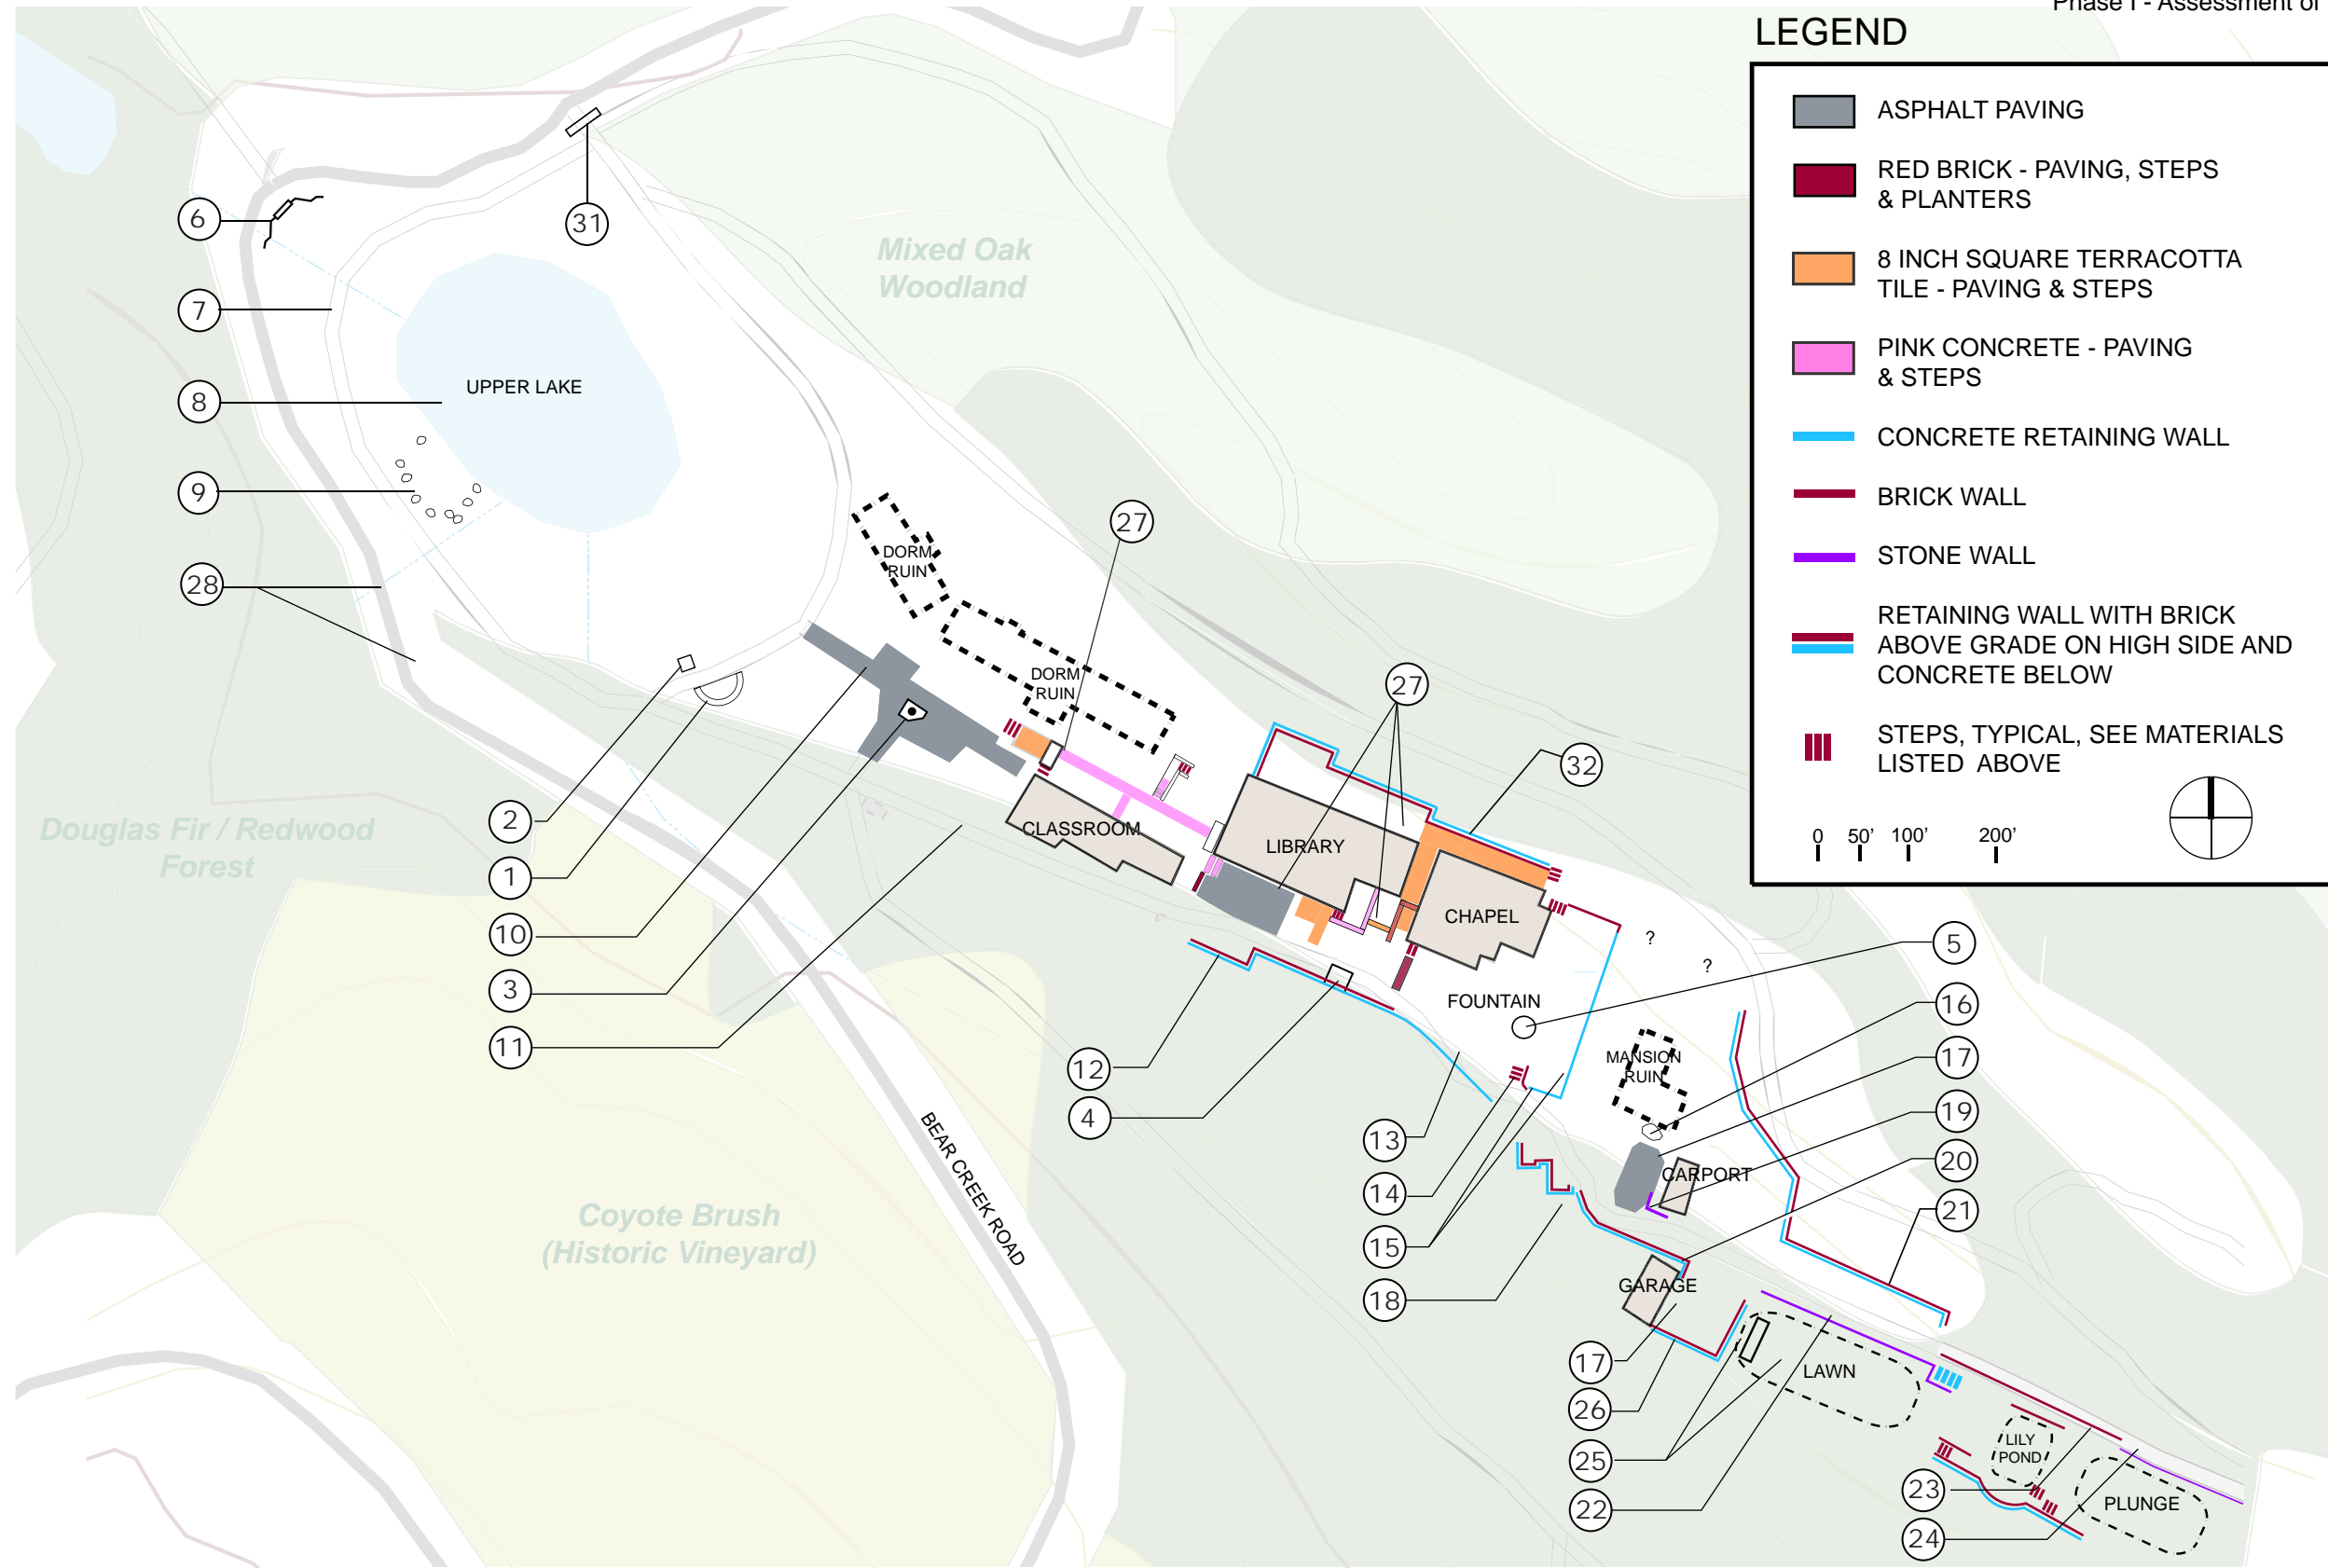
# ALMA COLLEGE SITE ASSESSMENT LANDSCAPE FEATURES PLAN

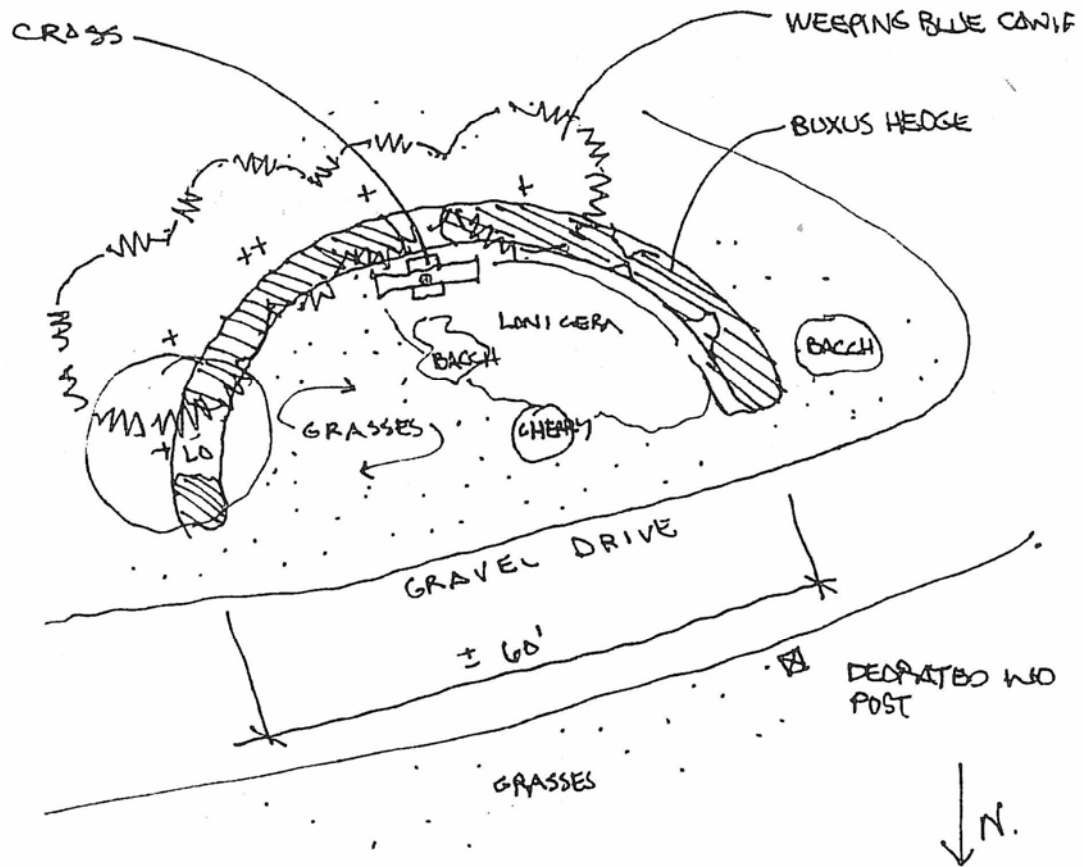
ITEM	CROSS W/	SEMI-CIRCULAR HEDGE	7.2.D9
L1	N.T.S.

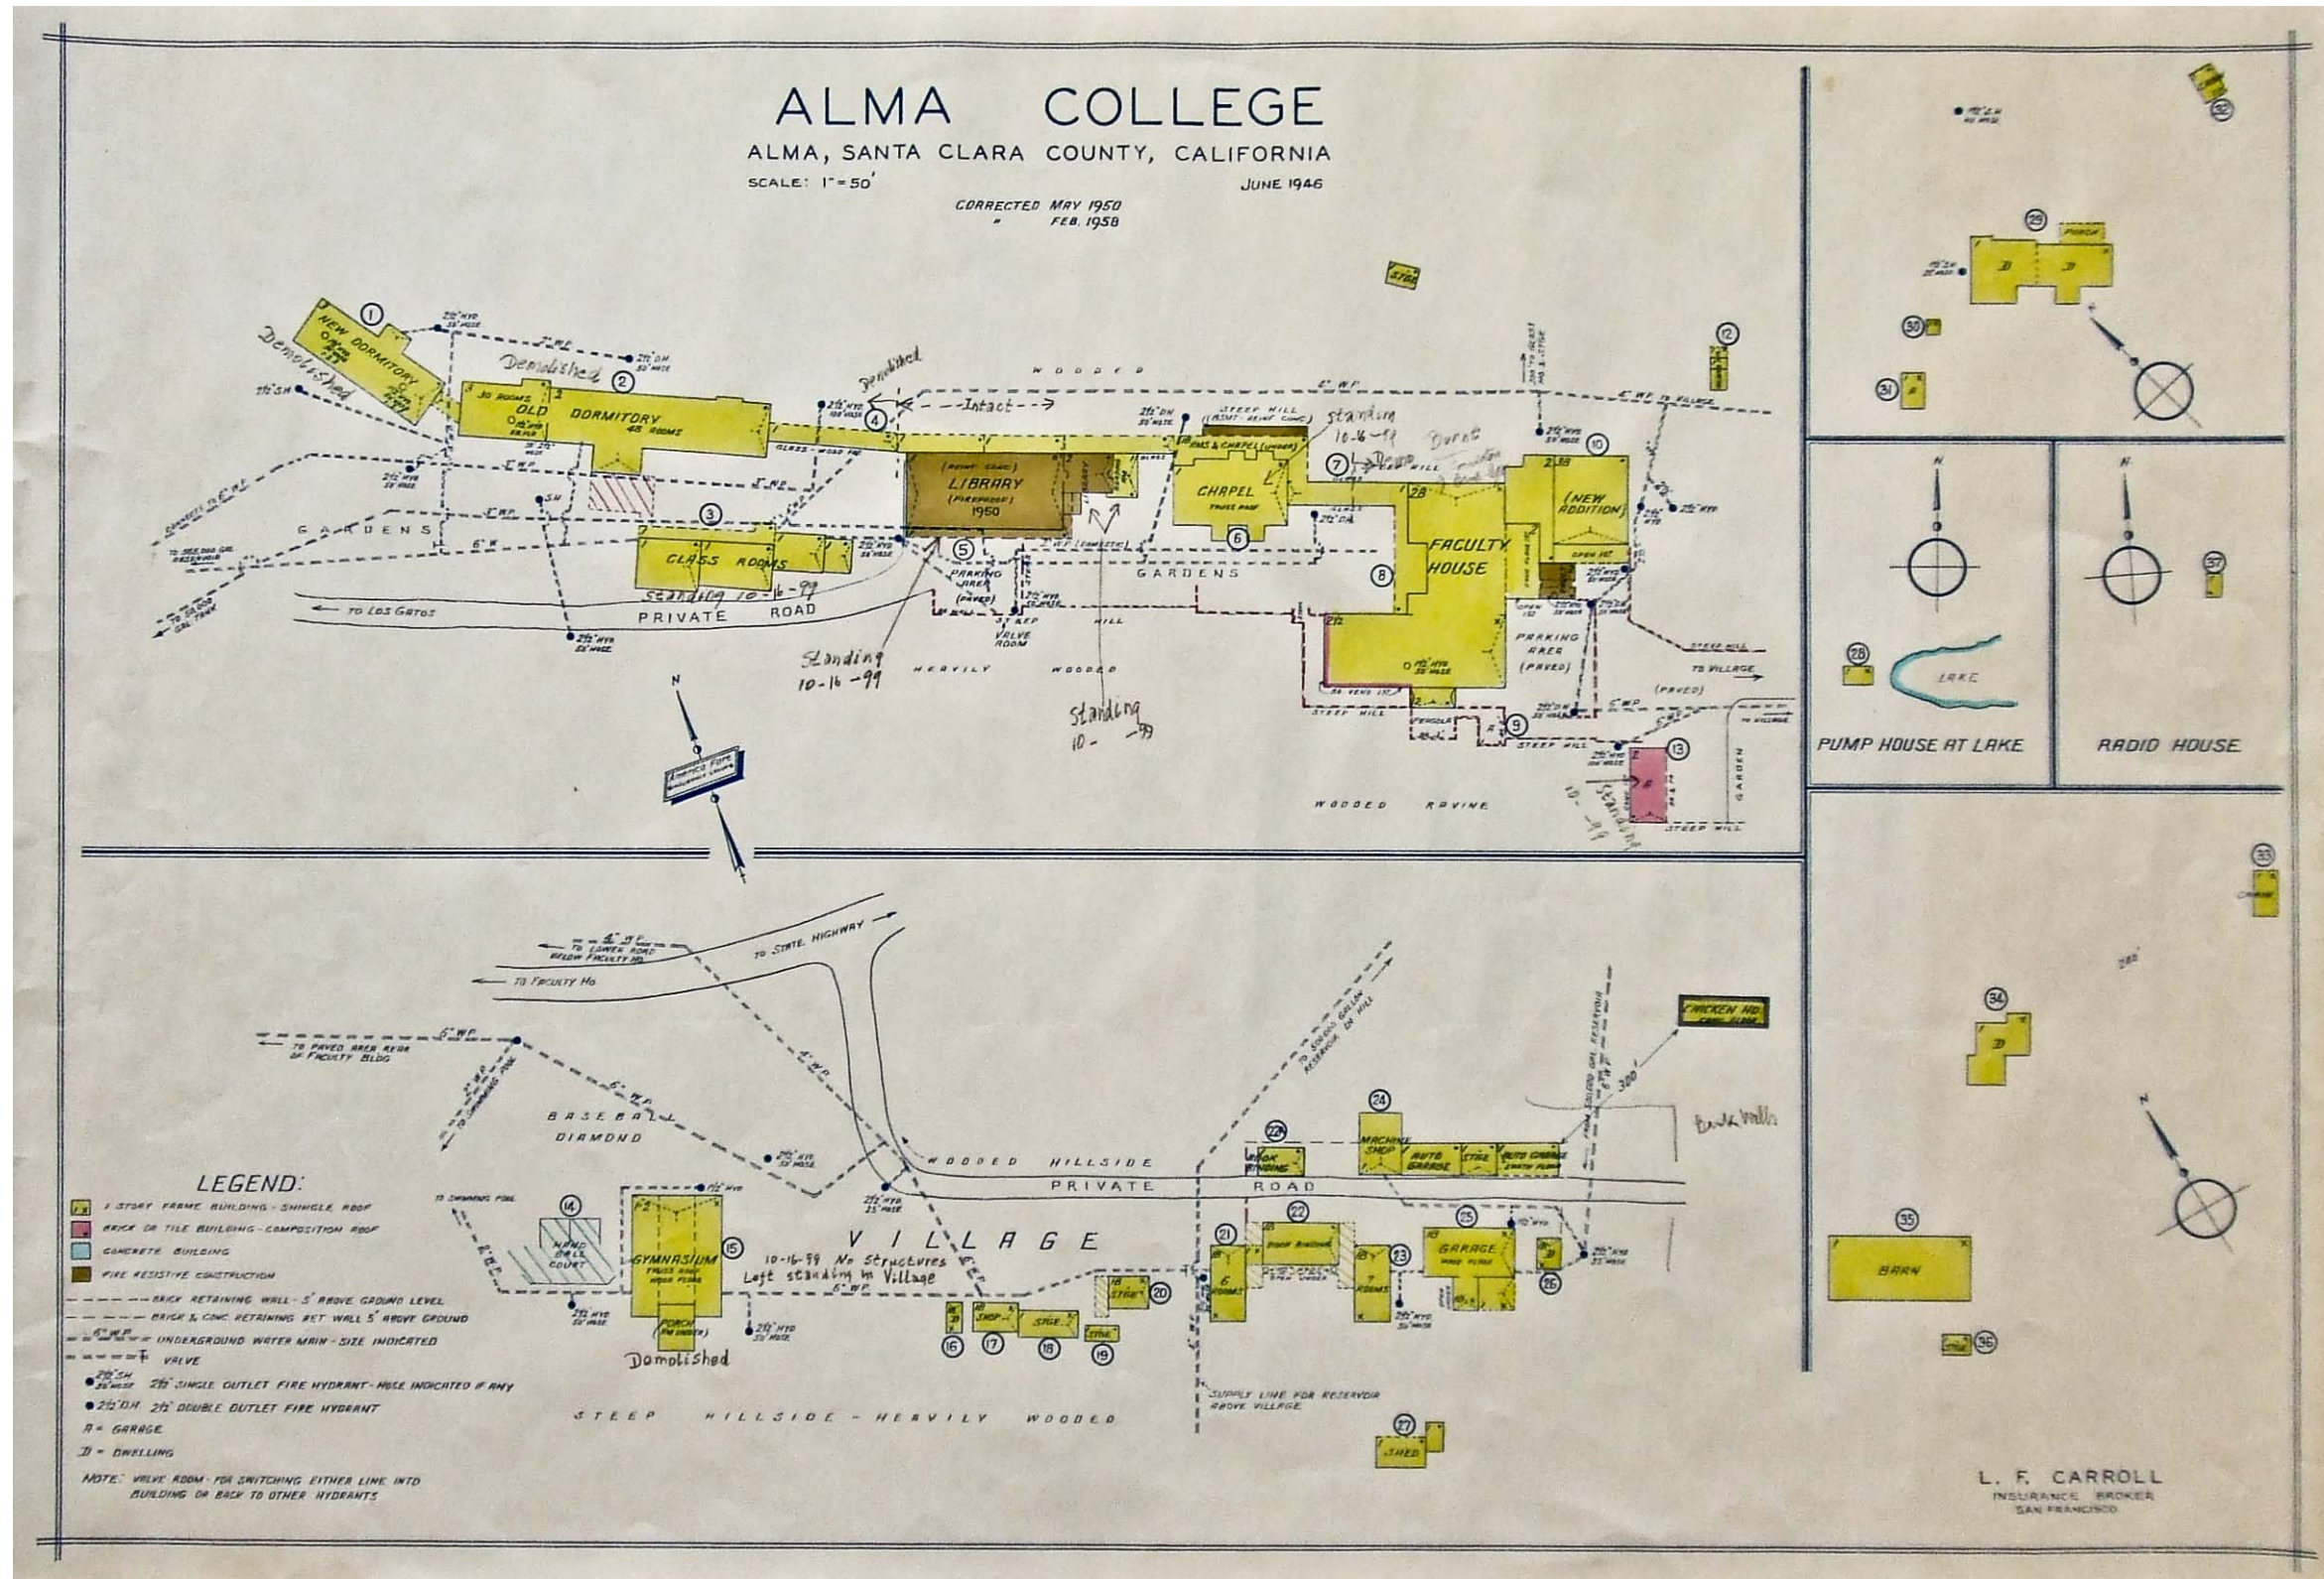
Alma College Fire Insurance Map. The map is dated last in 1958 but subsequent hand notations of condition were made in 1999. (L.F. Carroll, Insurance Broker. *Alma College, Alma, Santa Clara County, California (Map)*, 1958. California Jesuit Archives, Santa Clara. Alma College File.)
