**ALMA COLLEGE CONDITIONS ASSESSMENT PROJECT**  
Midpeninsula Regional Open Space District  
Santa Clara County, CA

Phase I: Assessment of Existing Conditions

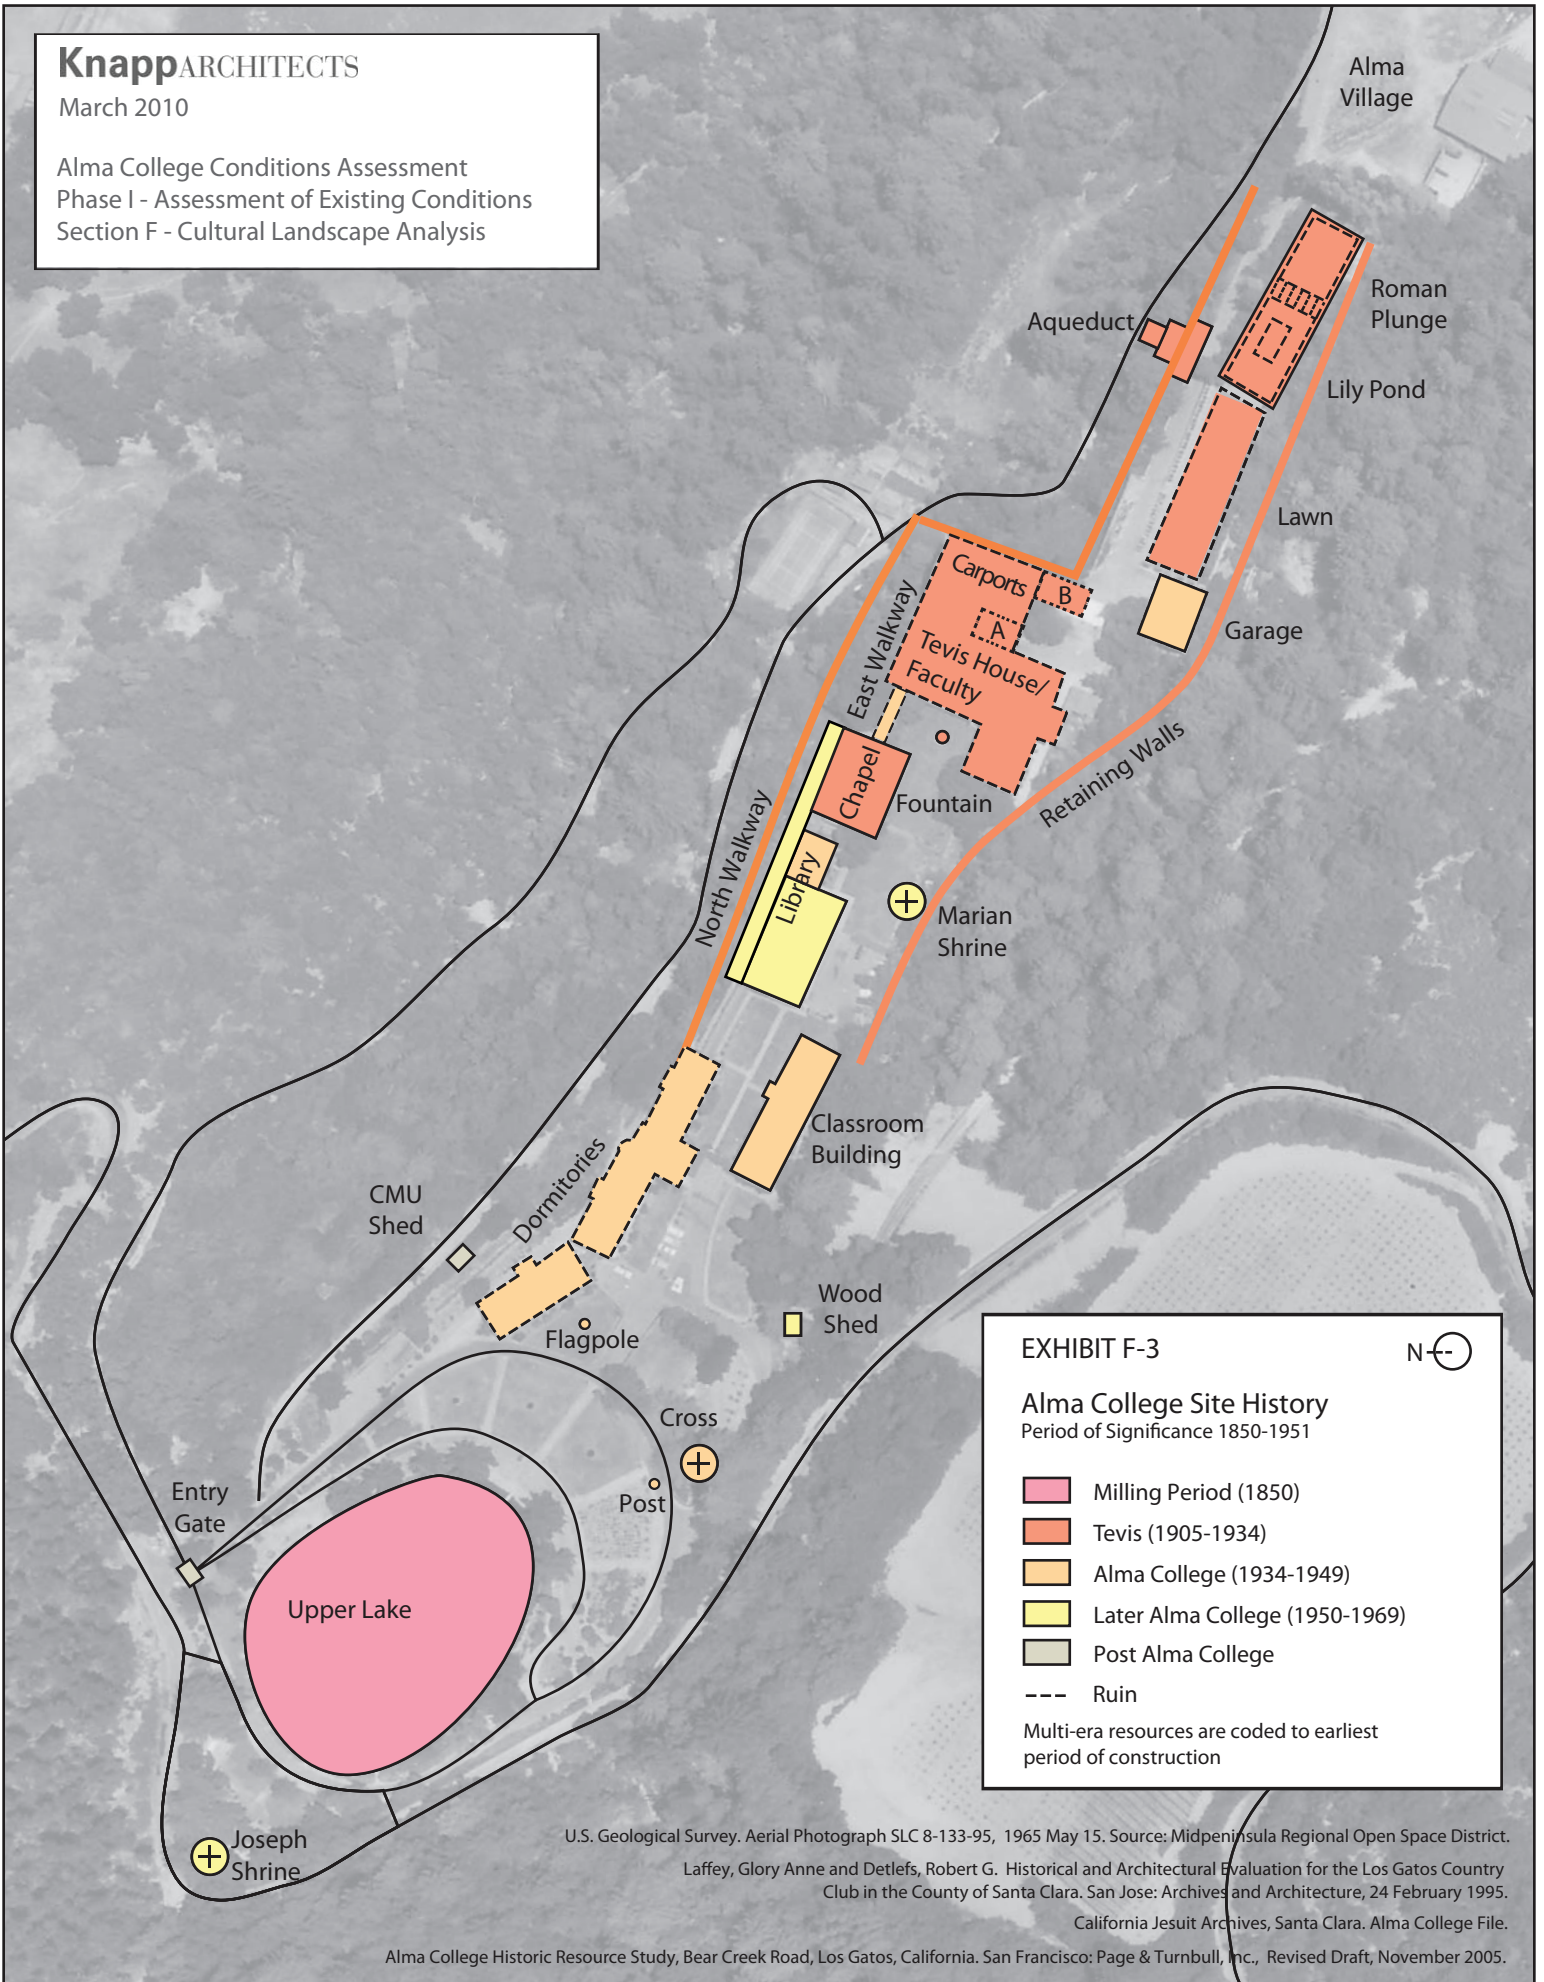
U.S. Geological Survey. Aerial Photograph SLC 8-133-95, 1965 May 15. Source: Midpeninsula Regional Open Space District.

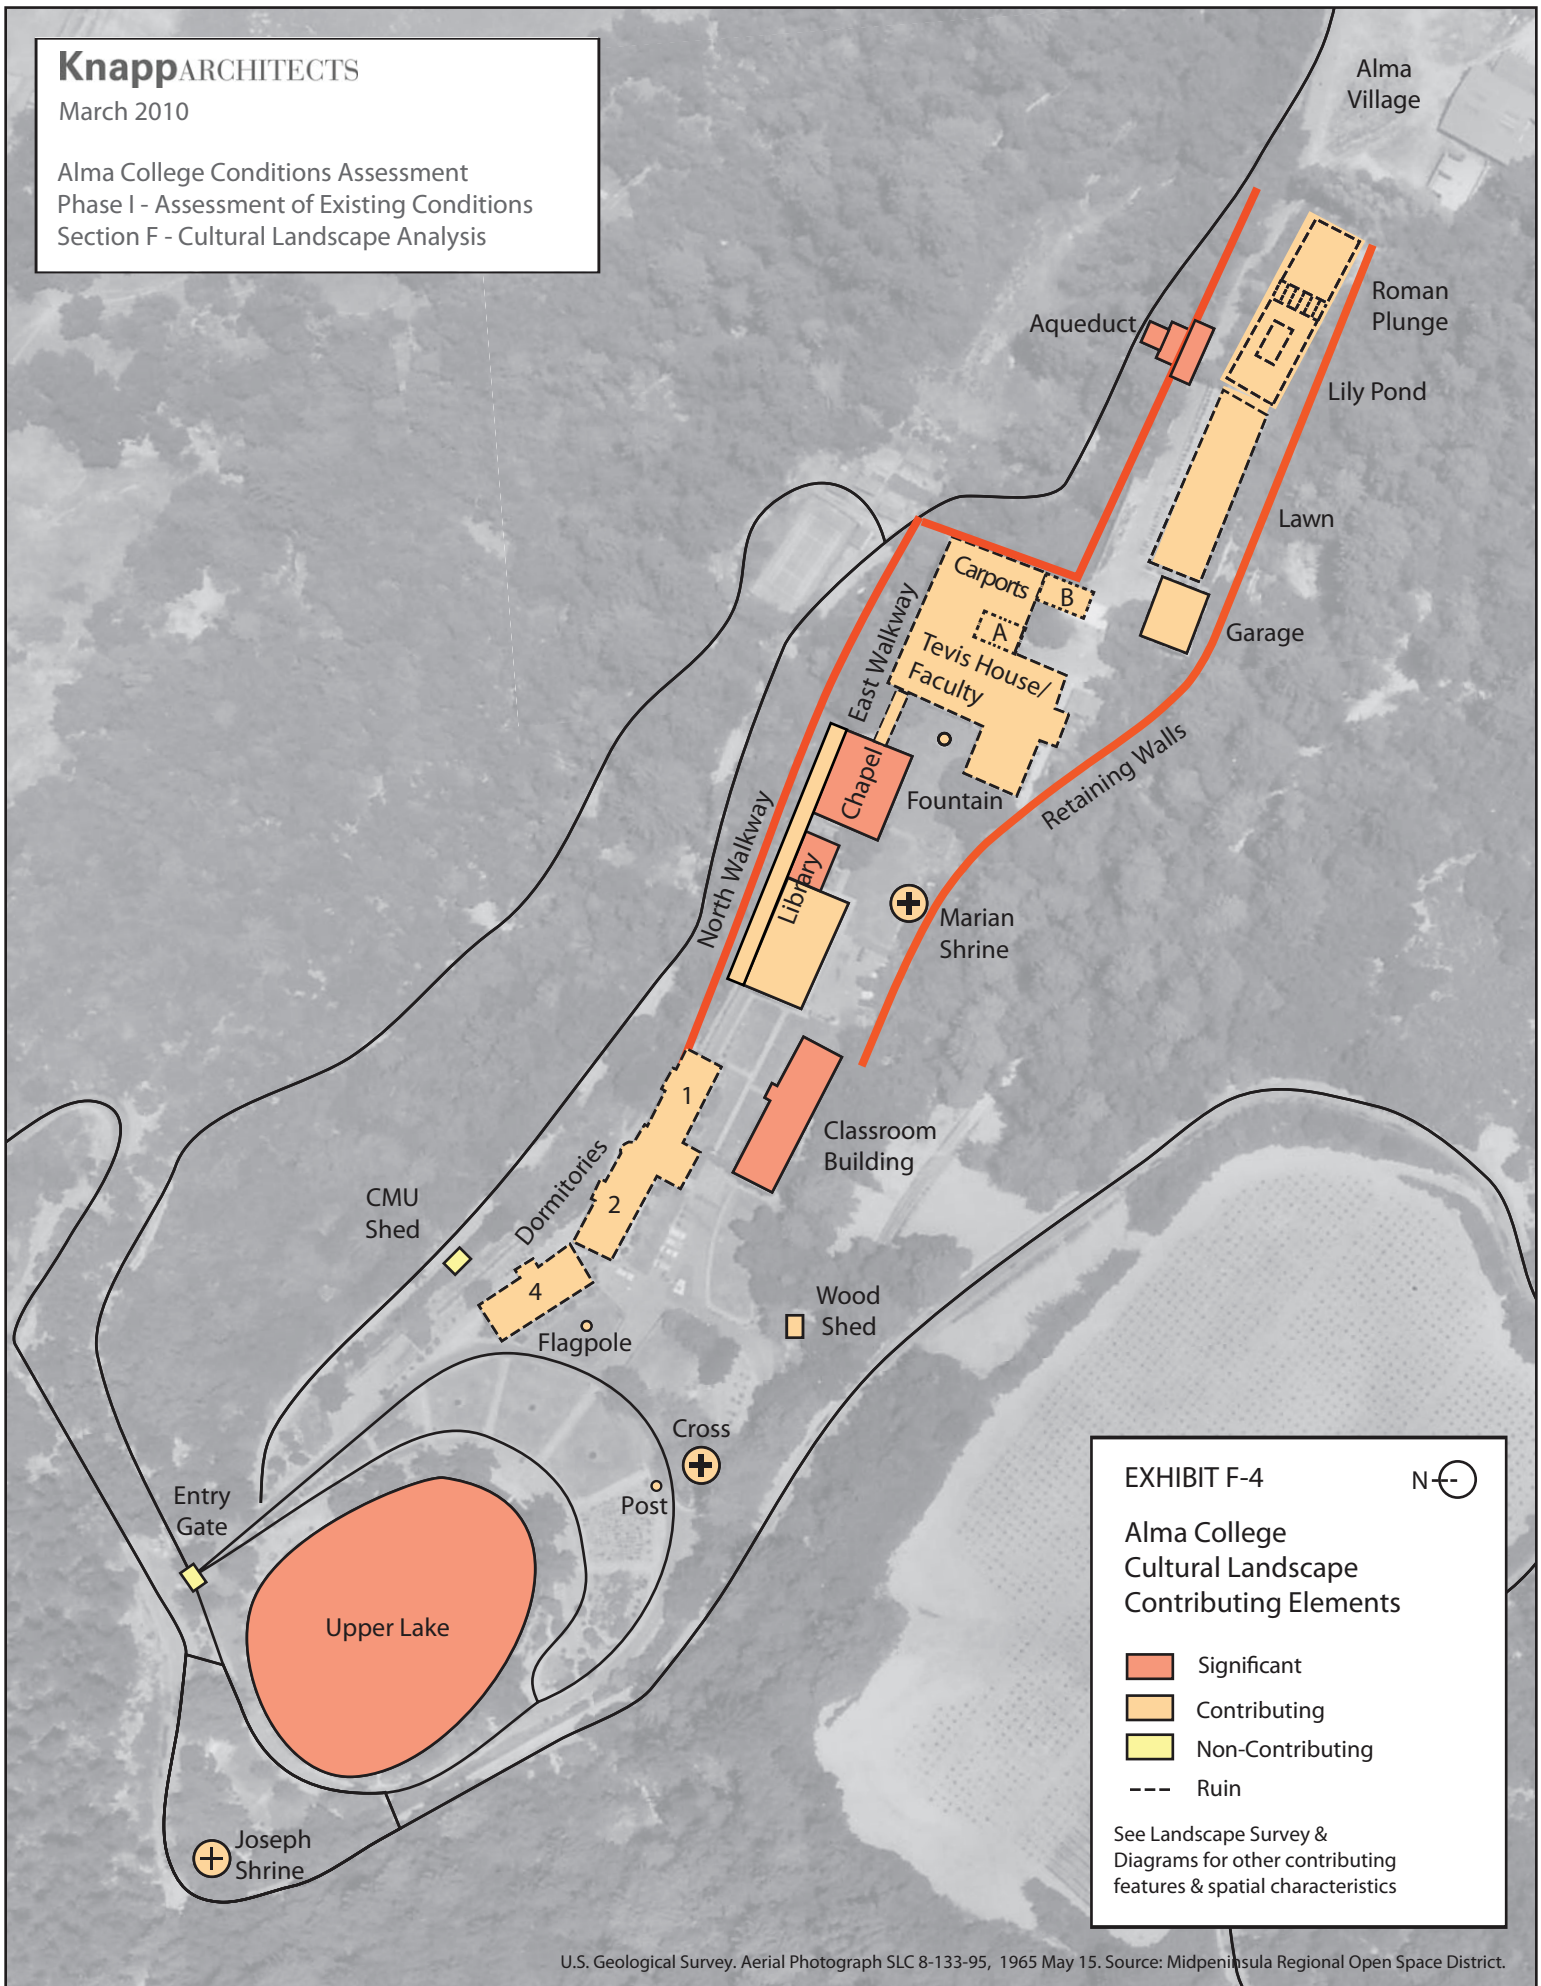
Alma College Conditions Assessment  
Phase I - Assessment of Existing Conditions  
Section F - Cultural Landscape Analysis
