Midpeninsula Regional  
Open Space District

R-23-88  
Meeting 23-19  
July 26, 2023

La Honda Creek Open Space Preserve - Forest Health Project

## Forest Assessment

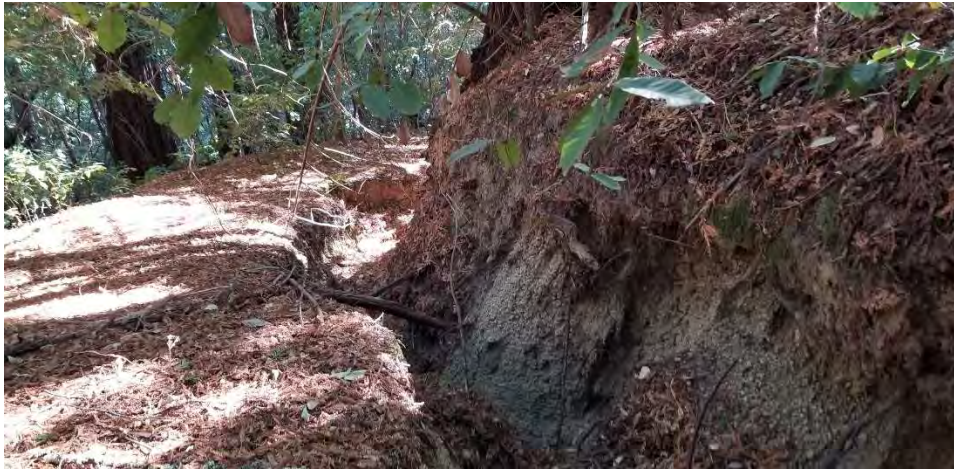
Photo 2: Gully from diverted watercourse down skid trail

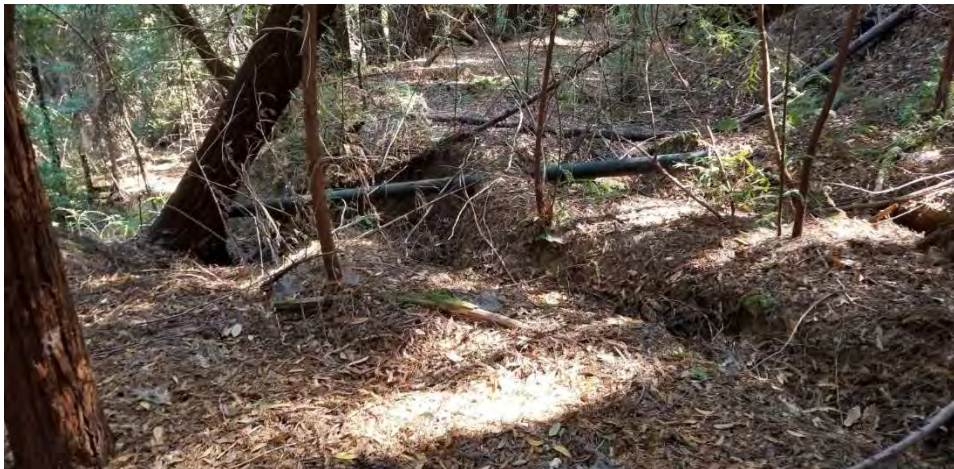
Photo 3: Partial washed out fill crossing

Based on our field review we estimate that there may be 500 cy of fill material still residing at the crossing. Because of site geometry this is a rough estimate and subsurface exploration would be required to confirm this estimate. We estimate that the two gullies indenting the fill embankment combined have eroded

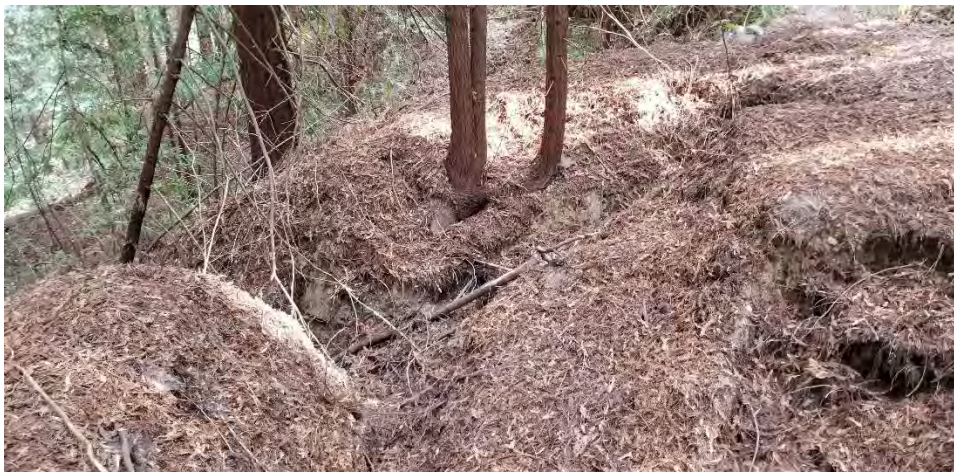
Photo 4: Partially washed out fill crossing

The fill crossing consists of 150 to 250 cy of fill placed about 9 feet deep. Of this material, we estimate that 40 to 60 cy of this material (25% of total) has eroded out over the past 50 years (1.25 cy/yr). Most of this erosion likely occurred early on and has decreased significantly due to the diversion of stream flow at **MP 2** which results in only limited flow reaching the **MP 7** crossing. For the purpose of this study we have assumed an average erosion rate of 0.65 cy/yr which is about half the historic average.

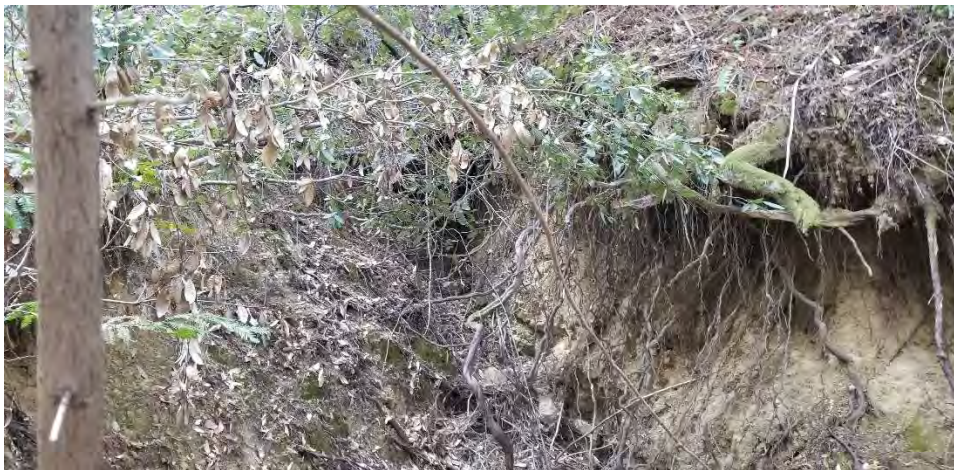
Photo 5: Gully in steep cutbank from diverted stream flow originating from MP 1 and MP2

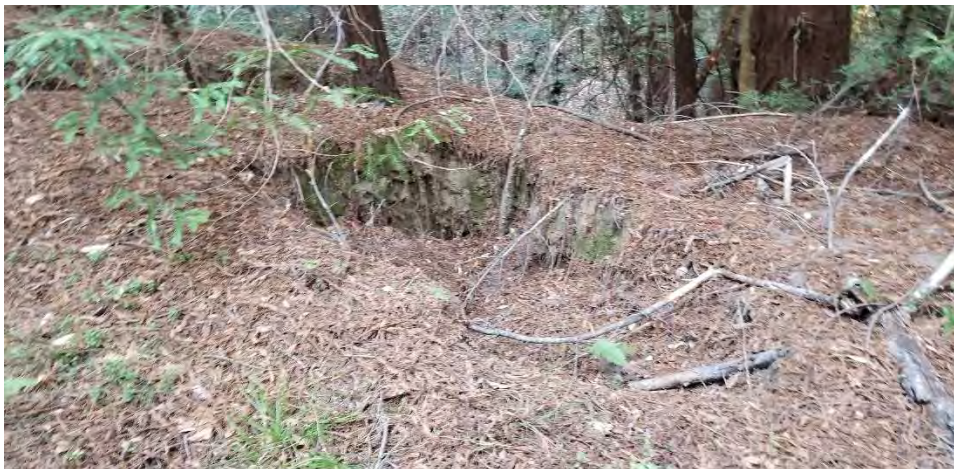
The landing is about 80 feet long and 35 feet wide, and constructed by cutting in to the 45% gradient hillside on cut and fill. A narrow tractor road traverses the hillside just below the landing. Currently streamflow is diverted 200 feet down the road to the east where it discharges into the eroding fill crossing at **MP 9**. In the past, stream flow had drained across the landing and lower skid trail where it had eroded narrow gullies into the fill embankments. We observed a couple of small sink holes in the tread of the skid trail indicating some subsurface soil piping may be occurring.

Photo 6: Sinkhole due to subsurface soil piping

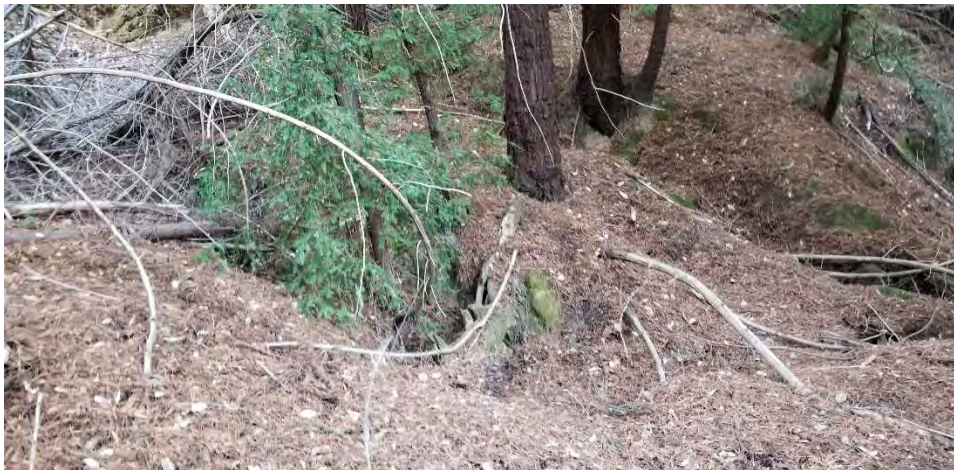
The Class III watercourse drains a 13-acre forested watershed. The active stream channel is approximately 2 to 3 feet wide with an average 25% channel grade. The crossing consists of approximately 120 to 250 cy of fill placed about 6 to 8 feet deep. The crossing is overtopped by 5 to 6 feet (~120 cy) of landslide debris originating from an upslope debris flow.

Photo 7: Two gullies at partially washed out watercourse crossing. The upper gully is from diverted stream flow coming down from MP8. The lower gully is from the watercourse.

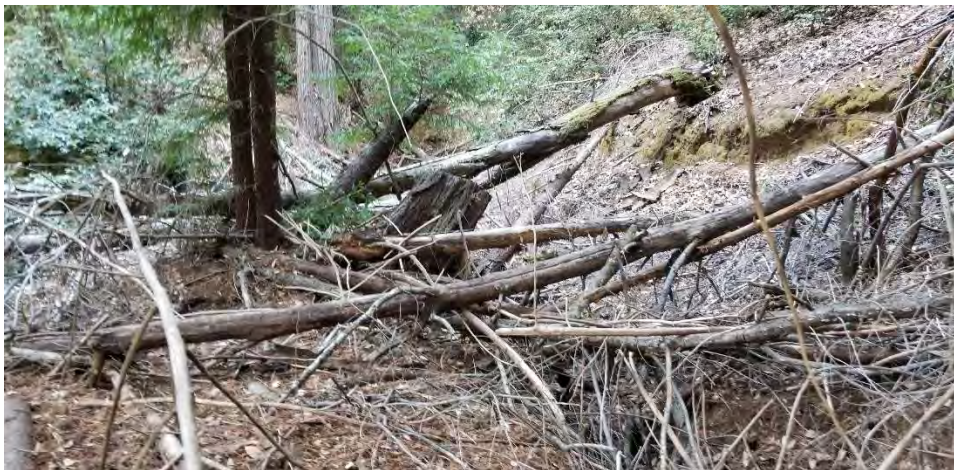
Photo 8: Looking upstream and slide debris deposited in the crossing. The stream is located right of center in the photo.

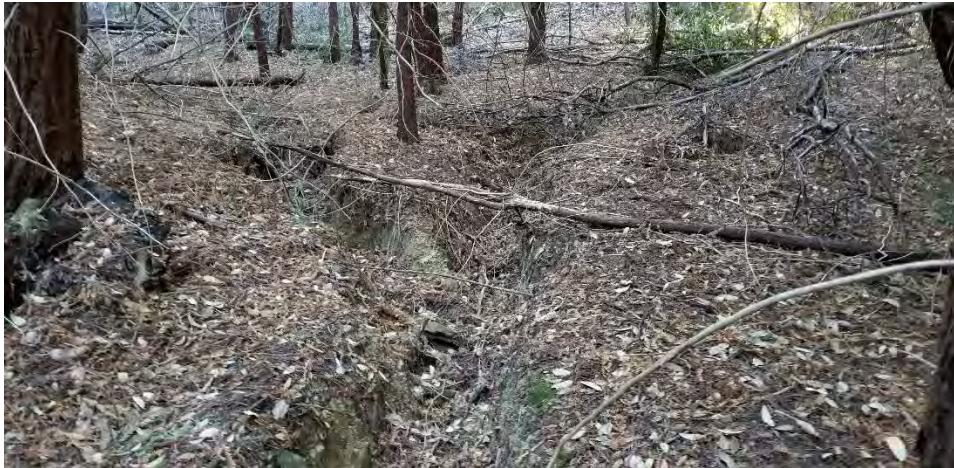
The combination of a lack of drainage structures at **MP 11** and the construction of the downstream landing resulted in the combined streamflow from **MP 10** and **11** to be diverted 450 feet down the road resulting in locally extensive gulying of the road prism. For the first 250 feet of the diversion the gully is modest in size averaging about 4 to 6 feet in width and 2 to 4 feet in depth. After this location at **MP 12**, the road grade steepens slightly and the gully becomes much more deeply incised at 10 to 20 feet in width and 7 to 12 feet in depth, and with little of the road tread remaining. As will be discussed at **MP 12**, the combination of the deep gulying and very steep (90%) sideslopes significantly constrains the feasibility of reopening the road past this location.

Photo 9: Diverted stream at MP 12. The left channel is the watercourse at MP12, the right channel extending up the road is from diverted flow from MP 10.

Overall, we estimate there has been 800 to 1,200 cy of combined erosion over the past 50+ years (15 to 25+ cy/yr) from **MP 10, 11** and **12** with the rate of erosion having decreased as the gullies have down cut into more stable material. We estimate the rate of future erosion at 10 to 15 cy/yr or about  $2/3$  the historic rate.

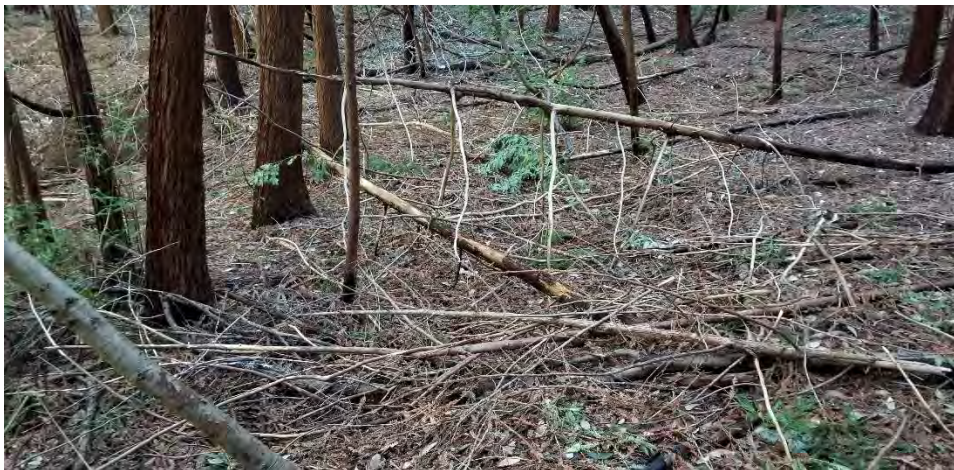
It appears that only limited grading was required to construct the road across the bench, though fill generated from the construction of the road across the steeper side slopes may have been pushed over the edge within the axis of the drainage. It is unknown how much fill material resides at the site, if any, but could be as much as 100 to 500 cy. Subsurface exploration will be required to more precisely determine the amount and level of stability of the fill material.

Photo 11: Looking east across bench. The gully at the outer edge of the road is barely visible behind the trees on the left side of the photo. The very subtle arcuate escarpment is also barely visible in the middle of the photo.

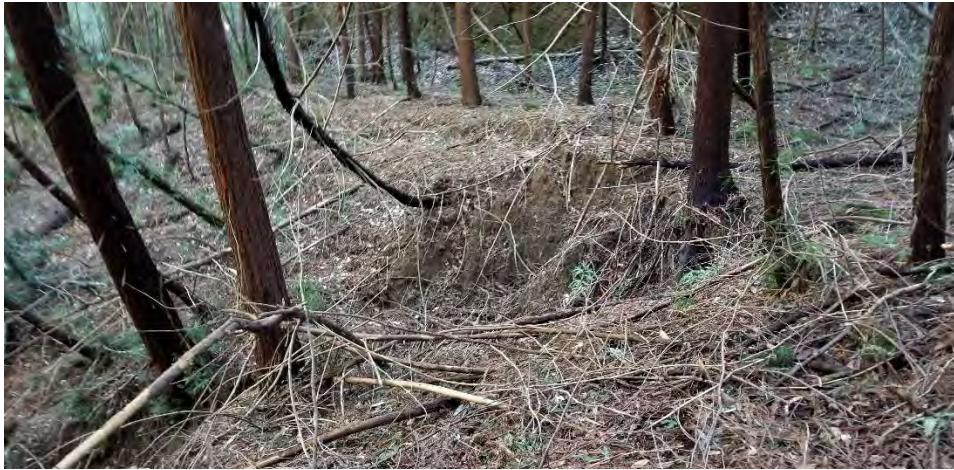
Photo 12: Looking east across the head of the gully eroded into the edge of the bench.

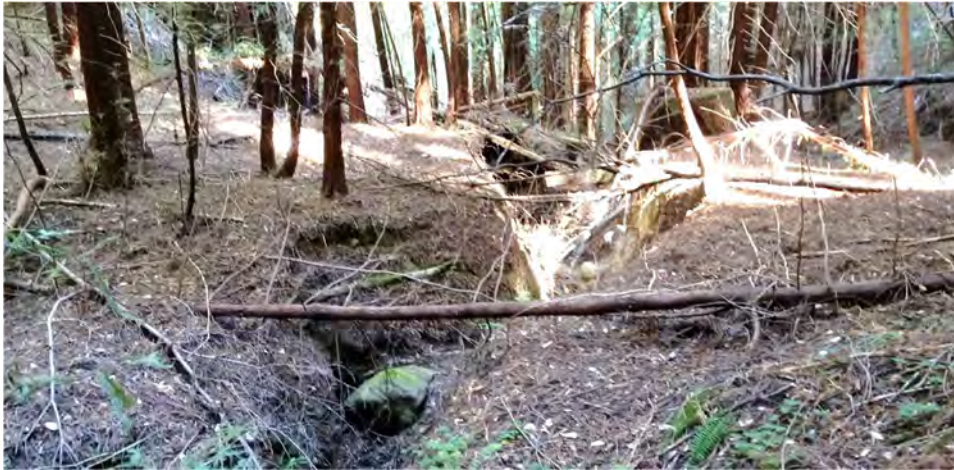
Presently the Class II watercourse flows in a shallow channel over the debris flow deposit of intermixed wood and sediment before reaching the upstream end of the Humboldt crossing. From there the stream has eroded an 80-foot-long, 5 to 15-foot-wide, 4 to 10-foot-deep channel across the old roadway, before draining underneath a root wad and across some stacked logs at the downstream end of the crossing. The road gully to the south of the crossing currently receives runoff from the small Class III tributary, adjacent sideslopes, and intercepted groundwater. The current rate of erosion within the gully appears low.

Photo 13: looking downstream at the partially washed out Humboldt crossing. Stream flow drains underneath a fallen stump just to the left of the eroded channel.

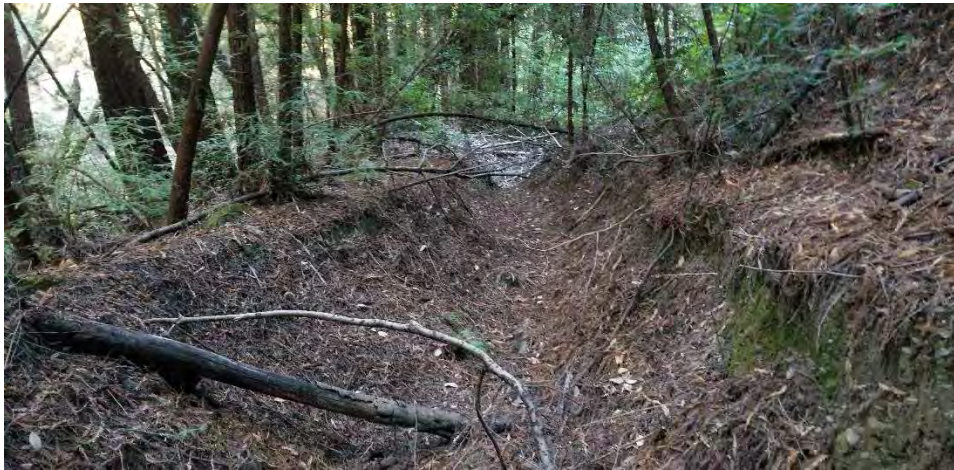
Photo 14: looking down the road at the eroded channel from diverted stream flow. This photo was taken along the lower portion of the gully where the incision is much greater. Note the heavy duff layer in the channel bottom.
