24 June 2013  
Project 770608301

Subject: Geotechnical Summary  
Hawthorns Historic Structures Assessment  
Midpeninsula Regional Open Space District Hawthorns Property  
Portola Valley, California

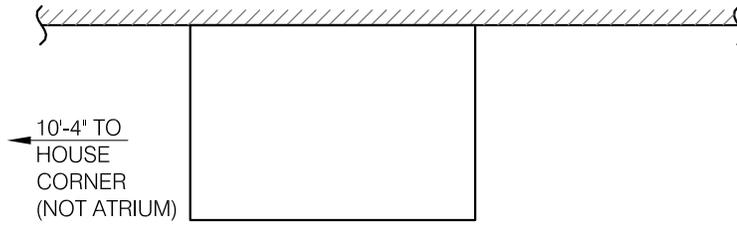
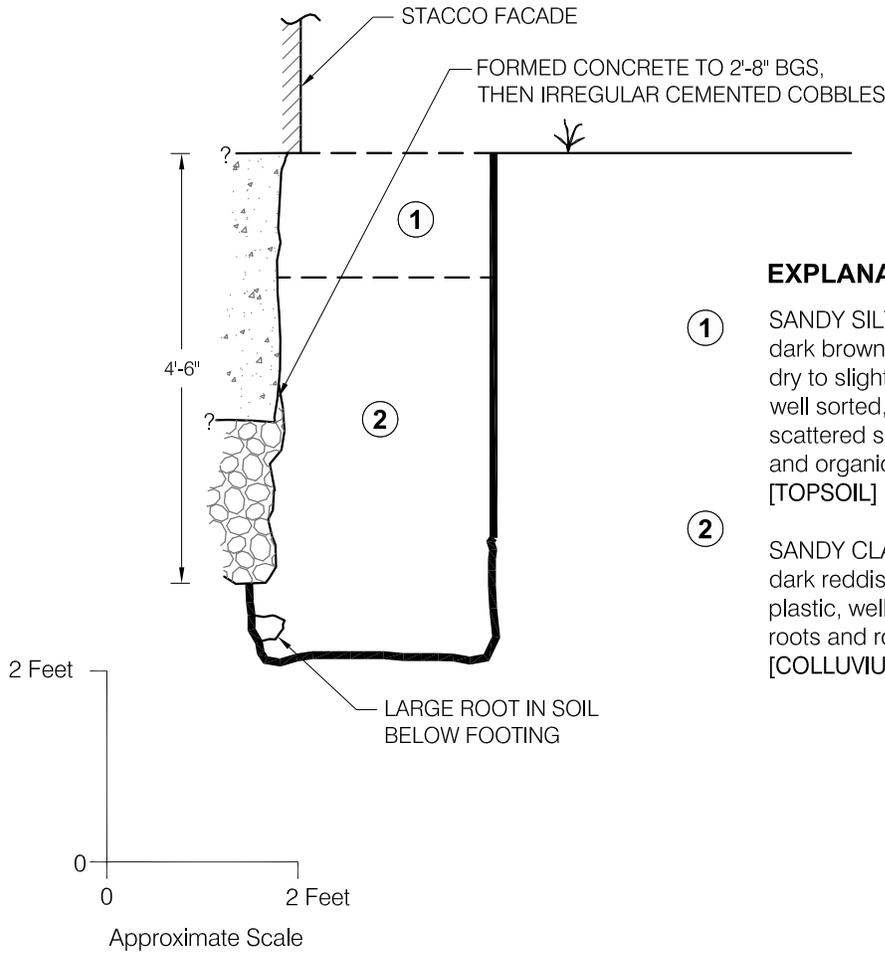
Two test pits designated TP-1 and TP-2 were excavated adjacent to the exterior footings of the Mansion, at the approximate locations shown on Figure 1a. The pits indicate that the footings extend about 3 feet 8 inches to 4 feet 6 inches below grade. The upper 1 foot 4 inches to 2 feet 8 inches appeared to be a formed footing, with firm, friable sandy silt with gravel backfill adjacent to the exterior face of the footing. The bottom of formed footings rest on cemented irregular cobbles that appear to have been placed in a trench into stiff sandy clay and very dense silty sand colluvium

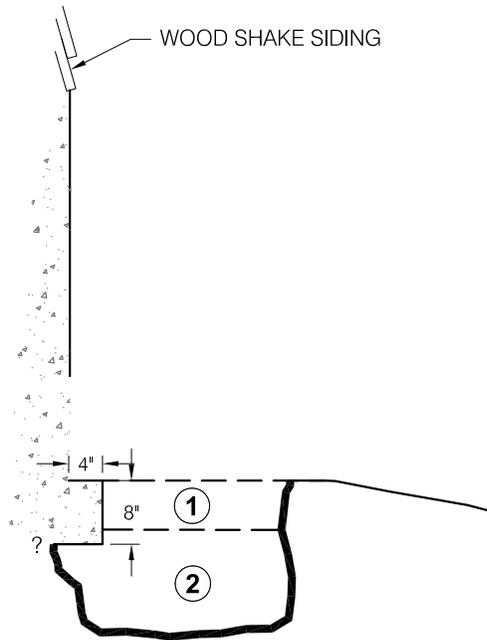
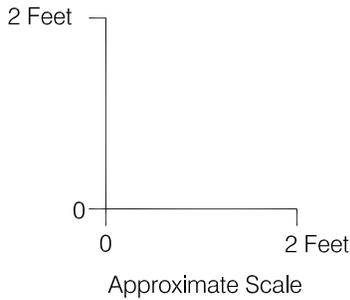
**LOG OF TEST PIT  
 TP-3**

Test pits TP-3 and TP-4 were excavated adjacent to the exterior footings of the Carriage House, at the approximate locations shown on Figure 1b. Test pit TP-3 on the southeast side of the structure within the area of the covered exterior lean-to, appeared to reveal the footing is an inverted "T" shaped concrete footing, embedded 8 inches below the exterior grade. The footing extends through 6 to 7 inches of firm to stiff sandy silt fill, gaining bearing support in stiff sandy silt colluvium. Test pit TP-4 excavated on the southwest side of the structure revealed the footing is about 16 inches below the exterior grade, bottomed on the underlying colluvium. About 16 inches of firm to stiff sandy silt with gravel fill is against the exterior side of the footing.

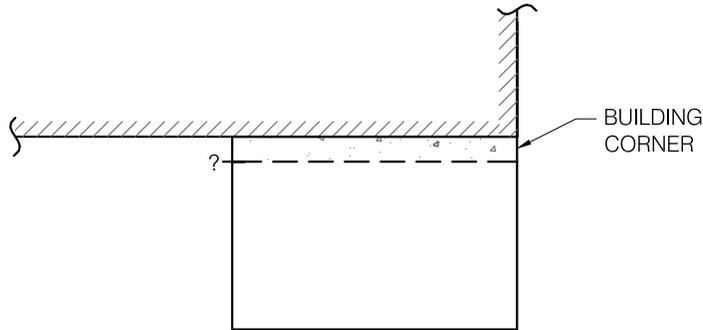
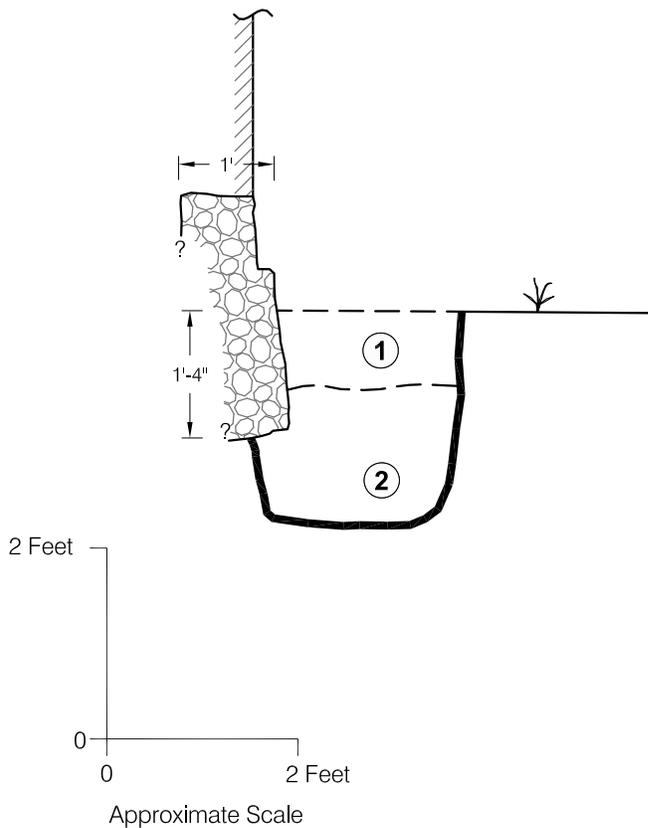
Test pit TP-5, excavated near the left front (southwestern) corner of the Cook House revealed the foundation for this structure consists of a 1-foot wide column of cemented cobbles, extending about 16 inches below grade, and about 7 inches into the underlying colluvium.

Footing = cement cobbles 3/8" to 4" diameter, locally cracked in many places, some roots growing into footing with/in soil in-filled cracks up to 1" wide
