HAWTHORNS HISTORIC STRUCTURES ASSESSMENT

Midpeninsula Regional Open Space District

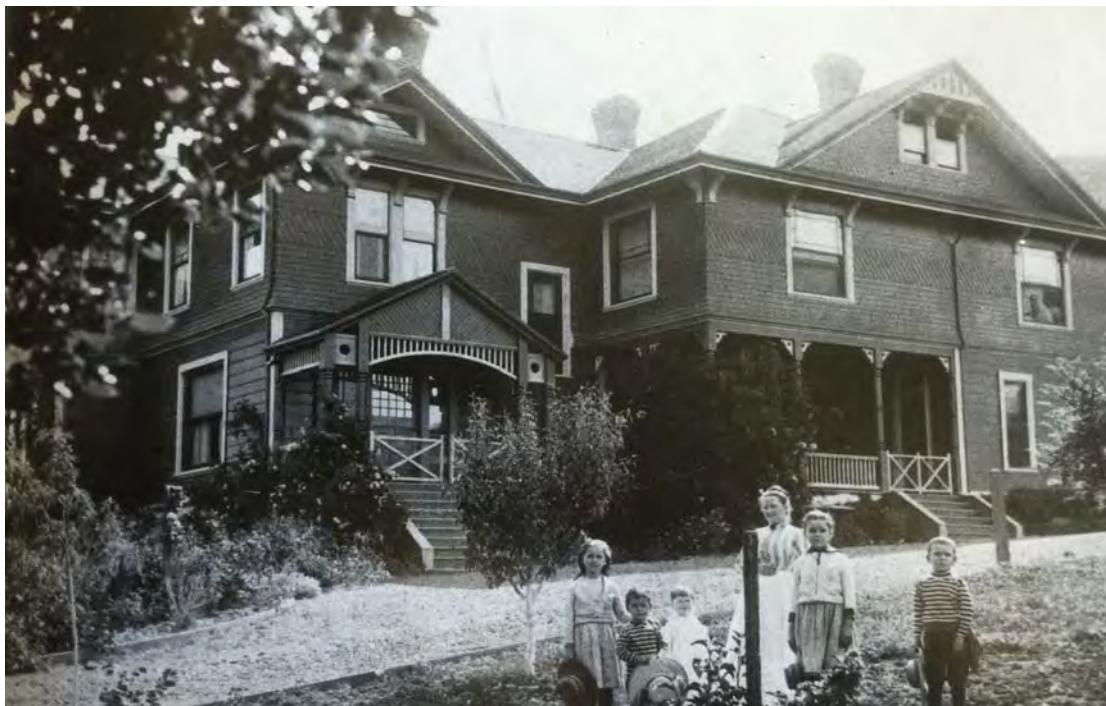
Deliverable 2: Structure Conditions Assessment

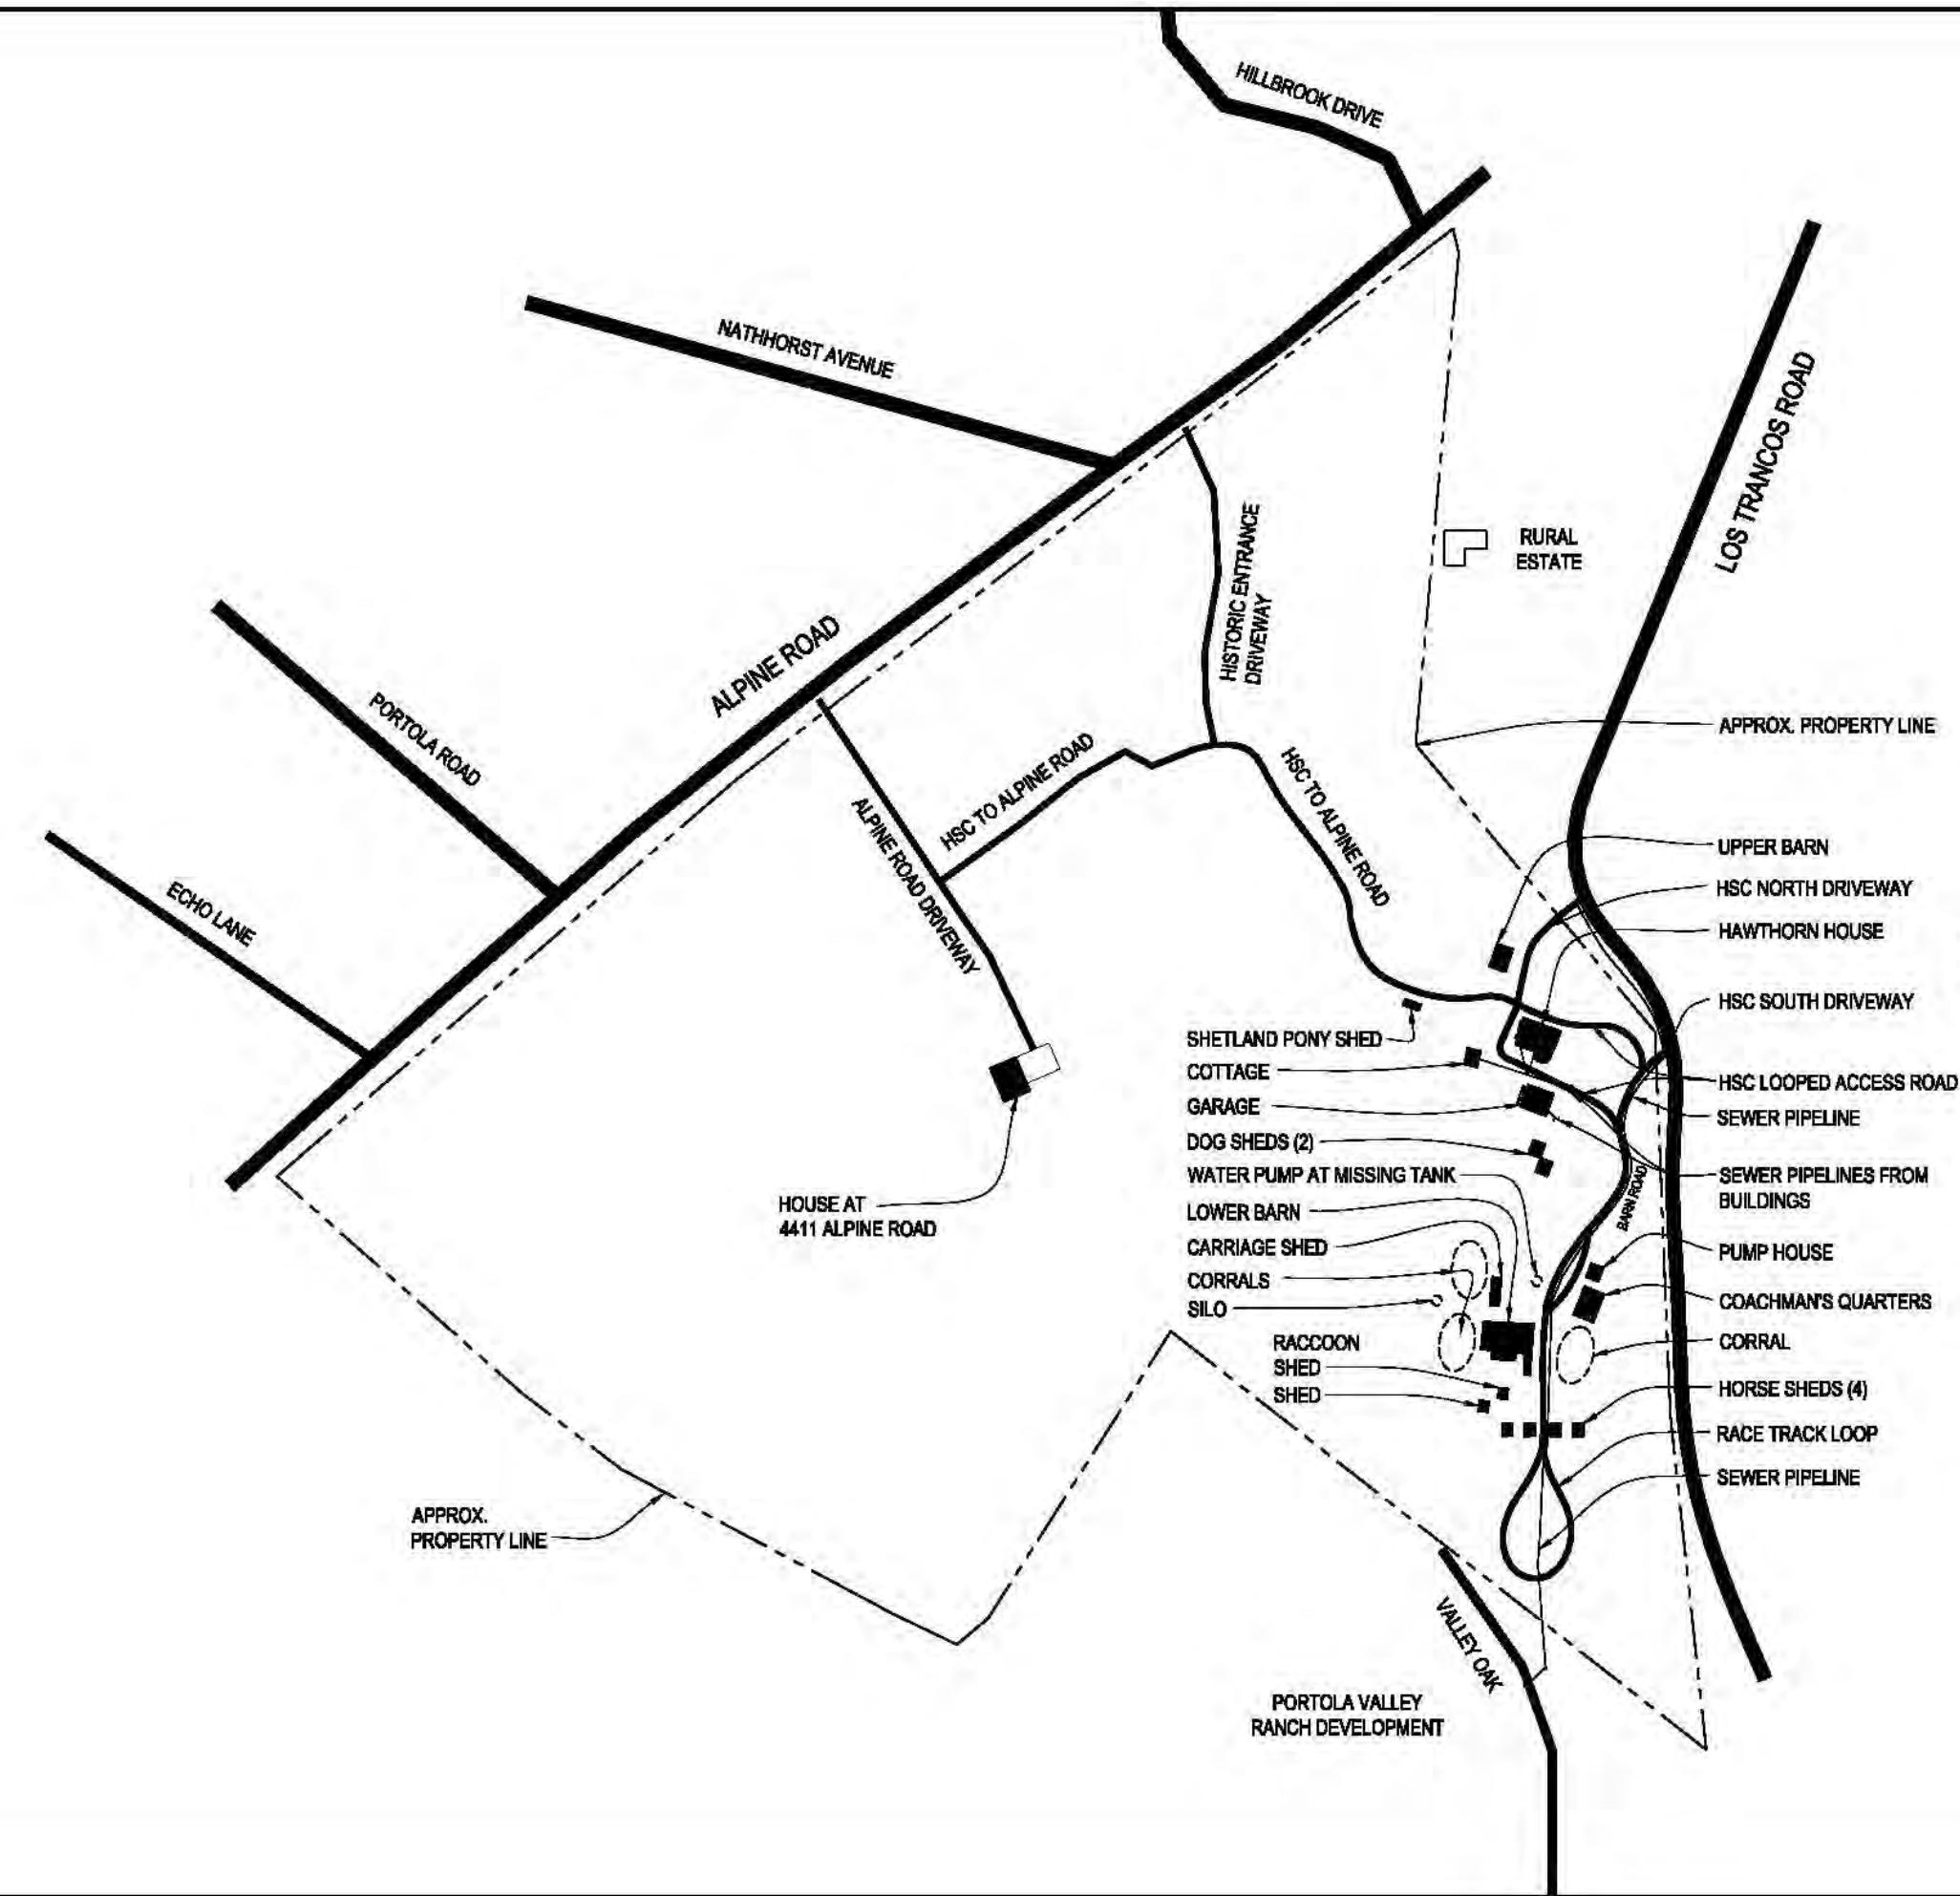
HISTORIC STRUCTURE COMPLEX (HSC)
AT 800 LOS TRANCOS ROAD INCLUDES:
HAWTHORN HOUSE, COTTAGE,
GARAGE, LOWER BARN

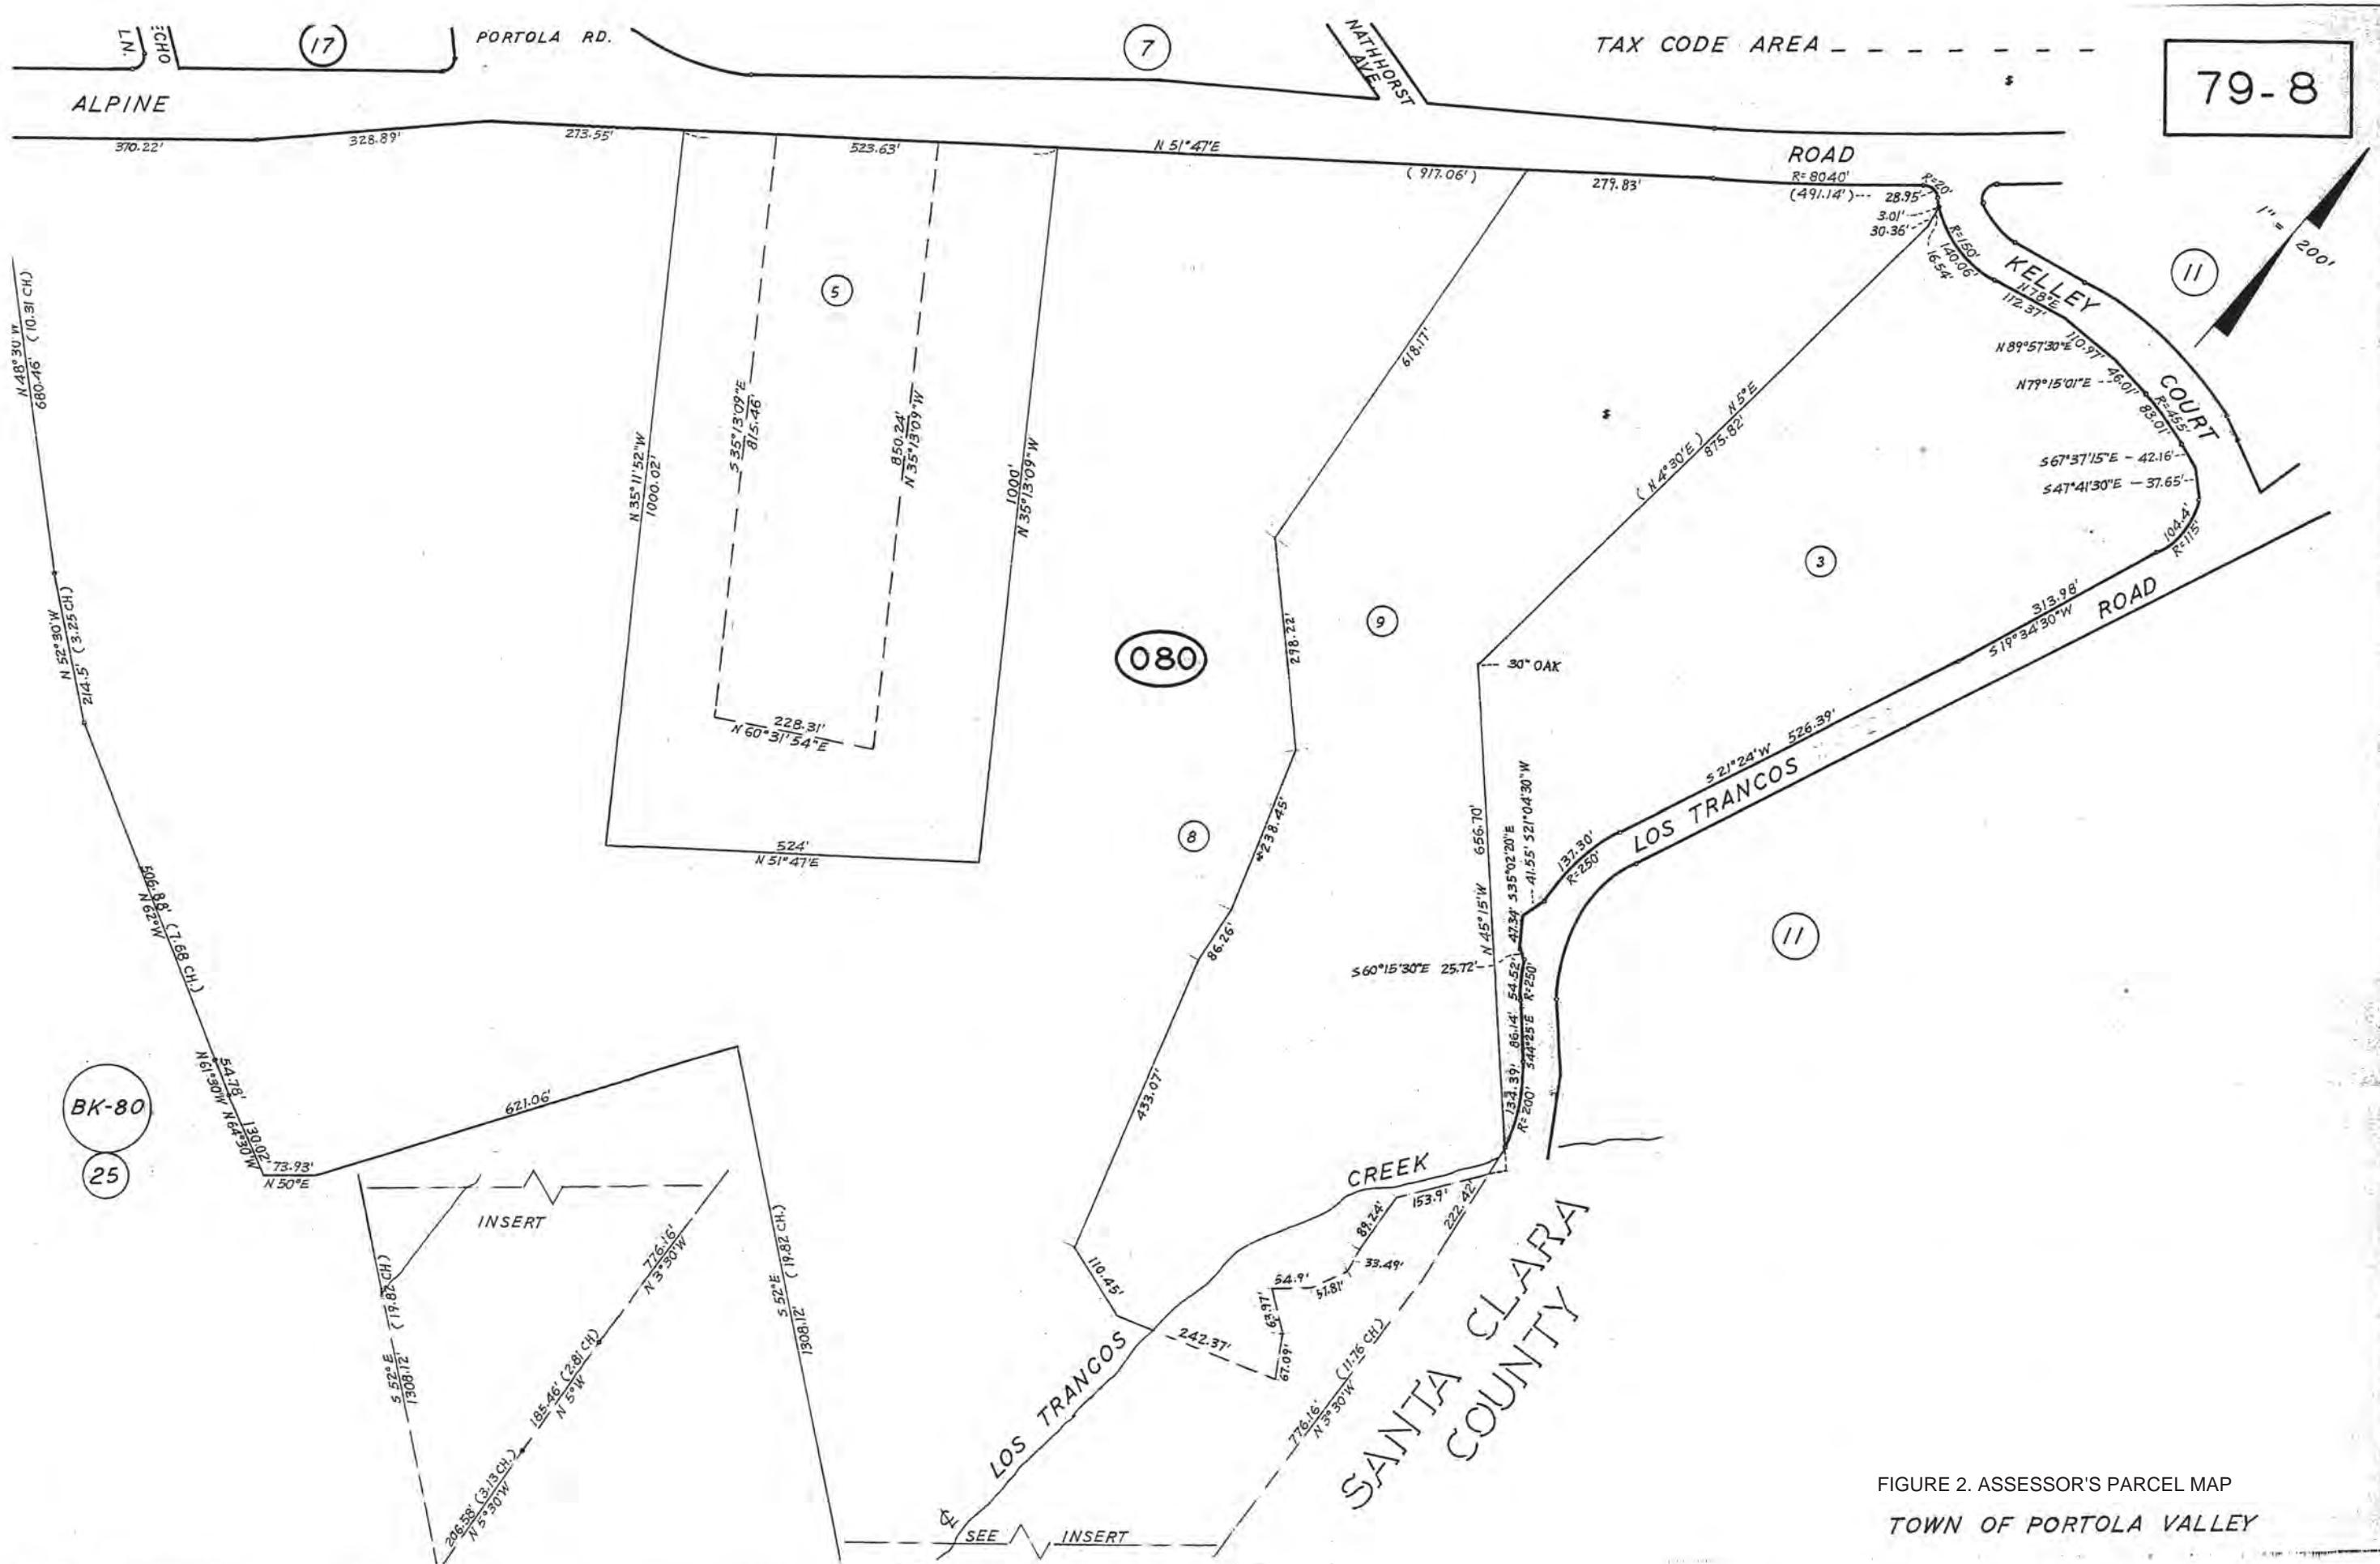
FIGURE 2. ASSESSOR'S PARCEL MAP
TOWN OF PORTOLA VALLEY

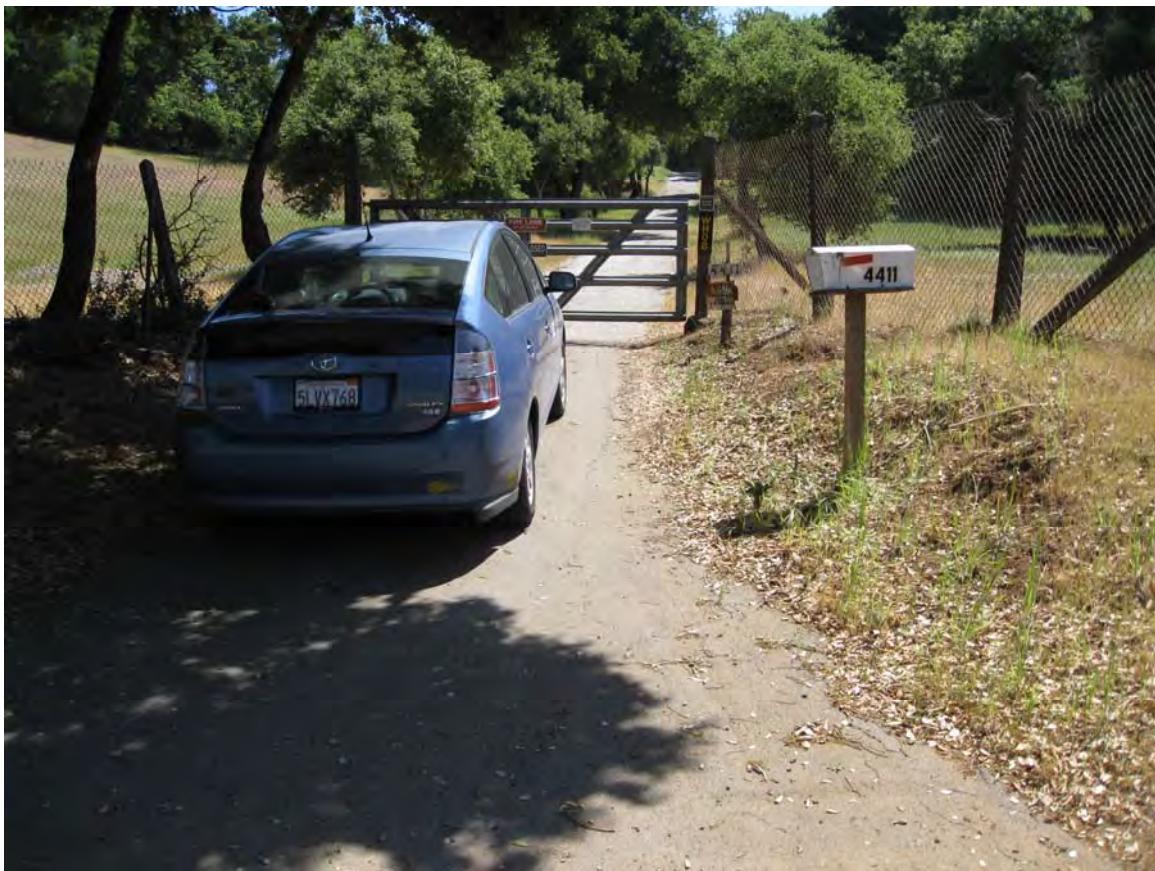
Image 1. Driveway to 4411 Alpine Road residence looking south from Alpine Road.

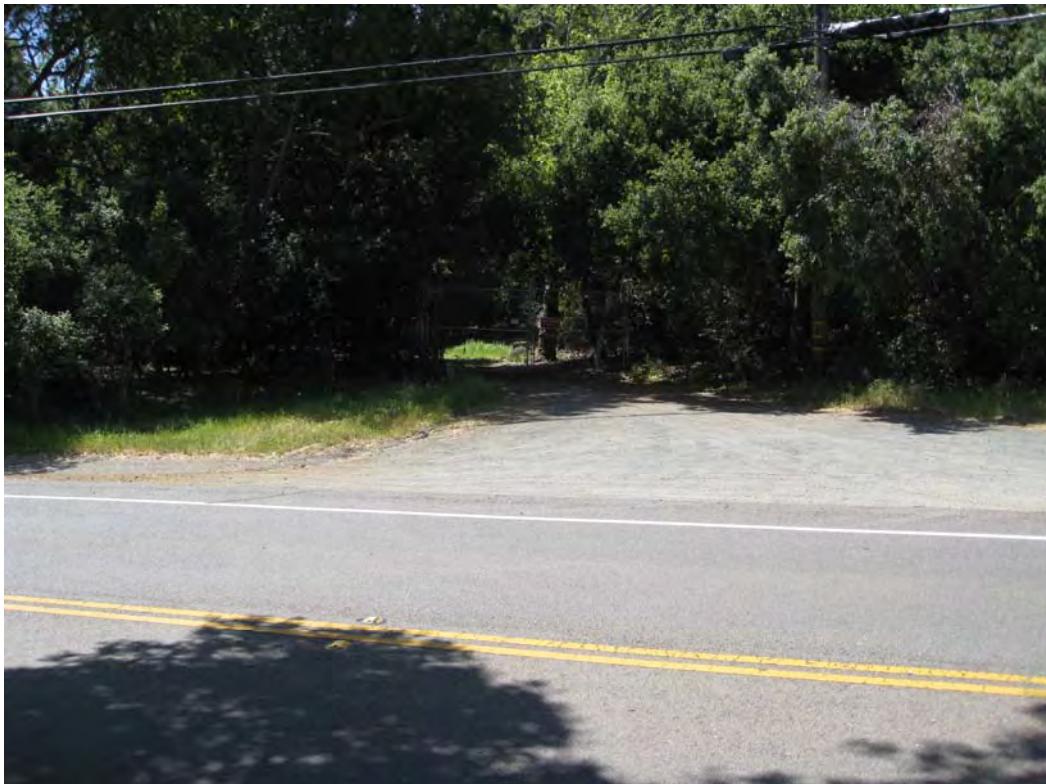
Image 2. View to HSC North Driveway entrance off Los Trancos looking west.

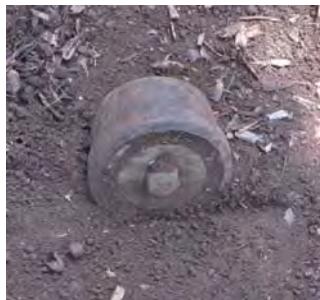
Image 6. Sewer service cleanout in center area between buildings.

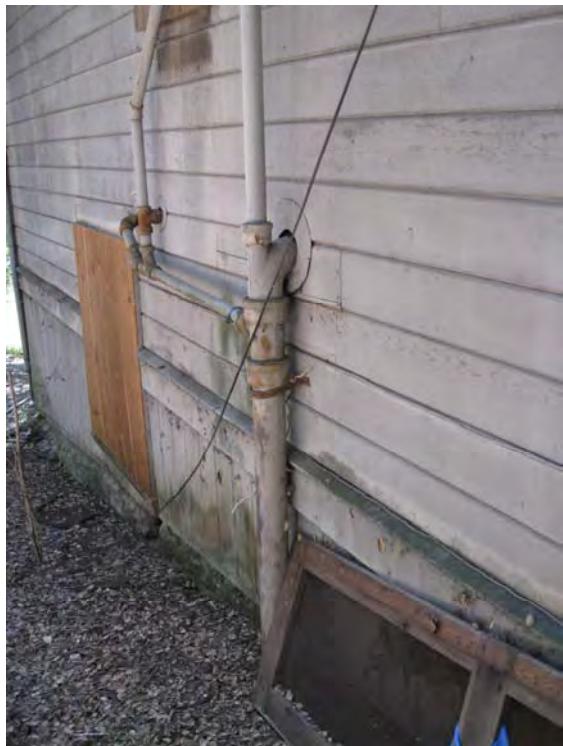
Image 8. Sewer lateral on east side of Cottage

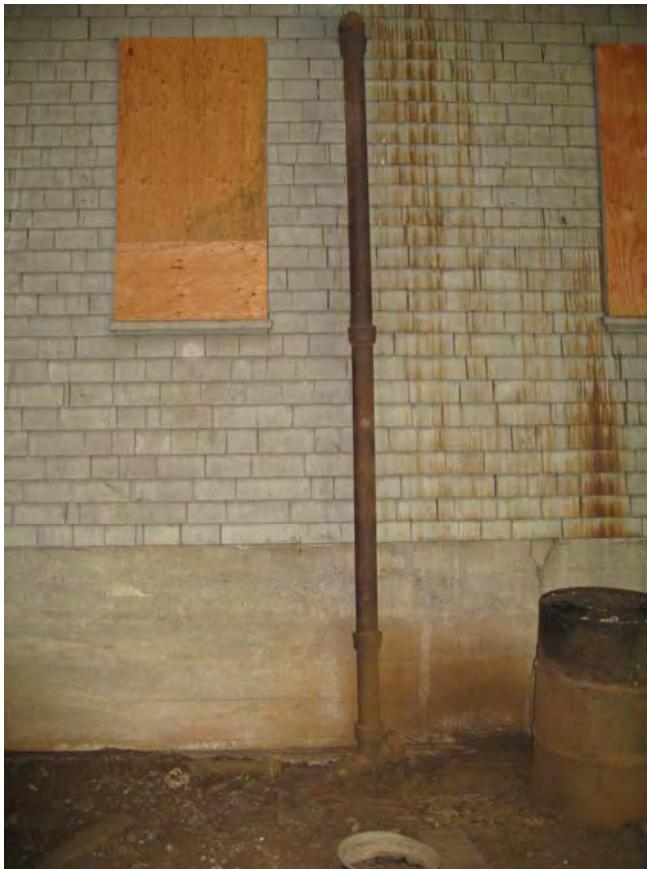
Image 10. Sewer Service at the east Garage façade under the east lean-to addition.

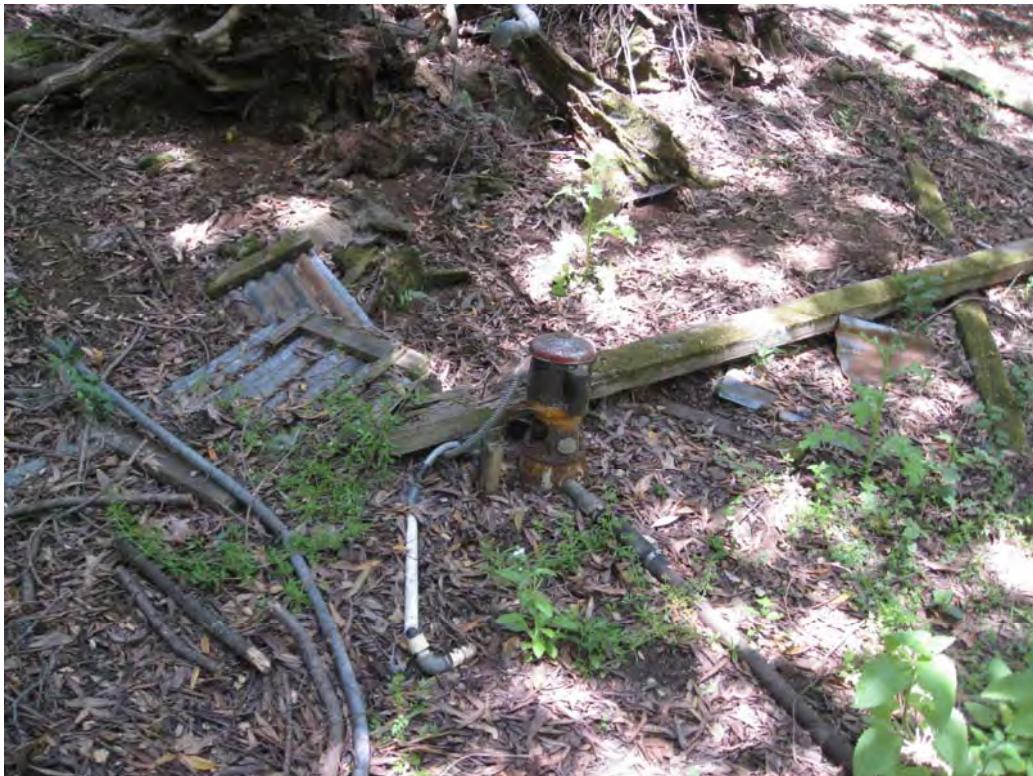
Image 12. Pump well head in wash area just north of the Lower Barn.

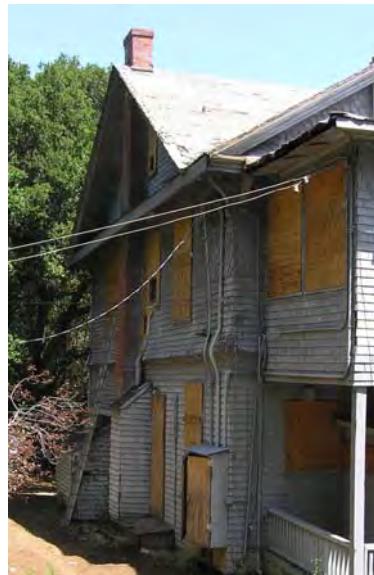
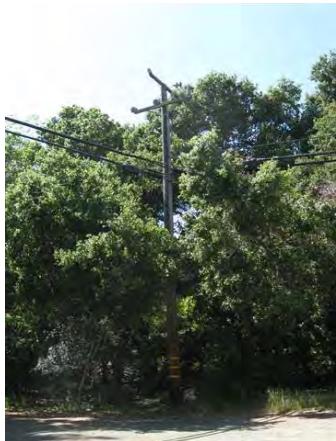
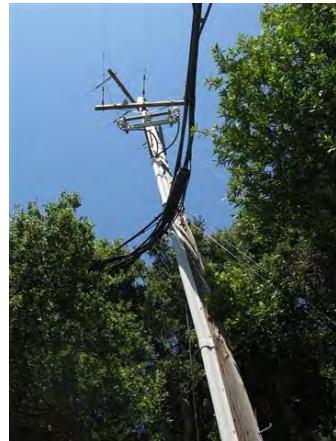
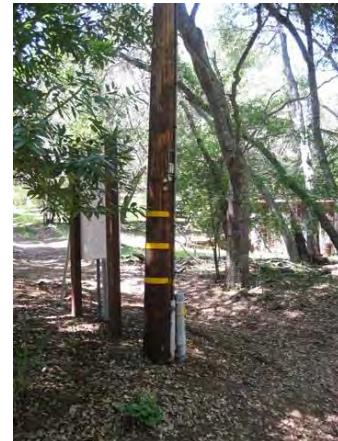
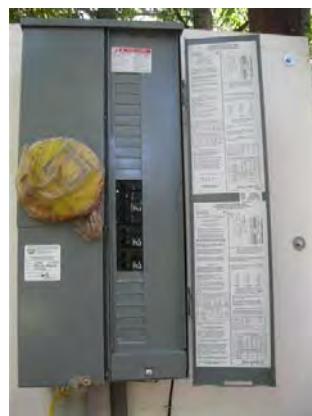
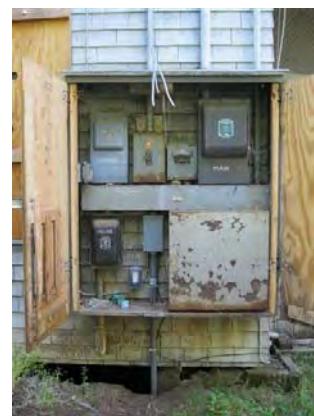
Figure 4. Site Power Components. Images of the existing power overhead lines at the Hawthorn House (top), PG&E pole at Los Trancos Road (middle left) and intermediate pole within site (middle center and right), and abandoned distribution panels at the intermediate pole (bottom left) and at the Hawthorn House (bottom right).

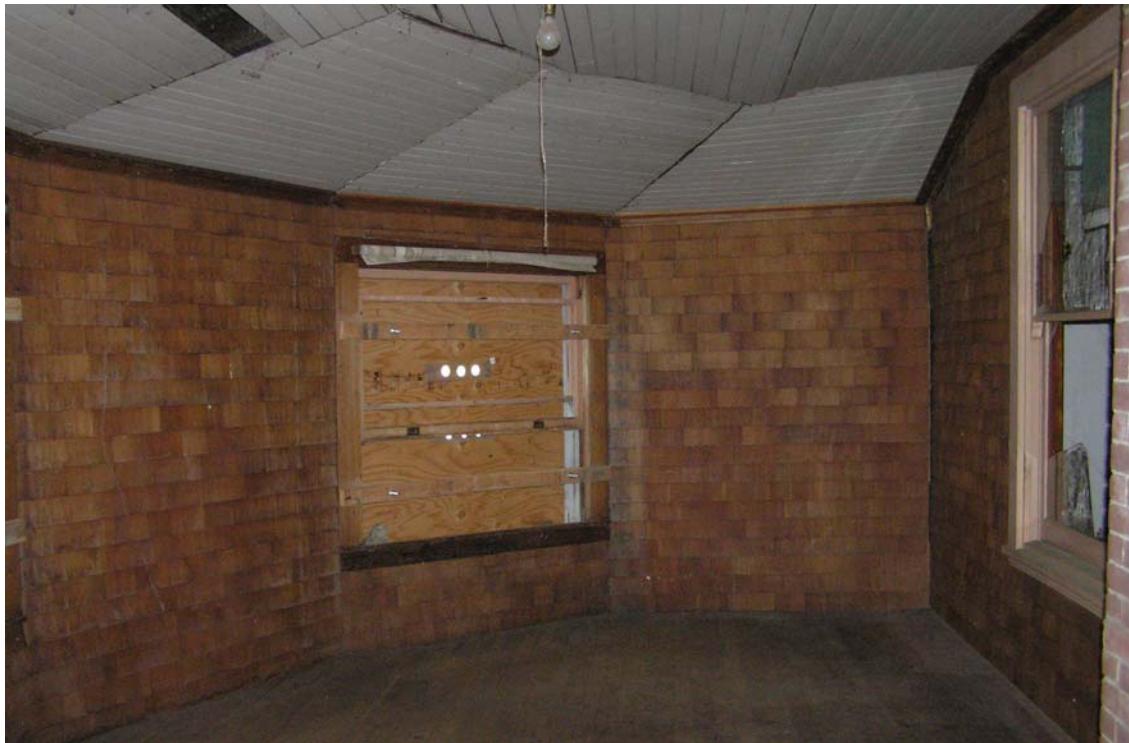
Image 22. Hawthorn House, southeast seven-sided library addition (Room 103).

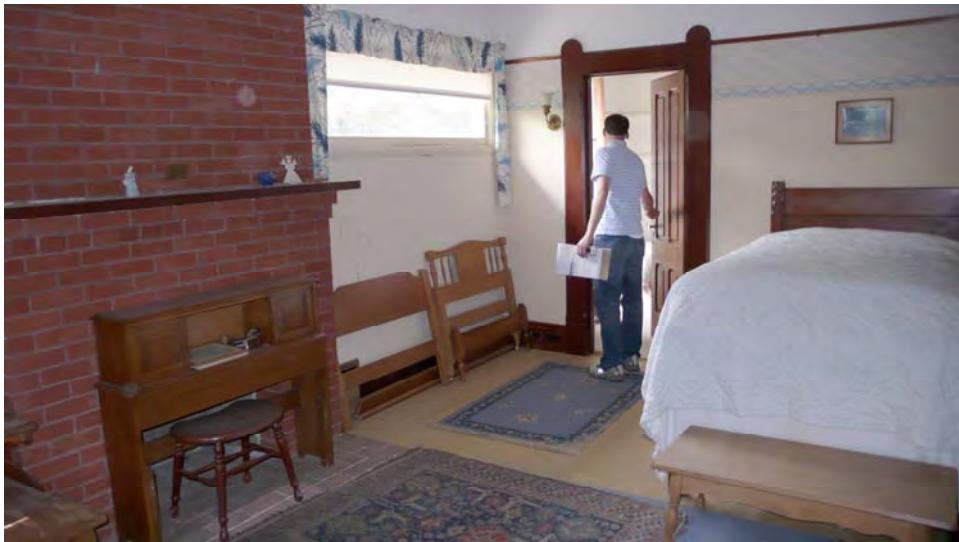
Image 28. Hawthorn House, Second Floor Master Suite, Room 203 (Credit: Tom Vlasic, 10/3/2008).

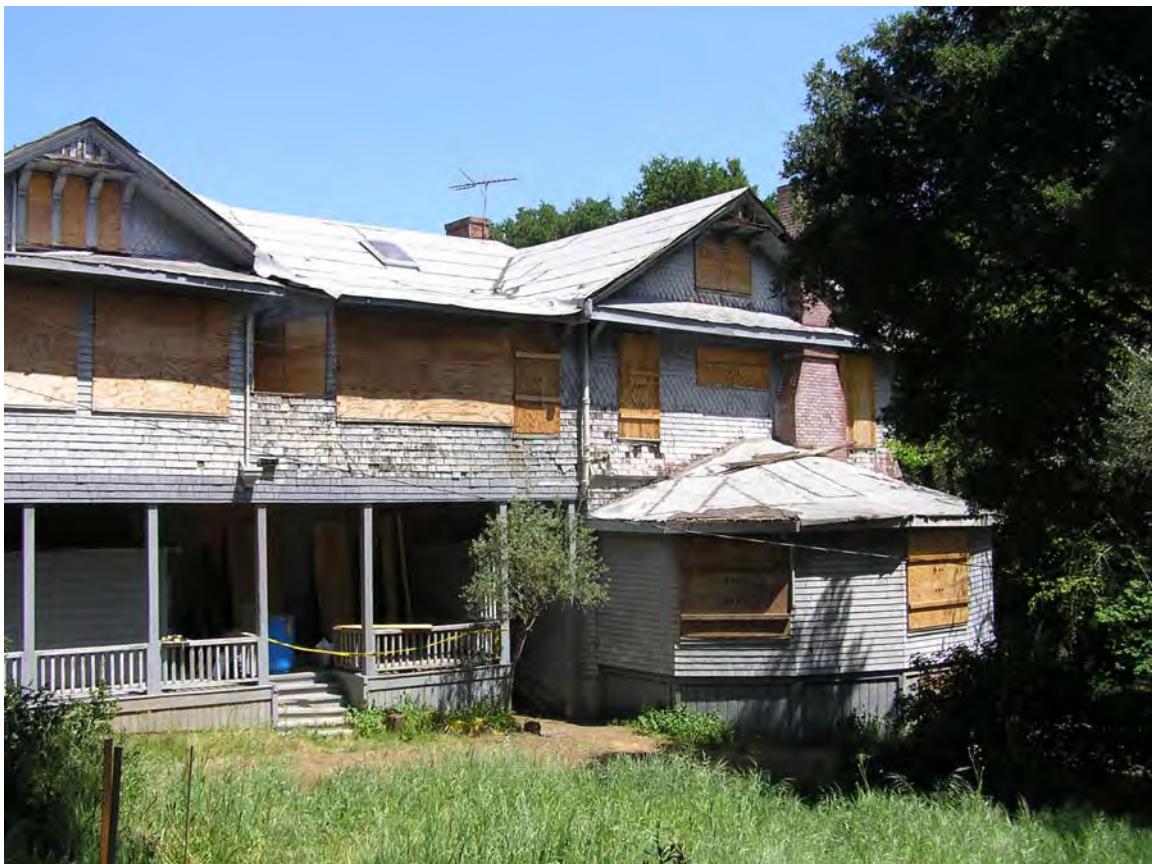
Image 32. Hawthorn House, south façade.

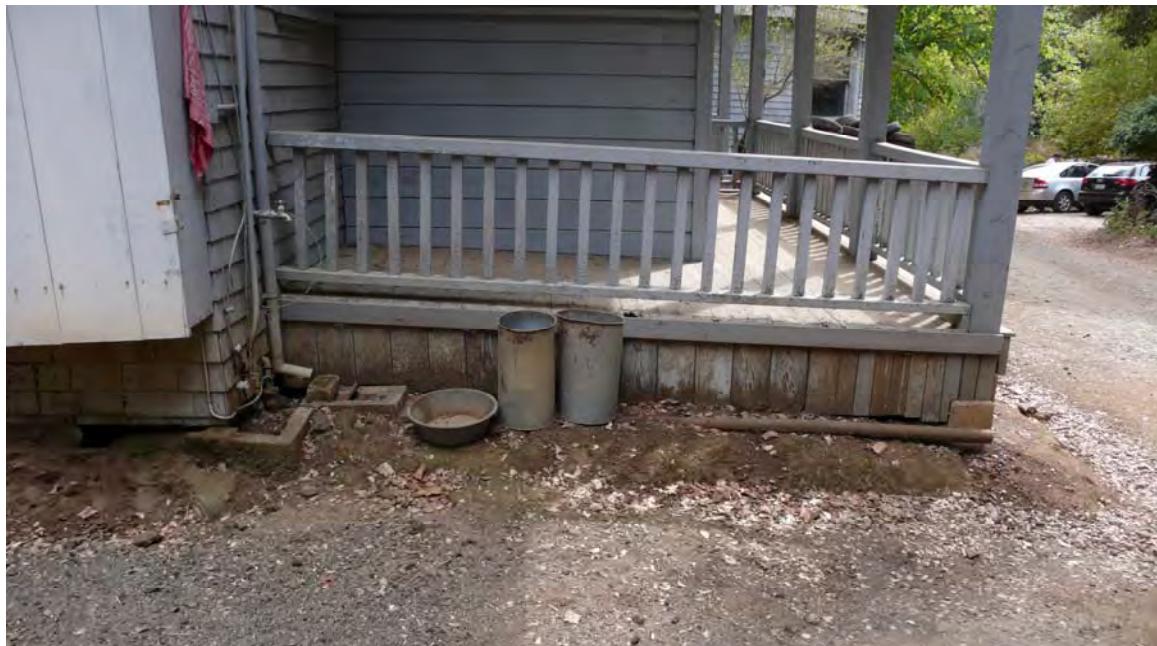
Image 33. Hawthorn House, southwest corner, damaged retaining structure at the corner of the building base (left) adjacent Porch 2, where siding is at grade.

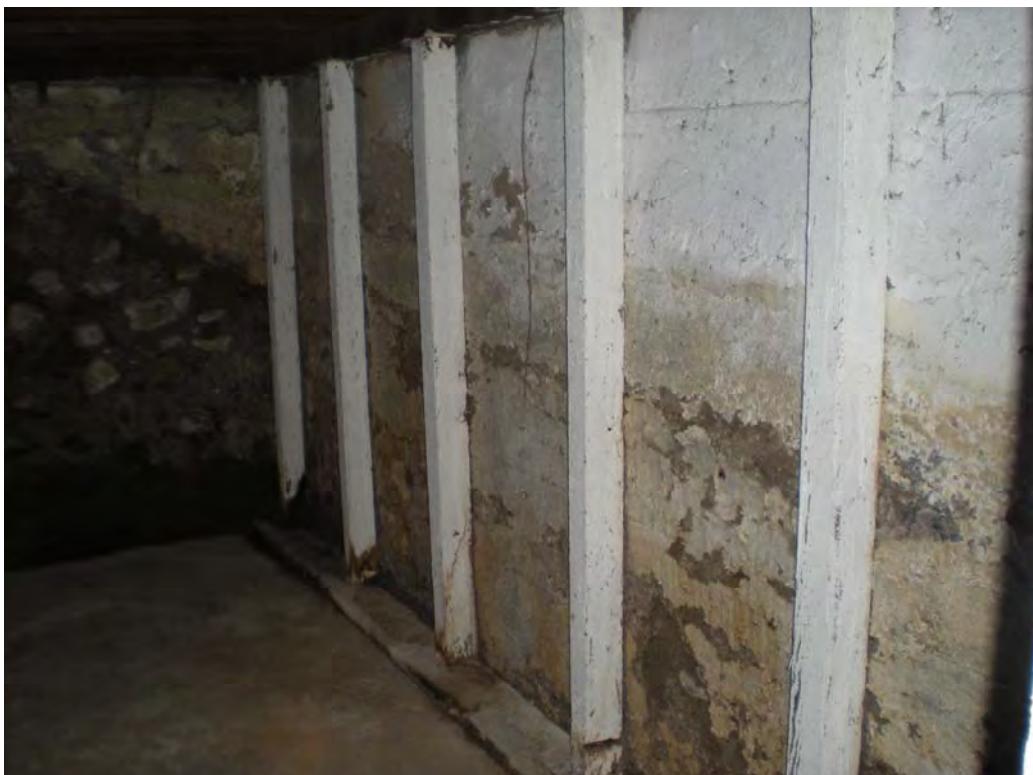
Image 35. Hawthorn House, Basement, Room A, north wall looking northwest.

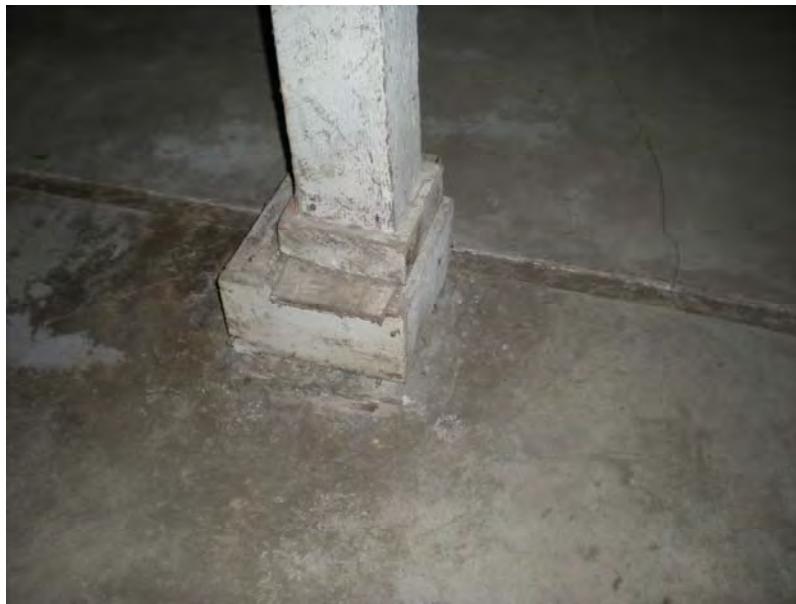
Image 36. Hawthorn House, post footing at main basement.

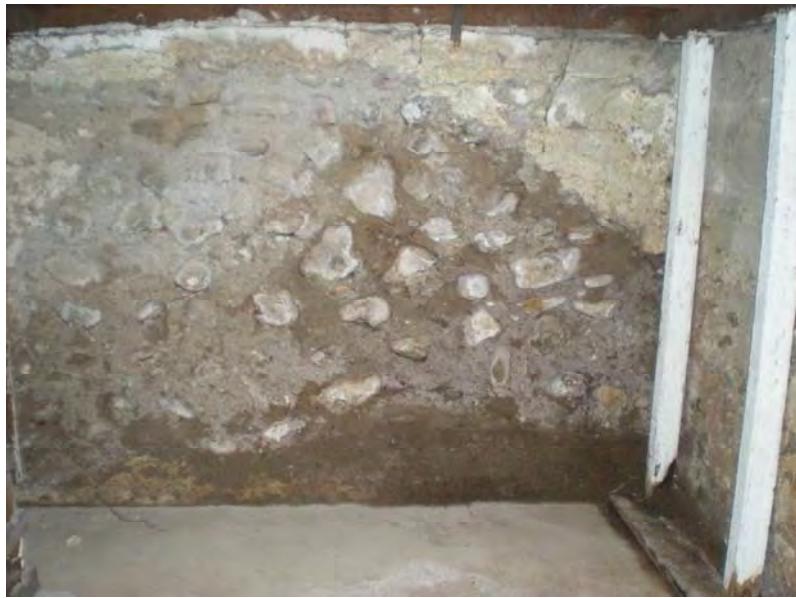
Image 37. Hawthorn House, Basement, Room A, west wall.

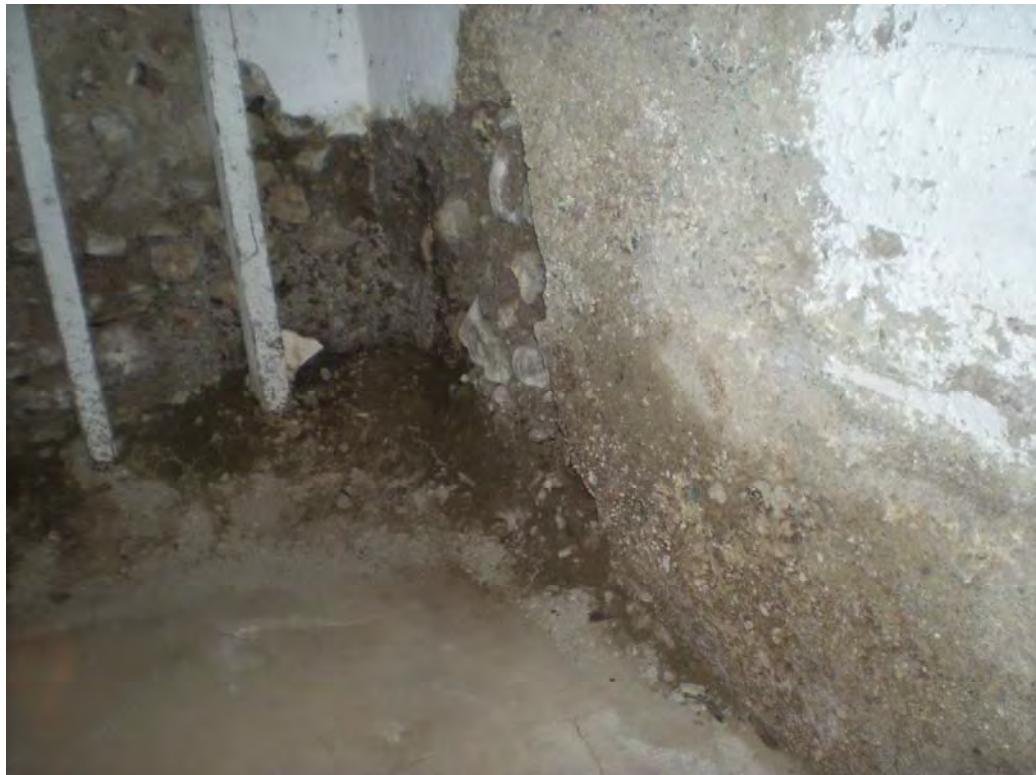
Image 38. Hawthorn House, corner east of basement entry.

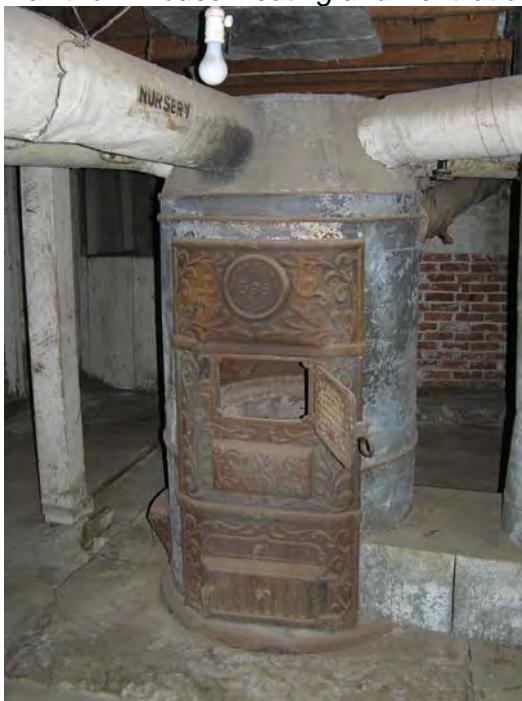
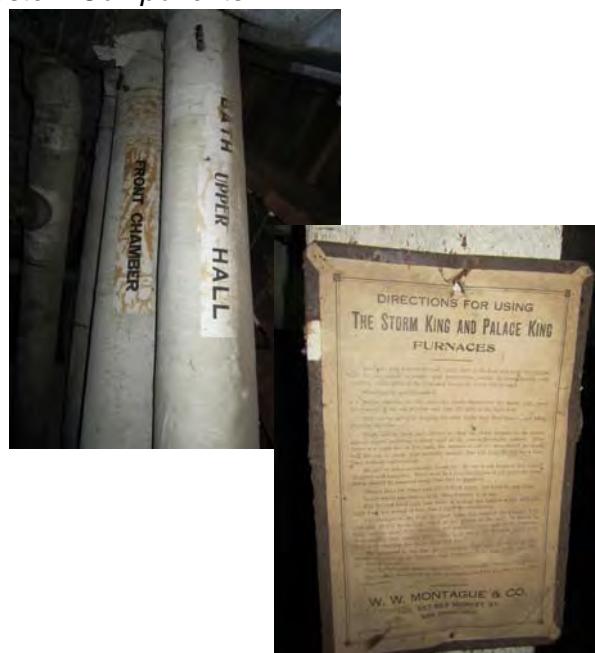
Image 39-41. Original Montague central furnace, ductwork, and original directions for use.

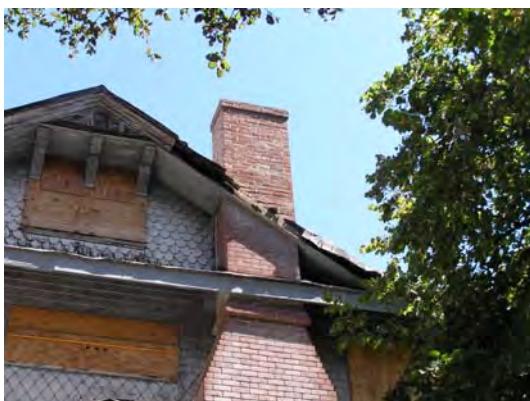
Image 44. Fireplace chimney.

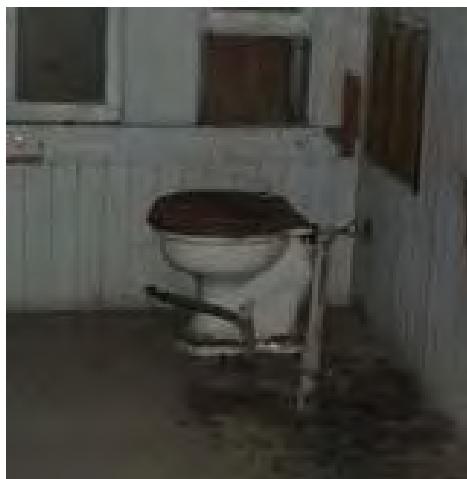
Image 55. Hawthorn House, Water Closet at Bathroom 304.

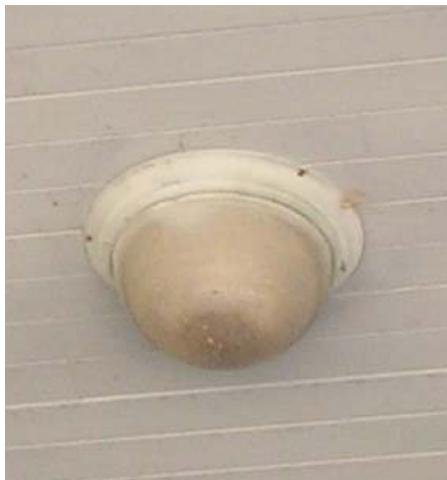
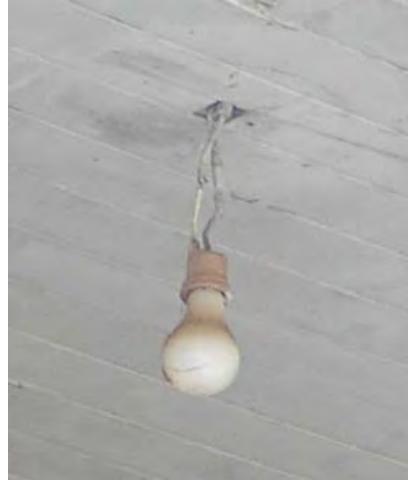
Image 56-57. Porch 1 dome fixture (left) and Porch 2 bulb with missing fixture (right).

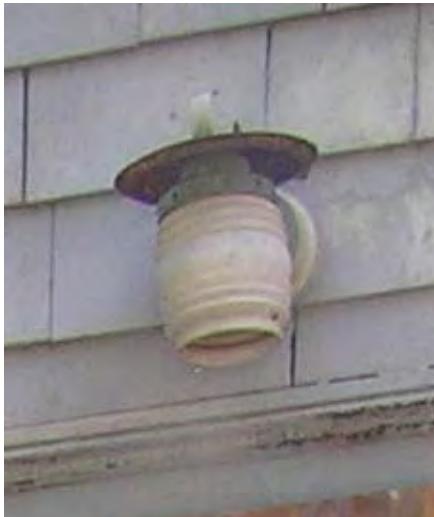
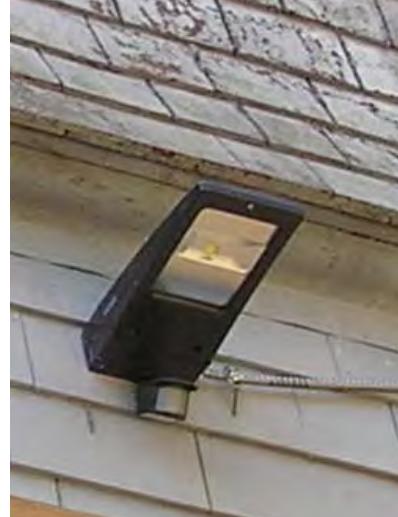
Image 58-59. West Entry lantern fixture (left) and non-historic security lighting (right).

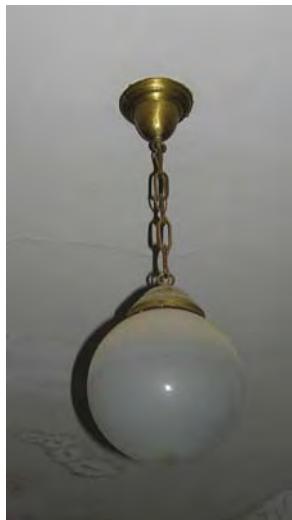
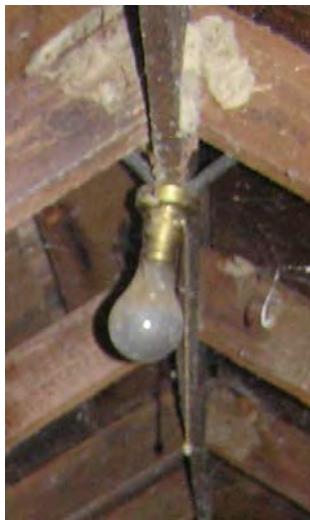
Image 63-64. Brass pendant globe fixture and basic lamp holder with exposed bulb.

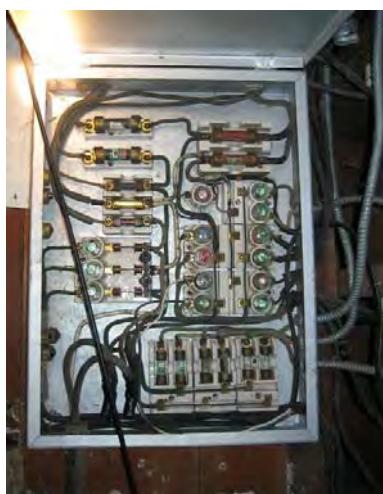
Image 65. Panel Board.

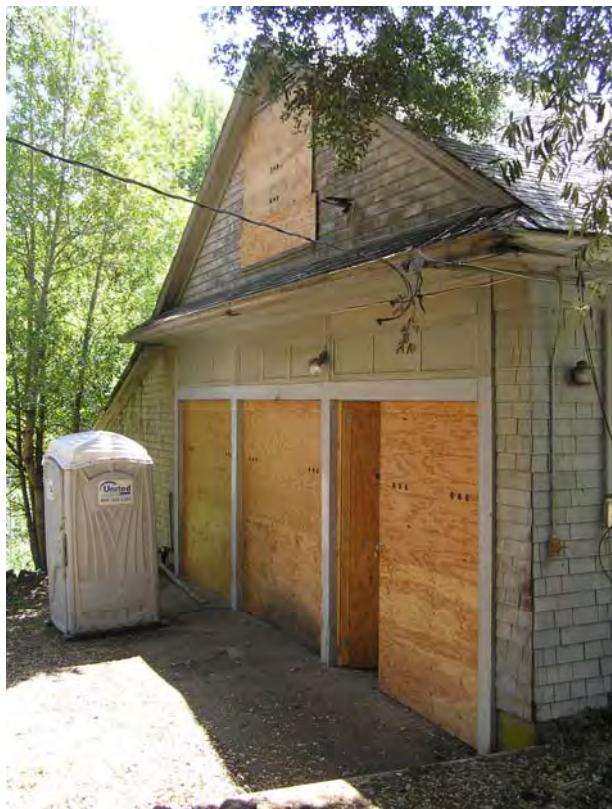
Image 70. Garage, north façade, view of the garage openings.

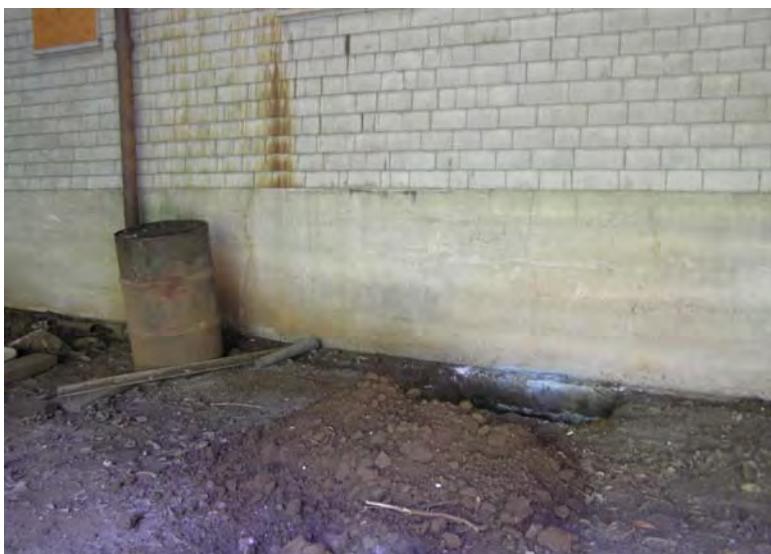
Image 72. Garage, concrete foundation at the east wall with vertical cracks and settlement.
