HAWTHORNS HISTORIC STRUCTURES ASSESSMENT

Midpeninsula Regional Open Space District

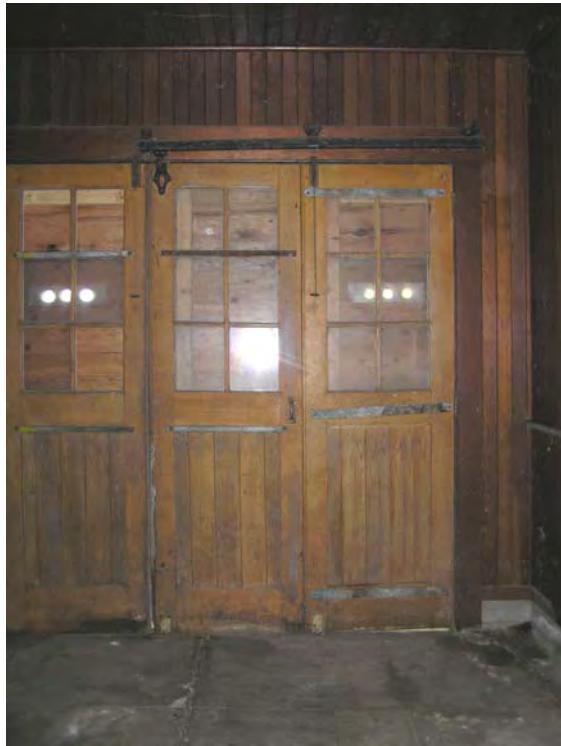
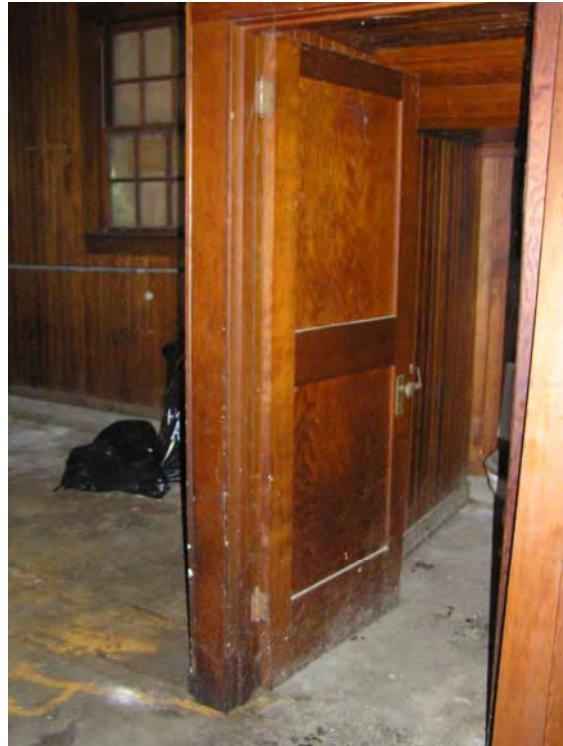
Image 73-74. Garage, interior view of garage door; window and toilet room door

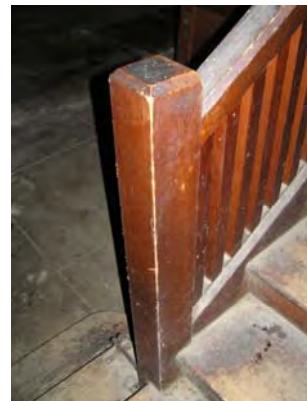
Image 78. Garage, newel post.

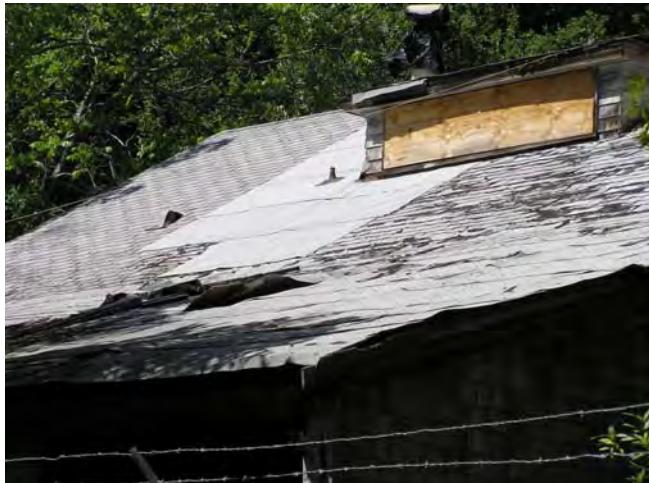
Image 79. Garage, deterioration at roof at east side (above).

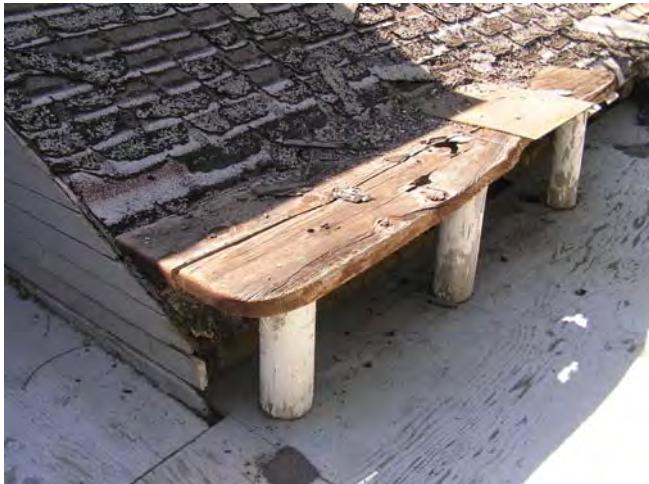
Image 80. West deck, severe deterioration at attic entry side walls and bench at eave.

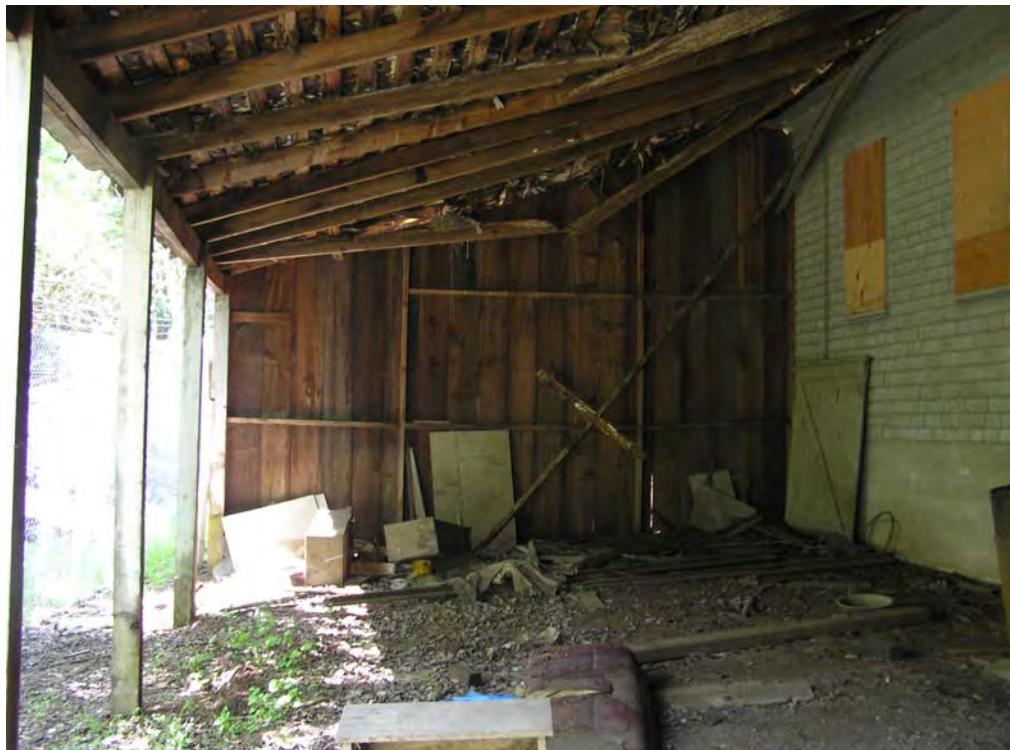
Image 81. Garage, lean-to addition at east side of building, view of collapsed roof.

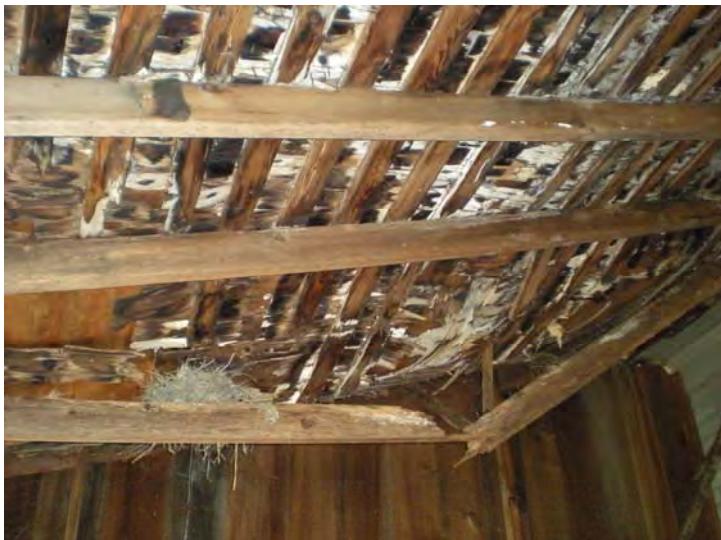
Image 82. Garage, east lean-to addition, detail of collapsed roof.

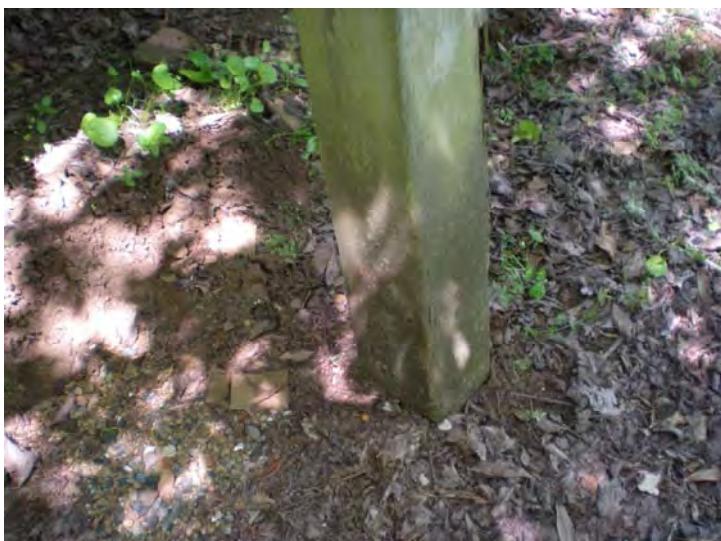
Image 83. Garage, east lean-to addition, post on grade.

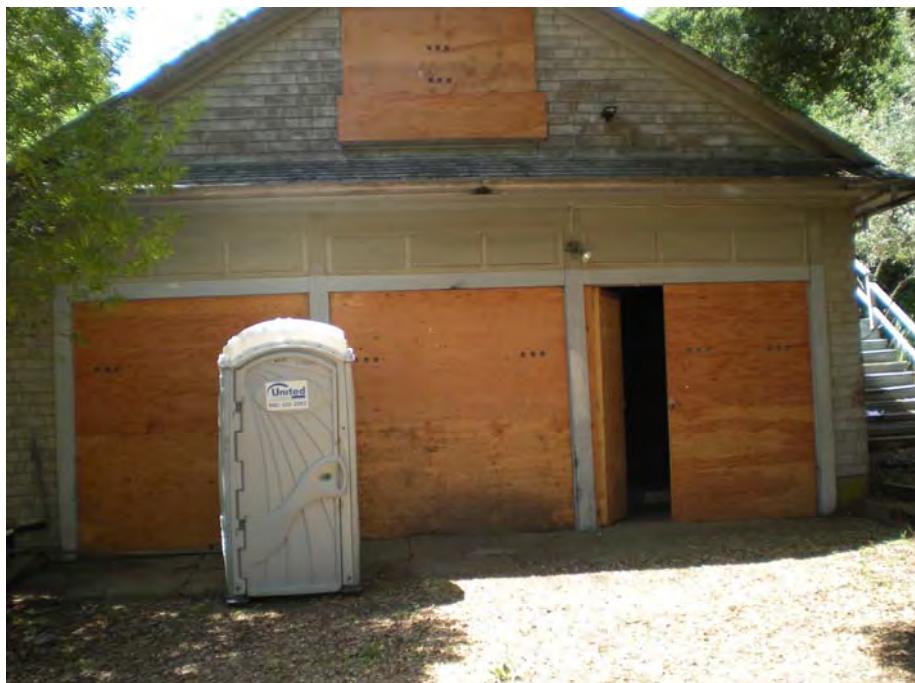
Image 84. Garage, north façade with three garage entryways.

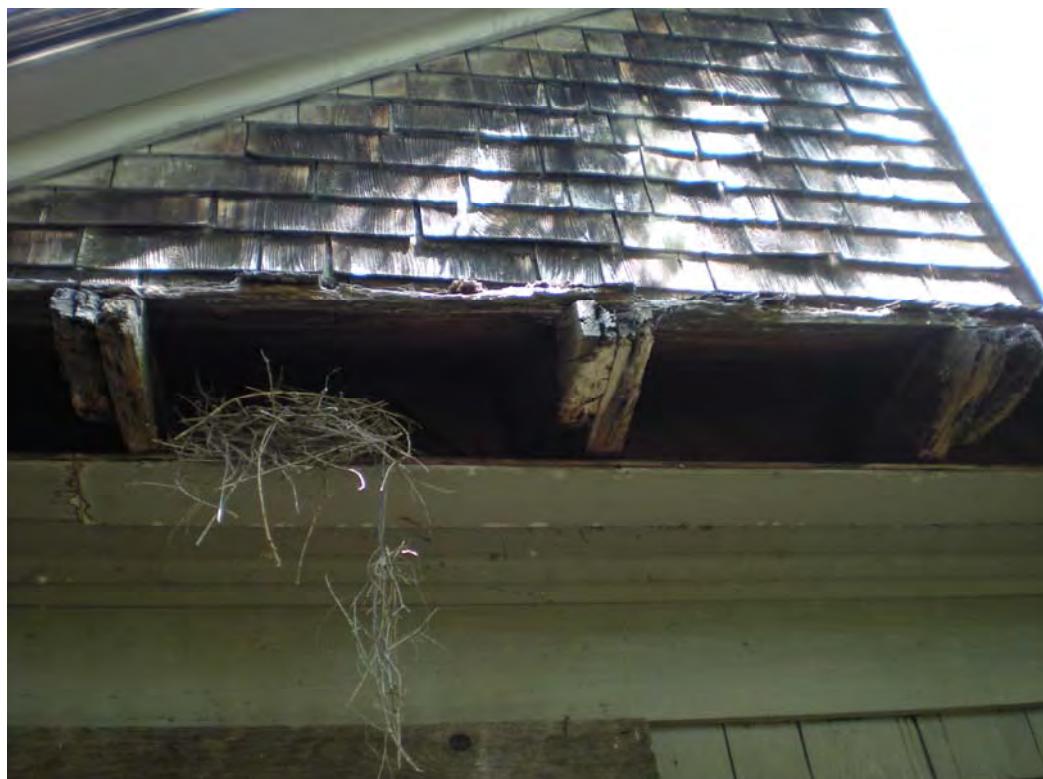
Image 85. Garage, south façade, detail of exposed rafters originally enclosed by eave and soffit boards, which should be rebuilt where missing.

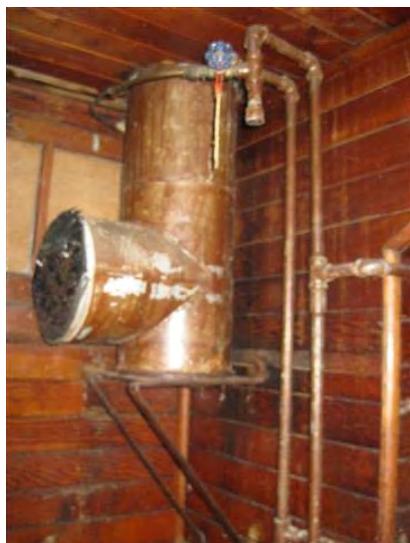
Image 86. Flue and Piping.

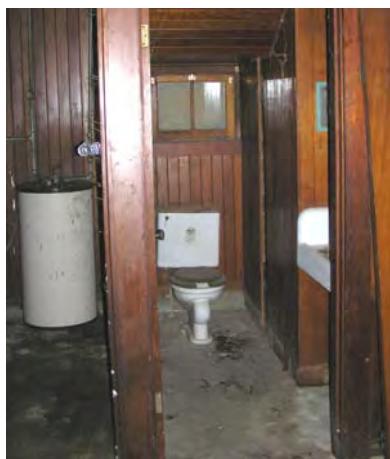
Image 87. Water Heater (left)

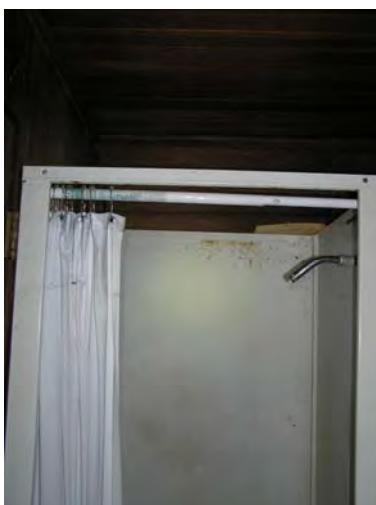
Image 95. Sink/Faucet

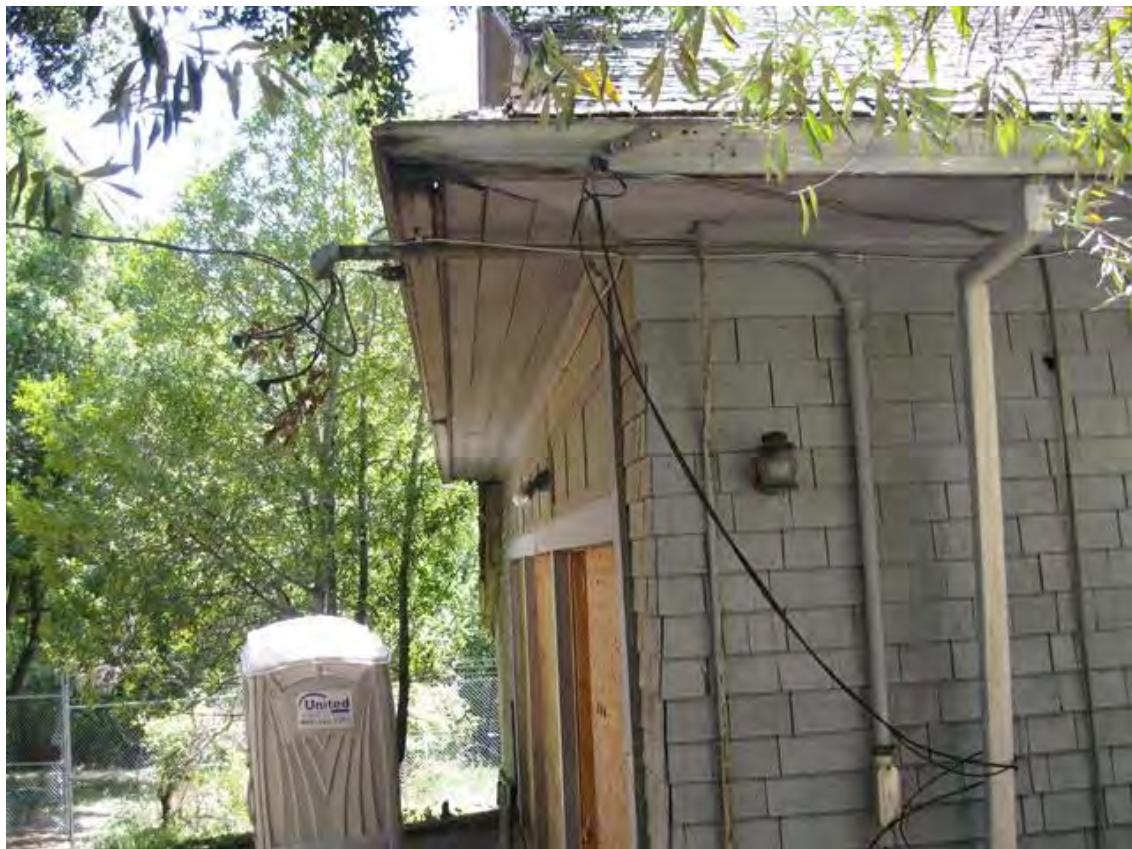
Image 98. Garage, electrical wires at exterior northwest corner.

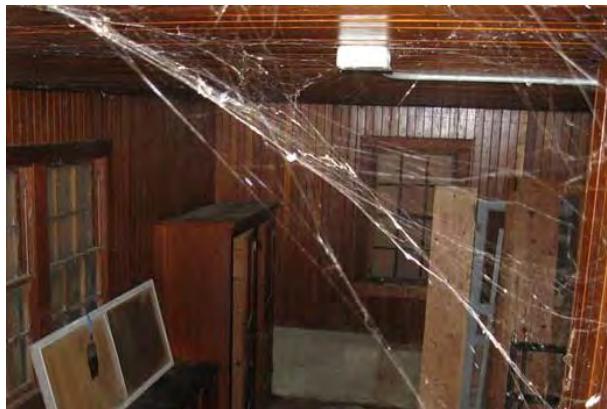
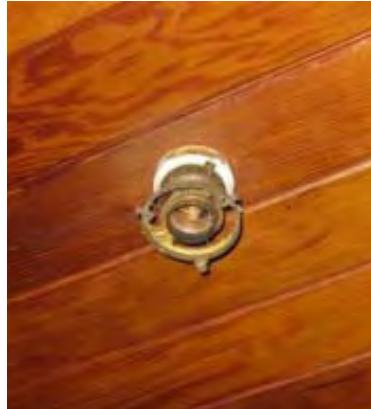
Image 99-100. Conduit and receptacle at garage ceiling; Light lamp holder.

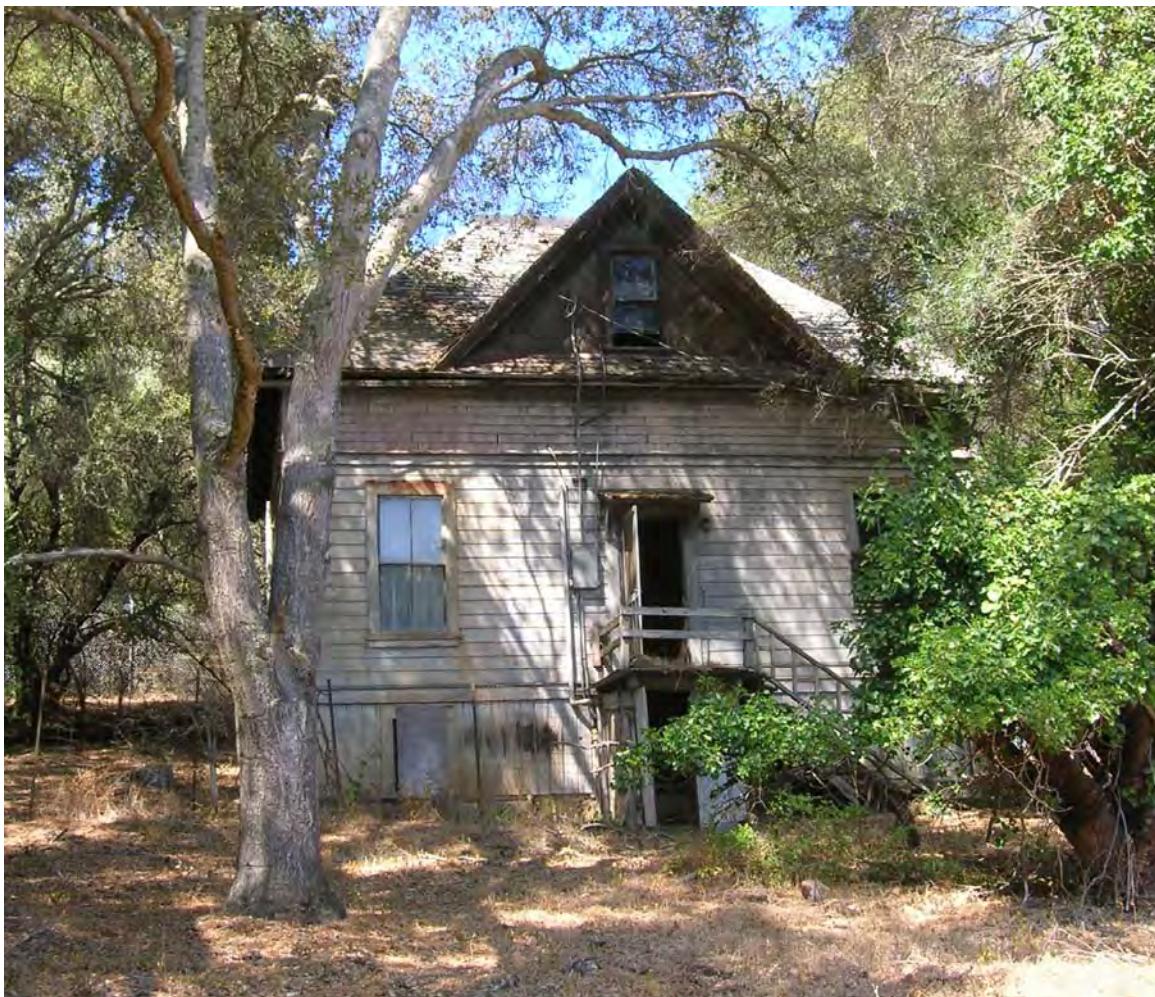
Image 104. Cottage, east façade.

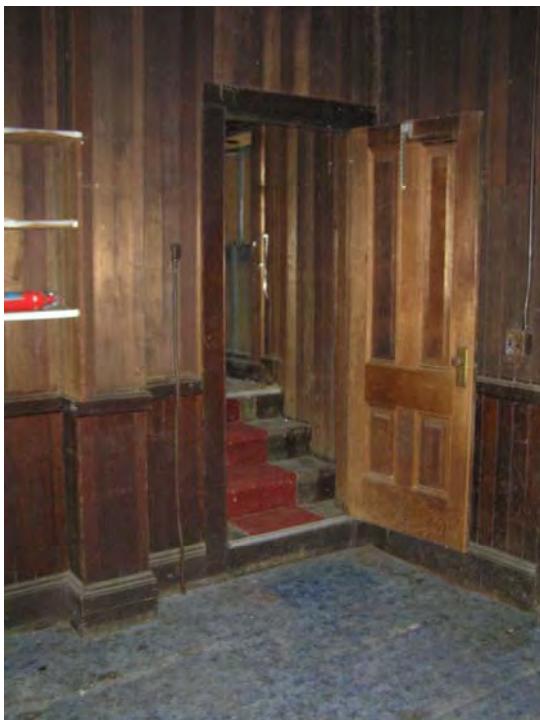
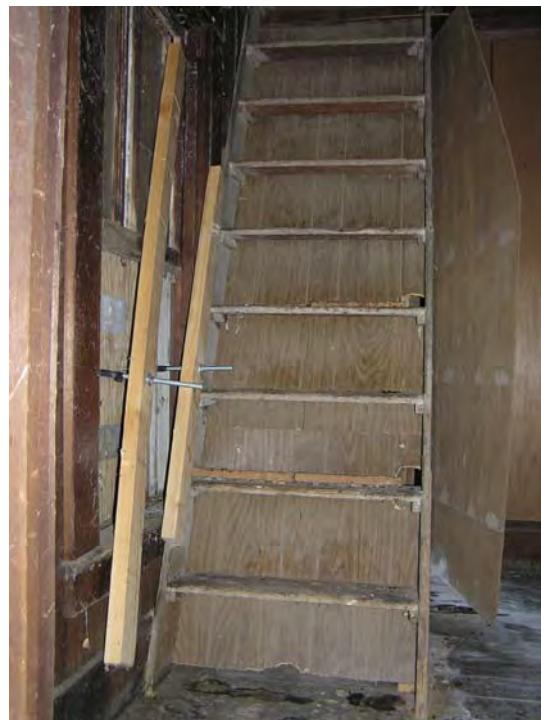
Image 107-108. Cottage, Door to room 104; Ladder/Stair to Attic at Room 105.

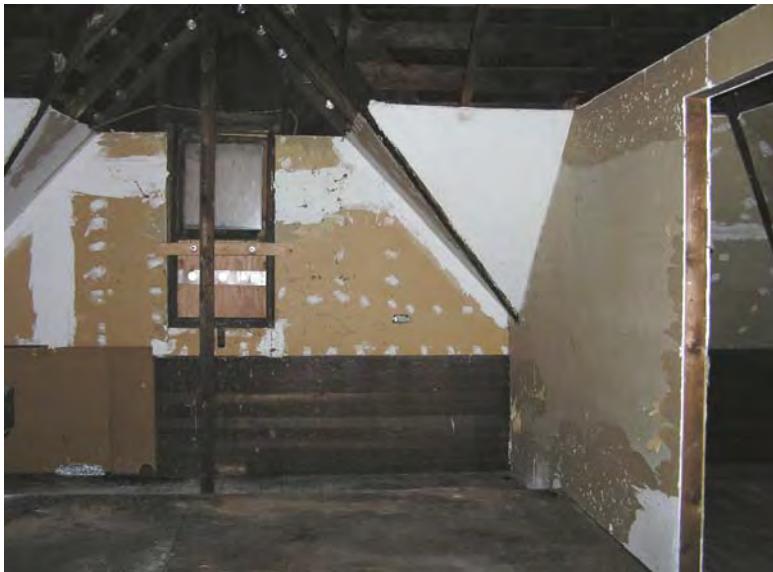
Image 110. Cottage, Attic framing partially finished with gypsum board.

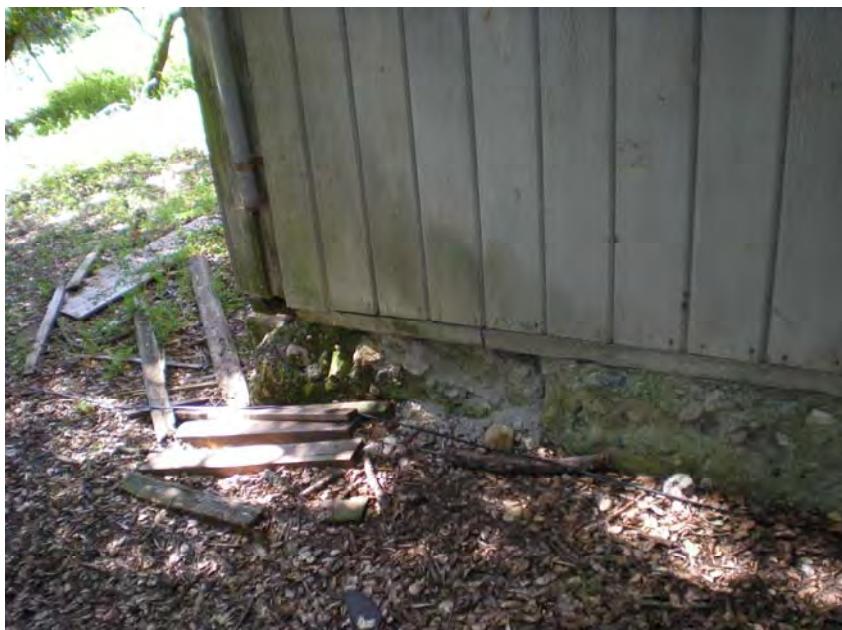
Image 111. Cottage, north façade, detail of east corner foundation.

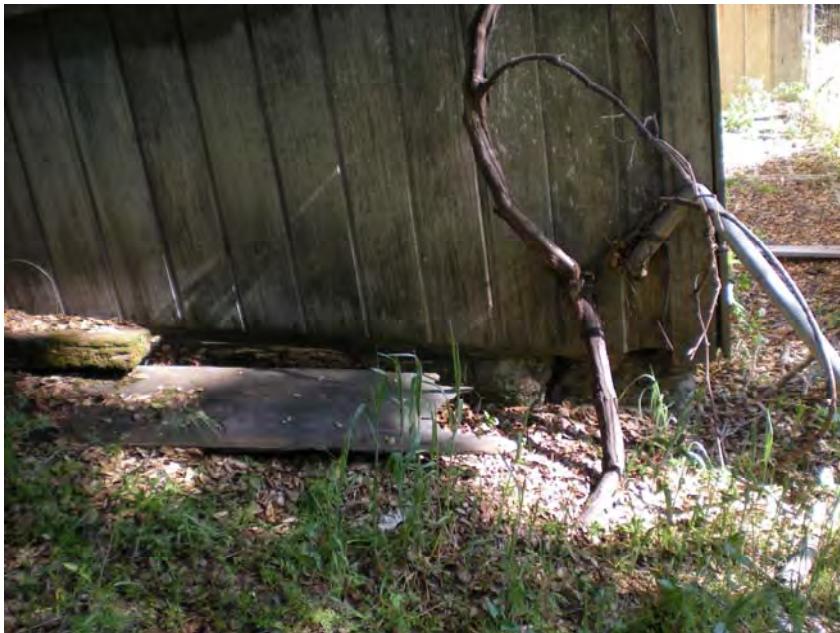
Image 112. Cottage, south façade, detail of east corner.

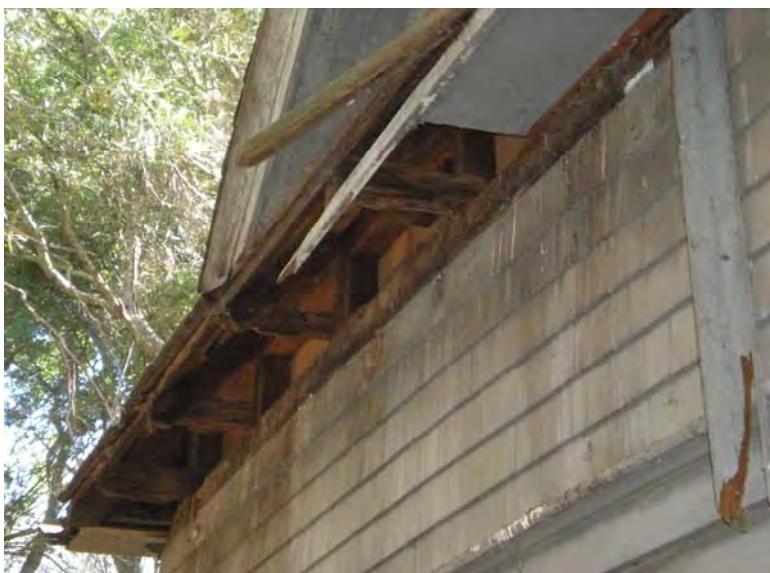
Image 113. Cottage, west façade, detail of exposed rafters.

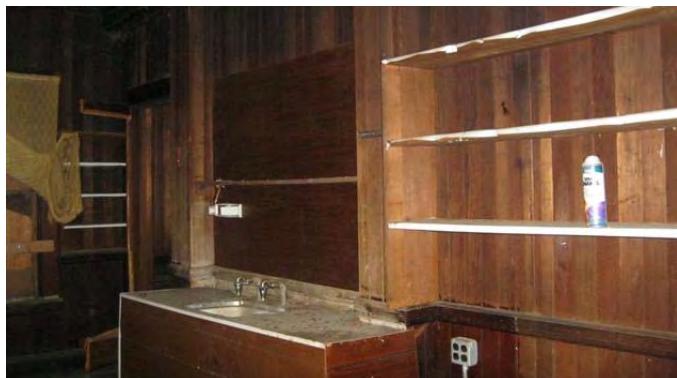
Image 116. Sink/Faucet

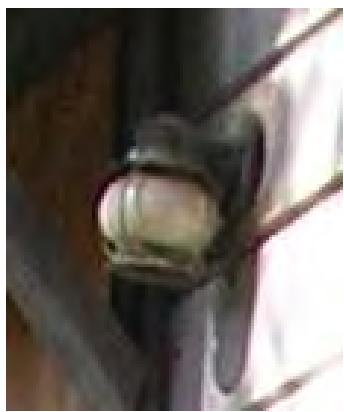
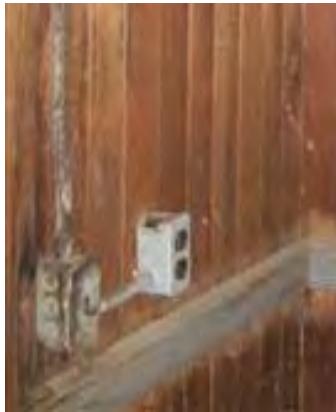
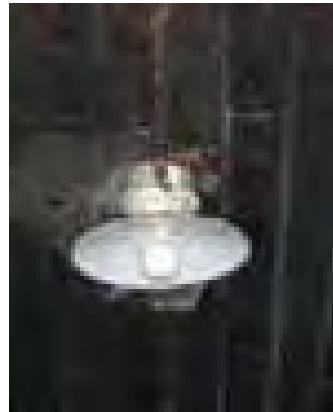
Image 117-119. Exterior Lantern; Surface Conduit & Receptacle; Cone Shade Fixture

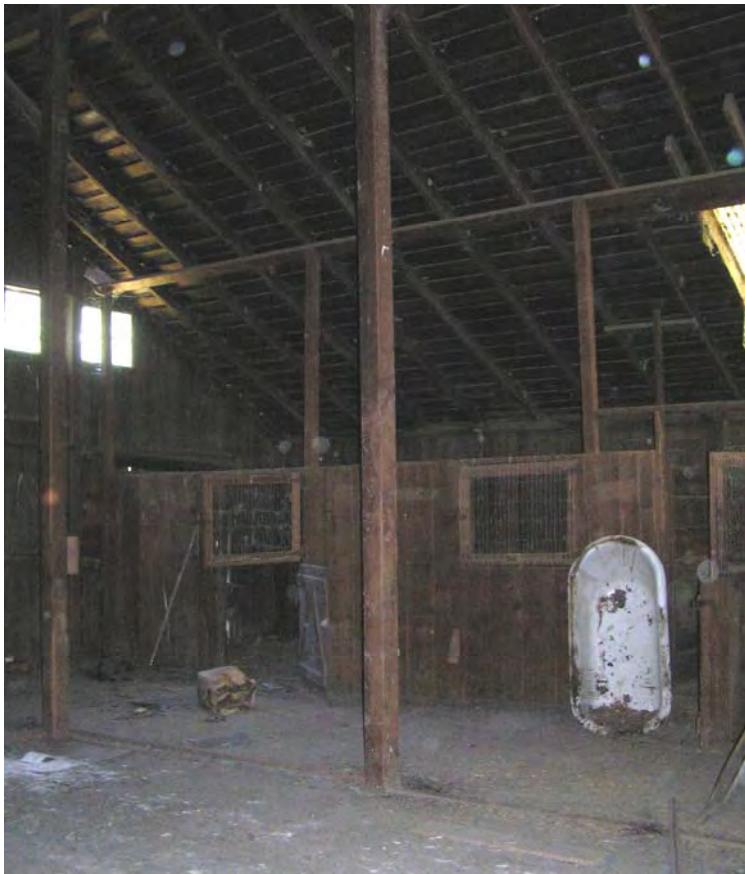
Image 123. Lower Barn, interior looking northeast.

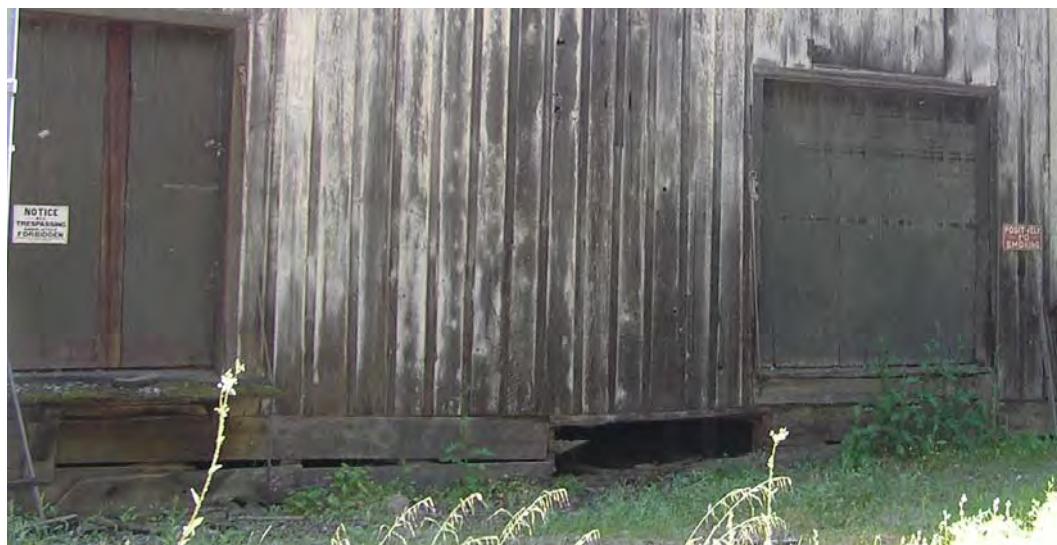
Image 124. Lower Barn, north façade, doorways are above grade, no foundations visible.

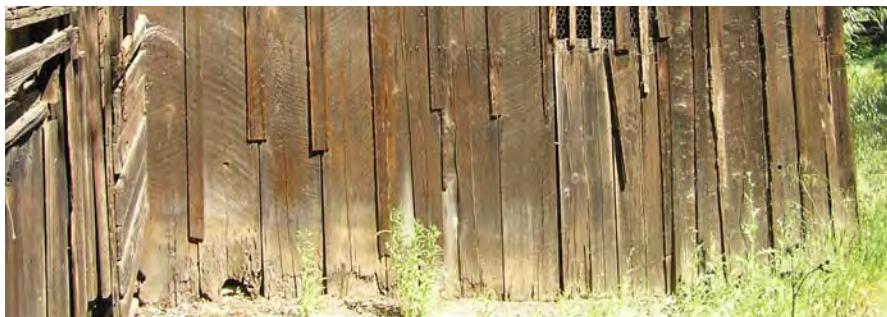
Image 125. Dry rot at base of walls.

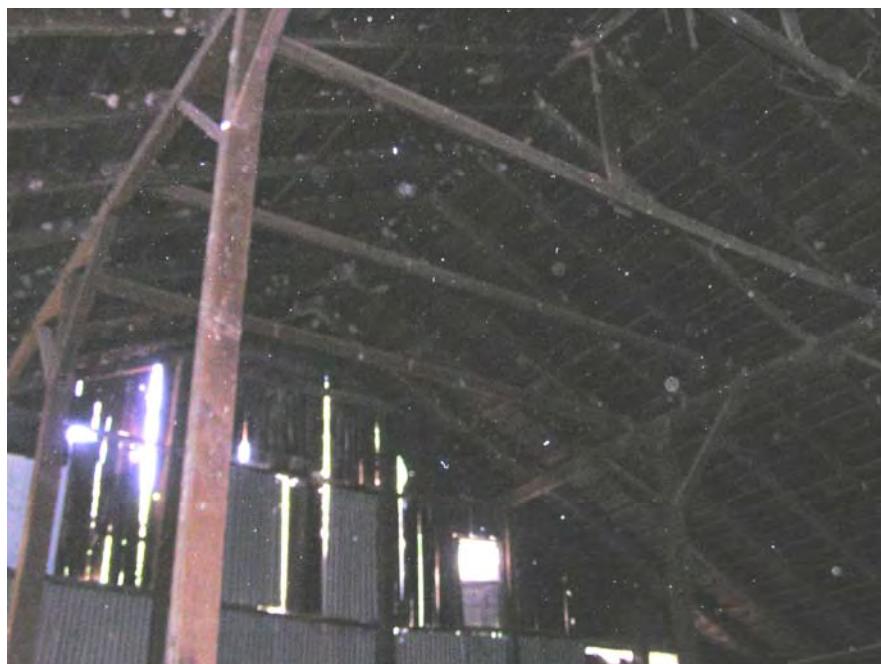
Image 126. Lower Barn, interior view of roof framing looking northeast.
