R-17-39
March 28, 2017

Schematic Design of the Alma College Parking Area and Bear Creek Road Trail Crossing at Bear Creek Redwoods Open Space Preserve

September 14, 2016

Subject: **Draft Culvert Condition and Capacity Technical Letter
Bear Creek Redwoods Open Space Preserve
Santa Clara County, California**

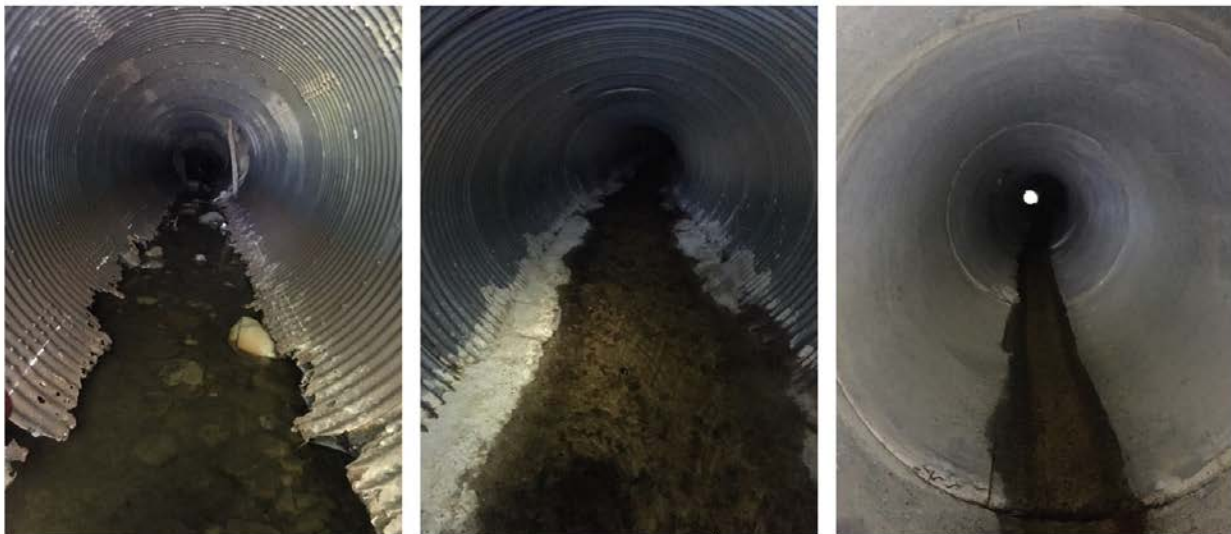
The original concrete culvert was constructed in 1916 and was later lined with a corrugated metal pipe (CMP) in 1950. Since then, a number of improvements have been made, most notable, a concrete slurry lining on the culvert invert. The existing culvert is 60" in diameter, spans 587 feet and is constructed using a variety of materials including: highly corroded CMP, concrete slurry lined CMP and reinforced concrete. A comparison of the culvert materials is shown in Figure 2

Figure 2. Pipe culvert materials. Left to right: highly corroded CMP, concrete lined CMP, and concrete

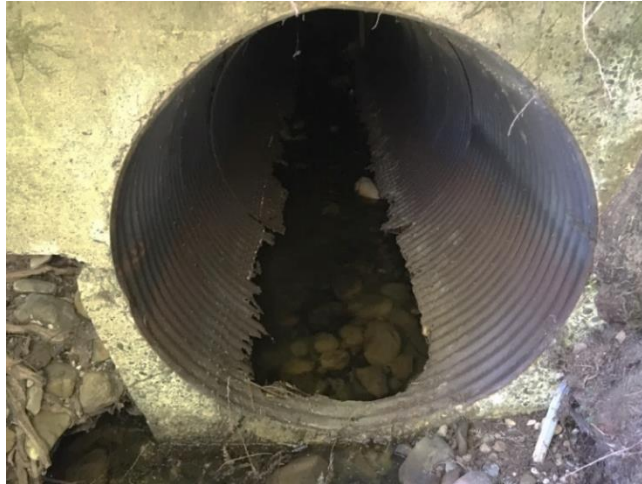
The condition of the culvert inlet on the along BCR is significantly damaged, and the damage can be visually noted from the outside of the culvert. Figure 4 shows the poor condition of the culvert; with up to 32" of the pipe invert completely corroded away, and up to 18" deep pools that expose the natural creek bed below the culvert.

Figure 4. Damaged culvert inlet on the southwestern side of BCR at Webb Creek

1. At minimum, replace the length of culvert that crosses underneath Bear Creek Road with a larger diameter culvert. In particular, the section that extends for the first 66 feet is the highest priority because it is the most structurally compromised.
2. As part of the continued culvert replacement design options, FCE recommends conducting additional analysis and assessment; including but not limited to: structural engineering, geotechnical engineering, biological surveys, hydrological modeling (HEC-RAS) and permitting requirement research.

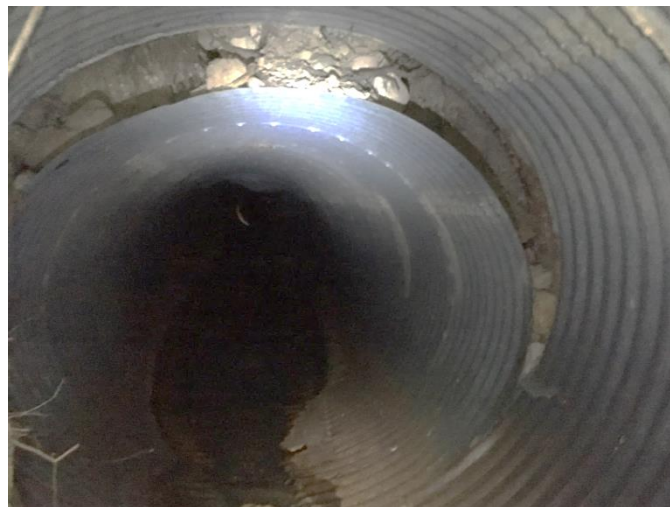
A significant separation of approximately 9 inches between pipe sections was noted 25.5 feet in from the culvert inlet and the damage can be seen in Figure 5.

Figure 5. Separation at CMP pipe joint (looking into culvert from Webb Creek Inlet)

Both sections of CMP culvert shown in Figure 5 were initially the same diameter, but over time, the corrosion along the pipe invert, combined with the soil pressure loading above, caused the pipe to

roll inwards and constrict the culvert's inner diameter. The constricted culvert extends from 25.5 feet from the inlet to 62 feet from the inlet (approximately 36.5 lineal feet). The culvert shows additional pipe sagging and overall roof distortion at 62 feet from the culvert entrance, and the damage is shown in Figure 6.

The presence of the fault line within such close proximity to the culvert may have been the cause of some of the pipe damage that was noted. The alignment of the culvert and the fault line parallel each other and slight subterranean shifts over the course of years may have impacted the culvert's integrity and caused some of the pipe joint separation that was noted in Figure 5, Figure 7, and Figure 11.

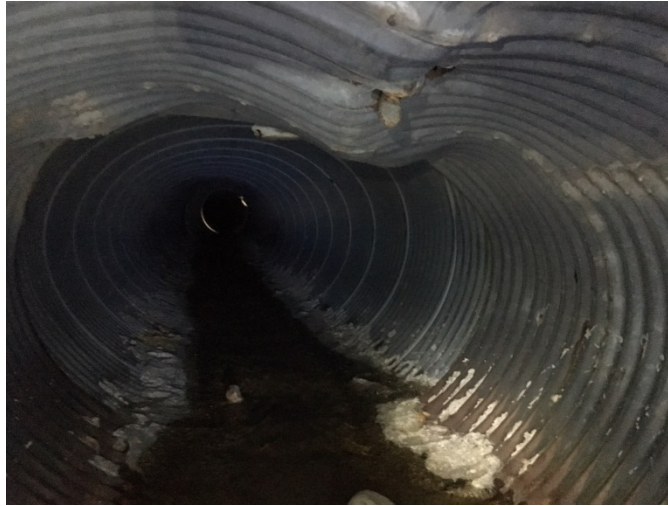
Figure 6. Roof collapse at 62 feet from entrance at Webb Creek (looking towards culvert outlet)

The distortions in the pipe are a clear indication that the structural integrity of the culvert has been severely compromised. Four feet past the pipe roof collapse, at 66 feet from the inlet, there is another pipe joint that has completely separated that can be seen in Figure 7.

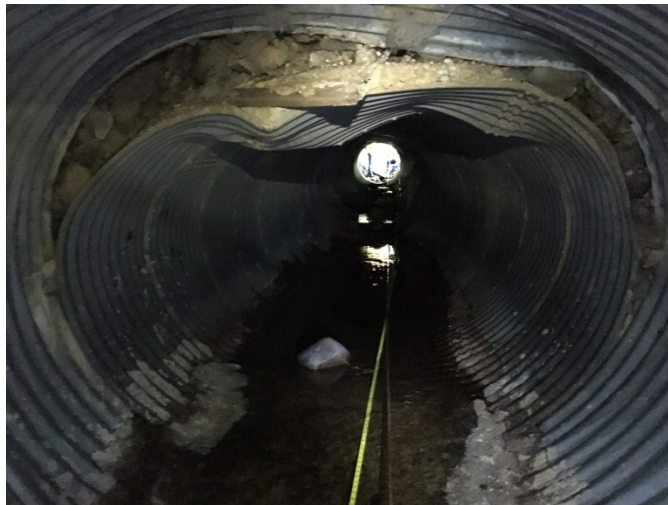
Figure 7. Pipe joint separation at 66 feet from the culvert inlet (looking towards culvert inlet)

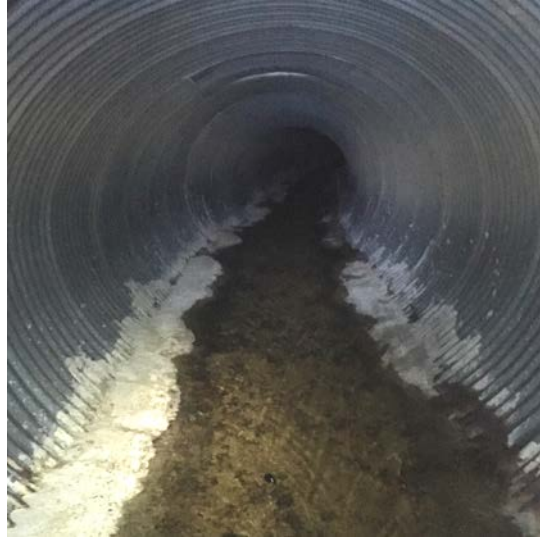
The general condition of the concrete slurry lined CMP was similar for the segment of pipe after the concrete culvert (171 feet) until the outlet along Alma College Road (416 lineal feet). Figure 10 shows a typical section of slurry lined CMP and indicates how the culvert is reliably transporting water during the conditions when the culvert was investigated.

Figure 8. Typical section of concrete slurry lined CMP

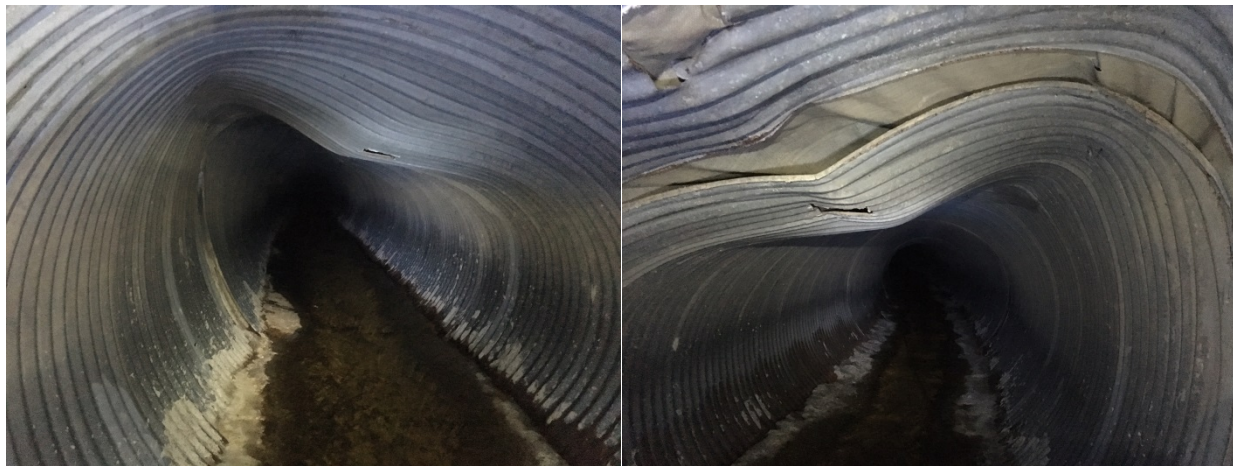
The single structural abnormality that was encountered within this segment of pipe was a significant pipe collapse at 422 feet from the inlet. The distortion impacts approximately 17 lineal feet of pipe and encompasses an approximately 9-inch pipe joint separation. The damaged section of pipe is shown in Figure 11.

Figure 9. Left: Distorted CMP pipe 422 feet from inlet along BCR (looking towards inlet). **Right:** The 9-inch gap (looking towards outlet along Alma College Road).

The cause of the roof collapse is unknown, however, it is apparent that the constriction in the pipe diameter would cause impeded flow during high flow conditions.

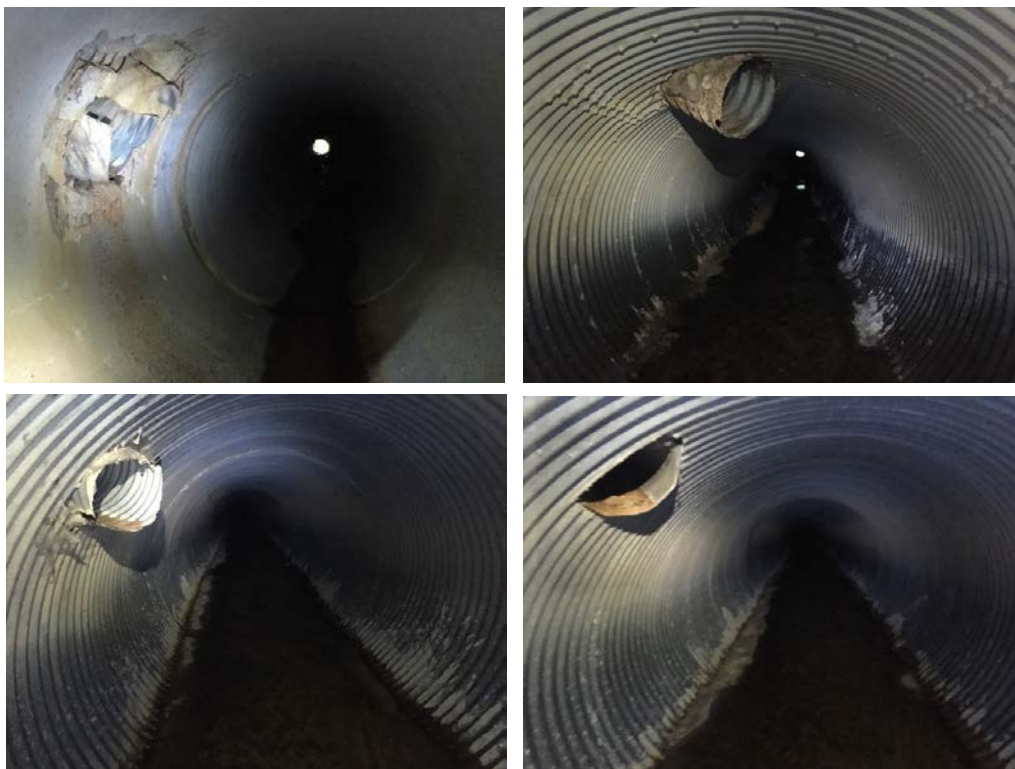
Figure 10. Four piped inlets. Starting top left: Clockwise: 24-inch, 12-inch, 12-inch, 8.5-inch

During the inspection, FCE was able to determine that three of the four piped inlets daylight as noted in Table 1. The fourth piped inlet had an old corroded steel pipe in the center that appeared to be approximately 4 inches in diameter and can be seen in Figure 9.

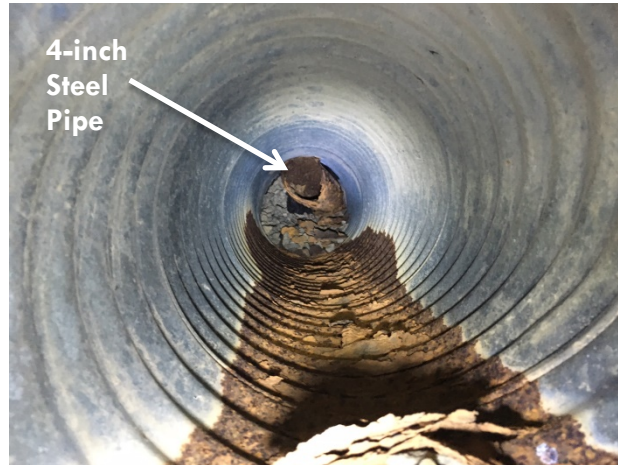
Figure 11. 12-inch piped inlet with steel pipe in center.

The inlet of the steel pipe is unknown; however it is clear that water has historically flowed in this inlet as indicated by the corrosion along the invert of the pipe.

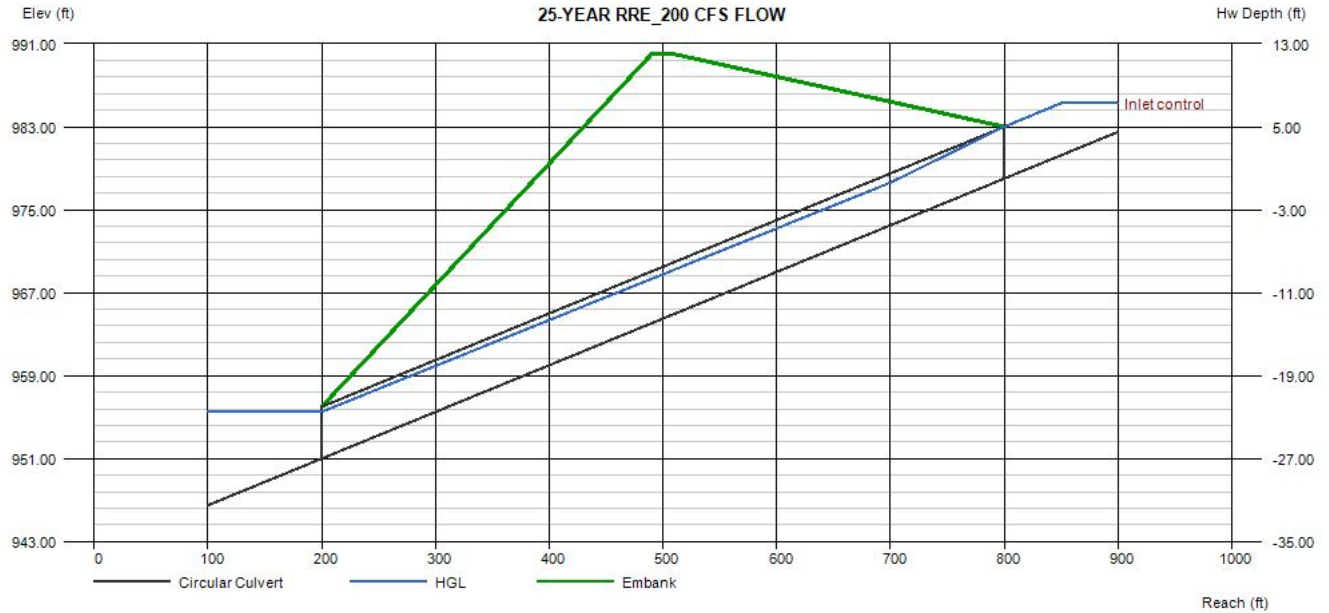
Figure 13. Hydraflow model for 25-year design storm

After running the Hydraflow model it was apparent that the 60" diameter culvert is adequately sized to convey the 25-year design storm flow. The water surface elevation at the inlet of the culvert along Bear Creek Road rises under these circumstances; however the culvert maintains several feet of freeboard from the top of the embankment. FCE also ran a 100-year storm flow value of 300 cfs using the Hydraflow model and the results can be seen in Figure 14.

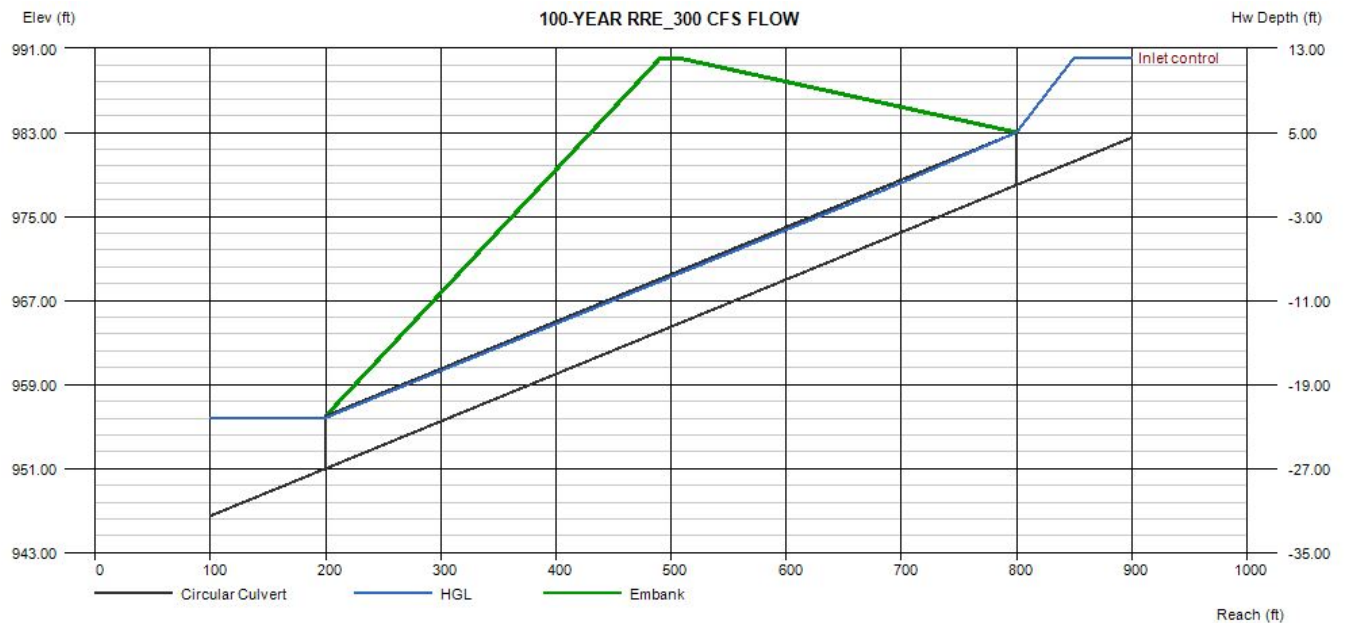
Figure 14. Hydraflow model for 100-year design storm

Based on the results of the Hydraflow analysis for the 100-year design storm, the existing culvert is inadequately sized to safely convey the design flow. The inlet of the culvert along Webb Creek is predicted to backwater and overtop the embankment, causing BCR to flood. The results of the

model suggest that the culvert needs to be replaced in order to satisfy the design requirements of the SCCDM and CALTRANS Highway Design Manual.
