ADA Self-Evaluation and Transition Plan Update

Midpeninsula Regional Open Space District

Appendix B

ADA Facility Assessment Reports

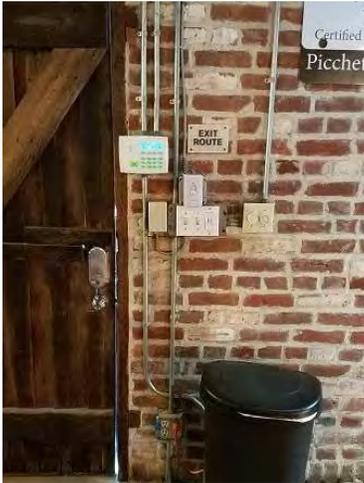
Building Winery		
8 - 1	Door/Gate	Category: 1

Raise or lower existing hardware	\$125
Notes: Door knob is 32" AFF (34" min to 44" max).	
ADA: 404.2.7	
Other: CBC 11B-404.2.7	
Replace door hardware	\$425
Notes: Door knob requires grasping and twisting.	
ADA: 309.4	
Other: CBC 11B-309.4, CBC 11B-404.2.7	
Provide or modify door kick plate	\$225
Notes: A smooth and uninterrupted kick plate surface is not provided. A doorstop is located in the 10" space above the finished floor.	
ADA: 404.2.10	
Other: CBC 11B-404.2.10	
Attach loose mat to the floor surface	\$125
Notes: Door mat is not securely attached to ground surface.	
ADA: 302.2	
Other: CBC 11B-302.2	
Adjust door closer	\$125
Notes: Door opening force is 7 lbs (5 lbs max).	
ADA: 404.2.9	
Other: CBC 11B-404.2.9

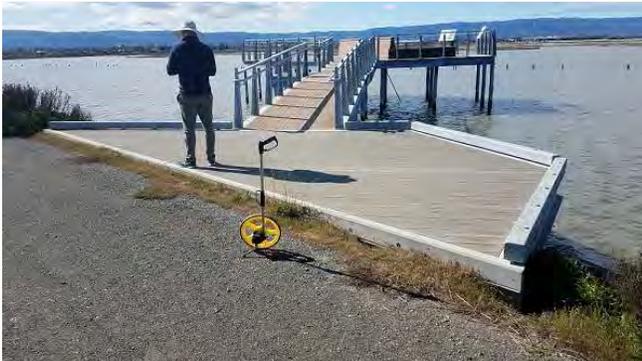
7 - 2 **Hazard** Category: 2

Notes: Openings in grate on the northern viewing platform at Ravenswood Trail Part II are 7/8" by 3-3/4" (max 1/2" in one direction required).

Reduce or eliminate opening \$250

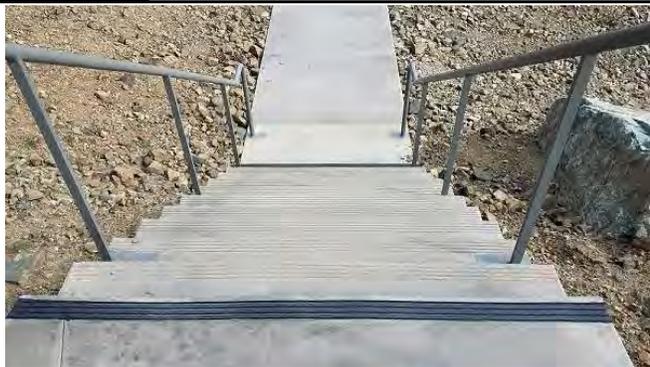
Preserve Mt Umunhum Summit		
6 - 2	Stairway	Category: 2

Install a handrail	\$125
Notes: Some of the bottom handrail extensions turn 90 degrees and are not aligned with stair runs. For new construction, handrail extensions must be in line with the stair run and are not allowed to turn. The allowance for a 90 degree is an exception that is allowed at alterations of existing facilities where this condition would create a hazard. On other runs, slope extension of 10" or 10-1/2" are provided.	
ADA: 505.10.3	
Other: CBC 11B-505.10.3

Install tread striping	\$990
Notes: Grooved nosing does not provided adequate contrast for tread striping. Painted striping is only provided on the top and bottom riser of each run (required for all treads on an exterior stairway).	
ADA: -	
Other: CBC 11B-504.4.1
