Midpeninsula Regional
Open Space District

Selection of Basis of Design Repair Options for the Mount Umunhum Radar Tower at Sierra Azul Open Space Preserve

Final Report

November 13, 2019

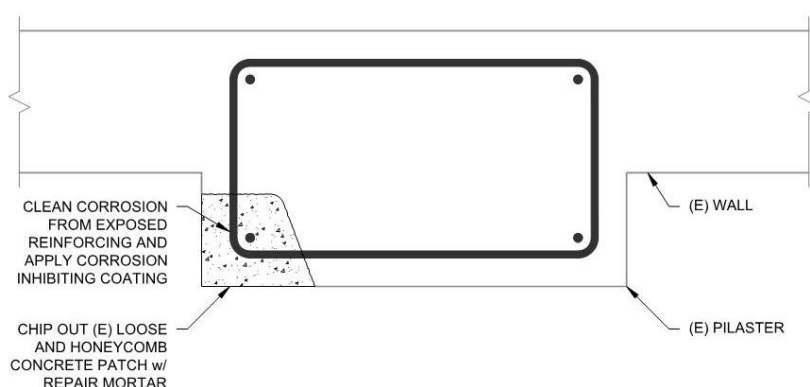
1 PILASTER REPAIR

Figure 6. Base concrete pilaster repair.

- Remove loose or delaminated concrete and sawcut the perimeter of the repair area.
- Chip out the concrete to allow access around the exposed reinforcing steel.
- Clean the corrosion and apply a protective coating to the exposed steel.
- Supplement severely corroded or missing reinforcing steel with new reinforcing steel.
- Patch the concrete spalls using an appropriate concrete repair mortar.
- Coat concrete walls and pilasters with an elastomeric coating.
- Re-apply an anti-graffiti coating on the lower portion of the walls, similar to what currently exists at the building.

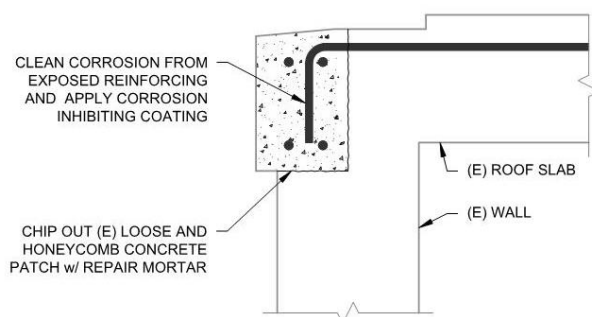
2 ROOF EDGE REPAIR

Figure 7. Base perimeter roof edge beam repair.

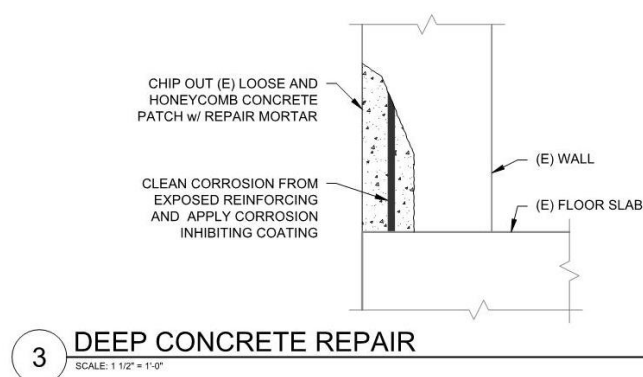
Figure 8. Base deep concrete void or spall repair.

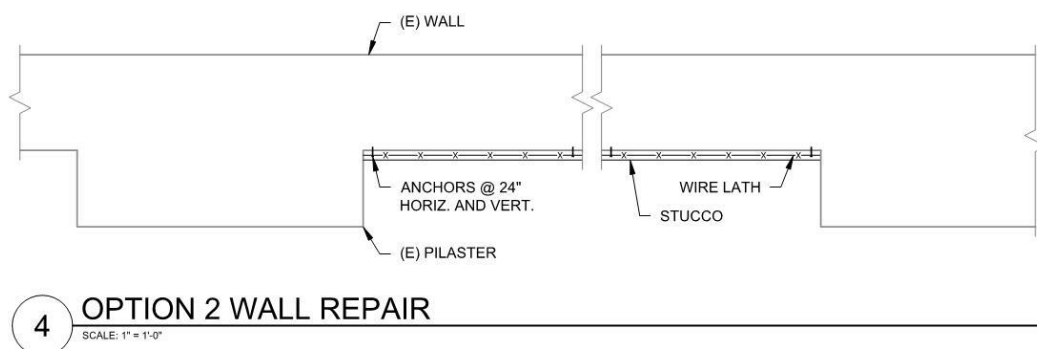
Figure 9. Wall repair option using a mechanically attached stucco system applied to the walls.

- Install horizontal control joints at the bottom of each floor slab level (top of each story wall), and intermediate horizontal control joints at the mid-height of the fourth and fifth floor walls.

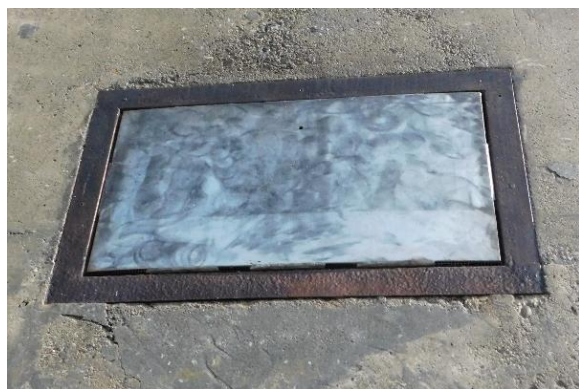
Figure 15. Typical opening in concrete wall, closed with steel plate.

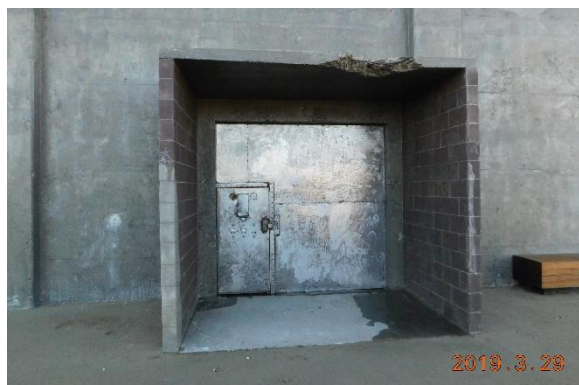
Figure 17. Covered exterior entryway around main entry door on west elevation. Note the spall at the edge of the roof slab.

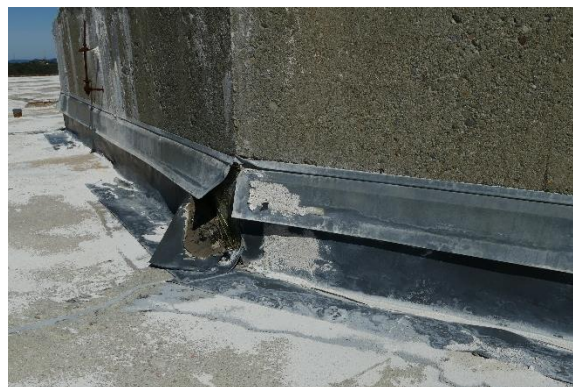
Figure 28. Counterflashing at concrete pedestal. Note the single-ply membrane flashing that was later added, and has failed.

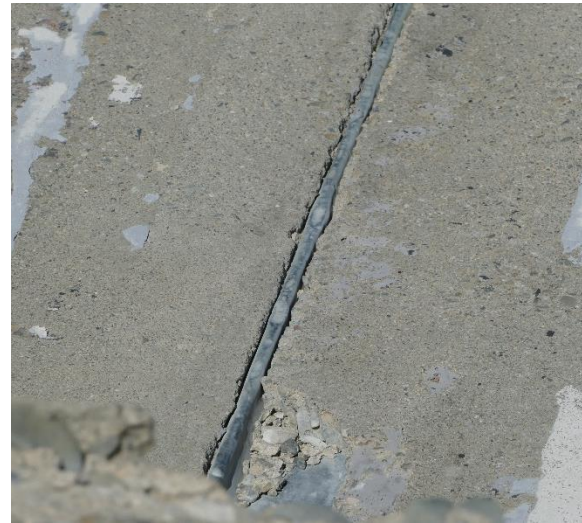
The roof is divided into quadrants by perpendicular expansion joints in the wearing slab (Figure 30) that do not extend through the structural slab (Figure 31). There is a roof drain (Figure 32) in the center of each quadrant, however the drain pipe was reportedly disconnected and sealed with grout to prevent animal intrusion. All four roof drains had plants growing out of them at the time of our observation.

Figure 30. Wearing slab expansion joint formed from folded copper sheet that was originally covered by sealant. Note that the other three joints in the slab were concealed by more modern repair sealant.

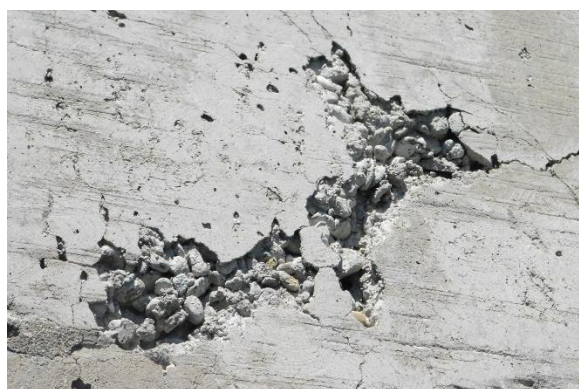
Figure 37. Poorly consolidated concrete.

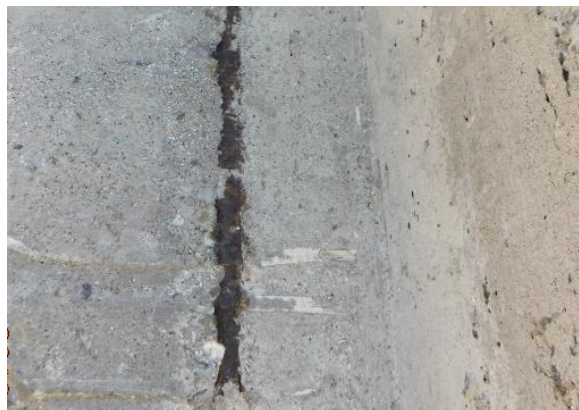
Figure 39. Corroded reinforcing steel with minimal concrete cover.

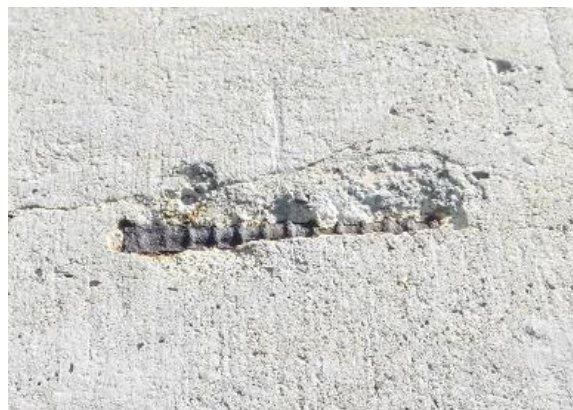
Figure 40. Reinforcing steel with little to no cover.

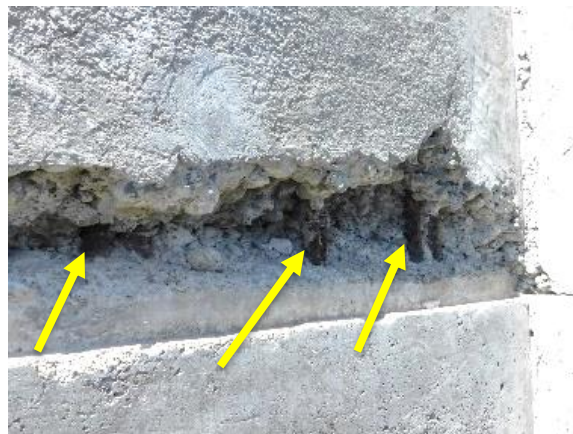
Figure 44. Poorly consolidated concrete above the horizontal construction joint above the floor slab revealing the joint key and reinforcing steel (arrows).

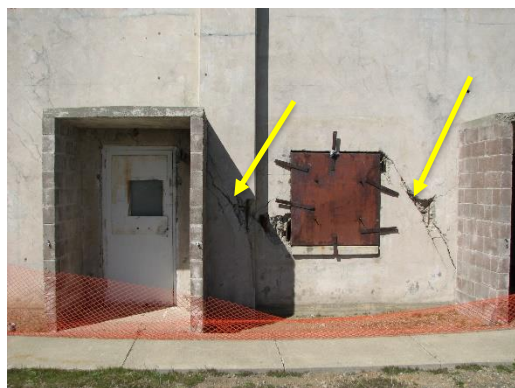
Diagonal cracks were observed at multiple locations on the exterior walls. At the first floor on the east side, previously patched cracks were observed between window and door openings (Figure 45) that likely formed during the Loma Prieta Earthquake in 1989, whose epicenter was only 5 miles to the southeast. The most significant of these cracks were present until about 2014 when they were repaired and the adjacent window and door openings were infilled with concrete (Figure 46).

Figure 45. Cracks visible at east elevation (arrows). (Photo taken in 2013 by WJE)

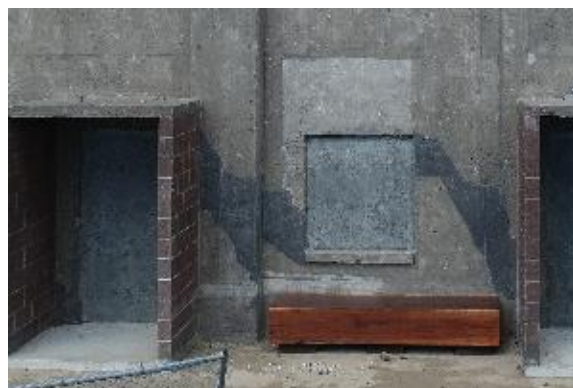
Figure 46. Repaired cracks and infilled openings at east elevation.

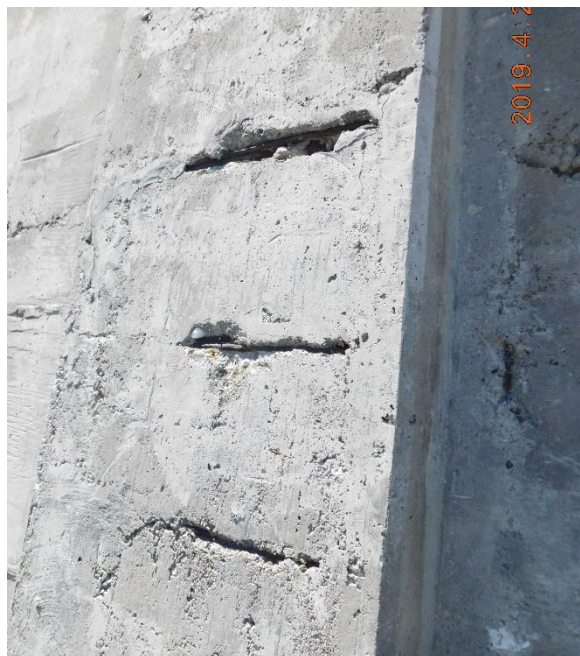
The concrete pilasters have experienced significantly more frequent and severe concrete spalling than the surface of the walls. This spalling has exposed corroded reinforcing steel. Most of the spalling at the horizontal reinforcing is the result of inadequate concrete cover over the horizontal reinforcing (Figure 47 and Figure 48).

Figure 47. Concrete spalling on face of pilaster due to inadequate concrete cover.

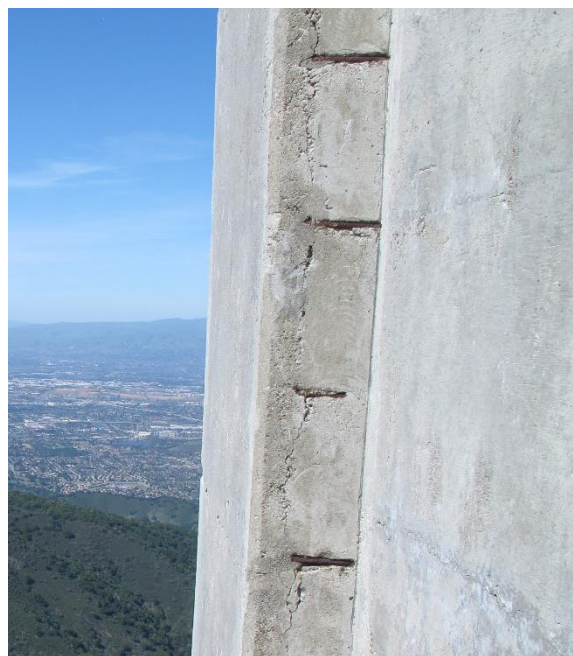
Figure 48. Concrete spalling on side of pilaster due to inadequate concrete cover.

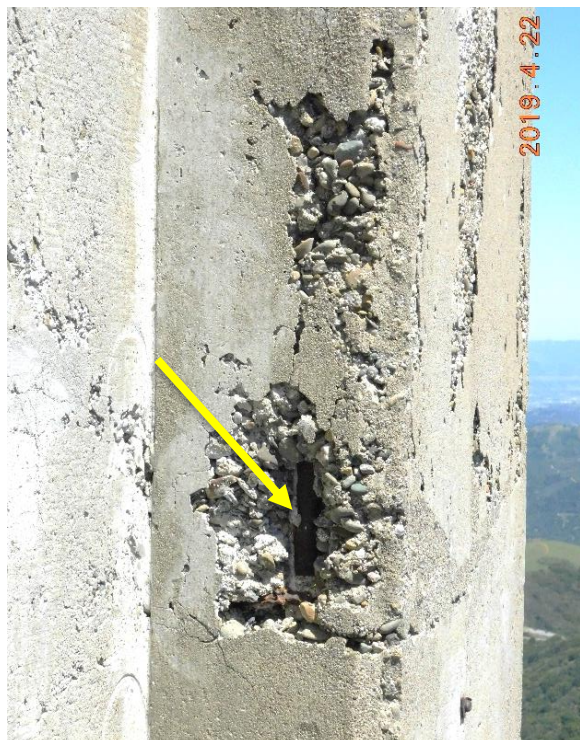
In other locations where the vertical reinforcing is exposed, spalling occurs in areas of poor concrete consolidation on the sides and corners of the pilasters between the vertical reinforcing bars and the finished exterior concrete surface (Figure 49 and Figure 50).

Figure 49. Poorly consolidated concrete on the side and corner of the pilaster. Note exposure of reinforcement steel (arrow).

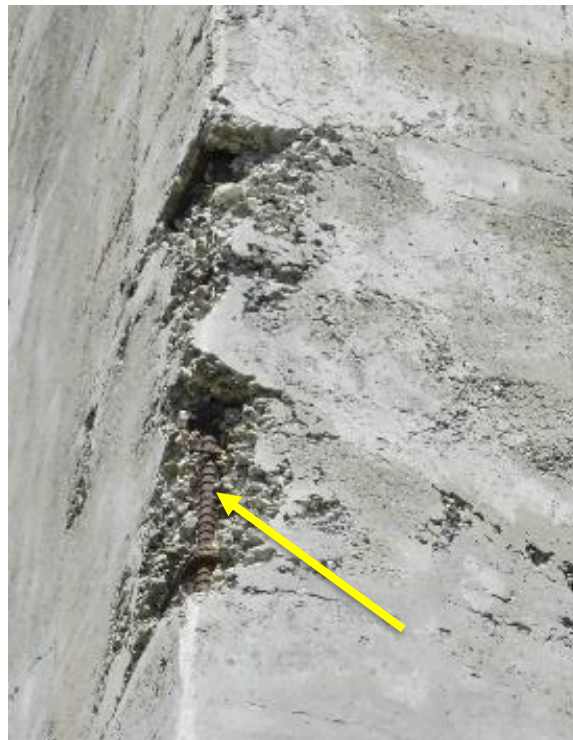
Figure 50. Poorly consolidated concrete on the sides and corner of the pilaster. Note exposure of reinforcement steel (arrow).

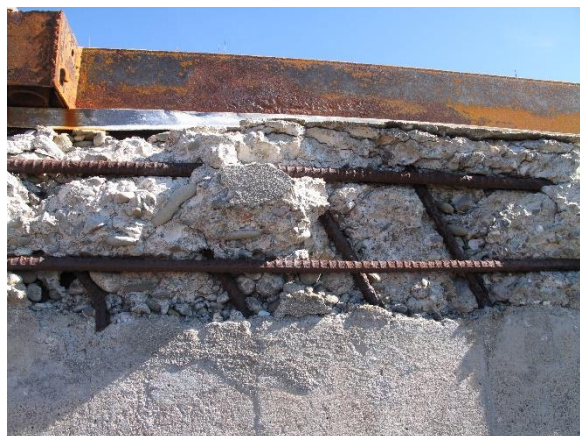
Significant concrete spalling has occurred along the perimeter beam along the edge of the roof slab, which it protrudes from the exterior face of the walls, exposing the wall and roof slab reinforcing steel in places (Figure 51 and Figure 52). Smaller concrete spalls that are not associated with corroded reinforcing are also present, primarily along the bottom of the perimeter roof edge beam at the drip (Figure 53 and Figure 54).

Figure 51. Concrete spalling and exposed reinforcing along the perimeter roof edge beam.

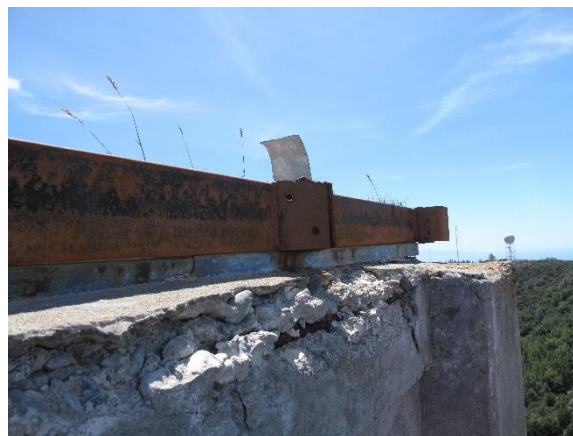
Figure 52. Concrete spalling and exposed reinforcing along the perimeter roof edge beam.

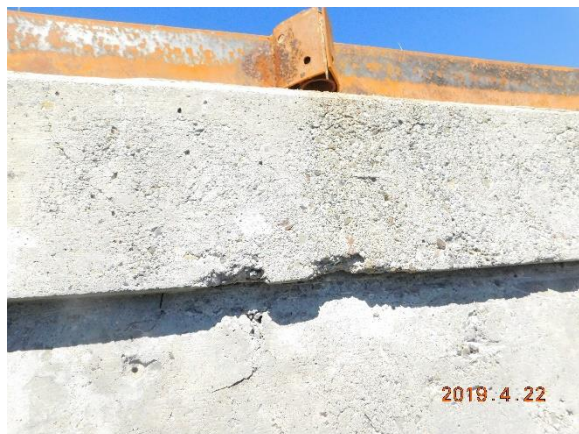
Figure 53. Small concrete spalls along the bottom edge of perimeter roof edge beam.

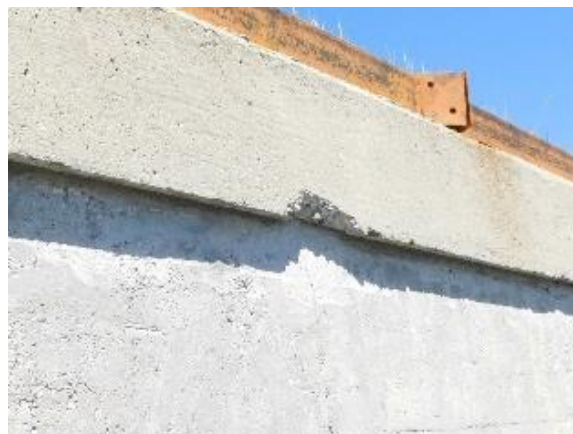
Figure 54. Small concrete spall along the bottom edge of perimeter roof edge beam.

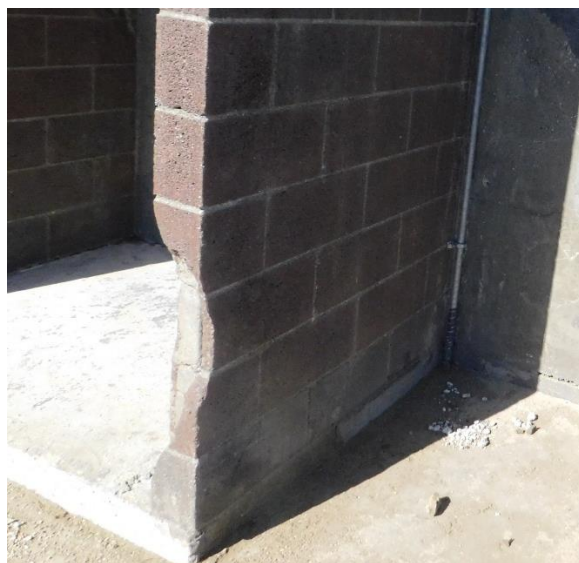
Several of the concrete block wind screens were also observed to have some spalling (Figure 55). Spalling of the concrete slab forming the roof of the wind screens was also observed (Figure 56).

Figure 55. Spalling of concrete block wall of wind screen

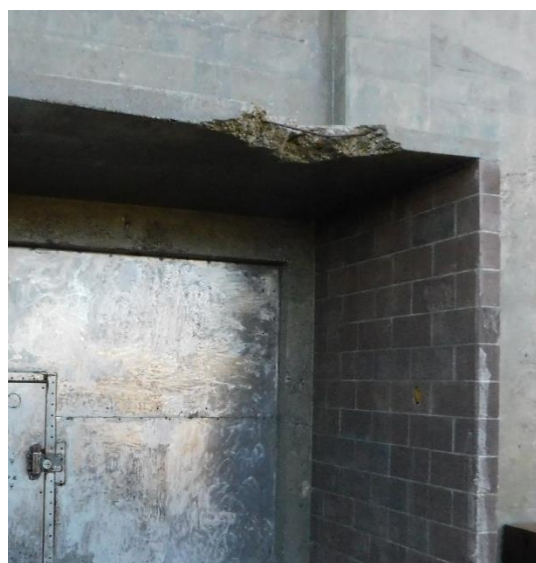
Figure 56. Spalling of concrete slab at top of roof of wind screen.

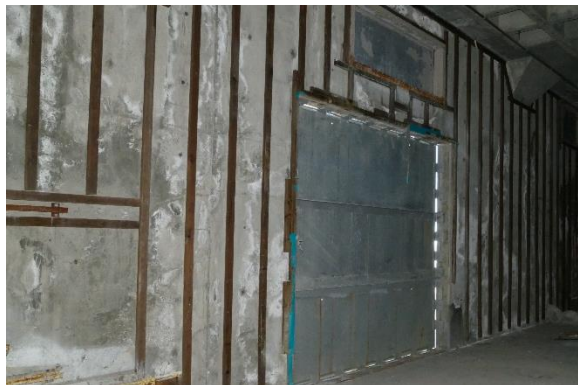
Figure 57. Efflorescence stains at interior of concrete walls.

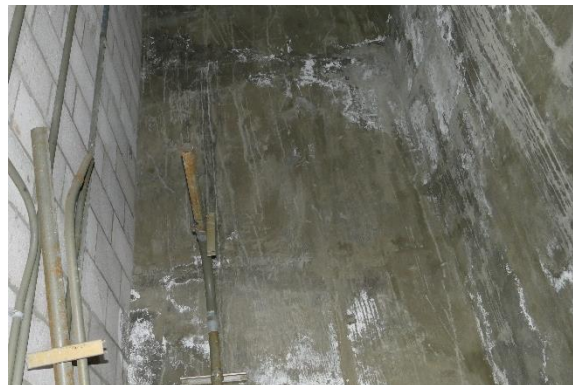
Figure 58. Efflorescence stains in utility shaft at southeast building corner, facing east.

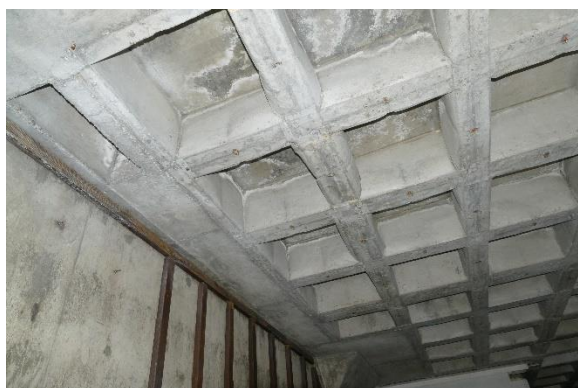
Figure 59. Efflorescence visible on the underside of the third floor slab where water leaks into the building and through the slab.

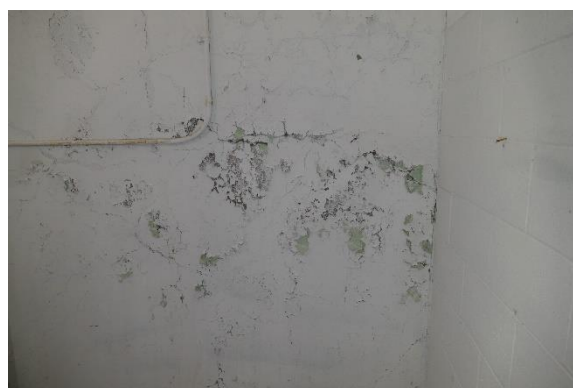
Figure 60. Peeling paint on the inside face of the exterior wall.

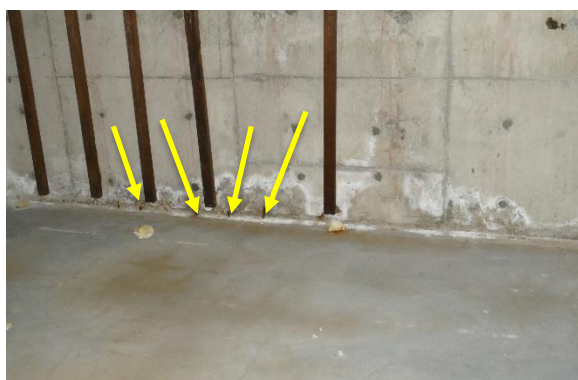
reinforcing steel is exposed and observed to be corroded along the base of the wall (Figure 61 and Figure 62),

Figure 61. Exposed reinforcing steel observed along the base of the wall (arrows).

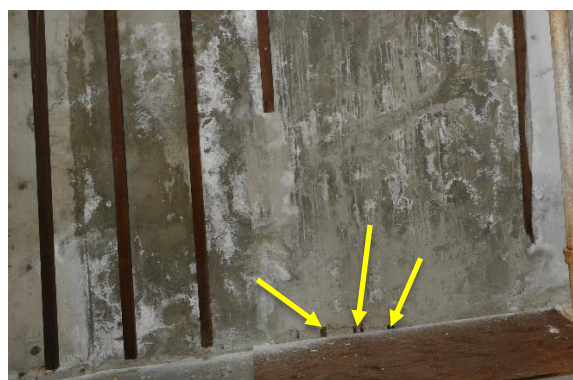
Figure 62. Exposed reinforcing steel observed along the base of the wall (arrows).

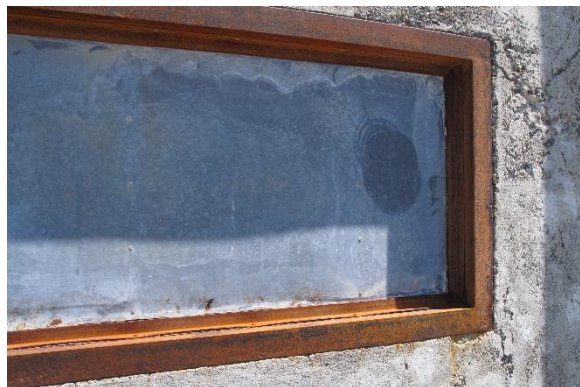
The galvanized steel plates that cover the wall openings are generally in good to fair condition (Figure 63) however some of the original steel frames embedded into the concrete wall around openings that they are attached to are corroded, with corrosion staining below and adjacent to some openings at the interior (Figure 64). The ventilation gap around the perimeter of these plates allows water to enter the building with no means to collect and discharge it. There was standing water on the floor in several locations below these openings at the time of our visit.

Figure 63. Galvanized steel plate with light oxidation and corroded steel frame.

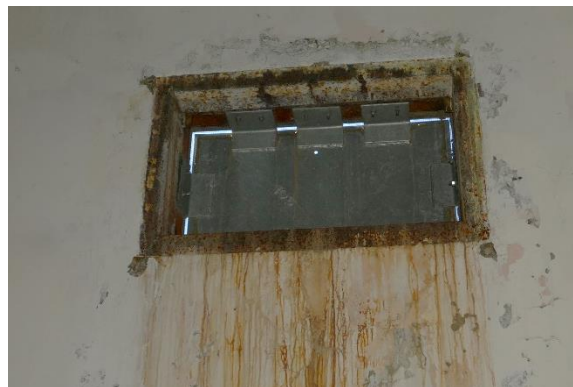
Figure 64. Water and corrosion staining below wall penetration.

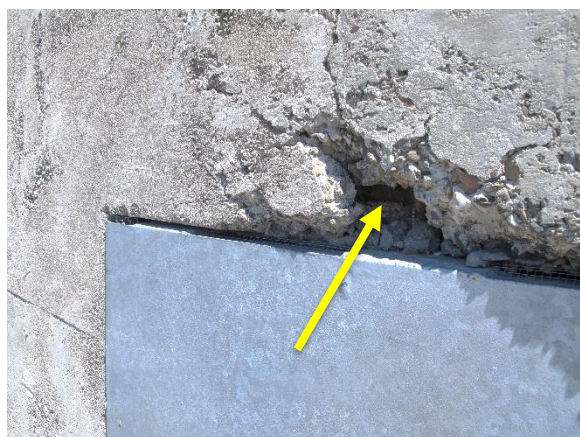
Spalling of the concrete was observed on the exterior adjacent to several of the openings. At some locations spalls expose corroded reinforcing steel (Figure 65), but at most locations there is poorly consolidated concrete adjacent to the steel frames (Figure 66).

Figure 65. Concrete spalling and exposed reinforcing steel (arrow) adjacent to infilled window opening.

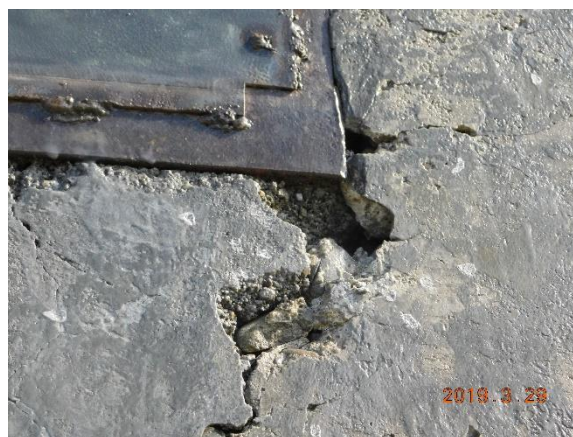
Figure 66. Voids in concrete due to poor consolidation adjacent to window opening.

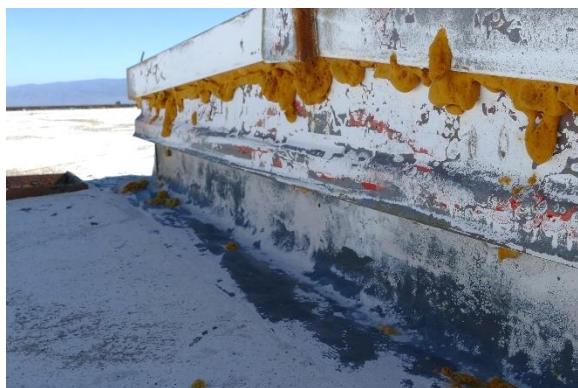
Figure 67. Single-ply membrane flashing (black), spray foam (yellow), and fluid-applied coating (white) at roof equipment hatch.

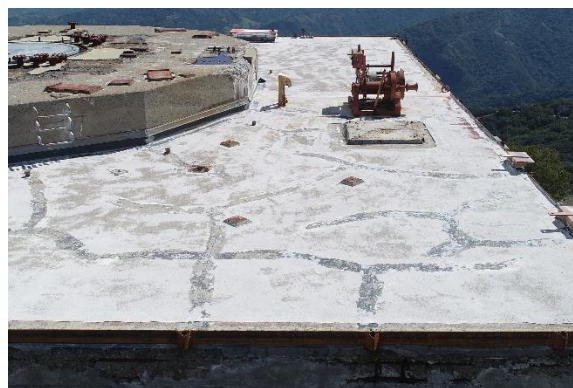
Figure 68. White traffic coating on main roof, facing east. Note the darker stripes where underlying cracks were treated.

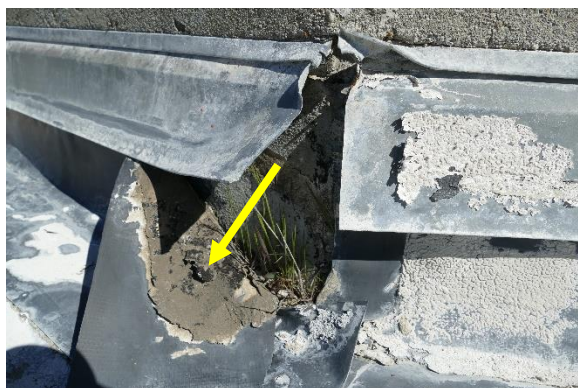
Figure 69. Damaged counterflashing at concrete pedestal showing single-ply membrane flashing (black sheet, damaged), fluid-applied coating (white), and original built-up flashing (black residue adhered to interior surface of single-ply flashing, arrow).

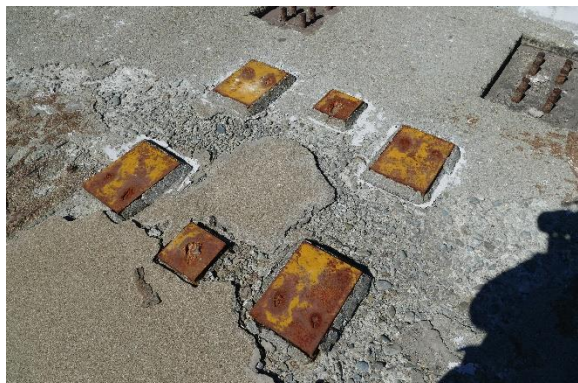
Figure 70. Concrete spalling and corroded steel plates on the top surface of the concrete pedestal.

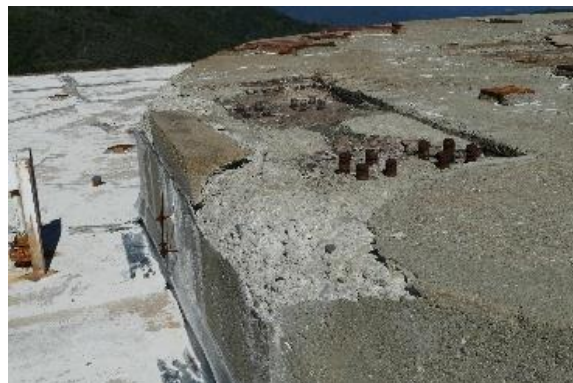
Figure 71. Concrete spalling along the edge of the concrete pedestal.

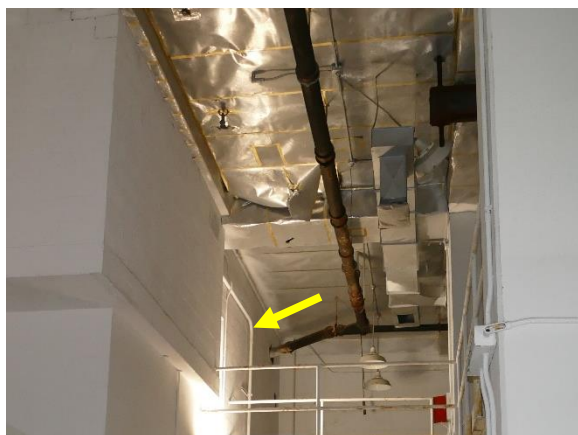
Figure 72. Cast iron drainage plumbing with widespread corrosion running into the utility shaft at the southeast corner (arrow). Photo facing south.

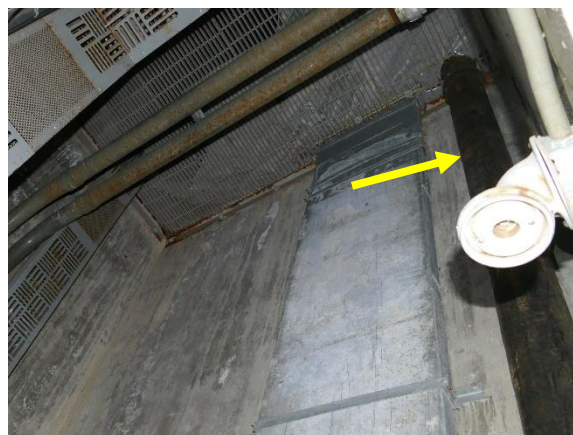
Figure 73. Cast iron drainage plumbing stack in utility shaft. Photo facing southeast.

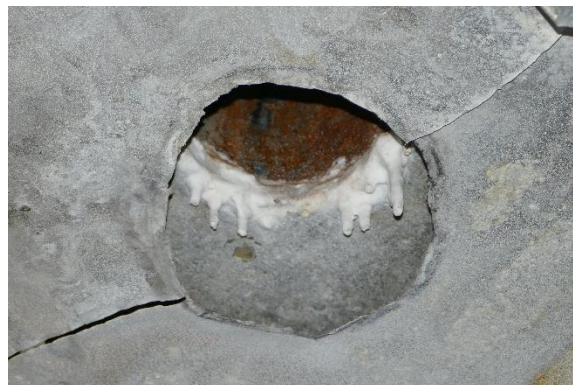
Figure 75. Efflorescence deposits around penetration in concrete roof slab, with aluminum sheets in foreground.

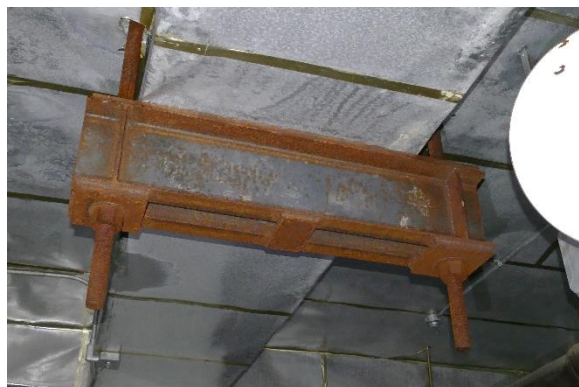
Figure 76. Surface corrosion on steel beam clamp.

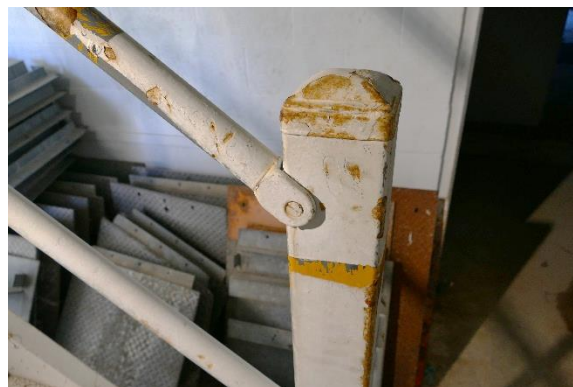
Figure 77. Surface corrosion on metal stair handrail.

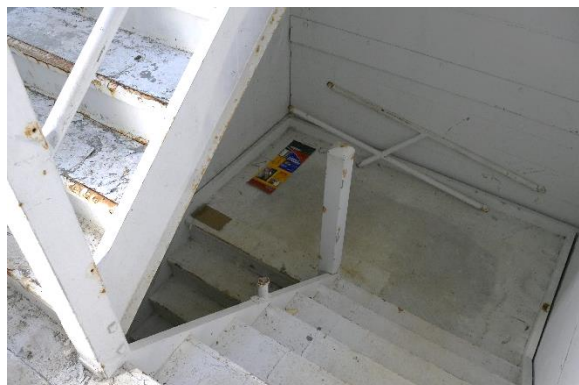
Figure 78. Missing guardrail.

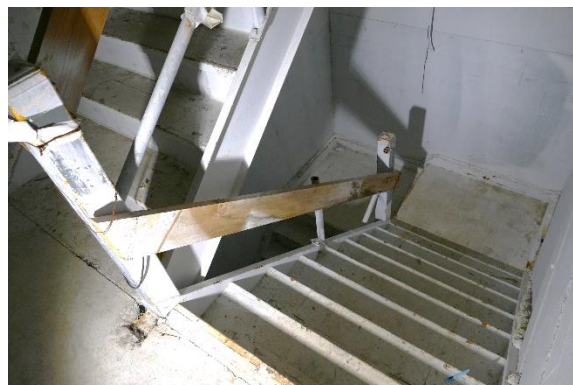
Figure 79. Partially missing handrail with temporary wood railing.

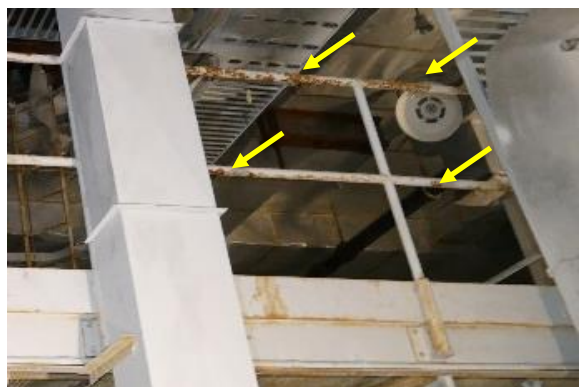
Figure 80. Corrosion of guard rails at the mezzanine.

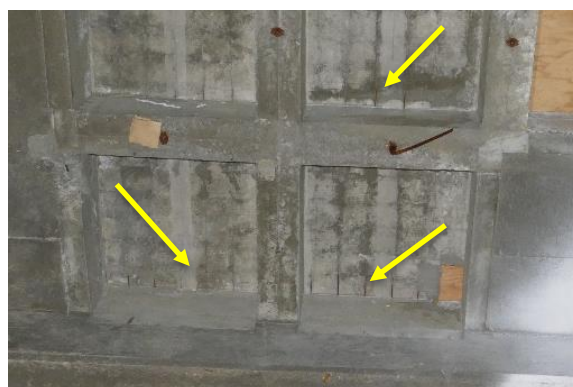
Figure 81. Corrosion staining of reinforcing steel at the soffit of the fifth floor (arrows)

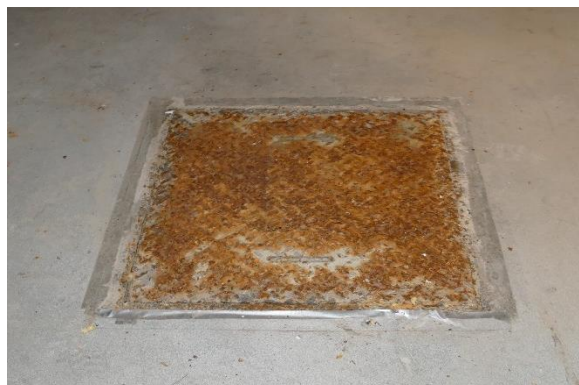
Figure 82. Corroded metal plate covering opening in floor.

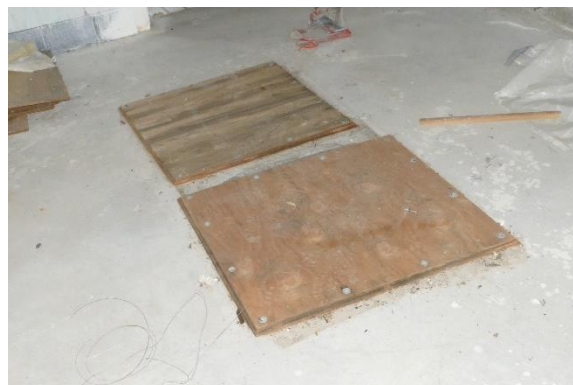
Figure 83. Plywood covering openings in floor.

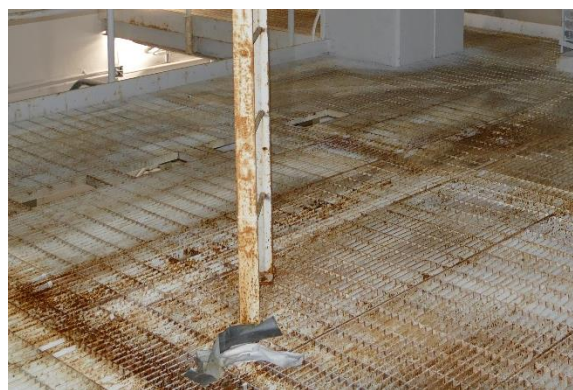
Figure 85. Surface corrosion at mezzanine floor grating below concrete pedestal at roof above.

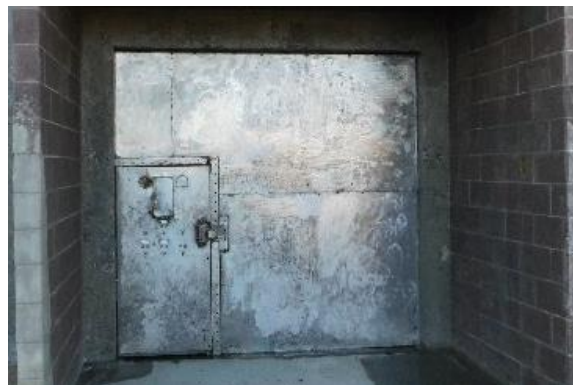
Figure 87. The west door was originally a double-leaf door, but appears to have been modified and has only a small access door in a larger metal plate.

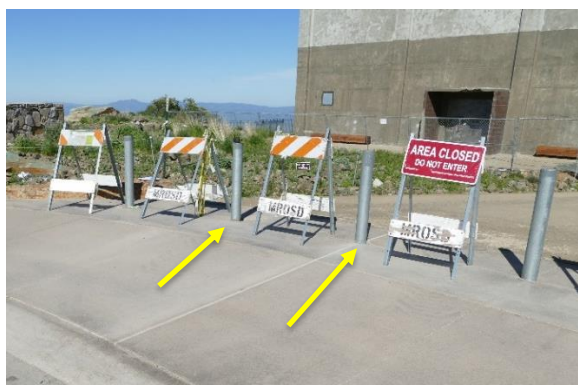
Figure 88. Bollards along the sidewalk. Arrows indicate the two removable bollards.

Replace the two removable bollards with a bollard system that is tolerant of exposure to sand and debris. A foldable bollard system, similar to that used along the roadway to the peak of Mount Umunhum (Figure 5) would appear to be easier to operate and would be less likely to become jammed with debris. Replacement bollards would be expected to last at least 30 years.

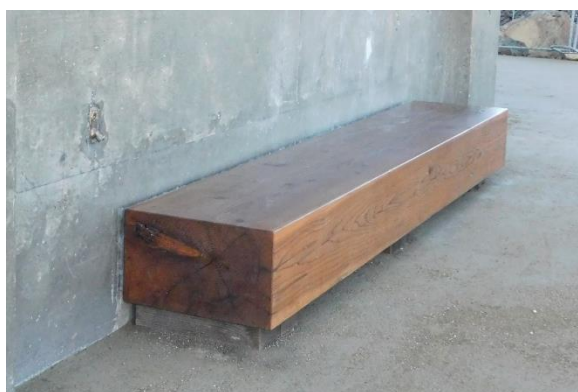
Figure 90. Wood benches are very close to the concrete walls.
