Approval of Basis of Design recommendations to complete the Deer Hollow Farm White Barn Structural Stabilization Project at Rancho San Antonio Open Space Preserve

### **Basis of Design**

December 18, 2019  
WJE No. 2018.0646

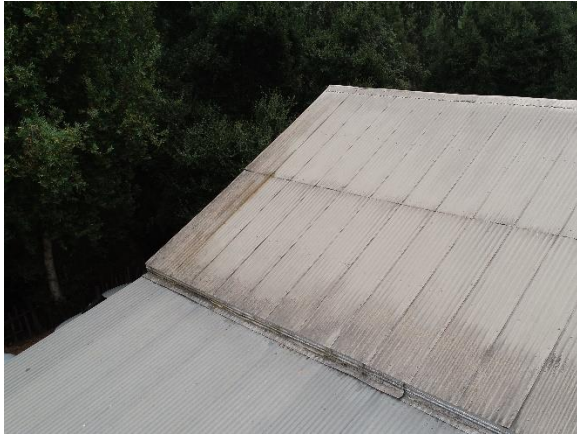
The corrugated metal roof panels are in fair condition. On the east side of the center gable, there appears to be biological growth and soil accumulation on the metal panels themselves as well as at the transition to the shed roof (Figure 28). Fasteners have become dislodged and are protruding from the roof surface (Figure 29). Several small holes were observed in the roof panels and leaking of the roof during rainstorms was reported. The ridge cap flashing is also showing signs of distress and fasteners are beginning to protrude from the roof surface at this location as well (Figure 30). The gutters on the east and west shed-roof eaves appear to be in fair condition when observed from the ground level. However, it is unclear how the gutters are flashed due to limited access. At the short gutter on east side of the barn, because there is no downspout, holes have been punched into the bottom of the gutter at one side and the gutter is beginning to corrode (Figure 33). At the west eave, where the gutter is attached directly to the rafter tails, we observed one rafter tail that was deteriorated (Figure 31). On the east side, where fascia is present, there are roughly six rafter tails that are deteriorated (Figure 32).

*Figure 28. Corrosion, biological growth, and soiling on roofing panels on the west side.*

- Remove and replace all sheet metal roof panels to match existing panels.
- Remove and replace damaged skip sheathing.
- Install sister rafter directly next to damaged rafters.
- Remove and replace existing gutters and downspouts.
- Install wood blocking.
- Replace missing knee brace and install metal straps on all knee braces.

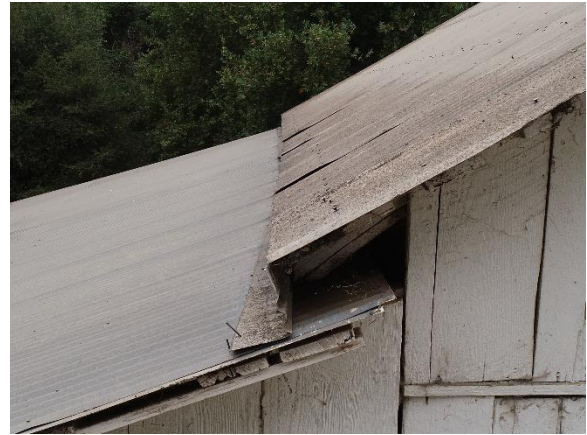
*Figure 29. Protruding fasteners at roof transition.*

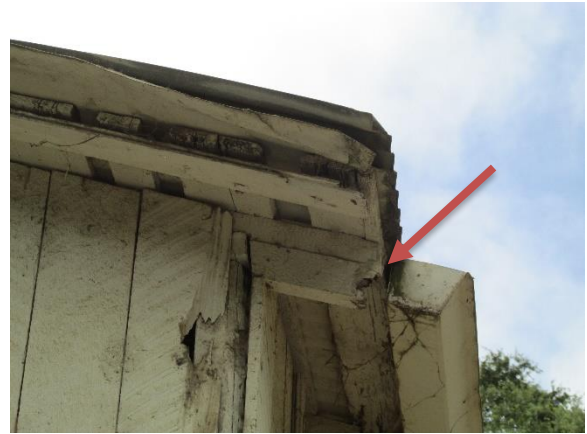
*Figure 31. Deteriorated rafter tail on west side.*

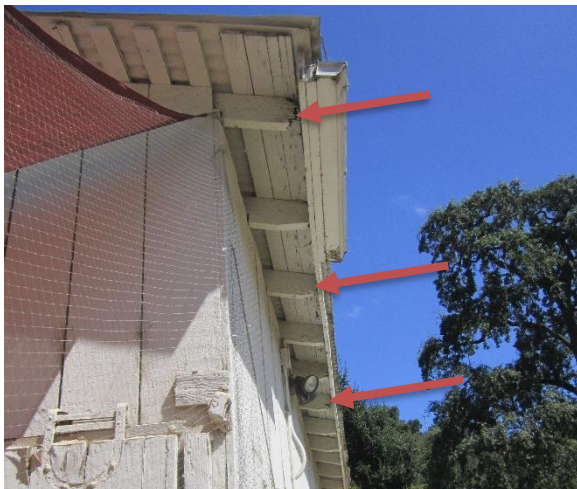
*Figure 32. Deteriorated rafter tails on east side.*

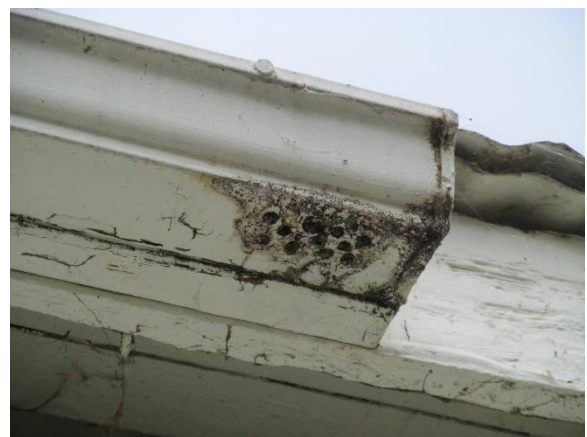
*Figure 33. Soiling and corrosion at the underside of the gutter on the east side.*

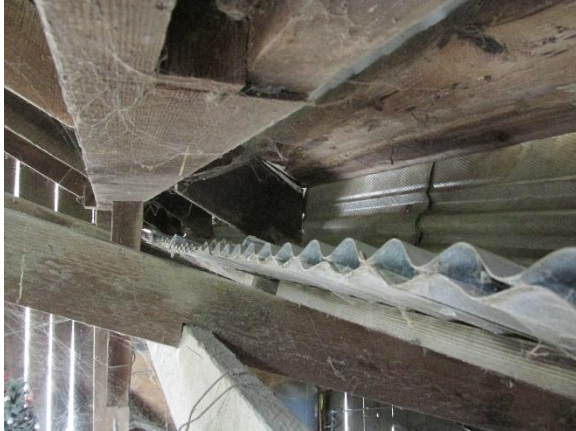
*Figure 34. “L” flashing from the interior.*

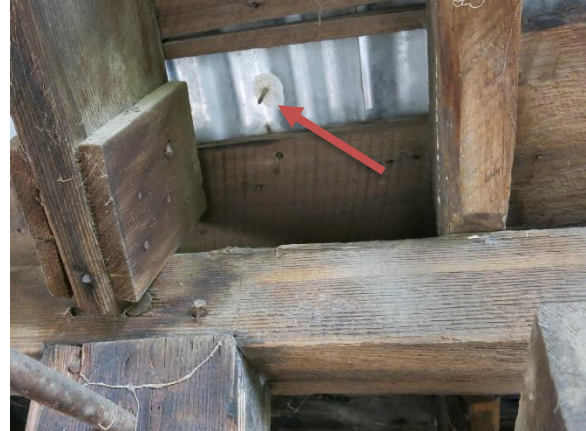
*Figure 35. Corrosion at fastener that did not penetrate skip sheathing.*

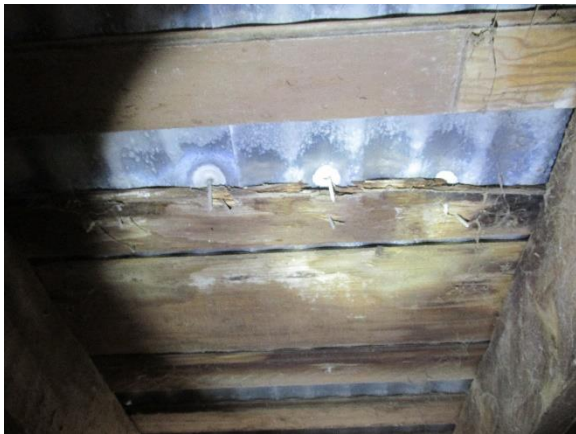
*Figure 36. Deteriorated skip sheathing.*

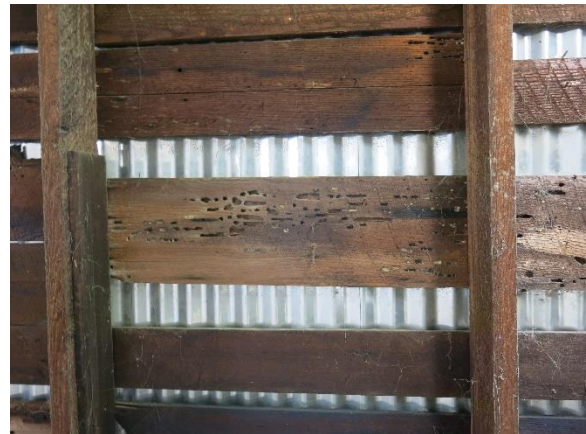
At the interior of the attic, where the roof transitions from the gable to shed roof, the “L” flashings appear to be in good condition; there are no visible signs of water infiltration at these two locations (Figure 34). At areas where numerous fasteners were used, or missed the underlying wood skip sheathing, the panels show signs of corrosion on the underside and the skip sheathing is deteriorated and split (Figure 35 and Figure 36). Additionally, throughout the skip sheathing boards, there is damage from wood-boring insects (Figure 37).

*Figure 37. Damage to the skip sheathing from wood-boring insects.*

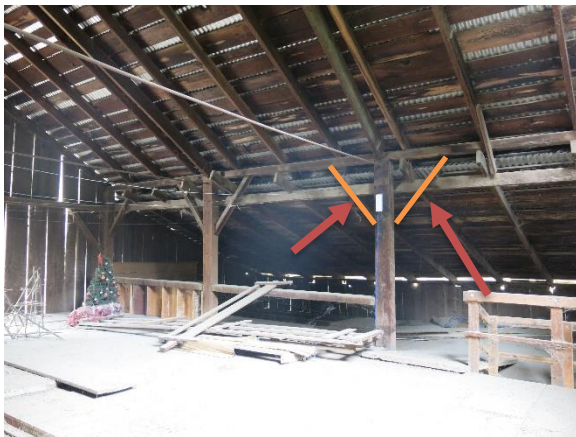
In addition, one set of diagonal knee braces for the beams that support the rafters for the center portion of the roof are missing and should be replaced (Figure 39). There is visible water staining of some of the rafters (Figure 40). Although these structural deficiencies are concerning, they are not an immediate concern for safety of the roof.

*Figure 39. Locations where diagonal knee braces are missing (arrows)*

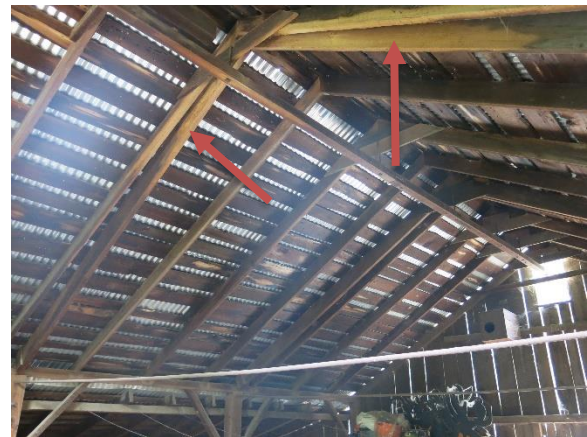
*Figure 40. Staining of roof rafters (arrows) likely caused by water leakage.*

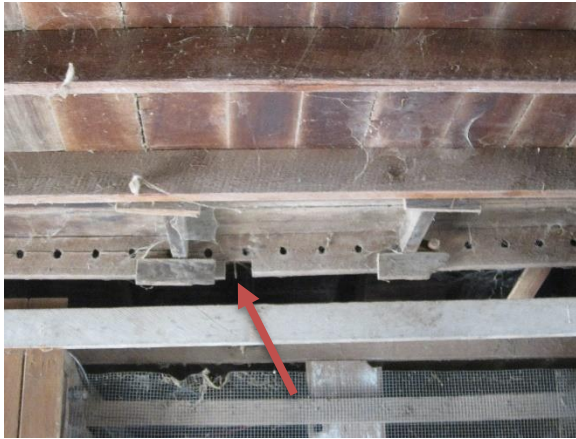
*Figure 41. Attic joist weakened by holes and notch (arrow).*

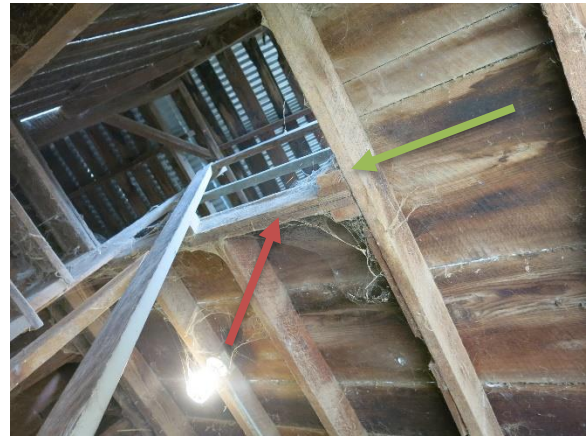
*Figure 42. Attic joists supported by beam (red arrow) along the side of the stair opening. Joist (green arrow) supporting beam is overstressed.*

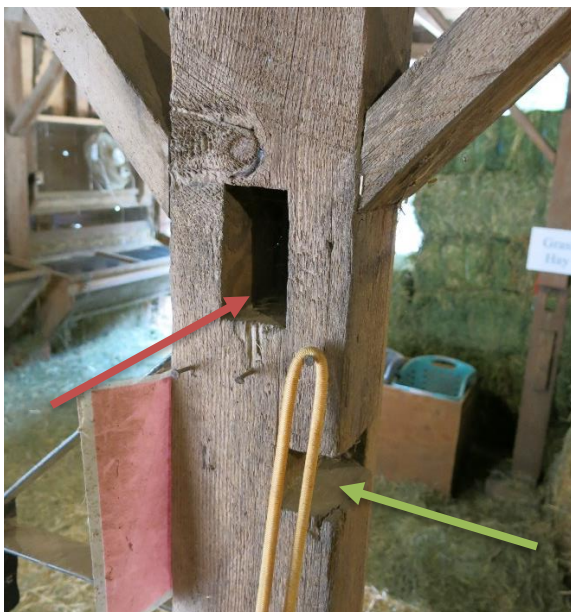
*Figure 43. Mortising of wood column (red arrow) and notch in column (green arrow).*

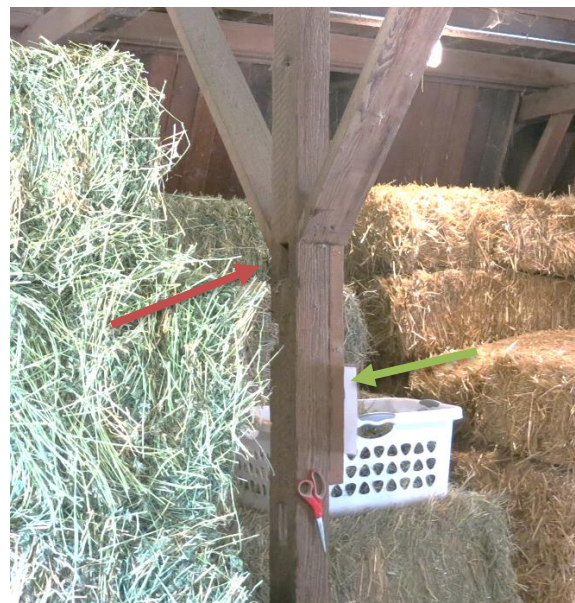
*Figure 44. Column mortise (Red arrow) and wood reinforcing plate (green arrow)*

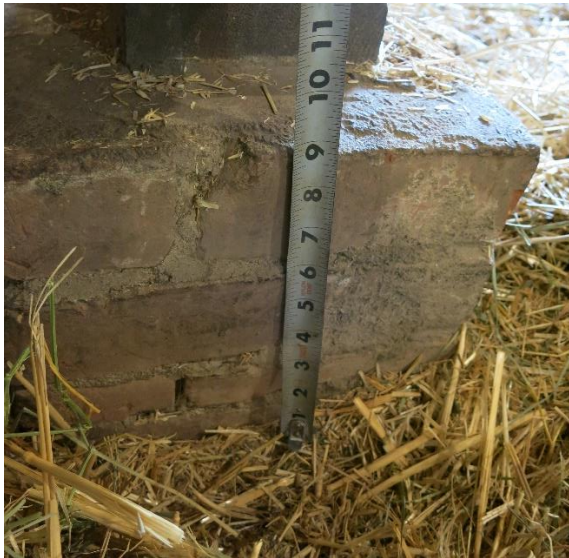
*Figure 45. Brick footing extending above the adjacent ground.*

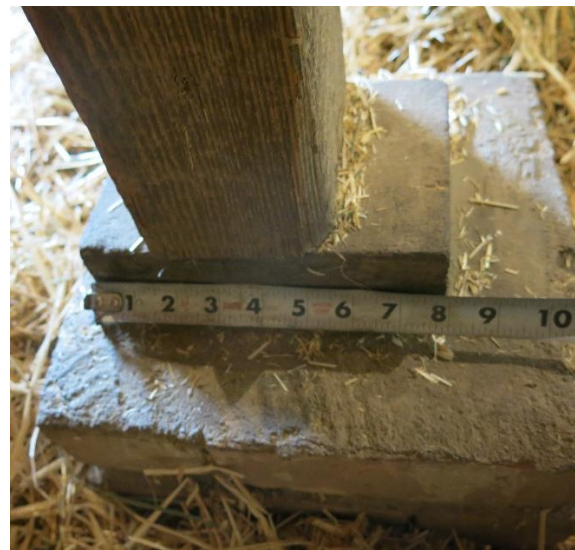
The wood columns are supported by wood shims on top of the brick footings that 12 inches square. The height of the brick footing above the adjacent ground varies from less than 4 inches to about 9 inches (Figure 45). The sizes of the footings below grade are not known. There is no observable structural connection of the column or wood shim to the brick footing (Figure 46). The brick footings appear to be in good condition with no obvious indications of deterioration, such as cracking or deterioration of the mortar. Since there is no damage to the footings, there is no CEBC requirement to upgrade the footings. However, voluntary strengthening of some of the footings may be performed where, based on our analysis, the soil pressures at the footings for design loads exceed the allowable bearing pressure provided by the geotechnical engineering report and to address the lack of connection of the columns to the footings.

*Figure 46. Wood shim between the column and the brick footing.*

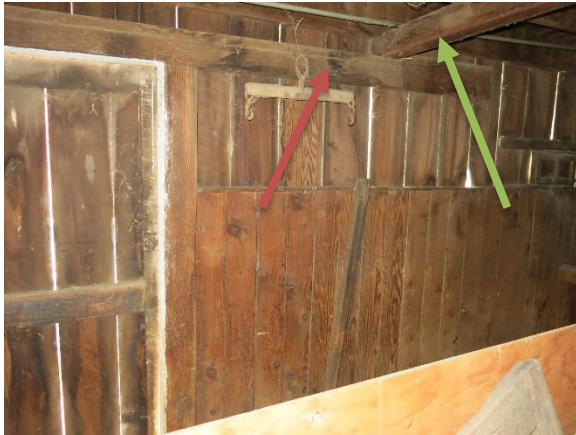
In the east section of the barn, the attic joists are supported by a wood beam that spans across the width of the building. At the north and south ends, this beam is supported by a wood beam that is an extension of the door header (Figure 47). On the interior, the attic beam is supported by five wood posts that are located between the former horse stalls. These posts are installed with a slope and are supported on the wood floor (Figure 48). The support framing for these inclined columns as well as the wood floor is unknown. Given that the wood flooring in the east section is decayed, we have assumed that the bases of these inclined columns are also damaged due to decay and that the bases of the posts will need to be strengthened to meet CEBC design requirements.

*Figure 47. Door header beam (red arrow) supporting attic support beam (green arrow).*

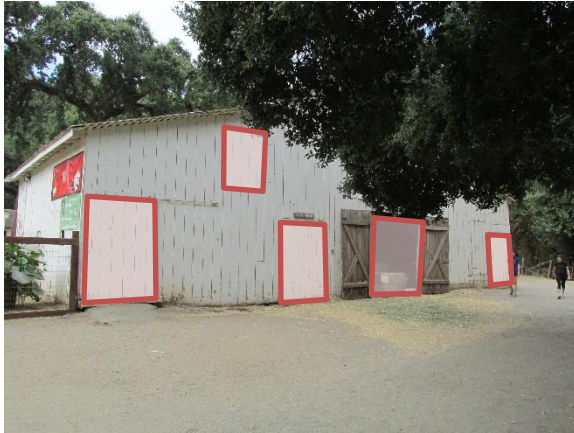
*Figure 49. Door openings in north side (red boxes)*

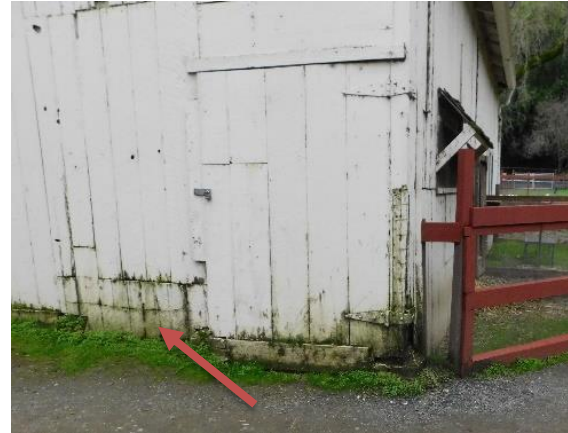
*Figure 50. Deteriorated wood sheathing at the base of the north side wall (arrow).*

- Remove damaged exterior sheathing and replace with wood sheathing to match.
- Strengthen sections of the exterior walls on each side of the White Barn to resist wind and seismic forces with diagonal wood braces installed between existing wood posts.

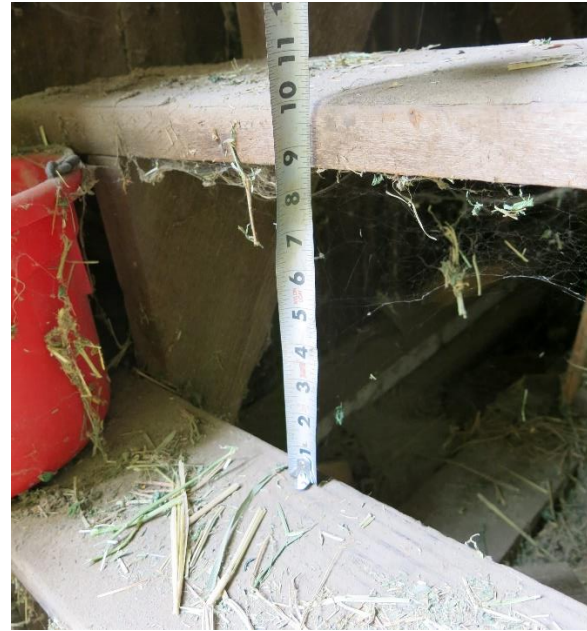
*Figure 52. Vertical rise of attic stair.*
