Midpeninsula Regional
Open Space District

R-20-35
Meeting 20-08
April 8, 2020

Select a design alternative for the La Honda Creek Redwood Cabin, La Honda Creek White Barn, and Sierra Azul Beatty House

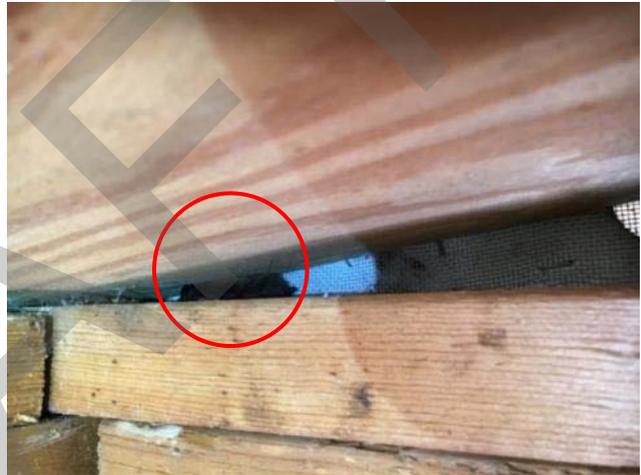
Photo 26. *Myotis sp.* (circled in red) observed roosting in crevice in nearby shed to the west of the structure to be removed.

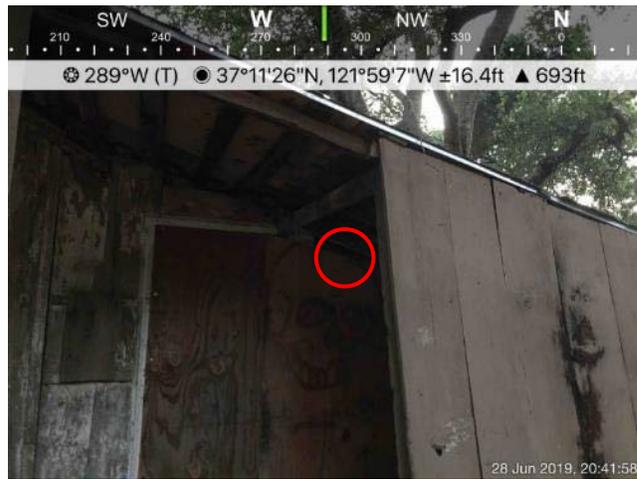
Photo 34. Bats observed emerging from hole in wall (circled in red) on east side of the house.

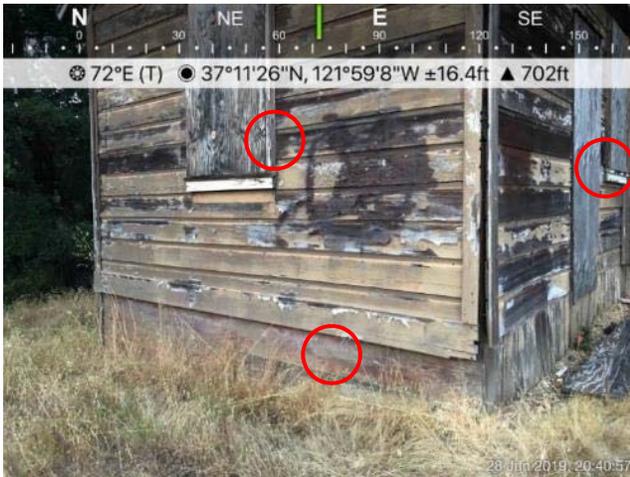
Photo 35. Bats observed emerging from wooden slats (circled in red) on west side of the house.

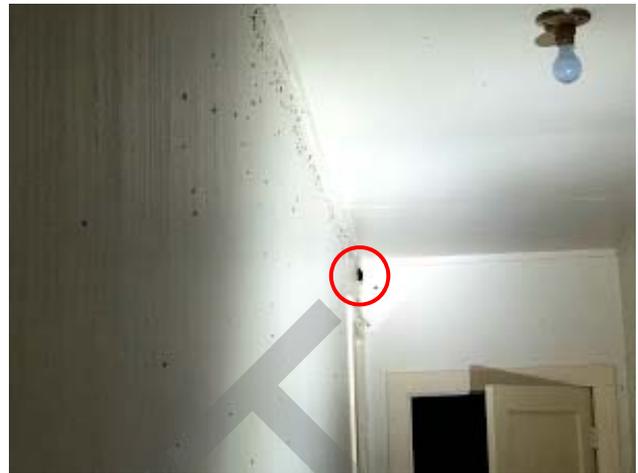
Photo 36. Bat urine staining and guano on wall; *Myotis* sp. (circled in red) observed roosting.

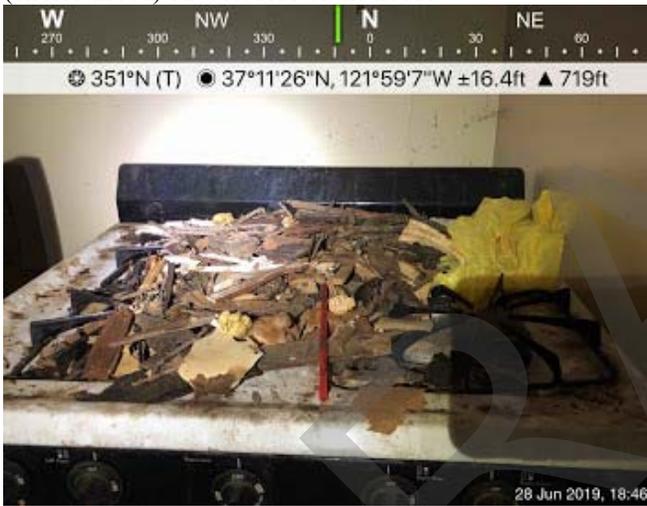
Photo 37. Stick pile on top of stove in kitchen.

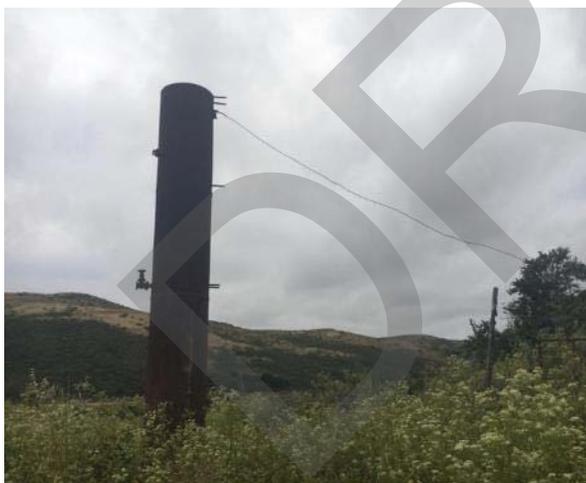
Photo 43. Area B – the distillation column was sealed on top but appeared to have a small opening on the left-hand side near the valve connection.

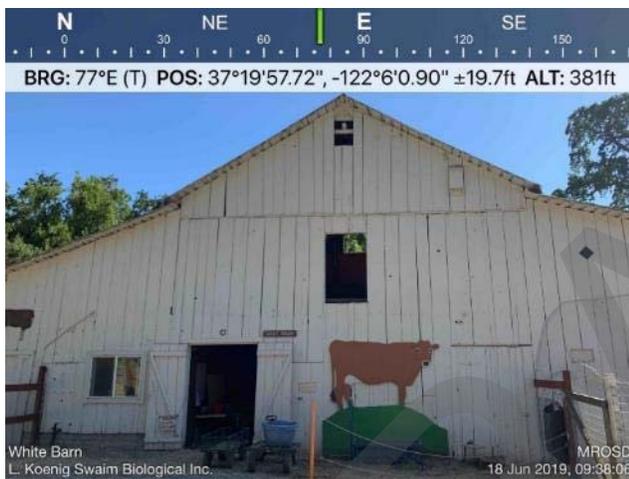
Photo 49. White Barn exterior showing hayloft doors and open access points.

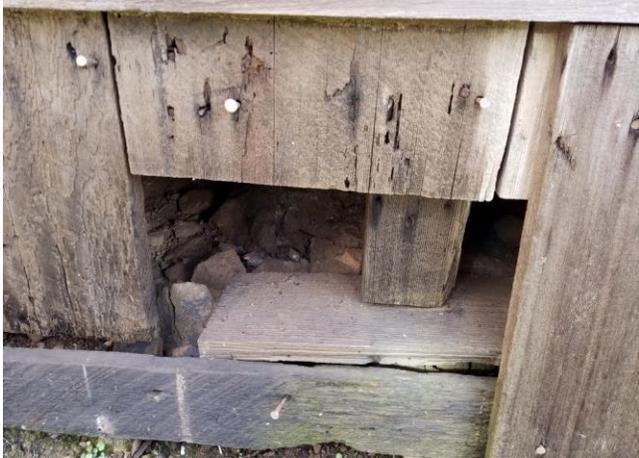
Photo 6. Missing siding on exterior wall, and lack of concrete foundation below bearing wall

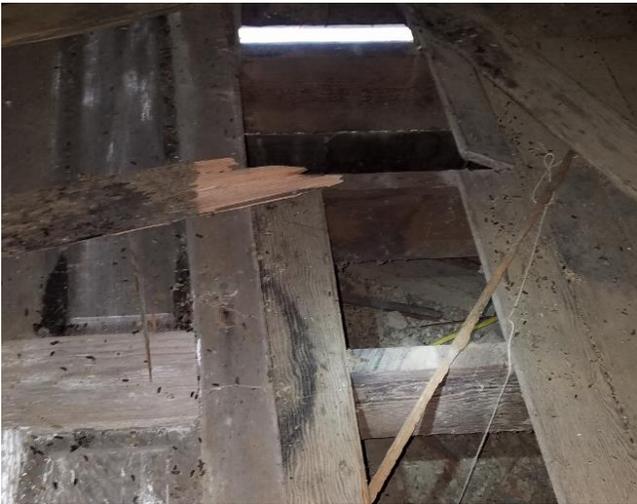
Photo 7. Missing wood planking at interior floor

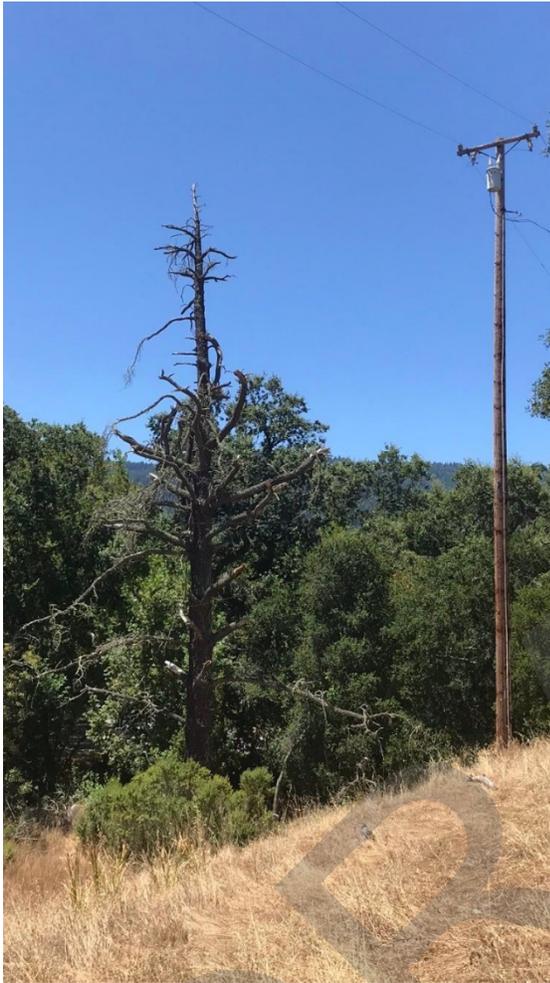
Dead Monterey pine trees were observed far from the building site (50 feet +). The dead pine trees are a fire hazard to the area and should be removed as soon as possible. Monterey pine trees are not native to this location and likely died due to bark beetles and the prolonged period of drought. The following tree protection plan will help to ensure the future survival of the trees on site.
