Memorandum

Project Hawthorns Area of Windy Hill Open Space Preserve
Portola Valley, California

Topic Historical Consultations - Olive Groves and Hawthorn Trees; Secondary
Ancillary Structures

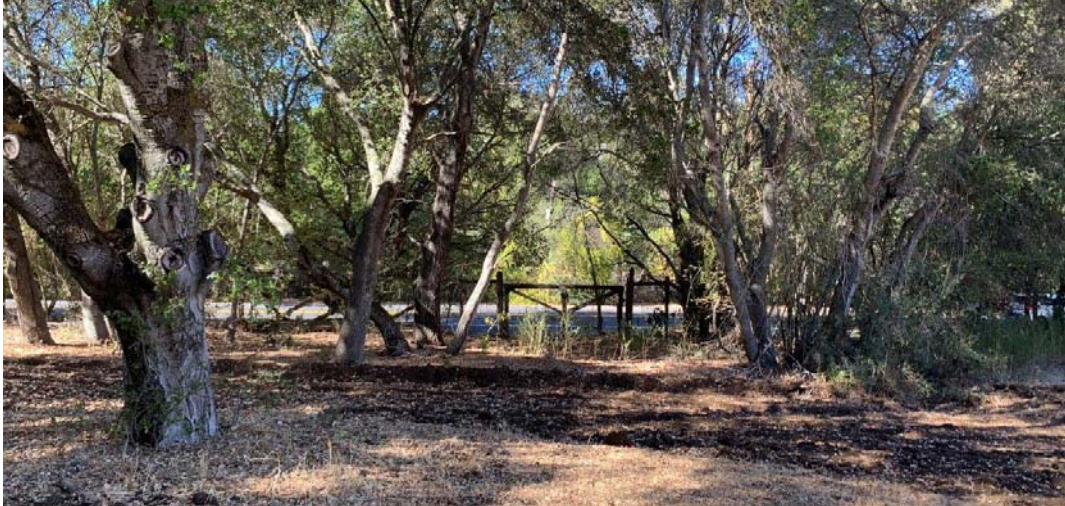
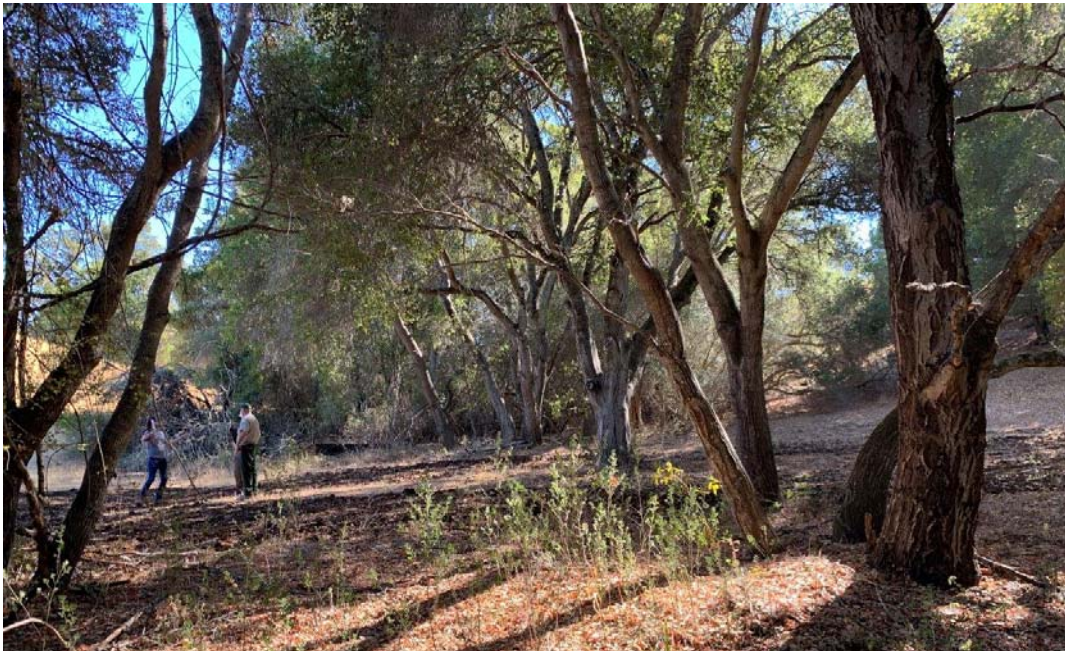
Trees at Historic Entrance Driveway – Above, the view looking northwest at the original entry at the gate flanked by oak trees and line of trees extending along one side (left). Below, the view looking southeast from the original entry with a line of trees to the right along one side extending to the woods where the driveway existed.

In terms of management, it is recommended to retain any aligned oak trees that recall the original driveway route and contribute to the overall historical character of the property.

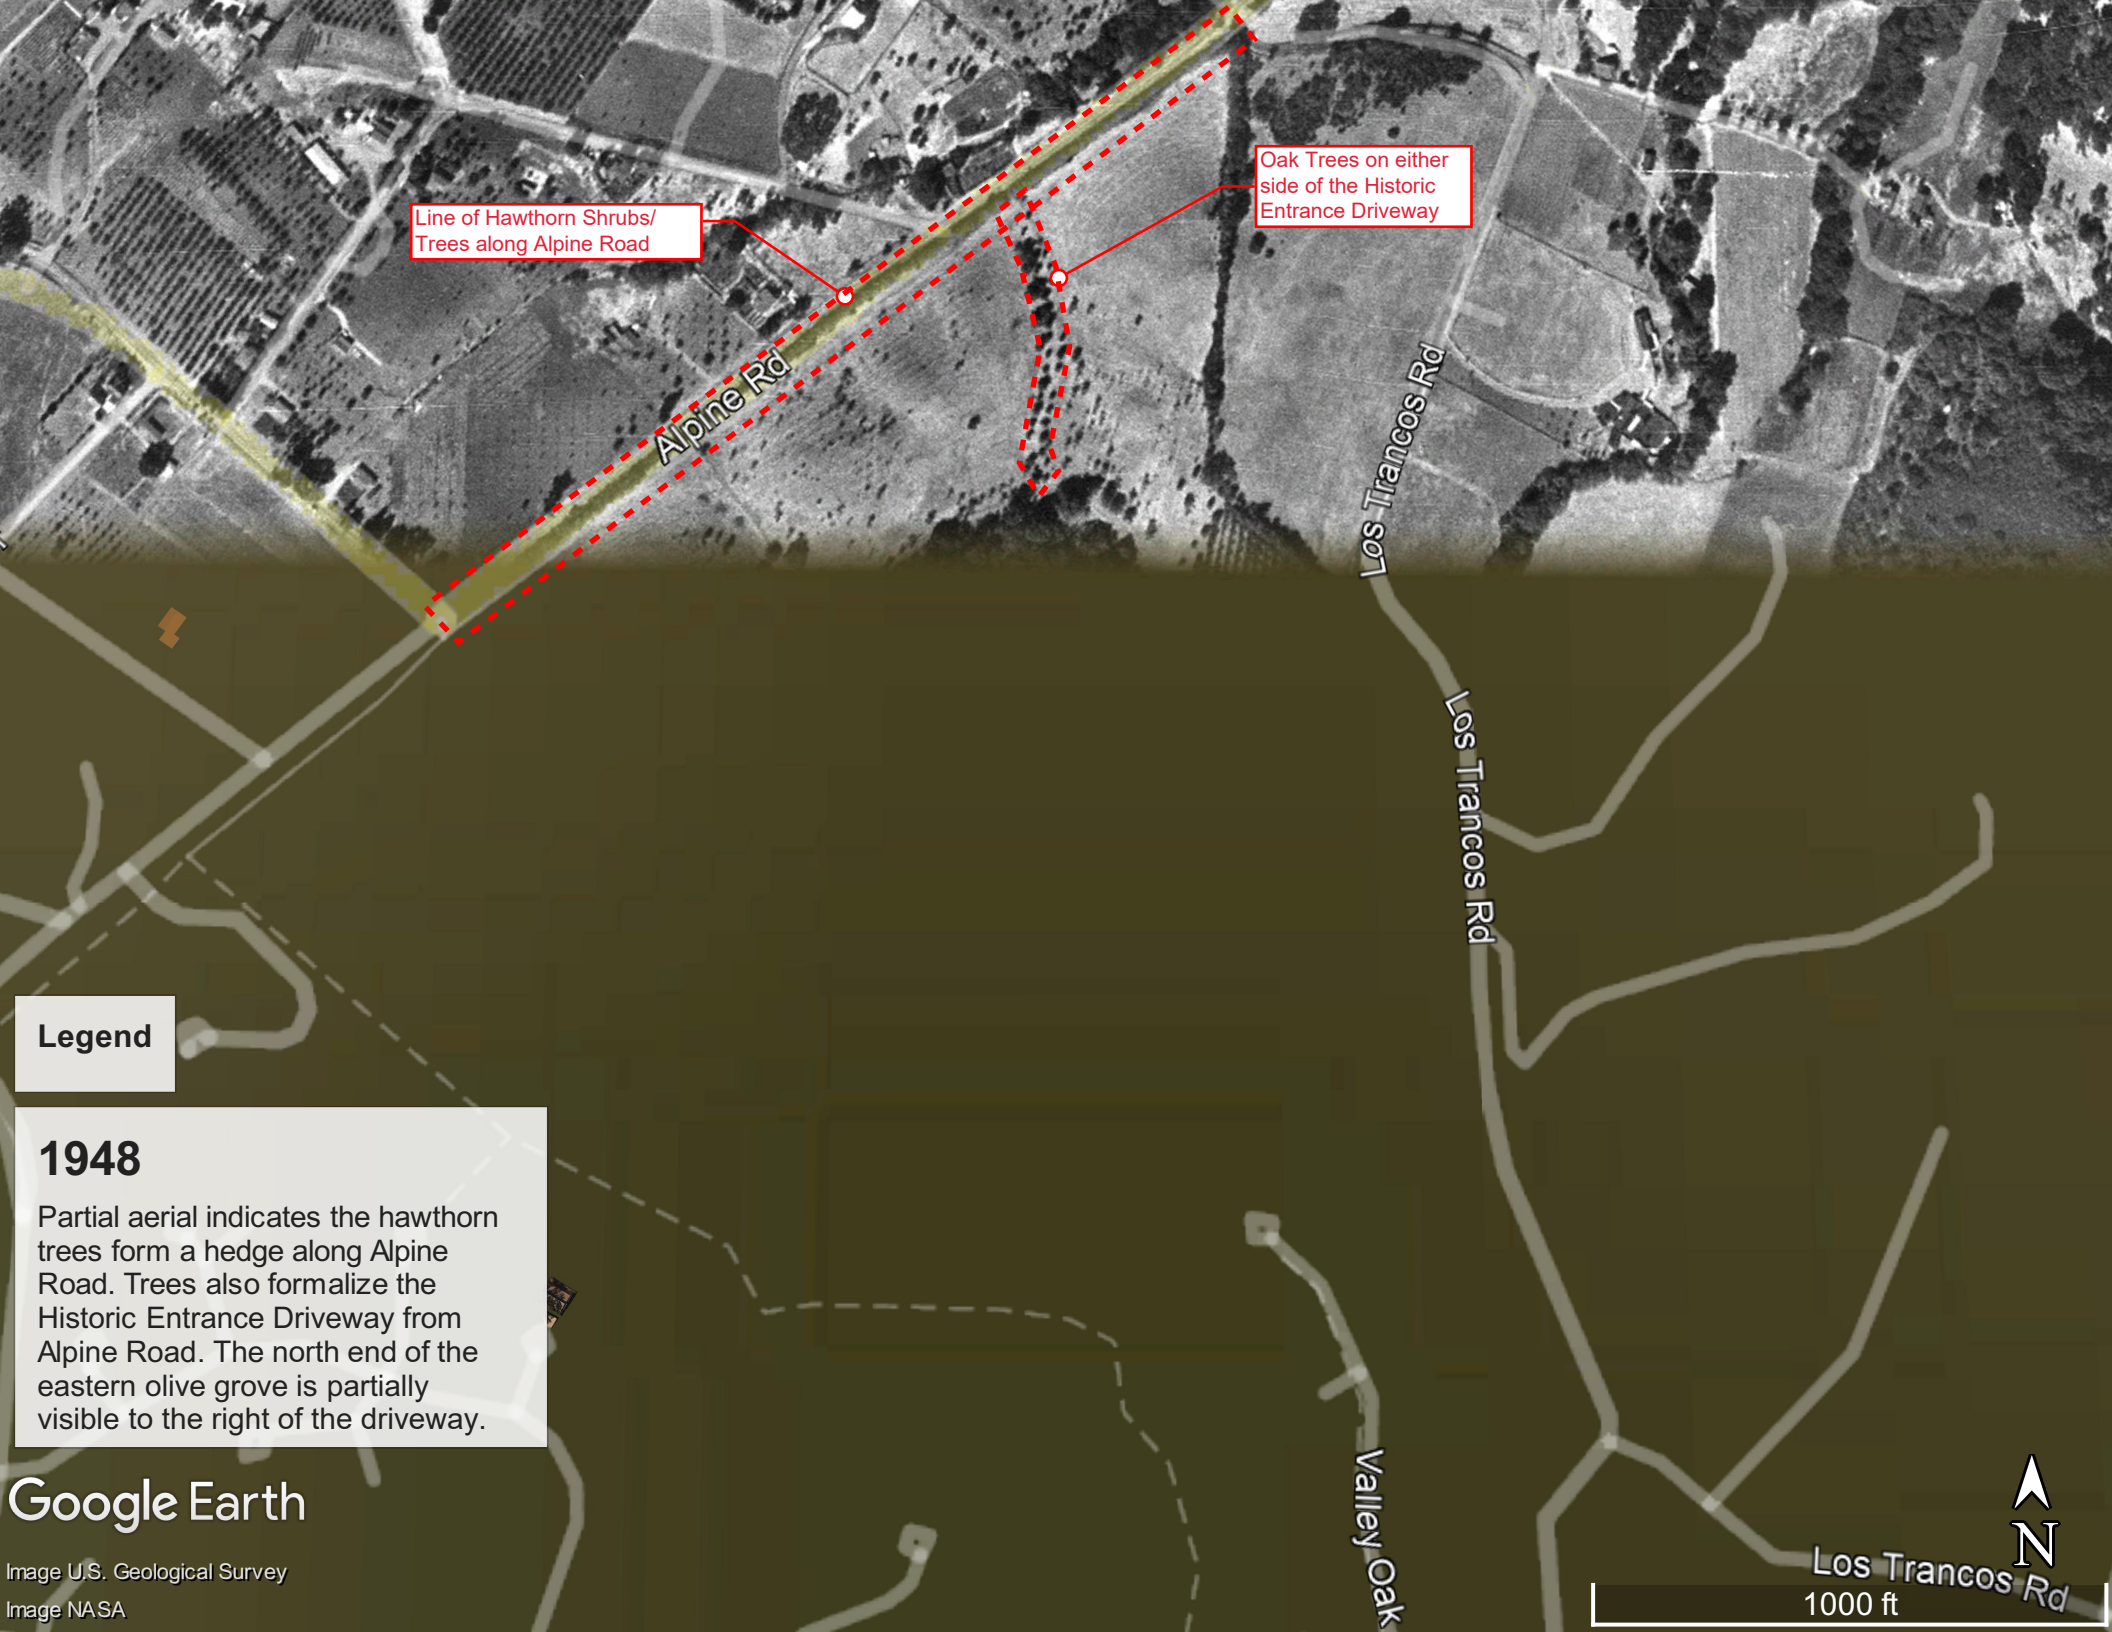
1948

Partial aerial indicates the hawthorn trees form a hedge along Alpine Road. Trees also formalize the Historic Entrance Driveway from Alpine Road. The north end of the eastern olive grove is partially visible to the right of the driveway.

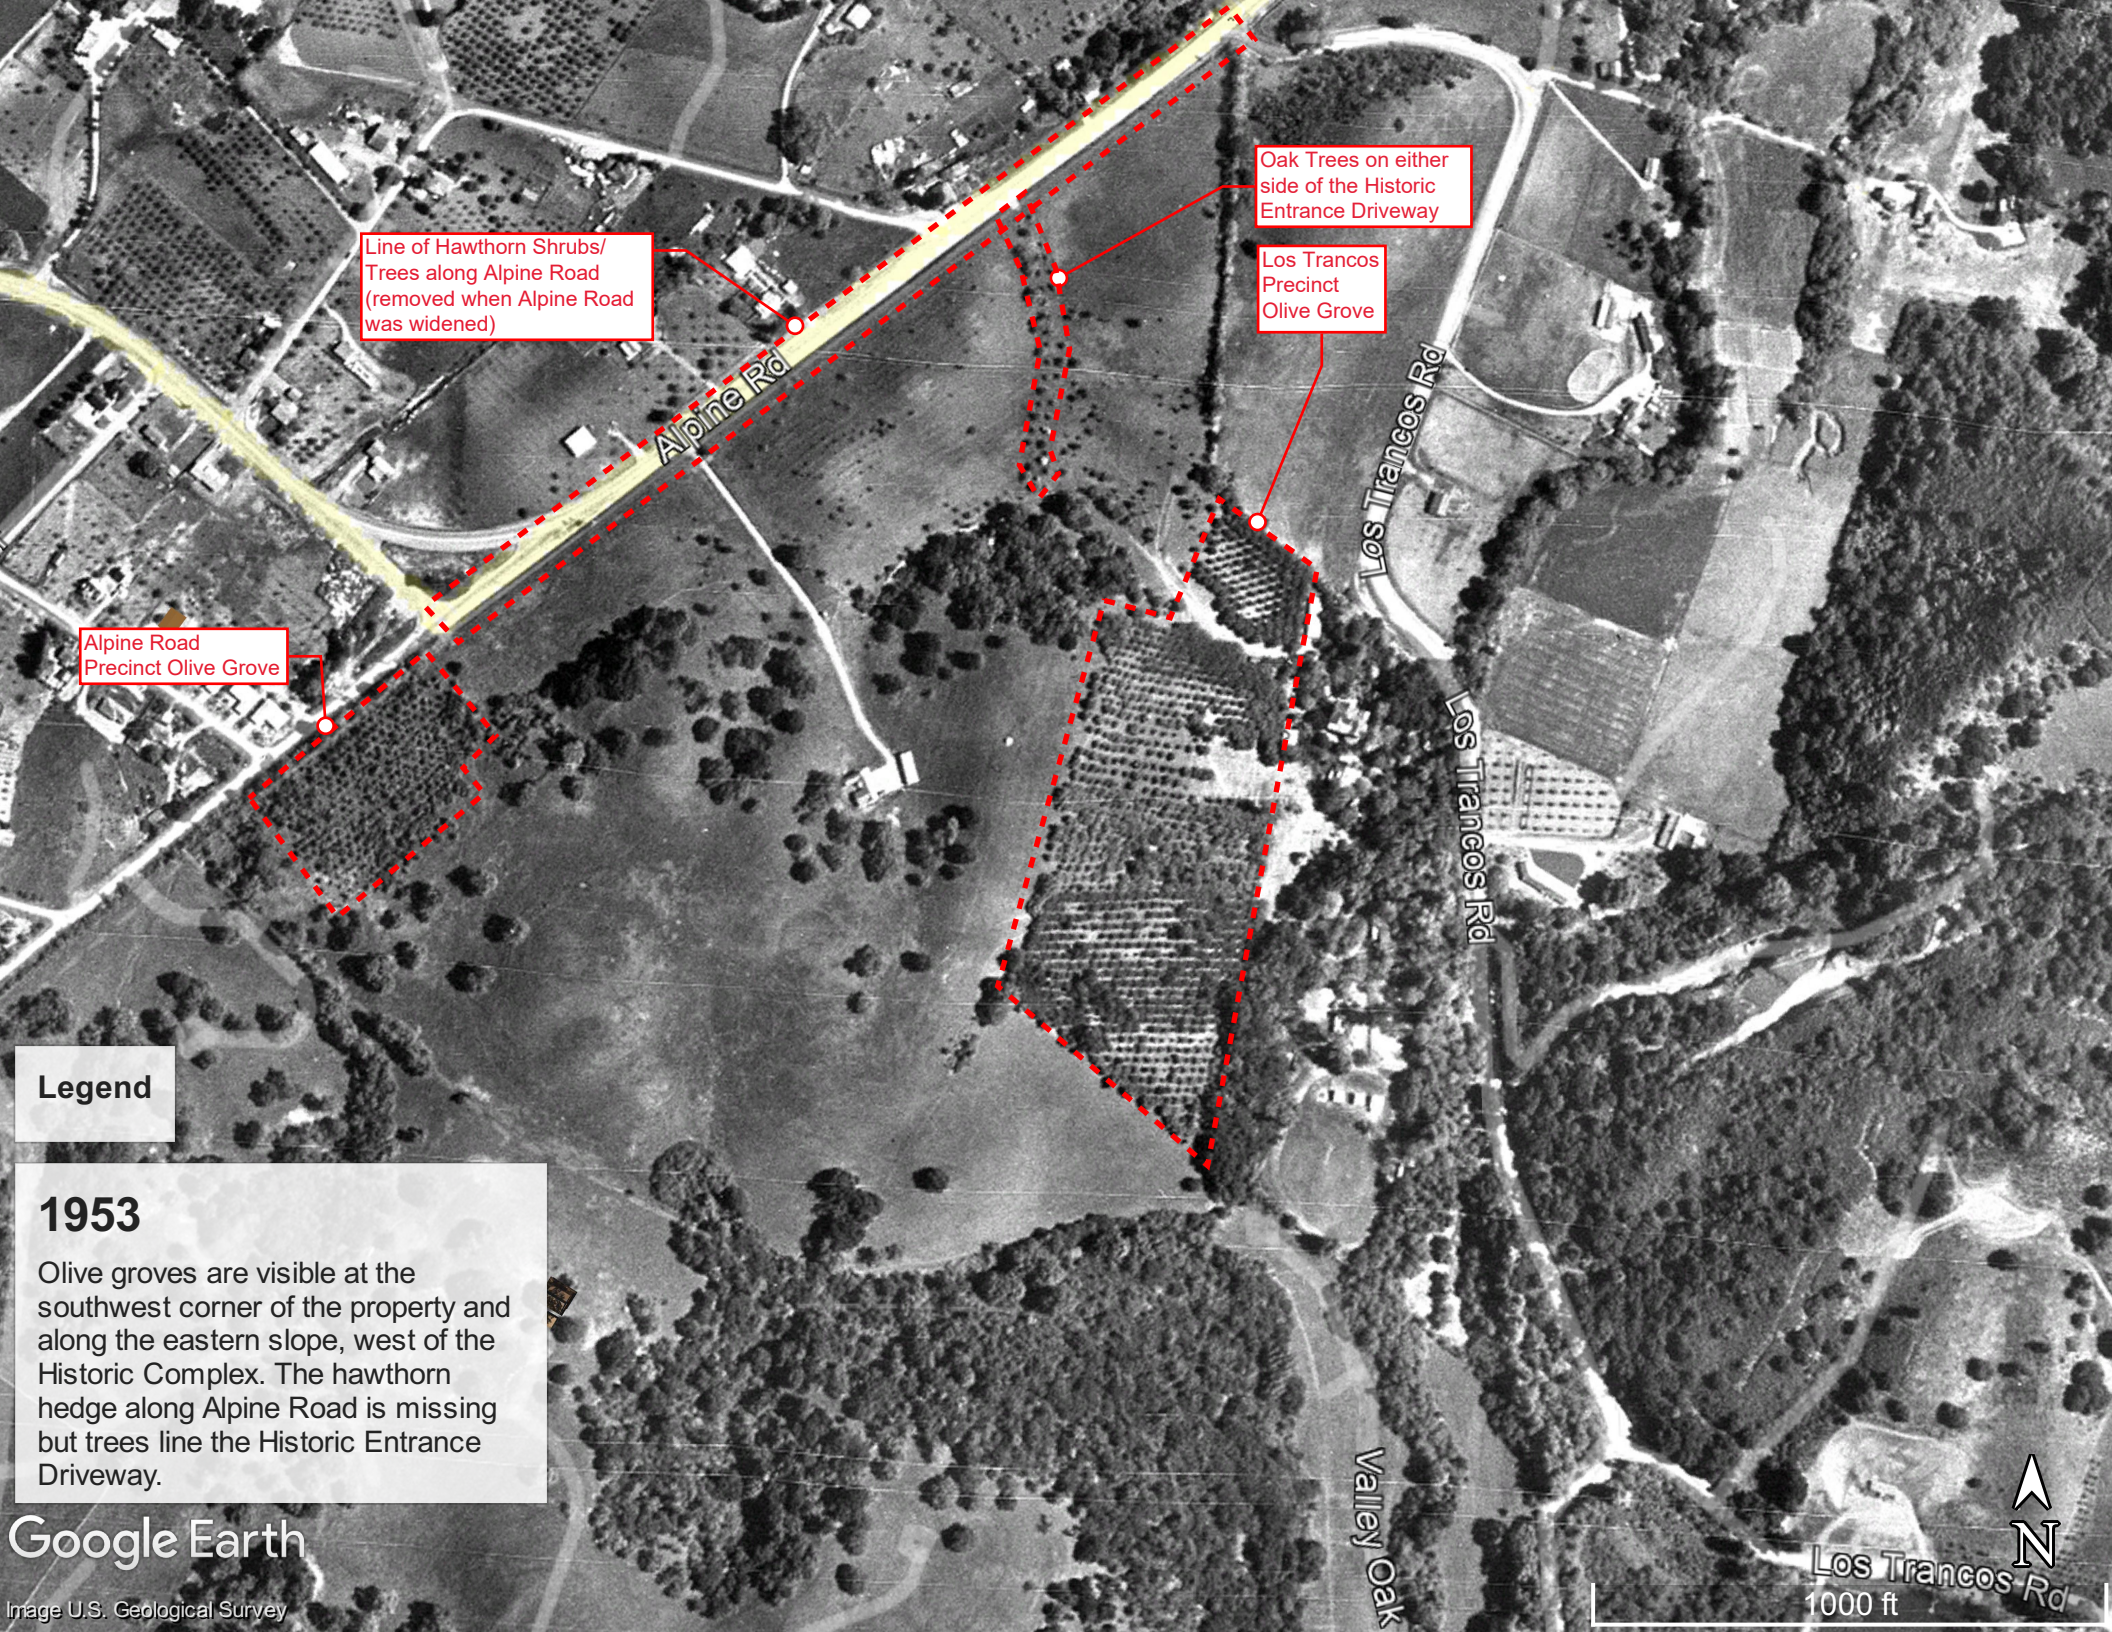
1953

Olive groves are visible at the southwest corner of the property and along the eastern slope, west of the Historic Complex. The hawthorn hedge along Alpine Road is missing but trees line the Historic Entrance Driveway.

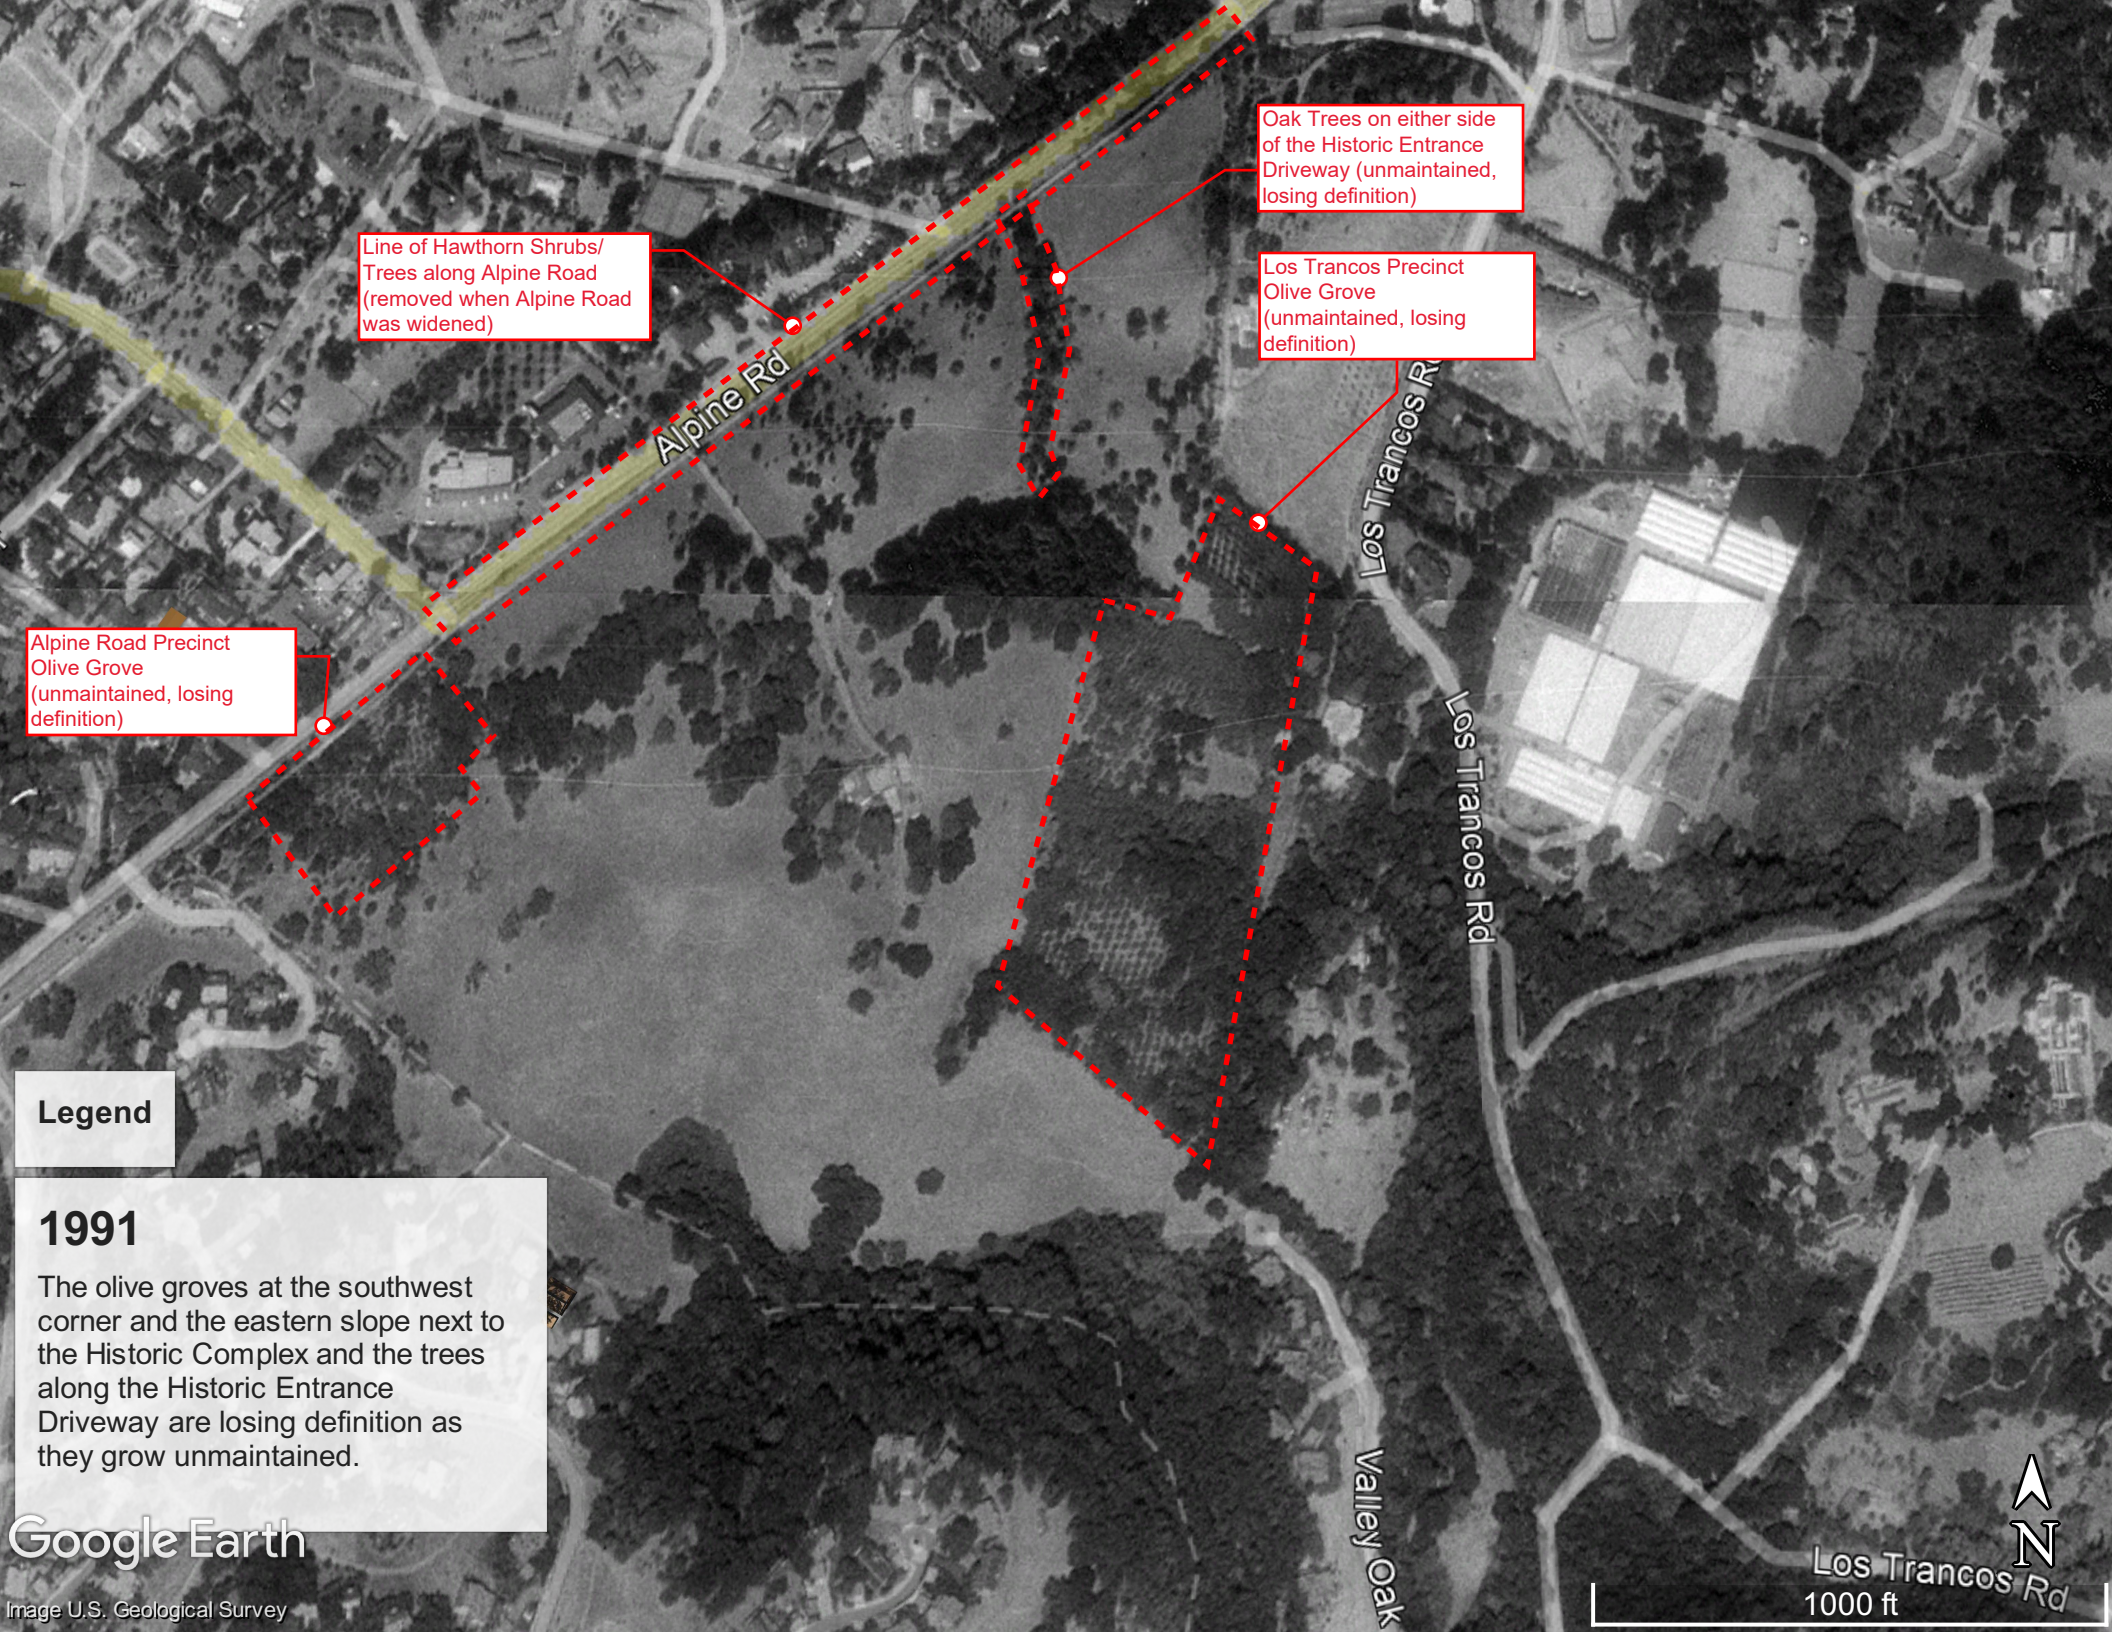
1991

The olive groves at the southwest corner and the eastern slope next to the Historic Complex and the trees along the Historic Entrance Driveway are losing definition as they grow unmaintained.

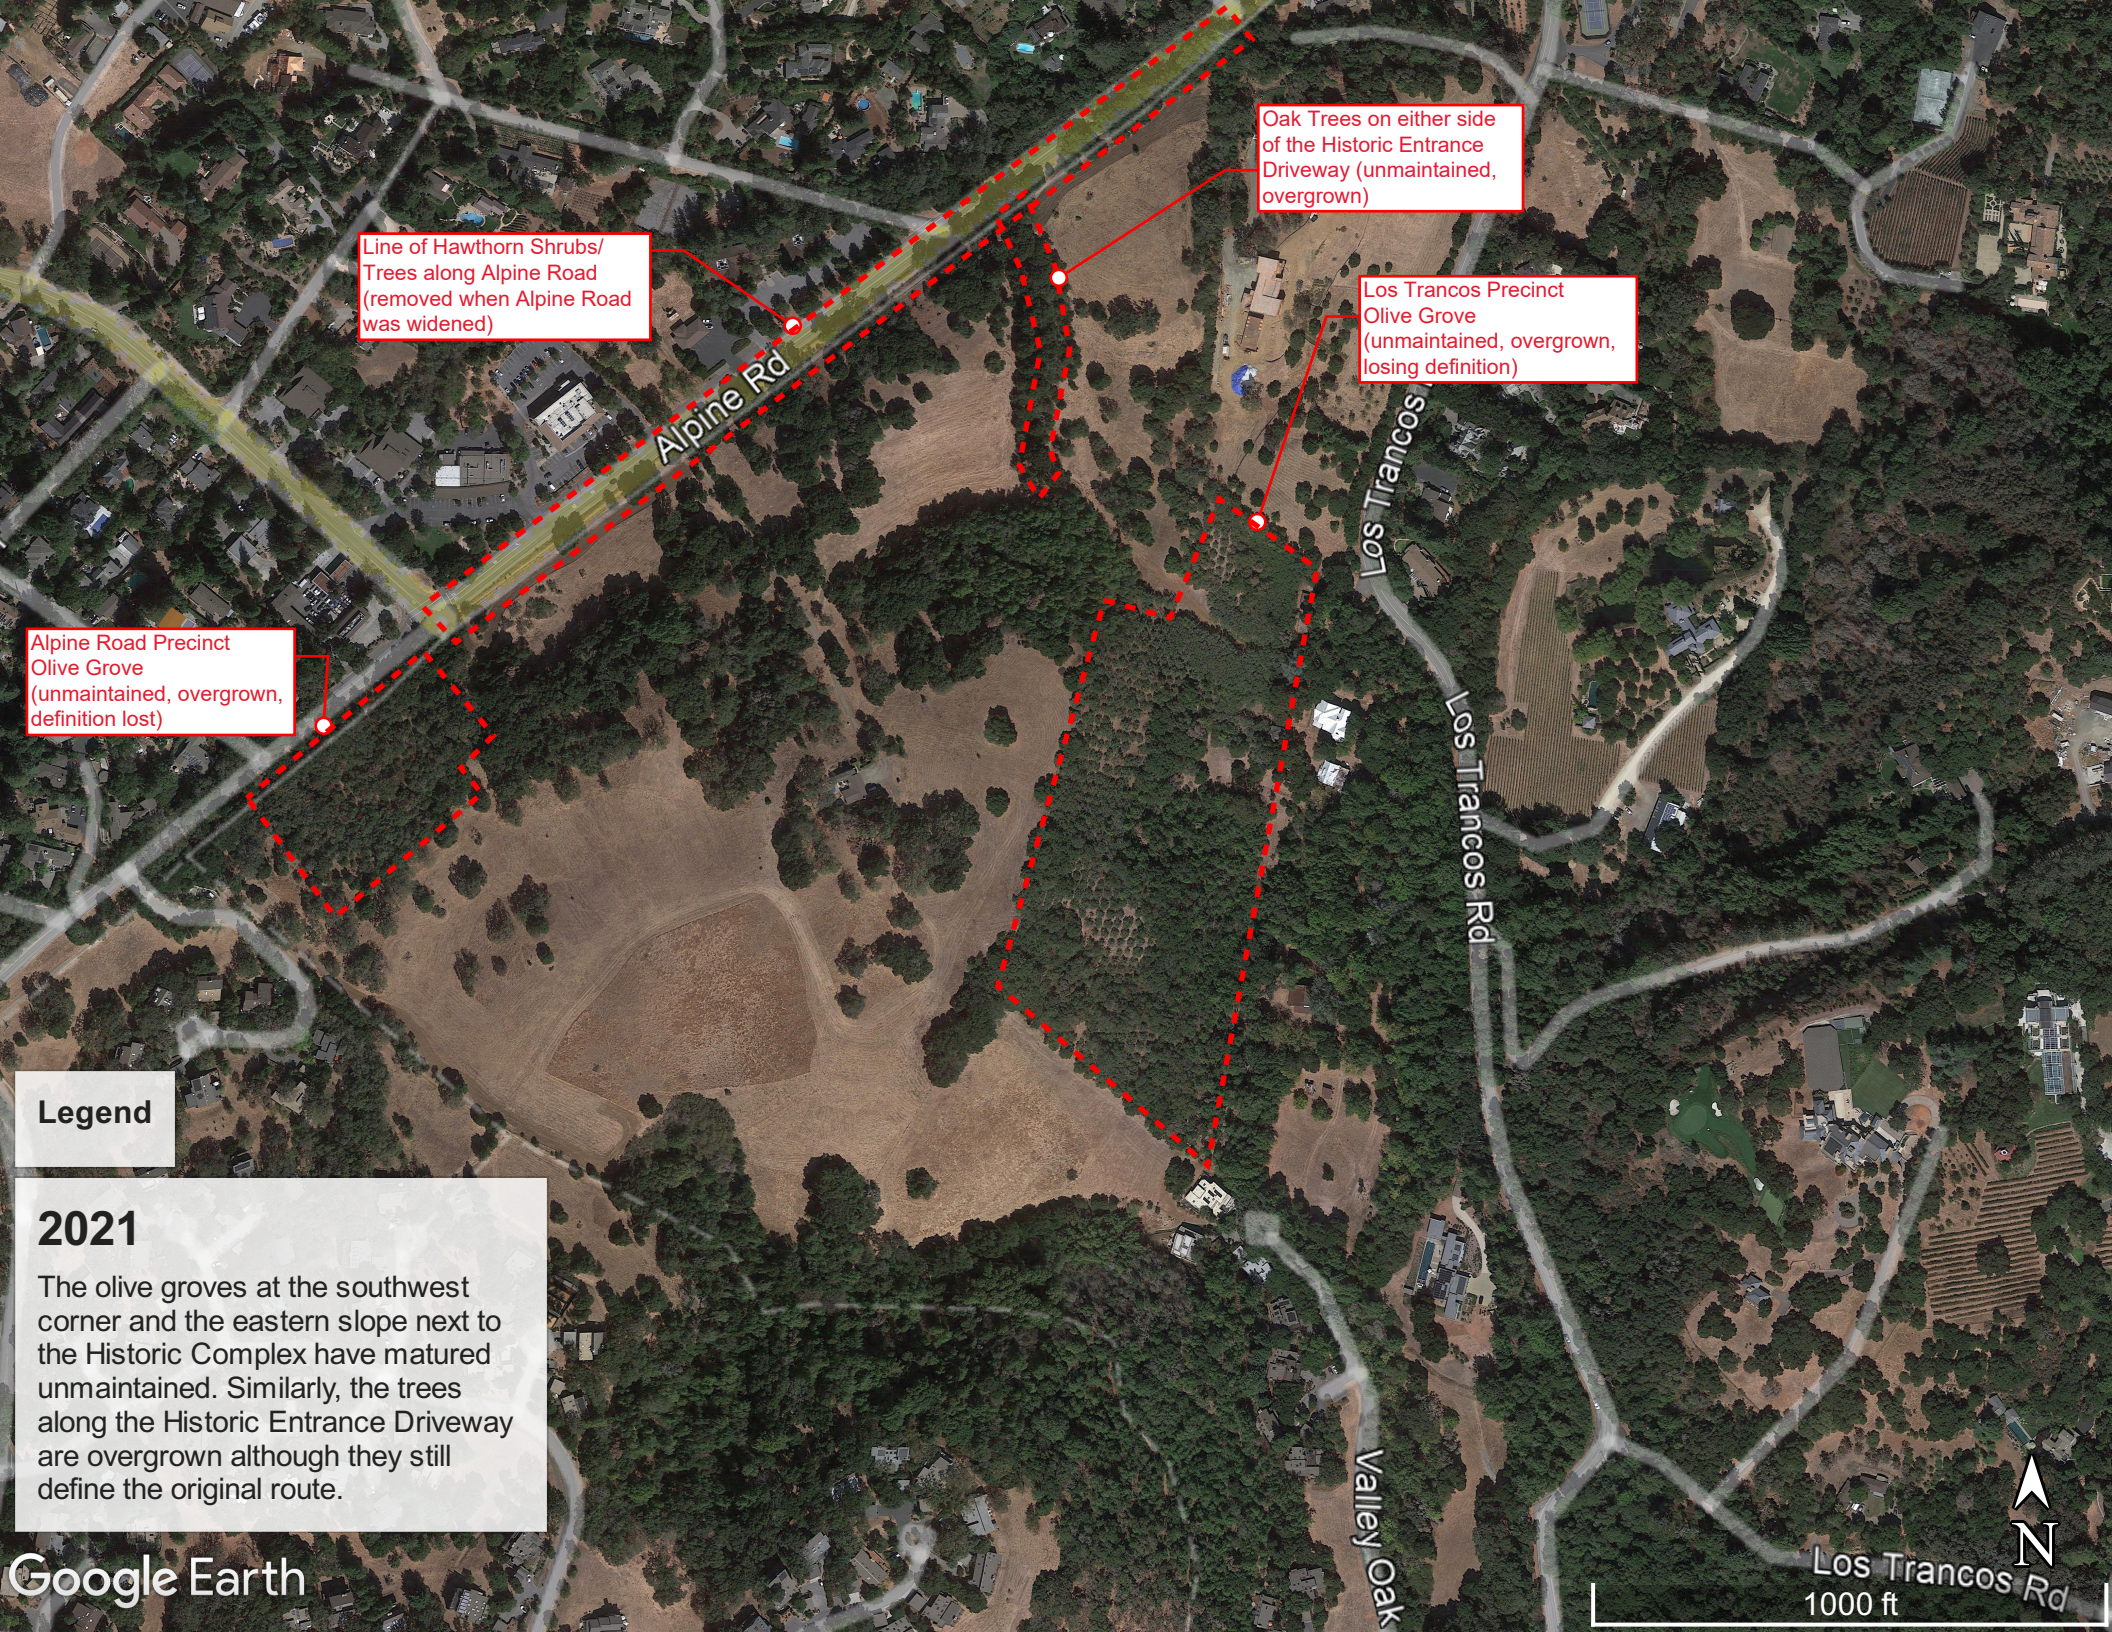
2021

The olive groves at the southwest corner and the eastern slope next to the Historic Complex have matured unmaintained. Similarly, the trees along the Historic Entrance Driveway are overgrown although they still define the original route.

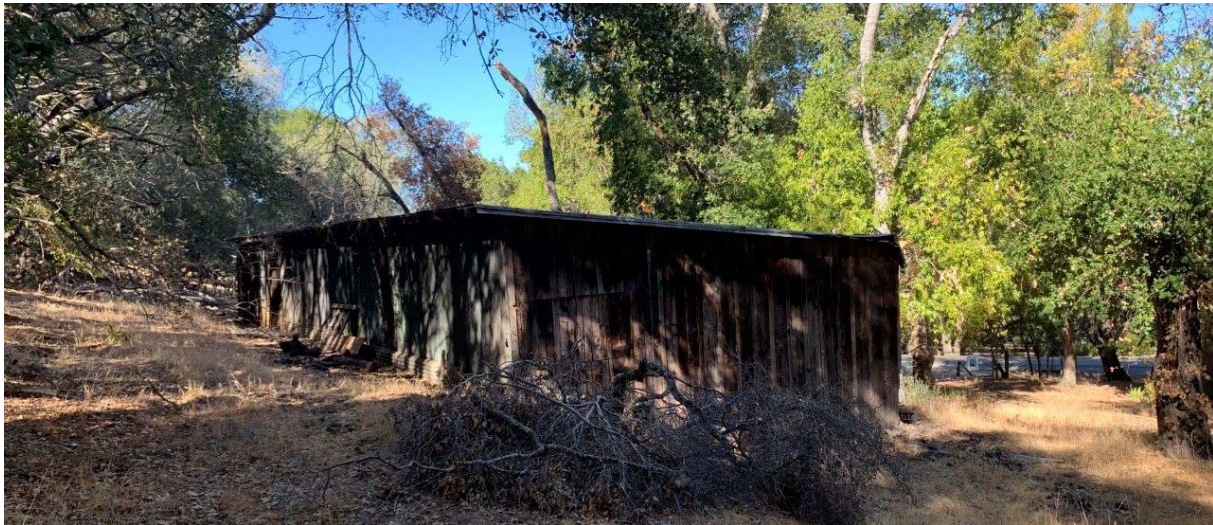
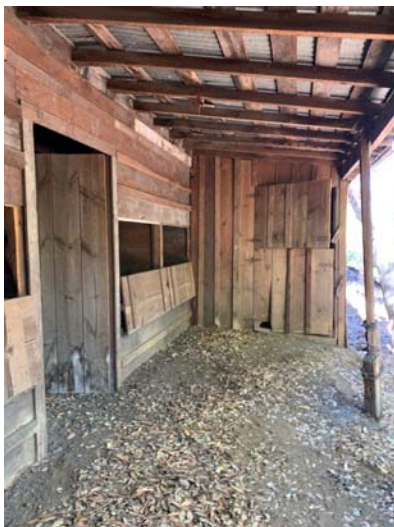
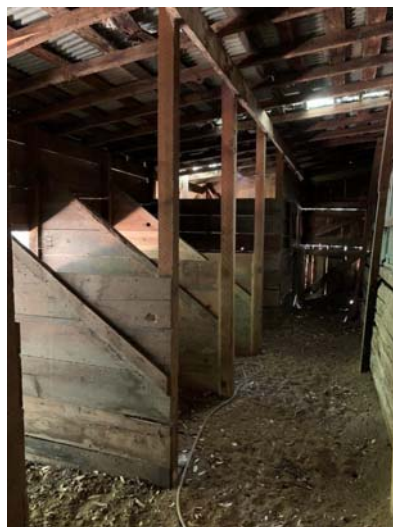
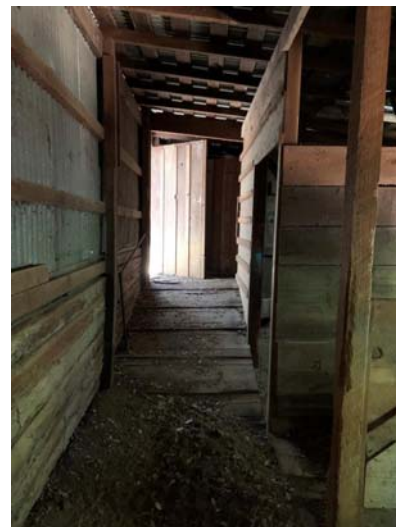
Upper Barn	
Description	Rectangular plan with inset porch, stalls and shed; corrugated steel roof; vertical board & batten wall & door finish; hopper shutters at window openings; horizontal board siding at stalls; wood frame on grade (roof 1x6 sheathing on 2x4 purlins, 4x4 posts); dirt floors
Location	North end of the site on HSC North Driveway in close proximity to Hawthorn House; east of north end of olive grove; visible from Historic Complex
Condition	Intact; Fair condition
Integrity	Retains integrity

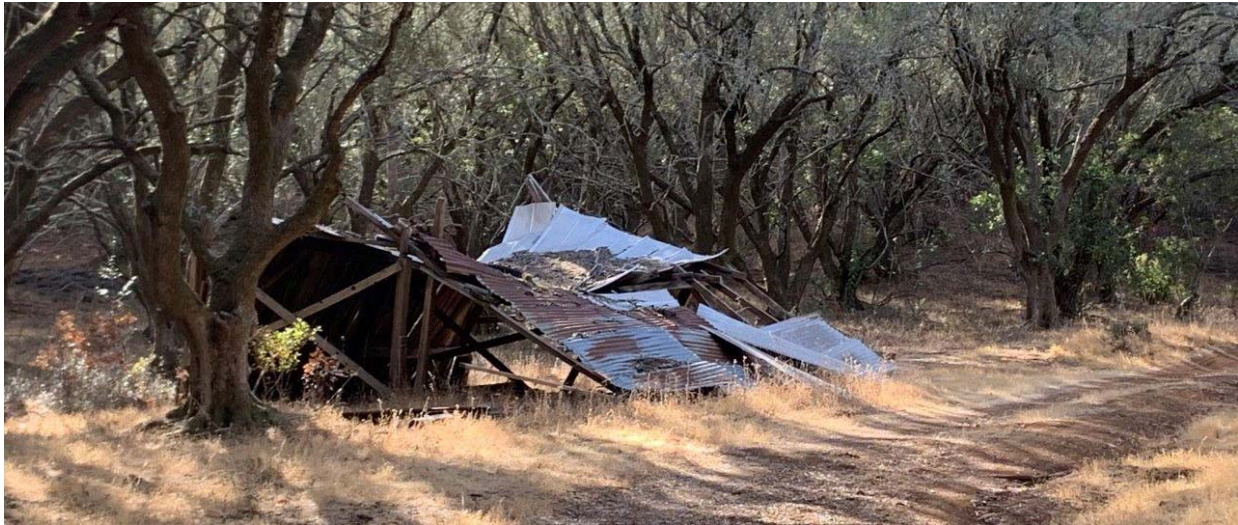
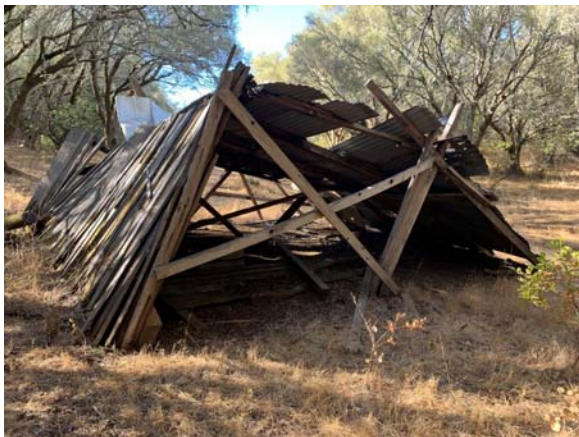
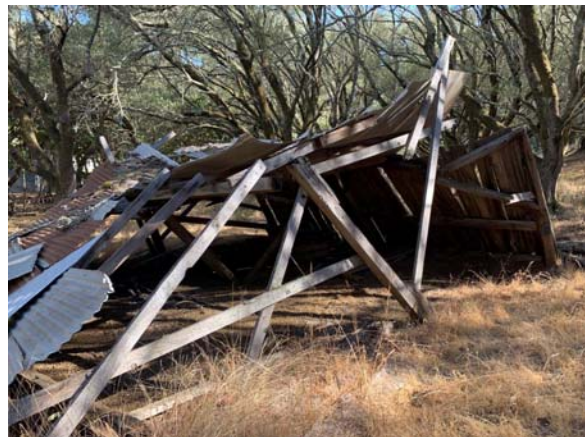
<i>Shetland Shed</i>	Appears to be shade device and may relate to Upper Barn with stalls
Description	Rectangular plan, open on three sides; corrugated steel roof; rear south wall with vertical board & batten finish; wood frame on grade (roof 4x4s sistered to 2x4s, 1x4 posts, 2x6 wall); dirt floors
Location	West of the Cottage; visible on drive from HSC to Alpine Road in between north and south olive groves across from Upper Barn
Condition	Collapsed; Poor condition
Integrity	Does not retain integrity

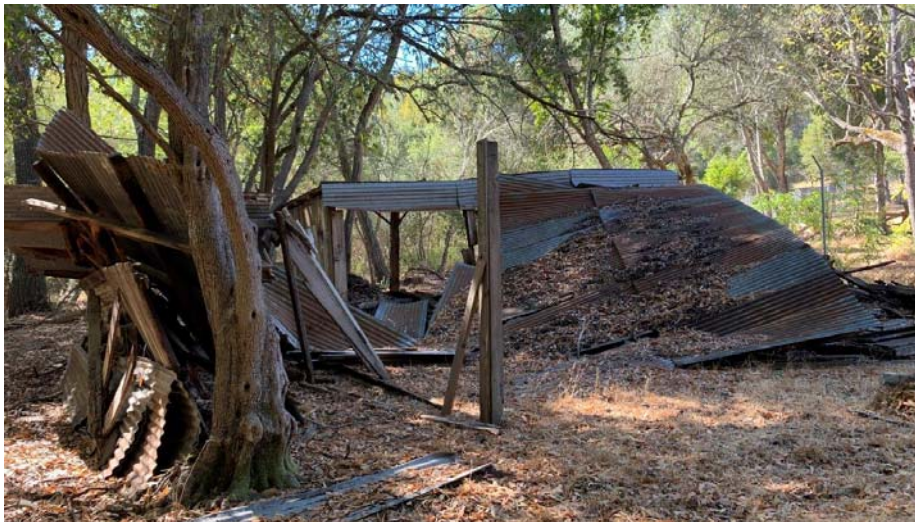
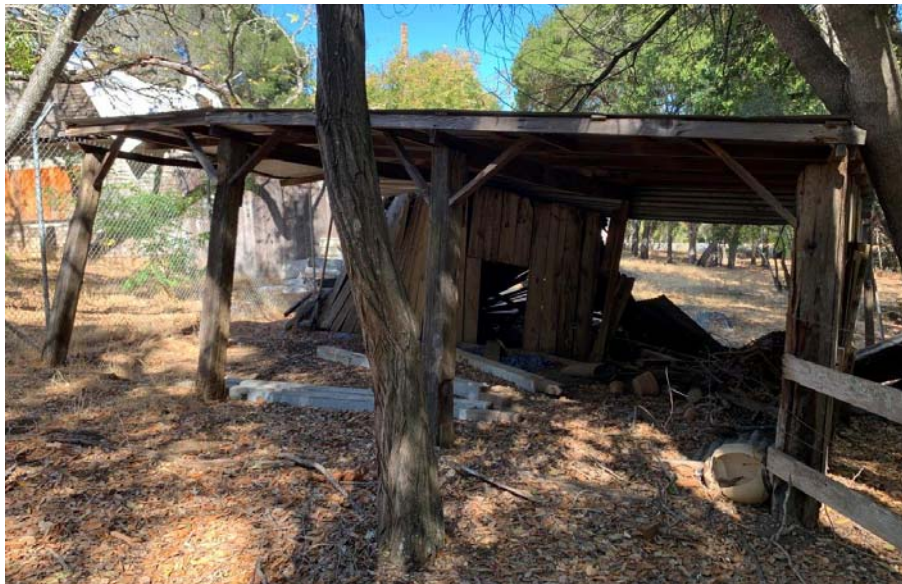
<i>Dog Sheds (2)</i>	Appears to be shelter enclosure
Description	Rectangular plan; corrugated steel roof; Shed 1 - 1x6 horizontal board finish; wood frame on grade (roof 4x4, 1x8 skip sheathing, 4x6 posts, 2x6 wall); dirt floors; Shed 2 – 1x6 vertical board finish; wood frame on grade (roof 2x4, 8x8 posts); dirt floors
Location	Southeast of Garage; somewhat visible within field west of Barn Road
Condition	Collapsed; Poor condition
Integrity	Does not retain integrity

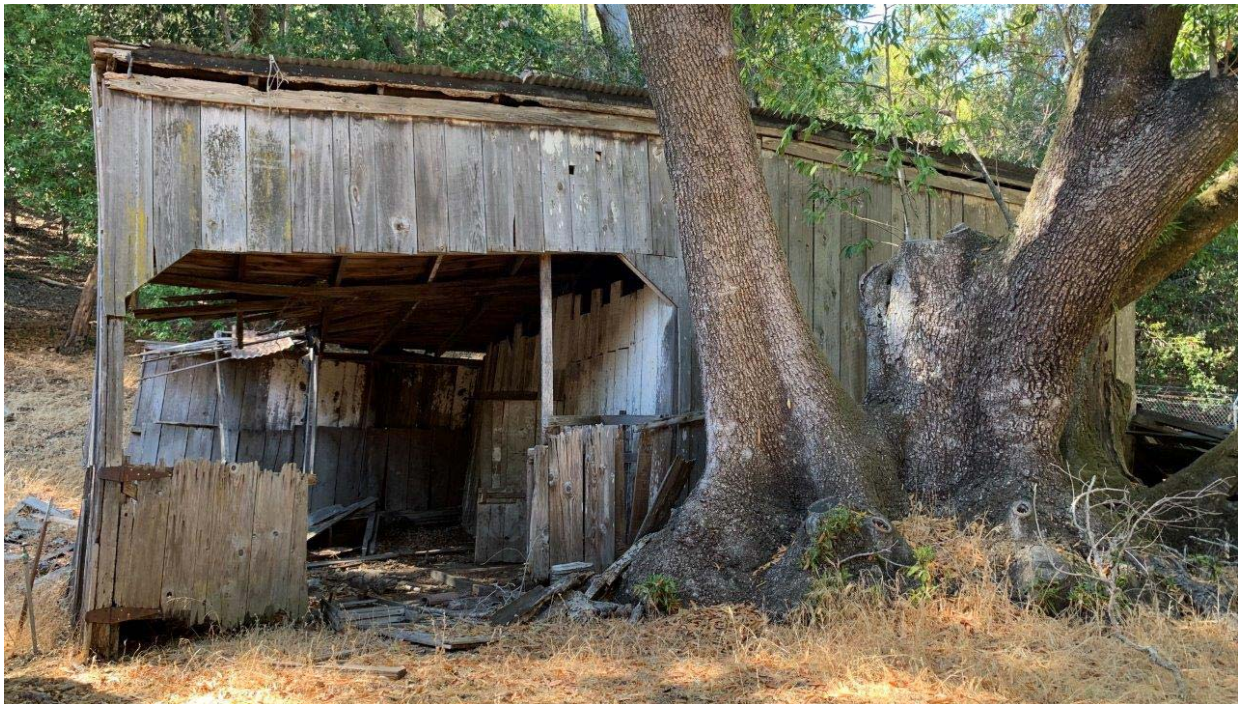
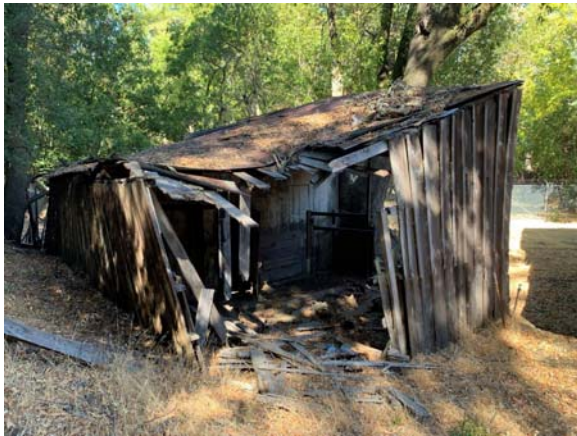
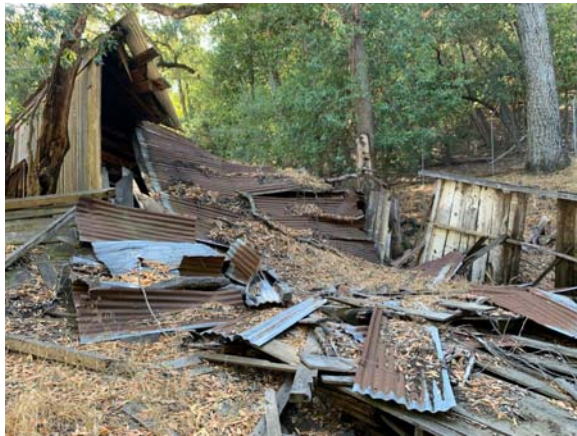
<i>Carriage Shed</i>	Appears to have an open shelter at the south and enclosed space at north with stalls
Description	Rectangular plan; corrugated steel roof; 1x12 vertical board finish; vertical board doors with strap hinges; wood frame on grade (roof 1x6 skip sheathing on 2x6 rafters, 1x4 posts & sills); 1x12 floors
Location	North of the Lower Barn; visible from Barn Road
Condition	Collapsed substantially at the north; Poor condition
Integrity	Does not retain integrity

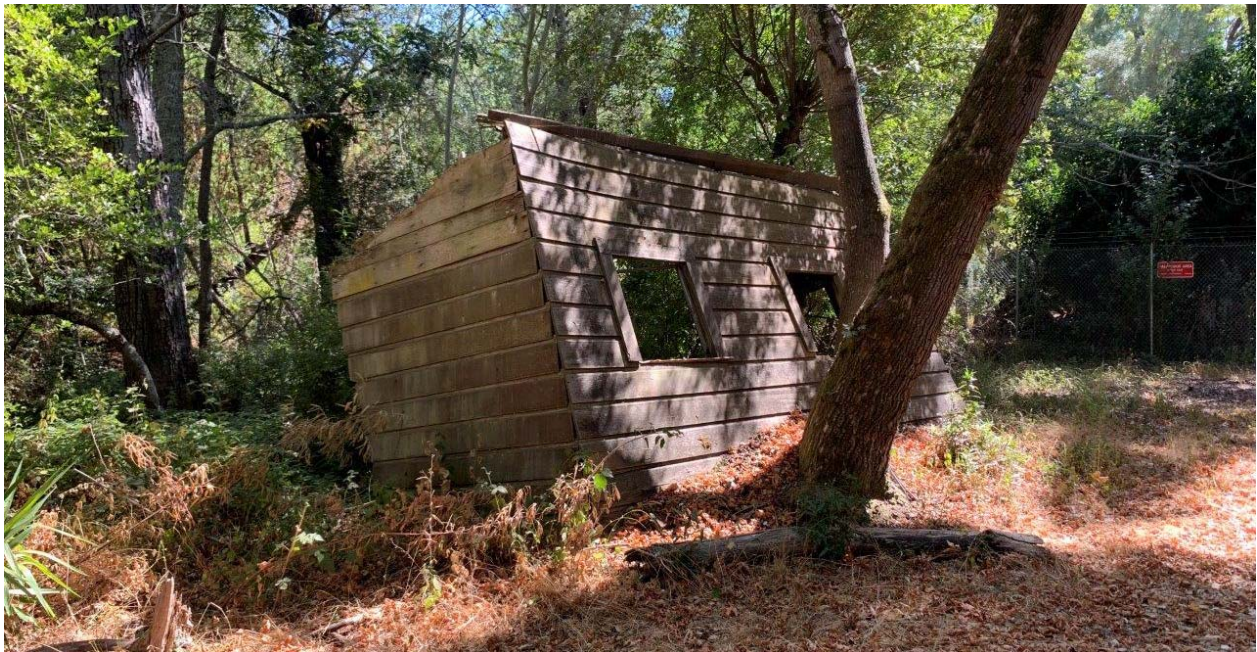
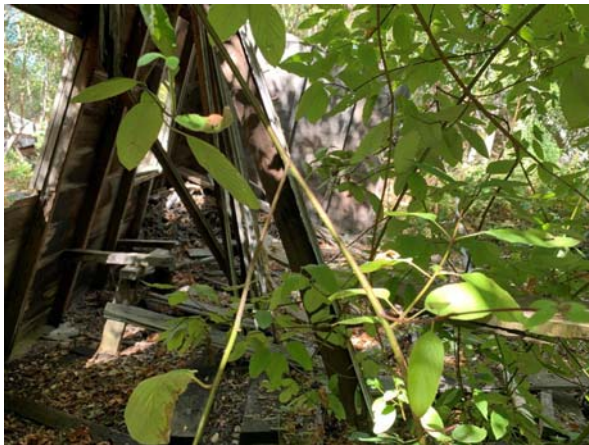
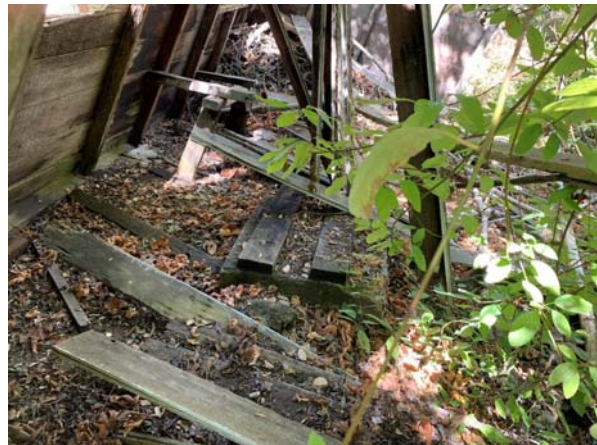
<i>Pump House</i>	Adjacent to creek with a concrete pad at the interior
Description	Rectangular plan; corrugated steel roof; 1x12 vertical board finish; vertical board doors with strap hinges; wood frame on grade (roof 1x6 skip sheathing on 2x6 rafters, 1x4 posts & sills); 1x12 floors
Location	East side of Barn Road, north of Coachman's Quarters, across from Lower Barn along sloping bank of north-south creek to the east
Condition	Collapsed; Poor condition
Integrity	Does not retain integrity
