Memorandum

Project Hawthorns Area of Windy Hill Open Space Preserve
Portola Valley, California

Topic Historical Consultations - Olive Groves and Hawthorn Trees; Secondary
Ancillary Structures

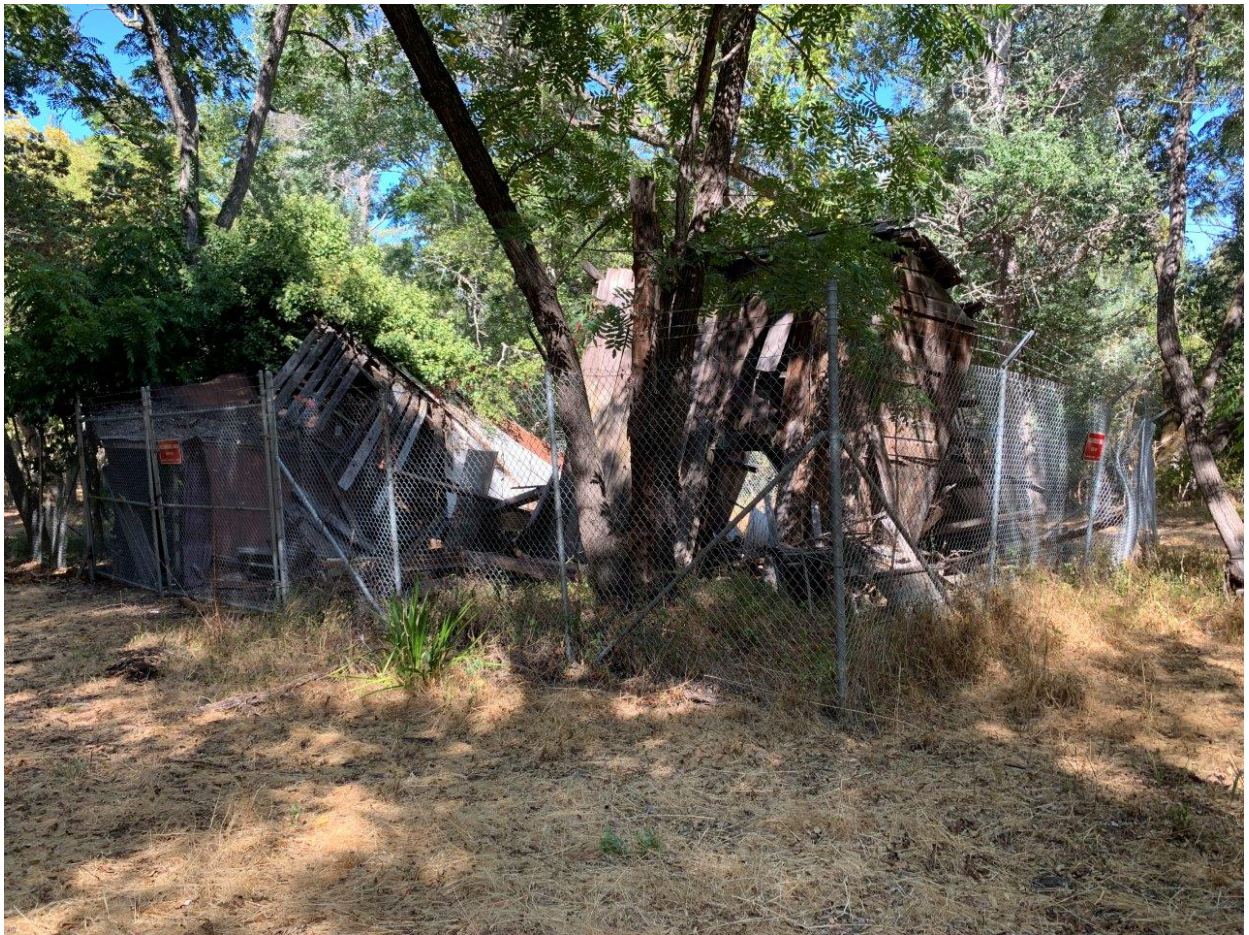
<i>Coachman's Quarters</i>	Appears to have small living quarters at the north end, central covered space, and grooming/tack room structure at the south
Description	Rectangular plan; corrugated steel roof; board & batten wall finish; wood frame on grade (roof exposed, 6x6 posts & 2x6 wall); wood tongue-and-groove
Location	East side of Barn Road, south of the Pump House, across from Lower Barn along sloping bank of north-south creek to the east
Condition	Collapsed substantially; Poor condition
Integrity	Does not retain integrity

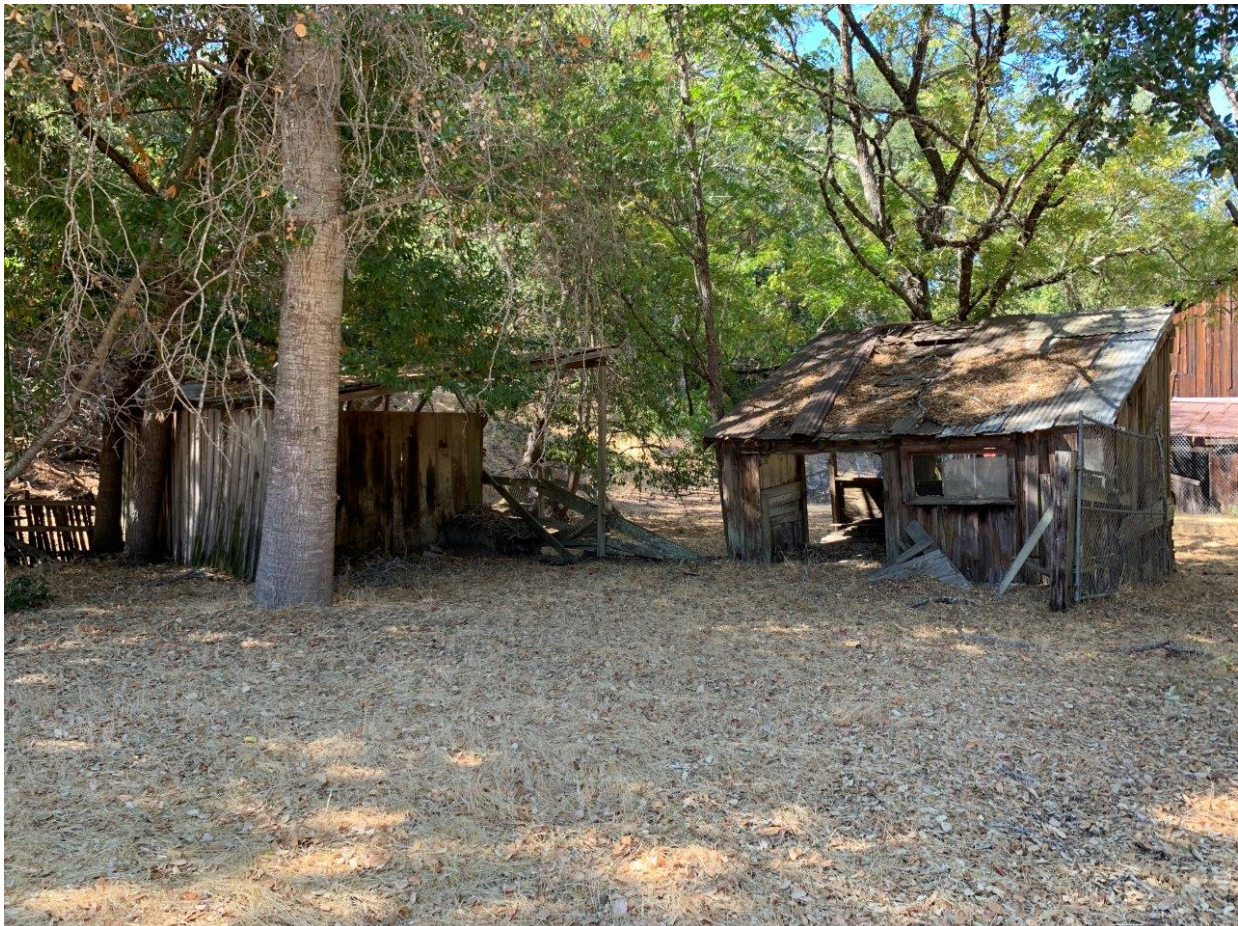
<i>Raccoon Sheds (2)</i>	Appears to be shelter enclosure
Description	Rectangular plan; corrugated steel roof; Shed 1 – board & batten short wall finish and horizontal boards long side; wood frame on grade (roof 1x8 skip sheathing, 4x4 posts, 2x4 plates); dirt floors; Shed 2 – board & batten south wall finish; wood frame on grade (roof 1x4 skip sheathing on 2x4 rafters, 4x4 posts); dirt floors
Location	South of the Lower Barn; visible within field west of Barn Road
Condition	Intact; Fair to poor condition
Integrity	Retain integrity

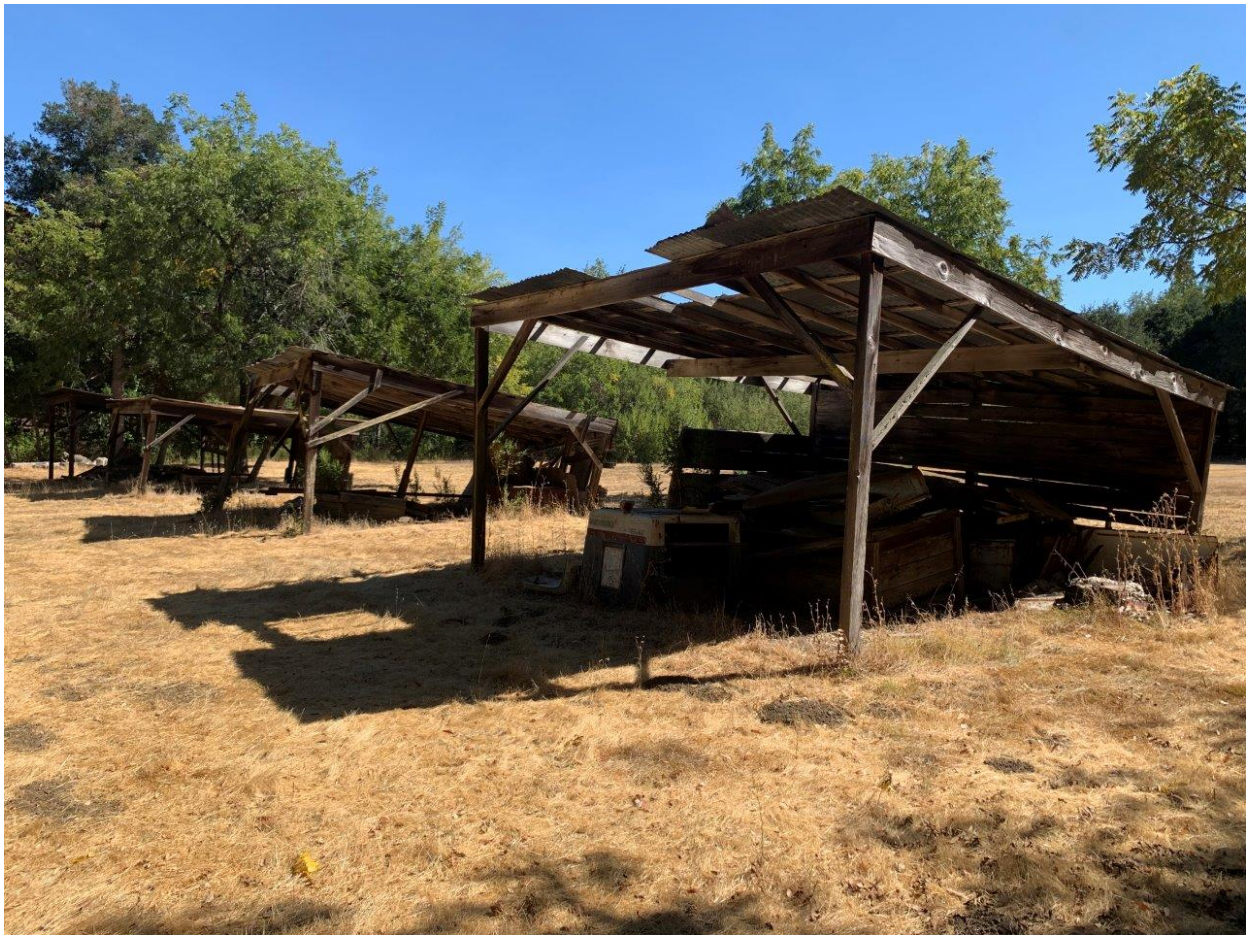
<i>Horse Sheds (4)</i>	Appears to be a series of shelters north of a large field and loop road
Description	Square plan, open three sides; corrugated steel roof; horizontal board siding at inside face of rear wall framing; wood framing (roof 2x4 rafters, 4x6 posts); rough concrete floors; central wooden trough
Location	Two sheds flank the end of Barn Road where it loops within a field south of the Lower Barn and Coachman's Quarters
Condition	Shed 1 & 2 Intact, Fair condition, 3 & 4 Partially collapsed, Poor condition
Integrity	Retains integrity

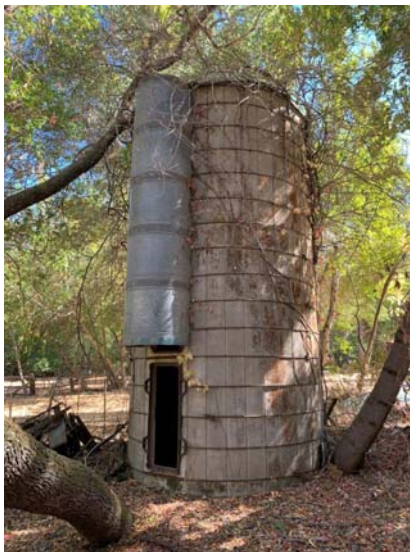
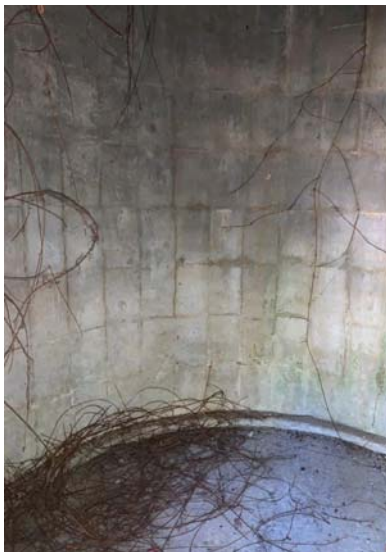
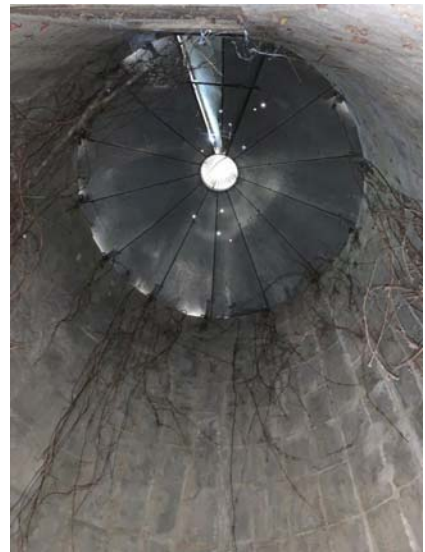
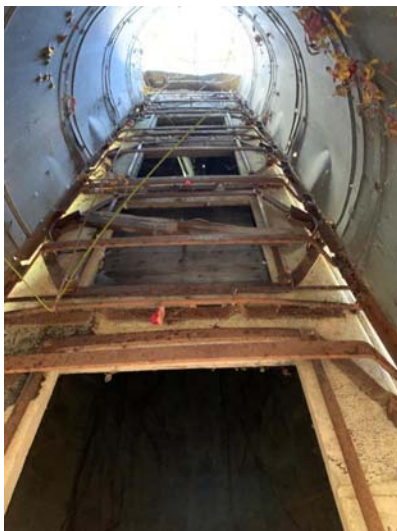
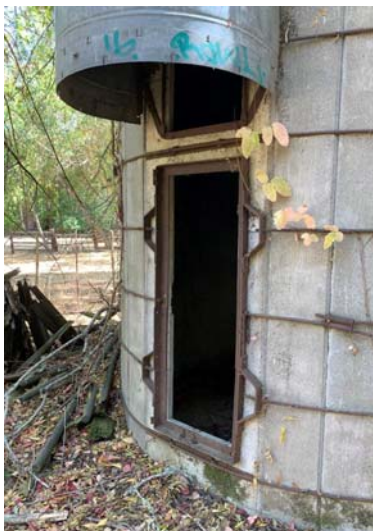
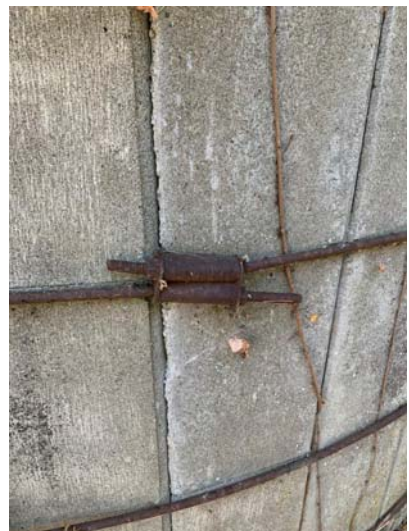
Silo	Storage cylindrical about 30 feet high and 15 feet in diameter,
Description	Circular in plan, clad in vertical concrete panels with metal rods wrapped horizontally at intervals along the height; ladder enclosed by a cylindrical metal attachment on the exterior; roof is sheet metal with a conical raised cap for ventilation
Location	East of the Raccoon Sheds
Condition	Intact; Good to fair condition
Integrity	Retains integrity
