Midpeninsula Regional  
Open Space District

R-21-40  
Meeting 21-10  
March 24, 2021

Review Beatty House Alternatives and Confirm Board Direction

1. Beatty House Basis of Design, Condition Assessment, and Estimate – ZFA December 2019
2. Renderings of Beatty House design alternatives
3. Beatty House Photographs – *Excerpt from Beatty House Basis of Design, Condition Assessment, and Estimate – ZFA December 2019*

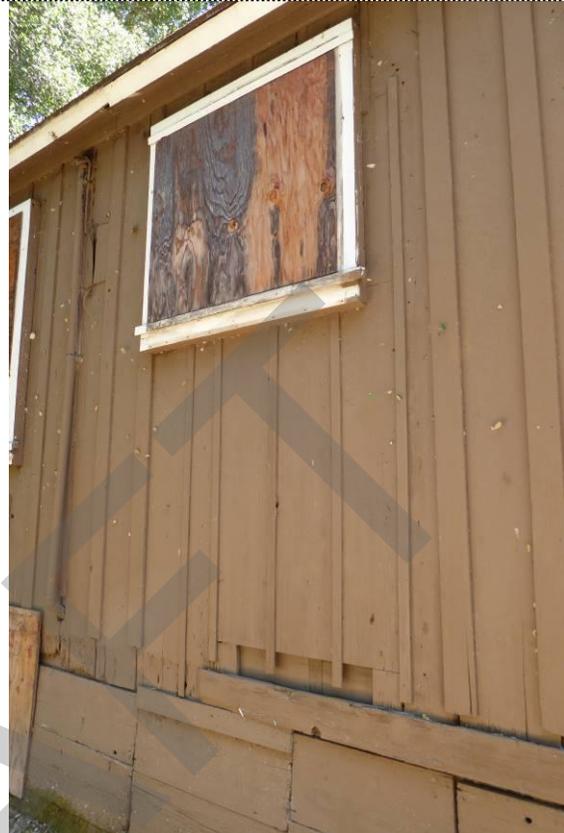
Windows of the north façade of the L-shape addition. The metal pieces under the sills indicates they were moved upwards or reduced in size during modifications to match height of other windows in the building

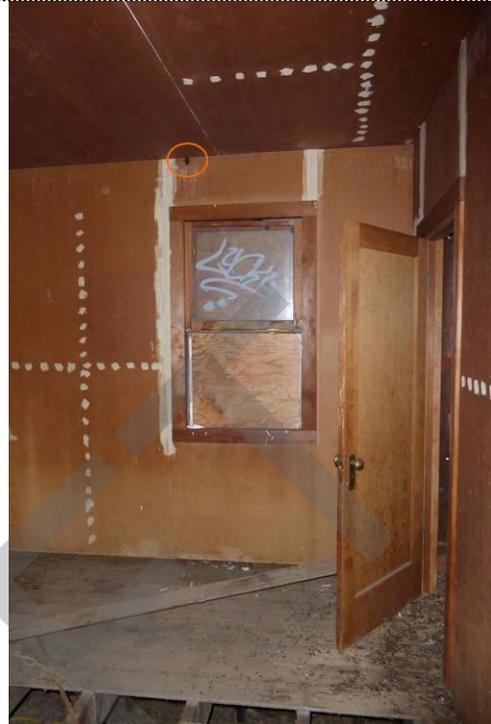
Opening in the ceiling to the roof structure in the parlor. Current nesting area for bats, sighting of bats not visible in this photo. Recommend removal by experienced personnel following appropriate directions by biological monitors prior to any repairs in these particular areas

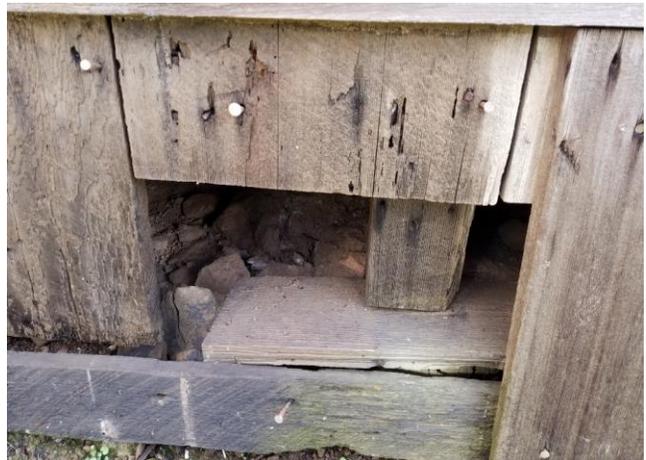
Photo 6. Missing siding on exterior wall, and lack of concrete foundation below bearing wall

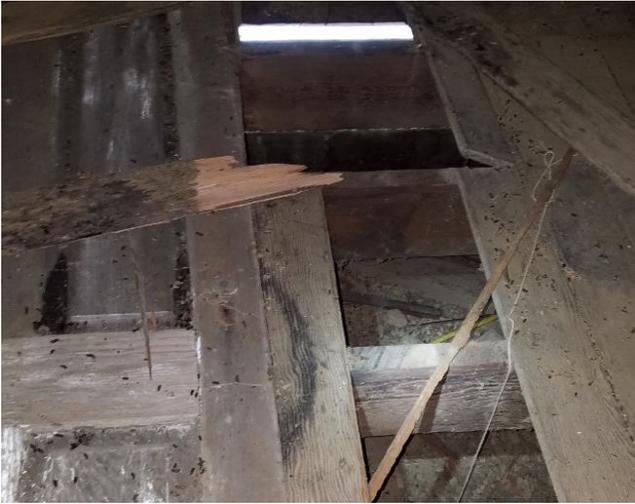
Photo 7. Missing wood planking at interior floor

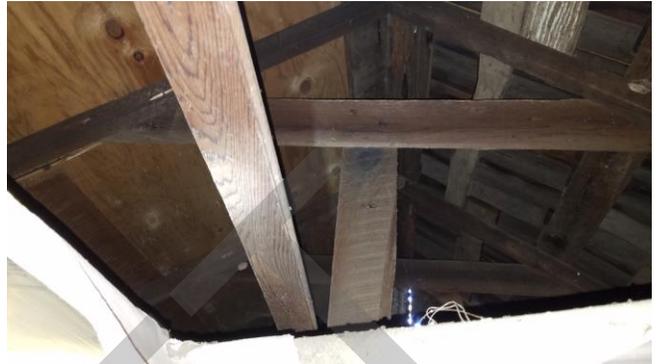
Photo 8. Hole in ceiling exposing collar ties, rafters, and 1x planking at roof

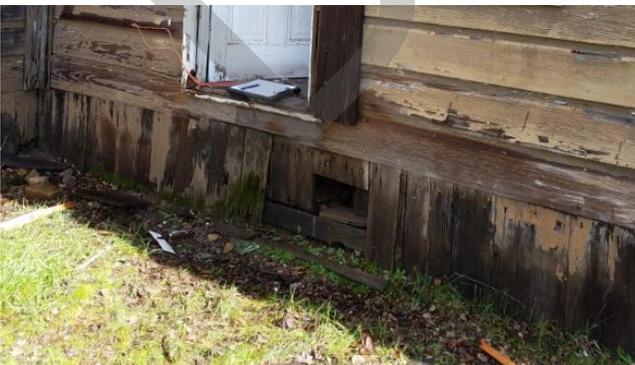
Photo 11. Moisture damage at exterior wall

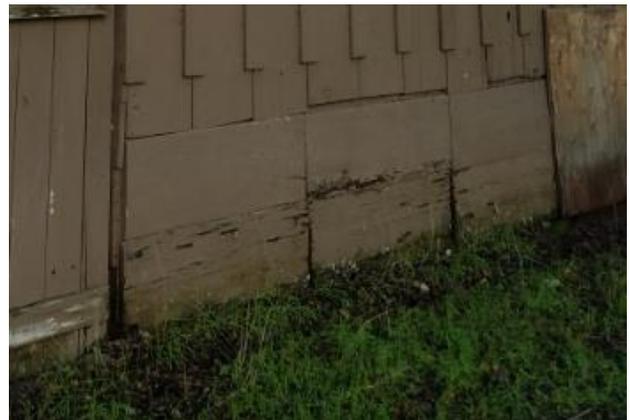
Photo 12. Moisture damage at exterior wall

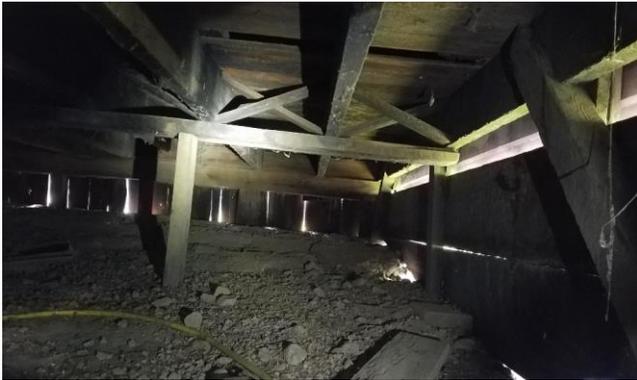
The foundations for this structure are limited to wood posts that bear either directly on grade, or on a small wood sleeper on grade. Some posts may be embedded an unknown distance into the ground. Moisture damage was observed at several posts in contact with the ground (see Photos 1, 5, 11, 12 and 13).

**Photo 13. Crawlspace framing showing lack of concrete foundation, wood posts sitting directly on grade, and diagonal framing at perimeter wall**

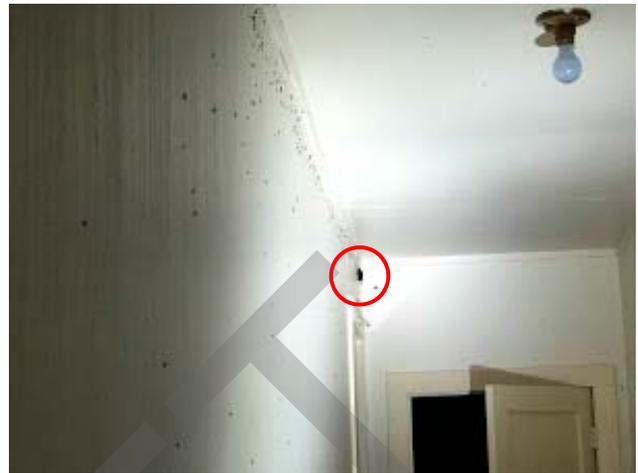
**Photo 36.** Bat urine staining and guano on wall; *Myotis sp.* (circled in red) observed roosting.

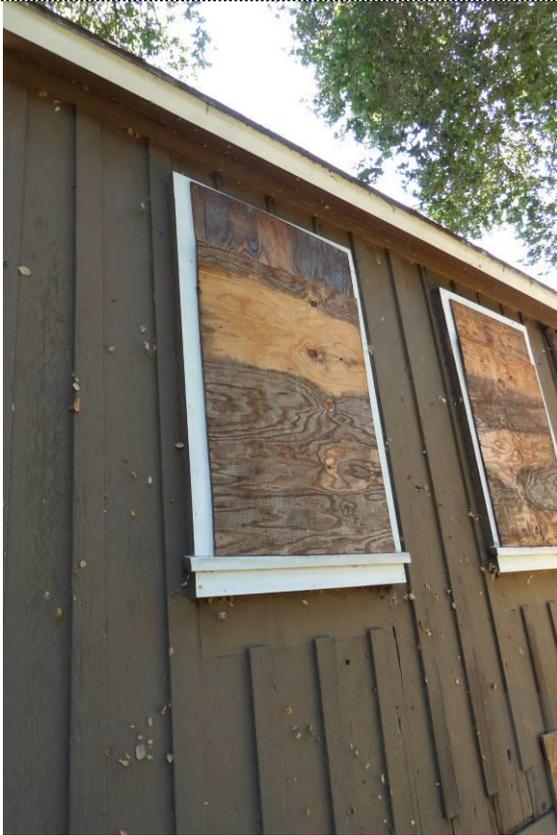
**Figure 9**

Windows of the north façade of the L-shape addition. The metal pieces under the sills indicates they were moved upwards or reduced in size during modifications to match height of other windows in the building

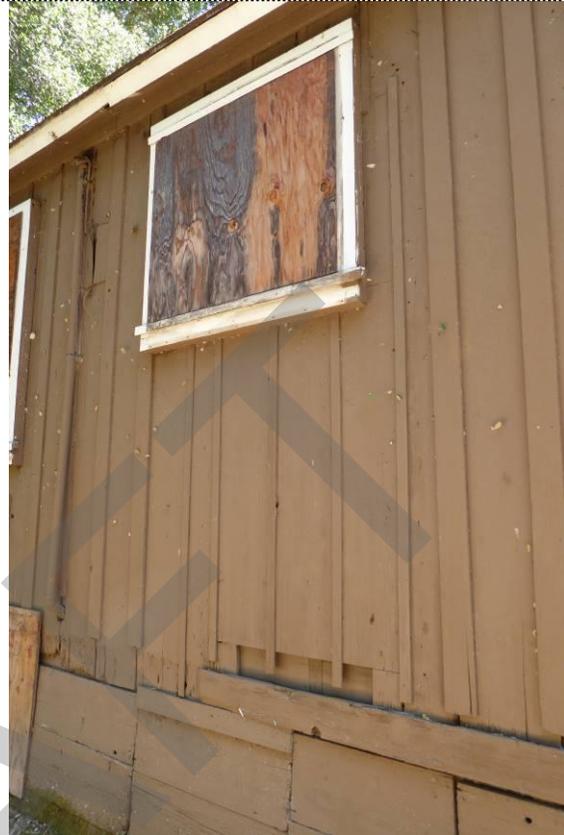
**Figure 10**

Bathroom window. Opening suspected to be created partially using the existing opening from a presumably previous existing door. The initial height of the cladding boards used insinuates the possibility of a landing and steps leading up to the house. Recommended archaeological study of the area beneath to verify preexisting conditions.

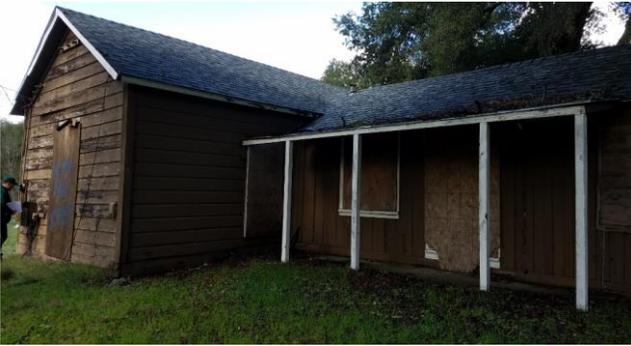
Photo 1. South elevation, showing shed roof support by posts

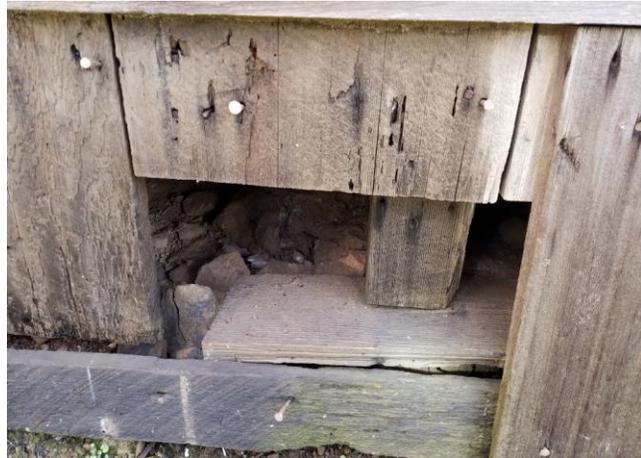
Photo 6. Missing siding on exterior wall, and lack of concrete foundation below bearing wall

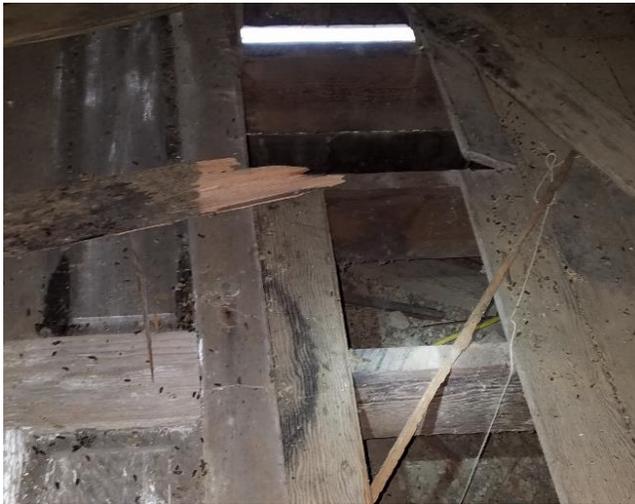
Photo 7. Missing wood planking at interior floor

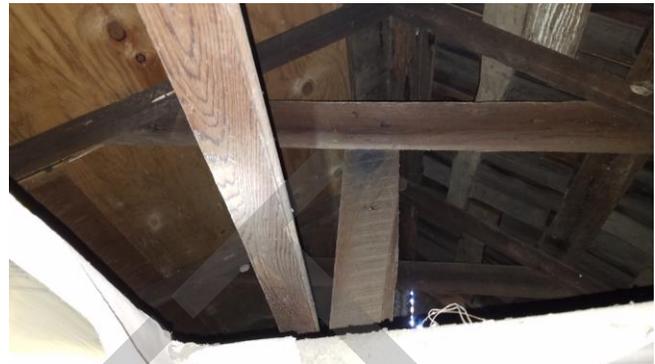
Photo 8. Hole in ceiling exposing collar ties, rafters, and 1x planking at roof

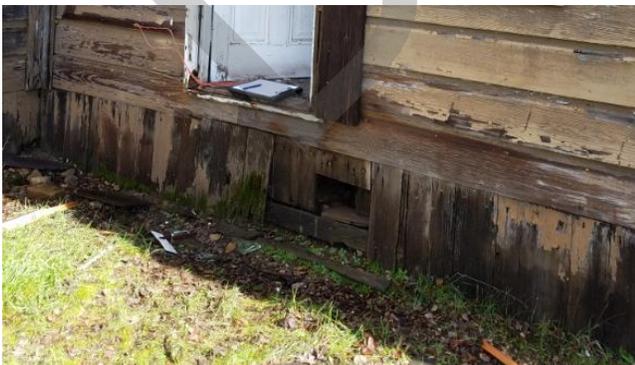
Photo 11. Moisture damage at exterior wall

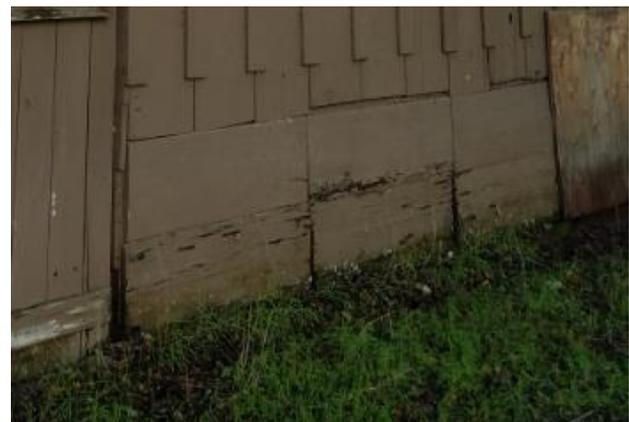
Photo 12. Moisture damage at exterior wall

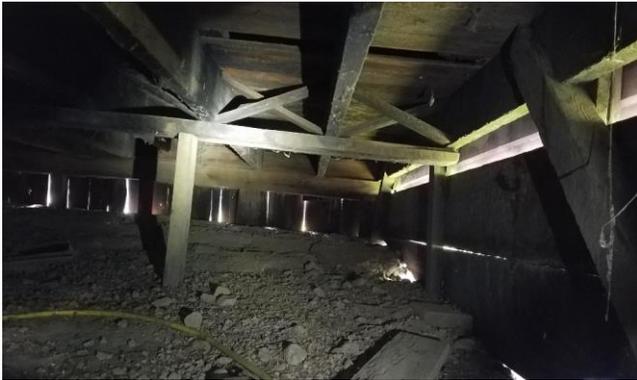
**Photo 13. Crawlspace framing showing lack of concrete foundation, wood posts sitting directly on grade, and diagonal framing at perimeter wall**
