Midpeninsula Regional
Open Space District

La Honda Creek Preserve Forest Health and Management Plan - Next Steps

LA HONDA CREEK OPEN SPACE PRESERVE

Forest Management Assessment

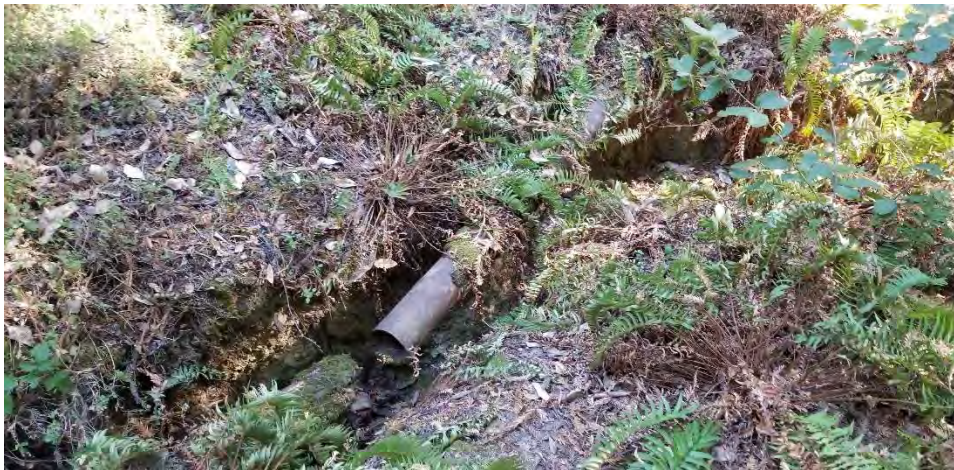
Photo 1: Looking downstream on diverted watercourse at skid trail crossing.

- Remove steel pipe
- Excavate crossing to native channel grade
 - Minimum 3-foot wide channel bottom with smooth uniform grade
 - Lay channel banks back to 2H:1V or flatter
 - Estimate 20 to 50 cy of excavation
- Install drain dips two drain dips at 100 foot spacings along the entrenched skid trail

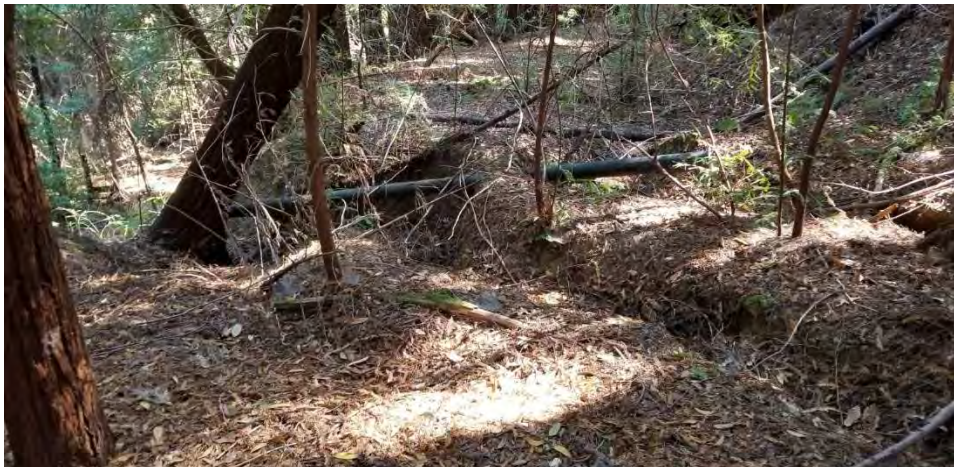
Photo 3: Partial washed out fill crossing

Based on our field review we estimate that there may be 500 cy of fill material still residing at the crossing. Because of site geometry this is a rough estimate and subsurface exploration would be required to confirm this estimate. We estimate that the two gullies indenting the fill embankment combined have eroded

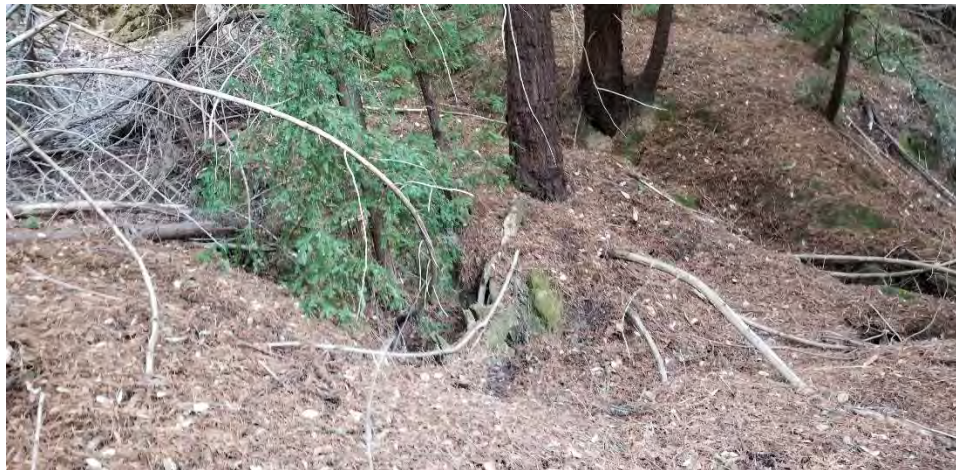
The Class III watercourse drains a 13-acre forested watershed. The active stream channel is approximately 2 to 3 feet wide with an average 25% channel grade. The crossing consists of approximately 120 to 250 cy of fill placed about 6 to 8 feet deep. The crossing is overtopped by 5 to 6 feet (~120 cy) of landslide debris originating from an upslope debris flow.

Photo 7: Two gullies at partially washed out watercourse crossing. The upper gully is from diverted stream flow coming down from MP8. The lower gully is from the watercourse.

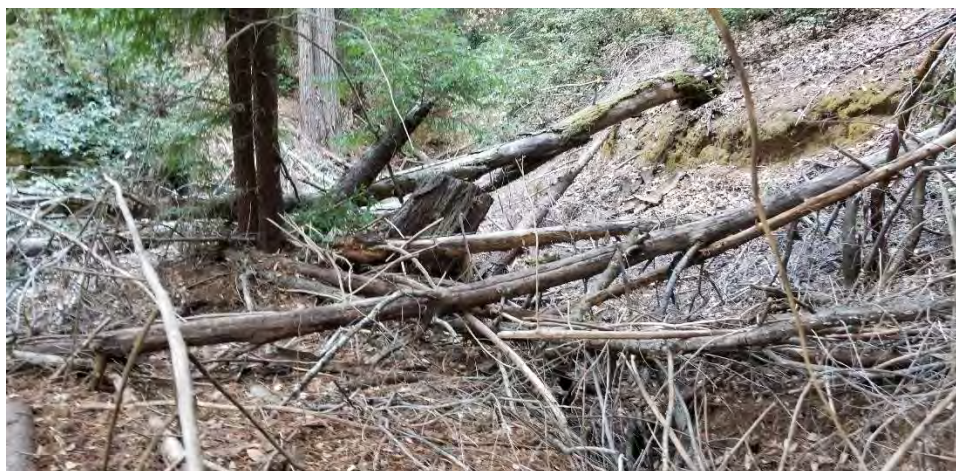
Photo 8: Looking upstream and slide debris deposited in the crossing. The stream is located right of center in the photo.

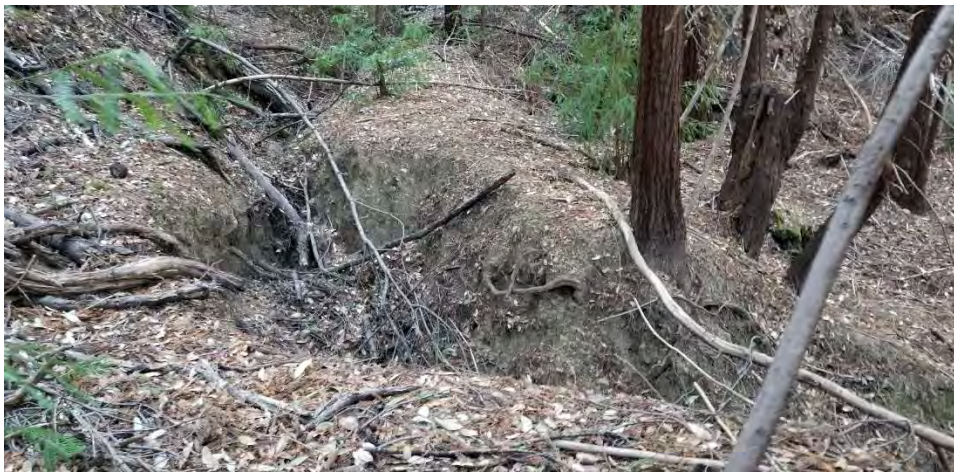
Diverted stream flow from crossings **MP 10** and **11** have eroded two deep gullies into the road prism. The first and currently active gully extends along the roadway for a distance of 140 feet before discharging off of the road. This gully is about 8 to 15-foot-wide, 5 to 10-foot-deep with less than 2 feet of roadway remaining where flow is discharged off of the roadway. Erosion is active and ongoing (See **MP 11** for erosion rates). The second, older and inactive gully is found about 40 feet further down the roadway. This gully has completely eroded out a 40-foot-long segment of roadway, 20 feet wide by roughly 12 feet deep.

Photo 10: Looking up the road at the first gully. The second gully located in the opposite direction from how photo was taken is much larger.

Reopening the road past these two gullies, and past site **13A** (combined fill and cutbank failure) located just past the gullies, is significantly constrained by the 70 to 90% slopes the road traverses. Reopening the road for permanent vehicle access will require reconstructing the outer edge of roadway on engineered fill with about 50+ feet of the fill supported by a 10 to 18-foot-high engineered retaining wall. The cost of these measures would likely be expensive, and could ultimately be found to be economically infeasible. Additional geologic and geotechnical work will be required to further assess the feasibility of a retaining wall and to develop design criteria.
