MOUNT UMUNHUM RADAR TOWER Condition Assessment and Recommendations

Sierra Azul Open Space Preserve
Santa Cruz Mountains, California

Final Report

November 13, 2019
WJE No. 2018.0484

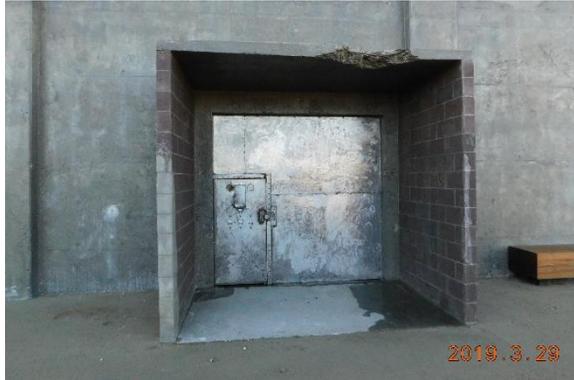
Figure 17. Covered exterior entryway around main entry door on west elevation. Note the spall at the edge of the roof slab.

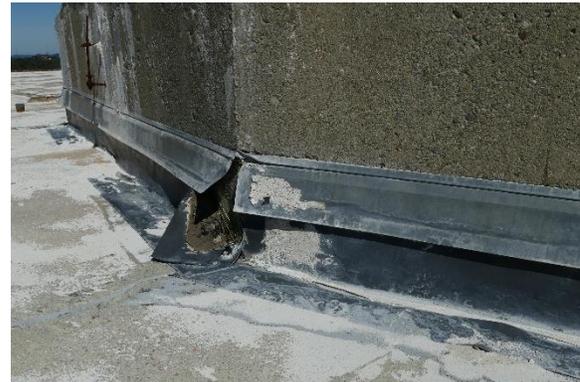
Figure 28. Counterflashing at concrete pedestal. Note the single-ply membrane flashing that was later added, and has failed.

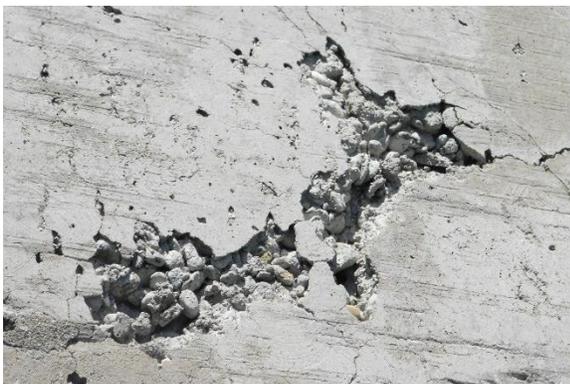
Figure 37. Poorly consolidated concrete.

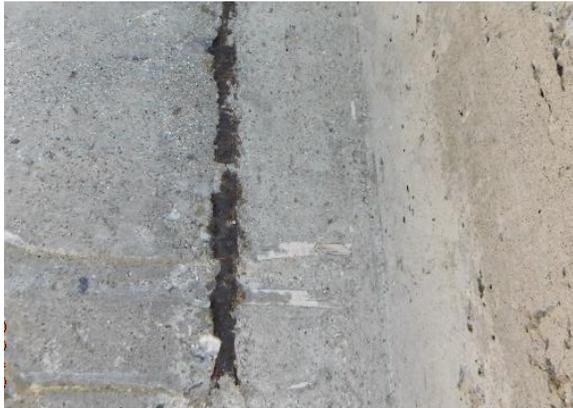
Figure 39. Corroded reinforcing steel with minimal concrete cover.

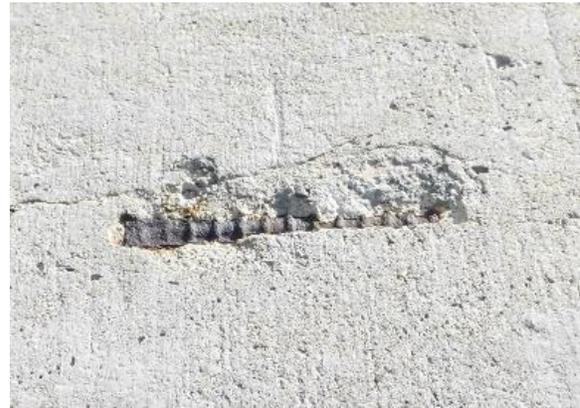
Figure 40. Reinforcing steel with little to no cover.

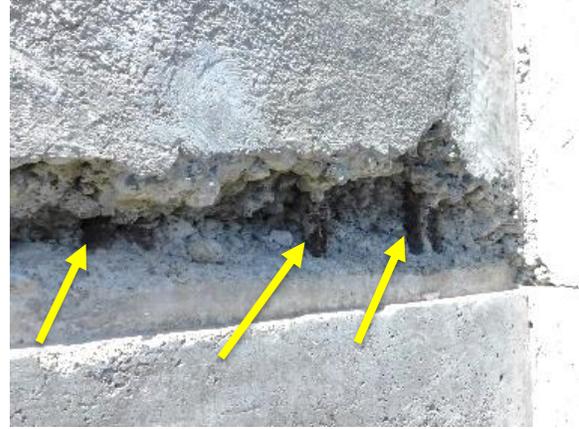
Figure 44. Poorly consolidated concrete above the horizontal construction joint above the floor slab revealing the joint key and reinforcing steel (arrows).

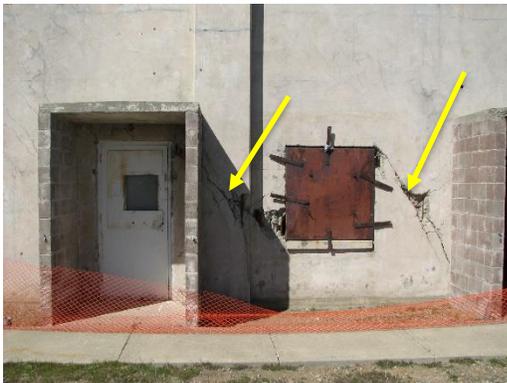
Diagonal cracks were observed at multiple locations on the exterior walls. At the first floor on the east side, previously patched cracks were observed between window and door openings (Figure 45) that likely formed during the Loma Prieta Earthquake in 1989, whose epicenter was only 5 miles to the southeast. The most significant of these cracks were present until about 2014 when they were repaired and the adjacent window and door openings were infilled with concrete (Figure 46).

Figure 45. Cracks visible at east elevation (arrows). (Photo taken in 2013 by WJE)

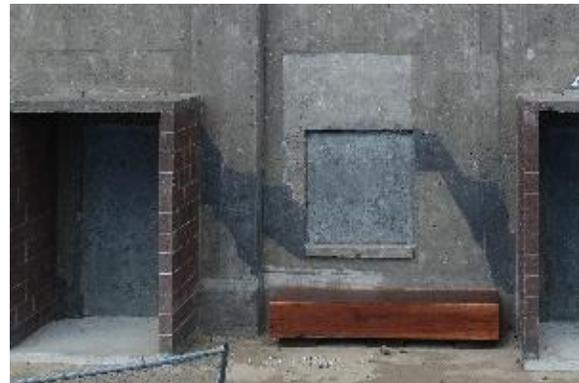
Figure 46. Repaired cracks and infilled openings at east elevation.

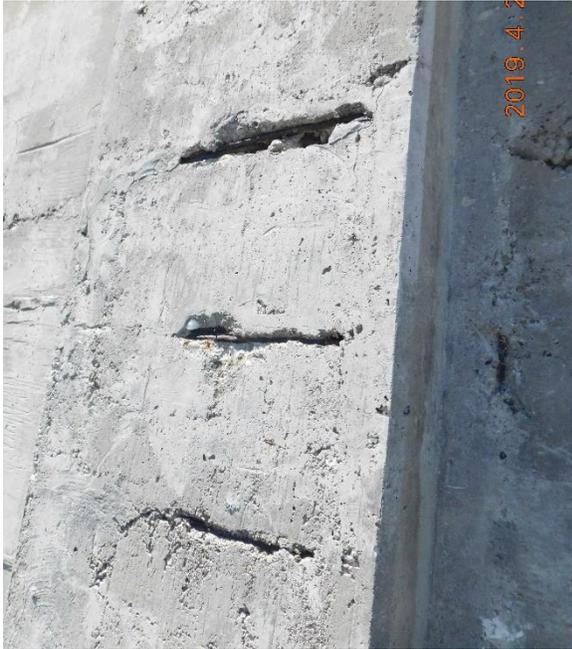
The concrete pilasters have experienced significantly more frequent and severe concrete spalling than the surface of the walls. This spalling has exposed corroded reinforcing steel. Most of the spalling at the horizontal reinforcing is the result of inadequate concrete cover over the horizontal reinforcing (Figure 47 and Figure 48).

Figure 47. Concrete spalling on face of pilaster due to inadequate concrete cover.

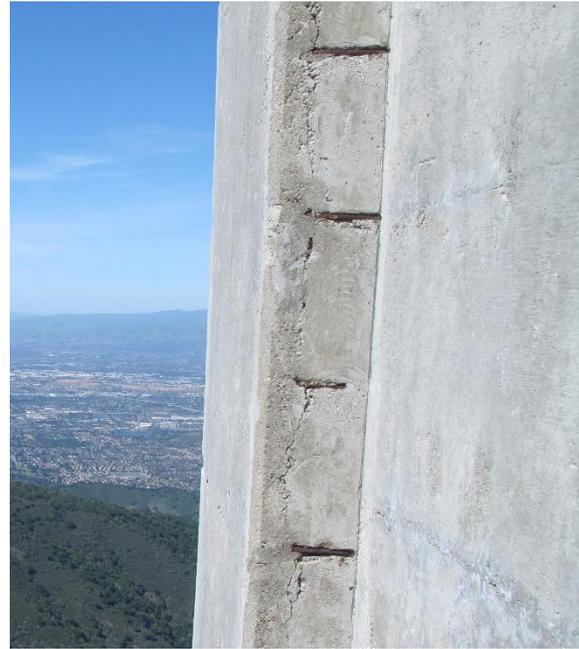
Figure 48. Concrete spalling on side of pilaster due to inadequate concrete cover.

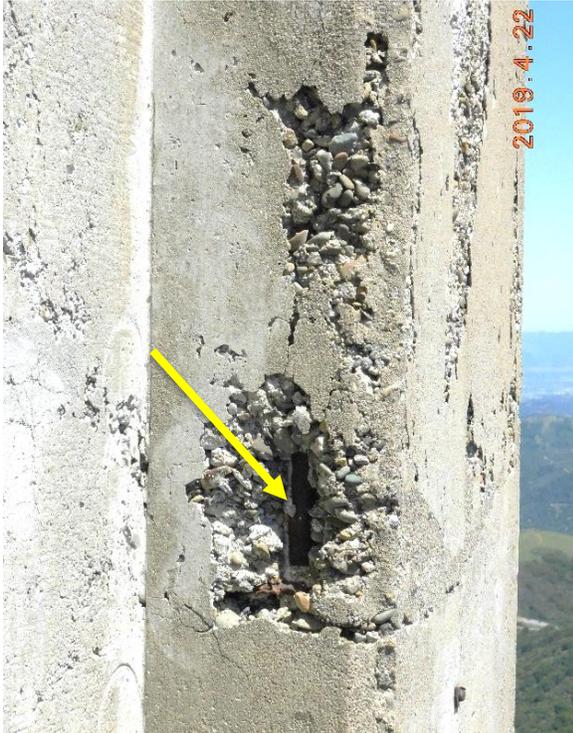
In other locations where the vertical reinforcing is exposed, spalling occurs in areas of poor concrete consolidation on the sides and corners of the pilasters between the vertical reinforcing bars and the finished exterior concrete surface (Figure 49 and Figure 50).

Figure 49. Poorly consolidated concrete on the side and corner of the pilaster. Note exposure of reinforcement steel (arrow).

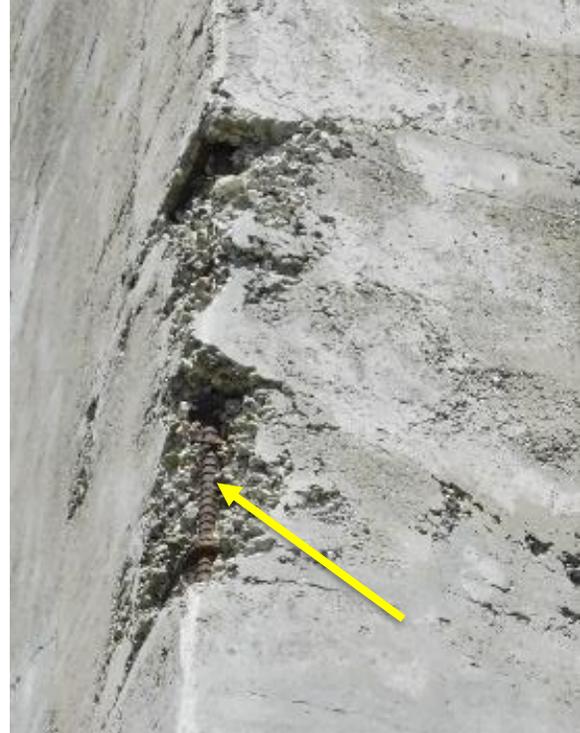
Figure 50. Poorly consolidated concrete on the sides and corner of the pilaster. Note exposure of reinforcement steel (arrow).

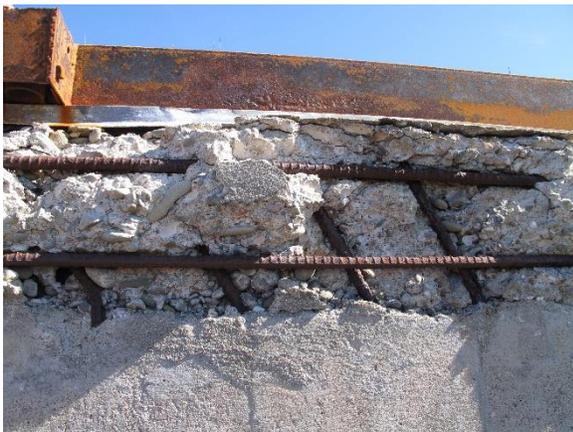
Significant concrete spalling has occurred along the perimeter beam along the edge of the roof slab, which it protrudes from the exterior face of the walls, exposing the wall and roof slab reinforcing steel in places (Figure 51 and Figure 52). Smaller concrete spalls that are not associated with corroded reinforcing are also present, primarily along the bottom of the perimeter roof edge beam at the drip (Figure 53 and Figure 54).

Figure 51. Concrete spalling and exposed reinforcing along the perimeter roof edge beam.

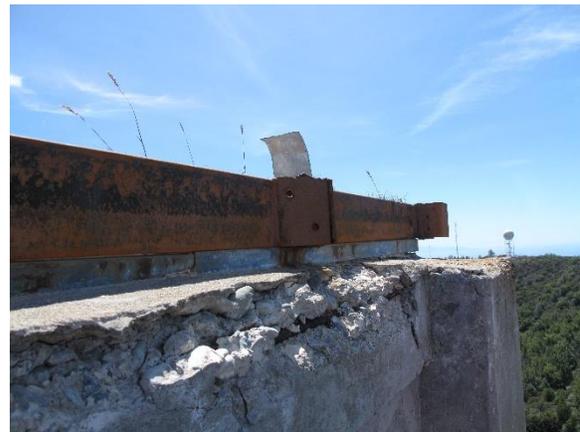
Figure 52. Concrete spalling and exposed reinforcing along the perimeter roof edge beam.

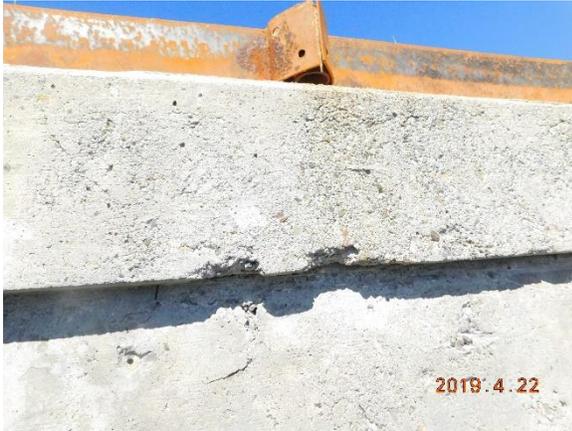
Figure 53. Small concrete spalls along the bottom edge of perimeter roof edge beam.

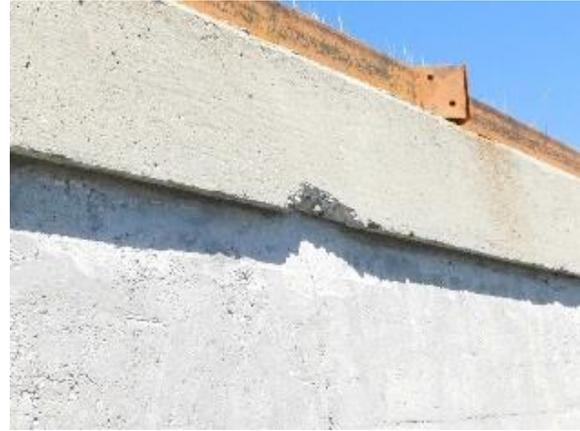
Figure 54. Small concrete spall along the bottom edge of perimeter roof edge beam.

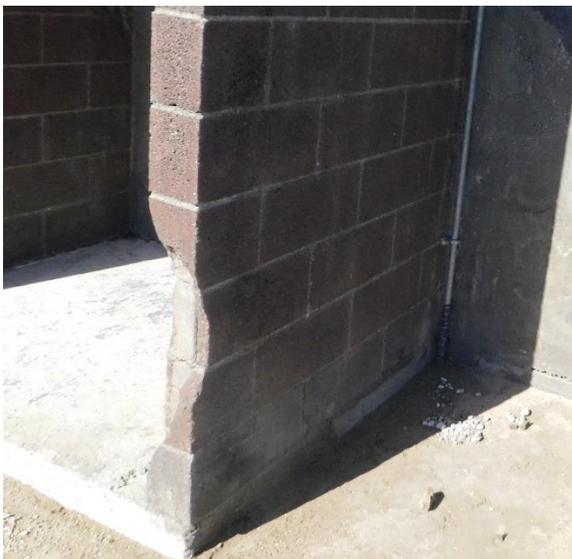
Several of the concrete block wind screens were also observed to have some spalling (Figure 55). Spalling of the concrete slab forming the roof of the wind screens was also observed (Figure 56).

Figure 55. Spalling of concrete block wall of wind screen

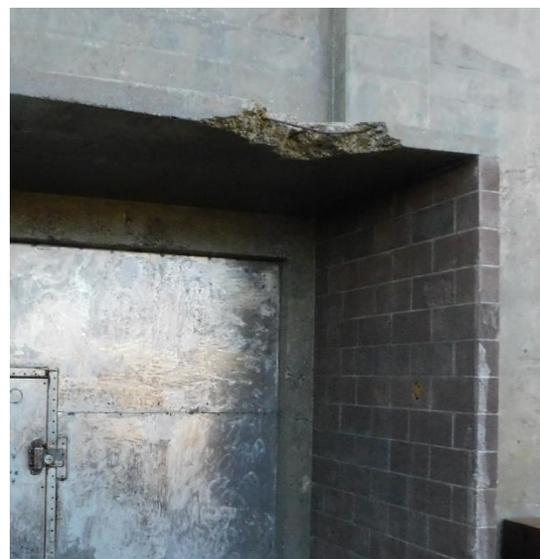
Figure 56. Spalling of concrete slab at top of roof of wind screen.

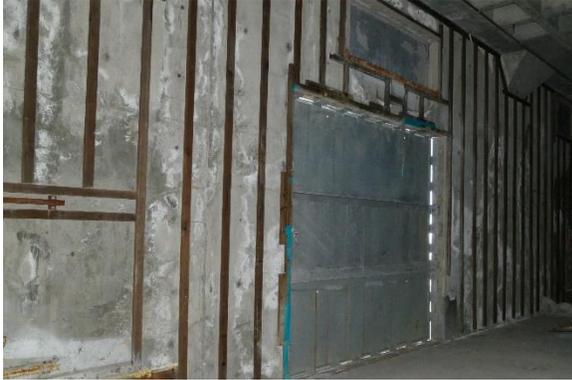
Figure 57. Efflorescence stains at interior of concrete walls.

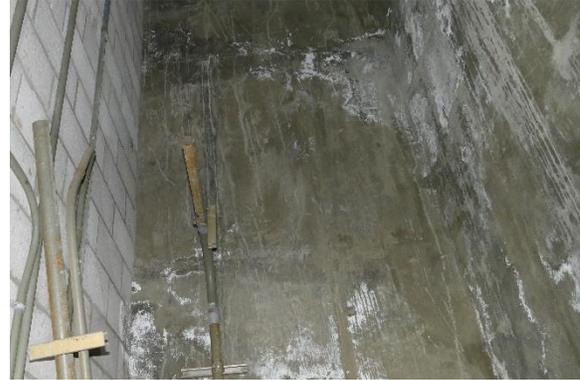
Figure 58. Efflorescence stains in utility shaft at southeast building corner, facing east.

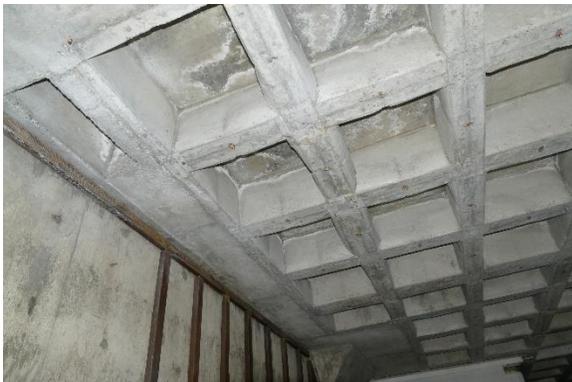
Figure 59. Efflorescence visible on the underside of the third floor slab where water leaks into the building and through the slab.

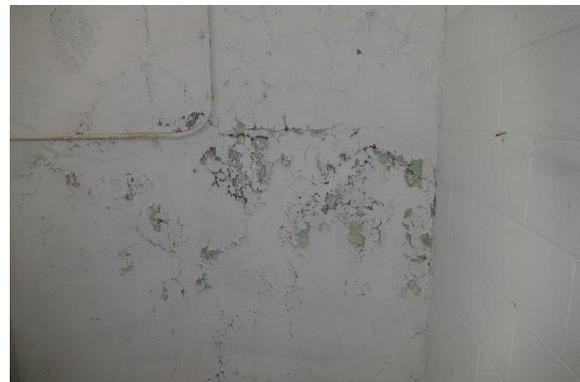
Figure 60. Peeling paint on the inside face of the exterior wall.

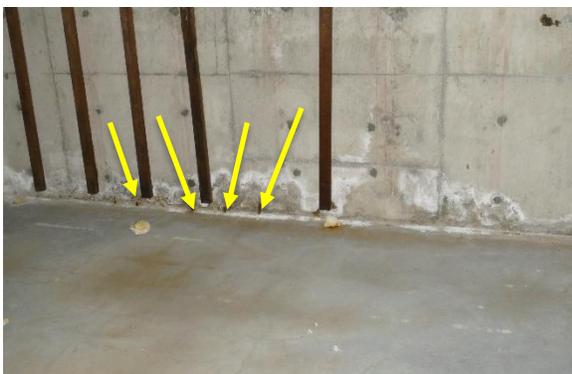
reinforcing steel is exposed and observed to be corroded along the base of the wall (Figure 61 and Figure 62),

Figure 61. Exposed reinforcing steel observed along the base of the wall (arrows).

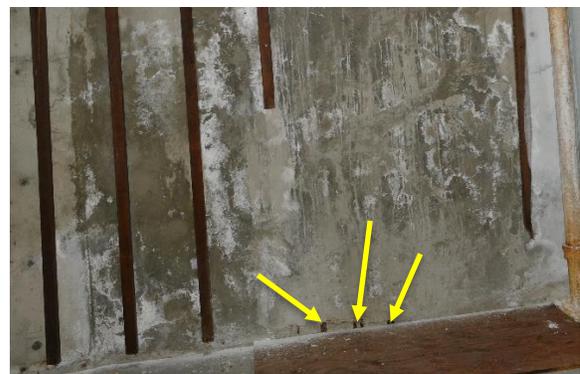
Figure 62. Exposed reinforcing steel observed along the base of the wall (arrows).

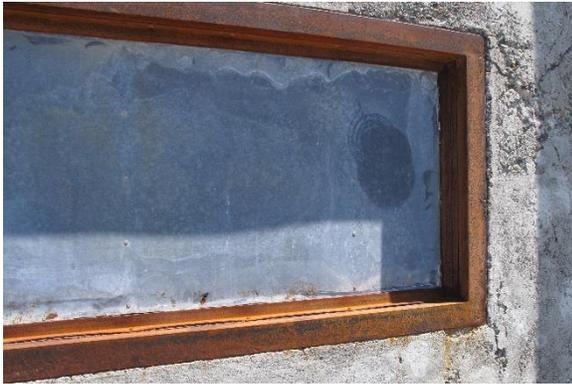
The galvanized steel plates that cover the wall openings are generally in good to fair condition (Figure 63) however some of the original steel frames embedded into the concrete wall around openings that they are attached to are corroded, with corrosion staining below and adjacent to some openings at the interior (Figure 64). The ventilation gap around the perimeter of these plates allows water to enter the building with no means to collect and discharge it. There was standing water on the floor in several locations below these openings at the time of our visit.

Figure 63. Galvanized steel plate with light oxidation and corroded steel frame.

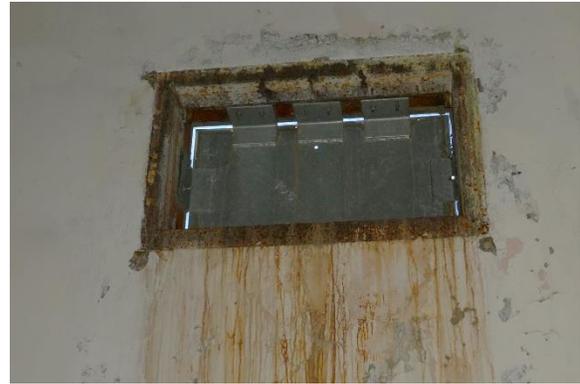
Figure 64. Water and corrosion staining below wall penetration.

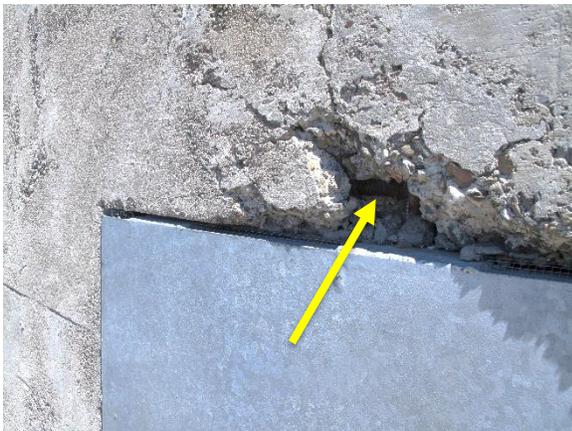
Spalling of the concrete was observed on the exterior adjacent to several of the openings. At some locations spalls expose corroded reinforcing steel (Figure 65), but at most locations there is poorly consolidated concrete adjacent to the steel frames (Figure 66).

Figure 65. Concrete spalling and exposed reinforcing steel (arrow) adjacent to infilled window opening.

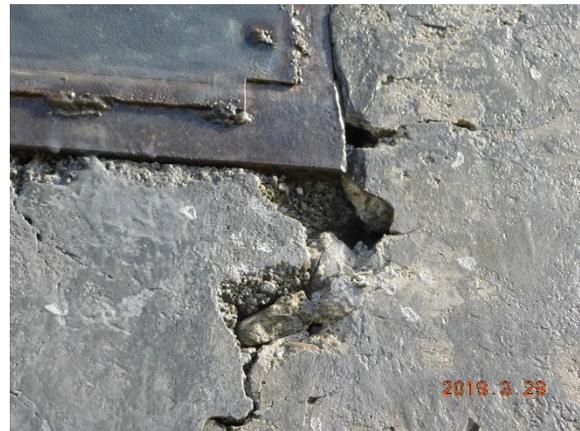
Figure 66. Voids in concrete due to poor consolidation adjacent to window opening.

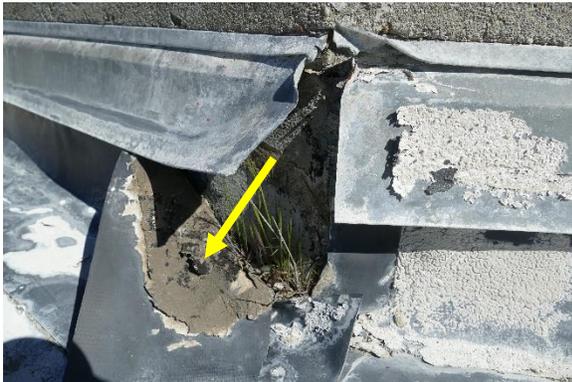
Figure 69. Damaged counterflashing at concrete pedestal showing single-ply membrane flashing (black sheet, damaged), fluid-applied coating (white), and original built-up flashing (black residue adhered to interior surface of single-ply flashing, arrow).

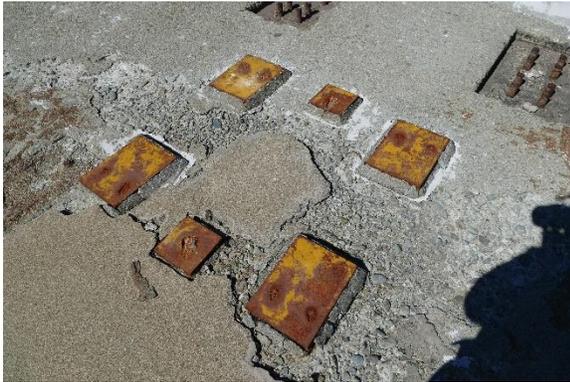
Figure 70. Concrete spalling and corroded steel plates on the top surface of the concrete pedestal.

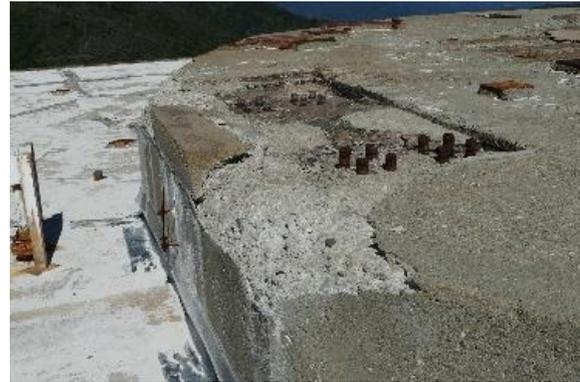
Figure 71. Concrete spalling along the edge of the concrete pedestal.

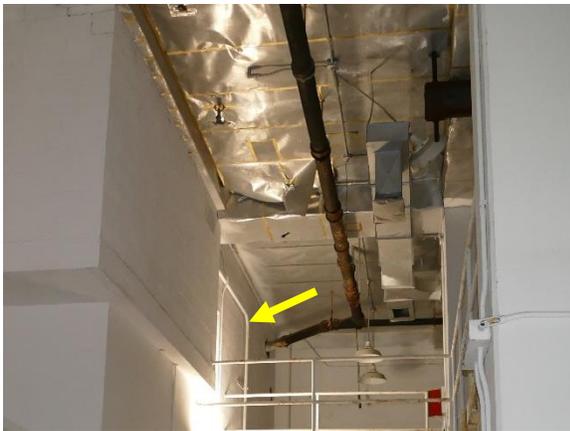
Figure 72. Cast iron drainage plumbing with widespread corrosion running into the utility shaft at the southeast corner (arrow). Photo facing south.

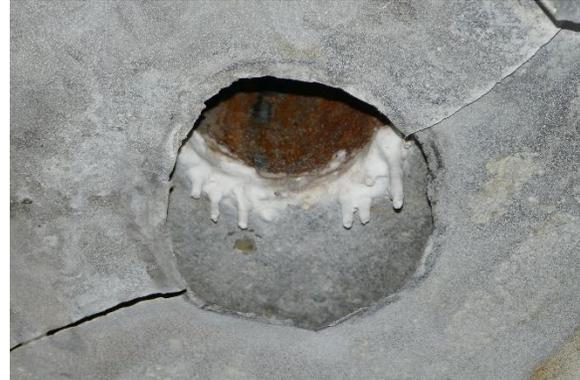
Figure 75. Efflorescence deposits around penetration in concrete roof slab, with aluminum sheets in foreground.

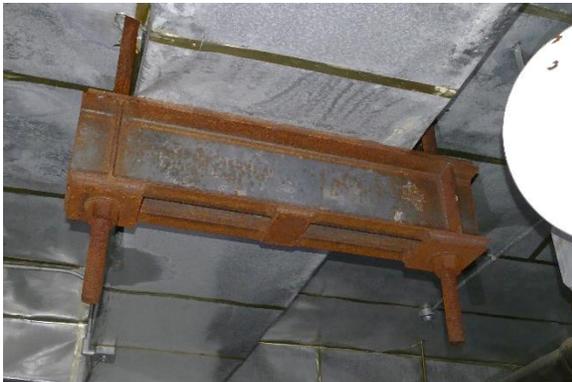
Figure 76. Surface corrosion on steel beam clamp.

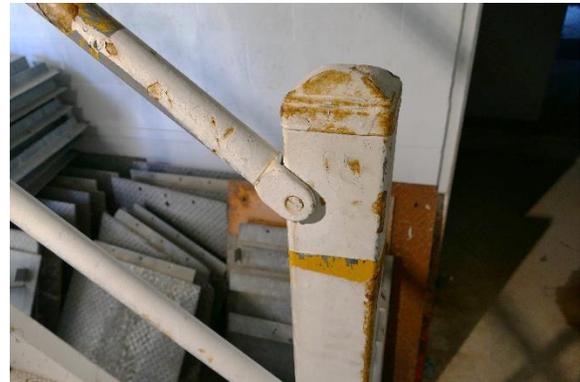
Figure 77. Surface corrosion on metal stair handrail.

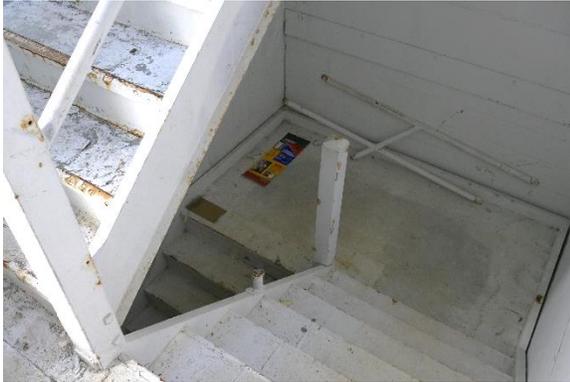
Figure 78. Missing guardrail.

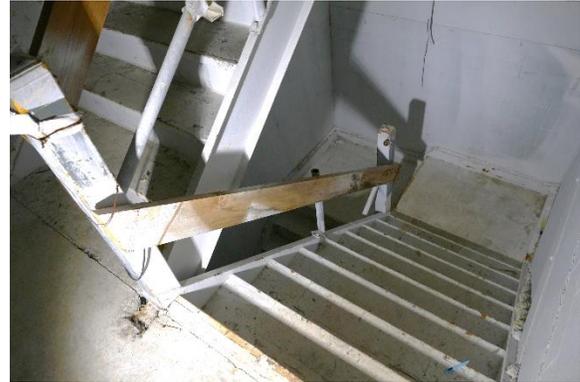
Figure 79. Partially missing handrail with temporary wood railing.

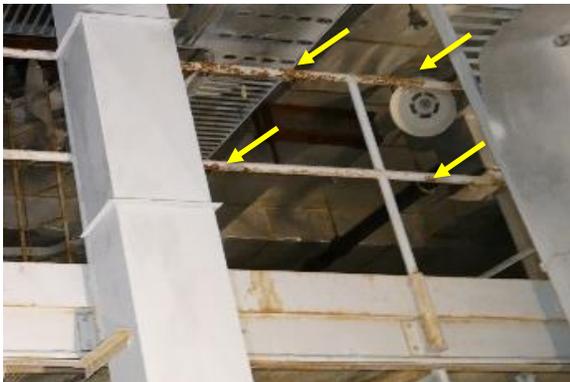
Figure 80. Corrosion of guard rails at the mezzanine.

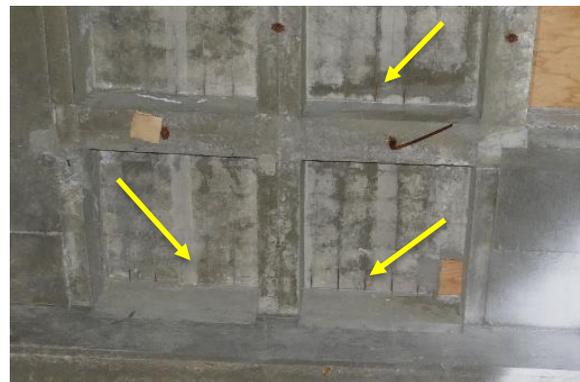
Figure 81. Corrosion staining of reinforcing steel at the soffit of the fifth floor (arrows)

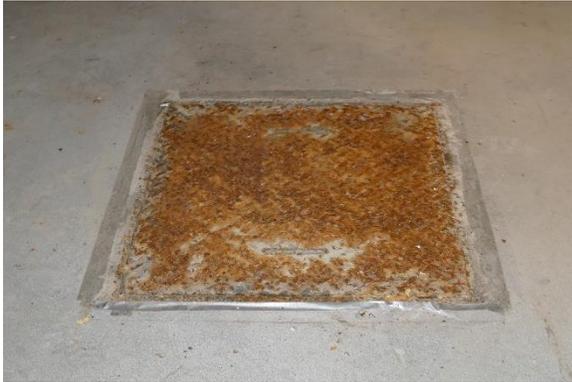
Figure 82. Corroded metal plate covering opening in floor.

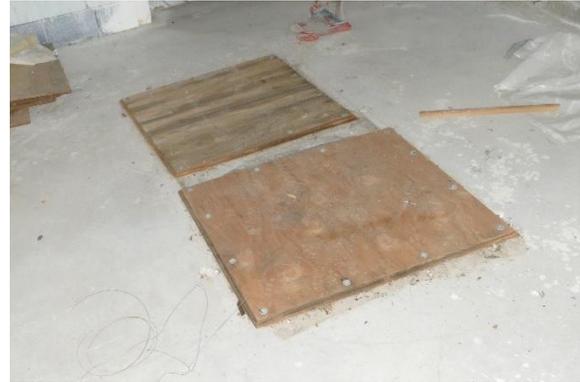
Risks to Maintenance Personnel - Existing plywood covers at floor openings in areas that may be exposed to water that leaks through the walls or wall openings are the items most likely to deteriorate into an unsafe condition in the near future if repairs to the building enclosure are delayed. Decay of the plywood could weaken these to a condition where they are unable to support the weight of a person that may inadvertently step on them.

Figure 83. Plywood covering openings in floor.

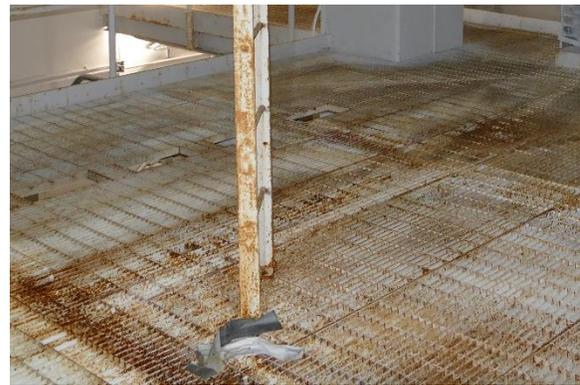
Figure 85. Surface corrosion at mezzanine floor grating below concrete pedestal at roof above.

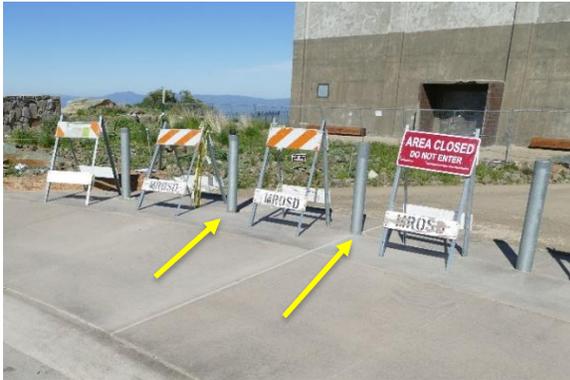
Figure 88. Bollards along the sidewalk. Arrows indicate the two removable bollards.

Replace the two removable bollards with a bollard system that is tolerant of exposure to sand and debris. A foldable bollard system, similar to that used along the roadway to the peak of Mount Umunhum (Figure 5) would appear to be easier to operate and would be less likely to become jammed with debris. Replacement bollards would be expected to last at least 30 years.
