R-20-39
Meeting 20-09
April 22, 2020

Select a design alternative for the La Honda Creek White Barn and Sierra Azul Beatty House

La Honda Creek White Barn

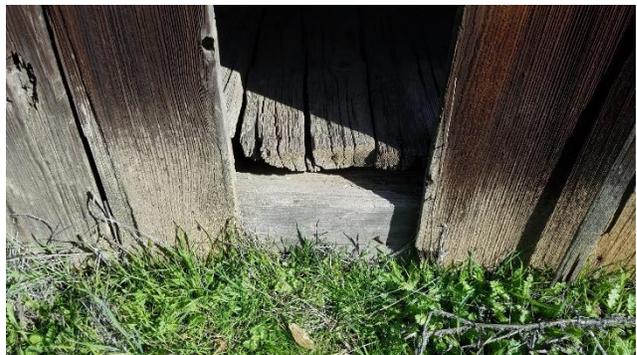
Photo 6. Deterioration at floor sheathing

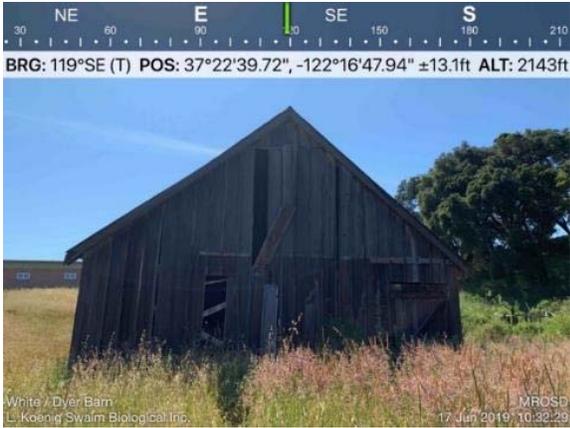
Photo 3. White Barn exterior missing wooden slats and entry points for bats.

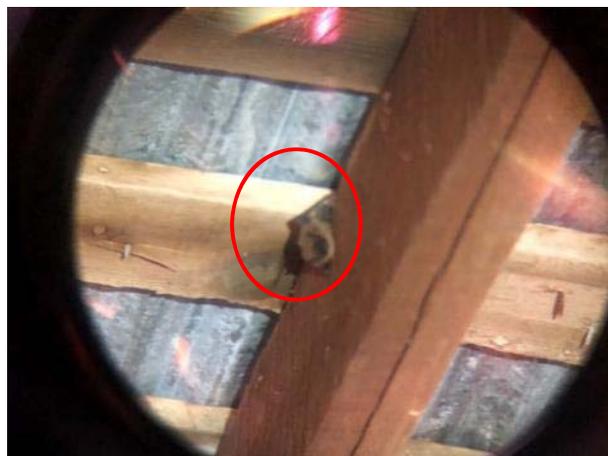
Photo 9. *Myotis sp.* (circled in red) observed roosting in rafters.

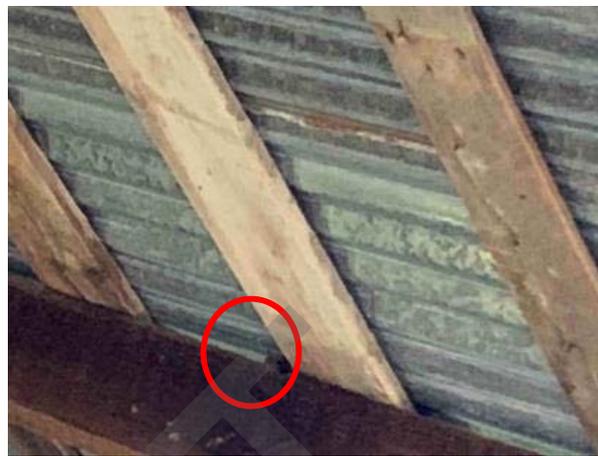
Photo 10. *Myotis sp.* (circled in red) observed roosting in rafters.

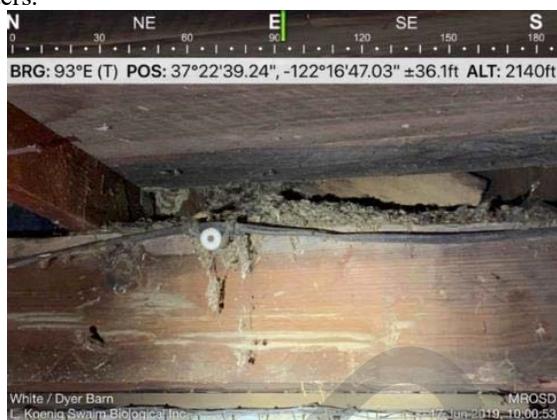
Photo 11. Rodent nests observed within the barn. These grass nests are most likely deer mouse (*Peromyscus sp.*) nests.

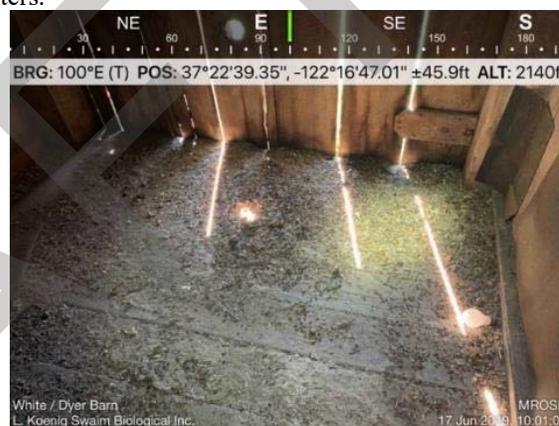
Photo 12. Rodent droppings and destroyed food caches observed within the barn.

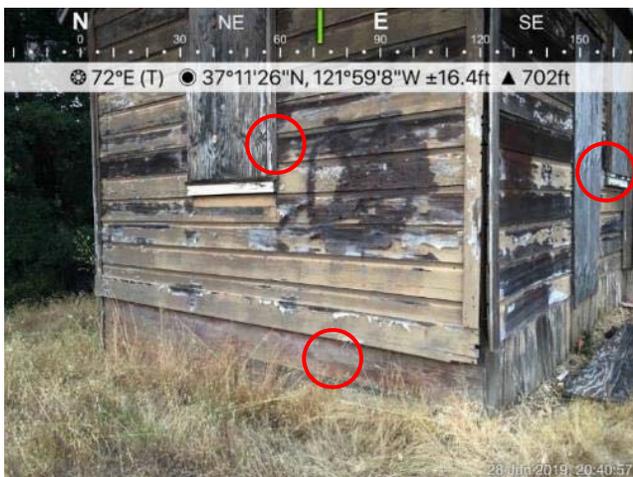
Photo 35. Bats observed emerging from wooden slats (circled in red) on west side of the house.

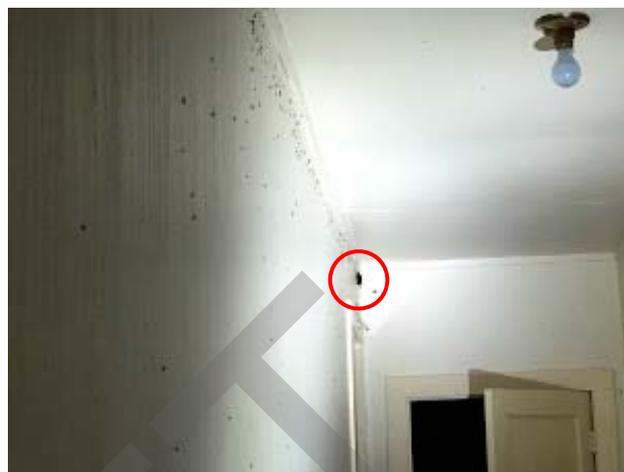
Photo 36. Bat urine staining and guano on wall; *Myotis sp.* (circled in red) observed roosting.

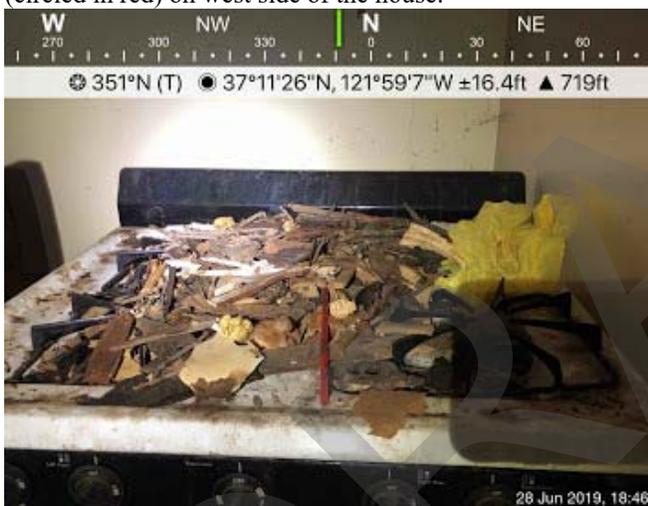
Photo 37. Stick pile on top of stove in kitchen.

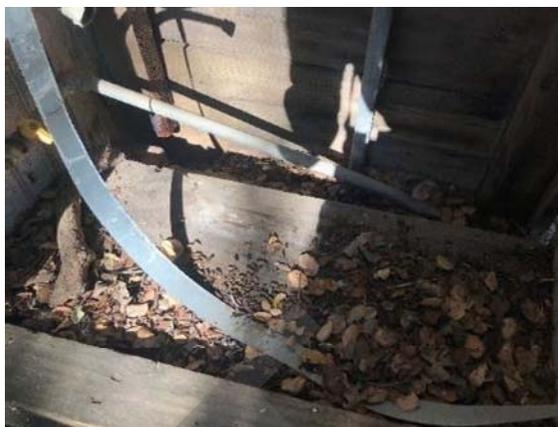
Photo 42. Woodrat A large amount of woodrat feces was observed in one location along the exterior of the structure.

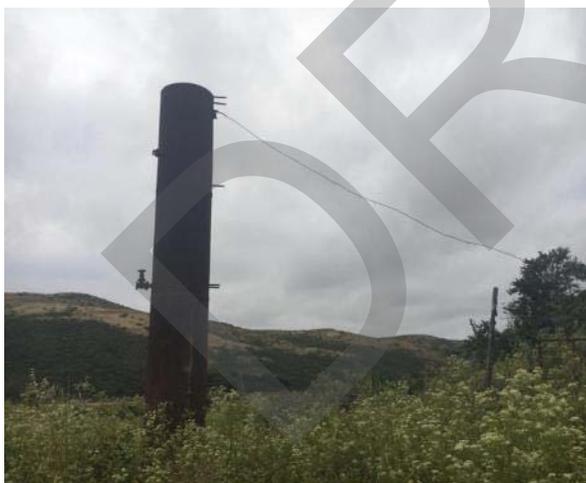
Photo 43. Area B – the distillation column was sealed on top but appeared to have a small opening on the left-hand side near the valve connection.

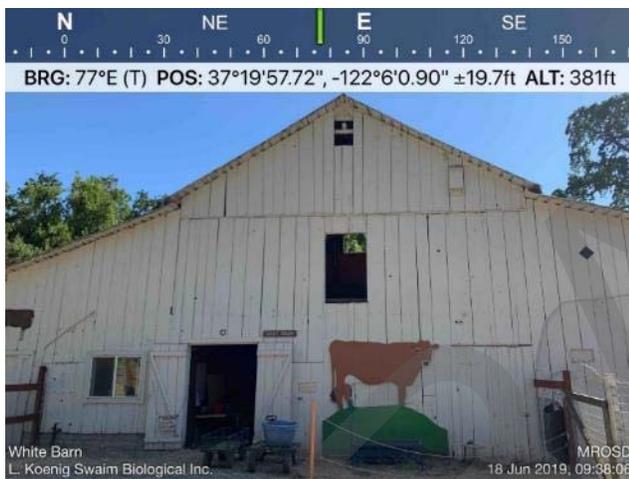
Photo 49. White Barn exterior showing hayloft doors and open access points.

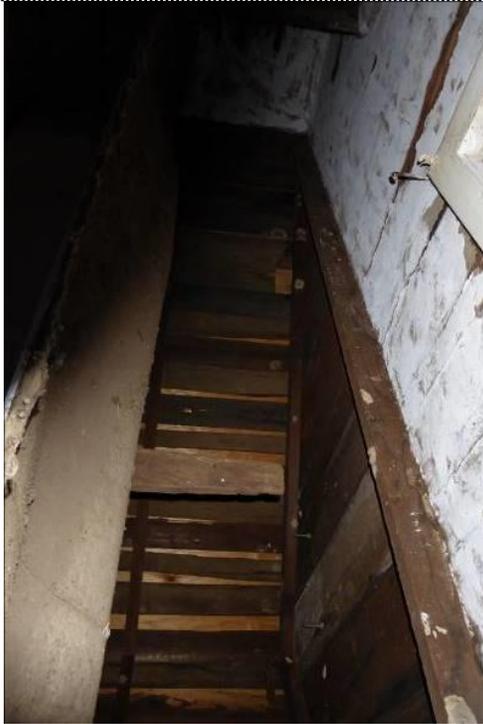
Figure 13

Opening in the ceiling to the roof structure in the parlor. Current nesting area for bats, sighting of bats not visible in this photo. Recommend removal by experienced personnel following appropriate directions by biological monitors prior to any repairs in these particular areas

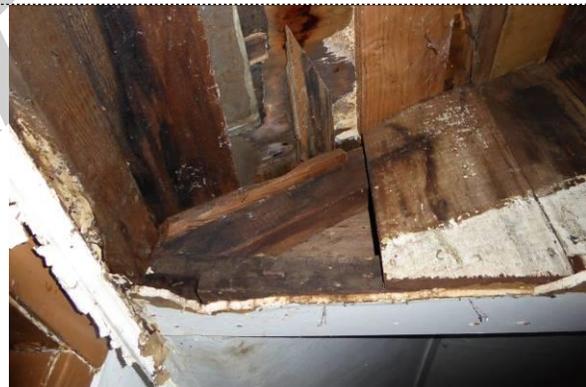
Figure 16

Hanging lower ceiling in the living room as seen through an opening. Clearly the vertical boards could be part of an original façade that was later modified. Evident humidity and rot signs, especially where the different roofing areas merge. Visible the new plywood sheathing directly over the historic one

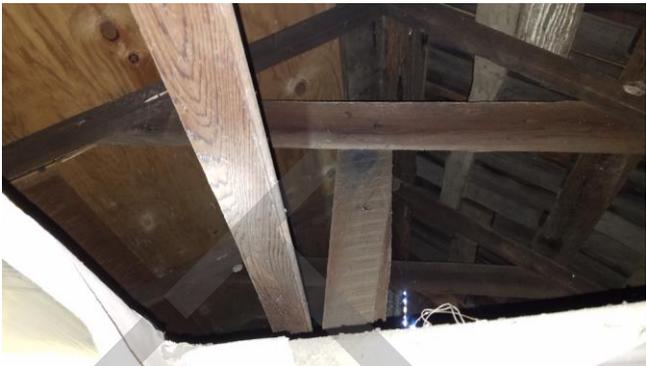
Photo 8. Hole in ceiling exposing collar ties, rafters, and 1x planking at roof

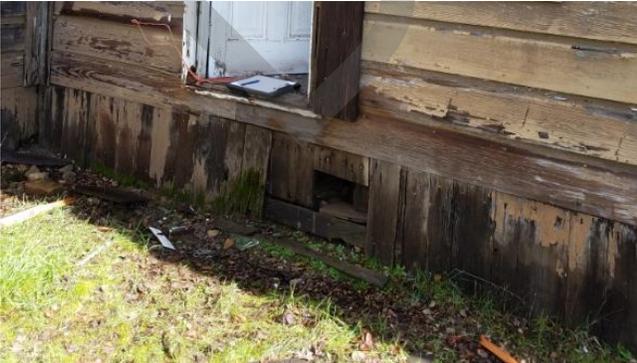
Photo 11. Moisture damage at exterior wall

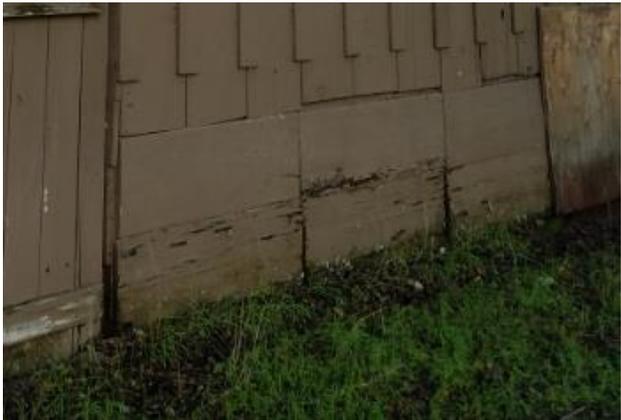
Photo 12. Moisture damage at exterior wall

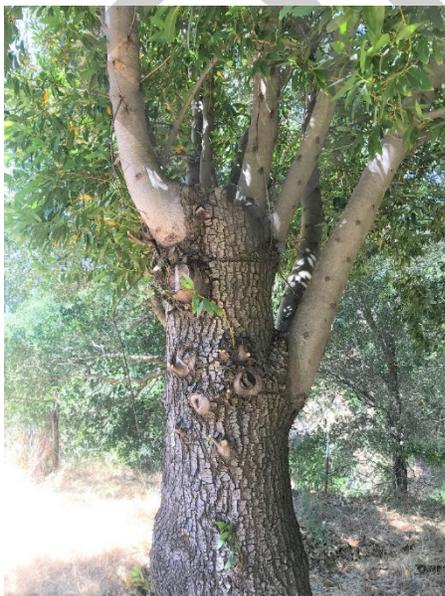
Laurel tree #8 is the only other tree on site in poor condition. The tree has been topped in the past. A wire is also girdling the tree trunk. Topped trees create hazardous conditions as the new growth is weakly attached. Also, the past topping cut is prone to decay. This tree has a high risk of limb failure. Tree removal is recommended as there is no way to mitigate the high risk of limb failure.

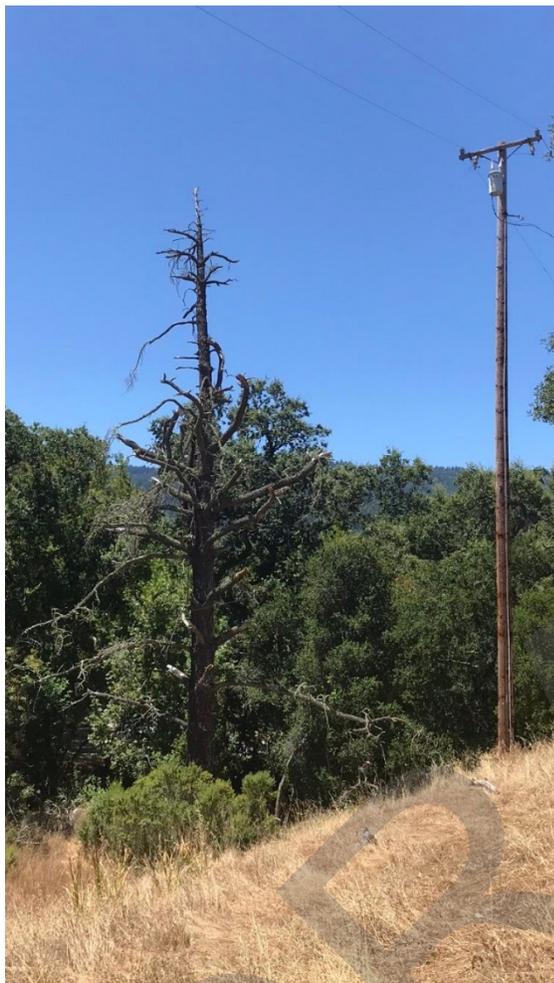
Dead Monterey pine trees were observed far from the building site (50 feet +). The dead pine trees are a fire hazard to the area and should be removed as soon as possible. Monterey pine trees are not native to this location and likely died due to bark beetles and the prolonged period of drought. The following tree protection plan will help to ensure the future survival of the trees on site.
