Midpeninsula Regional
Open Space District

La Honda Forest Health Management Assessment – Findings and Contract Amendment for Expanded Scope

LA HONDA CREEK OPEN SPACE PRESERVE

Forest Assessment

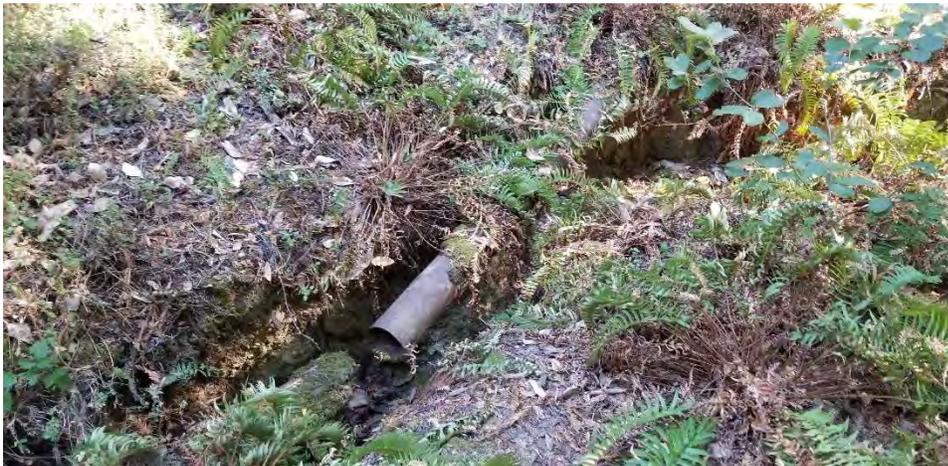
Photo 1: Looking downstream on diverted watercourse at skid trail crossing.

- Remove steel pipe
- Excavate crossing to native channel grade
 - Minimum 3-foot wide channel bottom with smooth uniform grade
 - Lay channel banks back to 2H:1V or flatter
 - Estimate 20 to 50 cy of excavation
- Install drain dips two drain dips at 100 foot spacings along the entrenched skid trail

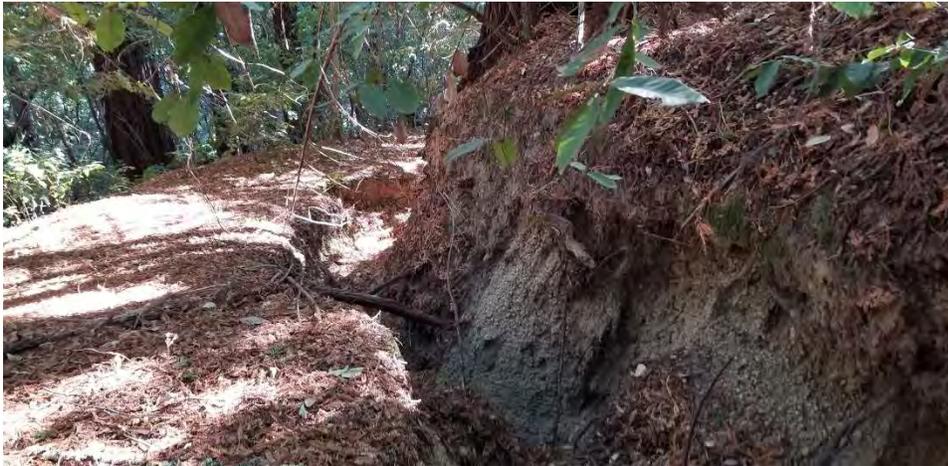
Photo 2: Gully from diverted watercourse down skid trail

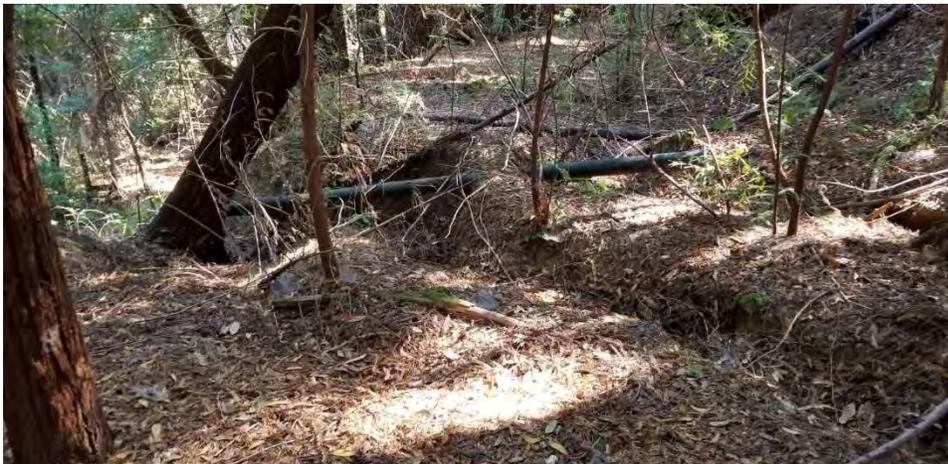
Photo 3: Partial washed out fill crossing

Based on our field review we estimate that there may be 500 cy of fill material still residing at the crossing. Because of site geometry this is a rough estimate and subsurface exploration would be required to confirm this estimate. We estimate that the two gullies indenting the fill embankment combined have eroded

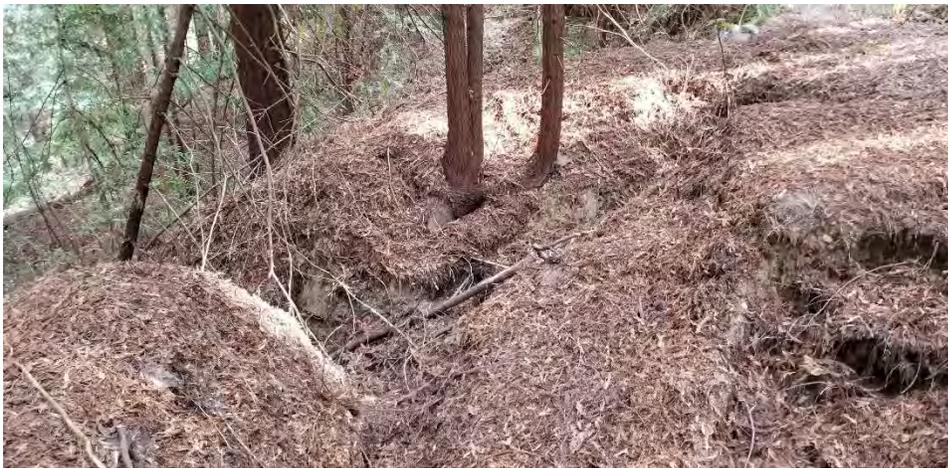
This is a partially washed out fill crossing on a steep (30%) Class III watercourse draining a 16-acre forested watershed. There does not appear to have been any drainage structures installed at this crossing and as a result stream flow has eroded 40-foot-long, 6-foot-wide and 5-foot-deep gully most of the way through the fill prism. Immediately east of the crossing is a second gully or fill failure. It is unknown if this failure is due to past stream flow being directed over the fill embankment at this location or instability of the oversteepened fill prism.

Photo 4: Partially washed out fill crossing

The fill crossing consists of 150 to 250 cy of fill placed about 9 feet deep. Of this material, we estimate that 40 to 60 cy of this material (25% of total) has eroded out over the past 50 years (1.25 cy/yr). Most of this erosion likely occurred early on and has decreased significantly due to the diversion of stream flow at **MP 2** which results in only limited flow reaching the **MP 7** crossing. For the purpose of this study we have assumed an average erosion rate of 0.65 cy/yr which is about half the historic average.

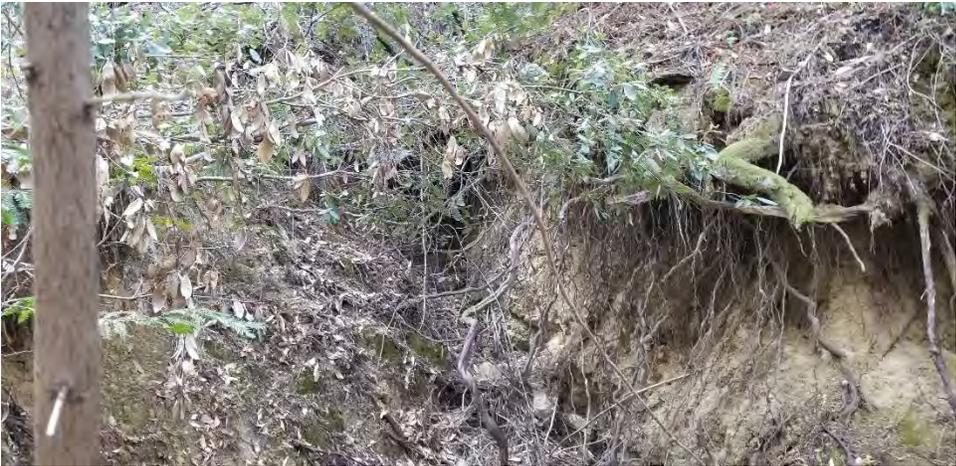
The landing is about 80 feet long and 35 feet wide, and constructed by cutting in to the 45% gradient hillside on cut and fill. A narrow tractor road traverses the hillside just below the landing. Currently streamflow is diverted 200 feet down the road to the east where it discharges into the eroding fill crossing at **MP 9**. In the past, stream flow had drained across the landing and lower skid trail where it had eroded narrow gullies into the fill embankments. We observed a couple of small sink holes in the tread of the skid trail indicating some subsurface soil piping may be occurring.

Photo 5: Gully in steep cutbank from diverted stream flow originating from MP 1 and MP2

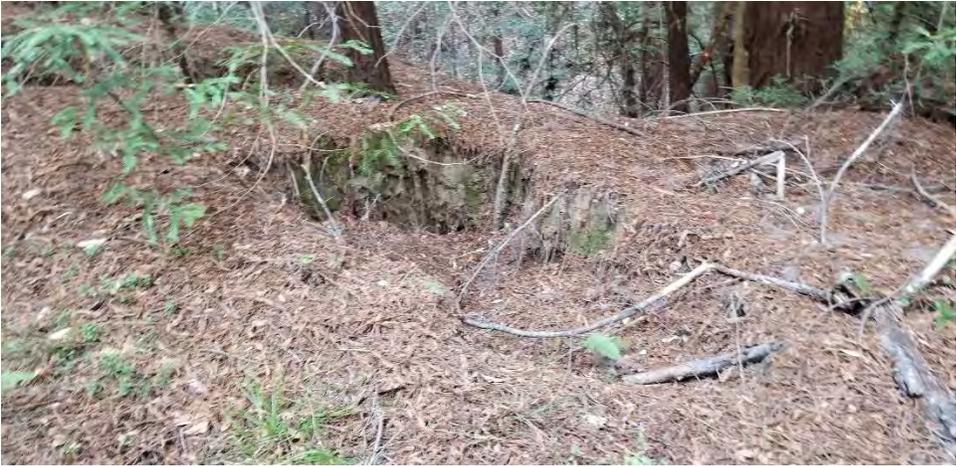
Photo 6: Sinkhole due to subsurface soil piping

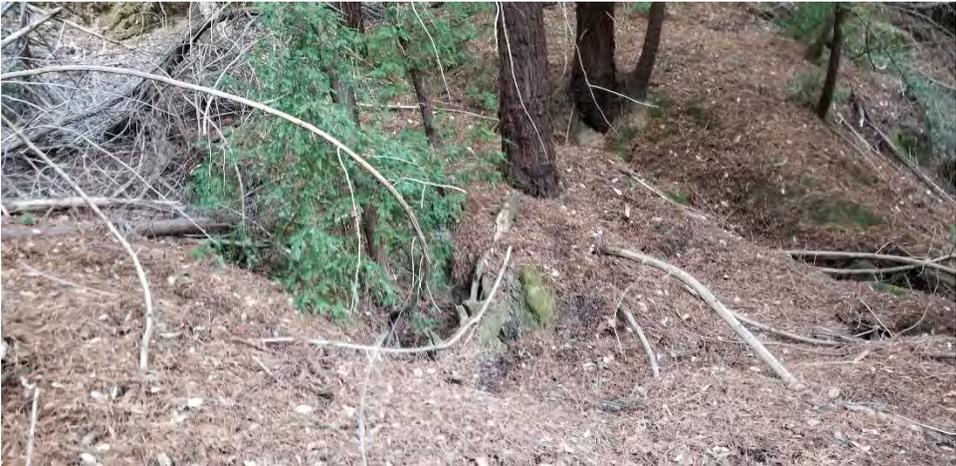
The Class III watercourse drains a 13-acre forested watershed. The active stream channel is approximately 2 to 3 feet wide with an average 25% channel grade. The crossing consists of approximately 120 to 250 cy of fill placed about 6 to 8 feet deep. The crossing is overtopped by 5 to 6 feet (~120 cy) of landslide debris originating from an upslope debris flow.

Photo 7: Two gullies at partially washed out watercourse crossing. The upper gully is from diverted stream flow coming down from MP8. The lower gully is from the watercourse.

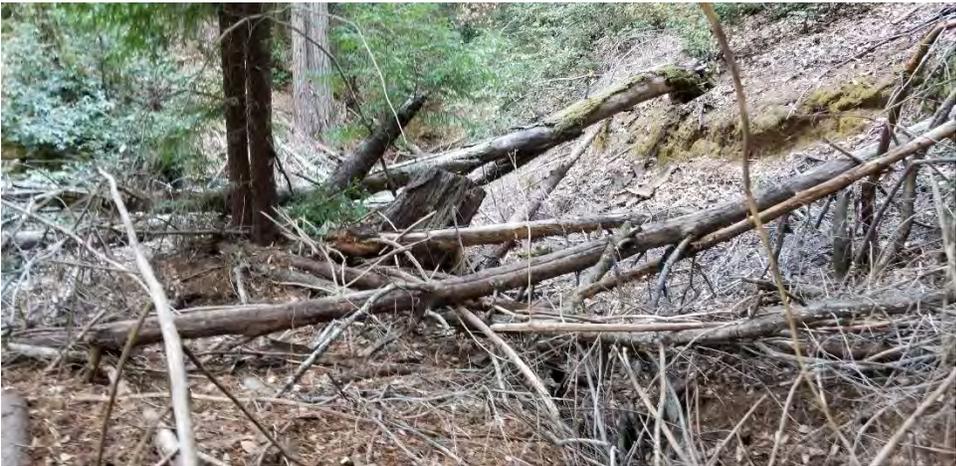
Photo 8: Looking upstream and slide debris deposited in the crossing. The stream is located right of center in the photo.

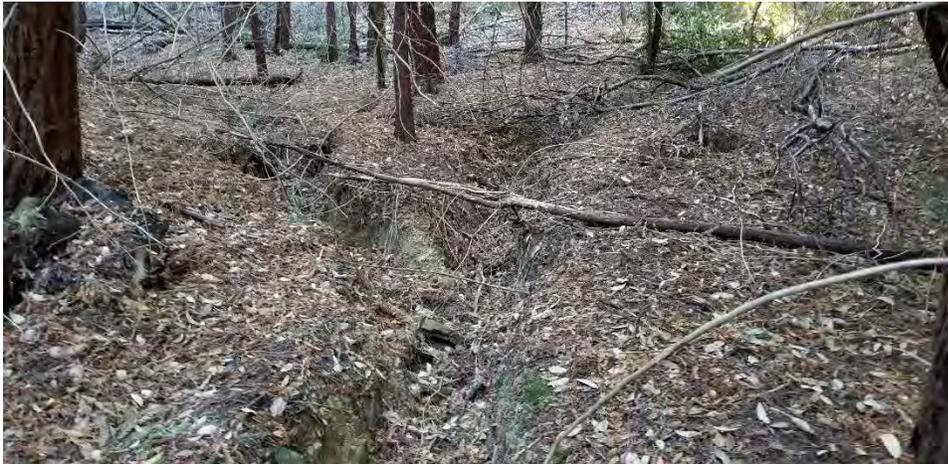
The combination of a lack of drainage structures at **MP 11** and the construction of the downstream landing resulted in the combined streamflow from **MP 10** and **11** to be diverted 450 feet down the road resulting in locally extensive gulying of the road prism. For the first 250 feet of the diversion the gully is modest in size averaging about 4 to 6 feet in width and 2 to 4 feet in depth. After this location at **MP 12**, the road grade steepens slightly and the gully becomes much more deeply incised at 10 to 20 feet in width and 7 to 12 feet in depth, and with little of the road tread remaining. As will be discussed at **MP 12**, the combination of the deep gulying and very steep (90%) sideslopes significantly constrains the feasibility of reopening the road past this location.

Photo 9: Diverted stream at MP 12. The left channel is the watercourse at MP12, the right channel extending up the road is from diverted flow from MP 10.

Overall, we estimate there has been 800 to 1,200 cy of combined erosion over the past 50+ years (15 to 25+ cy/yr) from **MP 10, 11** and **12** with the rate of erosion having decreased as the gullies have down cut into more stable material. We estimate the rate of future erosion at 10 to 15 cy/yr or about 2/3 the historic rate.

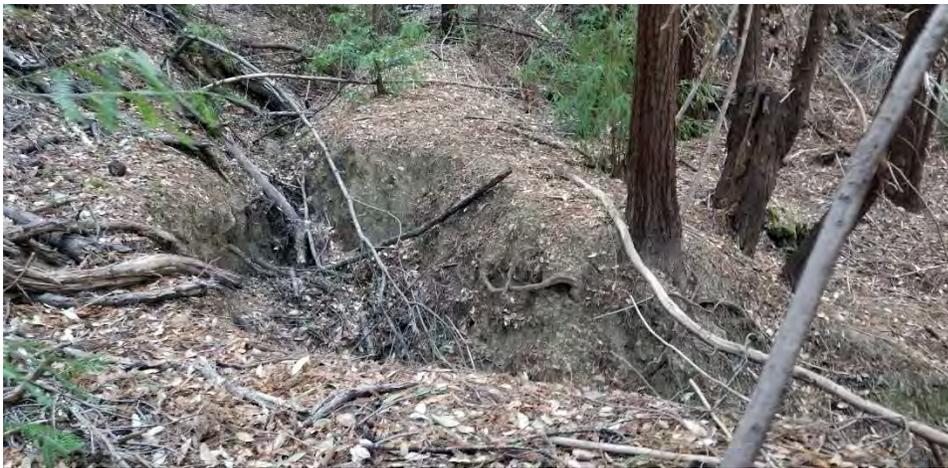
Diverted stream flow from crossings **MP 10** and **11** have eroded two deep gullies into the road prism. The first and currently active gully extends along the roadway for a distance of 140 feet before discharging off of the road. This gully is about 8 to 15-foot-wide, 5 to 10-foot-deep with less than 2 feet of roadway remaining where flow is discharged off of the roadway. Erosion is active and ongoing (See **MP 11** for erosion rates). The second, older and inactive gully is found about 40 feet further down the roadway. This gully has completely eroded out a 40-foot-long segment of roadway, 20 feet wide by roughly 12 feet deep.

Photo 10: Looking up the road at the first gully. The second gully located in the opposite direction from how photo was taken is much larger.

Reopening the road past these two gullies, and past site **13A** (combined fill and cutbank failure) located just past the gullies, is significantly constrained by the 70 to 90% slopes the road traverses. Reopening the road for permanent vehicle access will require reconstructing the outer edge of roadway on engineered fill with about 50+ feet of the fill supported by a 10 to 18-foot-high engineered retaining wall. The cost of these measures would likely be expensive, and could ultimately be found to be economically infeasible. Additional geologic and geotechnical work will be required to further assess the feasibility of a retaining wall and to develop design criteria.

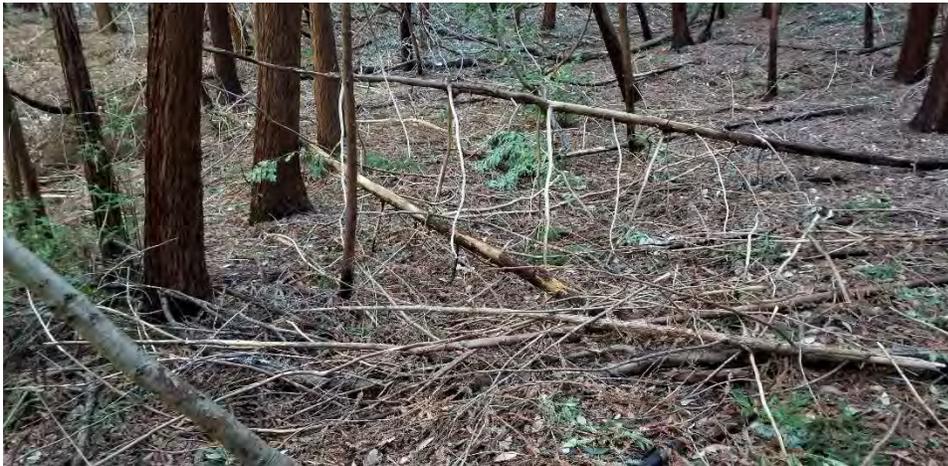
It appears that only limited grading was required to construct the road across the bench, though fill generated from the construction of the road across the steeper side slopes may have been pushed over the edge within the axis of the drainage. It is unknown how much fill material resides at the site, if any, but could be as much as 100 to 500 cy. Subsurface exploration will be required to more precisely determine the amount and level of stability of the fill material.

Photo 11: Looking east across bench. The gully at the outer edge of the road is barely visible behind the trees on the left side of the photo. The very subtle arcuate escarpment is also barely visible in the middle of the photo.

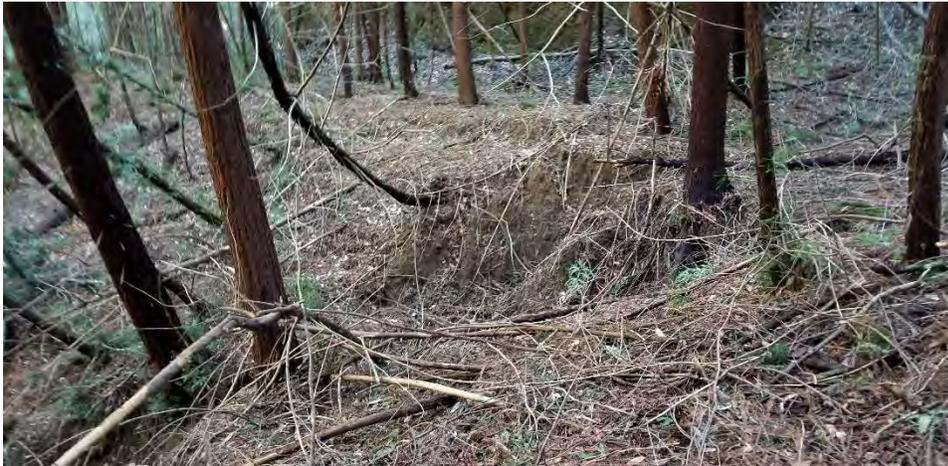
Photo 12: Looking east across the head of the gully eroded into the edge of the bench.

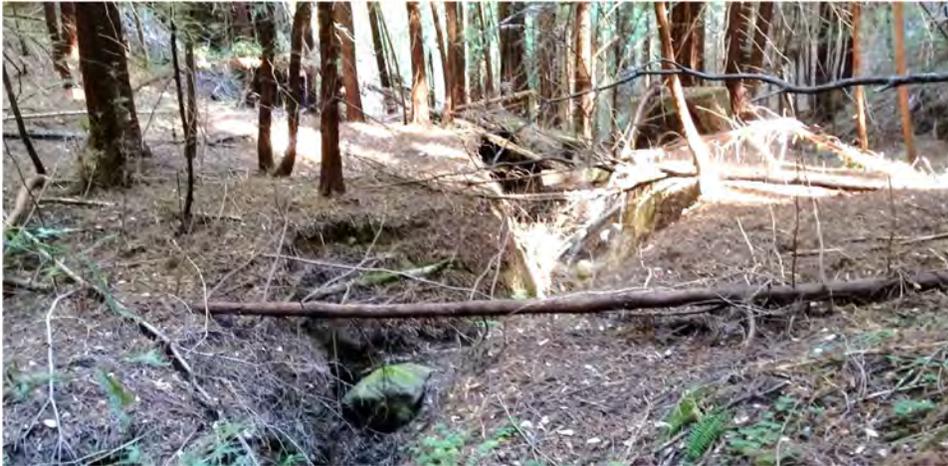
Presently the Class II watercourse flows in a shallow channel over the debris flow deposit of intermixed wood and sediment before reaching the upstream end of the Humboldt crossing. From there the stream has eroded an 80-foot-long, 5 to 15-foot-wide, 4 to 10-foot-deep channel across the old roadway, before draining underneath a root wad and across some stacked logs at the downstream end of the crossing. The road gully to the south of the crossing currently receives runoff from the small Class III tributary, adjacent sideslopes, and intercepted groundwater. The current rate of erosion within the gully appears low.

Photo 13: looking downstream at the partially washed out Humboldt crossing. Stream flow drains underneath a fallen stump just to the left of the eroded channel.

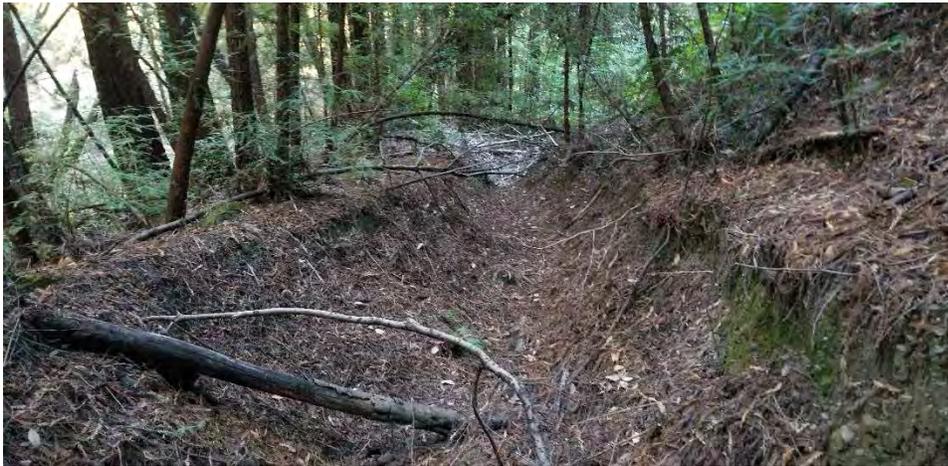
Photo 14: looking down the road at the eroded channel from diverted stream flow. This photo was taken along the lower portion of the gully where the incision is much greater. Note the heavy duff layer in the channel bottom.
