Contract Amendment for Engineering Services with ZFA Structural Engineers to complete Phase II of the La Honda Creek White Barn Structural Stabilization Project

WHITE (DYER) BARN

Structure Stabilization Basis of Design

Structural Condition Assessment and Basis of Design by ZFA Structural Engineers

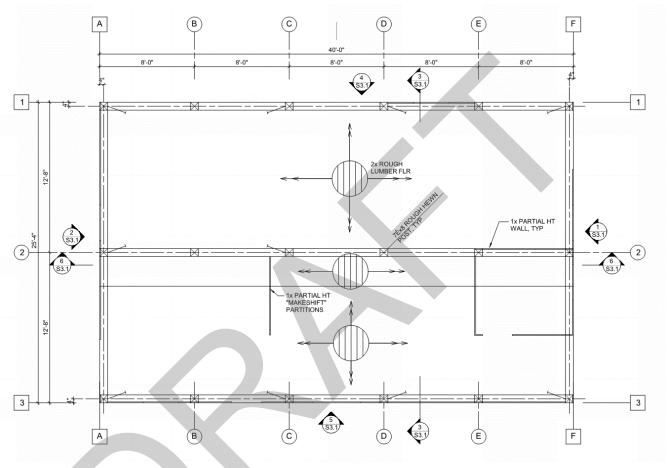
Figure 1: Existing Ground Floor Framing Plan developed by ZFA

At the ground floor level, the flooring is composed of 2x straight sheathing that is assumed to be supported by wood floor framing. The floor sheathing is in fair to poor condition with deterioration observed at some locations, particularly at the perimeter of the building. The floor framing sits just above or directly on the soil, so there is no access to observe the condition or type of framing. Deterioration due to soil contact is assumed in the floor framing throughout.

The foundations for this structure are limited to wood grade beams placed directly on the soil. This wood has significantly deteriorated and contributed to settlement of the structure over time.

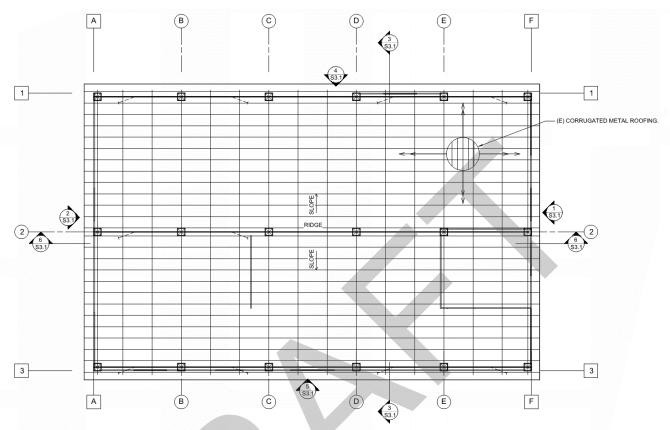
Figure 2. Existing Roof Framing Plan developed by ZFA

The roof is composed of corrugated metal sheathing that is supported by 1x6 skip sheathing spanning between 2x6 rafters spaced at 3 feet on center. The roof framing, viewed from the ground, appeared to be generally in good condition. Some localized deterioration due to weather ingress is assumed because of gaps observed in the corrugated metal roofing.

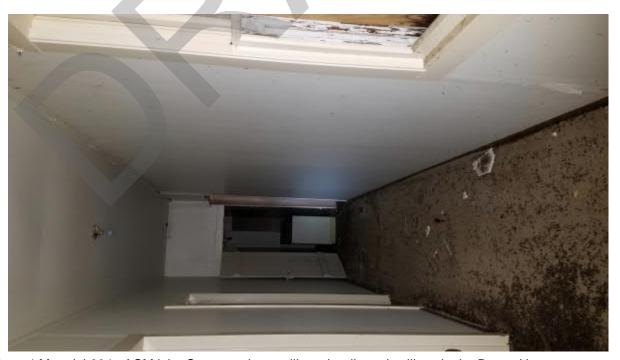
Photo 4 Material 204 - ACM joint Compound on wallboard walls and ceilings in the Beatty House

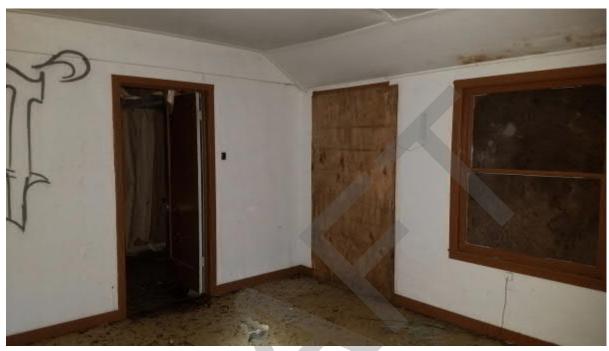
Photo 5 Material 201 ACM vinyl sheet flooring in the Beatty House
