## PRELIMINARY GEOLOGIC AND GEOTECHNICAL ASSESSMENT REPORT

# LA HONDA CREEK PARKING AREA AND TRAILHEAD FEASIBILITY STUDY

#### **CE&G DOCUMENT: 210881.001**

#### 01 MARCH 2022

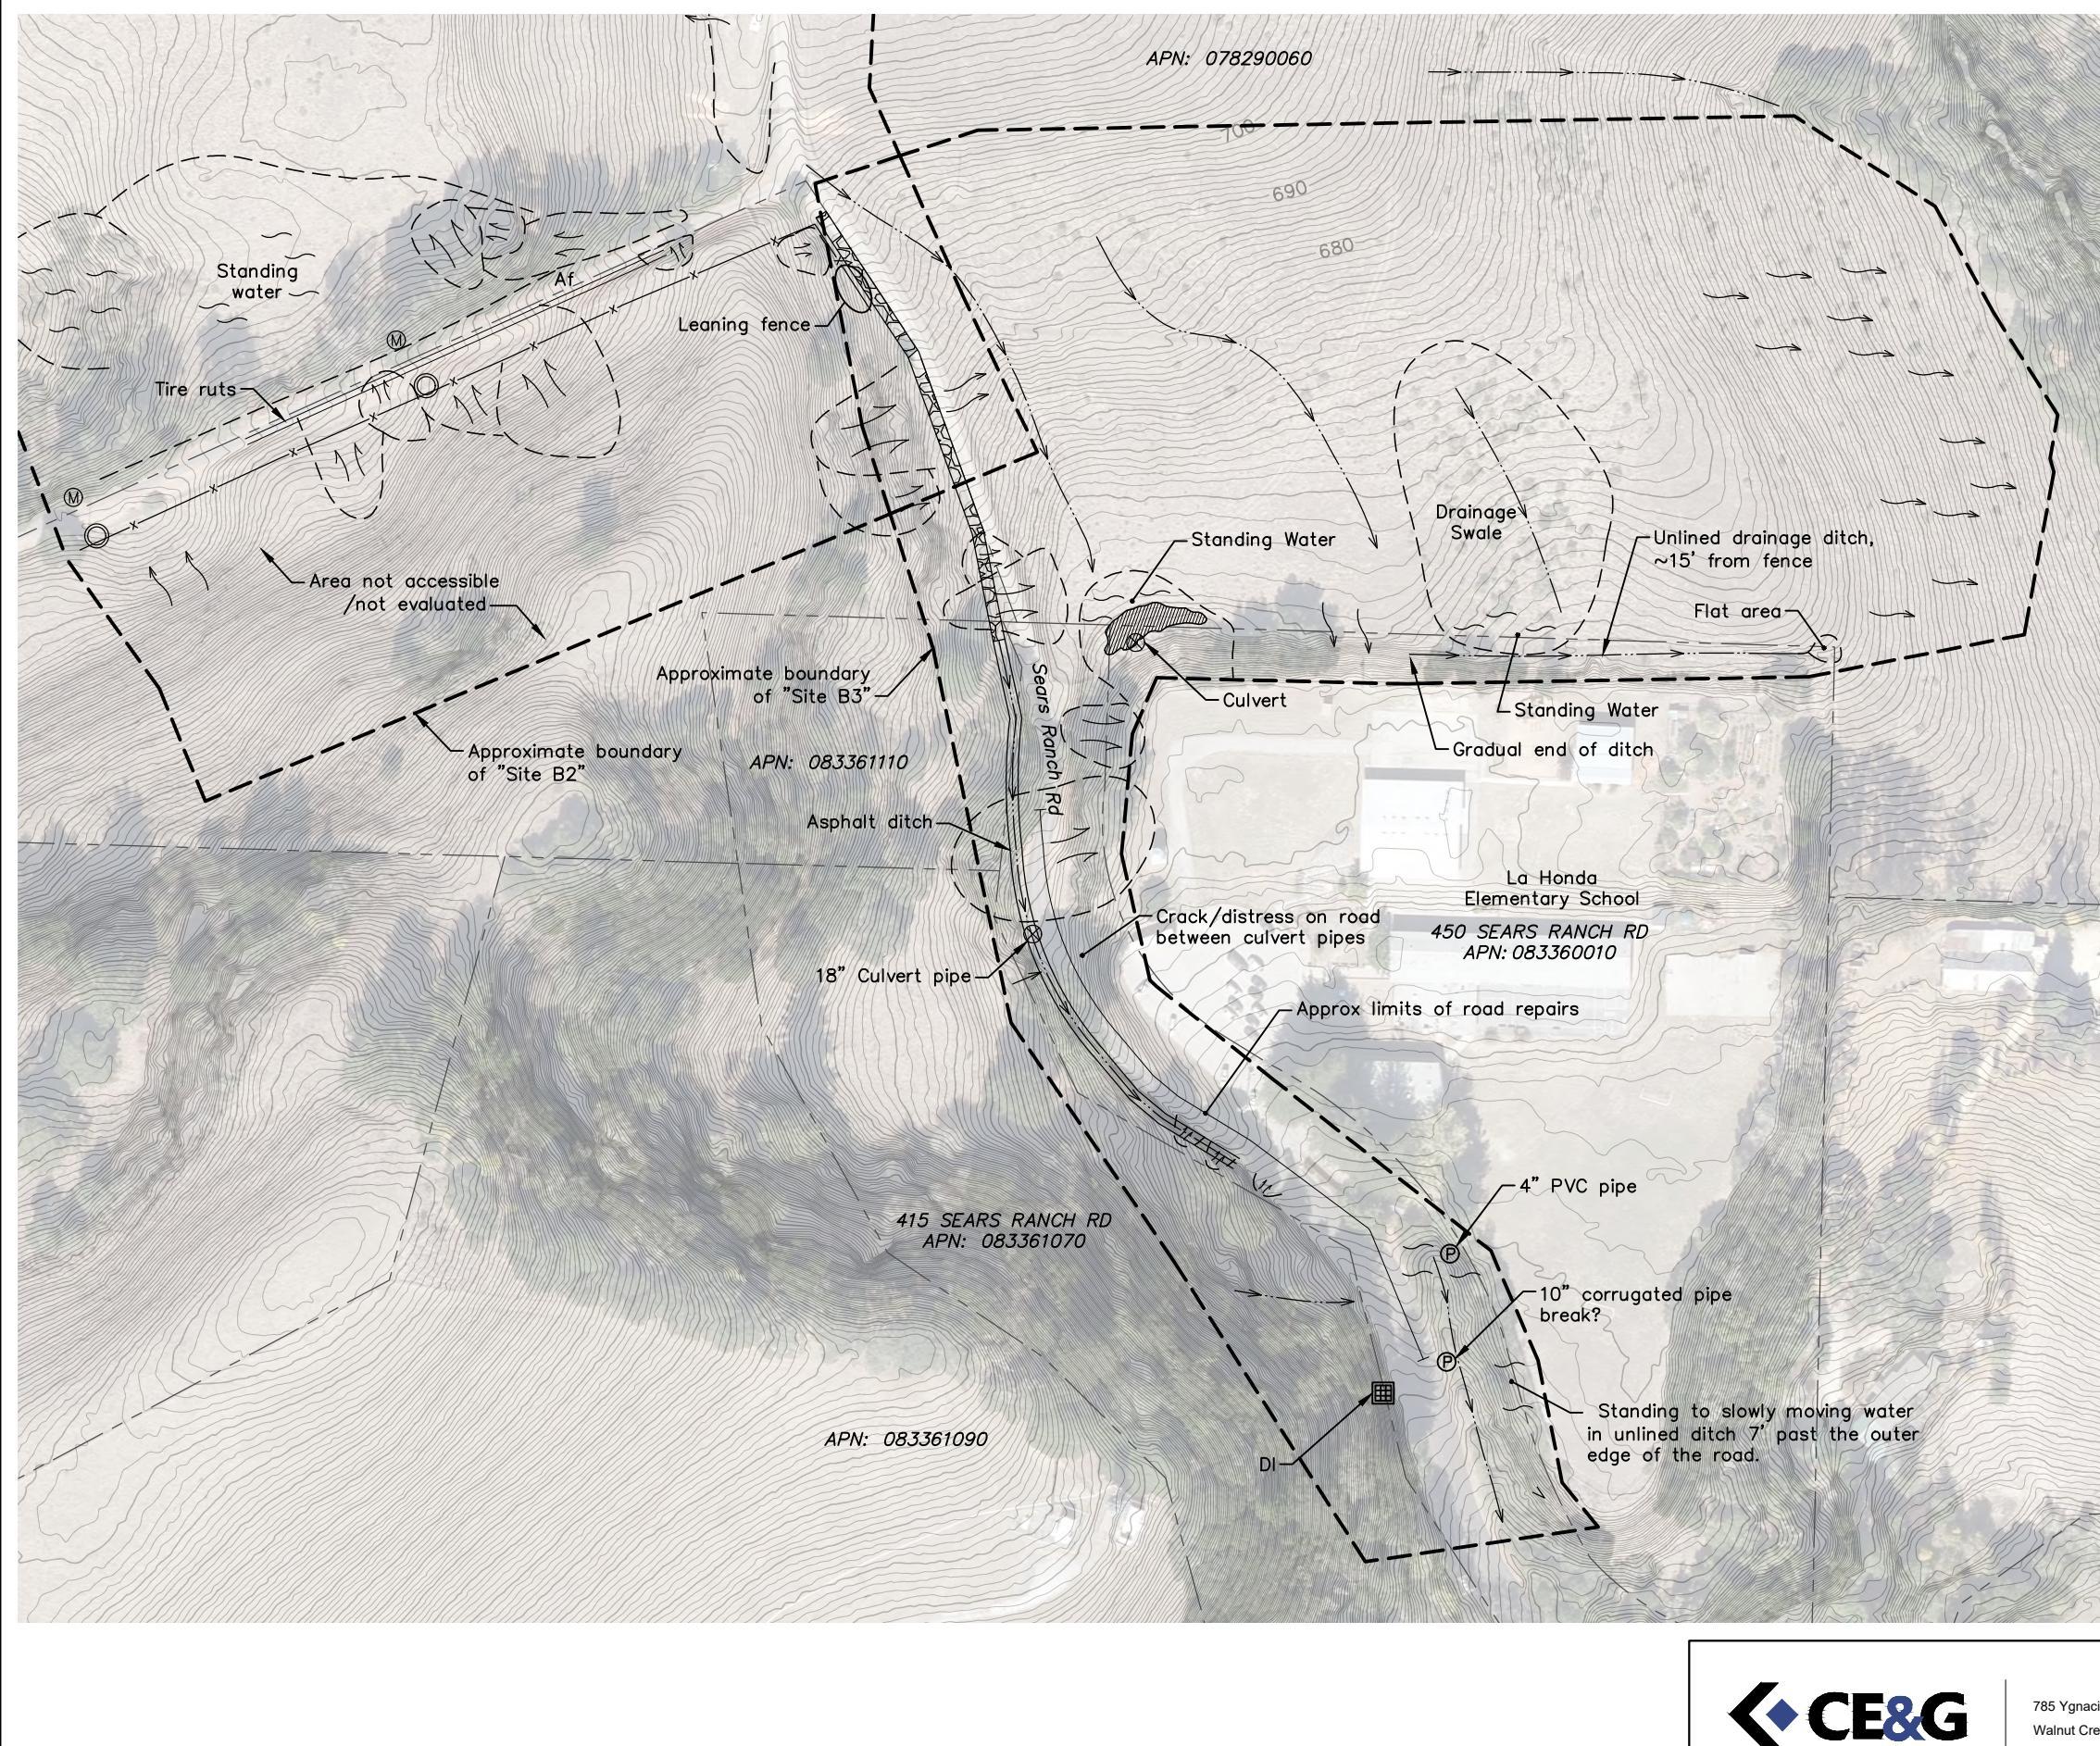
FIGURE 2A

We identified several features, including a wedge of undocumented fill, shallow slump failures, landslides, soil creep, and areas of standing water.

A wedge of undocumented fill is located across from the existing Sears Ranch Road Parking Area. Evidence of fill creep was identified along the west-facing slope along the downslope and outboard edge of Sears Ranch Road. Soil creep was also observed along the road cuts along the dirt trail north of the Sears Ranch Road Parking Area.

Documented shallow slump failures and landslides are shown on Figure 2A. Most of these features were identified in close proximity to saturated soils. Most of the landslides were identified along the private paved driveway branching from Search Ranch Road, mostly originating on the hillsides south of the driveway. The private driveway showed signs of distress in the form of deep tire ruts in the distressed pavement. Downslope of the private driveway, there are areas of standing water.
