Midpeninsula Regional  
Open Space District

R-26-78  
Meeting 26-15  
May 27, 2026

Path of Travel Delineation Design Alternatives for Rancho San Antonio Service Road and Americans with Disabilities Act (ADA) Path Improvement Project

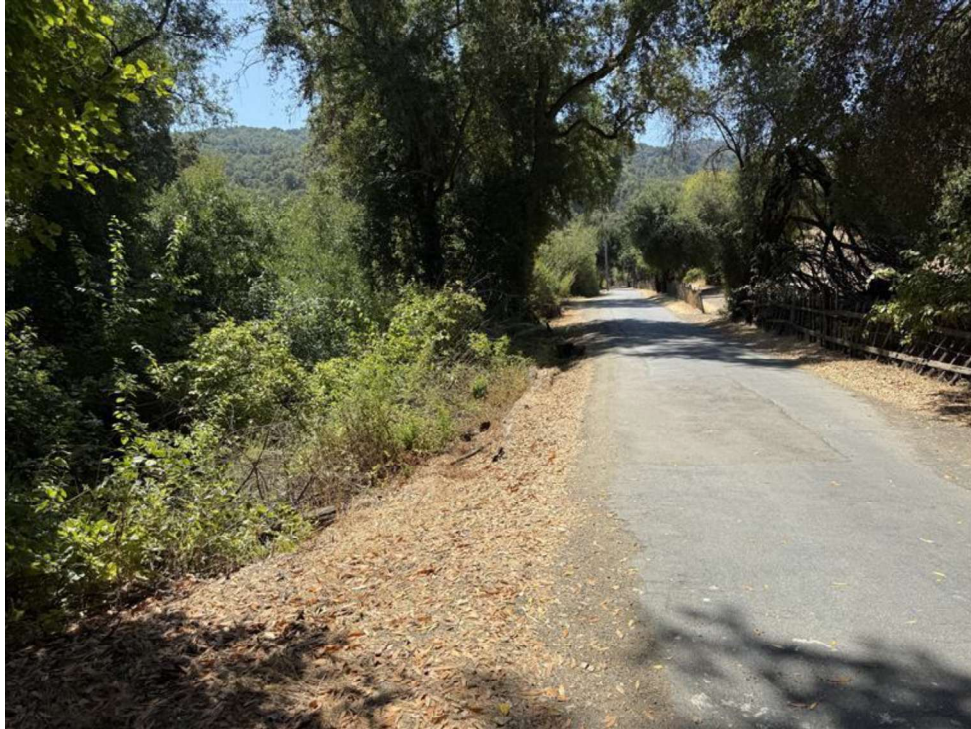
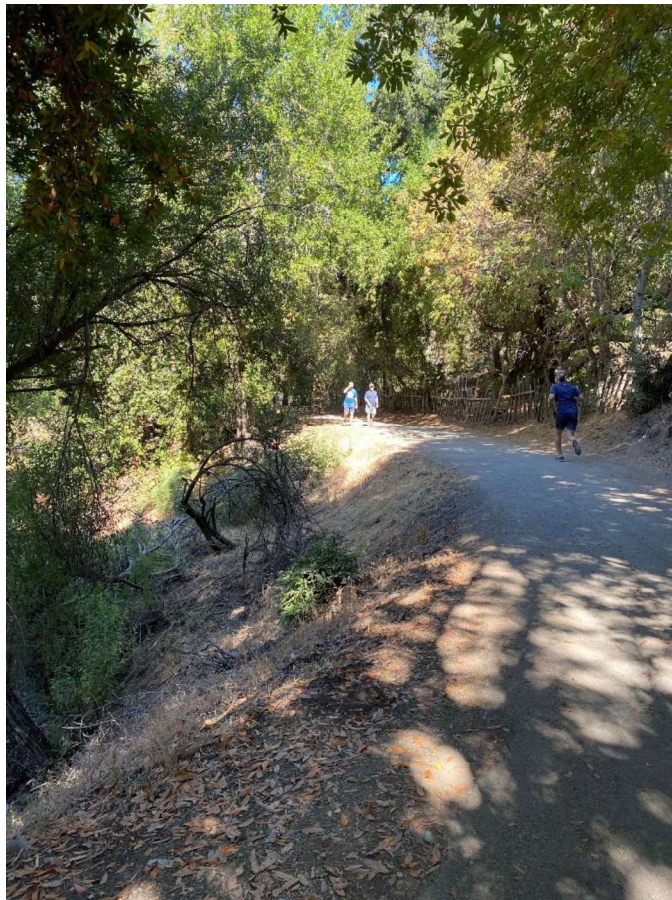
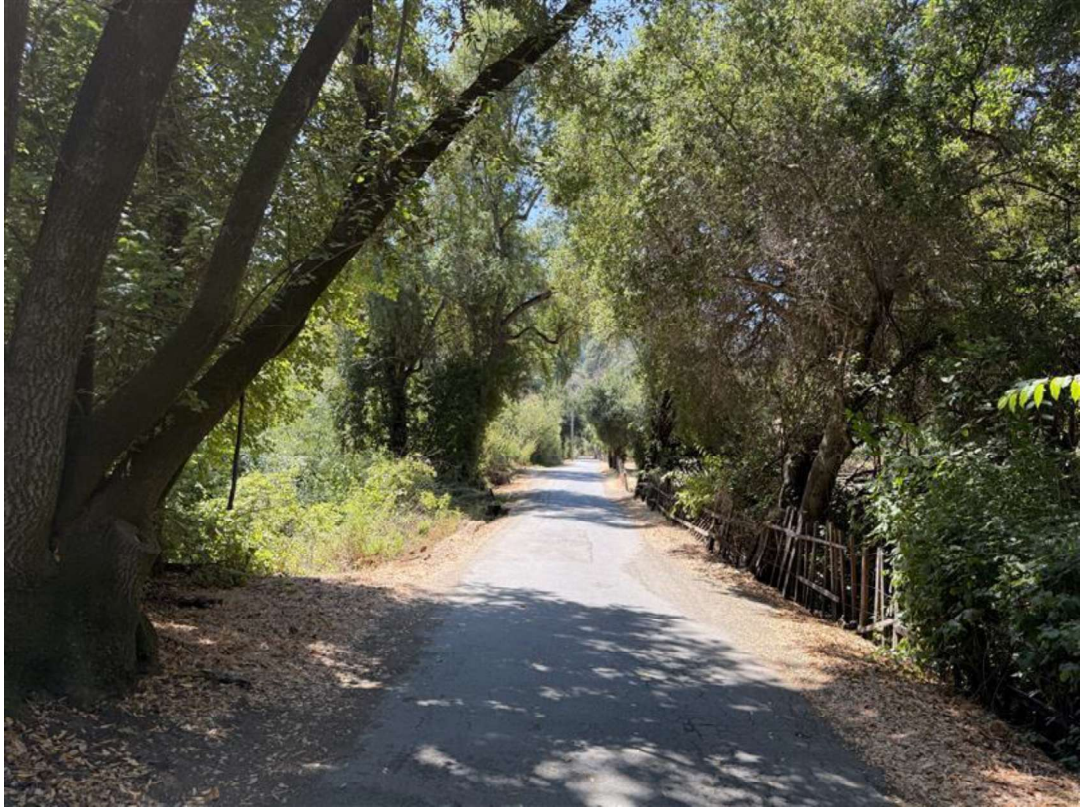
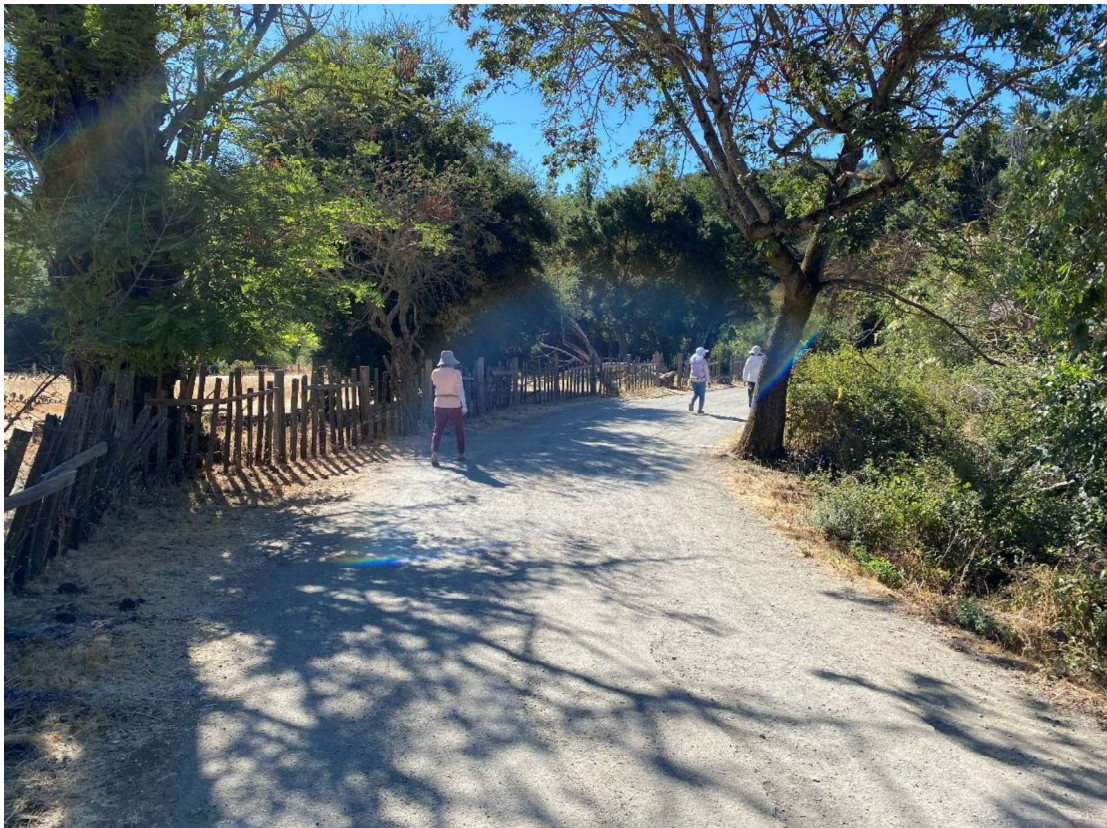
Current condition of Rancho San Antonio Service Road

The existing asphalt paving is in poor condition and in need of repair. Over the years, poor subgrade conditions have contributed to roadbed degradation and a reduction in road-width, with some sections narrowing down from the original 12 feet to 10 feet wide.

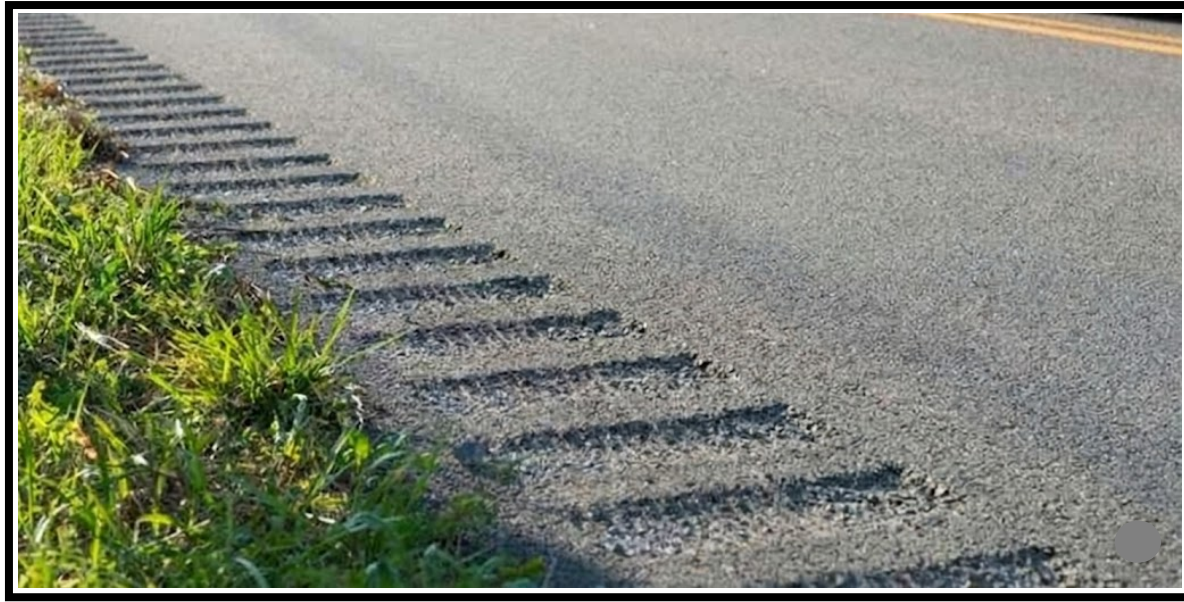
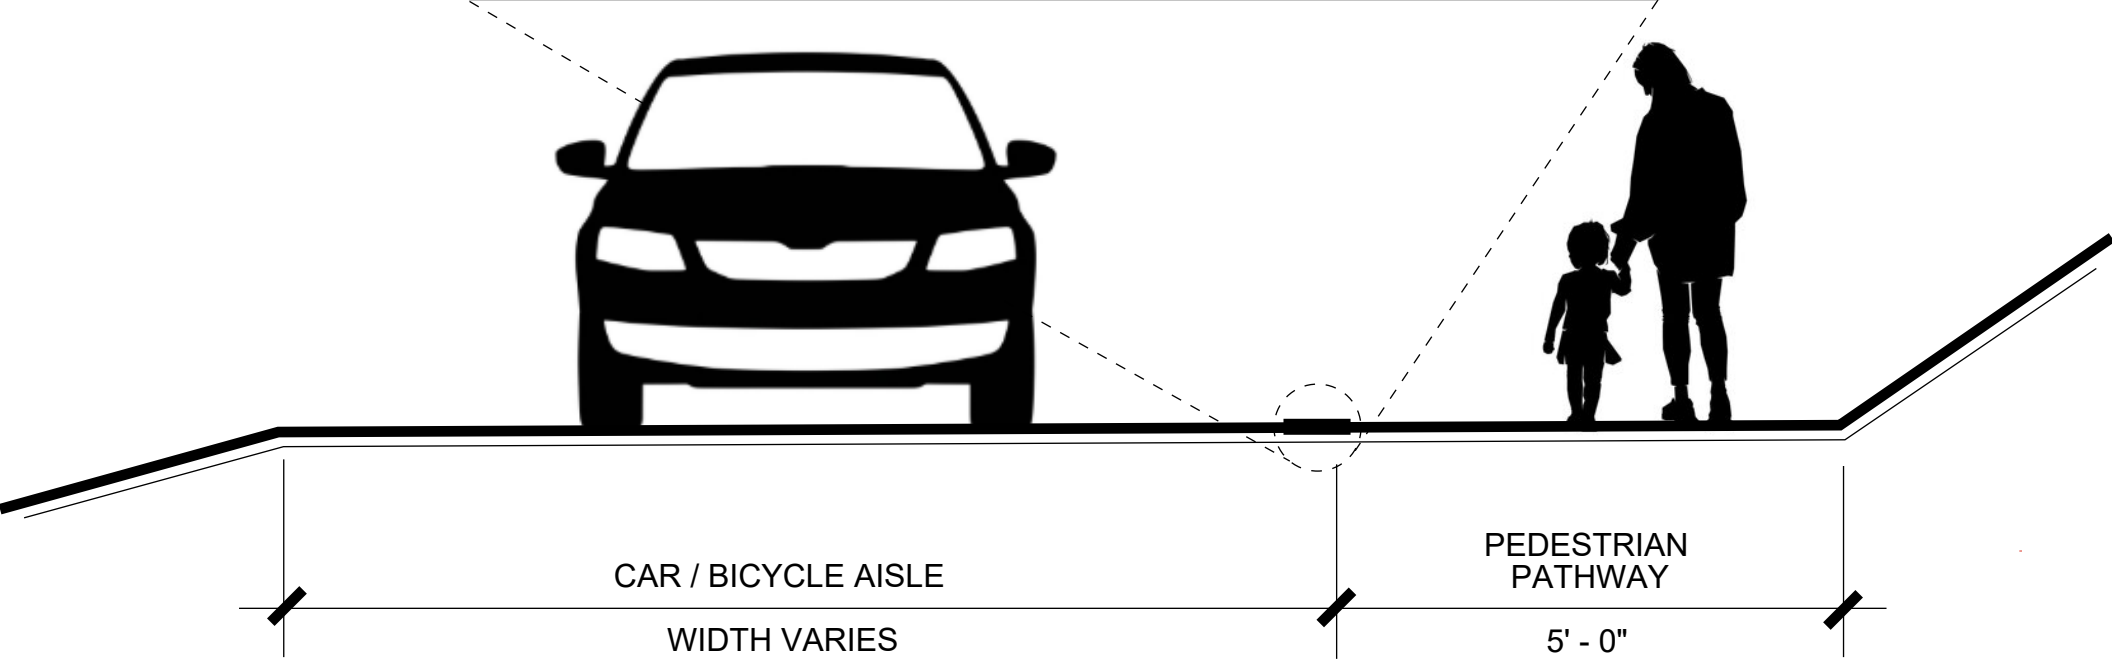
PHYSICAL DELINEATION (RUMBLE STRIP) ONLY

Option 1 proposes a continuous rumble strip to physically delineate the separation between the vehicular and pedestrian space to run along the entire length of the shared-use service road (0.6-miles). The rumble strip would be milled in-ground to serve as a textural indicator for users that they are crossing from one zone into the other. The final width of the rumble strips has not yet been determined, but would likely be between 4 inches and 8 inches wide. Raised barriers, such as curbs, were considered, but were deemed infeasible due to the potential tripping hazard. Milled rumble strips do not typically require regular maintenance, but they would need to be re-milled every time the pavement is replaced. Refer to Attachment 2, Option 1 for an example of the rumble strip.

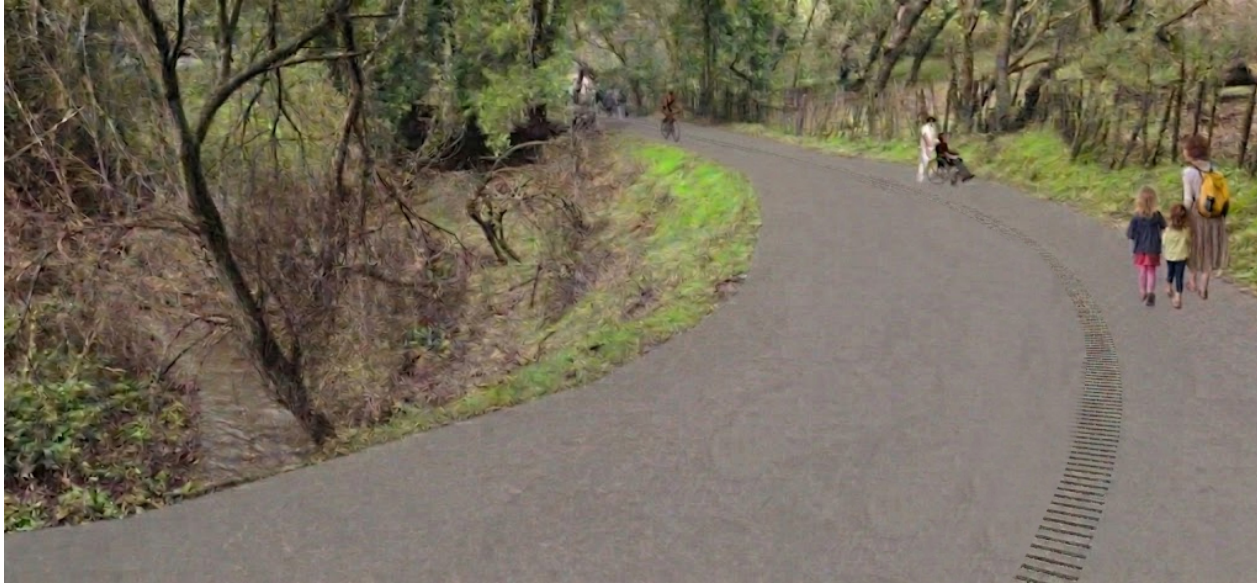
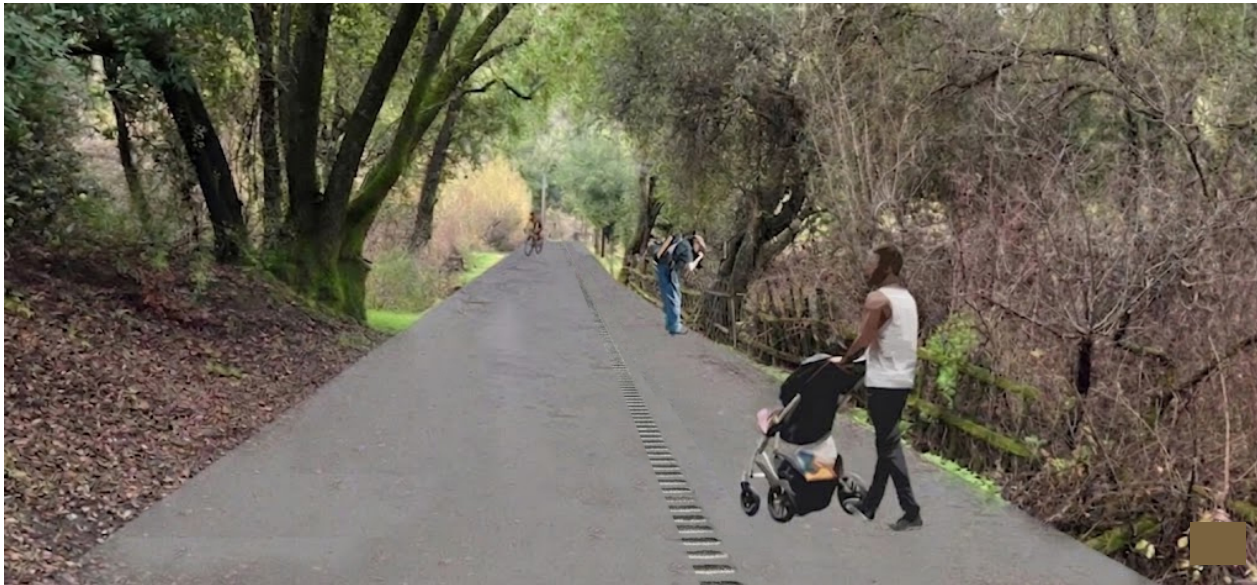
1

PHYSICAL DELINEATION (RUMBLE STRIP) ONLY

PERSPECTIVE RENDERINGS - ILLUSTRATIVE PURPOSES ONLY

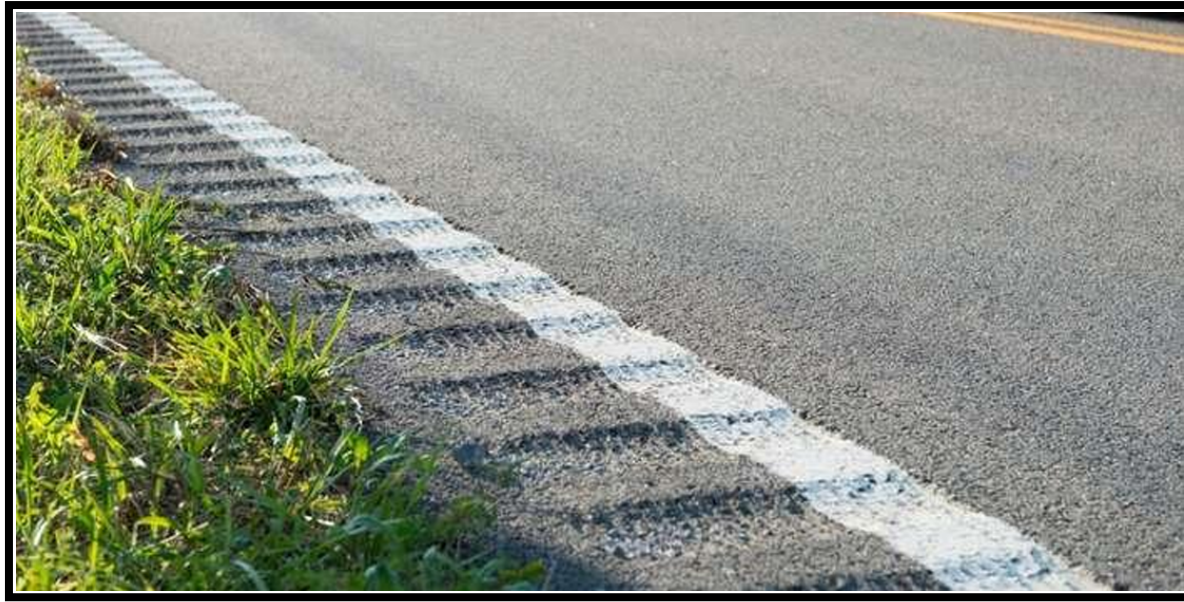
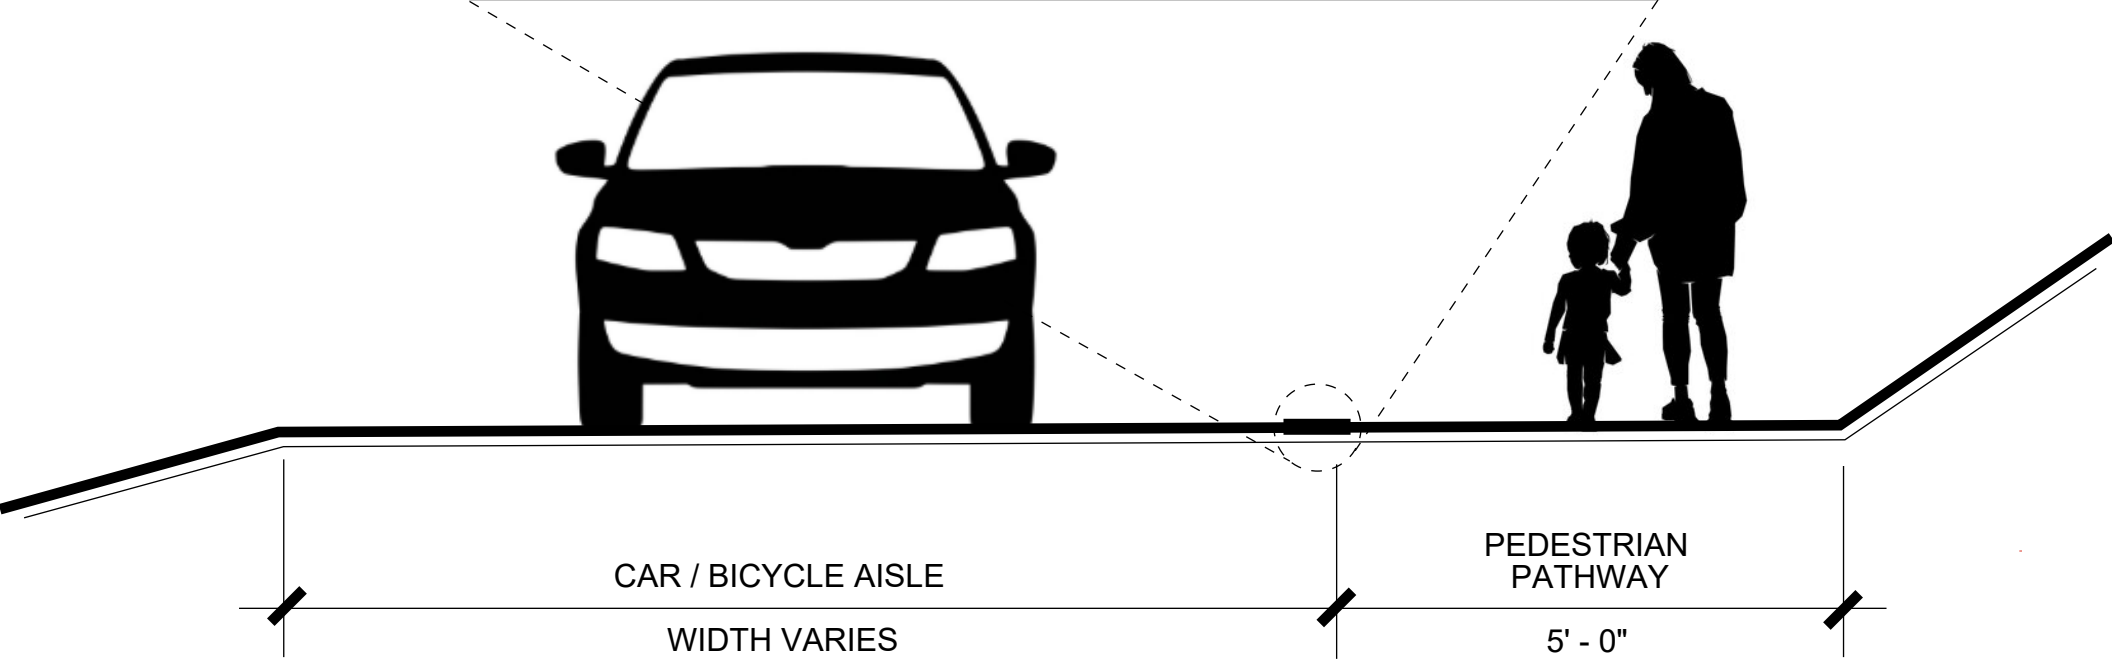
PHYSICAL DELINEATION (RUMBLE STRIP) WITH VISUAL DELINEATION (PAINTED WHITE STRIPE)

Option 2 proposes the same continuous rumble strip as Option 1 with a continuous, white stripe to establish the delineation of space. The painted white stripe would be a visual cue for all users, including the visually impaired. It would be a continuous 4-inch-wide thermoplastic or painted white line, applied to the asphalt pavement. This is a suggested option in the Governing Board guidance documentation and noted by accessibility interest groups. This option would have a greater maintenance demand than Option 1 due to the white stripe, which may require routine touch-ups at approximately \$1000 per year. Full restriping would be required at an approximate replacement cost of \$15,000 if the road is re-paved. Refer to Attachment 2, Option 2 for an example of the rumble strip with the painted white line.

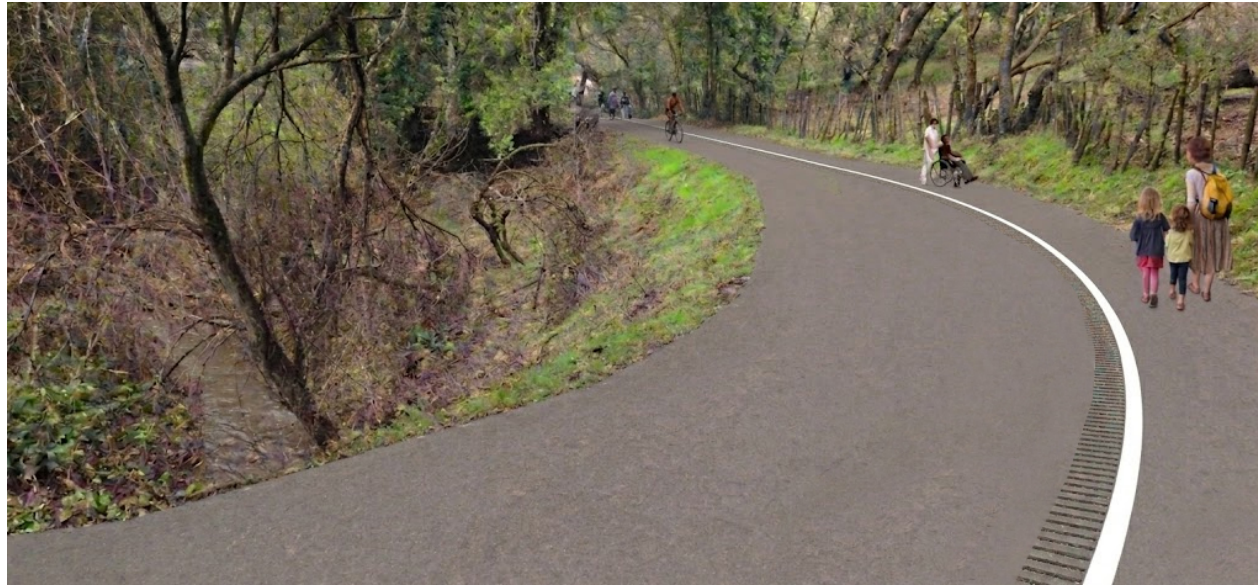
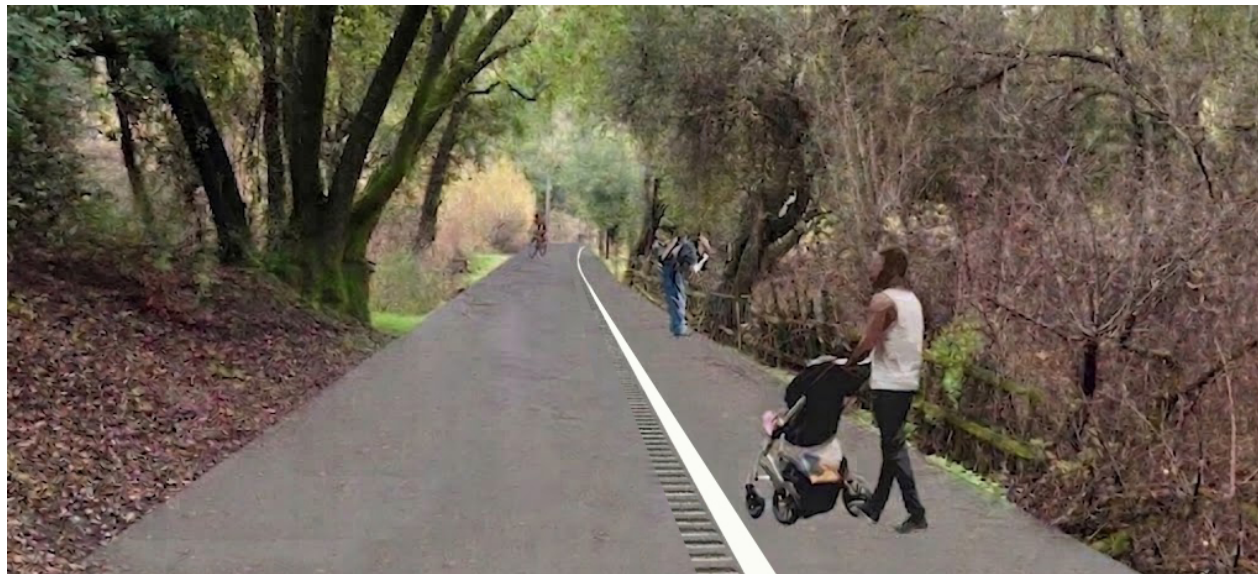
2

PHYSICAL DELINEATION (RUMBLE STRIP) WITH VISUAL DELINEATION (PAINTED WHITE STRIPE)

PERSPECTIVE RENDERINGS - ILLUSTRATIVE PURPOSES ONLY

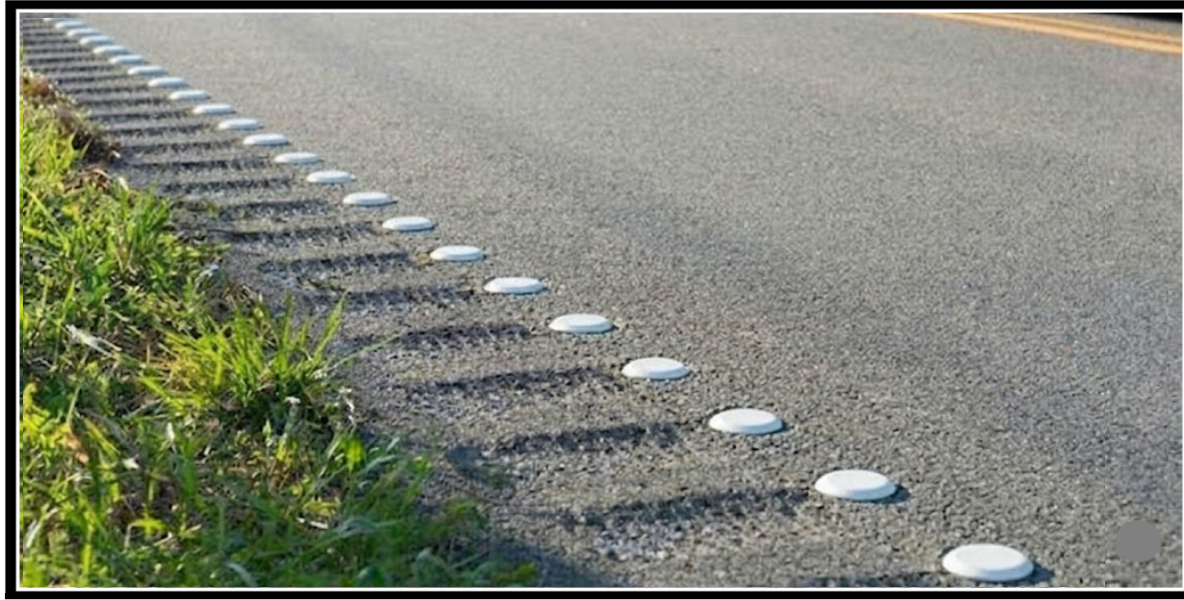
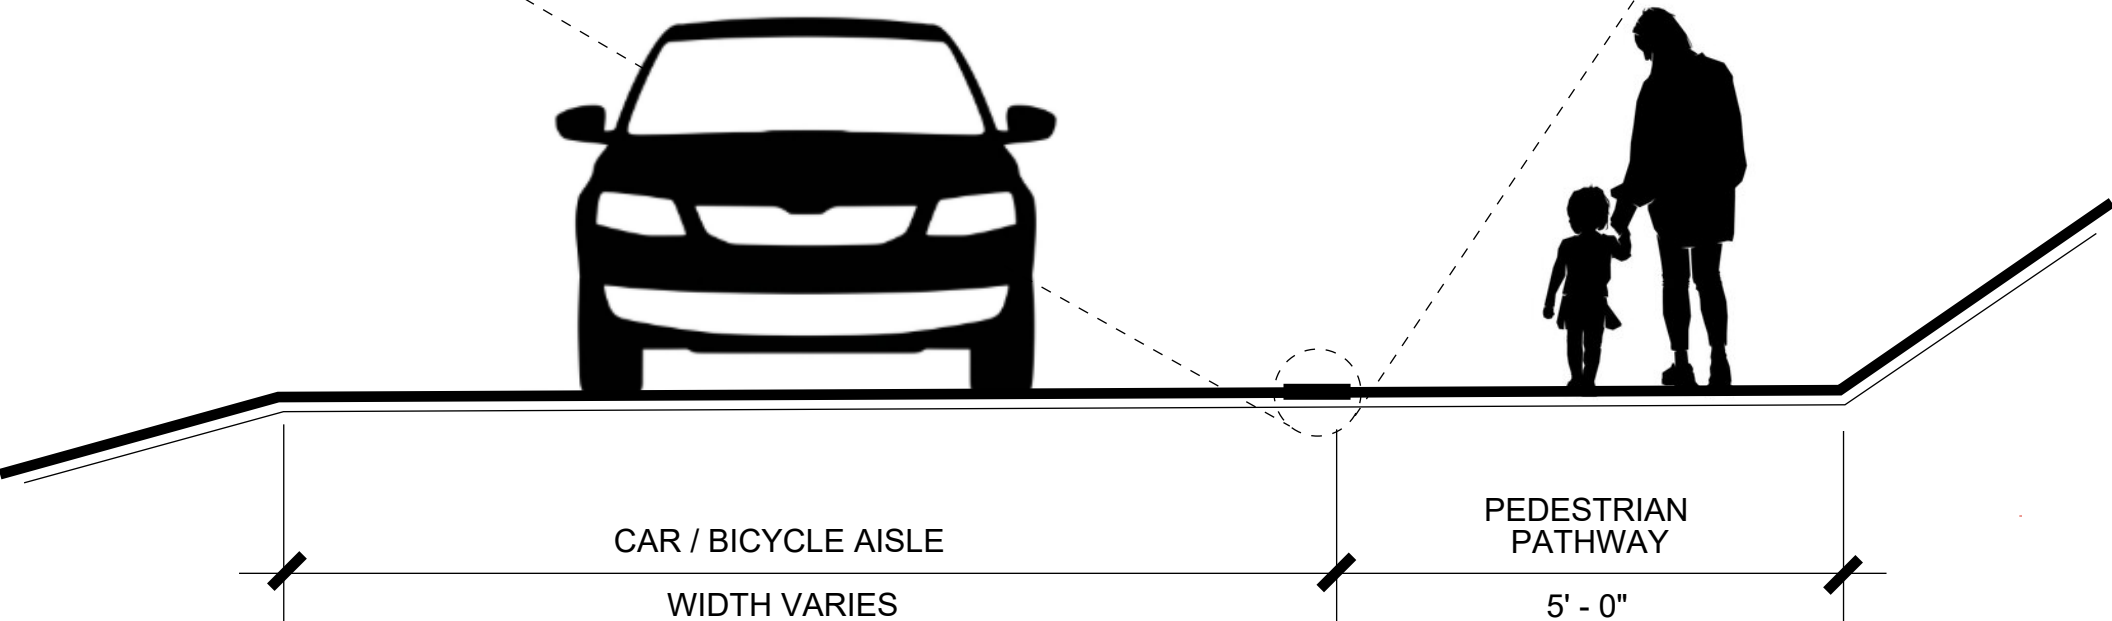
PHYSICAL DELINEATION (RUMBLE STRIP) WITH ALTERNATIVE VISUAL DELINEATION (ROADWAY DOTS)

Option 3 pairs the continuous rumble strip discussed in Option 1 with roadway dots. The dots would be white, non-reflective plastic, and placed at an interval of 12-inches to 24-inches apart. This option may require higher maintenance than Options 1 and 2, with an approximate cost of \$2,000 per year to replace dots that are damaged or dislodged. With consistent annual maintenance, the dot system would only need to be replaced if the road is re-paved at an approximate replacement cost of \$15,000. This option reduces the potential aesthetic concerns that Option 2 might introduce since the evenly spaced white dots are less striking as compared to a continuous white line. Refer to Attachment 2, Option 3 for an example of the rumble strip with roadway dots.

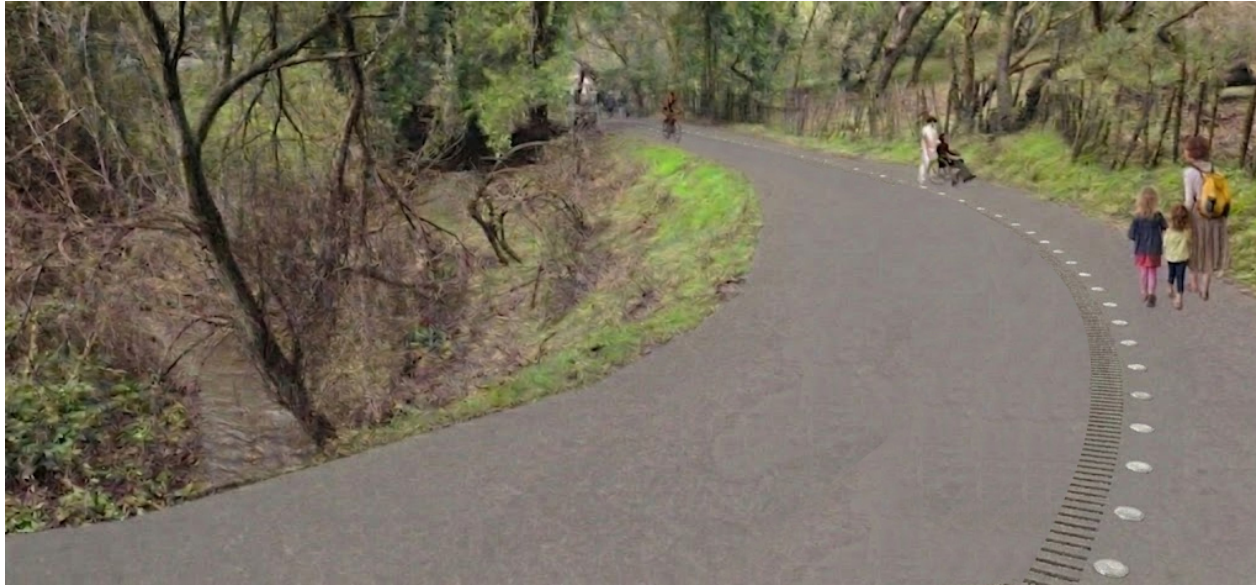
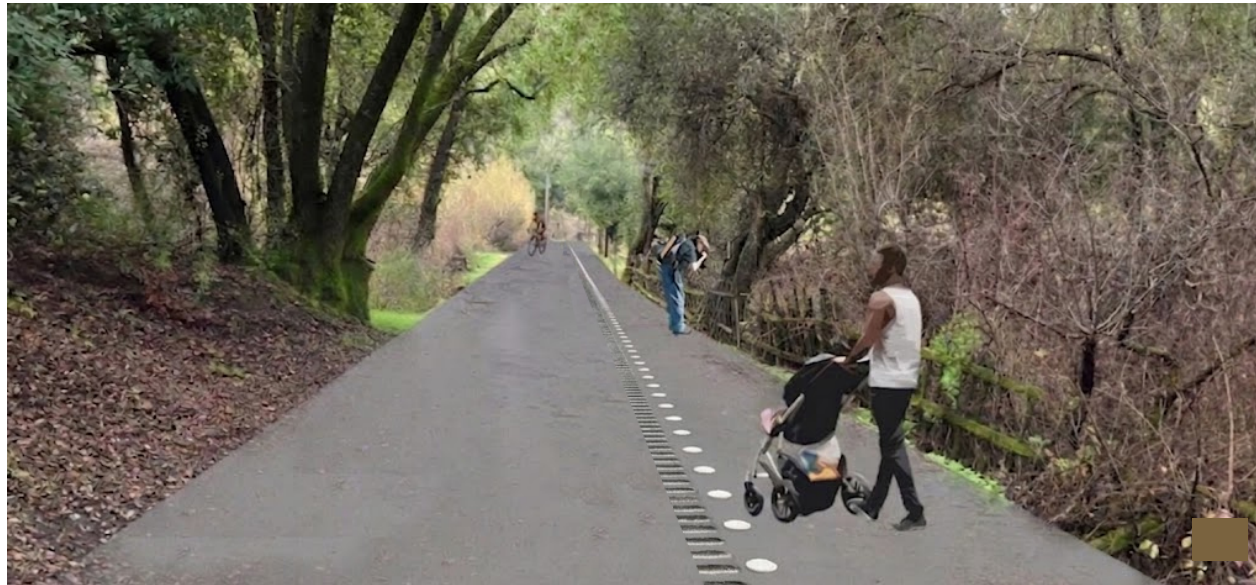
3

PHYSICAL DELINEATION (RUMBLE STRIP) WITH  
ALTERNATIVE VISUAL DELINEATION (ROADWAY DOTS)

PERSPECTIVE RENDERINGS - ILLUSTRATIVE PURPOSES ONLY
