**Request for Proposals (RFP) for Meyer Property Improvements
for the
Sierra Azul Open Space Preserve**

Midpeninsula Regional Open Space District
330 Distel Circle, Los Altos, CA
Issued: Friday, January 20, 2017

HISTORICAL RESOURCE EVALUATION OF THE MEYER PROPERTY

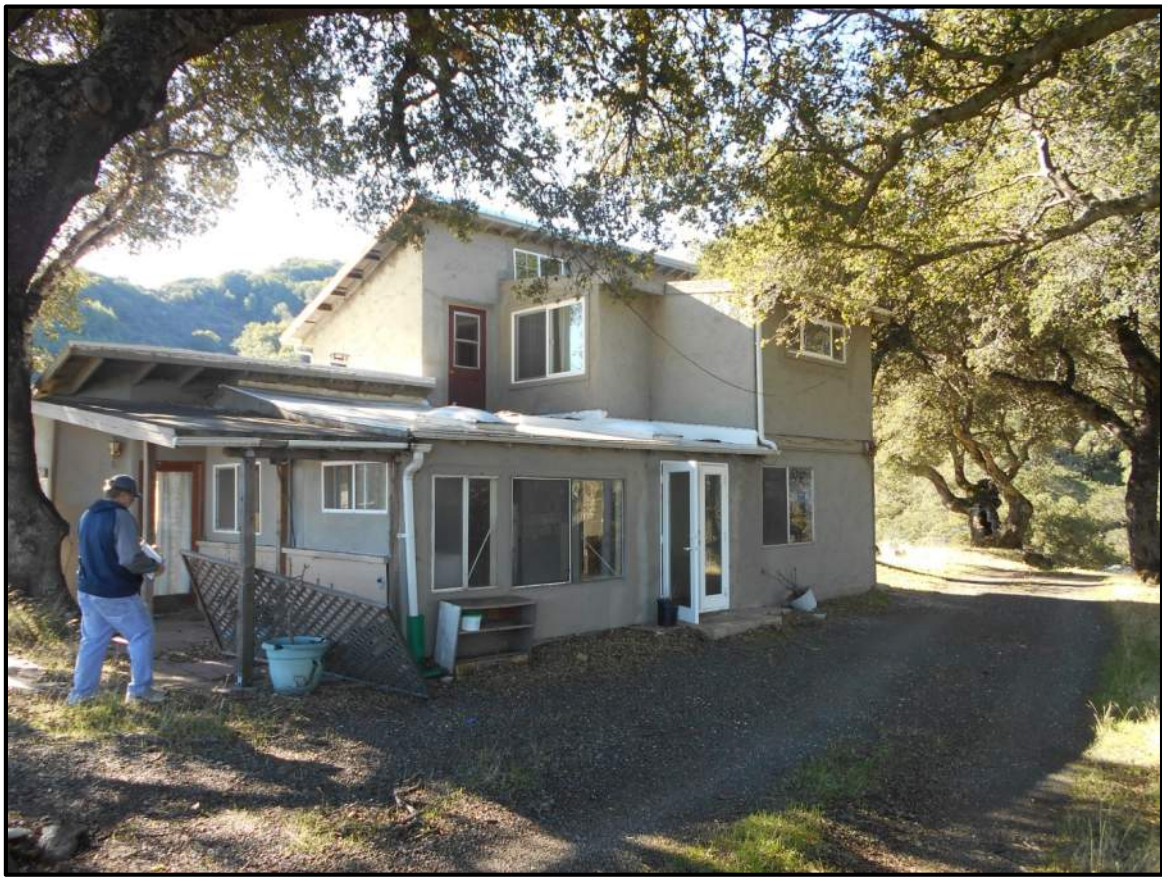
Photo 1 - One and Two Story Residence

This one and partial two-story residence has been remodeled on numerous occasions; see Appendix A, Photo 1. Please note that in most locations, because of interior and exterior finishes, the structural framing was not available for inspections. It is our opinion that the original building was constructed as a one story rectangular structure located at the approximate center of the building as it now stands.

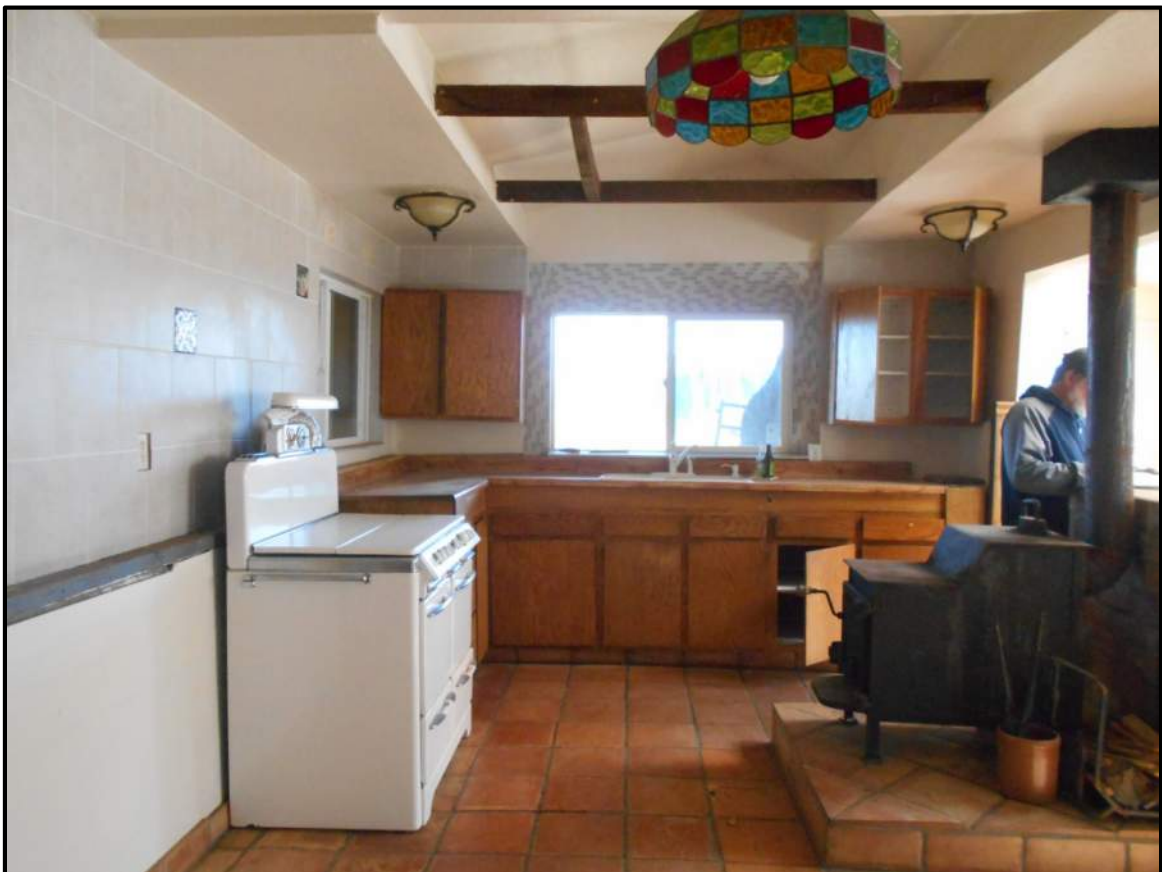
Photo 2 - Kitchen

At the present time, this original area has a small kitchen at its east end and a small living room at the west end; see Photo 2. The kitchen includes wood cabinets, a sink, a gas range and a wood burning fire box. A rough framed entrance porch which houses the hot water heater, washer and dryer along with a small bedroom was added on the north side of the original building; see Photo 3. On the south side of the original building a full bathroom with toilet, sink and shower was added next to the living room along with the addition of a small family room which is located next to the kitchen; see Photos 4 & 5. An exterior door which allows access to a patio which is located on the east side of the kitchen and the entrance porch is located in a portion of this family room that extends beyond the kitchen. A wood framed roof covers this exterior patio; see Photo 6.

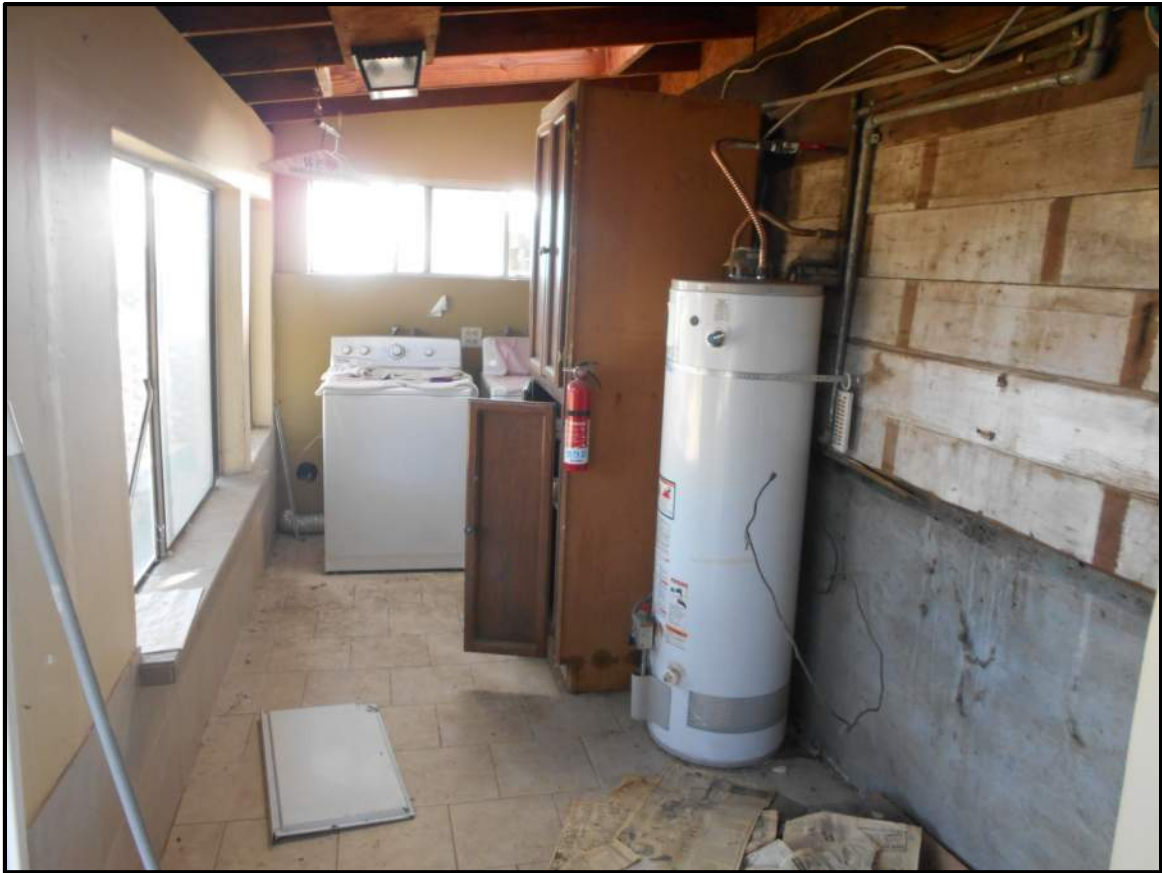
Photo 3 - Entrance Porch

- The ship's ladder is not an acceptable means as a fire exit from a second floor; see Photo 18.
- Exposed electrical wiring was observed in many locations; see Photos 3, 19, & 20.
- The grading of the patio area was poor. Water would collect at the door from the family room; see Photo 21.
- The flashing of the roof, gutters and windows, in some locations, are in poor condition; see Photo 22.

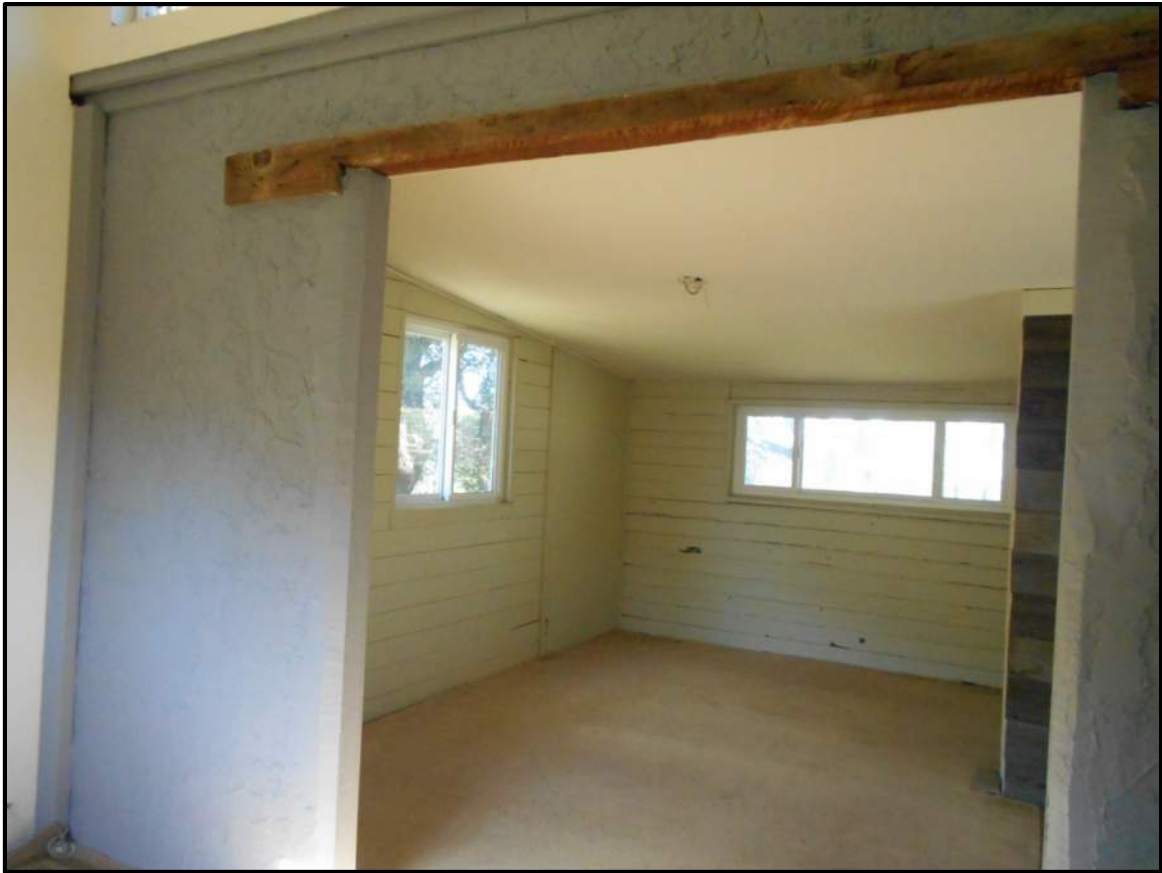
Photo 7 - Bedroom

The second floor, which has an unconventional floor plan, includes a number of small rooms and spaces, some of which are accessible only through other rooms; see Photos 7 & 8. This dressing room area has an exterior door which leads to a flat landing over the sloping first floor roof, see Photo 9. Access to the second floor is by a wood framed "ship's ladder" which is located between the kitchen and the living room on the first floor; see Photo 10.

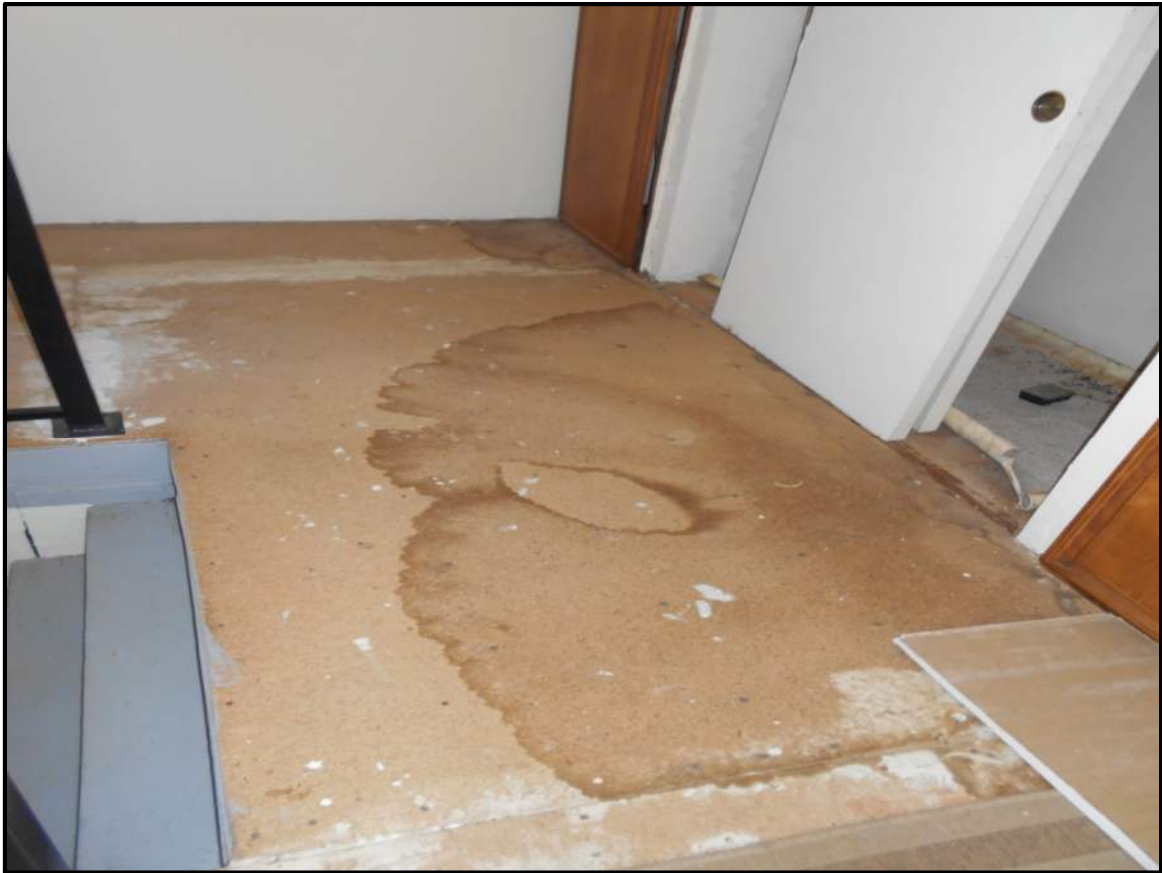
Photo 11 - Water Damage at 2nd Floor

Roof: Throughout the second floor signs of water damage were observed to the walls and floors finishes. It is difficult to determine what the causes of the existing water damage are; it could be the condition of the roofing or the details of the windows in the exterior plastered walls; see Photo 11. Some of the cantilevered 2x roof rafter outriggers have been replaced, which could mean that the roofing material was in poor condition, thus causing dry rot.

If the District wants to evaluate the possibility to rehabilitate and retrofit this structure, we recommend that portions of the existing interior wall and ceiling finishes be removed to expose the structural framing so that a thorough assessment can be performed by a licensed Structural Engineer. To be a meaningful assessment it should also include architectural, roofing, mechanical, electrical, plumbing and other items. After the assessment is complete and all deficiencies are noted, a conceptual design can be prepared to fix the deficiencies. At that time a construction cost estimator can be retained to prepare an estimate of probable construction costs. This estimated construction cost can be used by the District to determine if upgrading the

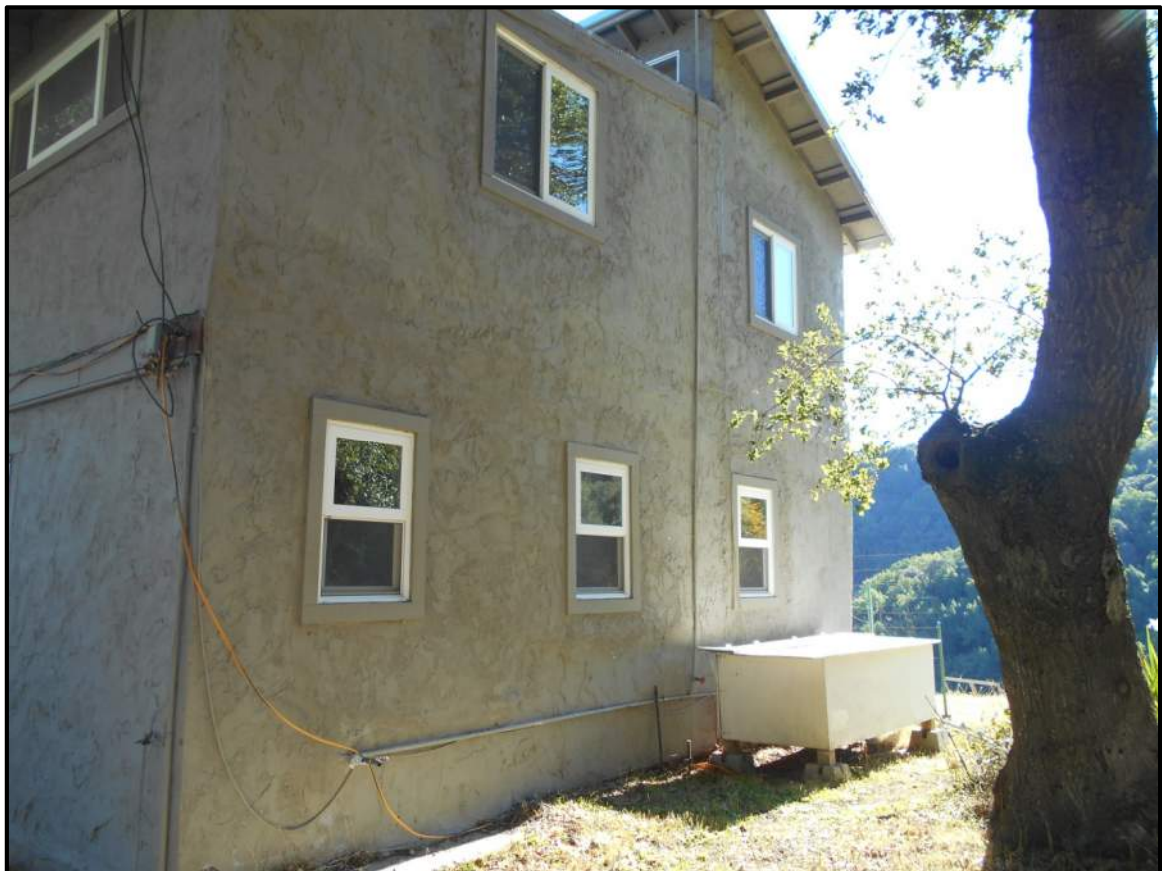
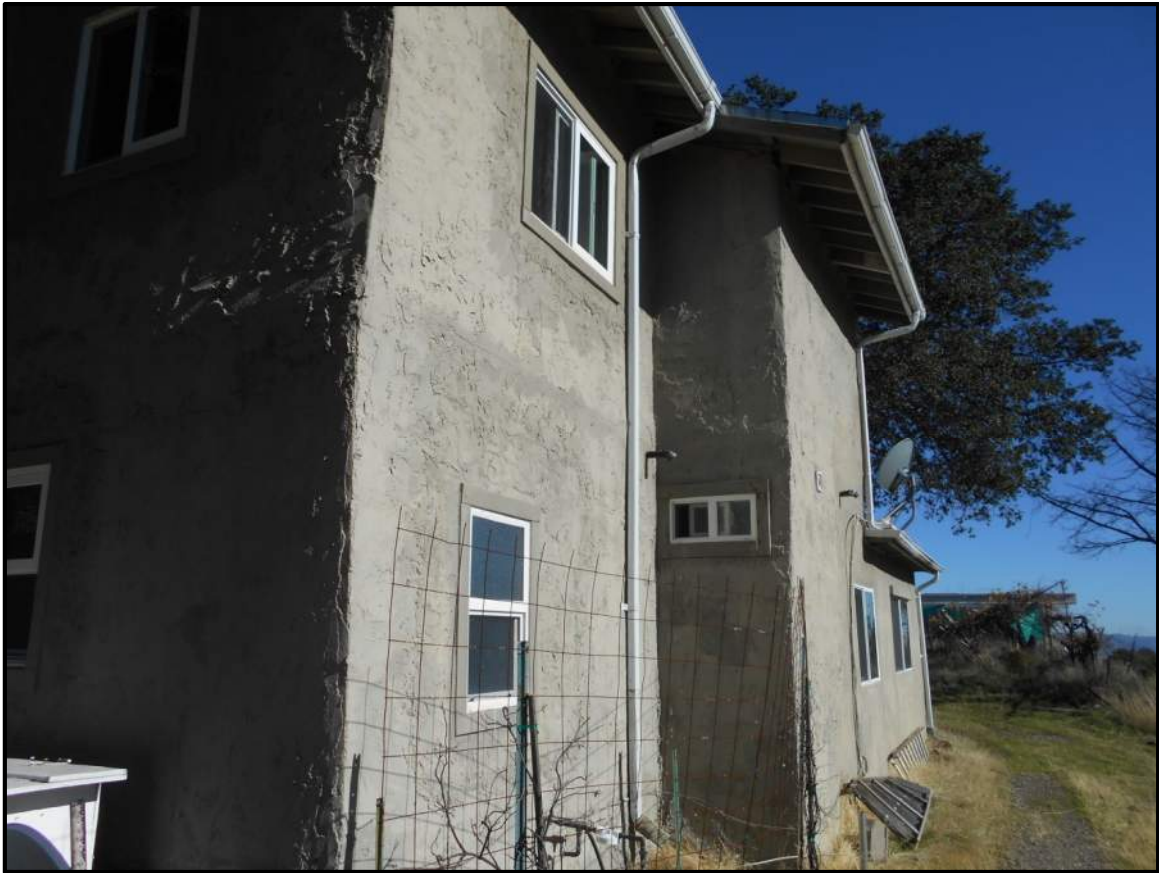
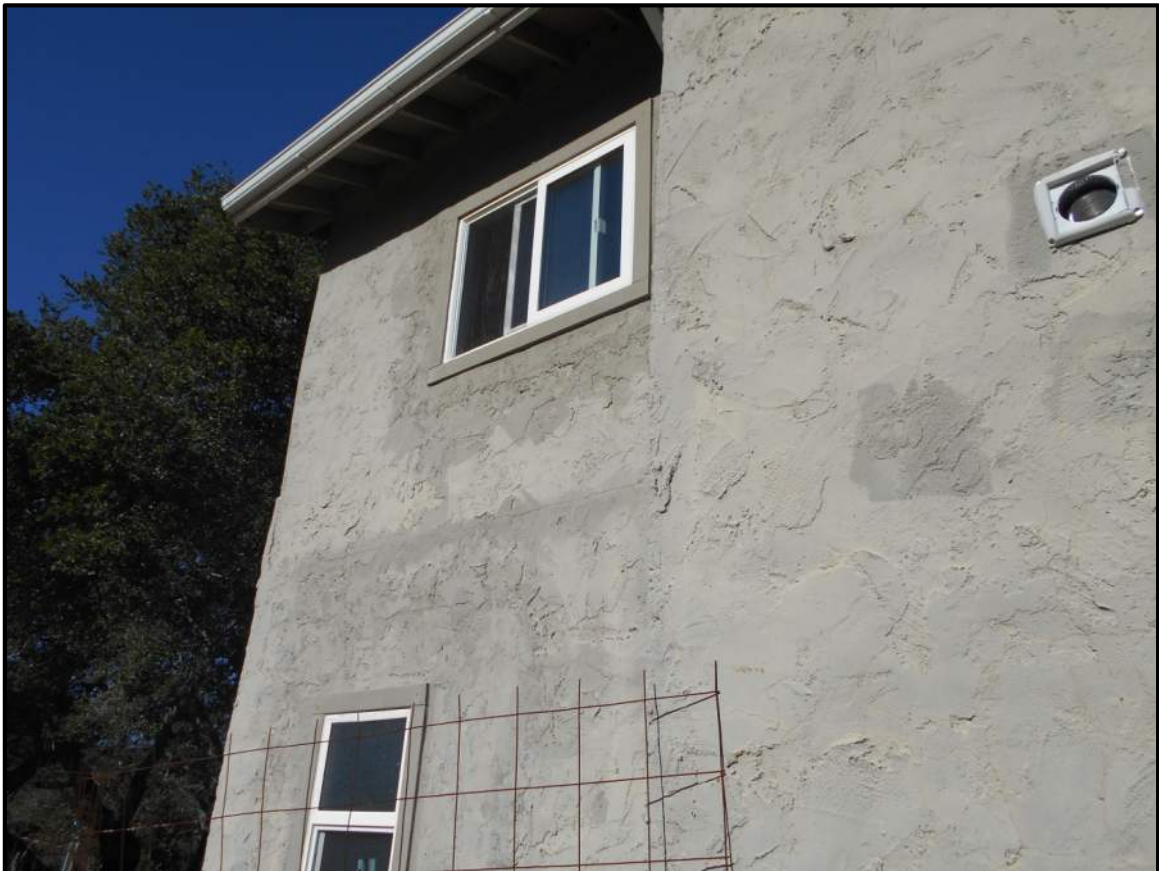
Walls: The exterior walls on the south and west elevations of the two story portion of the building are not plumb; see Photos 12, 13, &14. There is outward displacement of the plastered finish at the location of the second floor level. The displacement was also observed at the intersection of the first floor walls and the concrete foundation. In some location the finish of the exterior cement plaster is in very poor condition; it is our opinion that the exterior plastered walls were not installed by a professional. Random hairline cracks were observed in the exterior concrete plaster walls. These cracks were probably caused by the quality of the plastering and that there are no expansion and contraction joints. Water damage was observed on some of the interior finishes of the exterior walls. The finishes of the interior walls did not show signs of distress or damage.

Photo 12 - West Exterior, Non-Plumb Wall

Photo 13 - South Exterior, Non-Plumb Wall

Photo 14 - South Exterior, Non-Plumb Wall

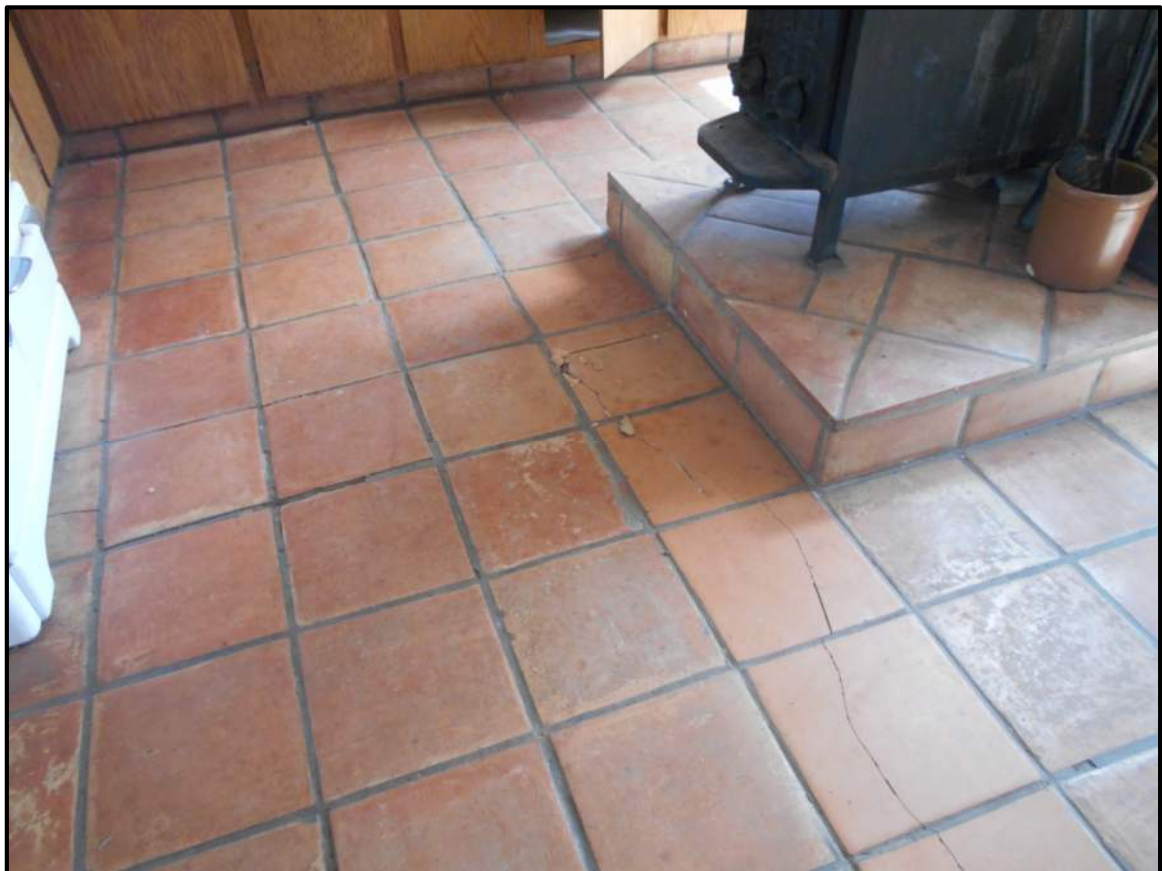
The tile floor in the kitchen area of the original portion of the building is cracked in many locations and is very uneven; see Photos 16 & 17. These cracks in the tile probably occurred because the concrete slab supporting the tile is unreinforced. The ground floor finishes in the two additions did not show signs of distress or damage.

Photo 16 - Cracks in Kitchen Floor

Photo 17 - Uneven Kitchen Floor

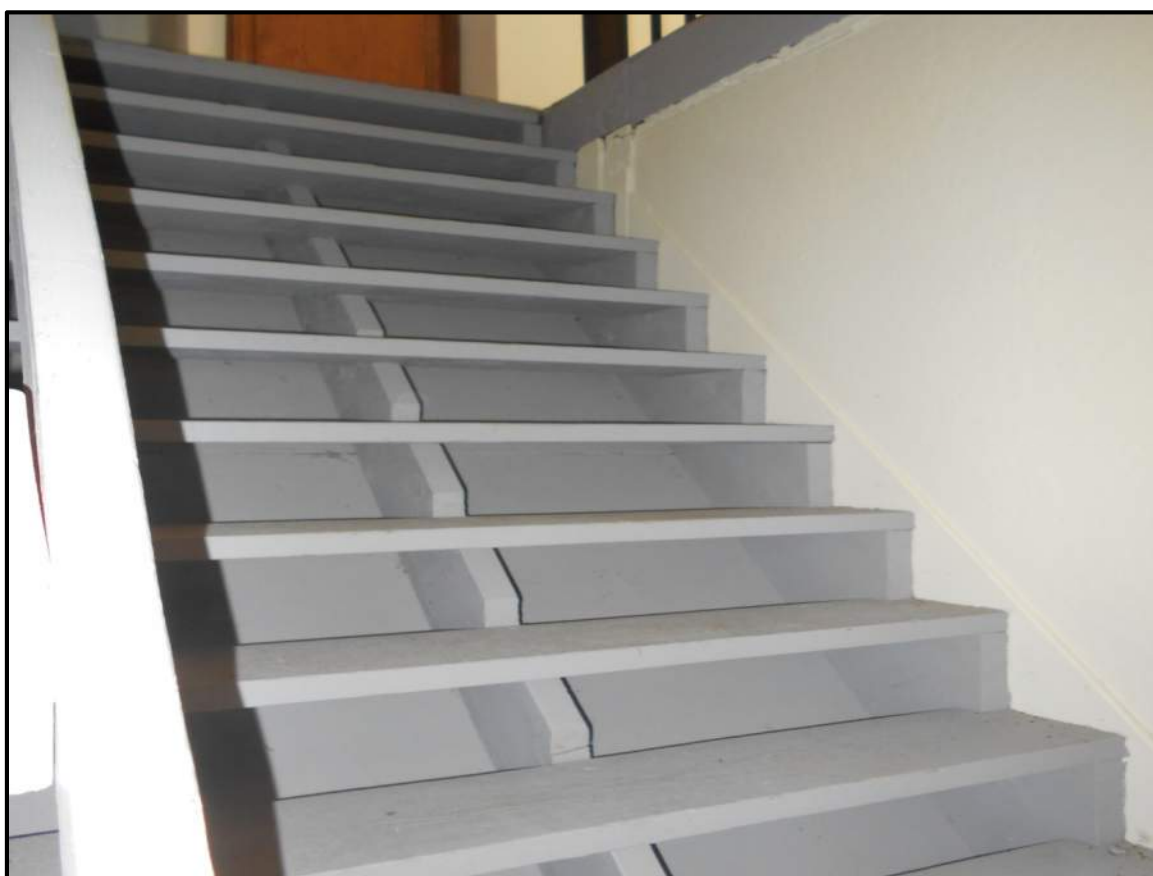
Photo 18 - Ship's Ladder, Not Acceptable Fire Exit

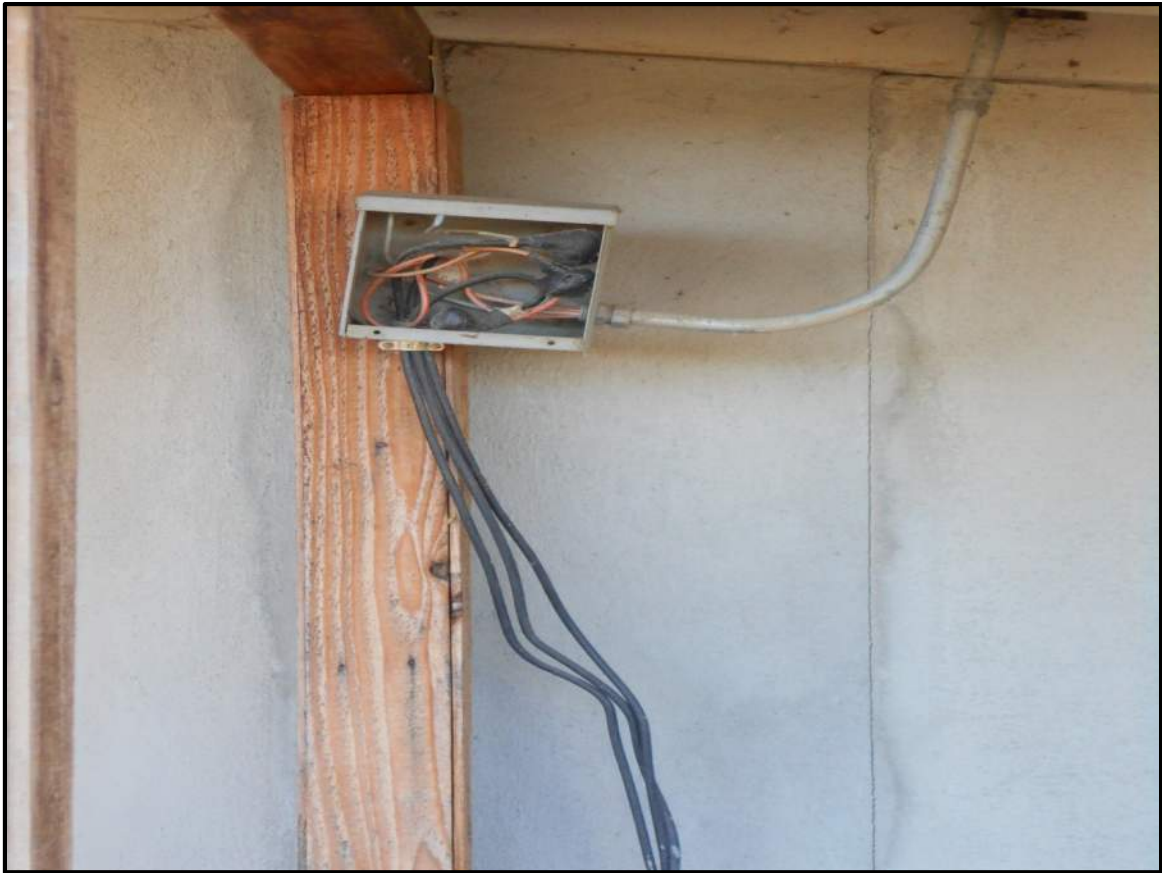
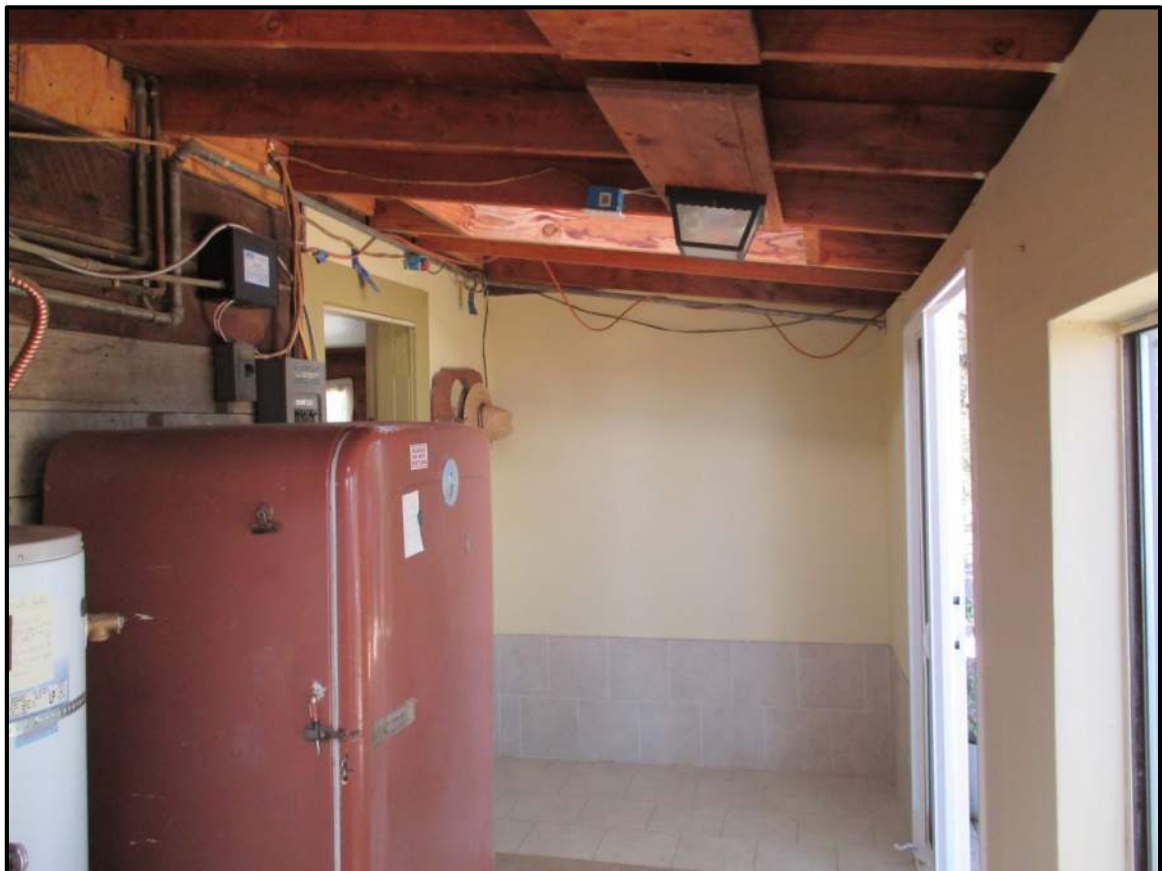
Photo 19 - Exposed Electrical Wiring

Photo 20 - Exposed Electrical Wiring

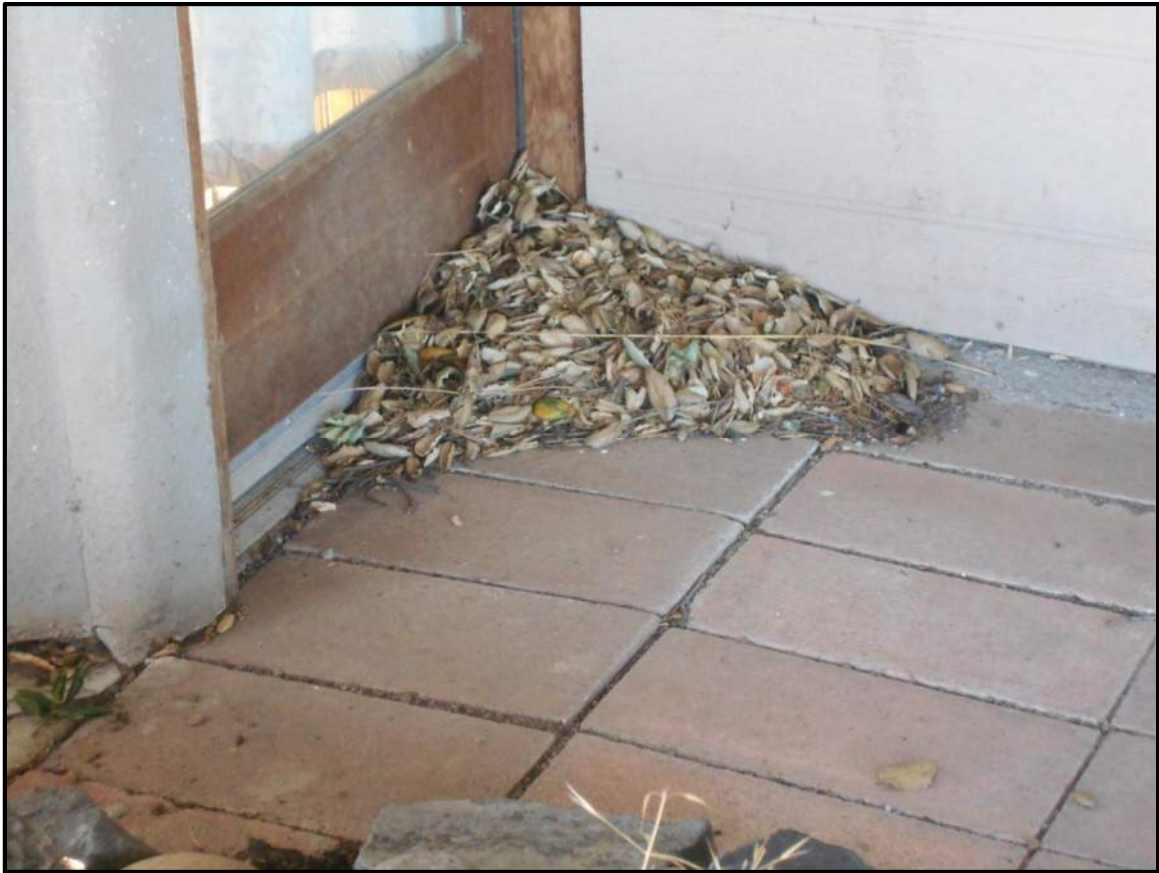
Photo 21 - Patio Pavers Slope into Family Room Door

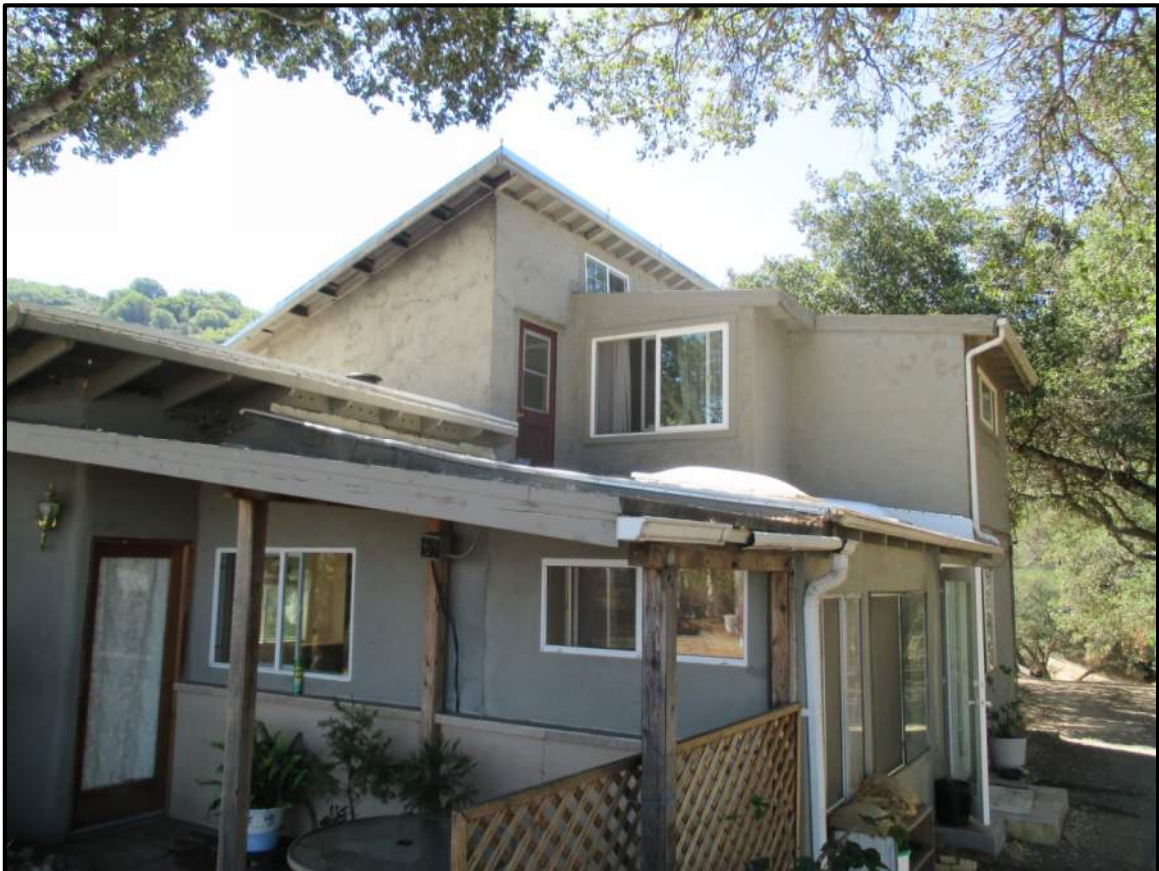
Photo 22 - Poor Flashing and Roof Gutters

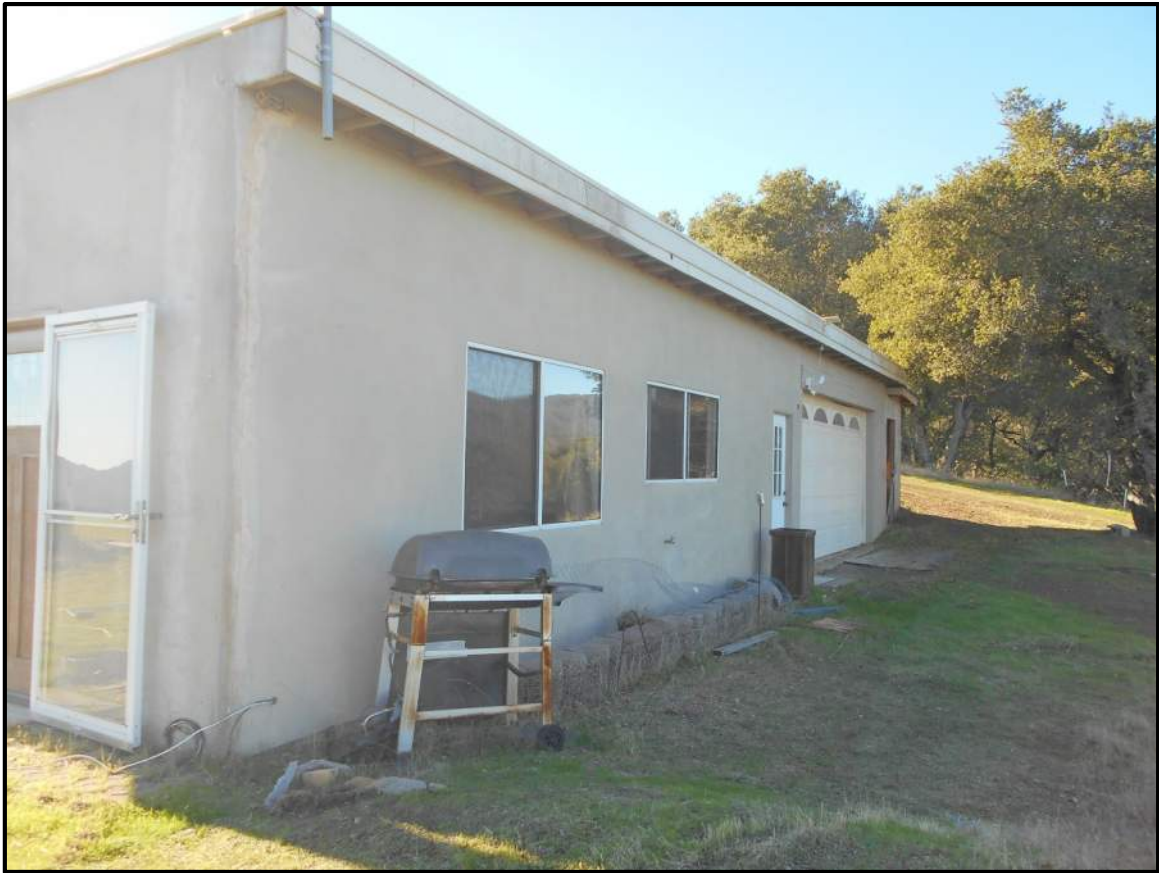
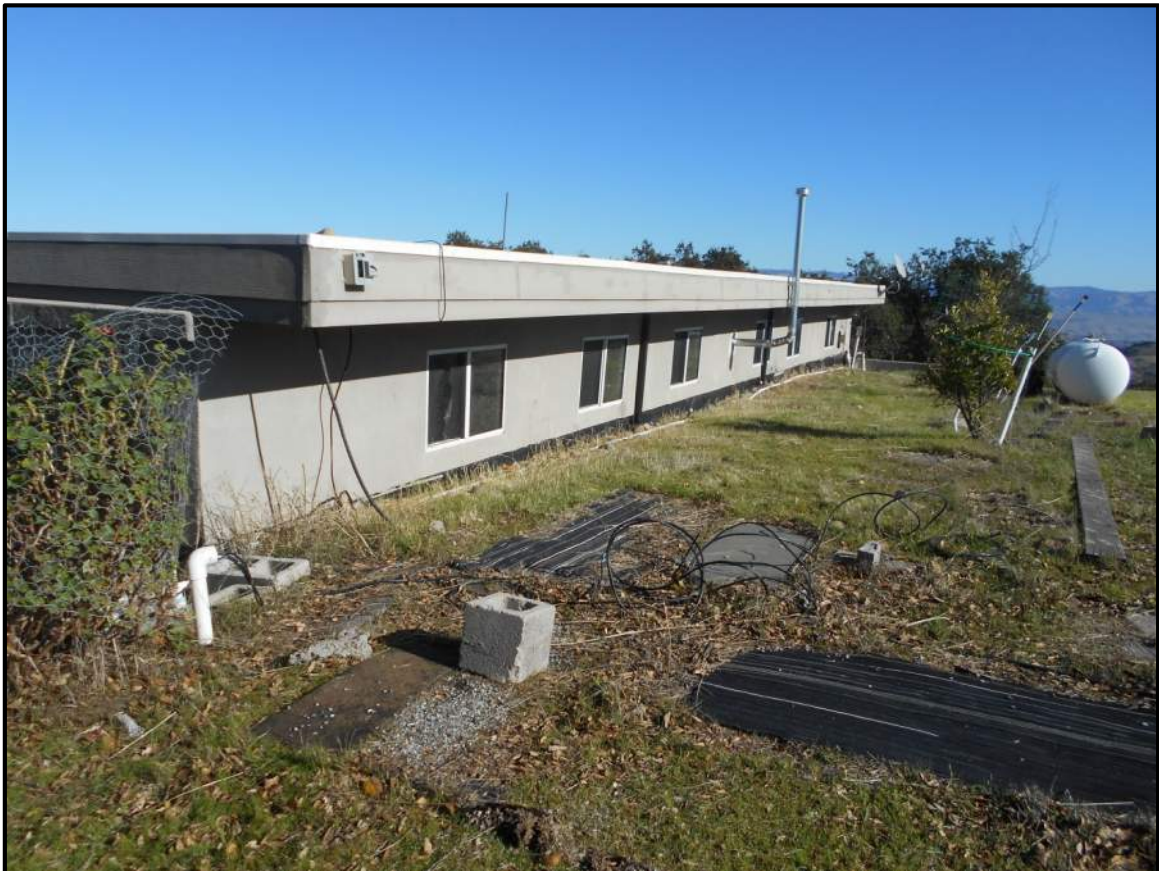
This 1,400 square foot one-story flat-roof rectangular structure, which includes an apartment space and a garage, is partially constructed into a mild sloping hill; see Photos 23 & 24. The roof and wall framing in the garage is exposed for inspection. We have assumed that the structure that we observed in the garage area will be typical for the rest of the building. Located on the east end of the building is a small living space or apartment. This apartment space has a relatively large open space which includes a kitchen, a dining/family room area and an area for a possible bedroom. The kitchen includes wood cabinets, a sink and a gas range; see Photos 25 & 26. A wood burning fire box is located in the dining/family room; see Photo 27. Located in the remainder of the apartment is a bathroom, which includes a sink, toilet and tub shower; see Photo 28. Next to the bathroom and across from the kitchen is a large storage closet; see Photo 29. Located west of the apartment area is a large two vehicle garage, which includes two refrigerators, hot water heater, wall cabinets, and work benches; see Photos 30, 31, 32, & 33. The garage door is power operated; see Photo 34. Located on the northwest corner of the building is a small addition which we think house a compressor that was used to operate a vehicle lift which is located in the ground in front of the garage door; see Photo 35.

Photo 23 - North Elevation - Apartment/Garage

Photo 24 - South Elevation - Apartment/Garage

This building seems to be in good structural condition with no major signs of damage, distress or deficiencies, and therefore is a good candidate for a structural upgrade. It is our recommendation that a more detailed structural evaluation and seismic analysis be performed by a licensed Structural Engineer. This would include removing some of the finishes to determine shear wall nailing, holdown requirements and anchor bolt spacing. A more detailed evaluation of the foundation to see if they capable of support the seismic and wind loads of the new code. The

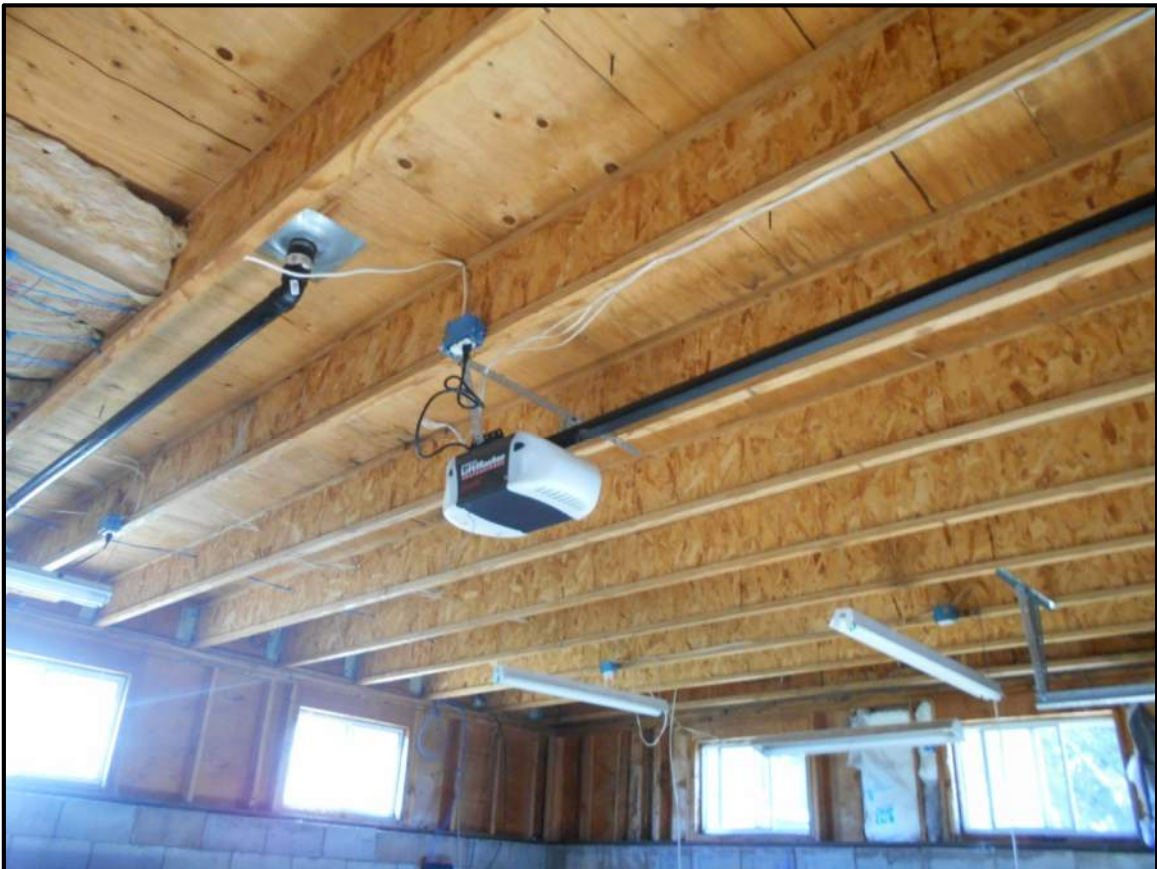
Photo 36 - Plywood and TJI Roof Rafters

The flat single-ply roofing is over plywood sheathing, which is supported on 12" deep "I" shaped wood Truss Joist (TJIs) spaced at 24" on centers. The TJIs span approximately 26 feet between the north and south exterior walls of the building; see Photo 36.

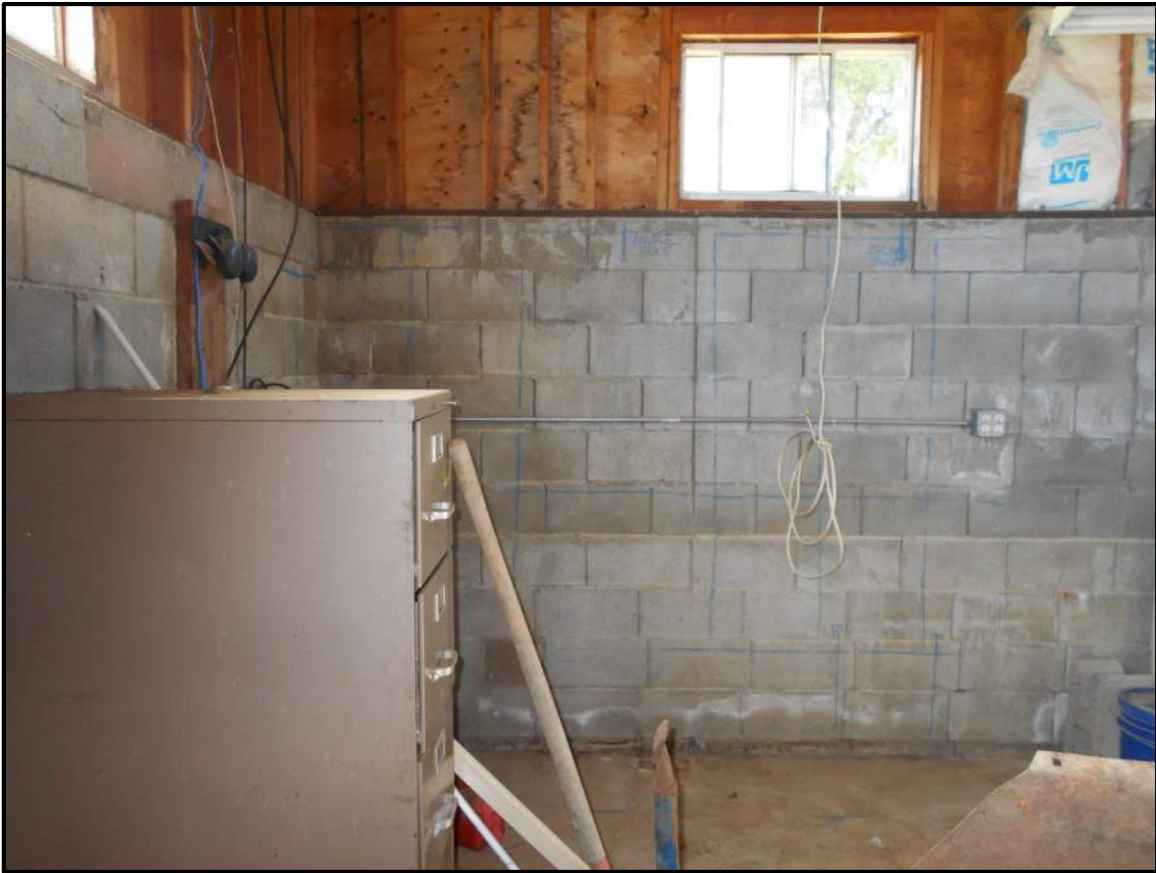
Photo 37 - CMU Retaining Wall and Wood Framed Pony Wall

The exterior walls of the building and the small addition are cement plaster. The south and west exterior walls, which are partial retaining walls, are construction with reinforced 8" concrete masonry block units (CMUs) to retain the soil and an approximate 4'-0" tall 2x4 at 16" on centers stud pony wall with exterior plywood sheathing; see Photo 37. The pony wall has a pressure treated 2x6 sill plate with ½" diameter anchor bolts at 4'-0" on centers embedded into the top of the CMU wall. The north and east walls are constructed with exterior plywood siding on 2x4 studs spaced at 16" on centers. The wall dividing the apartment from the garage is constructed with 2x4 studs spaced at 16" on centers with plywood on the garage side and gypsum wall board on the apartment side. The interior stud partition walls are probably 2x4 wood studs with gypsum wall board on each face. Interior plywood paneling was used as the ceiling in the apartment portion of this building; see Photos 25 & 26.

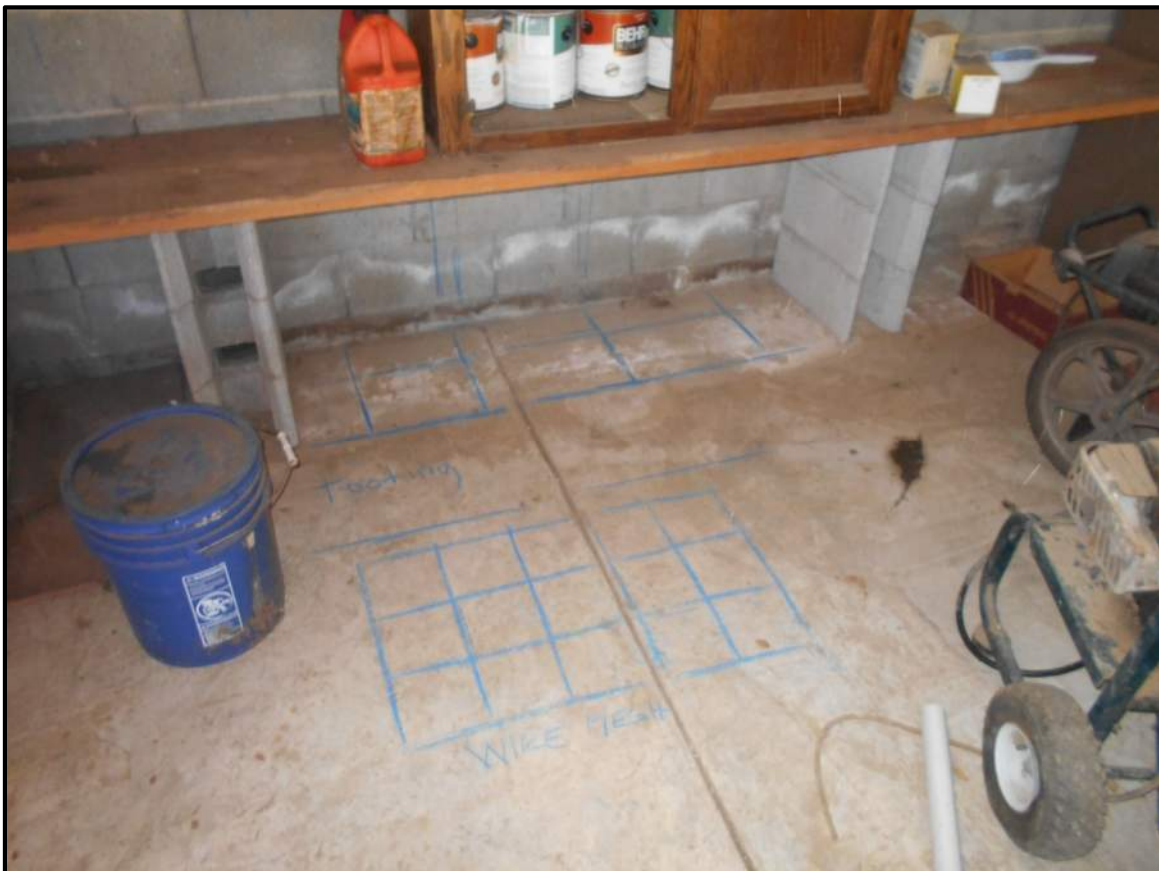
fabric reinforcing; See Photo 38. Refer to Appendix B for reinforcement that was located in the retaining wall and foundation.

The top of existing waterproofing on the exterior CMU retaining walls was observed. However sign of water penetration (efflorescence) was observed at the bottom of the retaining walls inside the garage. This could mean that waterproofing of the retaining wall has failed and needs to be inspected and if required repaired or replaced; see Photo 38.

Photo 38 - CMU Retaining Wall Footing and 5" Thick Slab-on-Grade

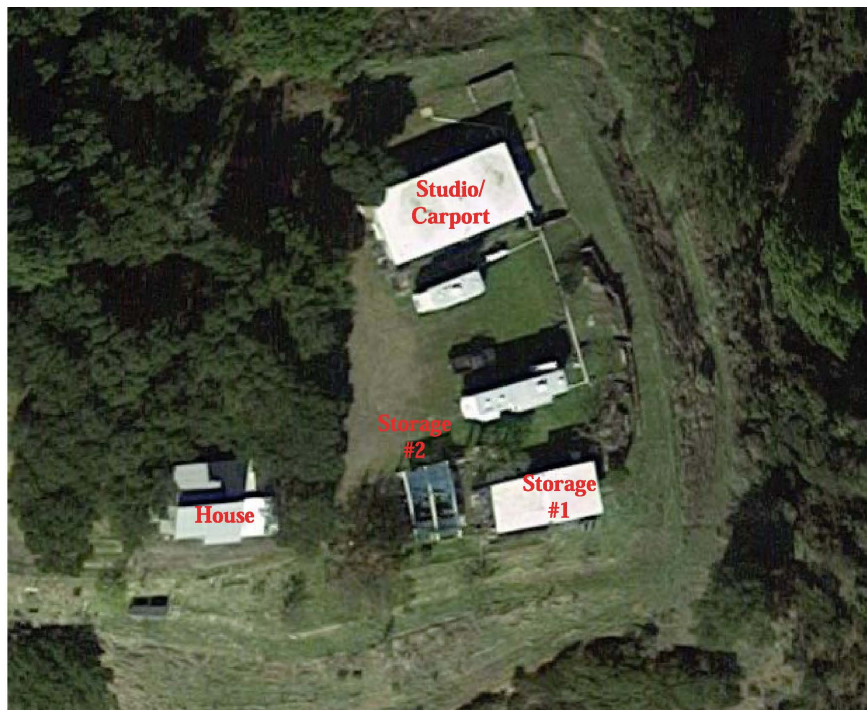
This report summarizes the results of the survey for hazardous materials at the above-referenced site. Sampling was conducted on October 5, 2017 by Tucker Kalman, CAC, CDPH. Sampling included collection of samples for asbestos, lead, polychlorinated biphenyls (PCBs), and arsenic analysis. SCA surveyed the following buildings on site as identified by MROSD and identified in the below figure:

- 2-story single family residence, approximately 1,200 SF (slated for demolition, destructive sampling)
- Carport with studio, approximately 1,000 SF (slated for renovation, non-destructive sampling)
- 2 storage structures (slated for demolition, destructive sampling)
