Midpeninsula Regional
Open Space District

Memorandum

SUBJECT: Natural Ecological Succession of Schilling Lake to a Meadow and Eventually a Forest

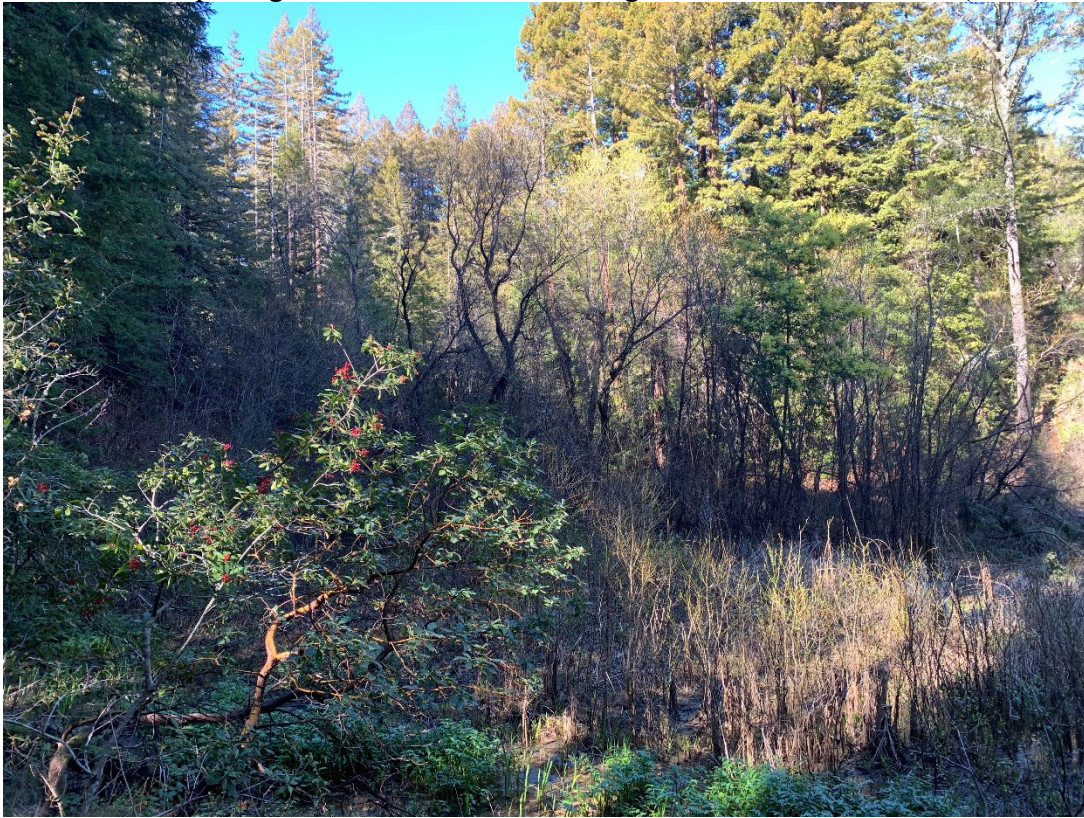
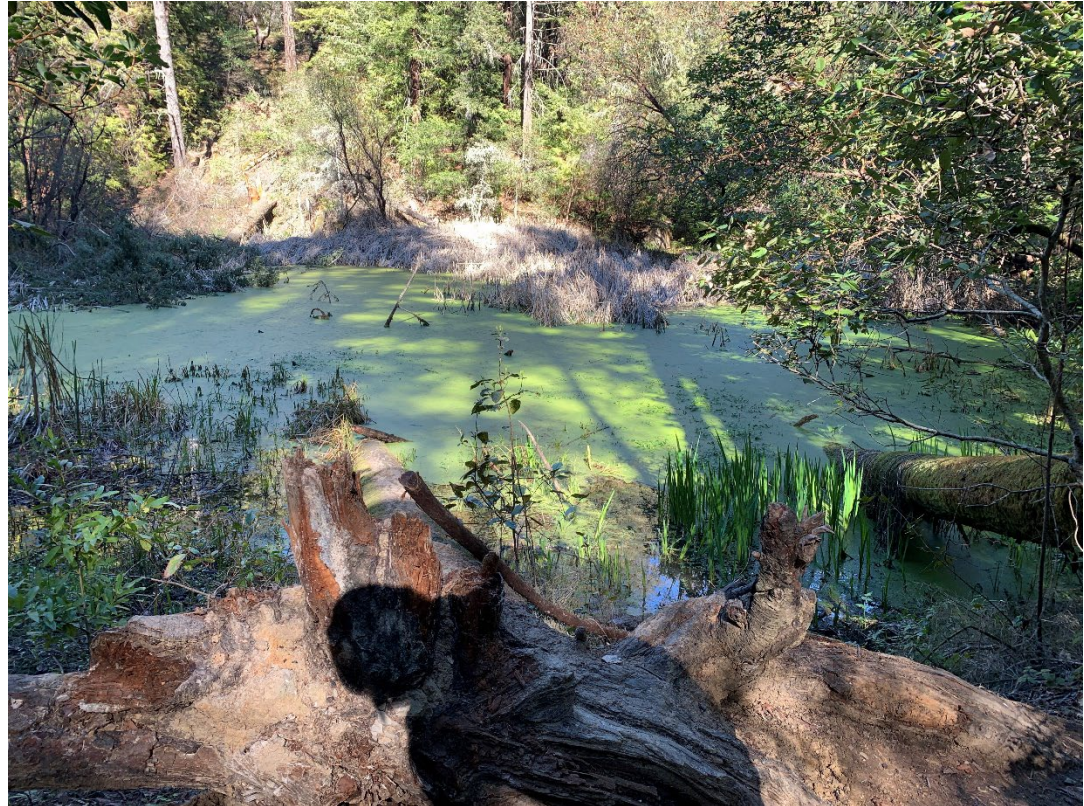
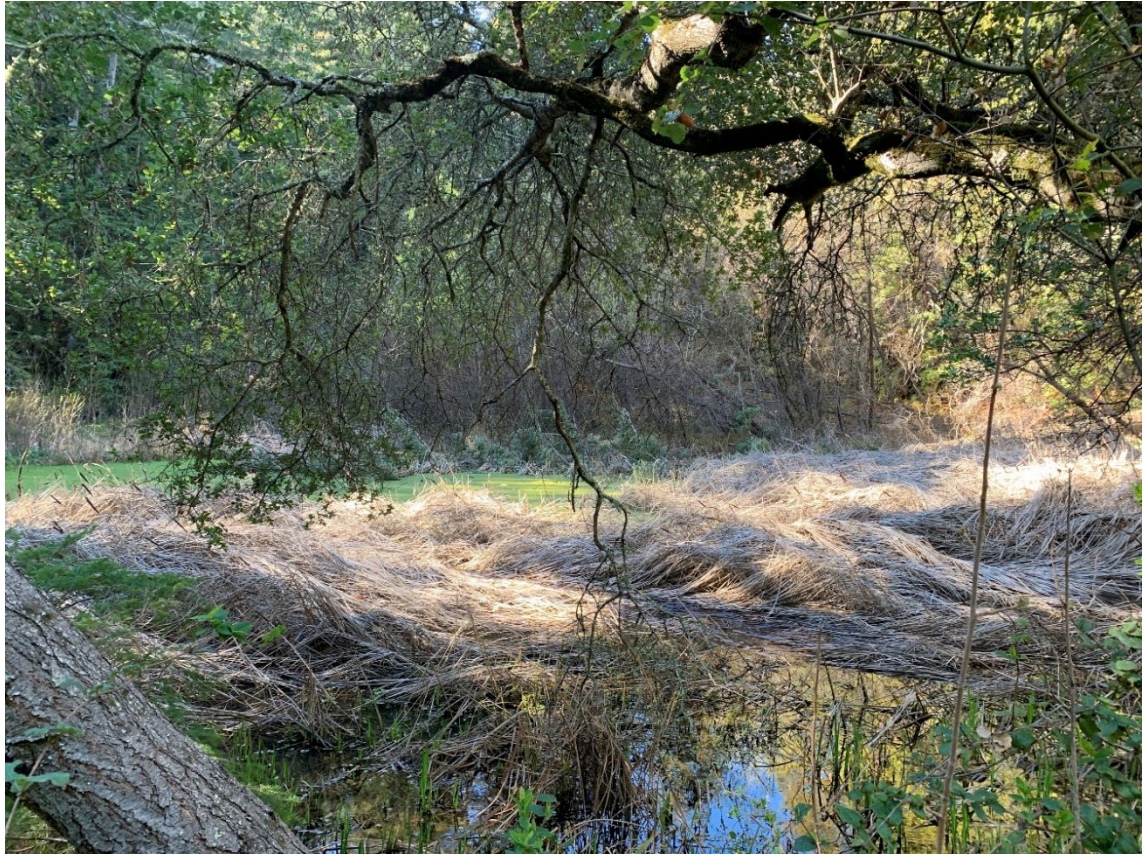
Even with the prior and ongoing maintenance, the lake has continued to experience heavy sediment deposition and the expanded colonization of cattail and willows (genus *Salix*). The eventual infill of Schilling Lake was anticipated under Option 2, which provided for only minor intervention of natural ecological succession. The combination of sediment accumulation and expanded vegetation growth has significantly reduced the extent of open water. As a result, the surface area that still retains suitable conditions where duck weed or water fern can grow has been greatly reduced. Therefore, Land & Facilities have suspended efforts to remove duck weed and water fern from the lake surface. Moreover, there is no longer a benefit to clearing the cattails from the spillway to allow the lake to flush out duckweed and water fern. However, annual preventative maintenance tasks to ensure proper flow of water through the concrete spillway, tree maintenance management throughout the site, and monitoring of the dam and spillway will continue while the site retains standing water to ensure that the water flow infrastructure remains functional. As indicated earlier, Option 2 fully anticipated the eventual natural succession of the lake to a meadow and eventually to becoming a part of the surrounding mixed evergreen forest. Once the lake fully transforms to a forest (or potentially sooner), the water flow infrastructure will no longer be necessary, and its maintenance would cease.

Pictures Depicting the Succession of Schilling Lake from East to West (Dam)

As discussed above, staff will continue annual monitoring of the site, spillway and dam and maintenance of the water flow infrastructure until the lake fully transitions to a forest or sooner if deemed appropriate by expert staff through site inspections. An interpretive sign describing the natural ecological transition and succession of the pond to a meadow and eventually a forest will be developed and installed at the site.
