Midpeninsula Regional
Open Space District

R-23-93
Meeting 23-19
July 26, 2023

Disposition of Paul Cabin and Rapley Barn

Attachment 1 - Paul Cabin

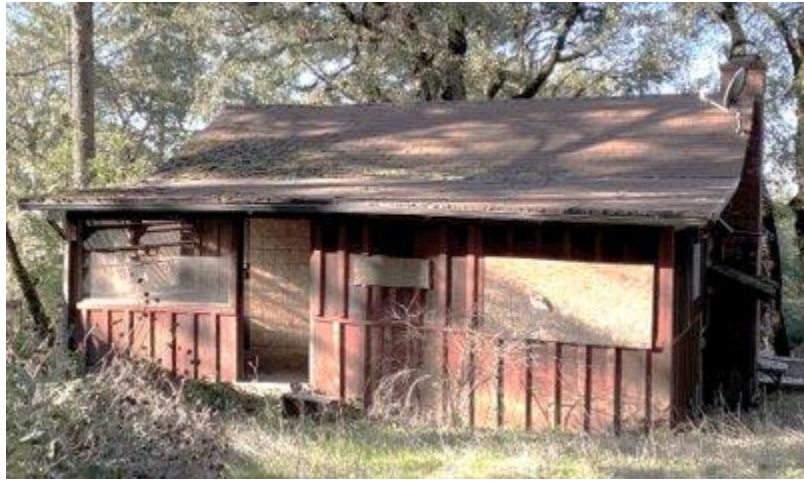
East Elevation

L. Condition of the Structure	Fair condition for the roof and siding; pier foundation may need stabilization; poor water service due to lack of potable water source

Removing the Paul Cabin includes removal of the main cabin and associated accessory structures, such as garden beds, chicken coop, tool sheds, and outdoor staircase; removal or abandonment of the septic system, and minor grading work and use of native seed to stabilize the area. Staff estimates the cost of removing the Paul Cabin and accessory structures to be \$125,000 based on recently completed similar projects.

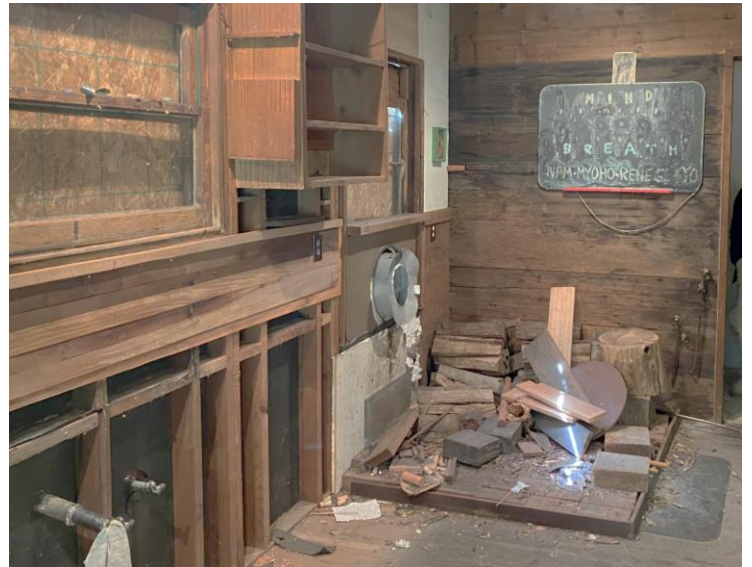
Interior
(missing cabinetry and counters)

To make the cabin habitable for rental reuse, staff estimates the construction cost at approximately \$150,000 to repair the roof and siding, replace windows, remodel the interior with new appliances, upgrade the septic system, repair the leach field, restore power, and bring the cabin up to code. These costs, however, **do not include** providing a viable potable water system. The driveway (0.33 mile) from Skyline Boulevard is estimated at an additional \$100,000 for repairs to provide year-round residential access.

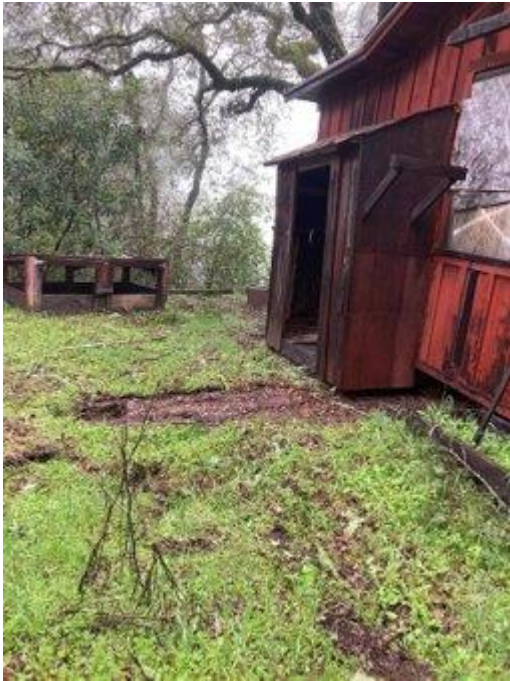
This option aims to preserve the cabin as-is whilst addressing immediate perimeter safety. A sink hole was discovered by patrol in March 2023 at the leach field site behind the cabin. Staff estimates \$20,000 to address and repair the leach field, with a 20-year maintenance cost of \$205,000 to account for staff time to check exterior and interior conditions for visual hazards and maintain defensible space. Note that retaining structures with no reuse will

Sink hole at leach field.

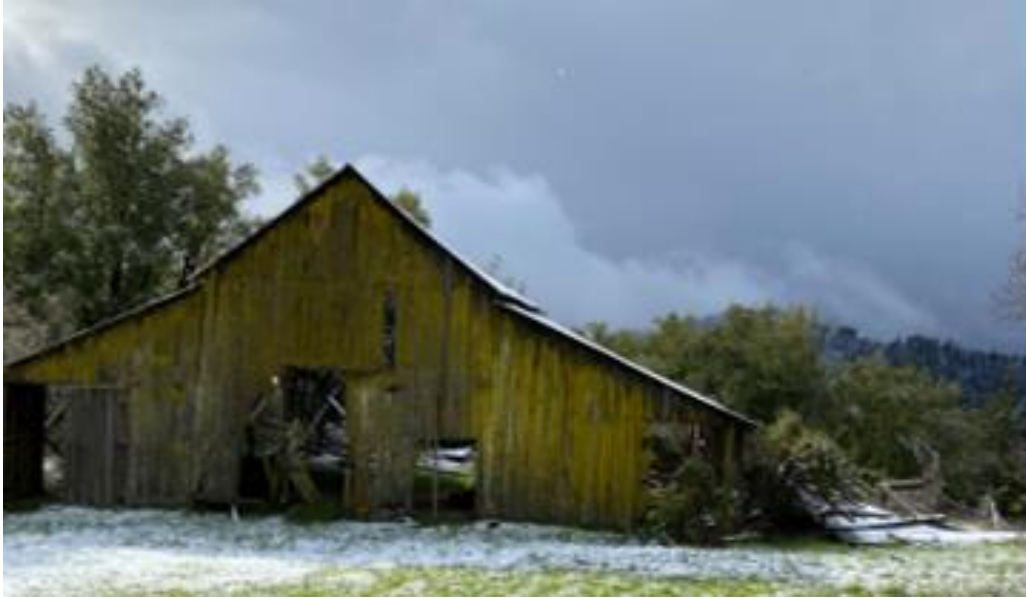
North Elevation

As part of the purchase, the District acquired the Rapley Barn and several outbuildings. The Rapley Barn is a 2,000 square foot, one-story broken gable barn comprised of three bays. The barn is in a dilapidated and unsafe condition and would require significant improvements to meet current codes. Other outbuildings in the vicinity of the site, including a 400-square foot tool shed west of the barn, are also in poor condition.

Factors to Consider for Structures:	Rapley Barn
I. Strategic Fit	Minimal - other priority barns with similar architectural features and with historic value have been stabilized at District preserves for reuse and/or ecologically sensitive public enjoyment and education.
J. Tradeoffs and Impacts on District Resources	Cost benefit analysis is discussed below.
K. Visitor Experience	In its current state, the area is unsafe to enter. There is no plan to make the structure available for public use and the value for interpretation is considered low.
L. Condition of the Structure	Extremely poor; main barn deteriorated due to fallen roof and siding. Accessory structures are either partially or completely collapsed.

Removing the Rapley Barn includes removal of the main barn and all accessory structures, such as the tool shed and collapsed cottage; minor grading work; and use of native seed to stabilize the area. Staff estimates the cost to be \$200,000 based on recently completed similar projects. The estimate does not include staff time to manage the contract and secure permits.

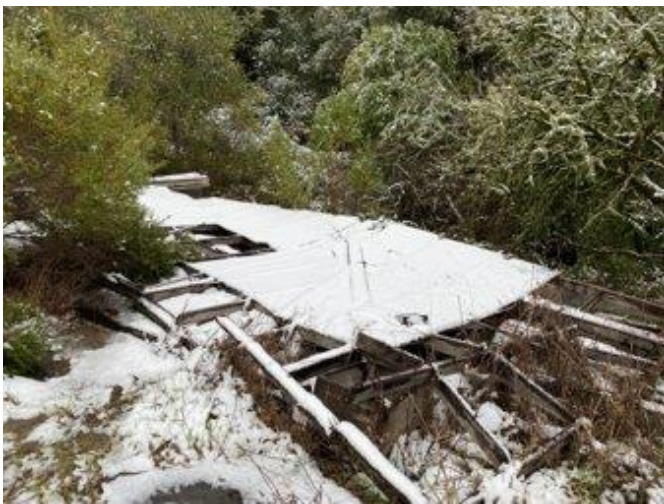
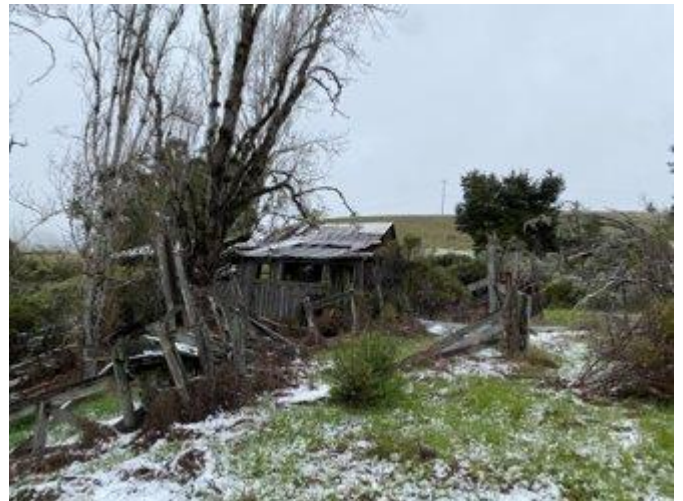
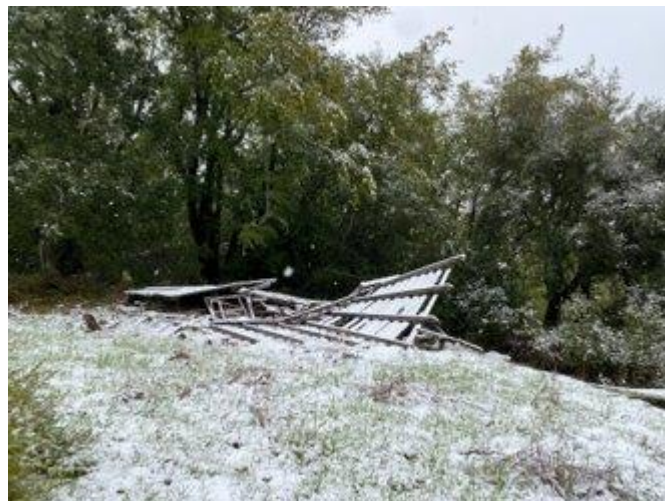
Collapsed Outbuildings
