Midpeninsula Regional
Open Space District

SUBJECT: Hawthorns Historic Complex at Windy Hill Open Space Preserve

**HAWTHORN PROPERTY
WINDY HILL OPEN SPACE PRESERVE**

STRUCTURE CONDITIONS ASSESSMENT – SUMMARY OF FINDINGS

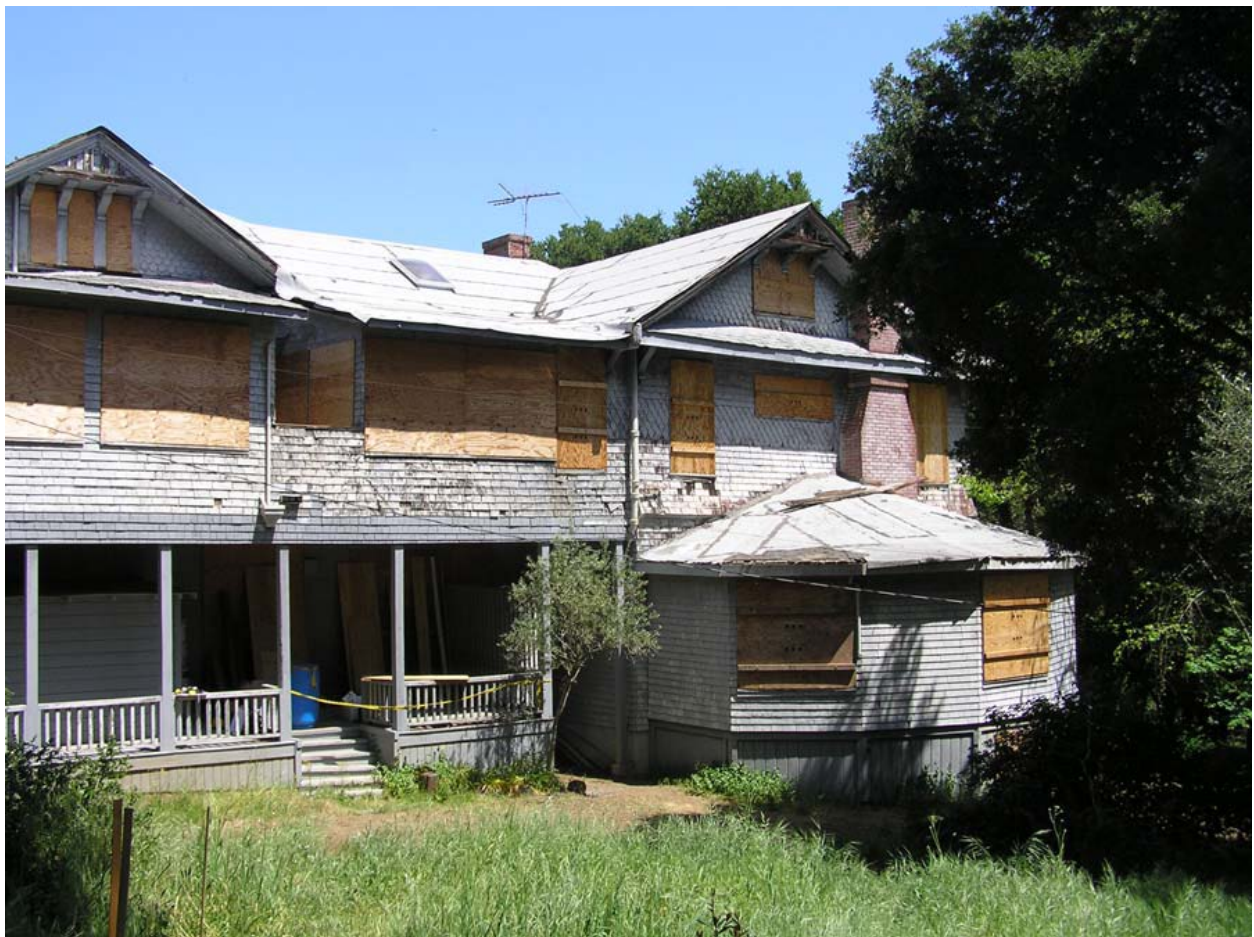
- Built in 1887
- Fair condition; good candidate for reuse

Hawthorns House circa 2013; photo courtesy of Knapp Architects

1. Replace roofs with new asphaltic roofing that matches the aesthetic of original shingles.
2. Strengthen roof framing.
3. Repair external additions and staircases that have deteriorated.

4. Repair or replace siding and shingles and repaint structures; match historic aesthetic.
5. Repair doors and windows and replace broken glazing.
6. Repair and refinish interior walls, ceilings, and floors as necessary, matching historic standards.

7. Implement pest intrusion and prevention measures.
8. Reinforce or replace foundations and bring up to code.
9. Replace deteriorated, inadequate, or dangerous system components in all structures with new electrical, plumbing, heating and ventilations systems.
