R-17-39
March 28, 2017

Schematic Design of the Alma College Parking Area and Bear Creek Road Trail Crossing at Bear Creek Redwoods Open Space Preserve

September 14, 2016

Subject: **Draft Culvert Condition and Capacity Technical Letter
Bear Creek Redwoods Open Space Preserve
Santa Clara County, California**

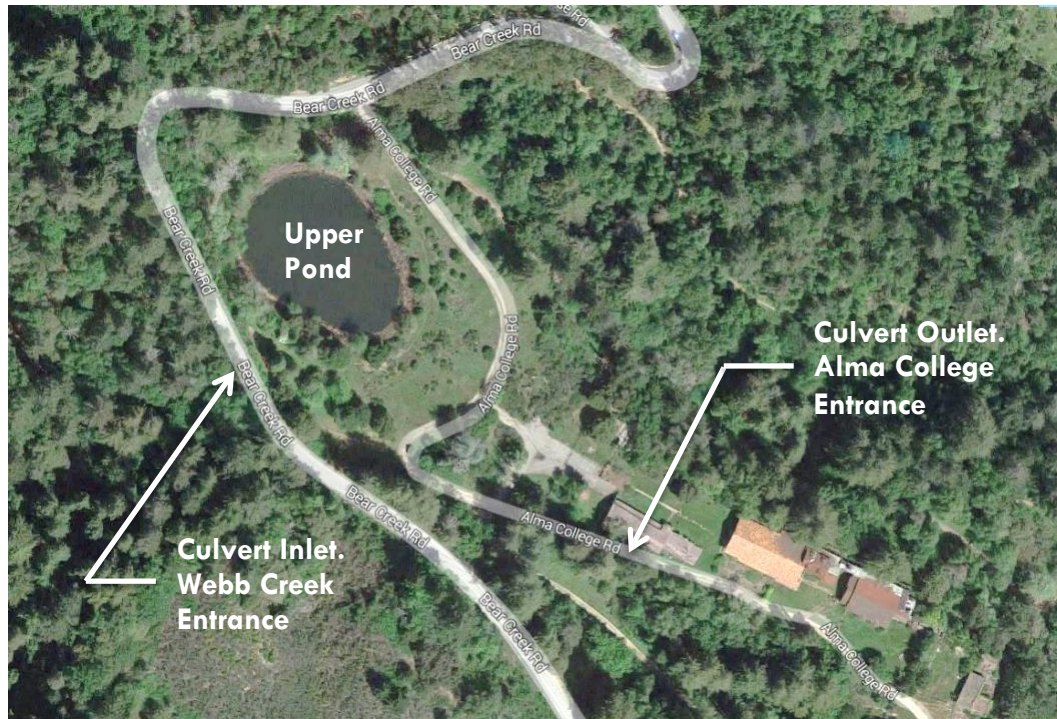
Figure 1. Approximate location of culvert inlet and outlet

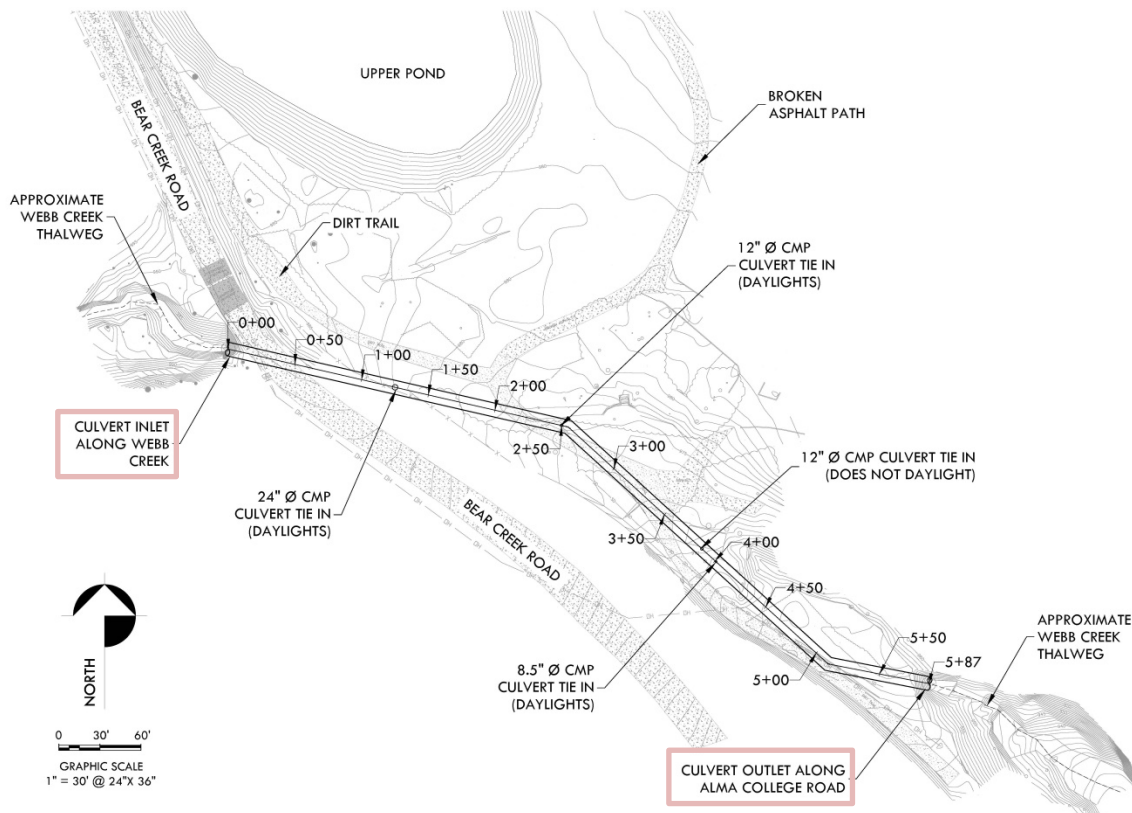
Figure 3. Approximate location of culvert with inlet and outlet highlighted in red. Note that minor pipe bends not shown and the true and accurate location of the culvert needs to be verified before any construction commences.

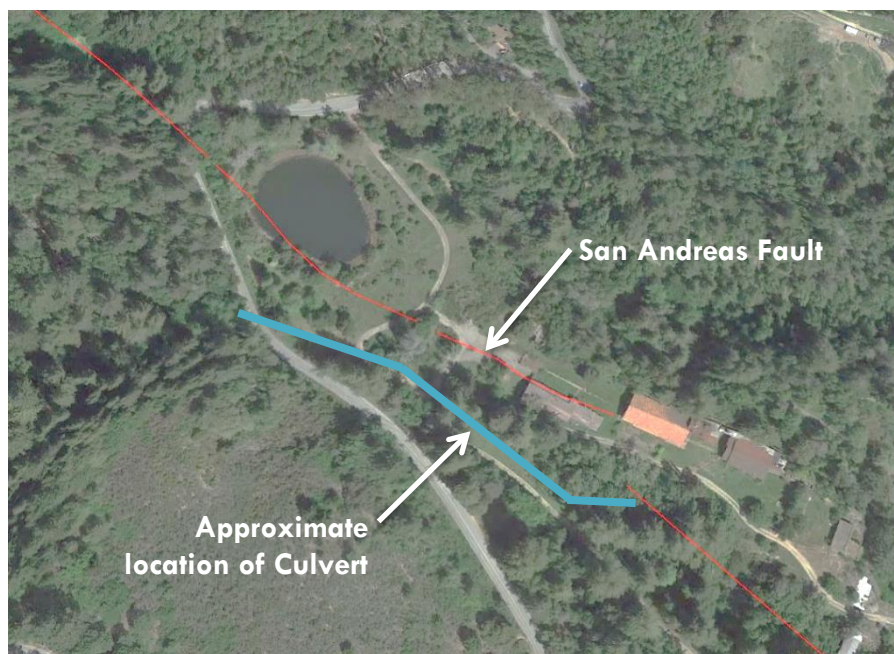
Figure 12. USGS generated map of San Andreas Fault crossing through site with approximate location of culvert shown. Actual location of culvert must be verified before any construction commences.

One of the added difficulties of the site is the presence of the San Andreas Fault line in relation to the culvert location. The fault line runs directly through the Preserve and can be seen in Figure 12.

The presence of the fault line within such close proximity to the culvert may have been the cause of some of the pipe damage that was noted. The alignment of the culvert and the fault line parallel each other and slight subterranean shifts over the course of years may have impacted the culvert's integrity and caused some of the pipe joint separation that was noted in Figure 5, Figure 7, and Figure 11.
