ADA Self-Evaluation and Transition Plan Update

Midpeninsula Regional Open Space District

Appendix B

ADA Facility Assessment Reports

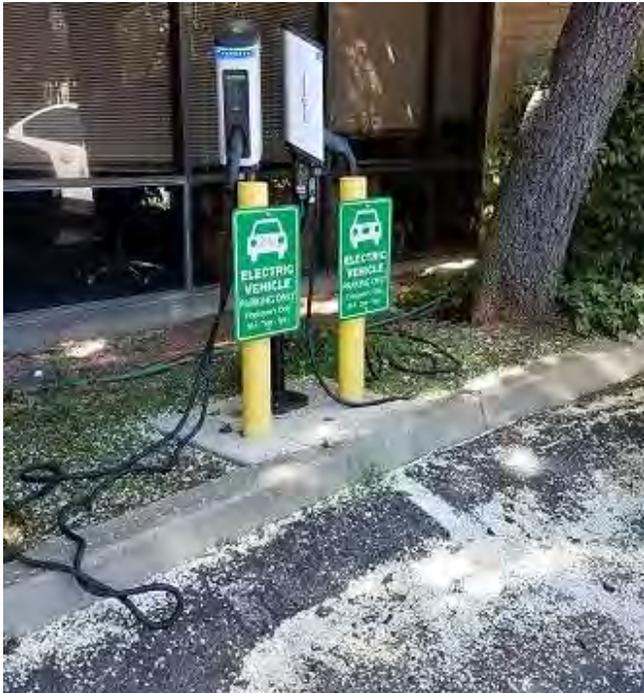
Administrative Office Lot

Exterior 330 Distel Circle
1 - 1 **Parking Area** Category: 1

Notes: An additional sign or language stating "Minimum Fine \$250" is not provided at either space.

Install reserved parking sign \$750

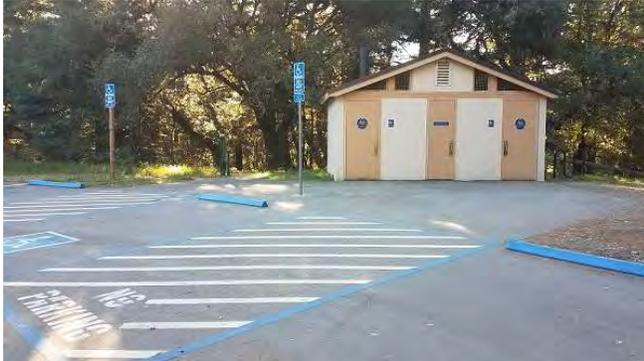
El Corte de Madera Main Parking Lot

Preserve		
1 - 1	Parking Area	Category: 1

Notes: Slopes of the three parking spaces and two access aisles at the Sierra Morena trailhead are 3.6% to 6.0% (2.0% max).

Regrade accessible parking space or access aisle \$8,000

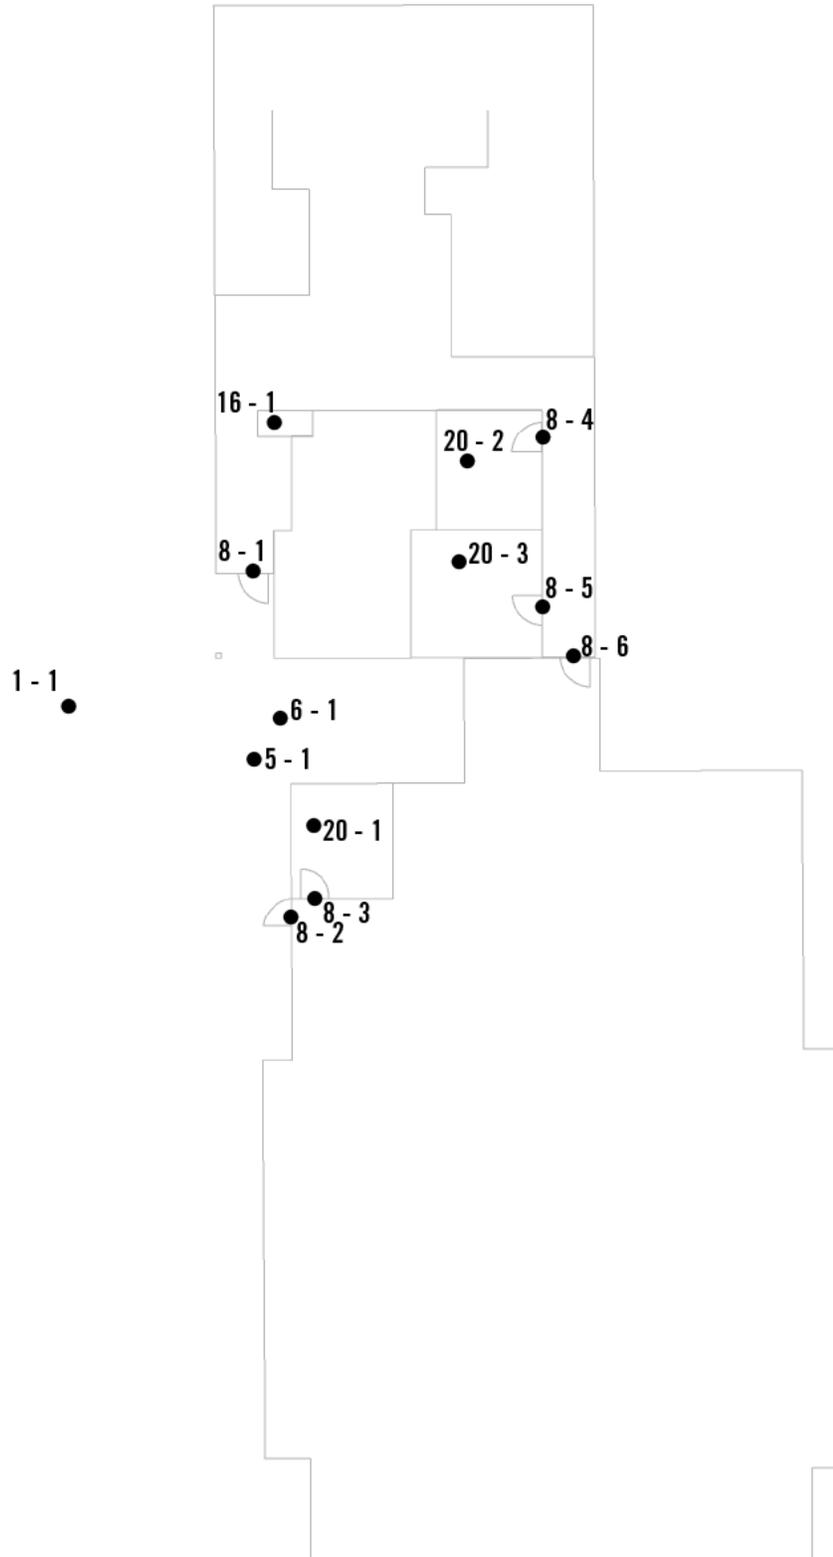
RANCHO SAN ANTONIO FOOTHILLS FIELD OFFICE

Building		
8 - 1	Door/Gate	Category: 1
Attach loose mat to the floor surface		\$125
Notes: Door mat is not securely attached to ground surface.		
ADA: 302.2		
Other: CBC 11B-302.2		
Install or modify sign		\$250
Notes: A tactile and braille EXIT sign is not provided.		
ADA: 216.4.1, 703.4.1		
Other: CBC 1011.4		
Replace or modify door threshold		\$125
Notes: Door threshold has a vertical change of level of 3/4" (1/4" max or 1/2" max with a 1:2 bevel).		
ADA: 404.2.5		
Other: CBC 11B-404.2.5		
8 - 2	Door/Gate	Category: 2
Modify door window or side light		\$500
Notes: Lower edge of door window is 52" AFF (43" max).		
ADA: 404.2.11		
Other: CBC 11B-404.2.11		
Install or modify sign		\$250
Notes: A tactile and braille EXIT sign is not provided.		
ADA: 216.4.1, 703.4.1		
Other: CBC 1011.4		
Adjust door closer		\$125
Notes: Door closer sweep time is 2-1/2 seconds (5 seconds min). Door opening force is 12 lbs (5 lbs max).

Building		
8 - 6	Door/Gate	Category: 1
Install or modify sign		\$250
Notes: A tactile and braille EXIT sign is not provided.		
ADA: 216.4.1, 703.4.1		
Other: CBC 1011.4		
Adjust door closer		\$125
Notes: Door opening force is 13 lbs (5 lbs max).		
ADA: 404.2.9		
Other: CBC 11B-404.2.9		
Modify door window or side light		\$500
Notes: Lower edge of door window is 54" AFF (43" max).		
ADA: 404.2.11		
Other: CBC 11B-404.2.11		
Attach loose mat to the floor surface		\$125
Notes: Door mat is not securely attached to ground surface.		
ADA: 302.2		
Other: CBC 11B-302.2		
Regrade surface		\$2,500
Notes: Slope on the push side of the door is 3.9% (2.0% max).		
ADA: 404.2.4.4		
Other: CBC 11B-404.2.4.4		
Provide strike edge clearance		\$2,500
Notes: Push side strike-edge clearance at front approach door with a closer is 9-3/8" (12" min).		
ADA: 404.2.4.1		
Other: CBC 11B-404.2.4.1		
16 - 1	Built-in Elements	Category: 2
Provide an accessible counter or table		\$1,500

Building	
20 - 1	Single User Restroom
	Category: 2
Replace or reposition dispenser	\$375
Notes: Height to operating mechanism of soap dispenser is 41-1/2" AFF (40" max). A 30" by 48" clear floor space in front of seat cover dispenser is not provided. The seat cover dispenser is located behind the front of the toilet fixture. Centerline of the toilet paper roll dispenser is 6" in front of the water closet (7" min to 9" max).	
ADA: 305.3, 604.7	
Other: CBC 11B-305.3, CBC 11B-603.5, CBC 11B-604.7	
Install restroom sign	\$250
Notes: A federal tactile and braille restroom sign is not provided (required federal sign is to be mounted on the latch side of the door).	
ADA: 703	
Other: -	
Replace or modify grab bars	\$300
Notes: Rear grab bar extends from the centerline of the water closet 14-1/4" and 21-3/4" (36" long min, extends 12" and 24" min from centerline of water closet). Seat cover dispenser is located 3-3/4" above the rear grab bar (12" min clear space above the bar).

ADA: 604.5.2, 609.3	
Other: CBC 11B-604.5.2, CBC 11B-609.3	
Replace or reposition fixtures	\$1,250
Notes: The water closet centerline is 18-1/4" from the wall (17" min to 18" max).	
ADA: 604.2	
Other: CBC 11B-604.2	
Modify stall partition and install new stall door	\$750
Notes: Restroom door swings into clear floor space of water closet.	
ADA: 603.2.3	
Other: CBC 11B-603.2.3	
Provide clear floor or turning space	\$3,000
Notes: A 60" min diameter turning space unobstructed from the floor to a height of 27" min is not provided.	
ADA: 304.3.1, 306.3.1, 603.2.1	
Other: CBC 11B-603.2.1, CBC 11B-604.3.2	
Increase water closet clear width or depth	\$500
Notes: Clear width over the water closet is 43-1/2" between side wall and lavatory (60" min).	
ADA: 604.8.1.1	
Other: CBC 11B-604.8.1.1.1

Building		
20 - 1	Single User Restroom	Category: 2
Reposition controls and outlets		\$200
Notes: Electrical outlet is 49-1/4" AFF (15" min to 48" max).		
ADA: 308.2.1, 308.2.2		
Other: CBC 11B-308.2.1, CBC 11B-308.2.2		
Replace or reposition mirror		\$150
Notes: Bottom of the mirror's reflecting surface above the lavatory is 44-3/4" AFF (40" max).		
ADA: 603.3		
Other: CBC 11B-603.3		
Modify operating mechanism		\$250
Notes: Pull handle for baby changing table is located at 53-3/4" AFF (48" max).		
ADA: 309.1		
Other: CBC 11B-226.4, CBC 11B-309.1		
Reposition clothing hooks		\$125
Notes: Coat hook is 72-7/8" AFF (48" max).		
ADA: 308.1		
Other: CBC 11B-603.4

Building	
20 - 2	Single User Restroom Category: 2
Install restroom sign	\$500
Notes: The state restroom sign is not provided (required state sign is to be mounted on the center of the door; all-gender - triangle on circle). Tactile and braille sign is mounted on the door (required federal sign is to be mounted on the latch side of the door) and tactile characters are serif.	
ADA: 703	
Other: CBC 11B-216.8, CBC 11B-703.7.2.6	
Modify lavatory or counter clearances	\$1,500
Notes: Lavatory counter is 34-1/2" AFF (34" max).	
ADA: 606.3	
Other: CBC 11B-606.3	
Replace or reposition dispenser	\$250
Notes: Height to operating mechanism of soap dispenser is 47-1/4" AFF (40" max). Centerline of the toilet paper roll dispenser is 1-1/4" in front of the water closet (7" min to 9" max).	
ADA: 604.7	
Other: CBC 11B-603.5, CBC 11B-604.7	
Replace or reposition mirror	\$150
Notes: Bottom of the mirror's reflecting surface above the lavatory is 41-3/8" AFF (40" max).

ADA: 603.3	
Other: CBC 11B-603.3	
Provide or replace compartment door hardware	\$175
Notes: Compartment door does not have handles an interior handle and is not self-closing.	
ADA: 604.8.1.2	
Other: CBC 11B-604.8.1.2	
Increase water closet clear width or depth	\$500
Notes: Clear width over the water closet is 58" from wall to partition (60" min).	
ADA: 604.8.1.1	
Other: CBC 11B-604.8.1.1.1	
Replace or reposition fixtures	\$1,250
Notes: The water closet centerline is 18-1/2" from the wall (17" min to 18" max).	
ADA: 604.2	
Other: CBC 11B-604.2	
Replace or modify grab bars	\$300
Notes: Side grab bar starts 14-3/4" from rear wall (12" max).	
ADA: 604.5.1	
Other: CBC 11B-604.5.1

ADA: 604.7	
Other: CBC 11B-603.5, CBC 11B-604.7	
Replace urinal	\$3,000
Notes: Urinal rim is 18" AFF (17" max).	
ADA: 605.2	
Other: CBC 11B-605.2	
Provide or replace compartment door hardware	\$175
Notes: Compartment door does not have an interior handle and is not self-closing.	
ADA: 604.8.1.2	
Other: CBC 11B-604.8.1.2	
Increase water closet clear width or depth	\$500
Notes: Compartment is 59-3/8" wide (60" min).	
ADA: 604.8.1.1	
Other: CBC 11B-604.8.1.1.1

Building	
20 - 3	Single User Restroom Category: 2
Modify stall partition and install new stall door	\$750
Notes: Compartment door opens in front of the water closet (should be in front of the clear floor space, diagonal to the water closet). Water closet is 47-1/2" from front partition (48" min).	
ADA: 604.8.1.1, 604.8.1.2	
Other: CBC 11B-604.8.1.2	
Replace or reposition fixtures	\$1,250
Notes: The water closet centerline is 18-1/2" from the wall (17" min to 18" max).	
ADA: 604.2	
Other: CBC 11B-604.2	
Modify grab bars	\$200
Notes: Side grab bar is 36-1/4" AFF (33" min to 36" max).	
ADA: 609.4	
Other: CBC 11B-609.4	
Replace or modify grab bars	\$300
Notes: Side grab bar starts 12-3/8" from rear wall (12" max).	
ADA: 604.5.1	
Other: CBC 11B-604.5.1

Exterior	
5 - 1	Ramp
	Category: 1
Provide a level landing	\$225
Notes: Slope of the top landing is 3.5% (2.0% max).	
ADA: 305.1, 405.7.1	
Other: CBC 11B-405.7.1	
Regrade or replace ramp	\$5,950
Notes: Slopes of ramp are inconsistent, bottom 3' has up to 11% running slope and top of ramp has up to 8.6% (8.33% max with no grade break).	
ADA: 405.2	
Other: CBC 11B-405.2	
Install a handrail	\$4,000
Notes: Handrails are not provided on either side of the ramp (handrails with continuous gripping surfaces are provided on both sides of ramp).	
ADA: 405.8, 505.10.1	
Other: CBC 11B-505.10.1, CBC 11B-505.2	
Grind or patch vertical change of grade	\$250
Notes: Surface level change is 1/4" at back of curb (changes in level are not permitted on ramps and landings).	
ADA: 405.4	
Other: CBC 11B-405.4	
6 - 1	Stairway
	Category: 2
Install a handrail	\$1,250
Notes: Handrails are not provided on either side of the stairway (handrails on both sides req).

ADA: 505.10.2, 505.10.3, 505.3	
Other: CBC 11B-505.10.2, CBC 11B-505.10.3, CBC 11B-505.3	
Replace stairs	\$600
Notes: One riser is 5-1/2" and the other 6" (uniform heights req).	
ADA: 504.2	
Other: CBC 11B-504.2	
Install tread striping	\$30
Notes: No tread striping provided (required for all treads on an exterior stairway).	
ADA: -	
Other: CBC 11B-504.4.1

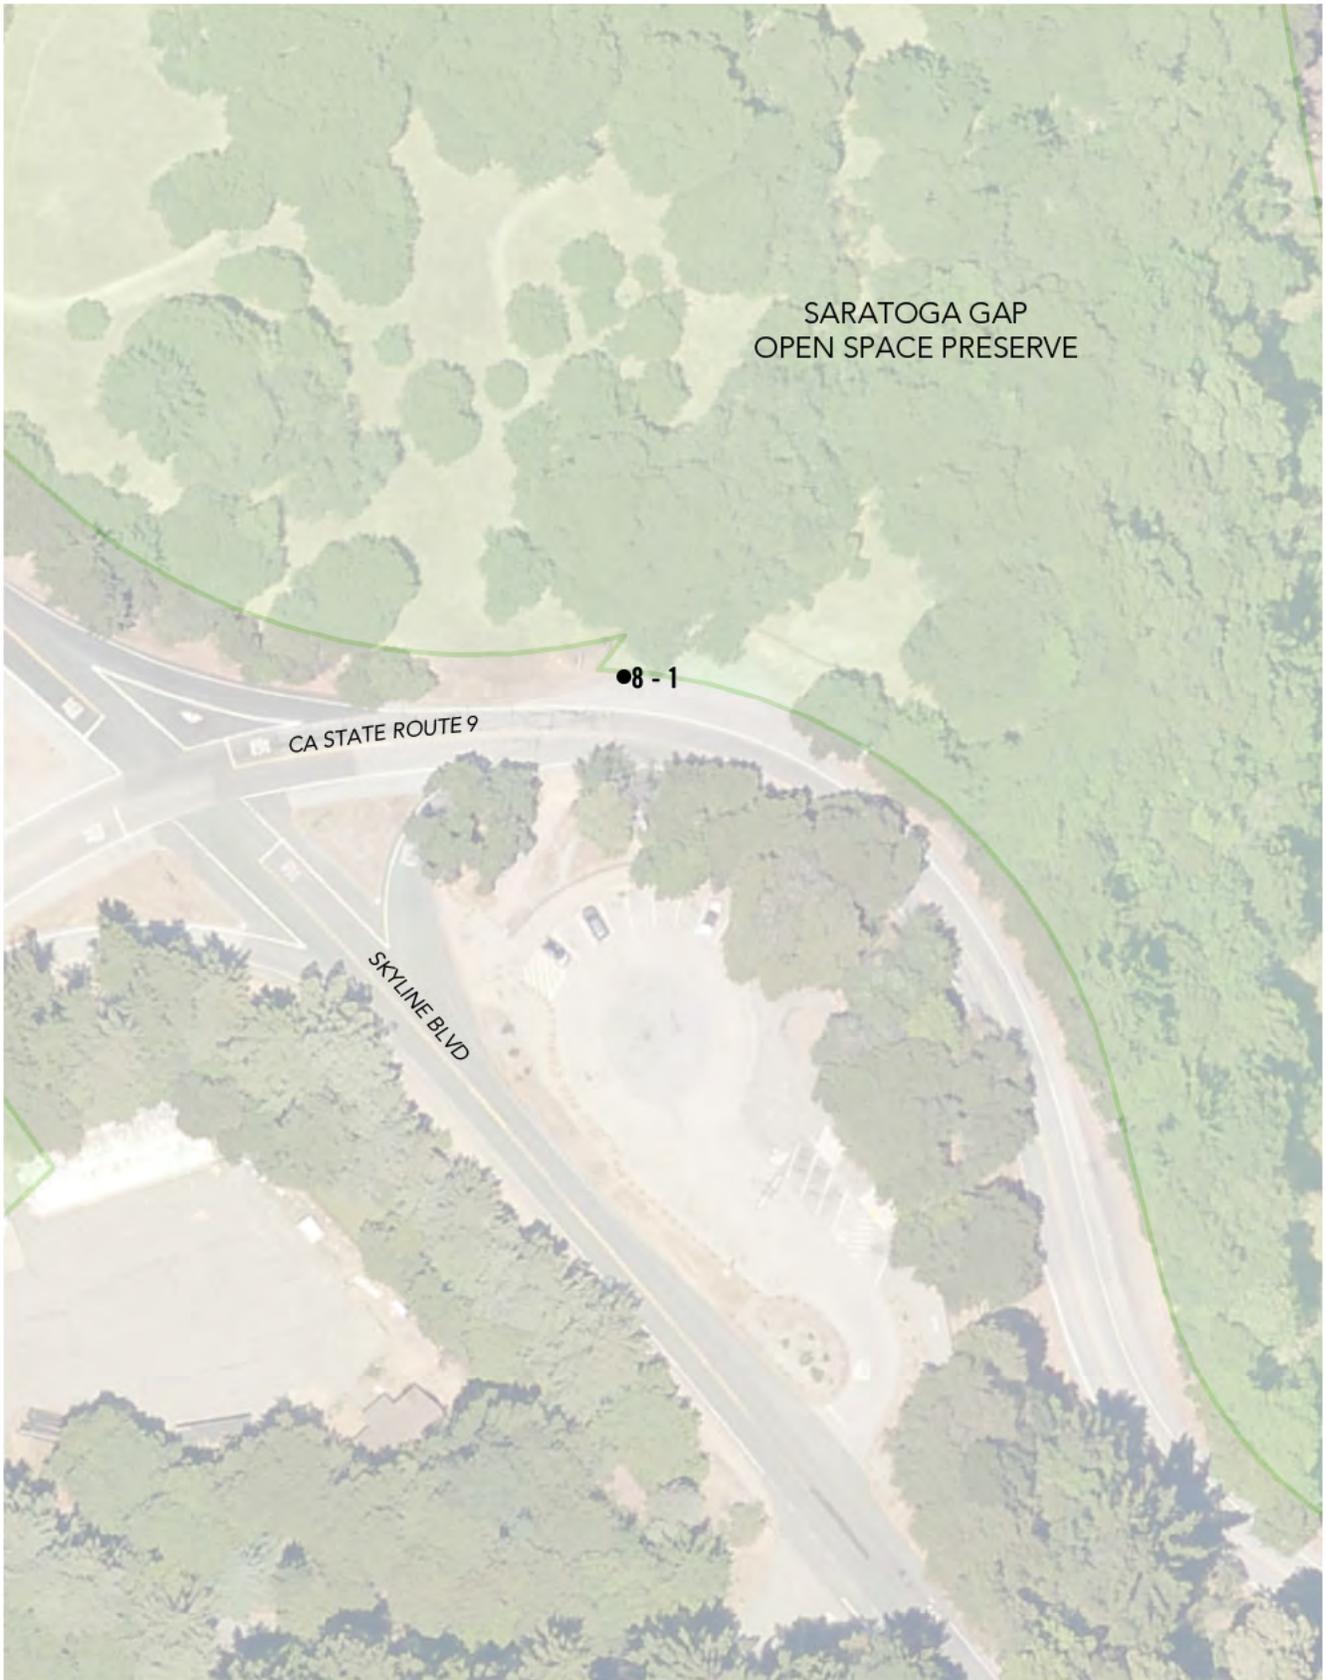
SARATOGA GAP PRESERVE

Preserve	
8 - 1	Door/Gate
	Category: 4
Enlarge gate opening	\$1,650
Notes: Clear width of block stile gate is 19" (36" min. when located along trails or at trailheads). Post extensions protrude 5-3/4" at 40" AFF (4" max between 34" and 80").	
ADA: 404.2.3	
Other: ABA 1017.3, CBC 11B-404.2.3	
Regrade surface	\$2,500
Notes: Slope through gate is 11.9% (5% max for natural surface).	
ADA: 404.2.4.4	
Other: CBC 11B-404.2.4.4

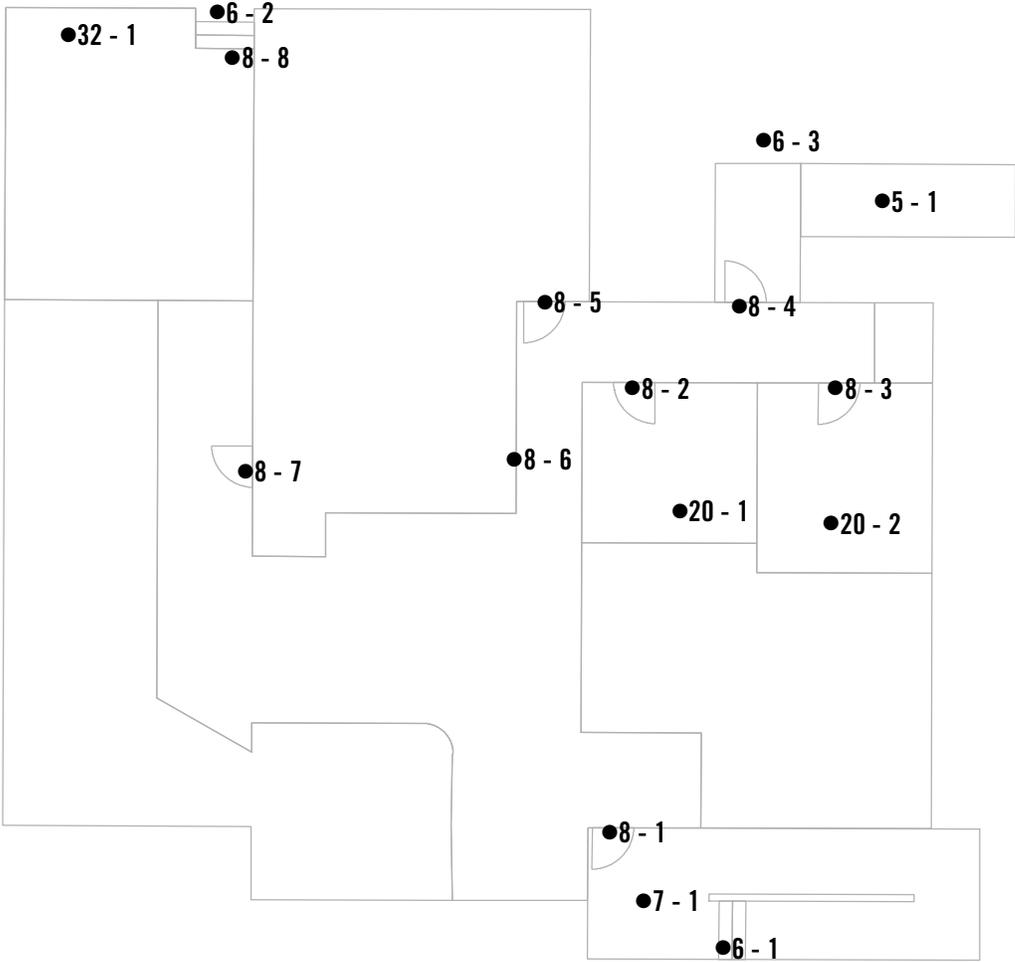
SKYLINE FIELD OFFICE

Exterior		
32 - 1	Picnic Area	Category: 2
Provide an accessible picnic unit		\$3,200
<p>Notes: The picnic table is not designed for accessibility. An accessible table has an area 30" min wide for knee space, 27" knee clearance above the ground measured 8" horizontally from the front face of the table, and 9" toe clearance above the ground extending 17" from the front face of the table. An accessible table top also has the dining surface 28" min to 34" max above the ground. Knee clearance is 26-7/8" above the ground and extends 9-3/4" from the front face of the tabletop (27" min).</p>		
<p>ADA: -</p>		
<p>Other: ABA F245.2.1, CBC 11B-246.5</p>

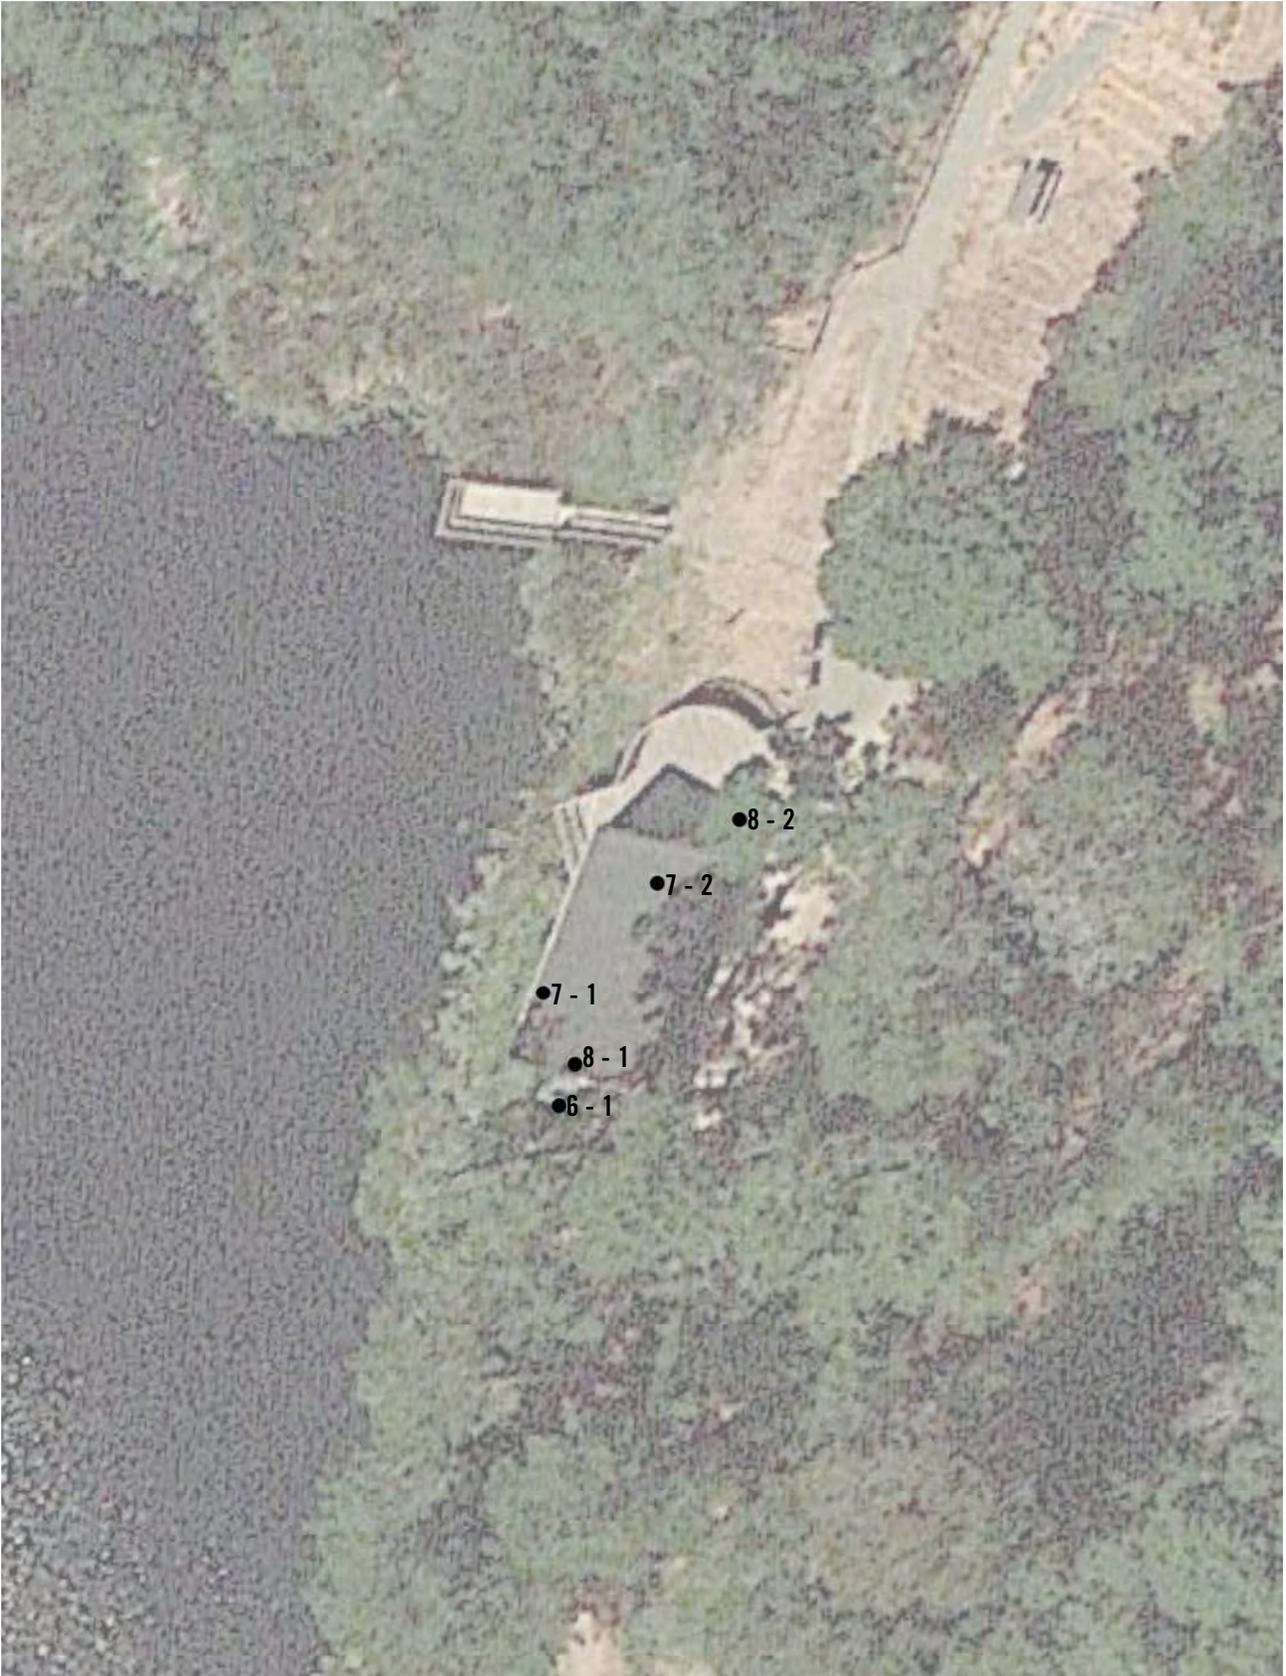
DAVID C. DANIELS NATURE CENTER BUILDING

Building	
8 - 2	Door/Gate Category: 1
Enlarge door opening	\$1,650
Notes: Height of clear opening at Nature Center door is 79-1/4" AFF (80" min).	
ADA: 404.2.3	
Other: CBC 11B-404.2.3	
Modify door window or side light	\$500
Notes: Lower edge of opaque door window is 50-1/2" AFF (43" max).	
ADA: 404.2.11	
Other: CBC 11B-404.2.11	
Attach loose mat to the floor surface	\$125
Notes: Door mat is not securely attached to ground surface.	
ADA: 302.2	
Other: CBC 11B-302.2	
Replace or modify door threshold	\$125
Notes: Door threshold has a vertical change of level of 1" (1/4" max or 1/2" max with a 1:2 bevel).	
ADA: 404.2.5	
Other: CBC 11B-404.2.5

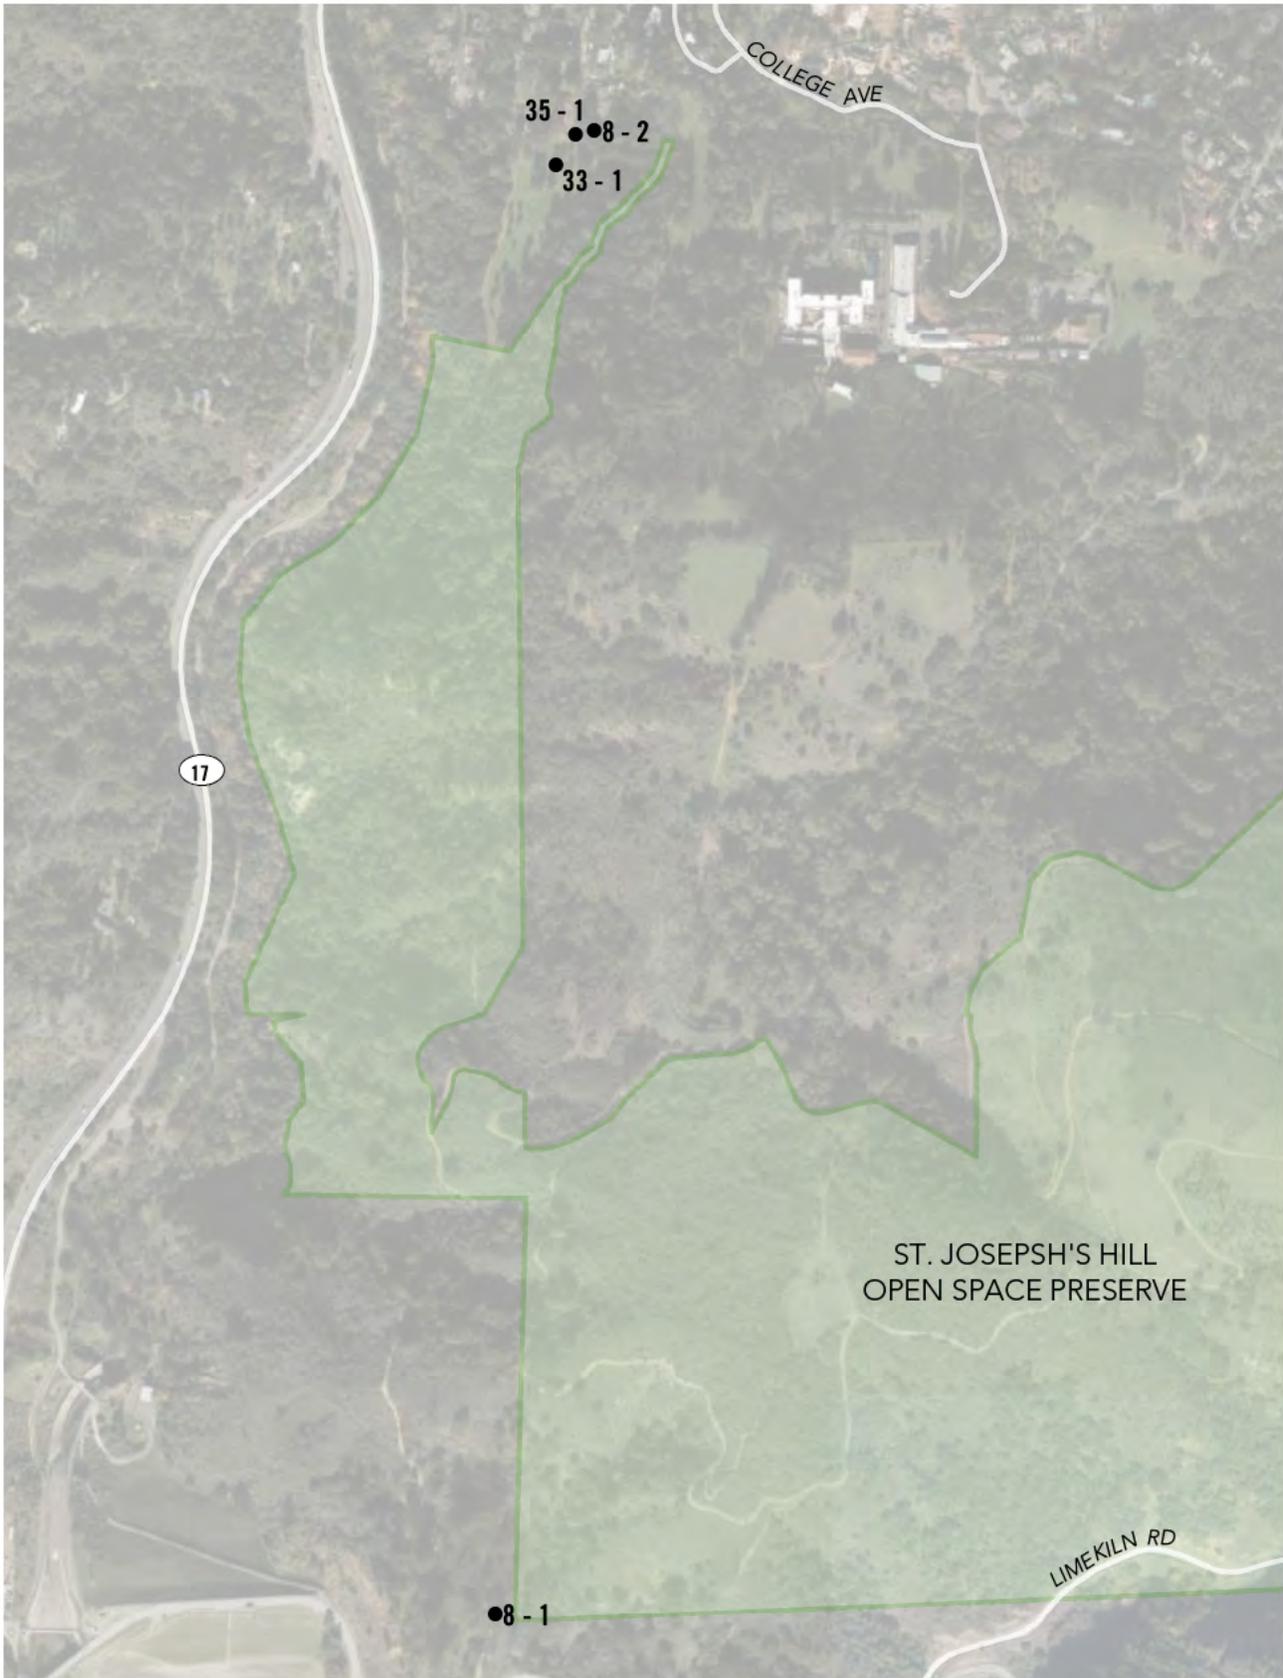
ST JOSEPH'S HILL PRESERVE

ADA: -		
Other: ABA 1011.2.1		
35 - 1	Other	Category: 2
Increase or provide maneuvering or clear floor area		\$500
Notes: Slope of the clear floor space at brochure box at northern Jones trailhead is 16.4% (5% max for natural surface).		
ADA: 305.3, 305.5		
Other: CBC 11B-305.5
