Midpeninsula Regional
Open Space District

Selection of Basis of Design Repair Options for the Mount Umunhum Radar Tower at Sierra Azul Open Space Preserve

Final Report

November 13, 2019

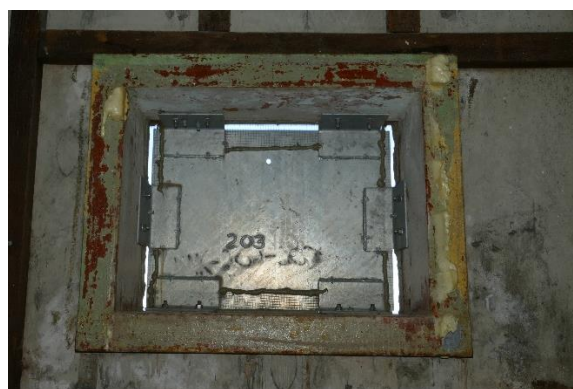
The exterior concrete walls have a variety of openings that served as windows, vents, louvers and removable panels for hoisting equipment (Figure 15). All of these openings have been closed off with steel plates or filled with concrete. The steel plates nearly fill the opening, allowing some ventilation (and moisture intrusion) into the building around their perimeter (Figure 16). Mesh installed in the perimeter gaps prevents wildlife intrusion. Reportedly some of these covers date from the building's operational period in the 1970s, but most were added in 2011 and 2016. At the top of the concrete walls, the roof slab extends past the exterior face of the walls creating a beam at the roof edge with a drip formed at the bottom edge.

Figure 16. Interior of similar opening in concrete wall with gap around steel plate perimeter.

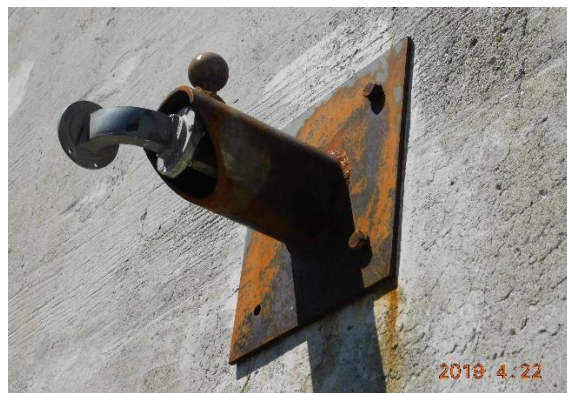
At the ground level, there are three single doors at the east wall and a double door at the west, all with covered exterior entryways (wind screens) constructed of concrete block walls and reinforced concrete slab roofs (Figure 17). There are a variety of small metal items embedded in, or protruding from, the exterior of the concrete walls including abandoned pipes, brackets, inserts, bolts, and other unknown items (Figure 18), as well as a newer stacked dipole repeater antenna at the building's northeast corner.

Figure 18. Steel fixture attached to concrete wall.

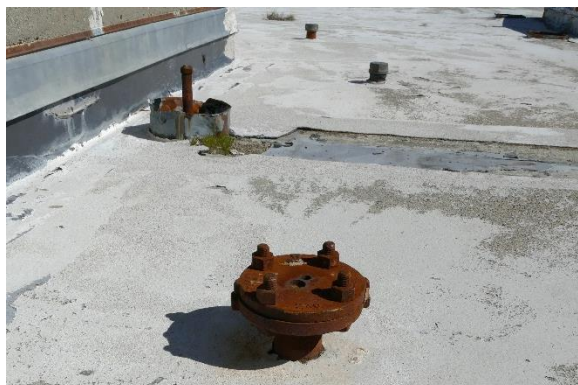
Figure 21. Various pipe penetrations, conduit in a pitch-pocket, and visible sealant repairs at the expansion joint. Photo facing north.

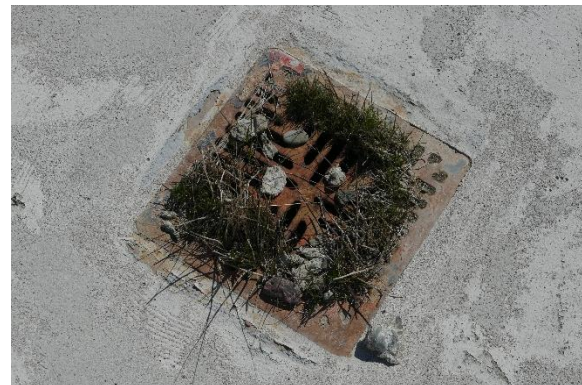
The roof is divided into quadrants by perpendicular expansion joints in the wearing slab (Figure 30) that do not extend through the structural slab (Figure 31). There is a roof drain (Figure 32) in the center of each quadrant, however the drain pipe was reportedly disconnected and sealed with grout to prevent animal intrusion. All four roof drains had plants growing out of them at the time of our observation.

Figure 32. One of four area drains with plants growing out of the drain.

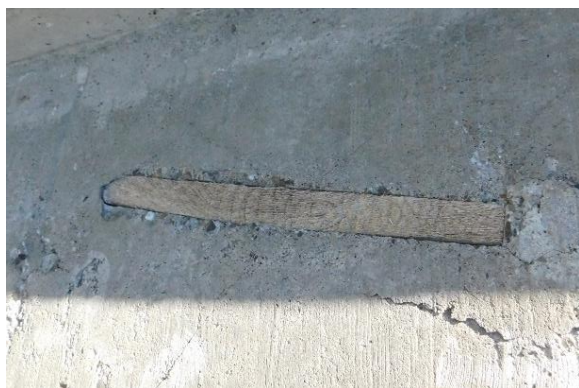
Figure 41. Piece of wood embedded in the concrete wall on the east elevation.

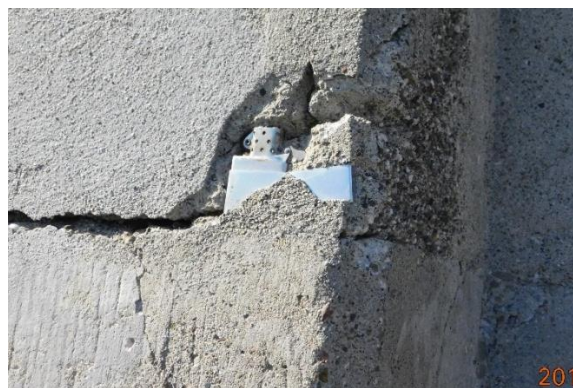
Figure 42. Cigarette lighter embedded in the concrete wall on the south elevation.

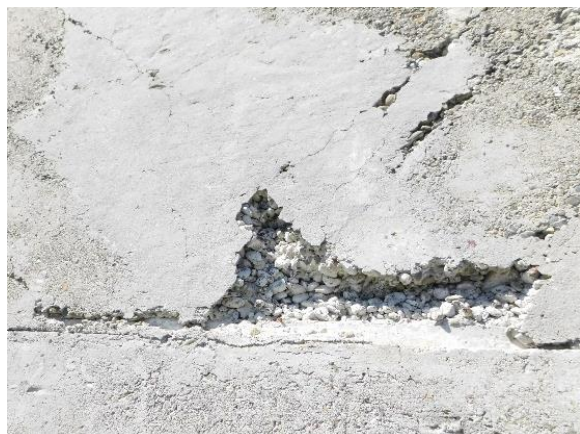
Areas of poor consolidation of the concrete are typically concentrated at the base of the walls immediately above the second through fourth floor slabs (Figure 43 and Figure 44). At these locations horizontal construction joints between the slab and wall concrete placements contain a key (a small formed ridge of concrete along the top of the top of the slab along and within the thickness of the wall to enhance the mechanical bond between the separately-placed slab and wall). At numerous locations, the poorly consolidated concrete extends sufficiently deep into the wall's thickness to expose the reinforcing steel. Acoustic hammer sounding suggested a majority of the concrete adjacent to the visible areas of poorly consolidated concrete with pockets of exposed aggregate are structurally sound, with aggregate well-bonded to the wall, despite their appearance and localized small areas of loose aggregate. Some of these areas of poor consolidation appear to have been modified at some time in the past, by the addition of a trowel applied patch material, possibly following initial concrete placement. These patches were identifiable by their surface finish and coloration, which distinctly differ from the cast-in-place concrete wall (Figure 43). Some of these patches appear to be delaminating from the concrete substrate.

Figure 43. Poorly consolidated concrete above the horizontal construction joint above the floor slab with a smooth patch area above.

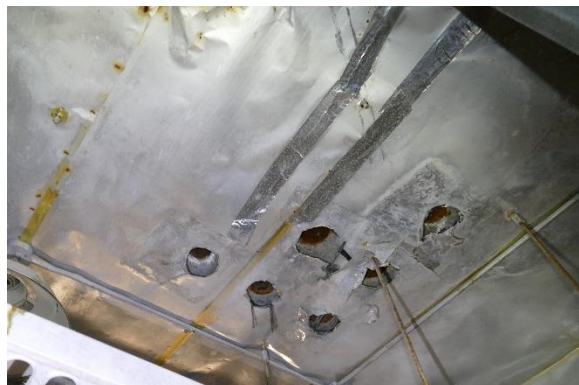
The ceiling beneath the roof is finished with aluminum sheets originally used as shielding (Figure 74), limiting direct observation of the underside of the structural slab. These aluminum sheets are generally oxidized, indicating long-term exposure to moisture, and there are signs of leakage at multiple areas throughout the ceiling including staining, heavier corrosion and efflorescence at the aluminum sheeting and adjacent materials (Figure 75). Several steel beams which serve to anchor steel rods extending through the roof slab that are visible at the underside of the roof have surface corrosion (Figure 76). Although the aluminum sheets prevent direct observation of the roof slab, the presence of staining of the aluminum sheets

indicates water leakage through the roof slab and some degree of corrosion of the reinforcing steel within the roof slab is likely.

Figure 74. Aluminum sheets installed beneath the roof slab are noted as radar shielding in the construction drawings.

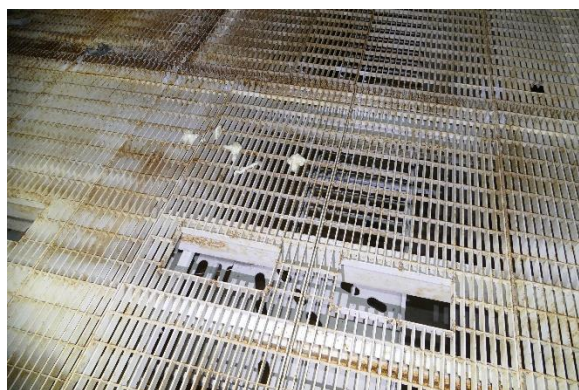
Several abandoned openings (former mechanical penetrations) in the floor slabs are covered with metal plates which may date to the building's decommissioning, but most floor openings are covered with plywood fastened to the floor, reportedly installed in 2016. The metal plates typically have surface corrosion (Figure 82), and the wood covers are generally in fair condition (Figure 83), though ongoing deterioration of these wood covers should be expected given the indications of moisture intrusion throughout the building. The metal grate floor of the fifth-floor mezzanine has a number of rectangular holes (Figure 84) that someone could be injured by stepping into, and generally has surface corrosion (Figure 85).

Figure 84. Rectangular holes in the mezzanine floor grating are large enough to accidentally step through.

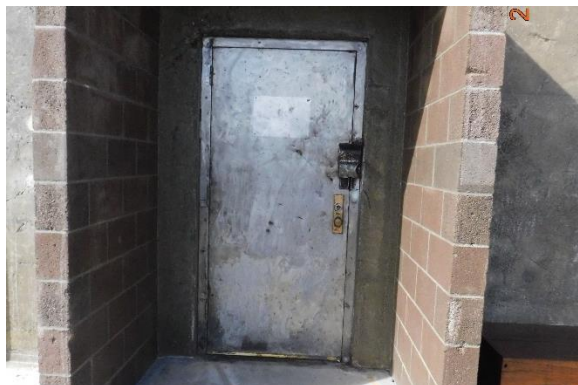
The paint has been removed from the two remaining exterior doors, exposing bare steel. Based on the absence of surface corrosion, the doors are assumed to be constructed of stainless steel. Both doors appear to be relatively secure and resistant to tampering, and have key-operated locks.

Figure 86. Steel door at south of east wall.
