Approval of Basis of Design recommendations to complete the Deer Hollow Farm White Barn Structural Stabilization Project at Rancho San Antonio Open Space Preserve

### **Basis of Design**

December 18, 2019  
WJE No. 2018.0646

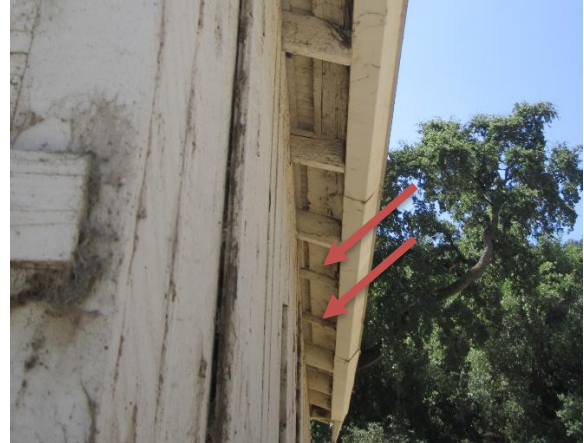
*Figure 9. Two rafter tails have been cut and are half the depth of other rafter tails.*

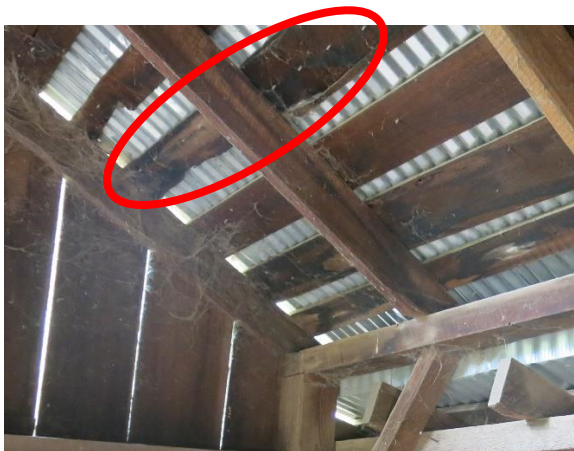
The underlying wood skip sheathing consists of 1-inch nominal boards with widths ranging from 4 to 12 inches in the center gable roof and 4 to 7 inches in the shed roofs. The spacing between the skip sheathing is consistently between 2 to 4 inches (Figure 11). Visible from the underside of the roof, there are areas where numerous fasteners were used during the installation of the roof panels have penetrated the underlying wood skip sheathing (Figure 12) or are not installed into the sheathing (Figure 13).

*Figure 12. Numerous fastener penetrations for roof panels.*

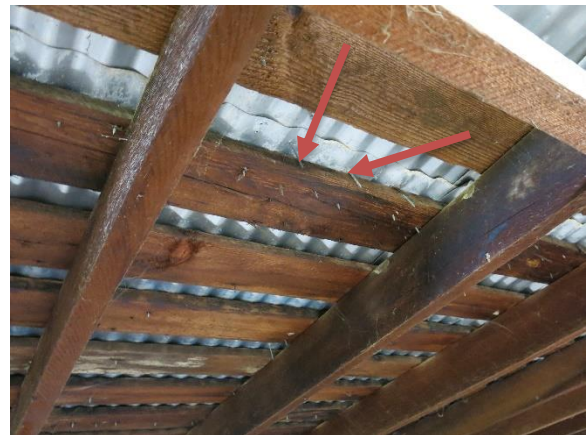
*Figure 13. Fasteners not attached to the wood skip sheathing (arrows).*

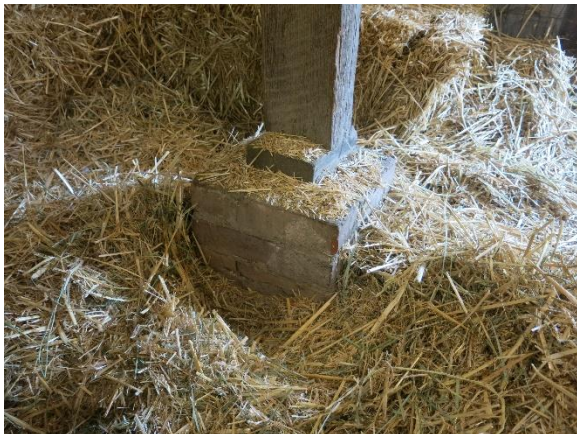
*Figure 24. Wood post supported on square brick footing.*

The wood columns are supported by wood shims on top of the brick footings that 12 inches square. The height of the brick footing above the adjacent ground varies from less than 4 inches to about 9 inches (Figure 45). The sizes of the footings below grade are not known. There is no observable structural connection of the column or wood shim to the brick footing (Figure 46). The brick footings appear to be in good condition with no obvious indications of deterioration, such as cracking or deterioration of the mortar. Since there is no damage to the footings, there is no CEBC requirement to upgrade the footings. However, voluntary strengthening of some of the footings may be performed where, based on our analysis, the soil pressures at the footings for design loads exceed the allowable bearing pressure provided by the geotechnical engineering report and to address the lack of connection of the columns to the footings.

Our preliminary analysis found that at some of the columns, the bearing pressure on the soil due to the design loads exceeds the allowable bearing pressure. This is based on the assumption that the footings are 12-inches square, as measured above the ground surface. If the footings increase in area below grade, most of the footings are adequate for gravity loads; however, footings that are required to resist wind and seismic loads will likely need to be enlarged by approximately 6 inches on each side.

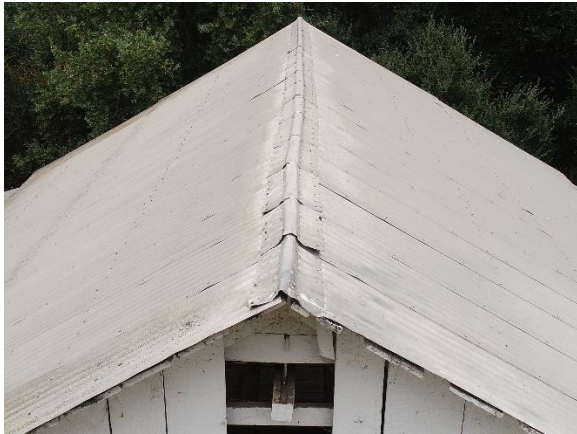
The corrugated metal roof panels are in fair condition. On the east side of the center gable, there appears to be biological growth and soil accumulation on the metal panels themselves as well as at the transition to the shed roof (Figure 28). Fasteners have become dislodged and are protruding from the roof surface (Figure 29). Several small holes were observed in the roof panels and leaking of the roof during rainstorms was reported. The ridge cap flashing is also showing signs of distress and fasteners are beginning to protrude from the roof surface at this location as well (Figure 30). The gutters on the east and west shed-roof eaves appear to be in fair condition when observed from the ground level. However, it is unclear how the gutters are flashed due to limited access. At the short gutter on east side of the barn, because there is no downspout, holes have been punched into the bottom of the gutter at one side and the gutter is beginning to corrode (Figure 33). At the west eave, where the gutter is attached directly to the rafter tails, we observed one rafter tail that was deteriorated (Figure 31). On the east side, where fascia is present, there are roughly six rafter tails that are deteriorated (Figure 32).

*Figure 30. Distressed ridge flashing.*

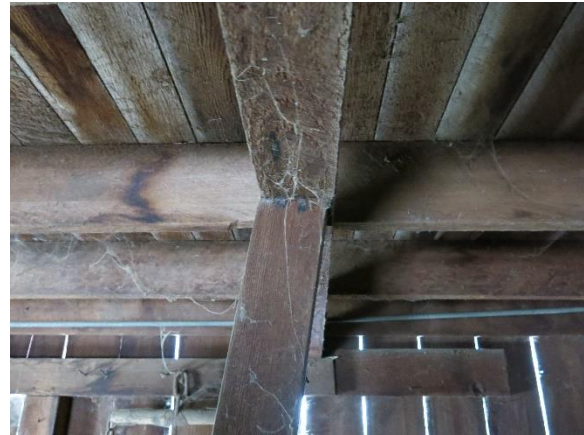
In the east section of the barn, the attic joists are supported by a wood beam that spans across the width of the building. At the north and south ends, this beam is supported by a wood beam that is an extension of the door header (Figure 47). On the interior, the attic beam is supported by five wood posts that are located between the former horse stalls. These posts are installed with a slope and are supported on the wood floor (Figure 48). The support framing for these inclined columns as well as the wood floor is unknown. Given that the wood flooring in the east section is decayed, we have assumed that the bases of these inclined columns are also damaged due to decay and that the bases of the posts will need to be strengthened to meet CEBC design requirements.

*Figure 48. Sloped wood column supporting attic beam.*

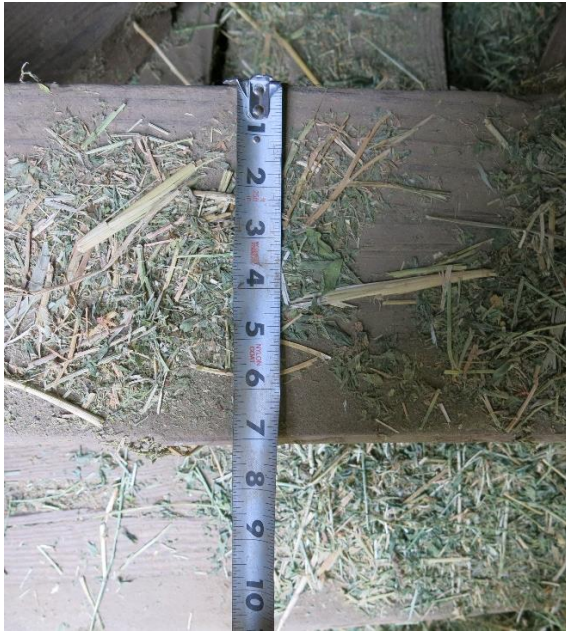
The wood stairs that provide access to the attic are not compliant with current building requirements, but the CEBC allows existing stairs and handrails to remain. The depth of the treads varies and is typically about 7 inches, which is less than the required width of 11 inches (Figure 51) and the height of the risers is typically about 10 inches, which is greater than the required maximum riser height of 7 inches (Figure 52). The width of the stairway is less than the current building code required minimum width of 36 inches. In addition, a handrail exists on only one side of the stair and the handrail does not meet the building code requirements for hand-grasp or extension at the top or bottom.

*Figure 51. Horizontal width of attic stair tread.*

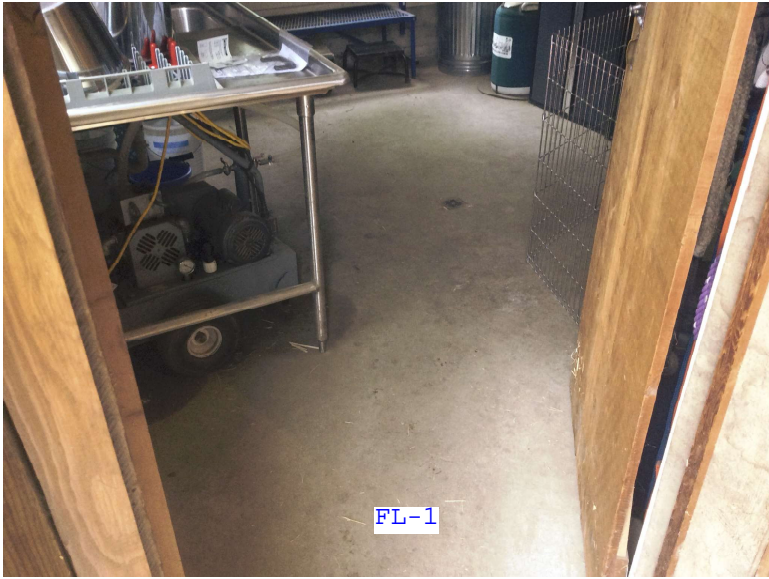
FL-1

Material ID	Non-asbestos Materials
FL-1-1,2	Gray concrete perimeter foundation wall (-) around milk room
WL-2-1,2	Gray concrete slab (-) in milk room
FOOT-3-1,2	Red brick (-) w/light gray mortar (-) support footings
CAULK-4-1,2	Off-white exterior caulking (-) around vinyl windows
ASPHALT-5-1,2	Black asphalt (-) ramp
FLOORS-NNN1	Dirt or wood floors
WALLS-NNN2	Wood walls
ROOF-NNN3	Corrugated metal roofing
ROOF-NNN4	Wood roofing shingles (No felt paper observed below shingles)

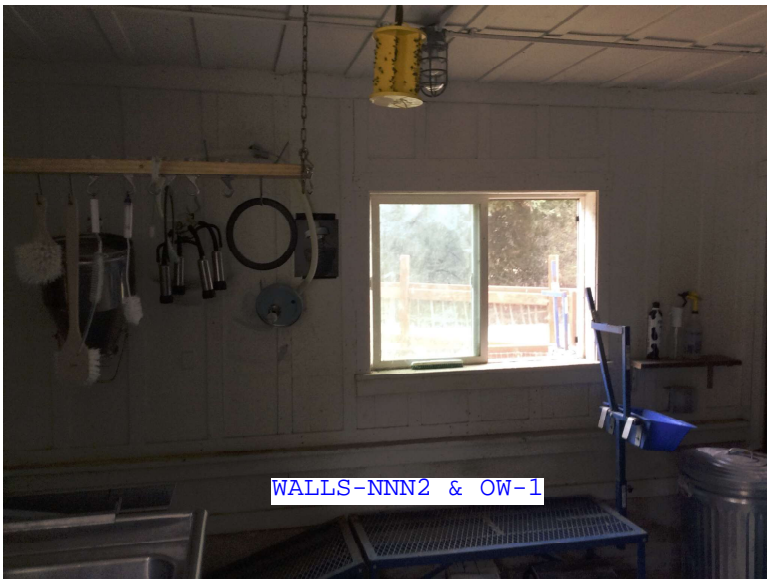
WALLS-NNN2 & OW-1

Sample ID	Location	Structure	Substrate	Color	FAA Results (ppm)	Condition
OW-1	Interior	Walls and ceilings	Wood	Off-white	<80	Intact
OW-2	Exterior	Walls	Wood	Off-white	<80	Loose & peeling

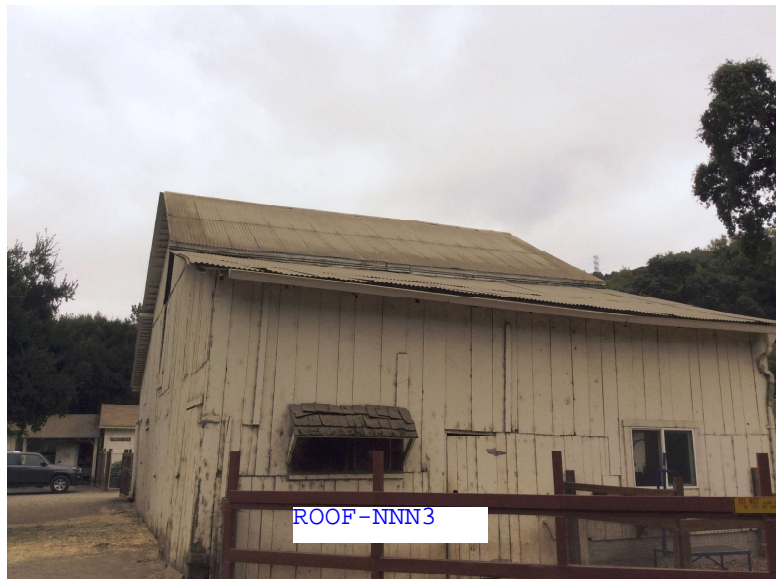
ROOF-NNN3	Corrugated metal roofing									SF			2200		2200	
ROOF-NNN4	Wood roofing shingles (No felt paper observed below shingles)									SF			20		20	
<b>LEAD</b>																
<b>PPM</b>																
OW-1	Off-white interior paint on walls and ceilings								<80	SF	PNQ				PNQ	
OW-2	Off-white exterior paint on walls								<80	SF				PNQ	PNQ

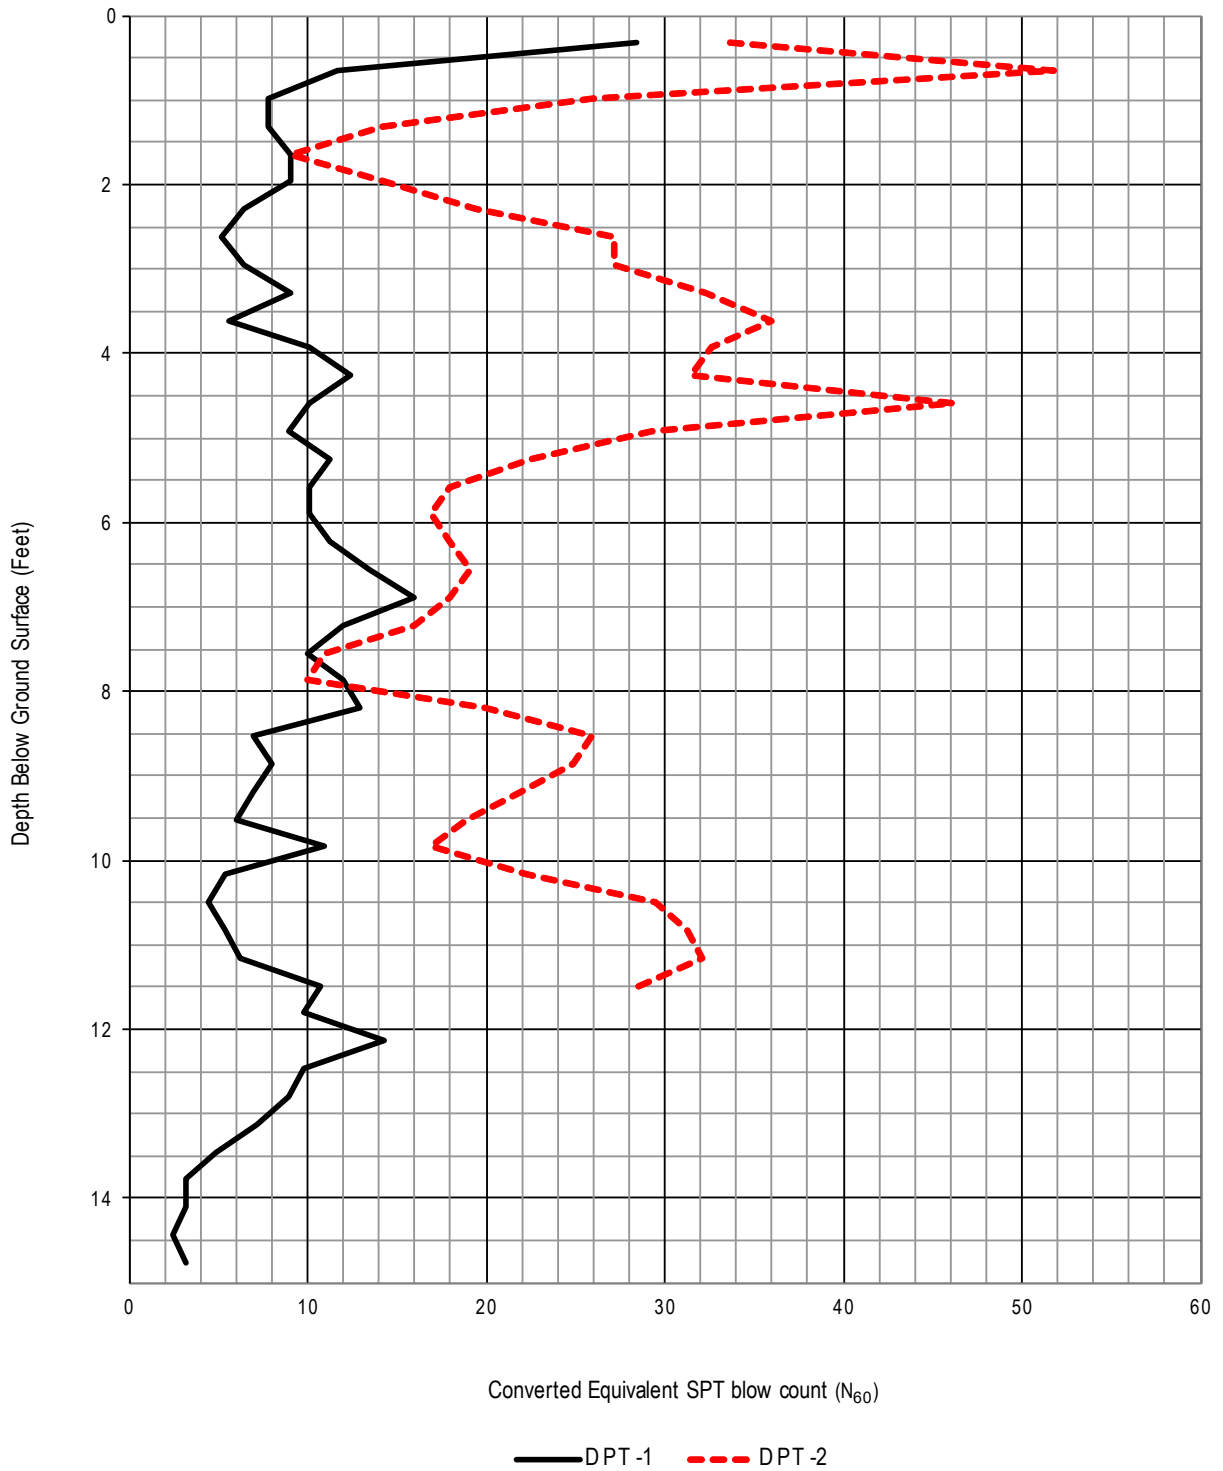
Figure  
**3**

the probe were converted to equivalent Standard Penetration Test (SPT) N-values for use in estimating the strength of the soil. The DPT results for DPT-1 and DPT-2 are presented on Figure 3.

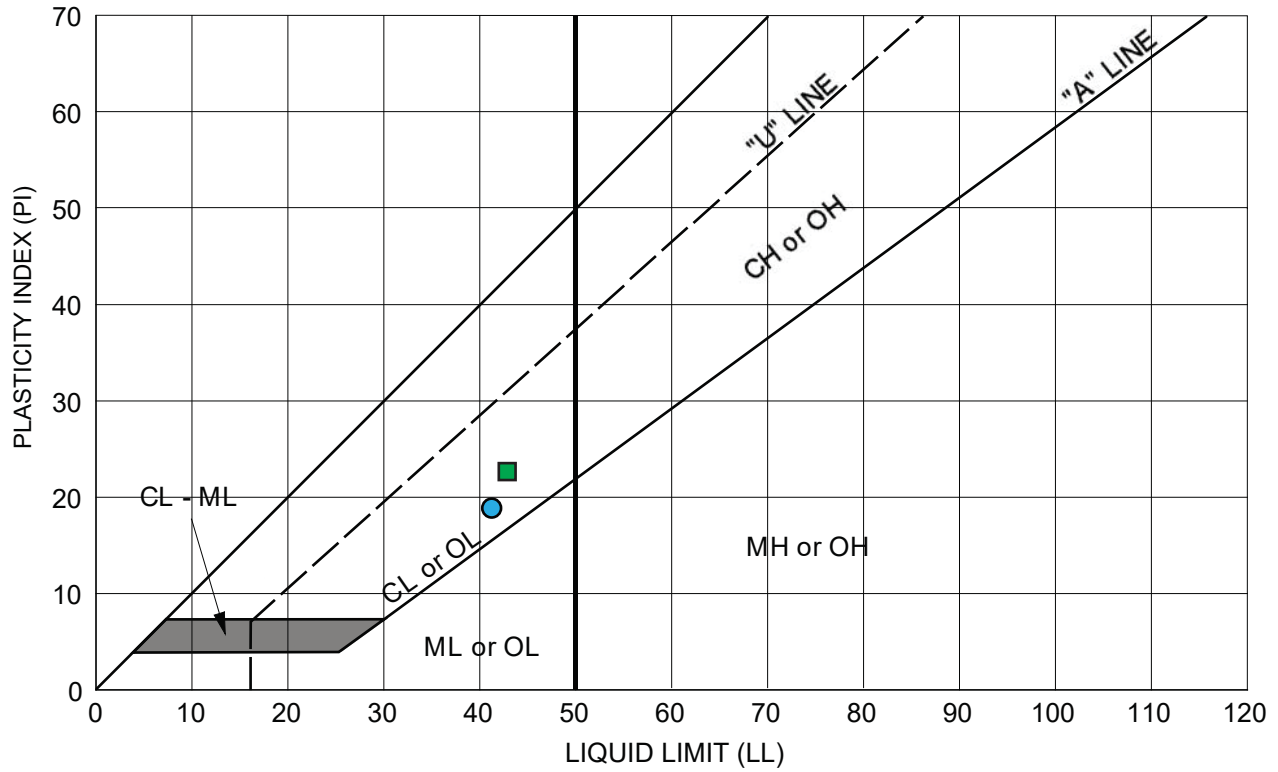
1. The results of the Atterberg Limits test are also presented on Figure 4.
2. The soil was logged in accordance with the soil classification system described in Figure 5.

Symbol	Source	Description and Classification	Natural M.C. (%)	Liquid Limit (%)	Plasticity Index (%)	% Passing #200 Sieve
●	HA-1 at 1.5 feet	CLAYEY SAND (SC), dark brown	19	43	22	--
■	HA-2 at 1.5 feet	CLAYEY SAND (SC), dark brown	12	41	19	--

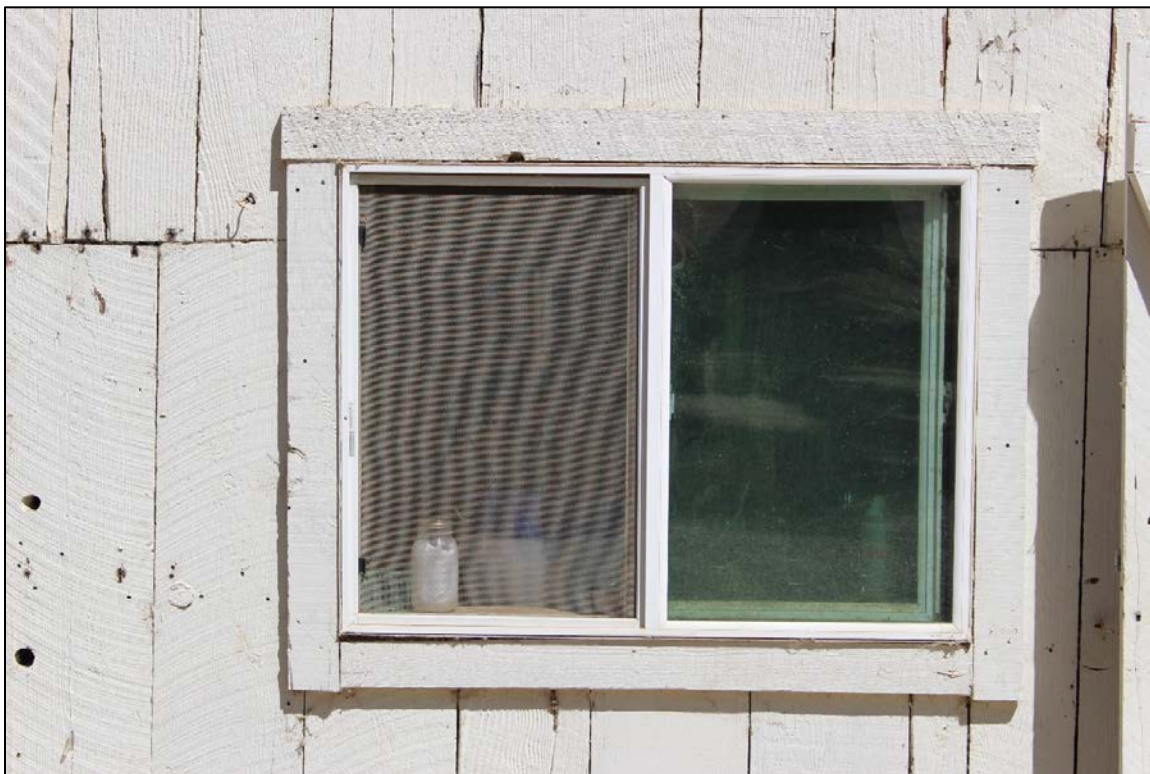
Since the time of completion, the barn has undergone alterations within the interior and to the floor and exterior of the Milk Room. Within the interior, horse stalls and hay compartments were installed. The barn was also retrofitted with electricity to accommodate overhead lighting in all three sections. The Milk Room is the most dramatically changed. Per the 2016–2017 building permit, the Milk Room was renovated to include installation of a shallow dug concrete drainage floor and solid walls. The walls on the southern and western sides included framing and installation of vinyl sliding windows (Photo 9), in compliance with the 2016 California Building Code. Wood cladding was cut to provide concrete stem walls.

**Photo 9.** Detail of vinyl window installed during milk room renovation, view southeast.
