Midpeninsula Regional
Open Space District

R-20-35
Meeting 20-08
April 8, 2020

Select a design alternative for the La Honda Creek Redwood Cabin, La Honda Creek White Barn, and Sierra Azul Beatty House

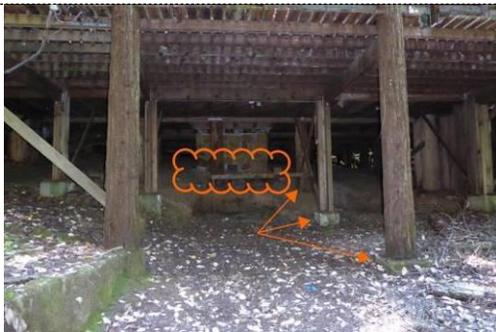
Figure 1

Central chimney supported by stone masonry foundation. Wood posts on the Eastern half of the building mostly standing directly on concrete foundations while those corresponding to the western half are embedded directly into the ground.

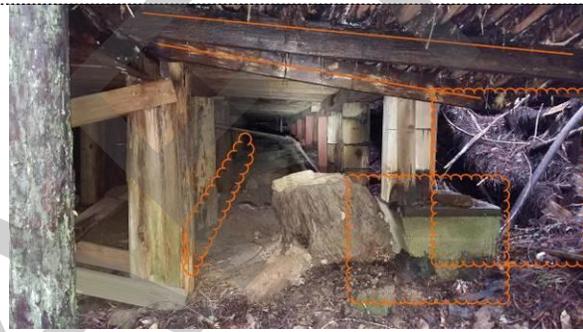
Figure 2

Different foundation systems for the wood posts appear to contribute to differential settlement of the structure, leading to the collapse of some sections of the porch and observed displacement of various architectural elements.

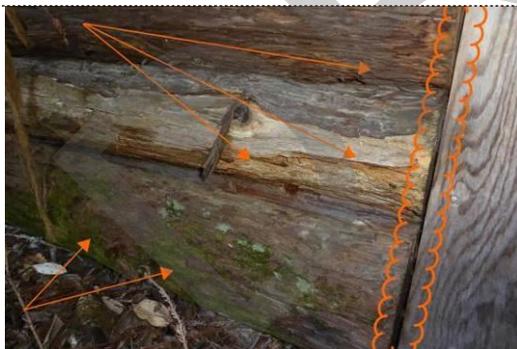
Figure 3

Deterioration of base of wall logs in the façades, including natural growth of moss and lichens, rot, loss of wood mass due to insect attacks (including termites). Separation from other elements such as door frames causes openings that facilitate the entry of humidity and organic attacks.

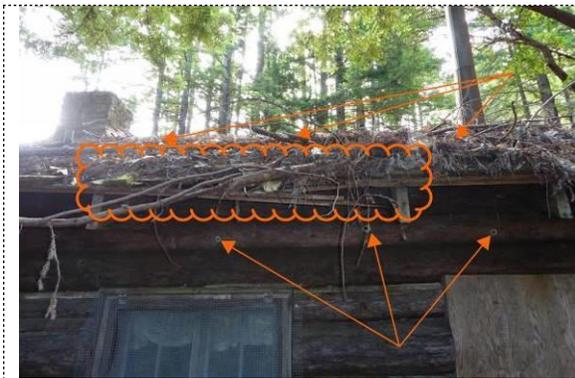
**Figure 4**

Ending edge of roof slope with deteriorated framing and supporting elements. Accumulated leaves, branches and debris increasing roof bearing load, and increasing water retention

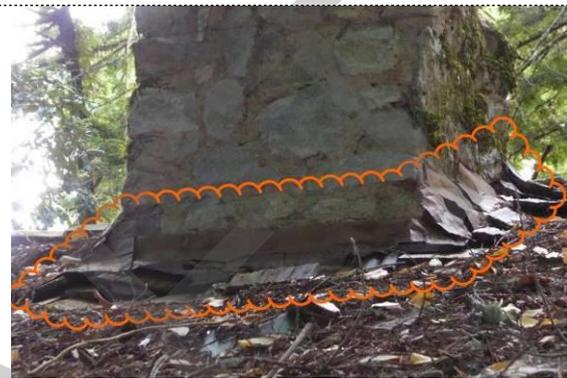
**Figure 5**

Joining of chimney and shingling. Differential movements of the wood structure elements with the stone masonry of the chimney have displaced the original position of the joining elements, creating openings that allow water intrusion around the chimney penetration.

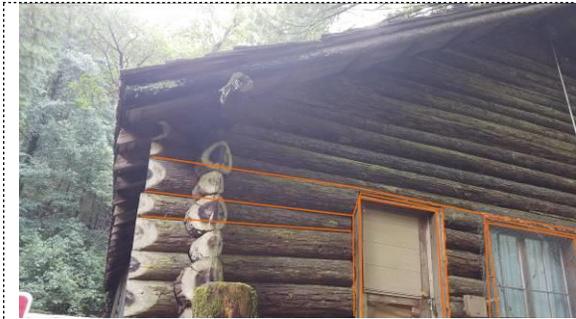
Figure 6

Effects of differential settling of supporting piles on North façade, displaying logs with loss of horizontality, and several logs displaced from the vertical plane of the wall. Evident signs of natural growth and other deterioration

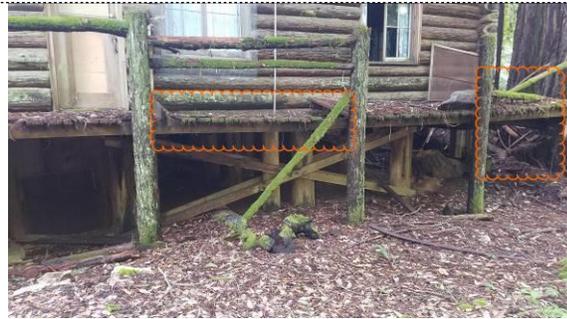
Figure 7

North side and North-West corner of porch partially collapsed due to differential settlement of supports. Several elements of the railing are missing or have collapsed

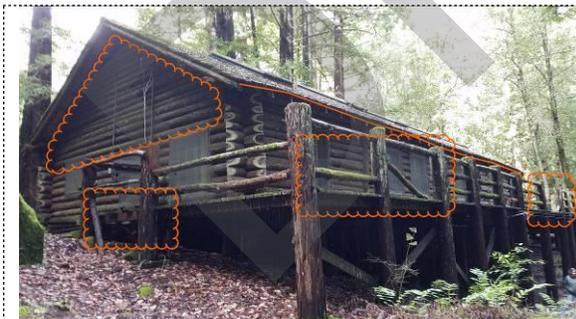
Figure 8

Partial collapse of floor boards at East porch. Several elements of railing are missing or have collapsed. Top half of log façade has several logs out of the vertical plane as they don't have the half log joint at either end to provide them with necessary stability. Warping and combing of roof structure clearly visible at the edge line.

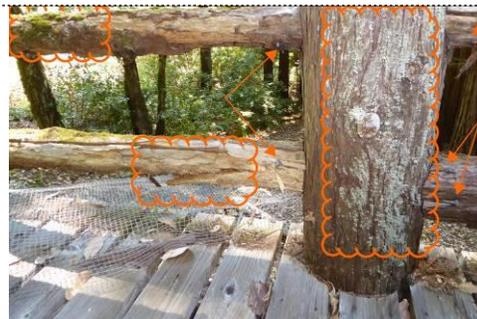
Figure 9

Deterioration of railing elements. Inefficient nailing originating cracks that facilitate termite and other insects' entry. Loss of mass of wood elements. Natural growth of moss and lichens

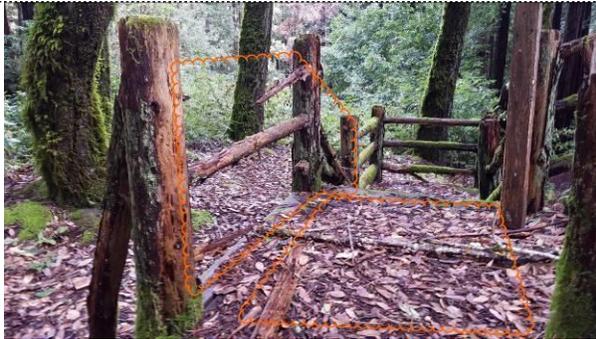
Figure 10

Railing of access stairs severely deteriorated in some sections. Natural growth of moss and lichens, evident display of termite and other insects' attacks and loss of mass of wood elements. Flooring covered with leaves and debris retaining humidity and increasing rot, growth and insect damage possibilities

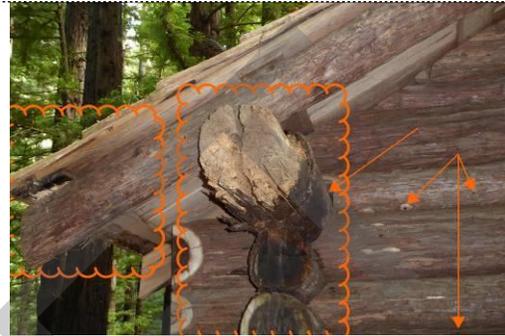
Figure 11

End of façade logs displaying evidence of mass loss, rot and high degree of humidity. Ring structure allows to consider logs from 2nd or 3rd growth woods. Higher deterioration of roof edge elements for lack of protection. Visible holes of insect attacks and damages. Opening at log joints allowing rodent entry.

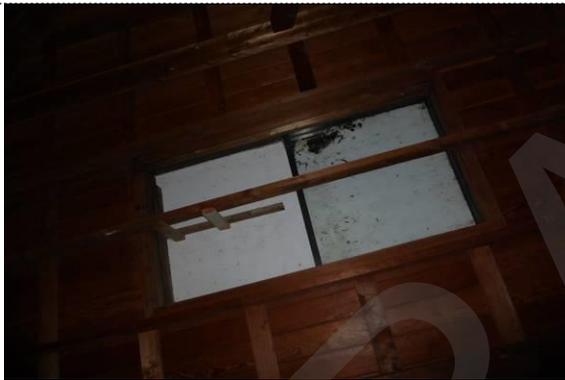
Figure 12

Skylight with broken glass possibly by fallen branch or excessive bearing load

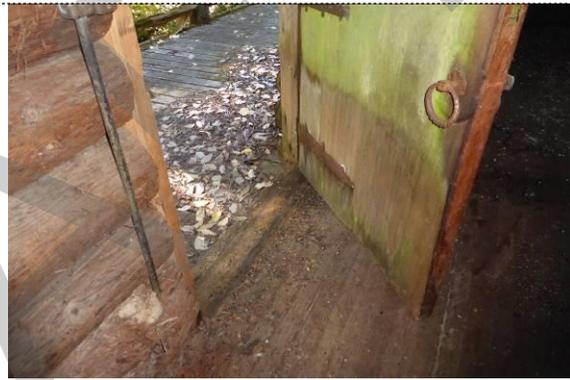
Figure 13

Primary entrance door. Sill shows heavy wear. Door and frame show biological growth and humidity. Current maximum opening 45 degrees.

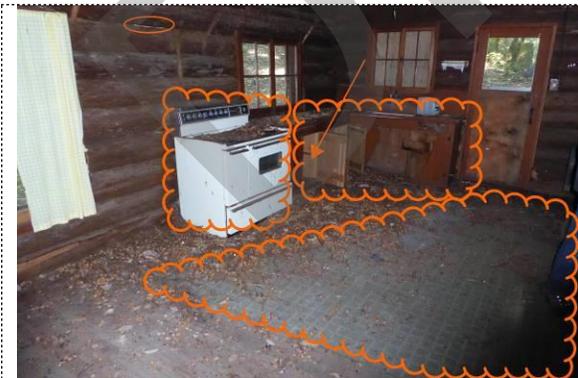
Figure 14

Kitchen area with estimated original mounted cabinets, modern oven and cooktops. Opposite is a wood fire stove with metal chimney. Some logs leave gaps and crevices due to shrinkage for humidity loss.

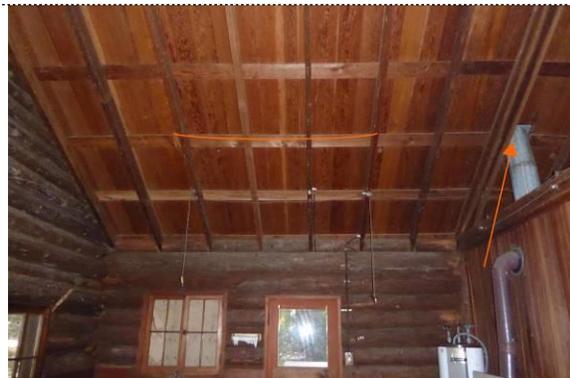
Figure 15

Roof framing appears to be in good condition. Some sagging in center sections between trusses. Exit through the roof of wood fire stove

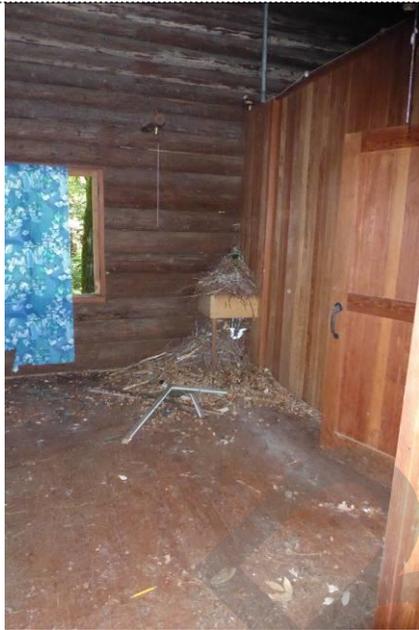
Figure 16

Woodrat nest next to north façade

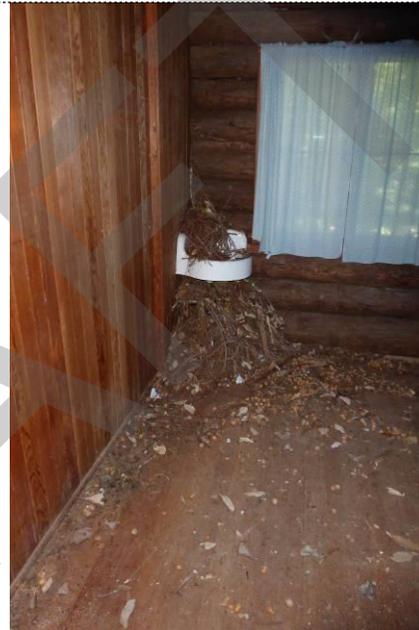
Figure 17

Woodrat nest next to north façade

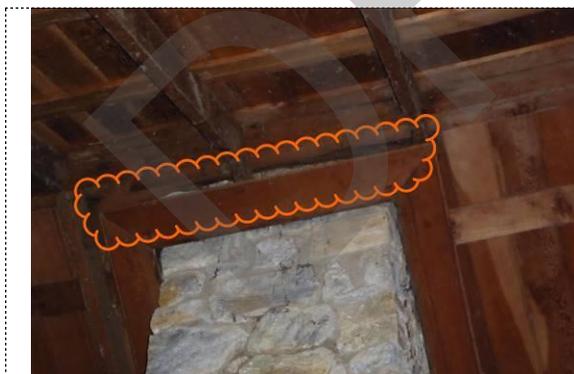
Figure 20

Separation between chimney and roof framing due to differential settling

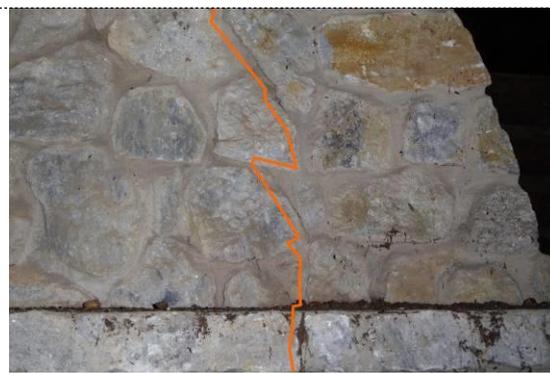
Figure 21

Crack along the center of the chimney originated by tensional differences from structure movements.

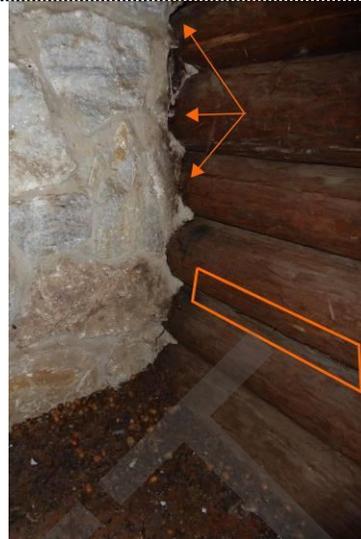
Figure 23

Decrease of log volume due to natural drying originates crevices and descent of total height of walls.

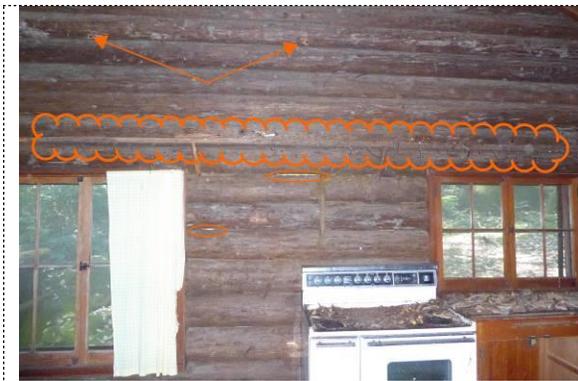
Figure 24

Kitchen area with estimated original mounted cabinets, modern oven and cooktops. Some logs leave gaps and crevices due to shrinkage for humidity loss. Logs out of plane for insufficient joining. Damages from termites and insect attacks

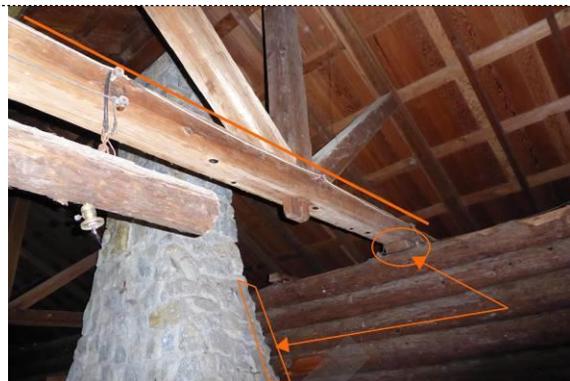
Figure 25

Shrinkage of wood originates differential movement from the chimney and trusses, creating separations and crevices between these elements. Electric wiring over top of log wall and side of truss beam.

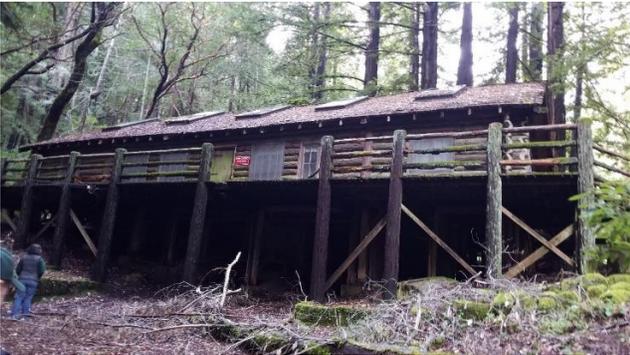
Photo 1. Front (east elevation) of structure, facing west (note missing guardrails)

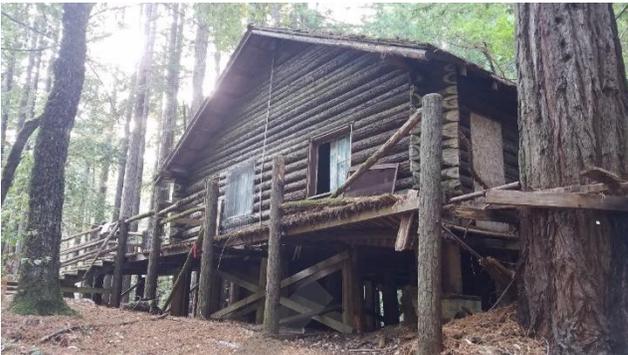
Photo 2. North elevation of structure, facing southeast (note collapsed deck area, failed railings and log wall displaced out of plane, observable by bend in conduit)

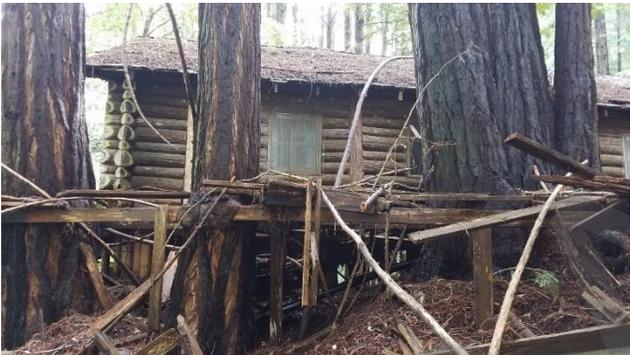
Photo 3. Partial rear (west) elevation of Structure, facing east (note collapsed deck framing)

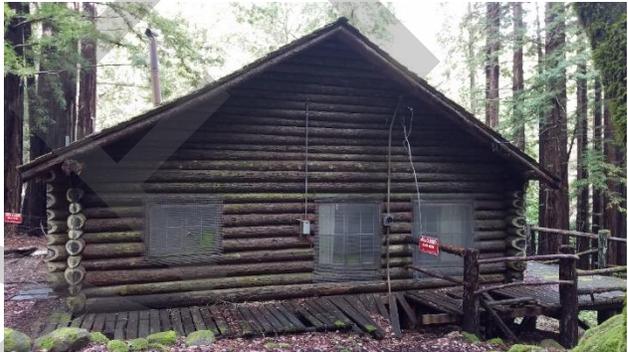
Photo 4. South wall elevation (note collapsed deck framing)

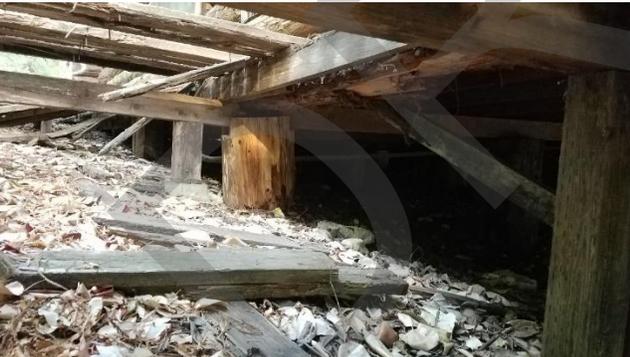
Photo 5. Log pole at south elevation (note severe rot and soil in contact)

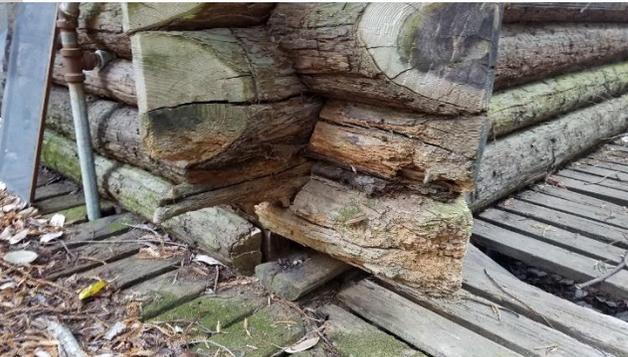
Photo 6. Close up of one of the areas of log wall corners showing signs of significant rot/decay

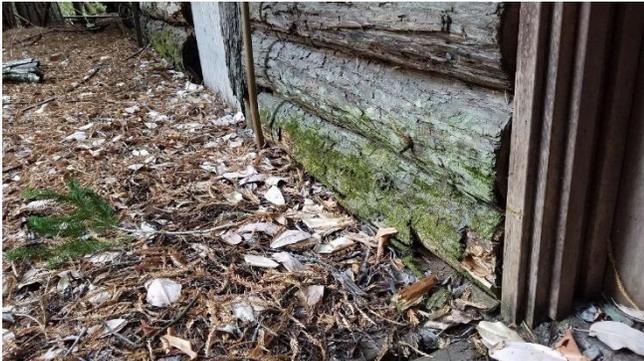
Photo 7. Area of base of log wall showing rot/decay (note buildup of debris on porch)

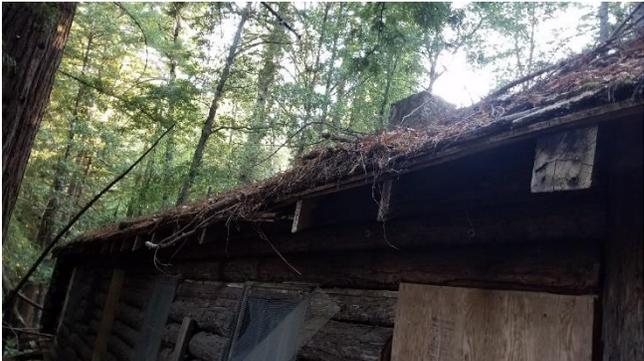
Photo 8. Location where significant buildup of leaves and debris have accumulated on the roof

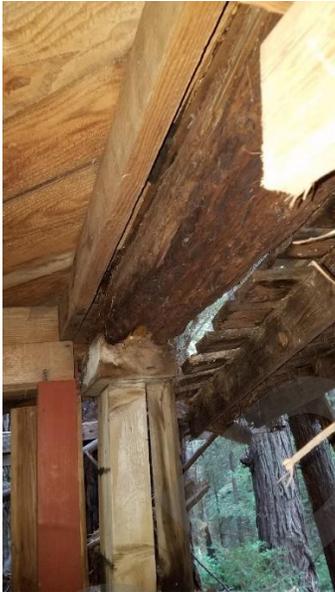
Photo 9. Area where dry rot/deterioration of base of log wall at corner of grid line D-1 was observed. This is likely a substantial contributor to the settlement observed in this area of the building.

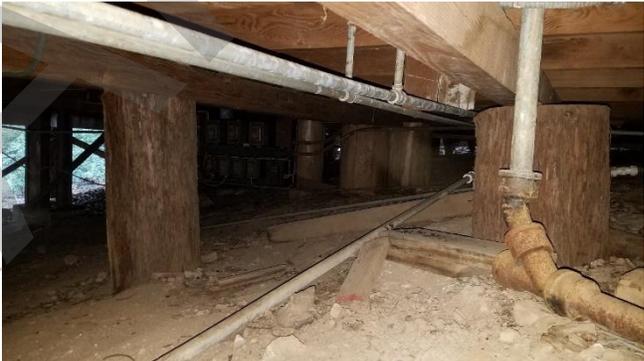
- The log poles at the building's interior, which have remained relatively dry are still mostly intact, though at all locations at the building's perimeter, rot and decay is observable in the post bases that are set directly on grade. The above-grade portions of the poles were typically found to be in a reasonably good condition (see Photo 10).

At the ground floor level, the flooring is composed of horizontal wood flooring directly over 1x8 diagonal lumber sheathing which serves as the building's floor diaphragm. The sheathing is supported by 4x6 (nominal) floor joists spaced at 24" on center (see Photo 10). The floor joists span between girder lines below the building's exterior walls as well as interior girder lines, resulting in maximum joist spans between 7'-0" to 9'-6" on center. No blocking or hardware was observed between the joists and girders. The girders are typically 4" to 6" wide and were notched in many locations at the ends to bear directly on the log poles below. The floor framing was observed to be in fair condition throughout. The log walls bear directly on top of the supporting vertical log poles below, with additional sawn lumber girders set adjacent to them for support of the floor framing. No positive connections were observed between the floor framing and the log wall elements. The log poles are typically spaced closer together and generally align below the bearing log wall lines above.

Photo 10. Ground floor framing and Interior log poles set directly into grade. Interior conditions are in fair condition.

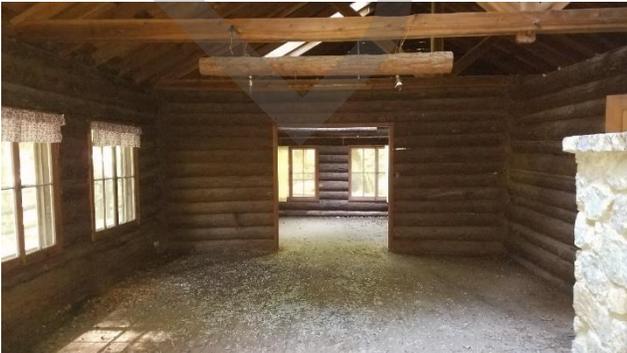
Photo 11. Interior view of main living room (note truss chords bearing on interior log walls and gaps evident between horizontal logs).

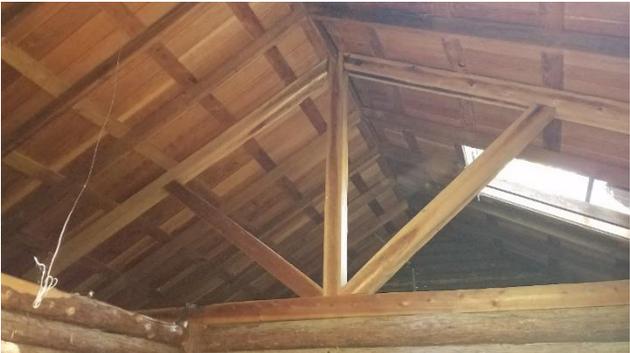
Photo 12. Interior view of roof framing, note gap at top chord showing evidence of load redistribution due to settlement of substructure.

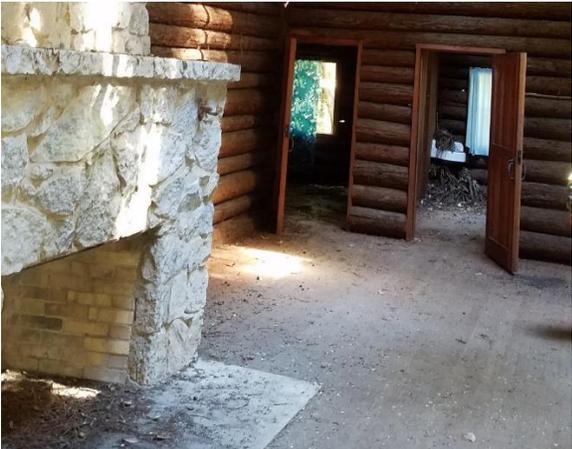
Photo 13. Woodrat middens in fireplace and bedroom beyond.

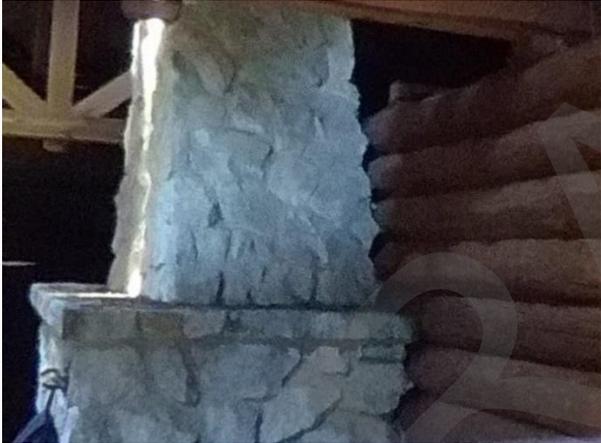
Photo 15. Settlement evident at displaced gaps between log wall and chimney.

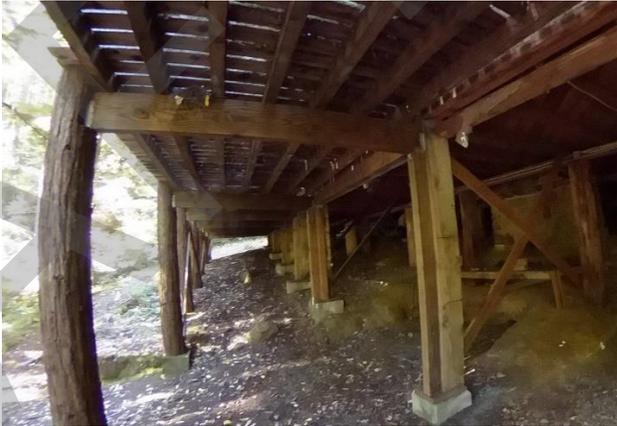
Perimeter walls and two interior transverse walls are present as lateral force-resisting elements, as shown in Figure 1. The diagonal lumber floor diaphragm transmits loads to the diagonal bracing at the cripple wall level below. The lateral framing below the ground floor (crawl space) is composed of irregularly spaced 2x wood bracing that does not appear to be of original construction, that are connected to wood poles (see Photo 16).

Photo 16. View of underside of deck and crawl space framing at east side of building (note concrete footings, fasteners and modern preservative treated lumber which shows that framing is not original).

- 6x members (see Photo 16) that do not appear to be positively anchored or well connected. These post bases are set on small concrete spread footings and many have had 2x brace elements added to them. See BOD summaries below for specific stabilization recommendations for each option.

- i) **Recommendations**
 - i. Due to lack of redundancy and capacity of existing crawl space bracing, strengthening of the braced bays in the crawl space is required to ensure structural adequacy. Additional braced bays should be provided to increase redundancy and limit brace and foundation demands on any individual elements. At least 1 bay of bracing with braces oriented to resist compression and tension loads should be provided below all exterior wall lines.

- ii. The existing brace connections are inadequate to develop the buckling/yield capacity of the braces. Of concern is the lack of anchorage at the brace to foundation connection which is necessary to resist the vertical reaction from the brace. Complete replacement of the existing deficient braces and their connections is recommended.

- iii. The existing log frame columns and anchorage are inadequate to resist axial forces due to frame overturning. The columns supporting new braced bays should be founded on new concrete footings designed to resist potential uplift and should have positive connections anchoring them to the log poles and bracing elements.

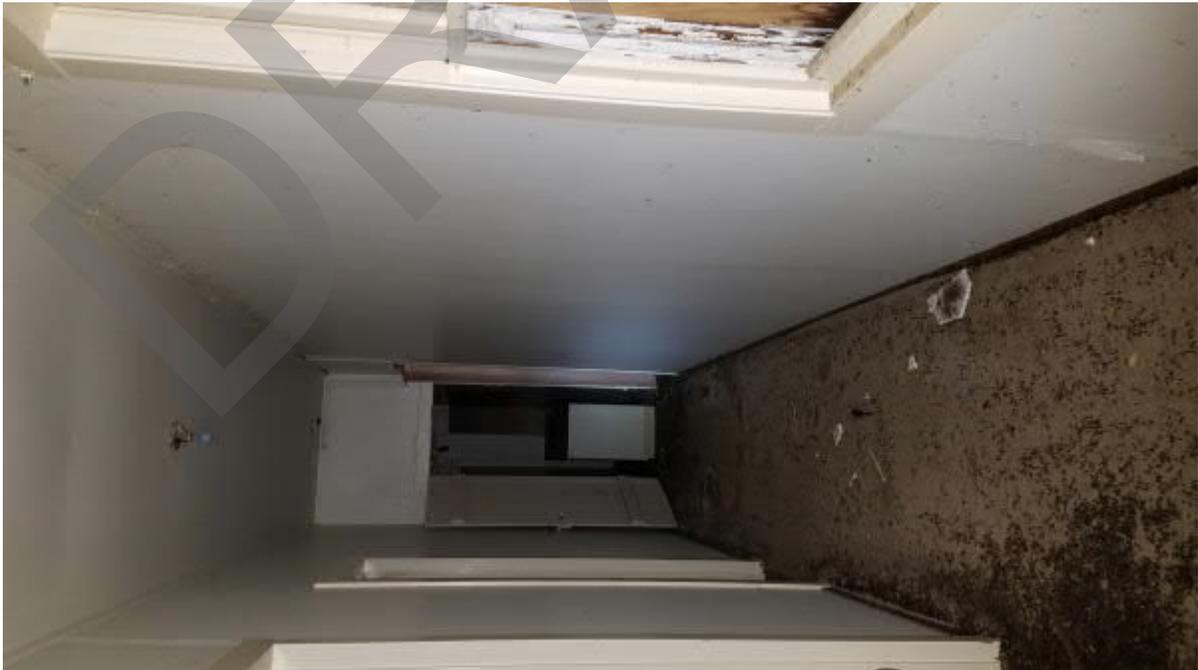
Photo 4 Material 204 - ACM joint Compound on wallboard walls and ceilings in the Beatty House

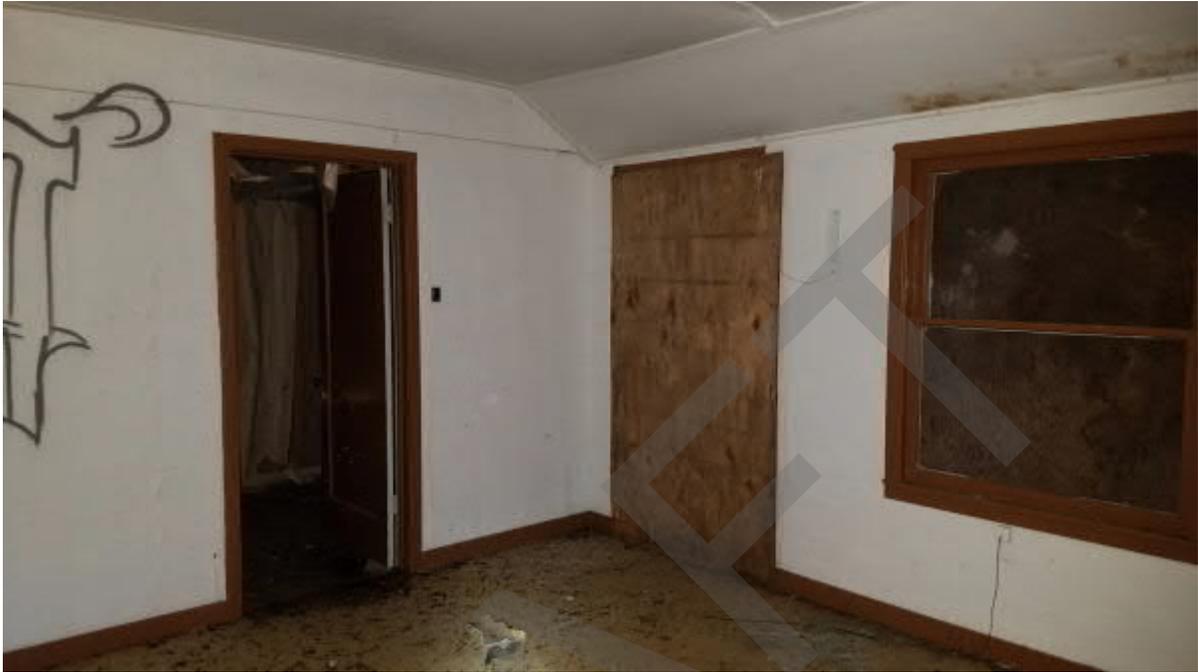
Photo 5 Material 201 ACM vinyl sheet flooring in the Beatty House

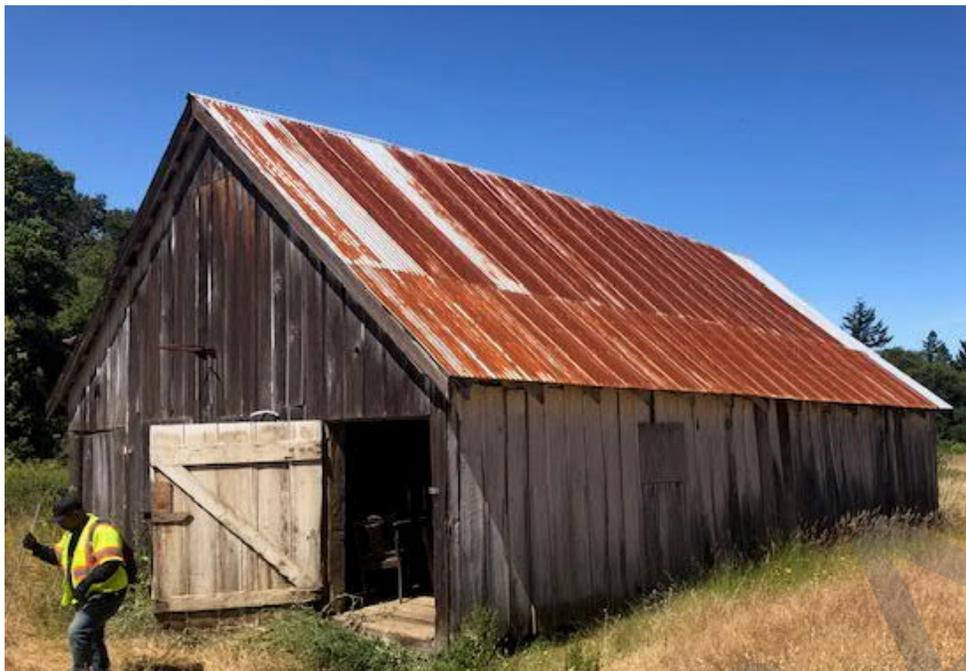
Sample L-3 white paint on wood siding collected from exterior of barn

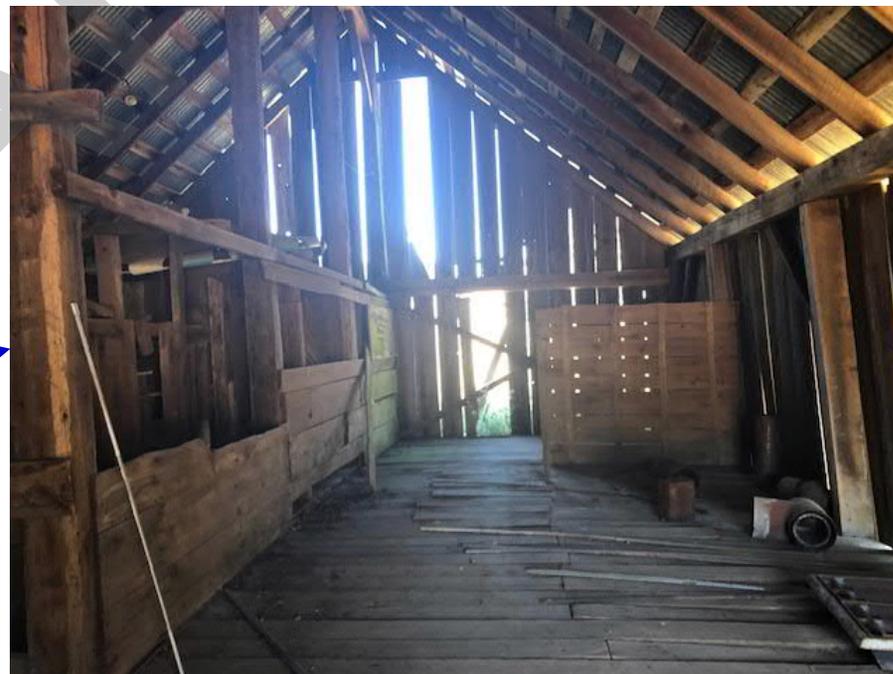
Samples 100A, 100B, and 100C Black 1/8" wiring collected from interior of barn

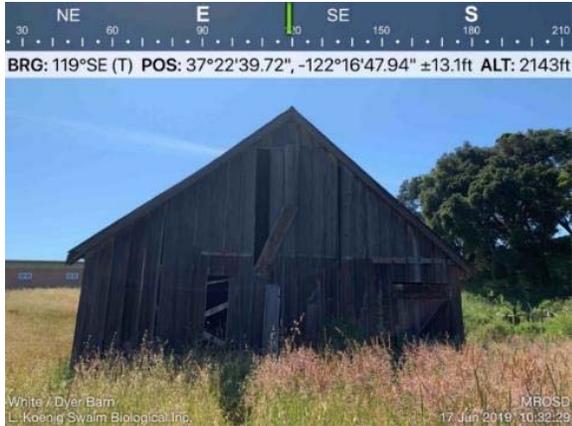
The barn surveyed receives partial shade from the riparian corridor to the west (Photo 3). Surrounding the barn is signs of wetland / wet meadow as demonstrated by the presence of (giant plantago (*Plantago major*), sedges (*Scirpus spp.*), elderberry (*Sambucus nigra spp. Caerulea.*), and willows (*Salix sp*). A concrete drainage adjacent to the east side of the barn appears to drain overland flow into the adjacent drainage (Photo 4). The barn itself is in a flat that leads to a downstream ravine and riparian corridor. The interior of the barn (Photo 5 and 6) is comprised of one area subdivided into sections by feeding stalls, an interior enclosed chicken coop, and an open space area. The barn has a pitched roof with corrugated metal sheets held up in regular intervals by rafters (Photo 7).

Photo 3. White Barn exterior missing wooden slats and entry points for bats.

- Preconstruction surveys for bats and woodrats prior to stabilization activities.
- Follow the general bat avoidance and minimization measures presented in Section 4.1.
- Development of bat roost deterrent plan for approval by the California Department of Fish and Wildlife (CDFW) prior to structure stabilization activities.
- The need for replacement habitat due to impacts on the maternity roost per District guidelines is dependent upon whether the planned stabilization activities will eliminate roosting habitat. Determination of the need for replacement habitat plan should coincide with the development of the deterrent plan.

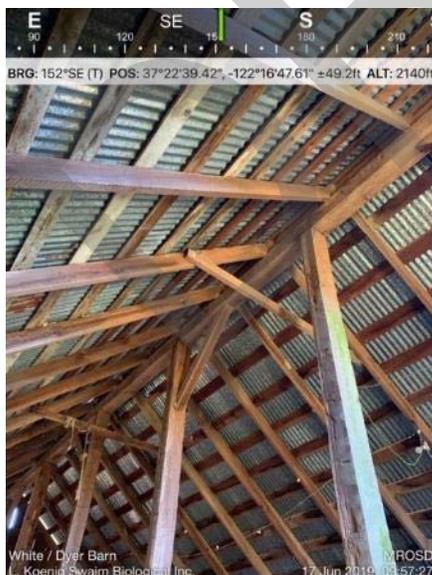
Photo 7. Corrugated roof slats and rafters provide suitable bat roosting habitat.

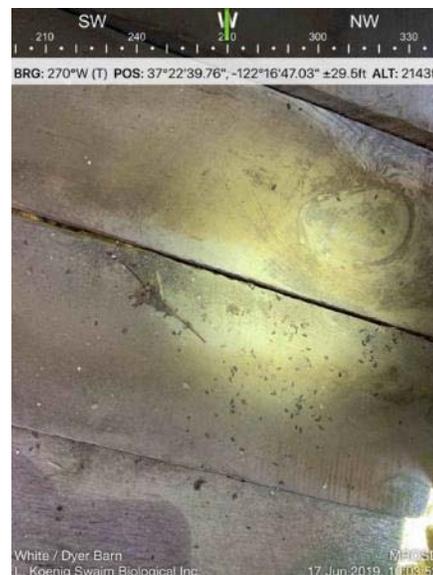
Photo 8. Bat guano present on the floor.

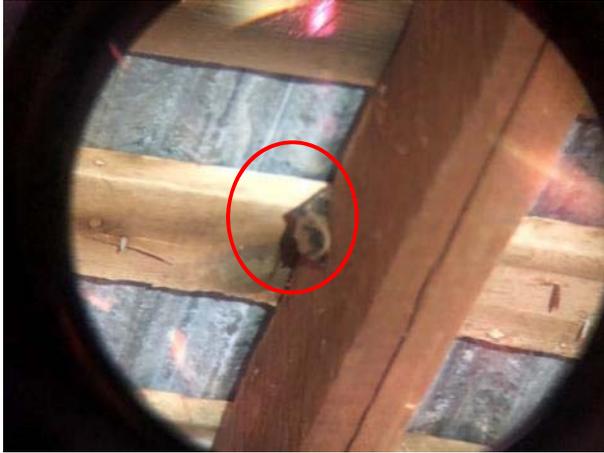
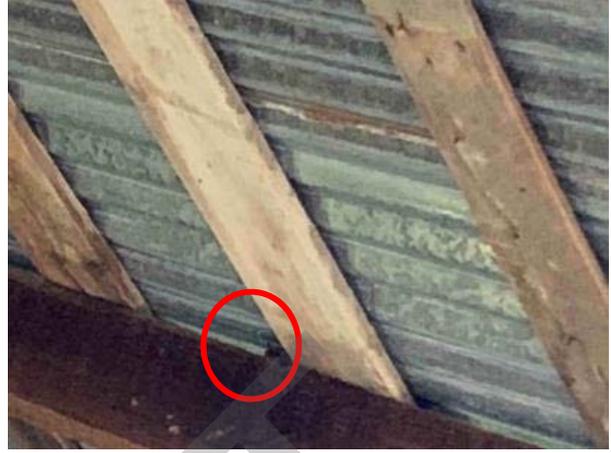
Photo 9. *Myotis sp.* (circled in red) observed roosting in rafters.

Photo 10. *Myotis sp.* (circled in red) observed roosting in rafters.

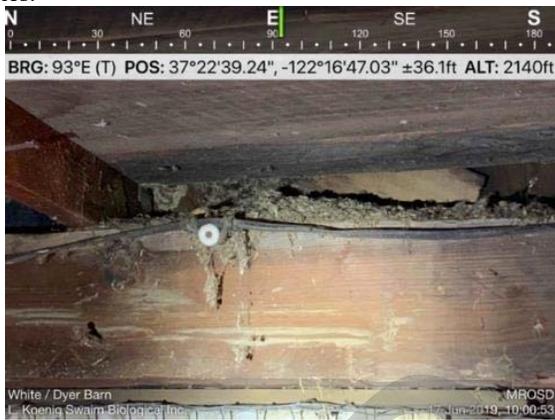
Photo 11. Rodent nests observed within the barn. These grass nests are most likely deer mouse (*Peromyscus sp.*) nests.

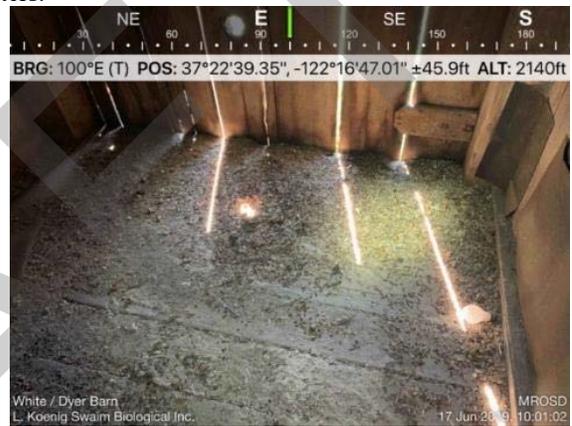
Photo 12. Rodent droppings and destroyed food caches observed within the barn.

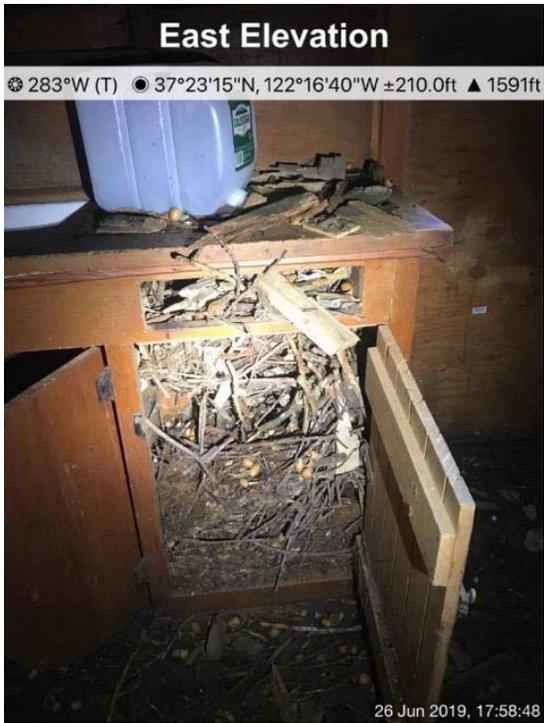
Signs of woodrats were present throughout the cabin including a large number of fecal pellets in all rooms of the cabin. One woodrat nest structure was built into a cabinet in the kitchen (Photo 15), twigs around and behind the oven, twigs on ceiling beams in between rooms (Photo 16), and two nest structures built on top of sinks in two rooms (possibly connected behind the wall) (Photo 17 – 18).

Photo 15. Woodrat nest built into kitchen cabinet of redwood cabin.

- Preconstruction surveys for bats and woodrats prior to stabilization activities.
- Follow the general bat avoidance and minimization measures presented in Section 4.1.
- Development of bat roost deterrent plan for approval by the California Department of Fish and Wildlife (CDFW) prior to structure stabilization activities.
- Follow general woodrat avoidance measures presented in Section 4.2.

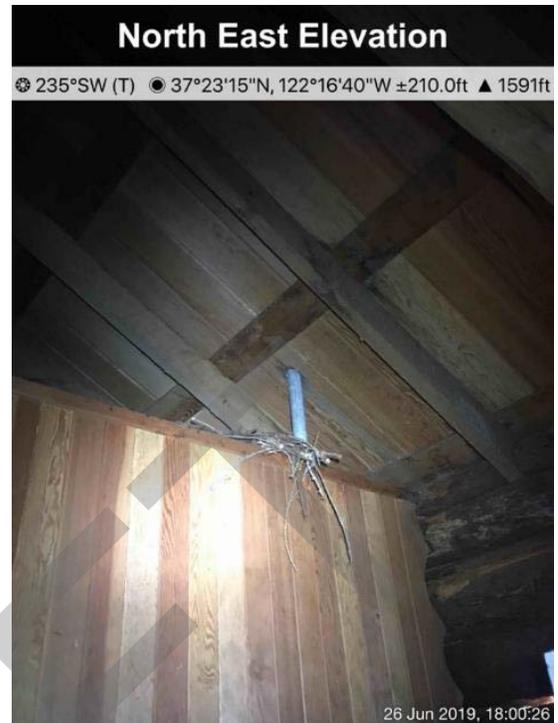
Photo 16. Woodrat nest on ceiling beams of redwood cabin.

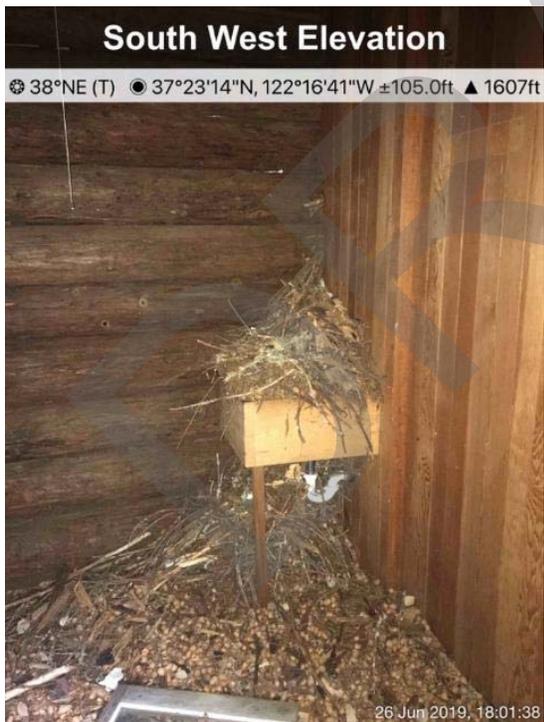
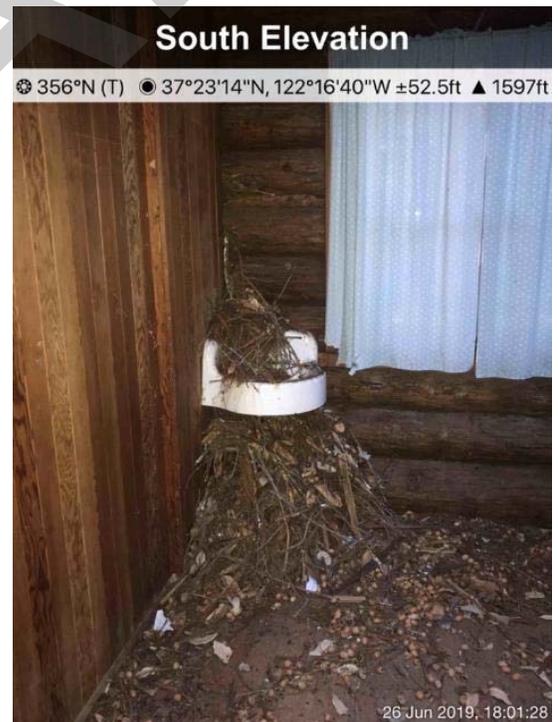
Photo 17. Woodrat nest on sink in Room A of redwood cabin.

Photo 18. Woodrat nest on sink in a Room B of redwood cabin.

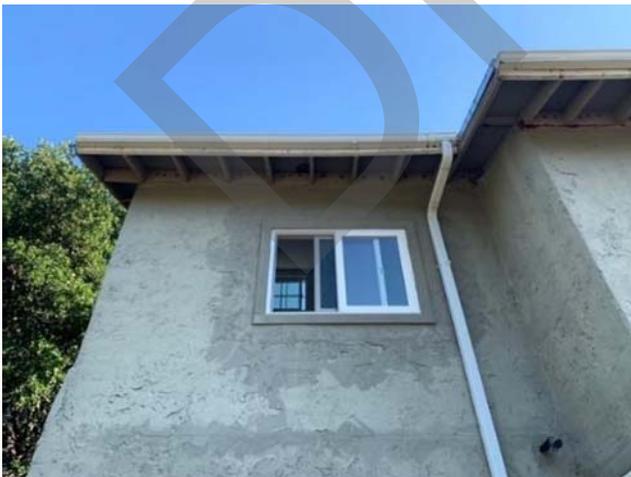
Structure A: The ceiling of Structure A is accessible to bats through a few entry points under the roof eaves and the interior is accessible through the chimney (Photo 21). The interior of the house is comprised of a lower level with six sections (kitchen, dining room, laundry room, living room, bedroom, bathroom, and a crawl space) and an upper level with two sections (hallway and bedroom). No visible sign of bat occupancy was observed inside the house. Some nearby oaks had hollows that could provide moderately to highly suitable bat maternity habitat, including a tree with full sun exposure with 20% exfoliating bark.

Photo 21. Ventilation holes under the eave of Structure A.

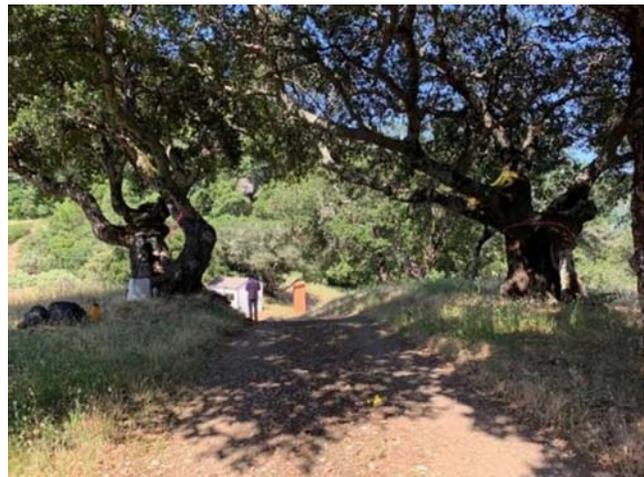
Two woodrat nests were located approximately 25-feet from Structure A in the hollowed-out trunks of two large coast live oaks (*Quercus agrifolia*) (Photo 22). A black phoebe (*Sayornis nigricans*) nest was observed under the eave of Structure A.

Photo 22. Woodrat middens in hollows of oak trees west of Structure A.

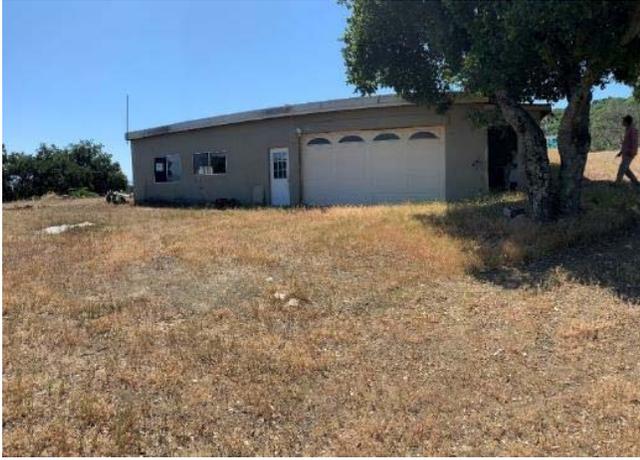
Structure B: A seam running under the roof eaves of Structure B was observed that could provide suitable bat roosting habitat although no roosting bats or signs of roosting bats were observed (Photo 23). Inside Structure B large quantities of woodrat fecal pellets were observed scattered throughout the shed.

Photo 23. Structure B – north-side view.

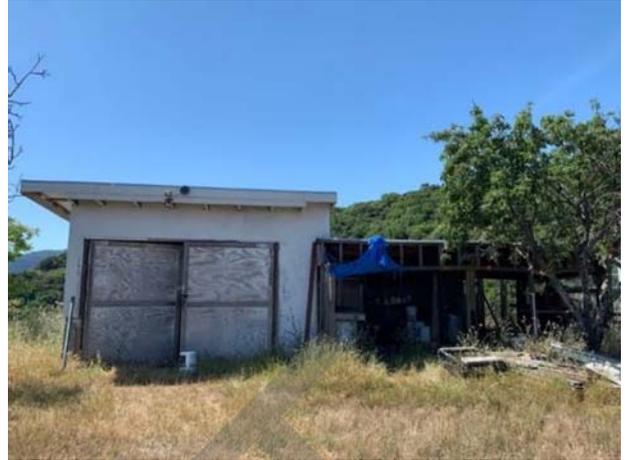
Structure C: The open structure has suitable bat maternity and night roosting habitat within (Photo 24). A potential woodrat midden is located outside of the shed on an upper shelf (Photo 25).

Photo 24. Structure C – shed west of Structure A.

- Preconstruction surveys for bats and woodrats prior to stabilization activities.
- Follow the general bat avoidance and minimization measures presented in Section 4.1.
- Develop a bat roost deterrent plan for approval by the California Department of Fish and Wildlife (CDFW) prior to structure stabilization activities.
- Follow general woodrat avoidance measures presented in Section 4.2.

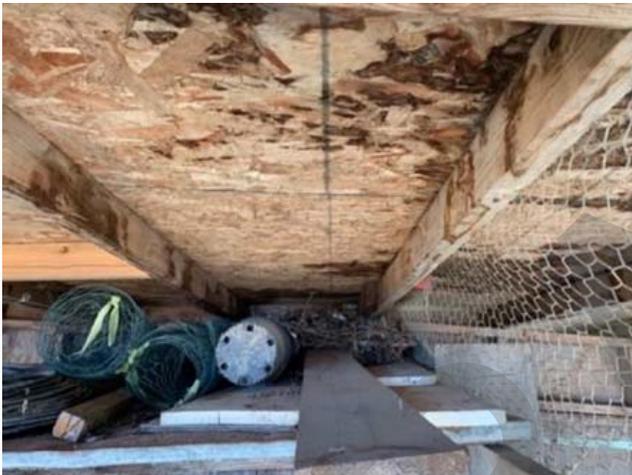
Photo 25. Possible woodrat midden on shelf in Structure C.

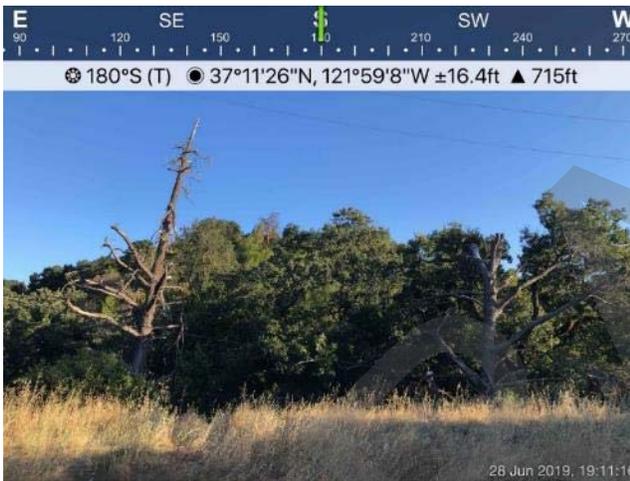
Photo 29. Two snags that could support roosting bats on west side of Beatty structure.

- Preconstruction surveys for bats and woodrats prior to removal activities.
- Follow the general bat avoidance and minimization measures presented in Section 4.1.
- Development of bat roost deterrent plan for approval by the California Department of Fish and Wildlife (CDFW) prior to structure stabilization activities.
- Provide replacement bat maternity roost habitat as part of the deterrent plan for approval by CDFW.
- Follow general woodrat avoidance measures presented in Section 4.2.

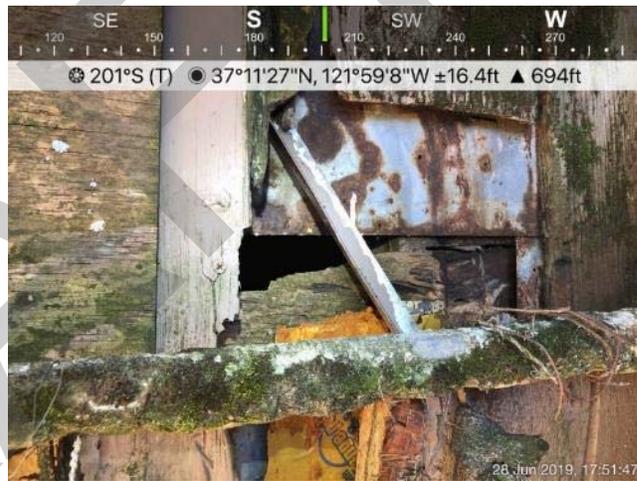
Photo 32. Hole on wall that could provide bat access.

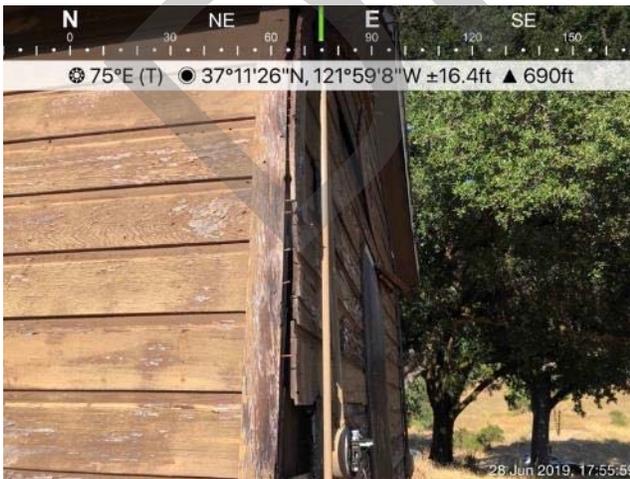
Photo 33. Wooden slats peeling away from the wall.

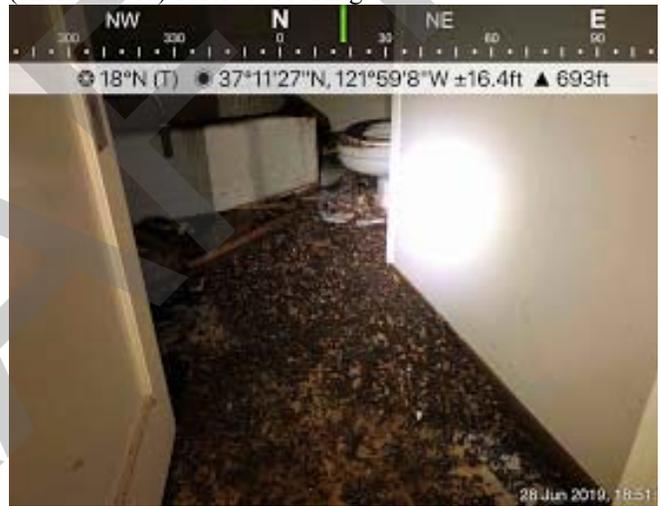
Upon entry to the house, large amounts of woodrat sign (e.g., fecal pellets) were observed throughout the entire house (Photo 37 and 38). Lots of debris on the floor of the house and two stick piles observed, one on top of the stove in the kitchen and one on top of the sink in the bathroom (Photos 37 - 42). No substantial woodrat nests were observed inside the structure, but there are numerous woodrat access points to the crawl space and area between ceiling and roof that were not surveyed. Three woodrat nests were observed within the 50 feet of the Beatty house structure (Photos 39 – 41).

Photo 38. Large amount of woodrat feces on floor.

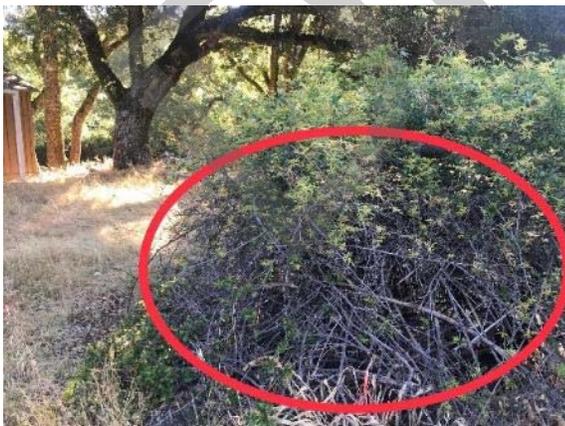
Photo 39. Woodrat nest number 1 is located under an ornamental bush 9 meters south of the structure

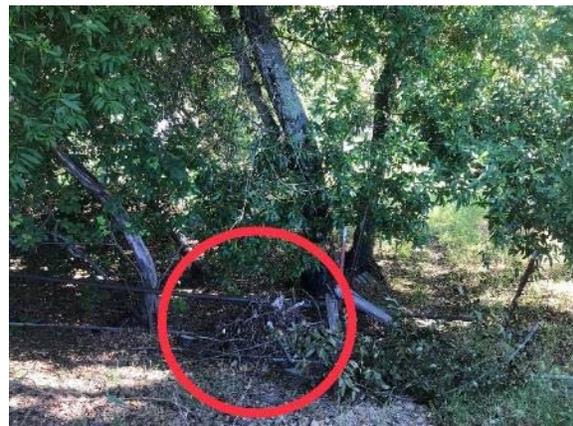
Photo 40. Woodrat nest number 2 is located along a fence 10 meters northeast of the structure.

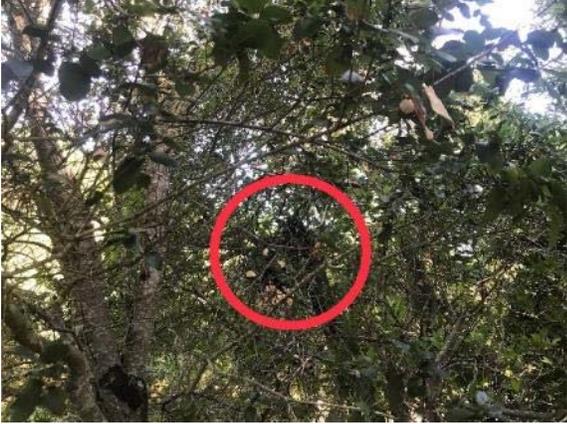
Photo 41. Woodrat nest number 3 is located in a tree, northwest of the structure.

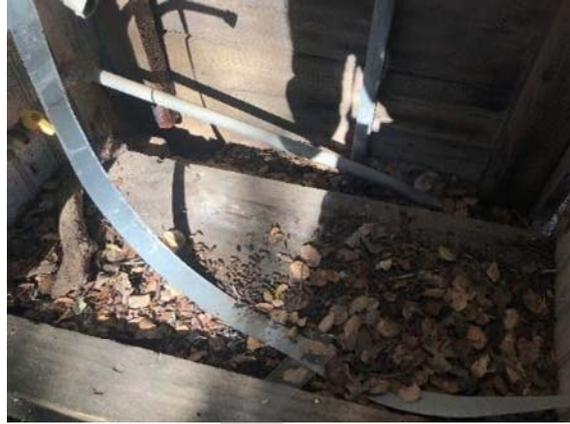
Photo 42. Woodrat A large amount of woodrat feces was observed in one location along the exterior of the structure.
