Midpeninsula Regional
Open Space District

R-20-35
Meeting 20-08
April 8, 2020

Select a design alternative for the La Honda Creek Redwood Cabin, La Honda Creek White Barn, and Sierra Azul Beatty House

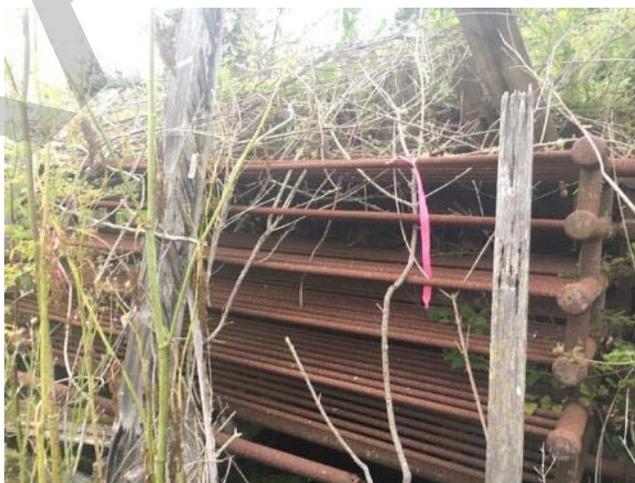
AREA B: The inside of Tanks 1-2 could not be observed due to their height, but both tanks appeared to be single-walled and open on the top. These tanks are likely unsuitable for day roosting bats due to exposure to the elements and the lack of additional surfaces that could create crevices. The distillation column was capped on the top but appeared to have a small opening on its side about 15 feet off the ground that could potentially be used by roosting bats (Photo 43). The structure on the east side of Area B included a series of iron grates over a concrete box filled with water as well as a dilapidated shed with a corrugated tin roof. The shed contained pieces of wood attached to corrugated tin that created small crevices that could be suitable for bats, but no signs of bats were observed. Large woodrat nest structures were observed inside the series of iron gates and inside the dilapidated shed, as well as behind the shed (Photo 44 and 45).

Photo 44. Area B – woodrat nest structure inside the series of iron grates. This structure sits over a concrete spring box filled with water.

- Preconstruction surveys for bats and woodrats prior to demolition and debris removal activities.
- Follow the general bat avoidance and minimization measures presented in Section 4.1.
- Development of bat roost deterrent plan for approval by the California Department of Fish and Wildlife (CDFW) prior to structure demolition activities at the Area E Hunting Cabin.
- Provide replacement bat maternity roost habitat for impacts to removal of maternity roost habitat at Area E Hunting Cabin as part of the deterrent plan for approval by CDFW. This replacement habitat will serve as replacement habitat for all bat roost habitat removed or disturbed during removal activities.
- Follow general woodrat avoidance measures presented in Section 4.2.

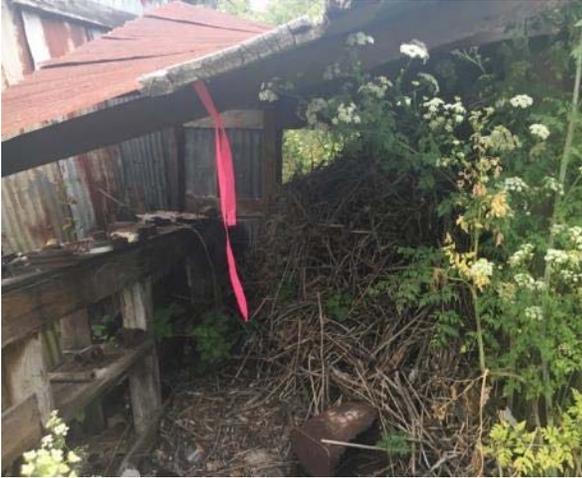
Photo 45. Area B – woodrat nest structure inside the dilapidated building.

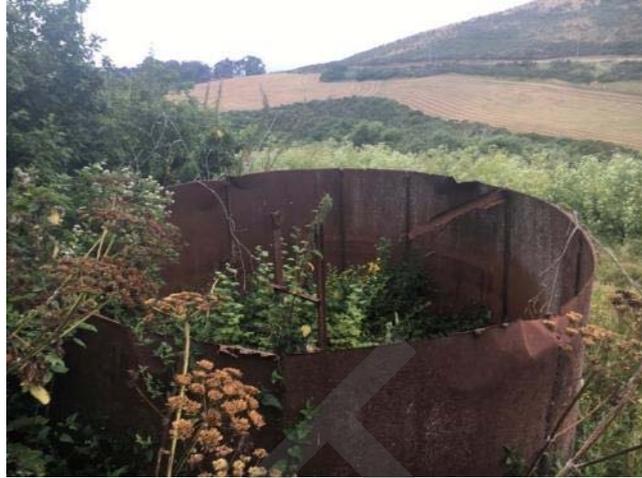
the elements that may preclude these structures from being used by bats (Photo 46). A large woodrat nest was observed inside Tank 11, and two smaller satellite nests were observed surrounding the tank.

Photo 46. Area D – most tanks were single-walled without any small crevice space for roosting bats.

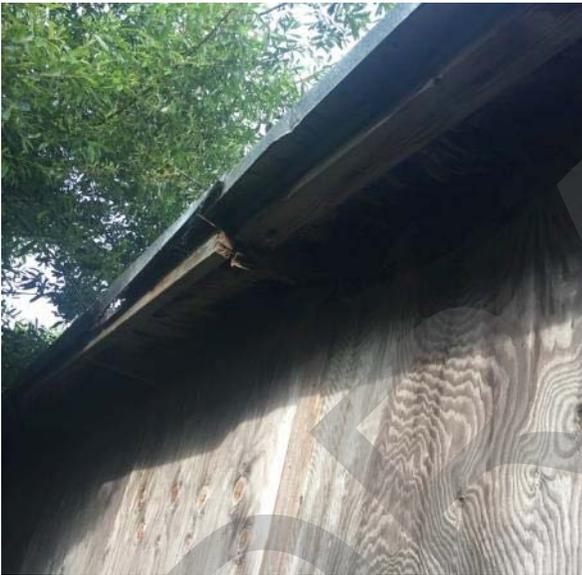
AREA E: The exterior of the hunting cabin had rotted and loose wood paneling, especially near the roofline, that could be suitable for roosting bats (Photo 47 and 48). A search of the structure's exterior found no sign of bats, however, many holes and crevices that led to the space between the roof and the structure's interior could not be fully observed. A search of the interior of the structure revealed that the previous owners had used the cabin recently. Maternity colony day-roosting habitat was observed inside the structure and no guano pellets or urine staining were observed. Additionally, no sign of woodrats were observed inside the cabin, however small mammals droppings (likely *Peromyscus* sp.) were present throughout the cabin. One large woodrat nest structure was observed behind the cabin.

Photo 47. Area E – additional openings and interstitial spaces underneath the roofline.

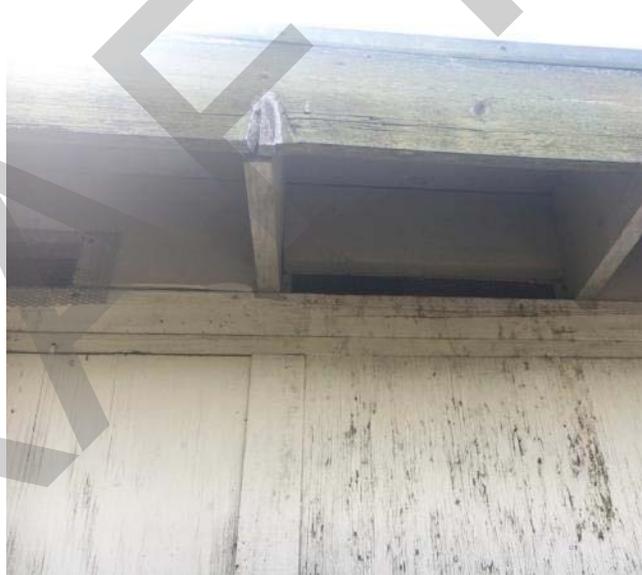
Photo 48. Area E – openings underneath the roofline of the hunting cabin.

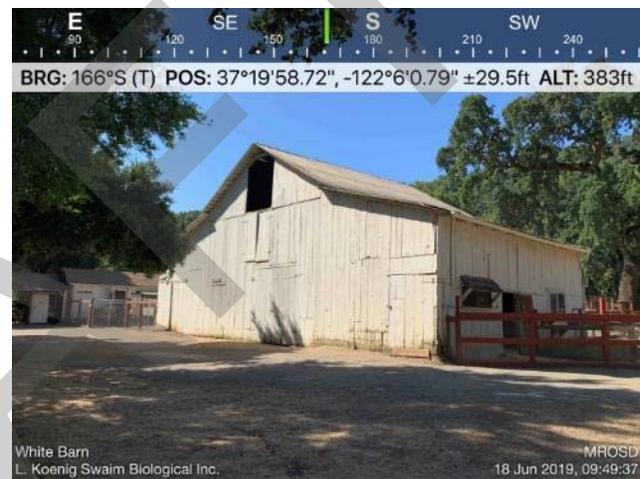
The barn that was surveyed is one of many structures in Deer Hollow Farm that is an active educational farm. The lower level of the barn is actively used as a goat milk barn, storage location, and hay barn (Photos 49 and 50). The upper level / former hayloft of the barn is less stable although it too is actively used for storage. The barn receives partial shade from the riparian corridor to the north and a large valley oak to the south. The barn has a pitched roof with corrugated metal sheets held up in regular intervals by rafters (Photo 51 and 52).

Photo 50. White Barn exterior showing hayloft doors and open access points.

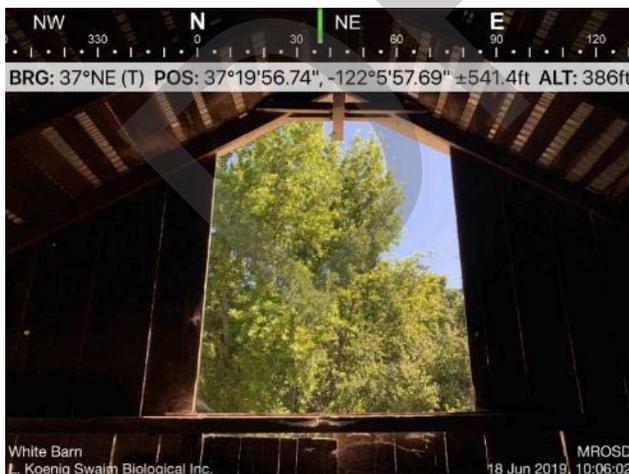
The entire structure is accessible to bats and rodents through the gaps between the roof and hayloft doors which are left open. The openings allow for bats to easily enter the building and roost although the openness may reduce the ability for the barn to be used as a maternity roost. These conditions provide suitable bat roosting habitat within the structure including the crevice habitat between the rafters and the corrugated roof.

Photo 51. White Barn hayloft with crevice roost habitat between roof and rafters.

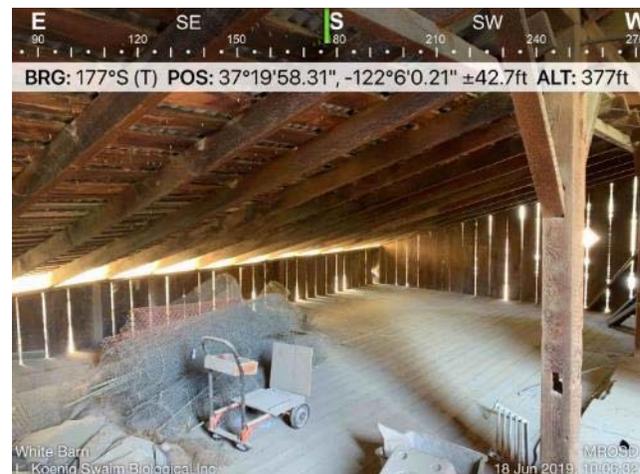
Photo 52. Interior of hayloft with wooden slat openings

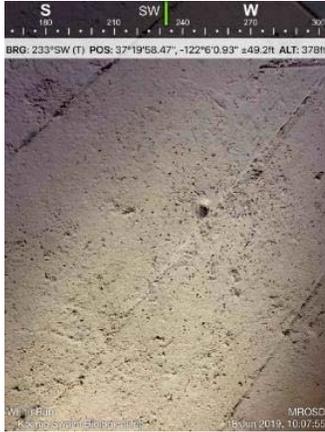
Bat guano was observed in the interior of the structure on the floor throughout the hayloft (Photo 53). Abundant insect activity was observed in the adjacent riparian area providing suitable bat foraging habitat and the adjacent riparian area has plentiful tree roost habitat available.

Photo 53. Bat guano on floorboards.

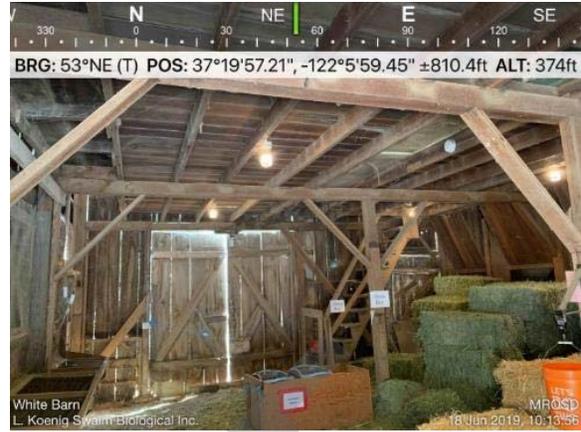
Photo 54. Lower level with hay storage and milk barn

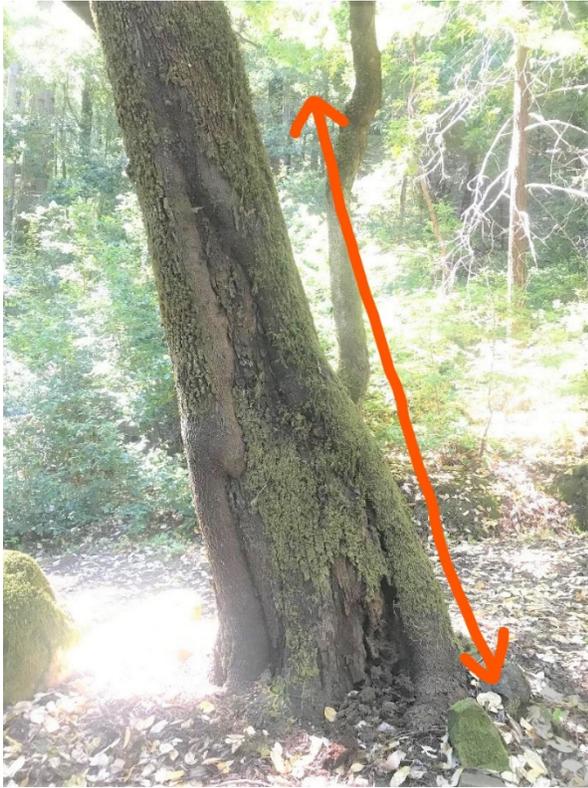
Madrone trees #26 and #35 are the only madrone trees in poor condition. Madrone tree #26 has poor vigor with 50% or more of the canopy being dead. This tree also is growing at a heavy lean. No mitigation measures would be expected to help improve the tree; therefore, tree removal is recommended. Madrone tree #35 has good vigor but poor form. The tree grows at a heavy lean over the existing cabin on site. A large decay section was observed on the compression side of the tree's lean. The decayed area starts at grade and extends 8 feet up the trunk of the tree. Because the decayed area is on the compression side of the tree's lean, it acts as a natural tree falling hinge. This tree is hazardous and should be removed as the target at the point of failure is the existing cabin.

(Red line showing large decayed area)**Summary continued:**

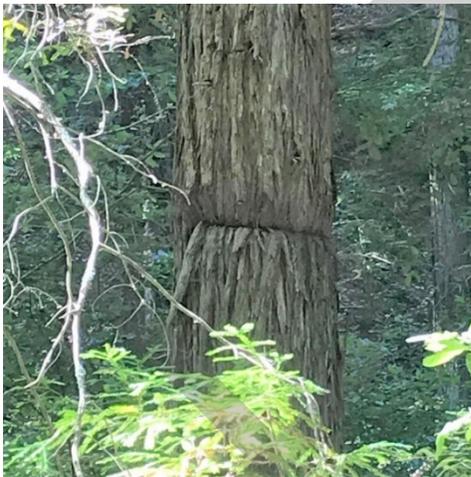
**(Showing girdled tree)**

The majority of the redwood trees on site are in fair to good condition. The only redwood trees that are recommended to receive maintenance are the codominant redwood trees and girdled redwood trees. Redwood trees rarely experience a whole tree failure. Redwood trees due tend to shed limbs when under drought like stress. The codominant redwood trees should be cabled and reduced where necessary to reduce stress to the poorly formed unions. This will help to reduce risk of a codominant leader failure due to the poor form. Redwood tree #14 is being girdled by the remaining portion of the existing deck. This portion of the deck should be removed to eliminate the trees risk of dying due to being girdled. Girdling trees chokes out the vascular cambium system and stops the flow of water and nutrients causing trees to eventually die. Redwood tree #32 is being girdled by a PG & E support wire. This wire should be removed as soon as possible. The trees on site should be reassessed every 3-5 years for any needed maintenance. The following tree protection plan will help to ensure the future survival of the trees on site.

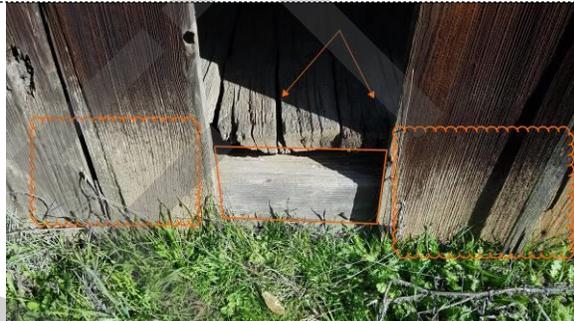
Figure 2

Foundation beam. Deterioration along lower section of boards conforming all façades. Heavy use and weathering deterioration of floor boards.

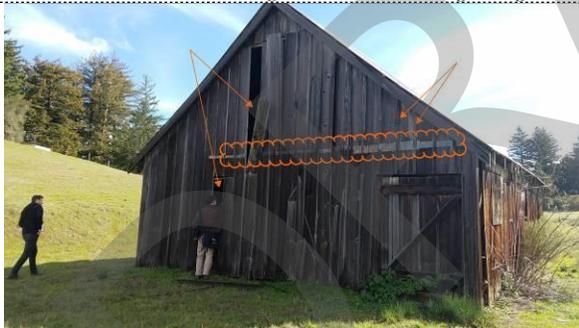
Figure 3

West façade, some boards have collapsed or are missing parts. Metal sheet addition to tie the boards to the beam on the other side

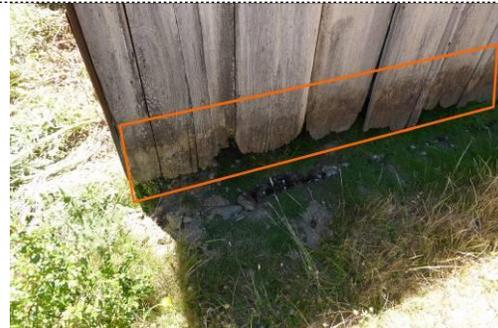
Figure 4

Heavy weathering and deterioration of the cladding in lower section of all façades

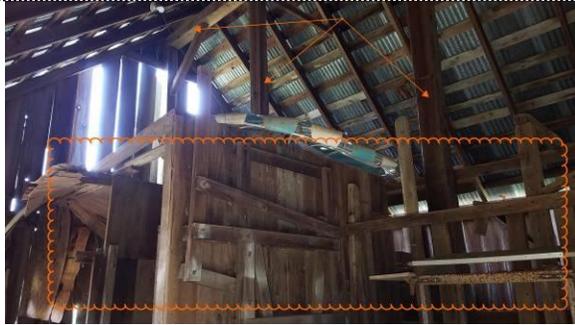
Figure 7

Main structure elements are hand-hewn while exterior cladding is machine sawn. Open separation between cladding boards corresponds to missing battens. Some boards are missing or have collapsed

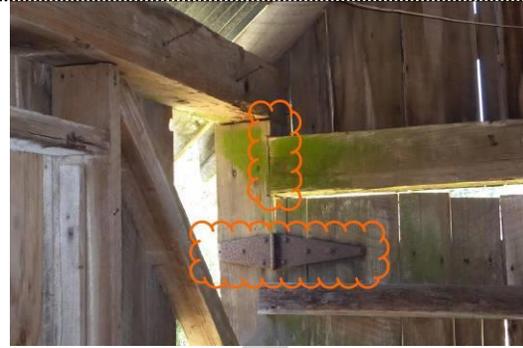
Figure 8

Mortise and tenon joints between main structure elements. Hinges for doors are attached using square headed nuts and bolts. Some boards from the cladding are missing. Display of humidity and moss growth

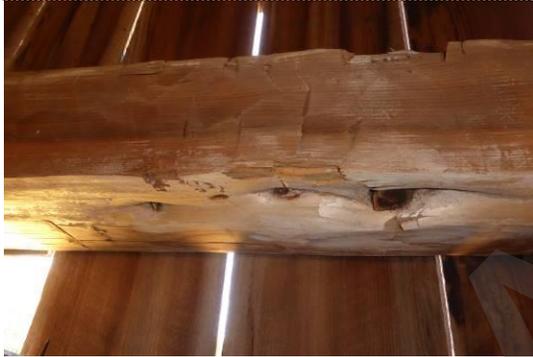
Figure 9

Main structure elements are hand-hewn while exterior cladding is machine sawn. Open separation between cladding boards corresponds to missing battens. Some boards are missing or have collapsed

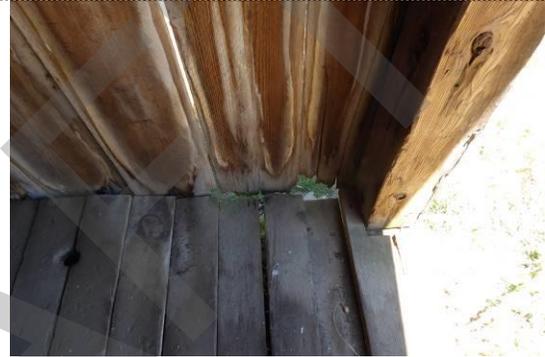
Figure 10

Image 35: Floor boards heavily weathered. Cladding boards missing or collapsed with openings due to missing battens. Evident signs of humidity and deterioration of floors and cladding

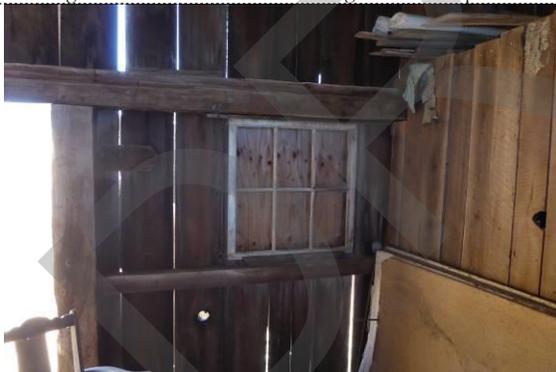
Figure 11

Boarded window of the east façade. Interior partitions added and modified as required by use needs

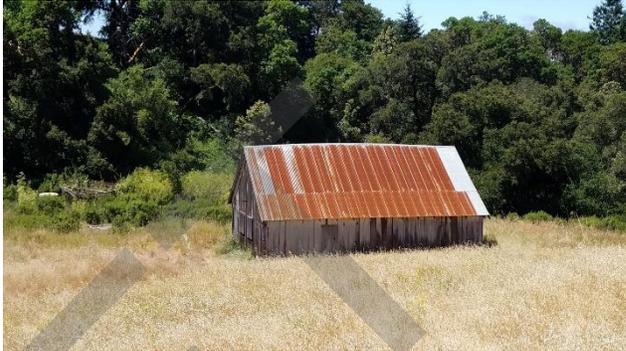
Photo 2. Side elevation

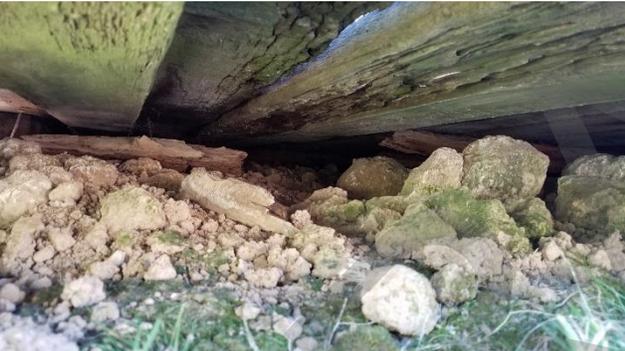
Photo 3. Existing condition at foundation

- a) The structure is founded on wood timber beams that are sit directly on the soil and have significantly deteriorated over time (see Photo 3 and Photo 4). No foundation is present.
 - i) **Recommendation:** Provide new concrete strip footing around perimeter of structure and concrete spread footings under interior posts. Repair deteriorated framing.
- b) Settlement was observed likely due to the deteriorating base of the structure. The structure is generally tilting in the downhill direction of the slope.
 - i) **Recommendation:** The recommendations for item (a) will address this deficiency.

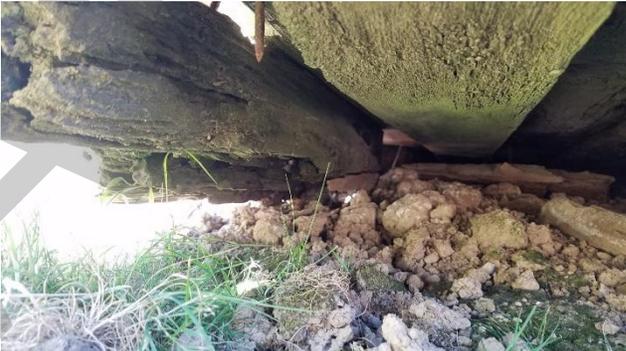
Photo 4. Existing condition at foundation

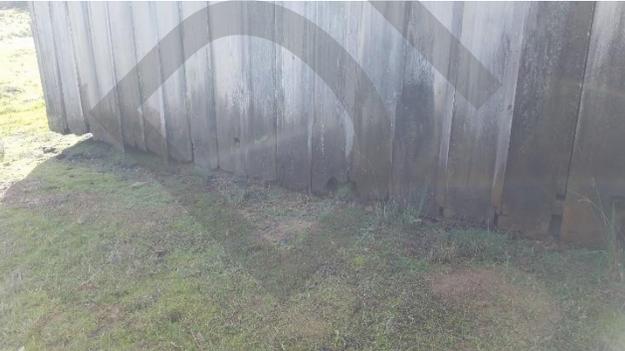
Photo 5. Deterioration of exterior siding

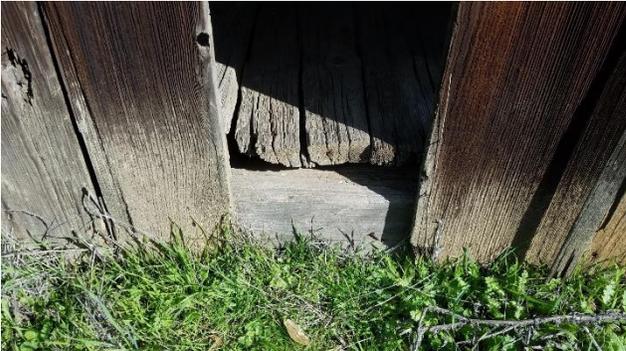
Photo 6. Deterioration at floor sheathing

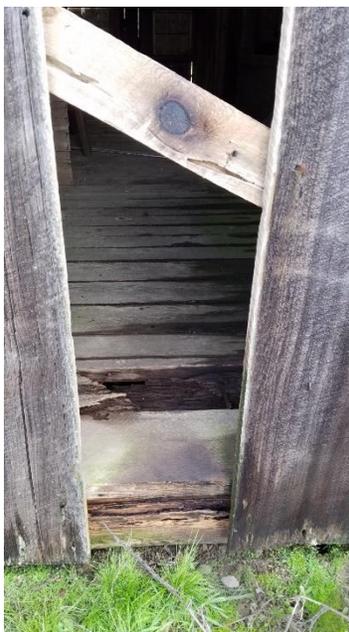
Photo 7. Deterioration at base of exterior wall

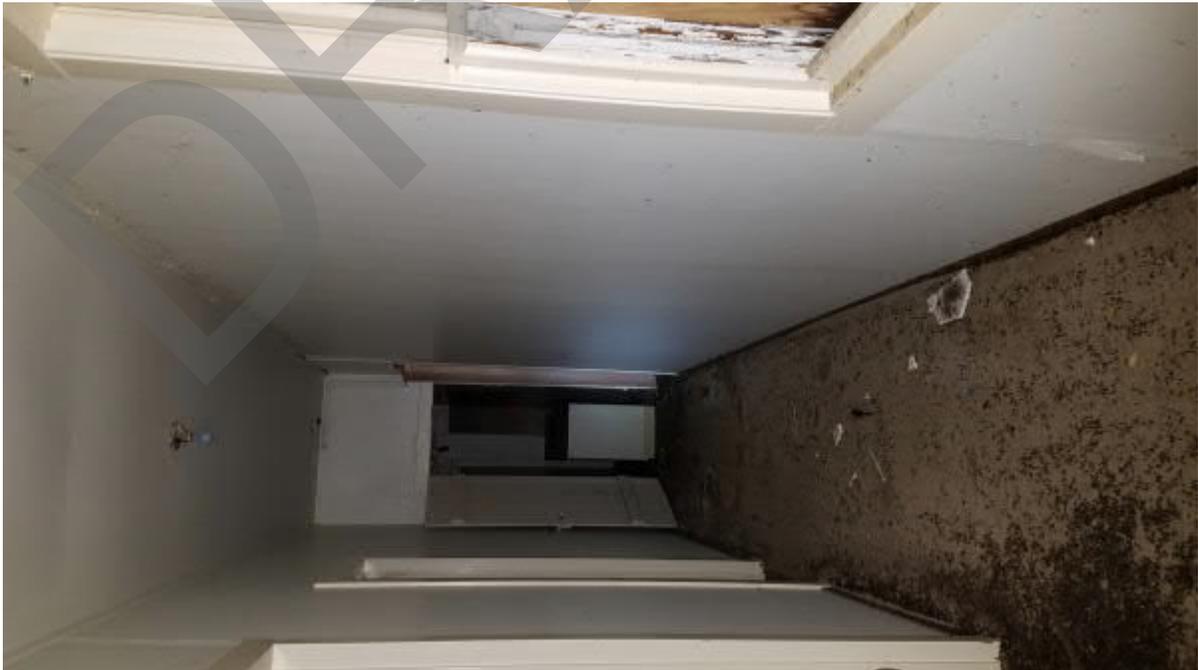
Photo 4 Material 204 - ACM joint Compound on wallboard walls and ceilings in the Beatty House

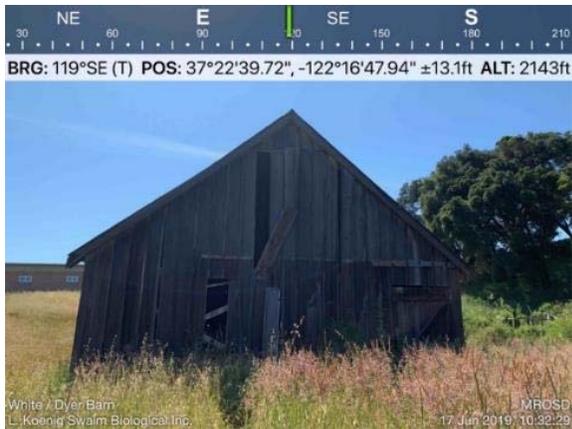
Photo 3. White Barn exterior missing wooden slats and entry points for bats.

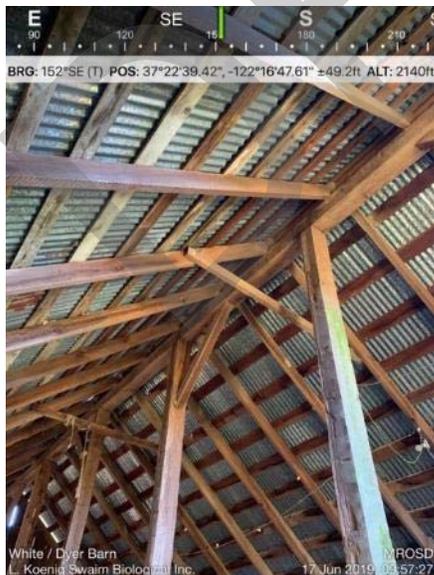
The barn surveyed receives partial shade from the riparian corridor to the west (Photo 3). Surrounding the barn is signs of wetland / wet meadow as demonstrated by the presence of (giant plantago (*Plantago major*), sedges (*Scirpus spp.*), elderberry (*Sambucus nigra spp. Caerulea.*), and willows (*Salix sp*). A concrete drainage adjacent to the east side of the barn appears to drain overland flow into the adjacent drainage (Photo 4). The barn itself is in a flat that leads to a downstream ravine and riparian corridor. The interior of the barn (Photo 5 and 6) is comprised of one area subdivided into sections by feeding stalls, an interior enclosed chicken coop, and an open space area. The barn has a pitched roof with corrugated metal sheets held up in regular intervals by rafters (Photo 7).

Photo 7. Corrugated roof slats and rafters provide suitable bat roosting habitat.

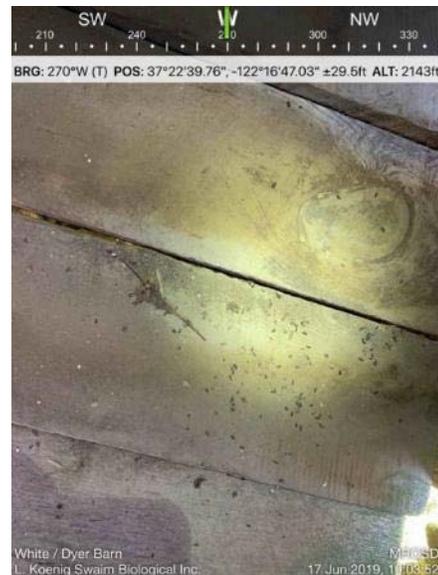
Photo 8. Bat guano present on the floor.

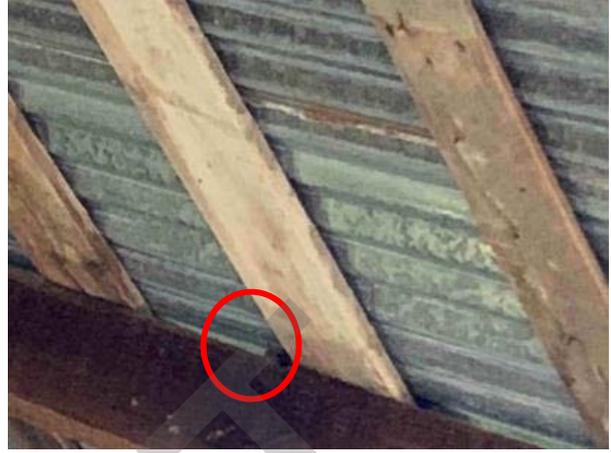
Photo 10. *Myotis sp.* (circled in red) observed roosting in rafters.

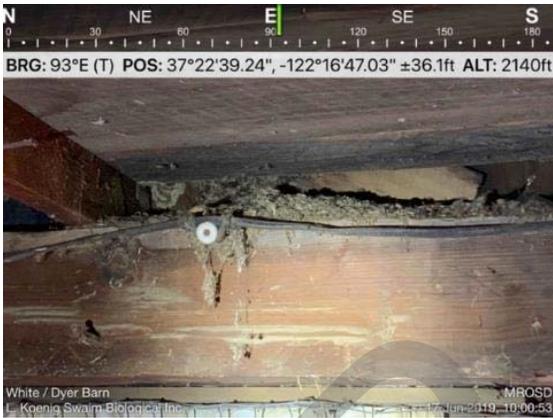
Photo 11. Rodent nests observed within the barn. These grass nests are most likely deer mouse (*Peromyscus sp.*) nests.

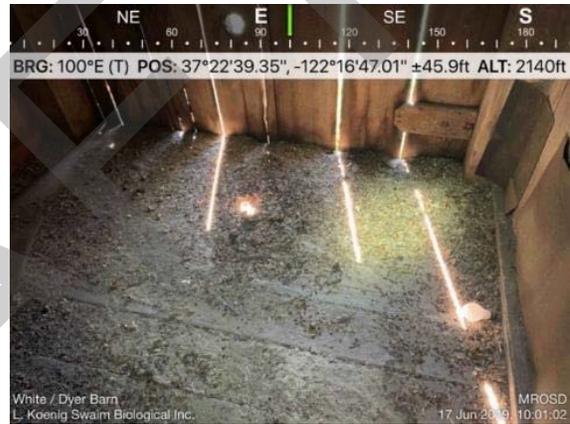
Photo 12. Rodent droppings and destroyed food caches observed within the barn.

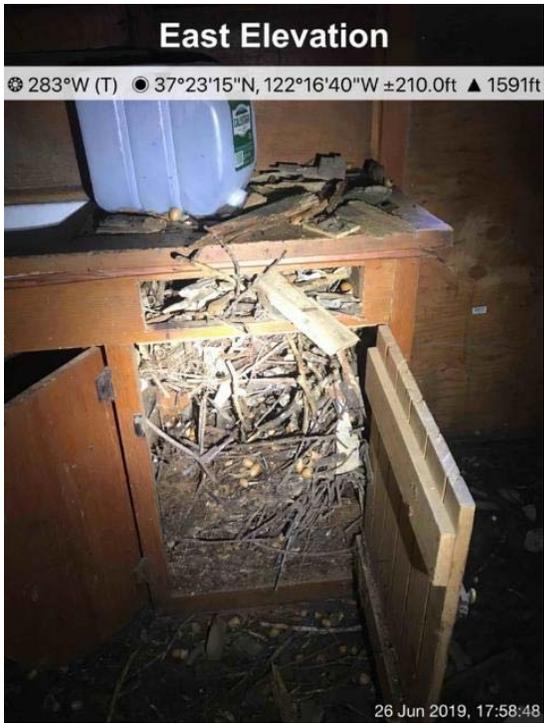
Signs of woodrats were present throughout the cabin including a large number of fecal pellets in all rooms of the cabin. One woodrat nest structure was built into a cabinet in the kitchen (Photo 15), twigs around and behind the oven, twigs on ceiling beams in between rooms (Photo 16), and two nest structures built on top of sinks in two rooms (possibly connected behind the wall) (Photo 17 – 18).

Photo 15. Woodrat nest built into kitchen cabinet of redwood cabin.

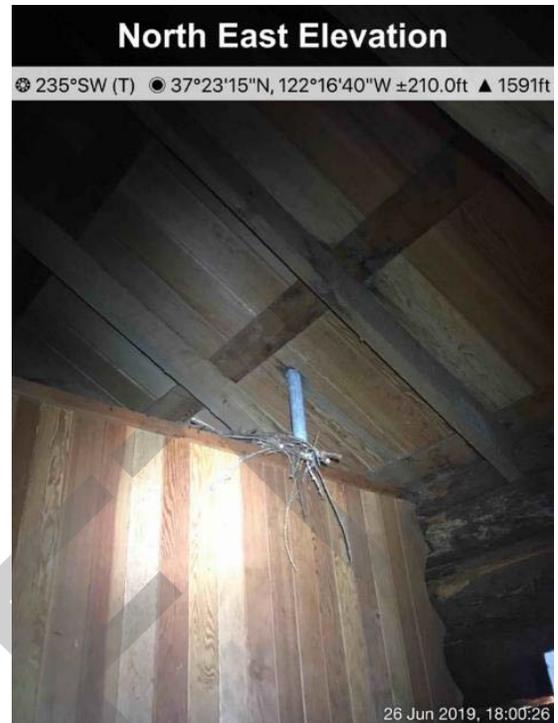
Photo 16. Woodrat nest on ceiling beams of redwood cabin.

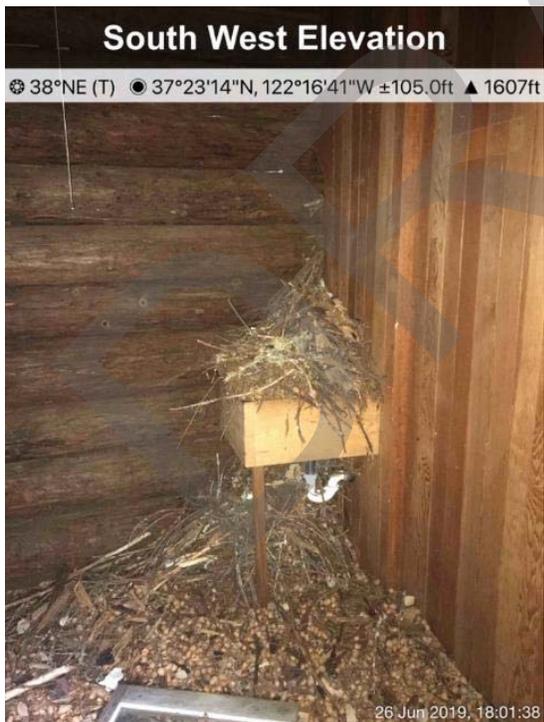
Photo 17. Woodrat nest on sink in Room A of redwood cabin.

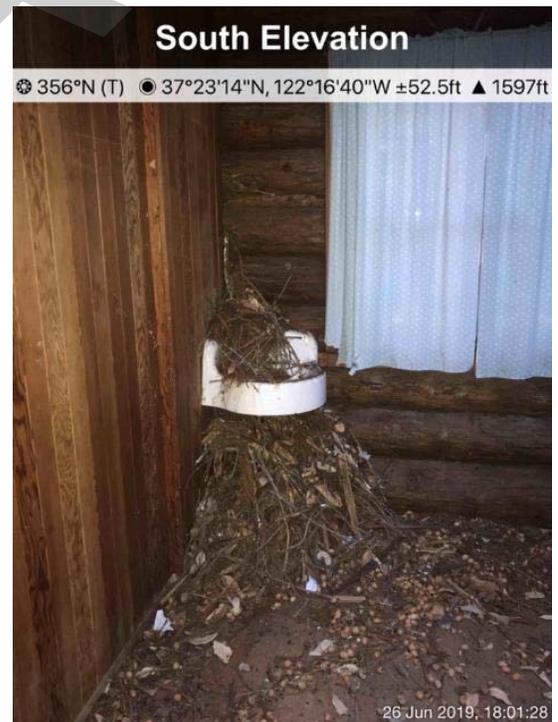
Photo 18. Woodrat nest on sink in a Room B of redwood cabin.

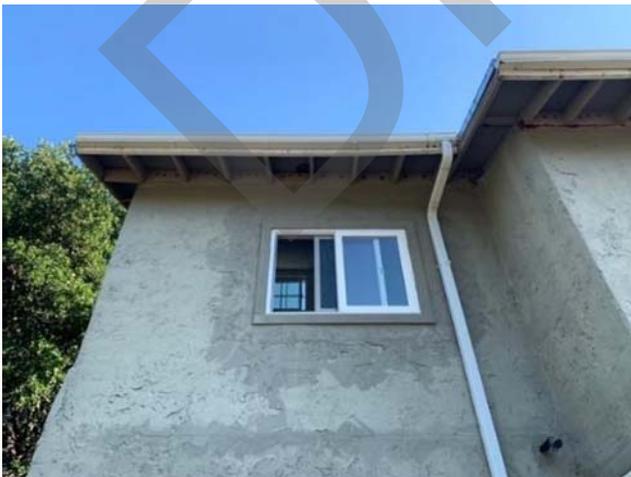
Structure A: The ceiling of Structure A is accessible to bats through a few entry points under the roof eaves and the interior is accessible through the chimney (Photo 21). The interior of the house is comprised of a lower level with six sections (kitchen, dining room, laundry room, living room, bedroom, bathroom, and a crawl space) and an upper level with two sections (hallway and bedroom). No visible sign of bat occupancy was observed inside the house. Some nearby oaks had hollows that could provide moderately to highly suitable bat maternity habitat, including a tree with full sun exposure with 20% exfoliating bark.

Photo 21. Ventilation holes under the eave of Structure A.

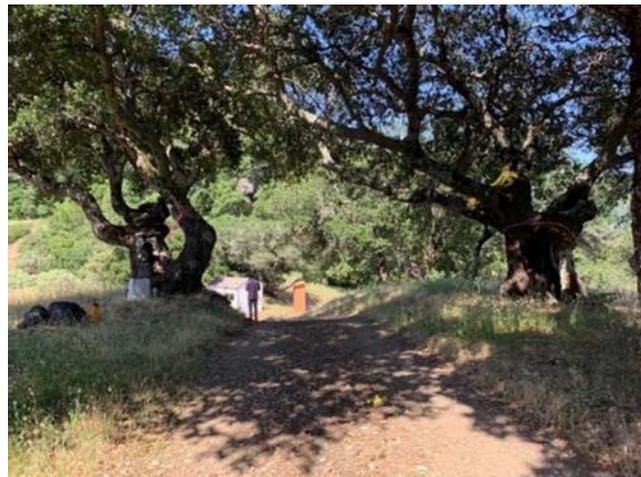
Two woodrat nests were located approximately 25-feet from Structure A in the hollowed-out trunks of two large coast live oaks (*Quercus agrifolia*) (Photo 22). A black phoebe (*Sayornis nigricans*) nest was observed under the eave of Structure A.

Photo 22. Woodrat middens in hollows of oak trees west of Structure A.

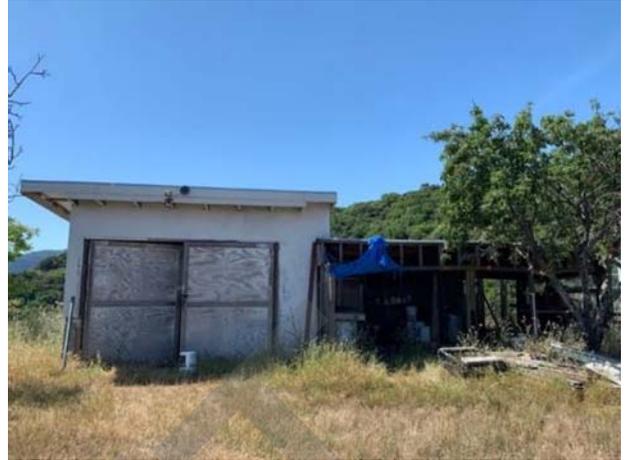
Structure C: The open structure has suitable bat maternity and night roosting habitat within (Photo 24). A potential woodrat midden is located outside of the shed on an upper shelf (Photo 25).

Photo 24. Structure C – shed west of Structure A.

- Preconstruction surveys for bats and woodrats prior to stabilization activities.
- Follow the general bat avoidance and minimization measures presented in Section 4.1.
- Develop a bat roost deterrent plan for approval by the California Department of Fish and Wildlife (CDFW) prior to structure stabilization activities.
- Follow general woodrat avoidance measures presented in Section 4.2.

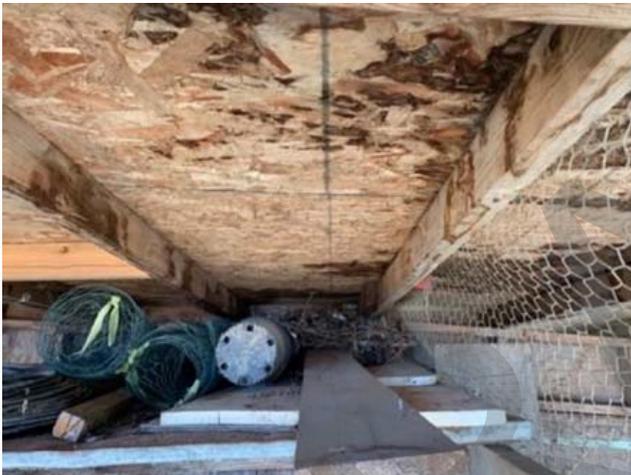
Photo 25. Possible woodrat midden on shelf in Structure C.

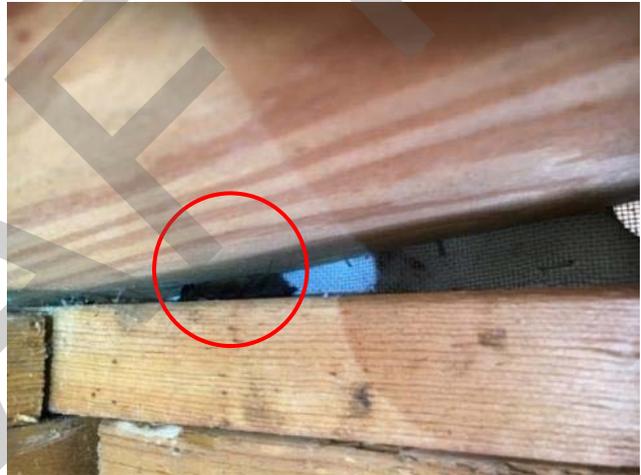
Shed: There is a shed to the west of the structures that were to be surveyed where a day roosting *Myotis* sp. was observed on June 11 (Photo 26). No roosting bats were observed on June 25.

Photo 26. *Myotis sp.* (circled in red) observed roosting in crevice in nearby shed to the west of the structure to be removed.

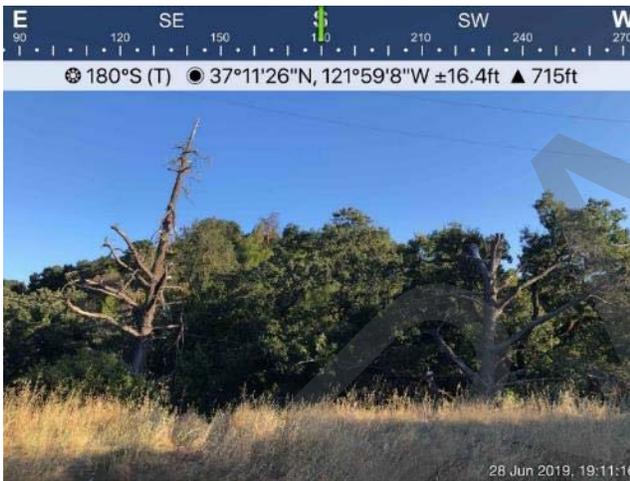
Photo 29. Two snags that could support roosting bats on west side of Beatty structure.

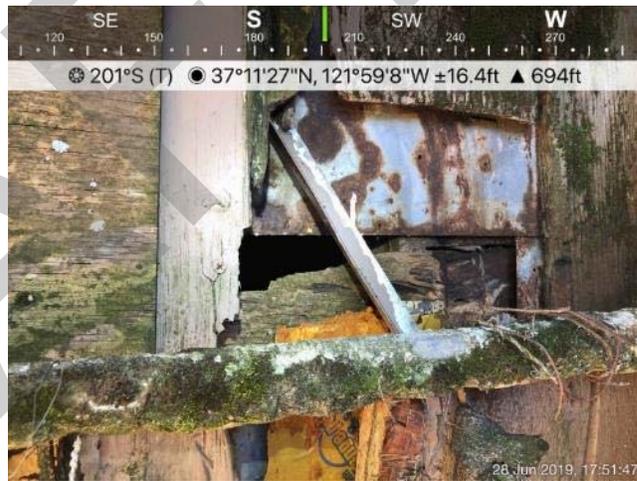
Photo 32. Hole on wall that could provide bat access.

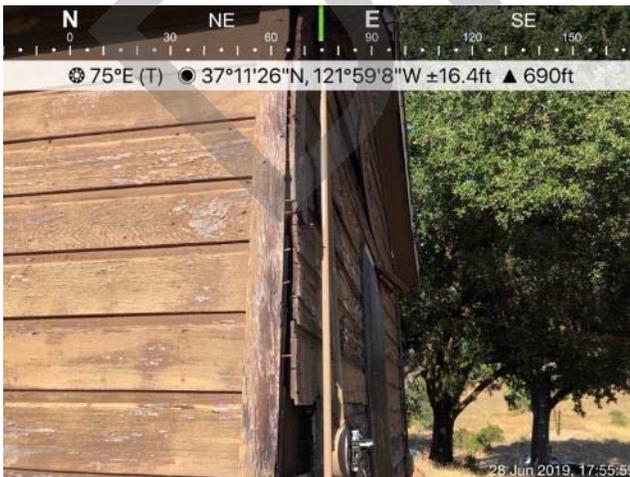
Photo 33. Wooden slats peeling away from the wall.

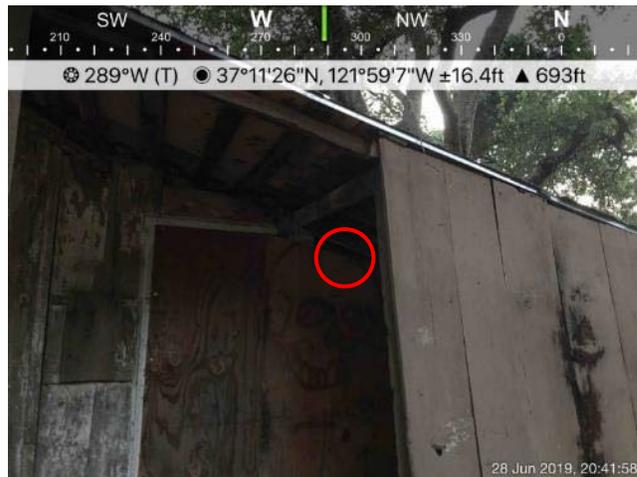
The bat emergence survey was conducted one-half hour before sunset and continued until one half hour after sunset. Eight bats were observed exiting the structure (Table 3) at four locations (Photo 34 and 35).

Photo 34. Bats observed emerging from hole in wall (circled in red) on east side of the house.

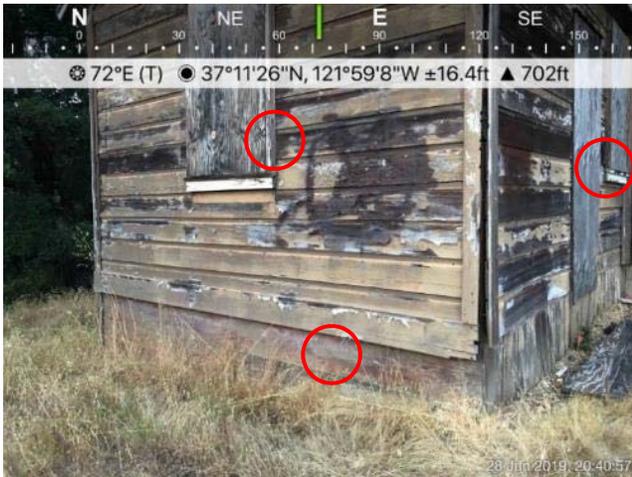
Photo 35. Bats observed emerging from wooden slats (circled in red) on west side of the house.

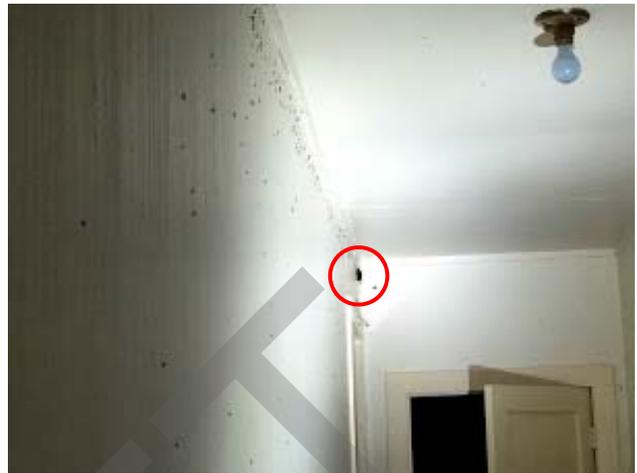
There are large amounts of bat signs (e.g., urine staining and guano) on the walls of the interior of the house and all rooms showed signs of bat use (Photo 36). Six bats (*Myotis sp.*) were observed in various places throughout the house.

Photo 36. Bat urine staining and guano on wall; *Myotis sp.* (circled in red) observed roosting.

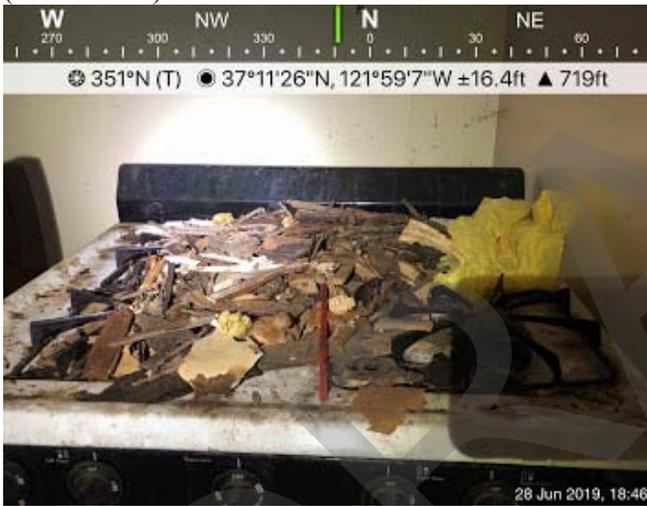
Upon entry to the house, large amounts of woodrat sign (e.g., fecal pellets) were observed throughout the entire house (Photo 37 and 38). Lots of debris on the floor of the house and two stick piles observed, one on top of the stove in the kitchen and one on top of the sink in the bathroom (Photos 37 - 42). No substantial woodrat nests were observed inside the structure, but there are numerous woodrat access points to the crawl space and area between ceiling and roof that were not surveyed. Three woodrat nests were observed within the 50 feet of the Beatty house structure (Photos 39 – 41).

Photo 37. Stick pile on top of stove in kitchen.

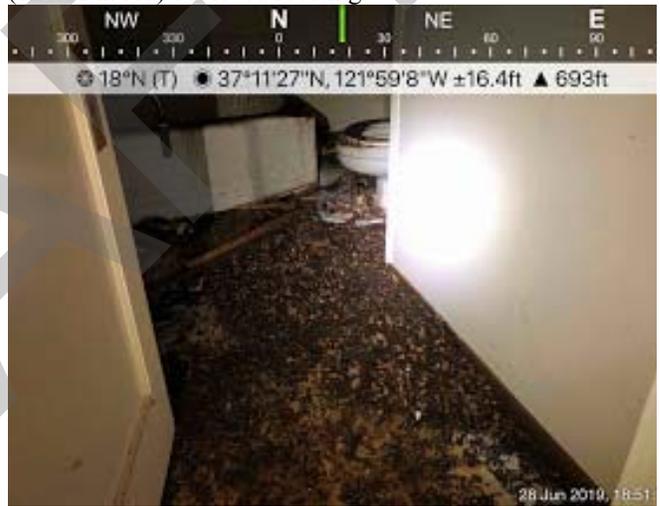
Photo 38. Large amount of woodrat feces on floor.

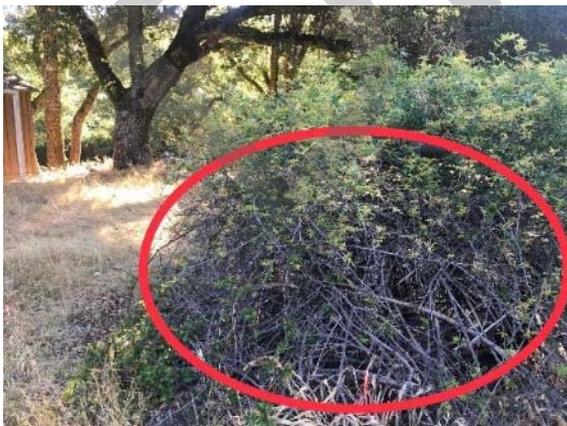
Photo 39. Woodrat nest number 1 is located under an ornamental bush 9 meters south of the structure

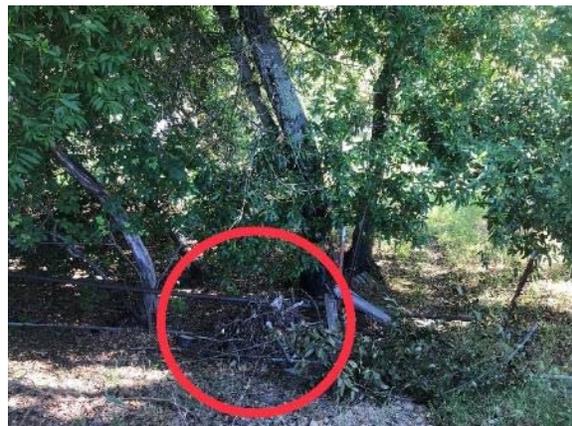
Photo 40. Woodrat nest number 2 is located along a fence 10 meters northeast of the structure.

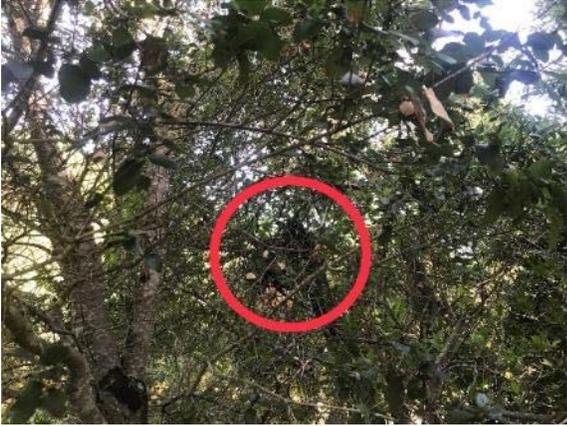
Photo 41. Woodrat nest number 3 is located in a tree, northwest of the structure.

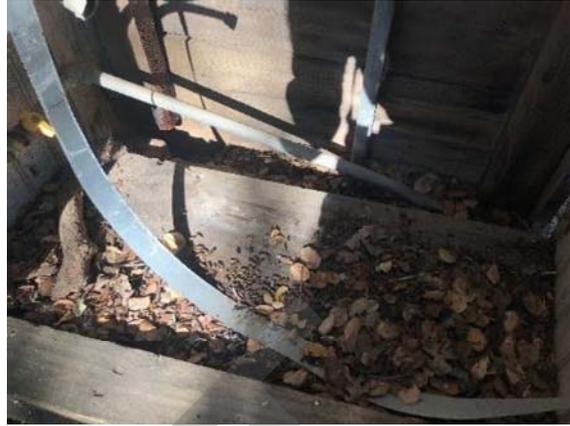
Photo 42. Woodrat A large amount of woodrat feces was observed in one location along the exterior of the structure.

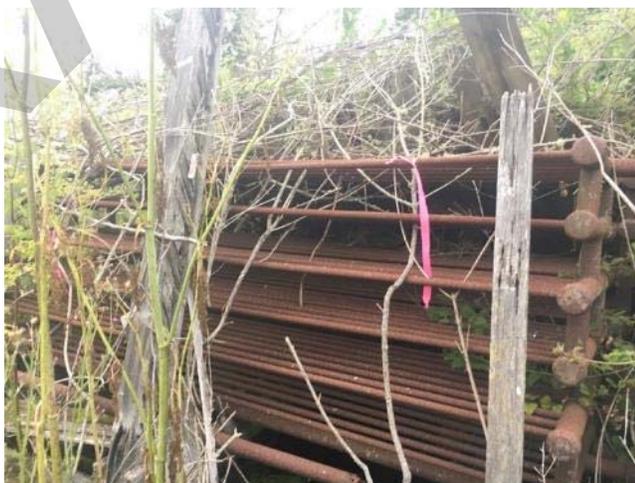
AREA B: The inside of Tanks 1-2 could not be observed due to their height, but both tanks appeared to be single-walled and open on the top. These tanks are likely unsuitable for day roosting bats due to exposure to the elements and the lack of additional surfaces that could create crevices. The distillation column was capped on the top but appeared to have a small opening on its side about 15 feet off the ground that could potentially be used by roosting bats (Photo 43). The structure on the east side of Area B included a series of iron grates over a concrete box filled with water as well as a dilapidated shed with a corrugated tin roof. The shed contained pieces of wood attached to corrugated tin that created small crevices that could be suitable for bats, but no signs of bats were observed. Large woodrat nest structures were observed inside the series of iron grates and inside the dilapidated shed, as well as behind the shed (Photo 44 and 45).

Photo 44. Area B – woodrat nest structure inside the series of iron grates. This structure sits over a concrete spring box filled with water.

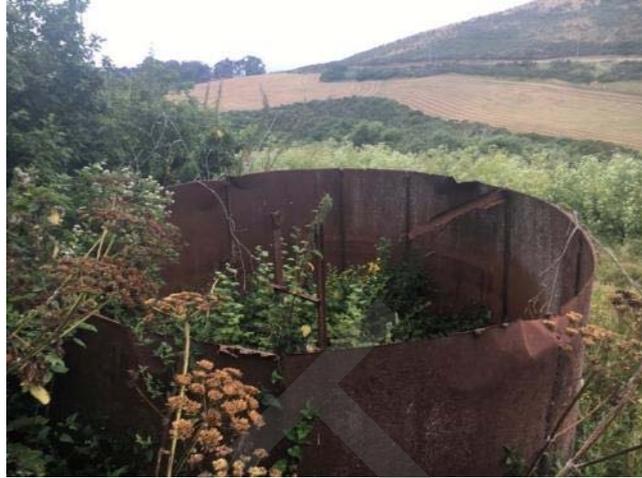
Photo 46. Area D – most tanks were single-walled without any small crevice space for roosting bats.

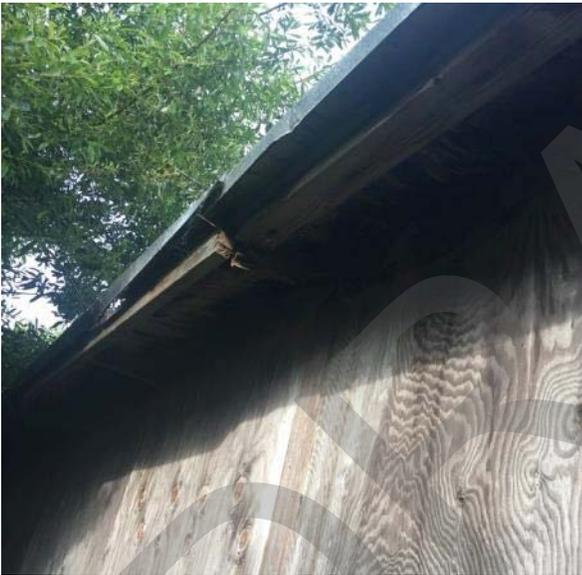
AREA E: The exterior of the hunting cabin had rotted and loose wood paneling, especially near the roofline, that could be suitable for roosting bats (Photo 47 and 48). A search of the structure's exterior found no sign of bats, however, many holes and crevices that led to the space between the roof and the structure's interior could not be fully observed. A search of the interior of the structure revealed that the previous owners had used the cabin recently. Maternity colony day-roosting habitat was observed inside the structure and no guano pellets or urine staining were observed. Additionally, no sign of woodrats were observed inside the cabin, however small mammals droppings (likely *Peromyscus* sp.) were present throughout the cabin. One large woodrat nest structure was observed behind the cabin.

Photo 47. Area E – additional openings and interstitial spaces underneath the roofline.

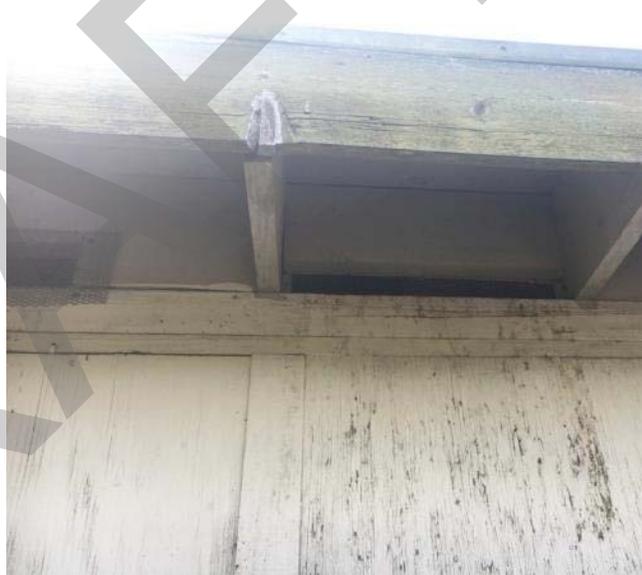
Photo 48. Area E – openings underneath the roofline of the hunting cabin.

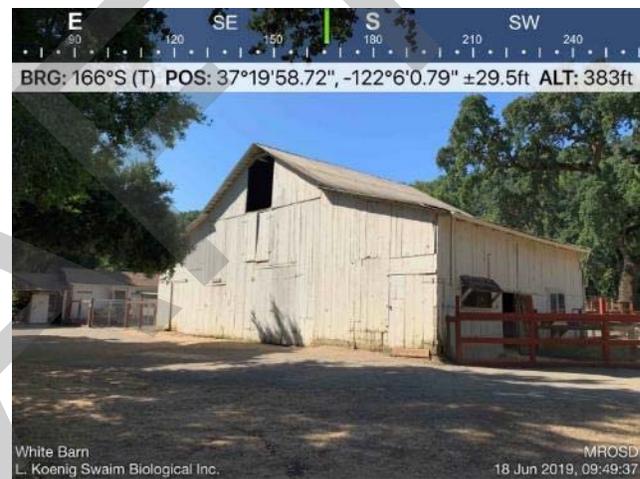
Photo 50. White Barn exterior showing hayloft doors and open access points.

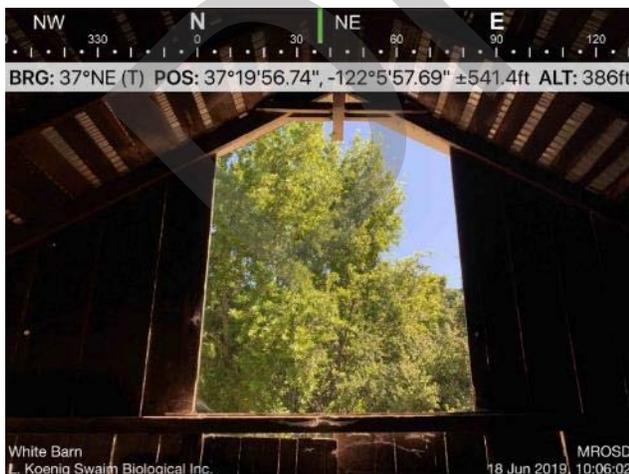
Photo 51. White Barn hayloft with crevice roost habitat between roof and rafters.

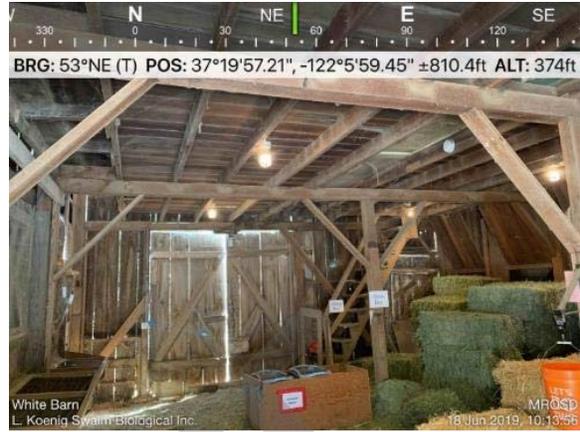
Photo 54. Lower level with hay storage and milk barn

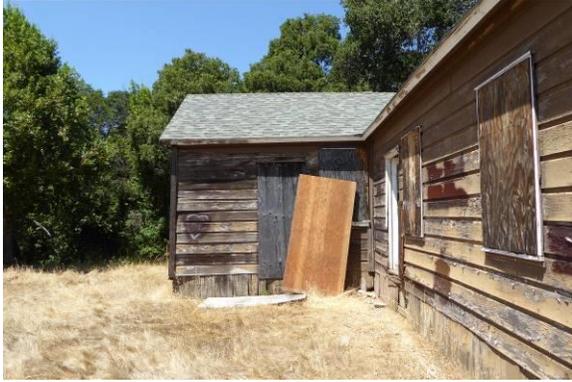
Figure 1

South façade of ca. 1870 addition. Window is addition possibly from the World War II interior modifications as it doesn't have the metal piece under the sill that other windows do on the façades with this cladding
