Midpeninsula Regional
Open Space District

R-20-35
Meeting 20-08
April 8, 2020

Select a design alternative for the La Honda Creek Redwood Cabin, La Honda Creek White Barn, and Sierra Azul Beatty House

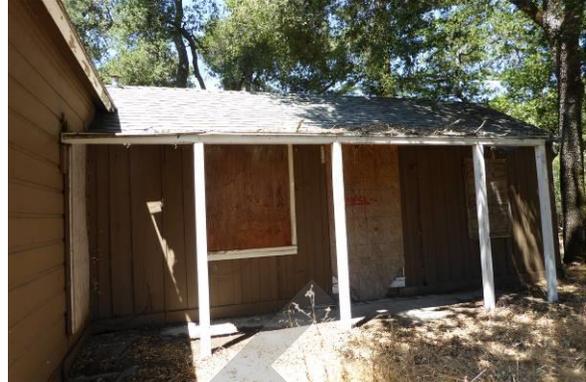
Figure 2

South façade of ca. 1877 addition. Windows and door correspond to the World War II modifications. Porch is addition covering partially the door exiting from the original dwelling.

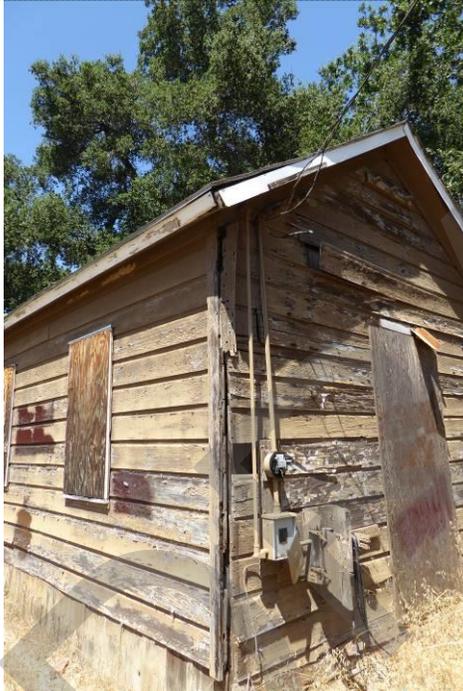
Figure 3

South and west façades of the ca. 1870 addition. Second cladding horizontal layer heavily weathered due to lack of protective treatment and care. Electric connections and meter are in this corner.

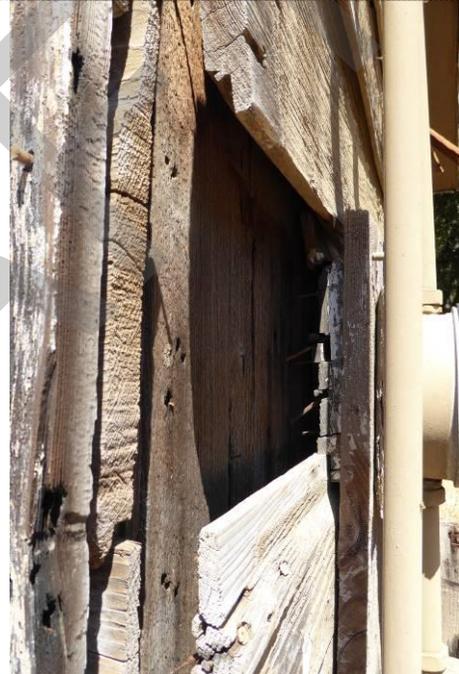
Figure 4

Close-up of lost piece of horizontal cladding where underlying vertical original cladding can be seen, also heavily weathered

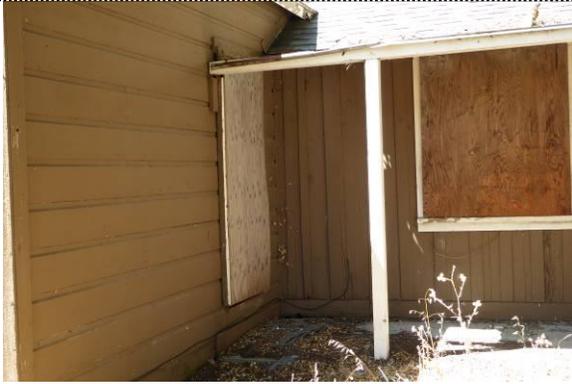
Figure 5

East façade (left) of the L-shaped addition. Door is blocked at the top end by the porch. The horizontal second layer of cladding was added before the extra feet connecting the buildings was added as it continues beneath the façade of the connection

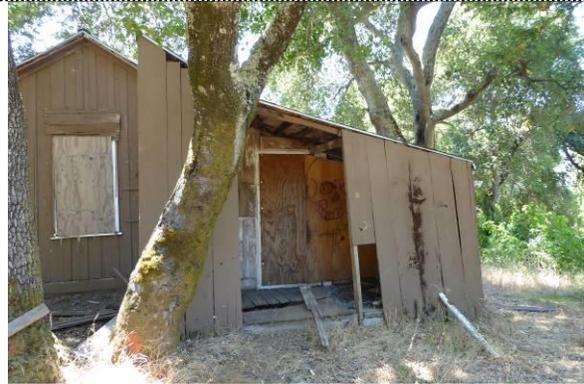
Figure 6

Right side of the East façade. Open shed is the latest addition to the building and has direct access to the pantry from the previous addition. The visible change in roof slope corresponds to the original building vs the kitchen and pantry addition

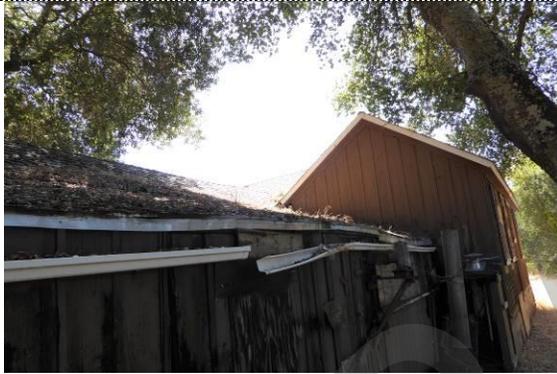
Figure 7

North façade of the kitchen and pantry. Roof has a gentler slope indicating its' belonging of a later addition date. Several elements have been replaced by more modern materials like T-111 siding

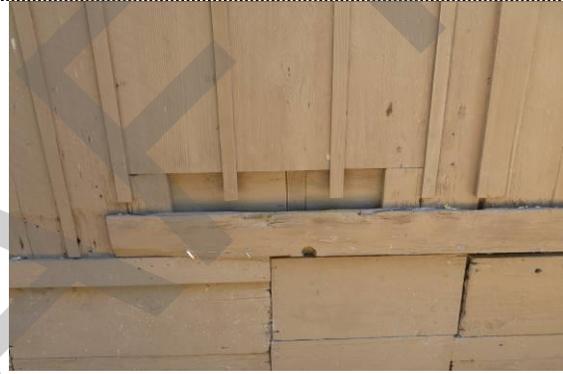
Figure 8

Close-up of cladding under the bathroom window, clearly different from the cladding of the rest insinuating it may have been originally a door opening that was later partially closed to form the current bathroom window

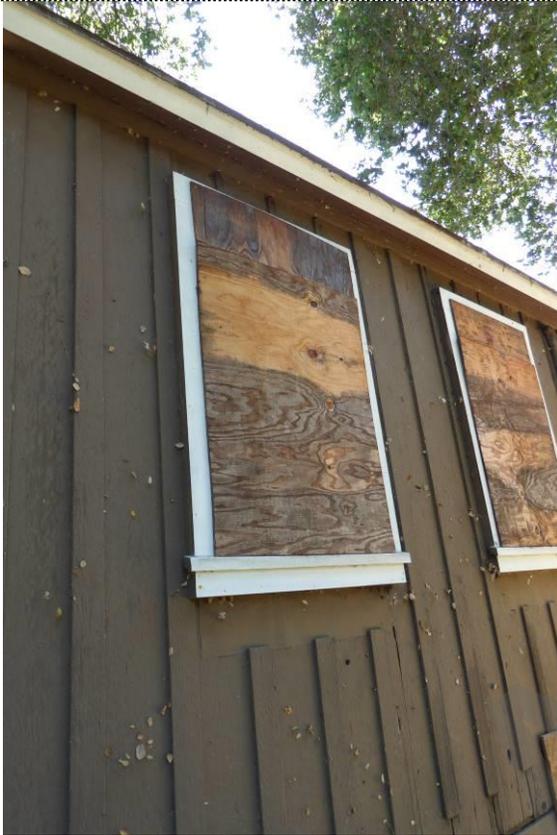
Figure 9

Windows of the north façade of the L-shape addition. The metal pieces under the sills indicates they were moved upwards or reduced in size during modifications to match height of other windows in the building

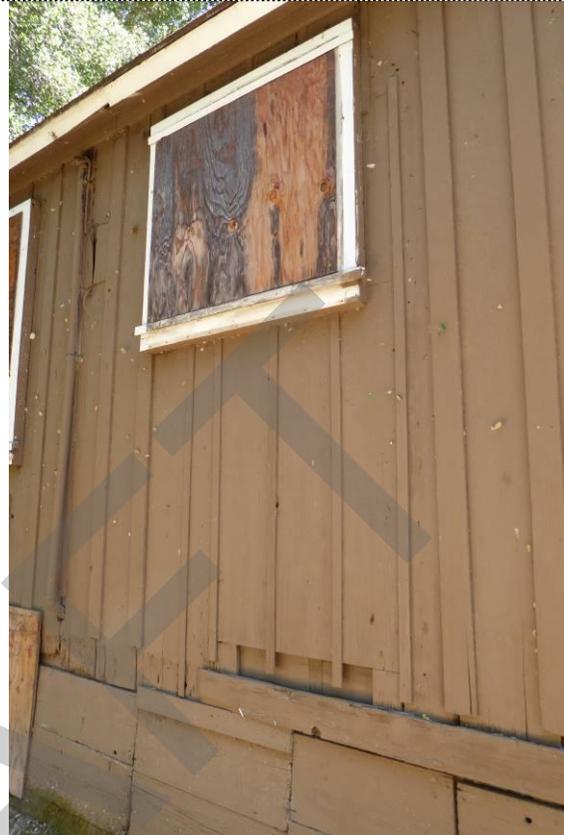
Figure 10

Bathroom window. Opening suspected to be created partially using the existing opening from a presumably previous existing door. The initial height of the cladding boards used insinuates the possibility of a landing and steps leading up to the house. Recommended archaeological study of the area beneath to verify preexisting conditions.

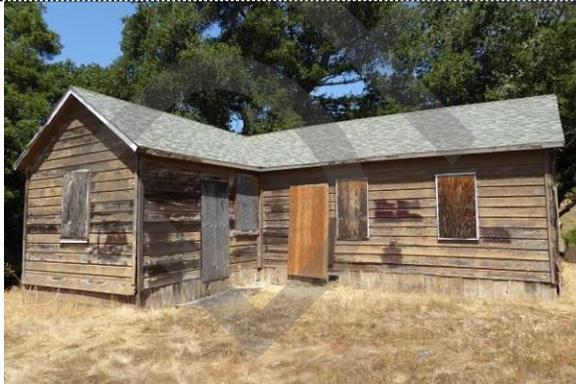
Figure 11

West façade and westernmost section of south façade. Corresponding to the L-shaped addition. All windows except the one in the center, belonging to the hallway, have been moved upwards or modified and reduced in size after the second layer of cladding was installed having a metal piece under the sills to cover up the gap originated during this modification

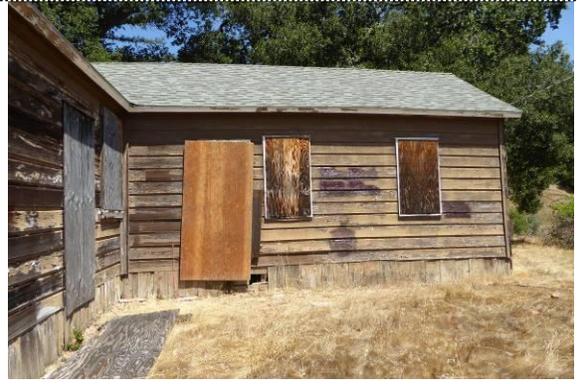
Figure 12

West façade of the L-shape, corresponding to the dining room and pantry. The roofs of the entire dwelling are relatively new, consisting of recent plywood sheathing nailed to historic spaced sheathing and covered in asphalt shingles.

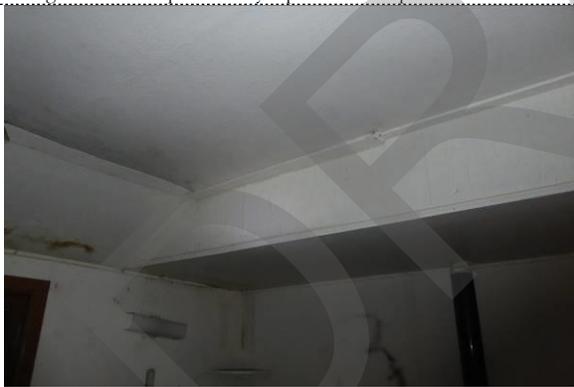
Figure 15

Double level ceiling of the living room. The lower section could have been part of the original east façade of the building or a porch covering its eastern side

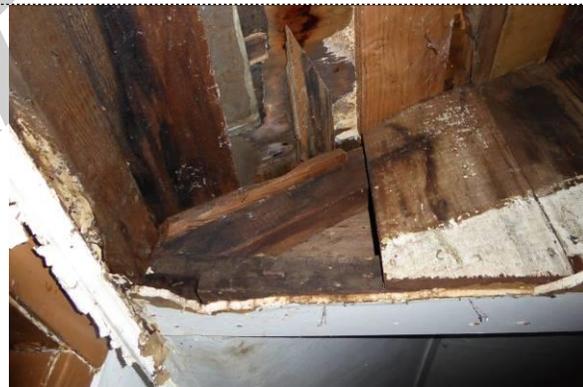
Figure 16

Hanging lower ceiling in the living room as seen through an opening. Clearly the vertical boards could be part of an original façade that was later modified. Evident humidity and rot signs, especially where the different roofing areas merge. Visible the new plywood sheathing directly over the historic one

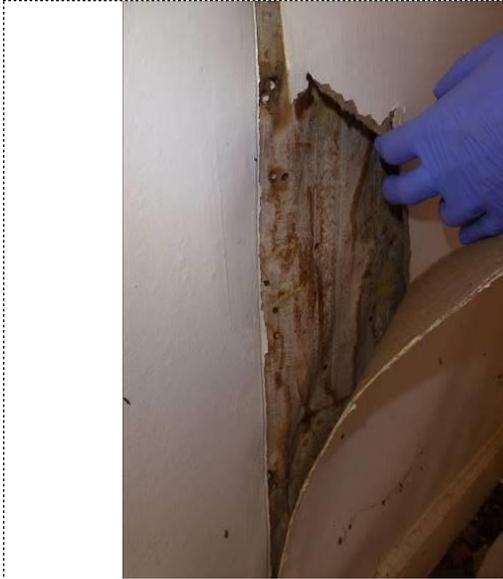
Figure 17

Current gyp board finish nailed over pre-existing floral painting finish board

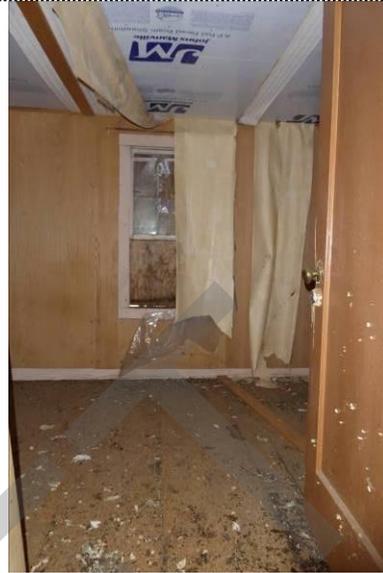
Figure 18

Bedroom 2 is accessed descending one step from the living room, insinuating construction at a later phase. Carpeted floor, single flush door, 1/1 window, and isolation on ceiling insinuate a relatively modern build

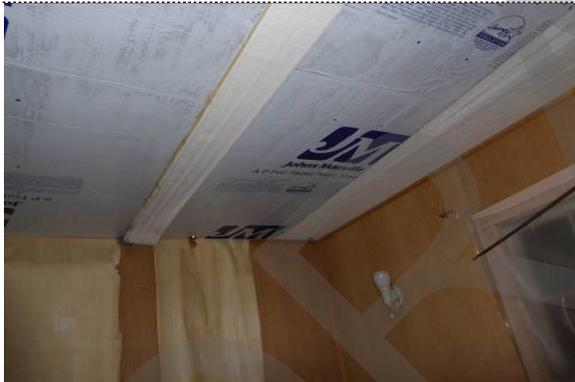
Figure 19

Current ceiling of bedroom 1 include modern materials as fiberglass isolation and others. Walls are covered in faux wood paneling over isolation with fiberglass, indicating it underwent modifications in more recent times.

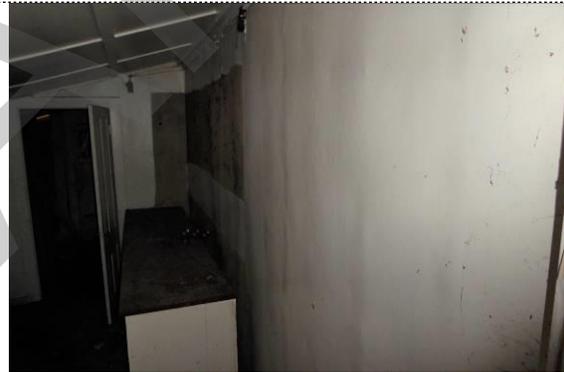
Figure 20

Kitchen with access to the pantry on the far side. Several cabinets have been removed. These rooms belong to the latest addition (not counting the shed) and add little value to the historic elements of the dwelling.

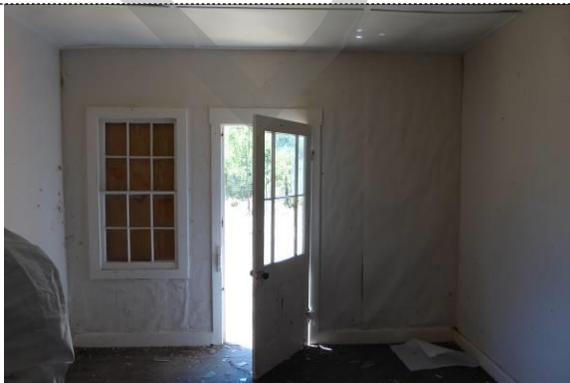
Figure 21

Living room, exit door with mid-19th century rim locks, and window to the west façade. Wall finish not properly attached needs reattachment if possible or replacement when not possible to reattach.

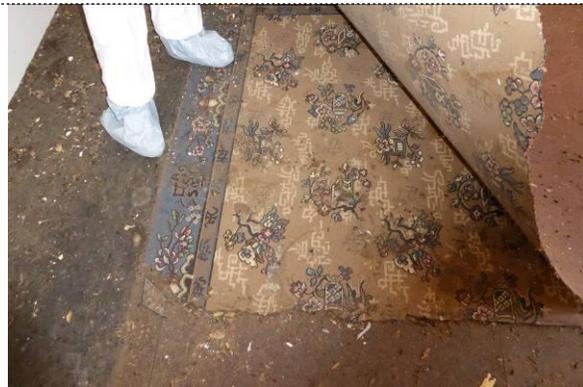
Figure 22

Original floor sheet in rug pattern over tar paper currently folded in half. Would require rehabilitation treatment to rejoin both halves and to bring out the original colors prior to final reinstallation

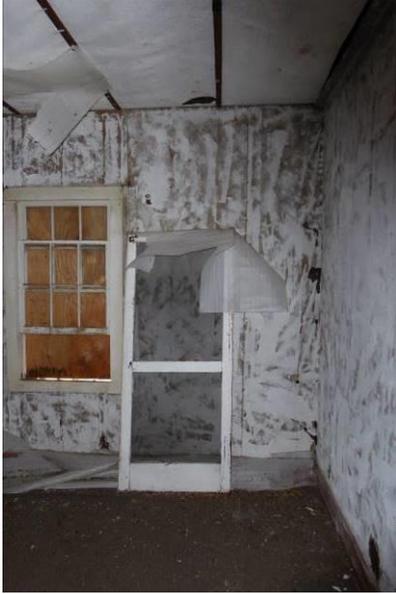
Figure 23

Parlor, with carpeted floor and unfinished walls and ceiling insinuate that it was previously used as a bedroom before the final modifications to the house

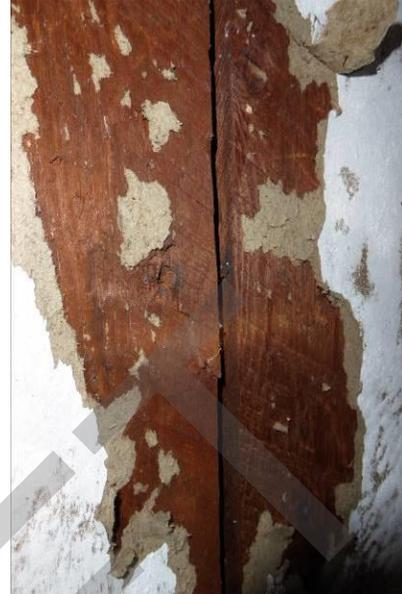
Figure 24

Wall boards conforming the façades and partitions are covered directly by the interior finish cardboard with no isolation layers in between

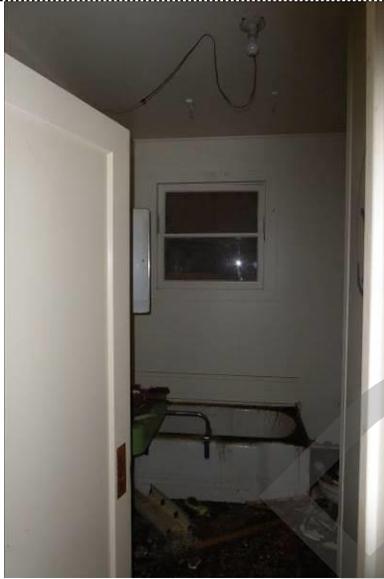
Figure 28

Bathroom window where presumably there was originally an exit door

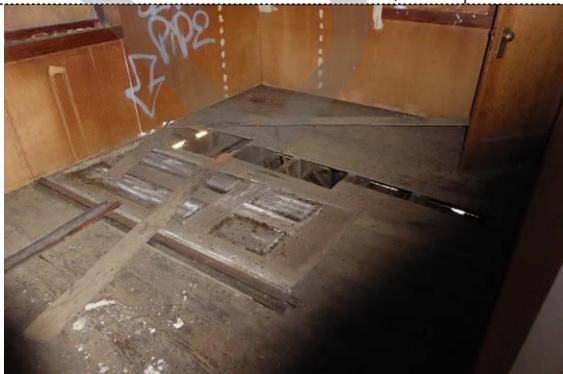
Figure 31

South façade and door opening of the storeroom don't have finish treatment, currently the door is laying on the floor of the room

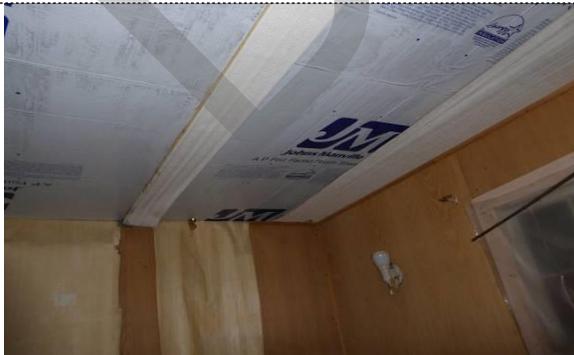
Figure 37

Bedroom 2 is accessed descending one step from the living room, insinuating construction at a later period. Carpeted floor, single flush door, 1/1 window, and isolation on ceiling insinuate a relatively modern build

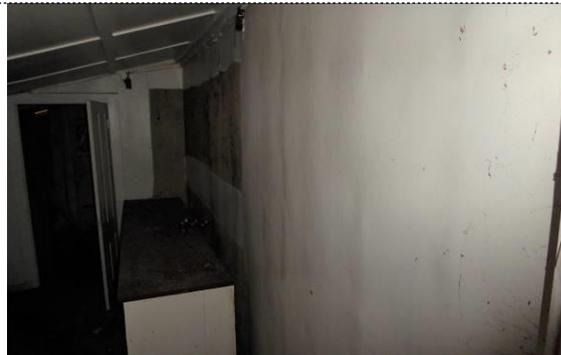
Figure 38

Current ceiling of bedroom 2 include modern materials as fiberglass isolation and others. Walls are covered in faux wood paneling over isolation with fiberglass.

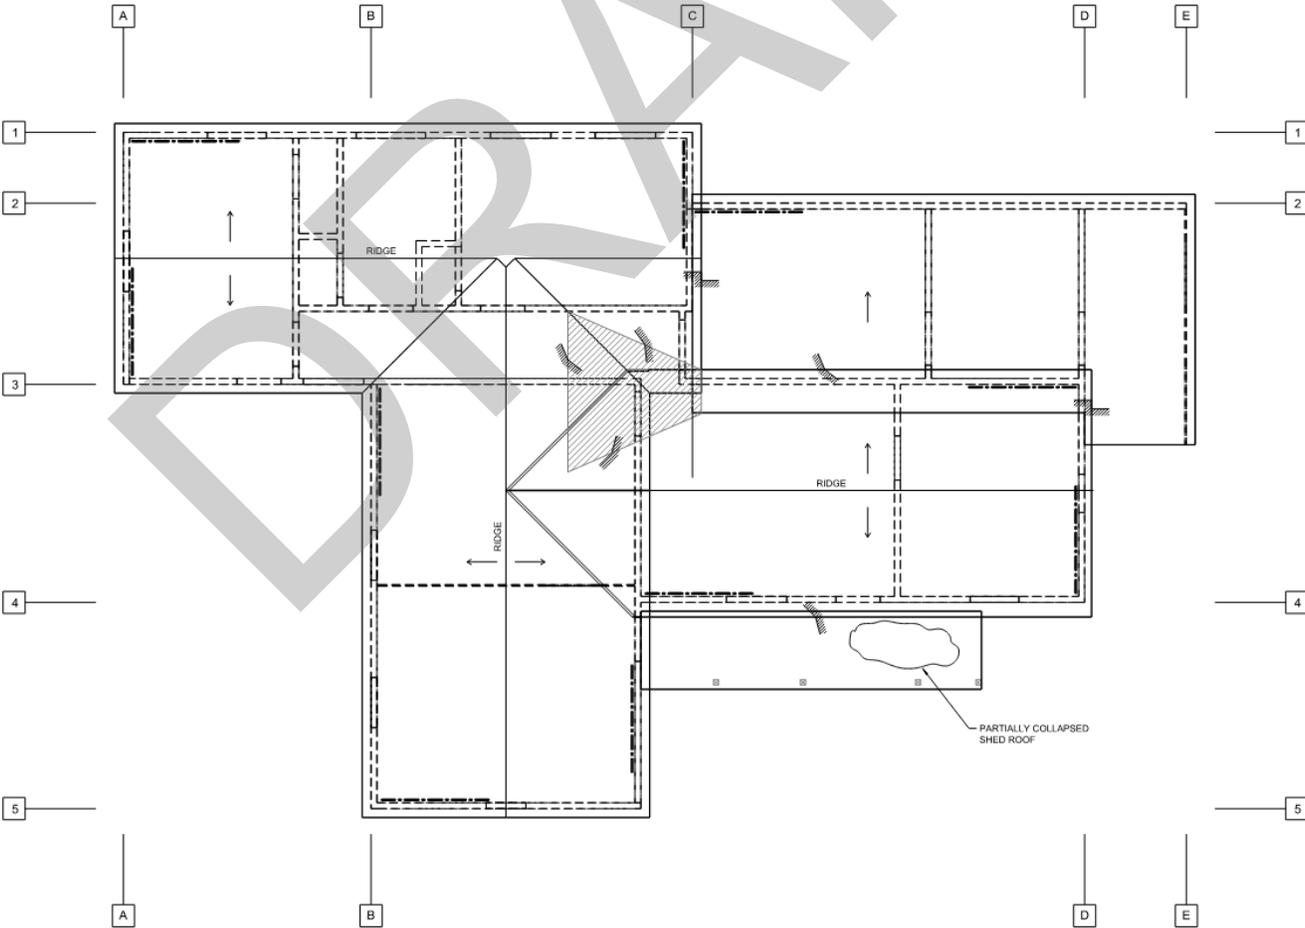
Figure 1: Roof Framing Plan from ZFA-prepared Existing Condition Drawings

The roofing is composed of asphalt shingles supported directly on 1x horizontal lumber decking oriented up-down slope that forms the roof diaphragm. The 1x decking is supported by 1x framing at approximately 24” on center which spans between the roof rafters. The roof rafters are 2x4 nominal spaced approximately 36” on center and clear span from the ridge to the exterior walls (See photo 8). 1x6 collar ties span between the rafters below the ridge to help resist horizontal thrust and allows the rafters to span between exterior bearing walls. There does not appear to be a ridge beam or ridge board. The existing roof framing plan is shown in Figure 1 below.

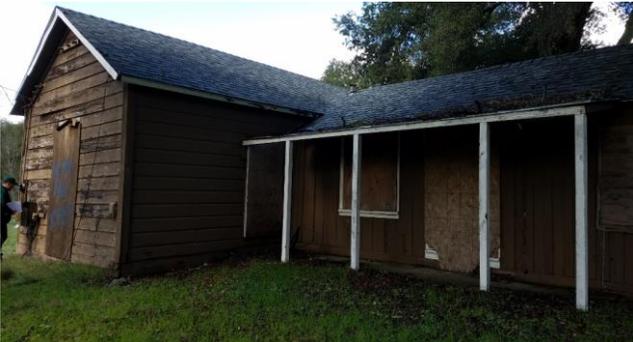
The foundations for this structure are limited to wood posts that bear either directly on grade, or on a small wood sleeper on grade. Some posts may be embedded an unknown distance into the ground. Moisture damage was observed at several posts in contact with the ground (see Photos 1, 5, 11, 12 and 13).

Photo 1. South elevation, showing shed roof support by posts

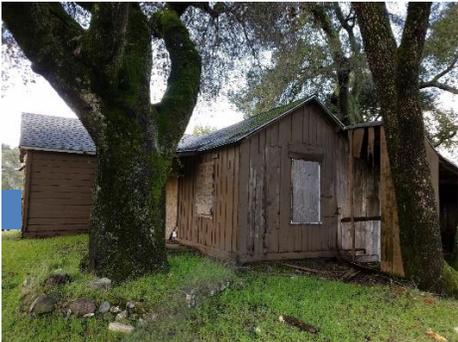
Photo 2. East elevation – dilapidated shed shown on the right

To provide safe perimeter access to the Beatty Property Home for the purposes of maintenance and interpretation, the derelict, framed shed on the east side of the home should be carefully dismantled and removed. The wildlife currently inhabiting the building should be relocated per District standards. Holes and gaps in the envelope that allow for the intrusion of wildlife and water into the building interior should be patched per preservation best practices. Other deteriorated elements of the historic building envelope described in the Conditions Assessment should also be repaired per preservation best practices. Areas and/or elements of the building envelope that are deteriorated beyond repair should be replaced in-kind to match the original elements and construction techniques. Extant original board-and-batten siding should be repaired. The collapsing floor should be stabilized, and the existing hole in the floor should be covered securely. The existing plywood covering the doors and windows should be inspected semi-annually and re-secured as required. Adequate ventilation shall be installed that is sufficiently protected from the intrusion of additional insects and wildlife. Following necessary repairs, exterior wooden elements should be prepared and painted; building should be repainted every 7-10 years to maintain the coating protecting the historic substrate.

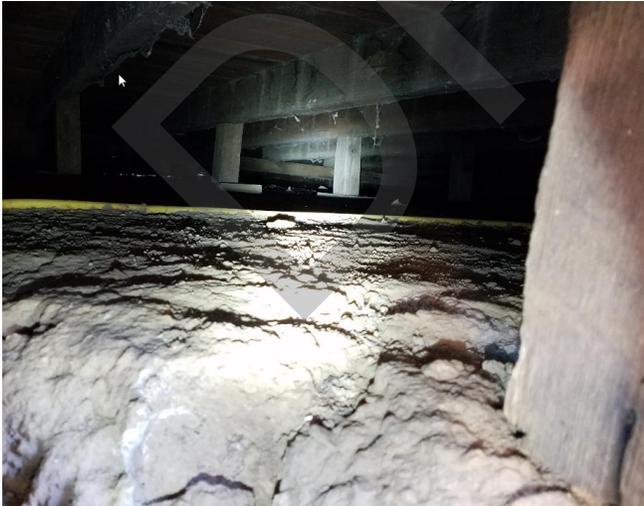
Photo 5. Interior crawlspace framing, showing posts bearing on grade or on wood sleepers

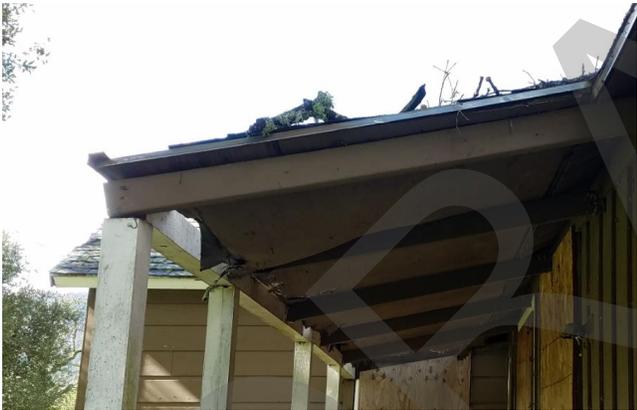
Photo 9. Partially collapsed portion of shed roof

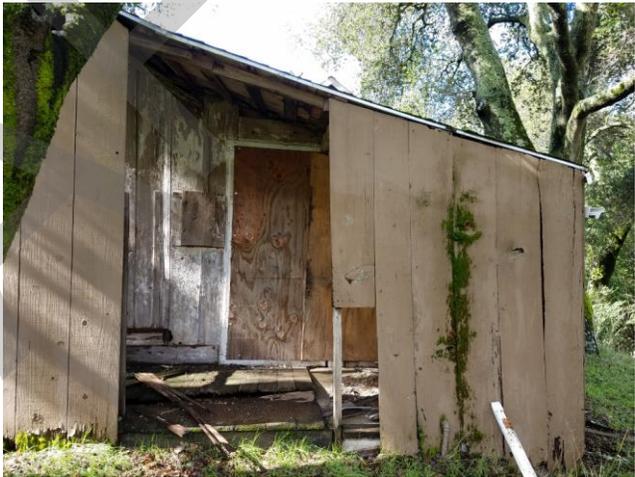
Photo 10. Dilapidated shed

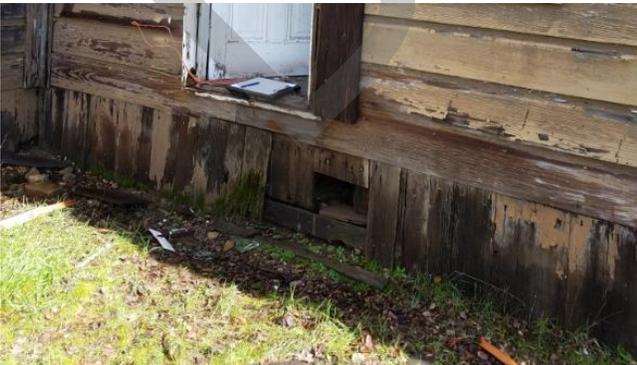
Photo 11. Moisture damage at exterior wall

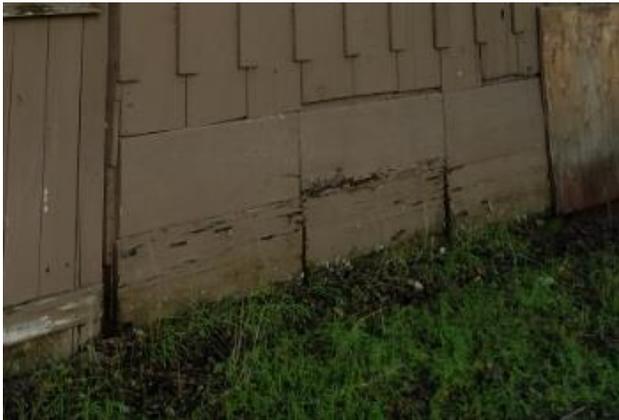
Photo 12. Moisture damage at exterior wall

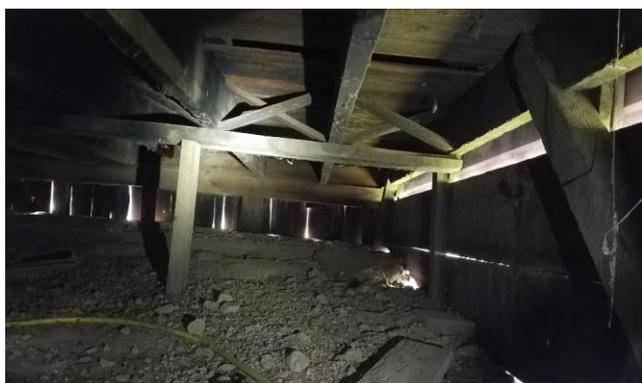
Photo 13. Crawlspace framing showing lack of concrete foundation, wood posts sitting directly on grade, and diagonal framing at perimeter wall

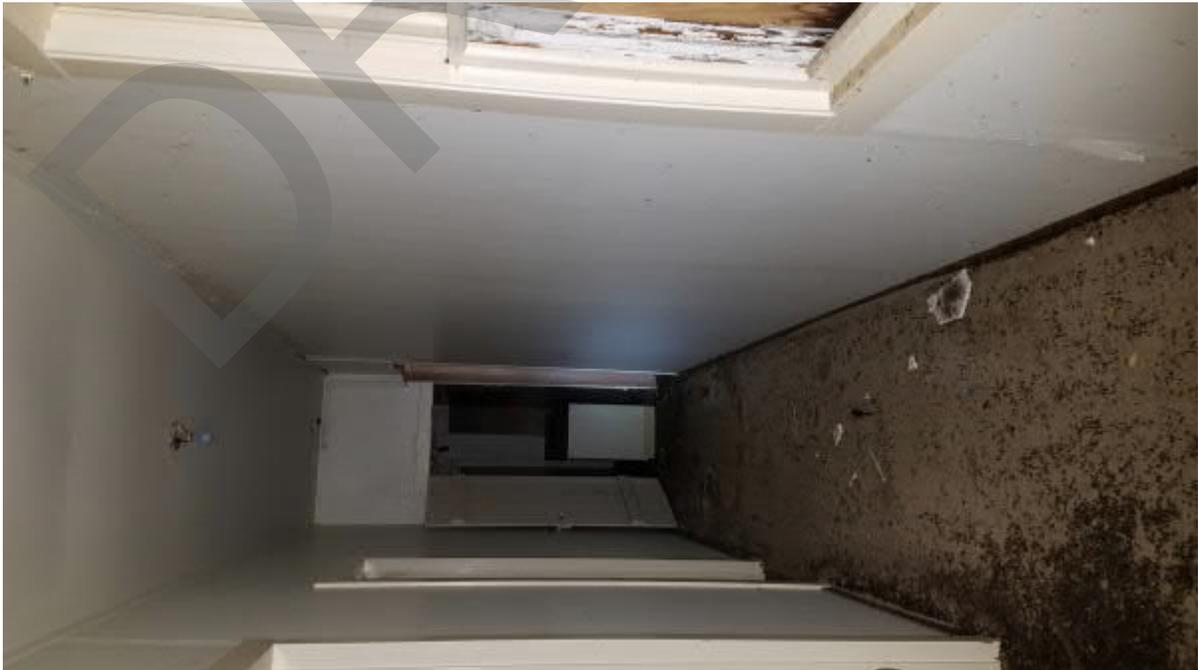
Photo 4 Material 204 - ACM joint Compound on wallboard walls and ceilings in the Beatty House

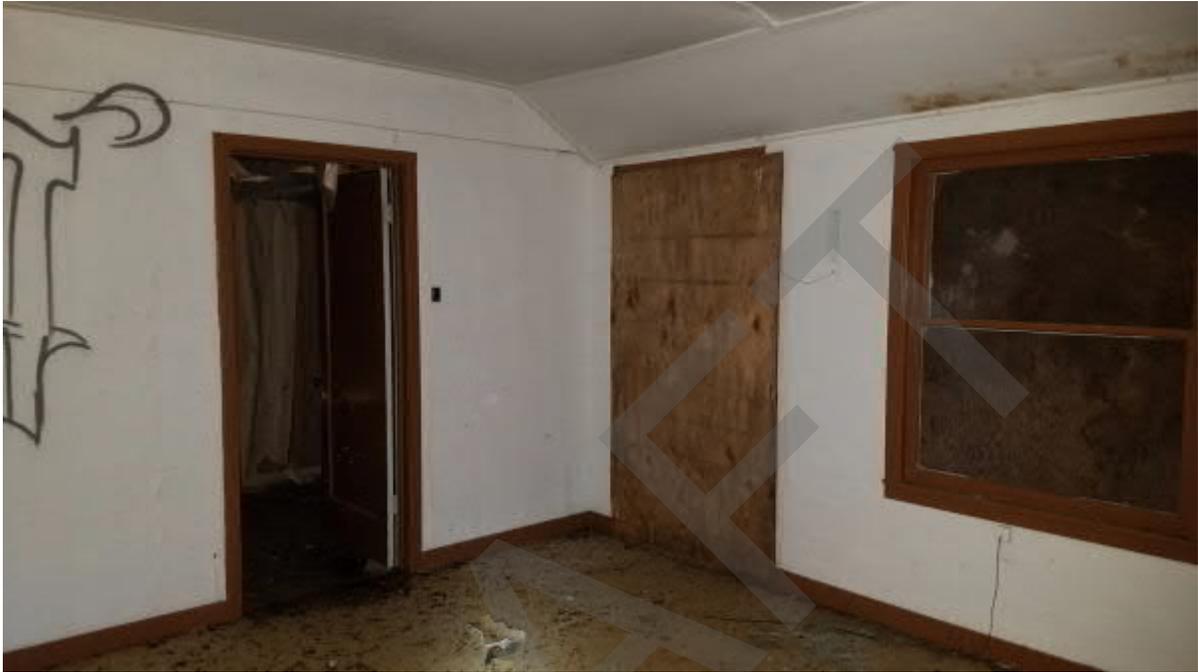
Photo 5 Material 201 ACM vinyl sheet flooring in the Beatty House

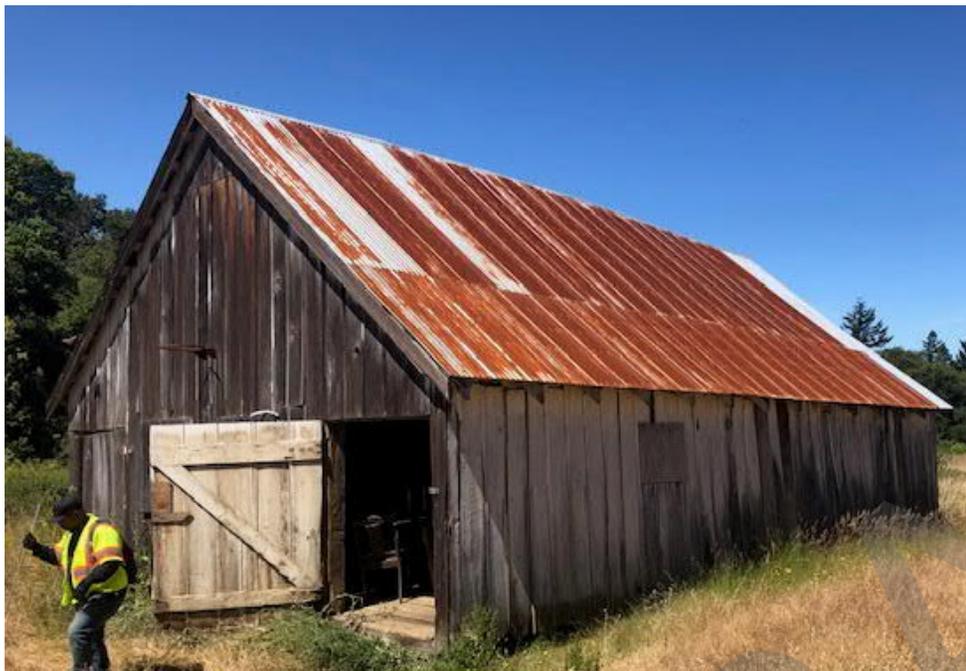
Sample L-3 white paint on wood siding collected from exterior of barn

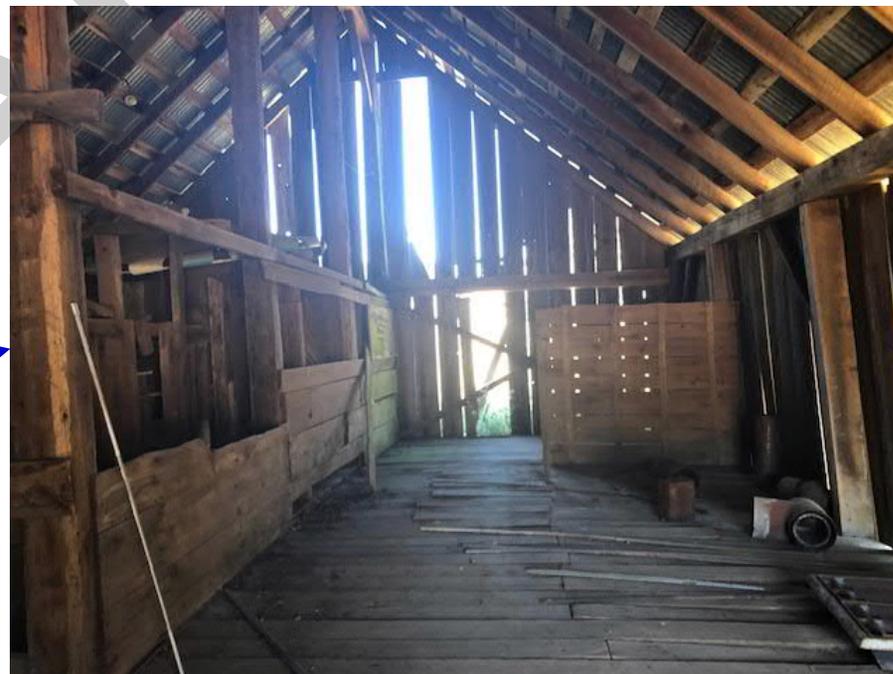
Samples 100A, 100B, and 100C Black 1/8" wiring collected from interior of barn

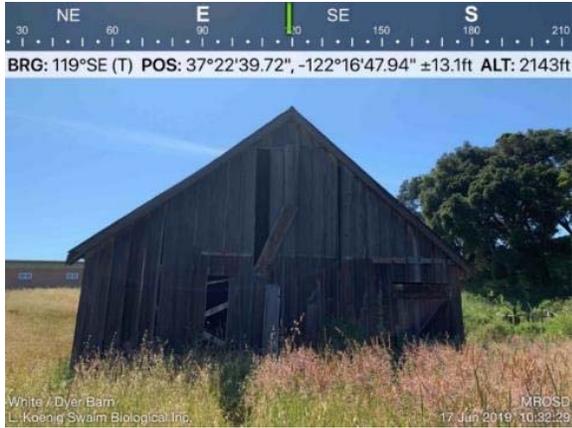
Photo 3. White Barn exterior missing wooden slats and entry points for bats.

- Preconstruction surveys for bats and woodrats prior to stabilization activities.
- Follow the general bat avoidance and minimization measures presented in Section 4.1.
- Development of bat roost deterrent plan for approval by the California Department of Fish and Wildlife (CDFW) prior to structure stabilization activities.
- The need for replacement habitat due to impacts on the maternity roost per District guidelines is dependent upon whether the planned stabilization activities will eliminate roosting habitat. Determination of the need for replacement habitat plan should coincide with the development of the deterrent plan.

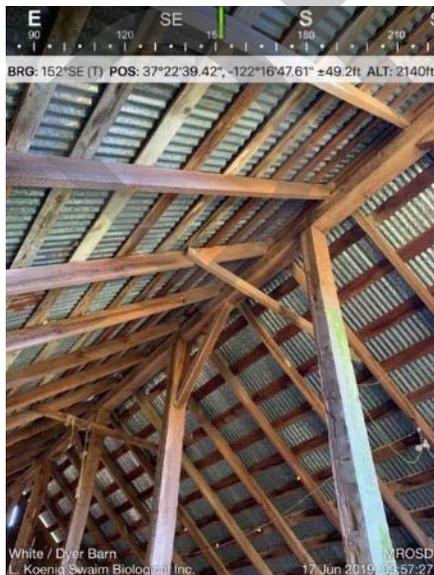
The barn surveyed receives partial shade from the riparian corridor to the west (Photo 3). Surrounding the barn is signs of wetland / wet meadow as demonstrated by the presence of (giant plantago (*Plantago major*), sedges (*Scirpus spp.*), elderberry (*Sambucus nigra spp. Caerulea.*), and willows (*Salix sp*). A concrete drainage adjacent to the east side of the barn appears to drain overland flow into the adjacent drainage (Photo 4). The barn itself is in a flat that leads to a downstream ravine and riparian corridor. The interior of the barn (Photo 5 and 6) is comprised of one area subdivided into sections by feeding stalls, an interior enclosed chicken coop, and an open space area. The barn has a pitched roof with corrugated metal sheets held up in regular intervals by rafters (Photo 7).

Photo 7. Corrugated roof slats and rafters provide suitable bat roosting habitat.

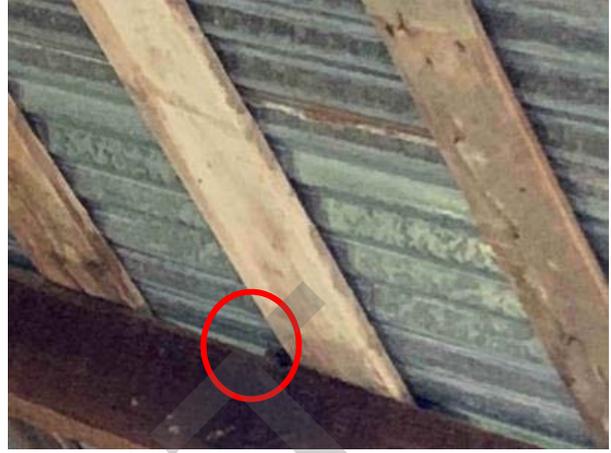
Photo 10. *Myotis sp.* (circled in red) observed roosting in rafters.

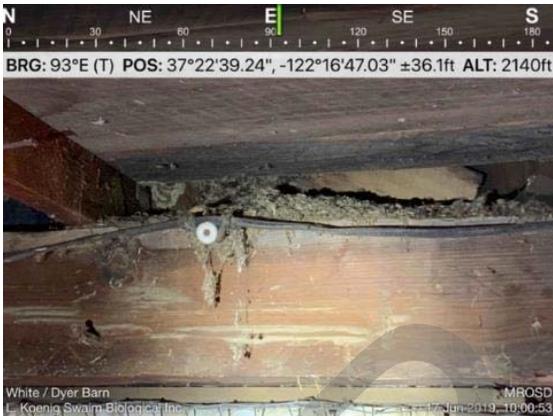
Photo 11. Rodent nests observed within the barn. These grass nests are most likely deer mouse (*Peromyscus sp.*) nests.

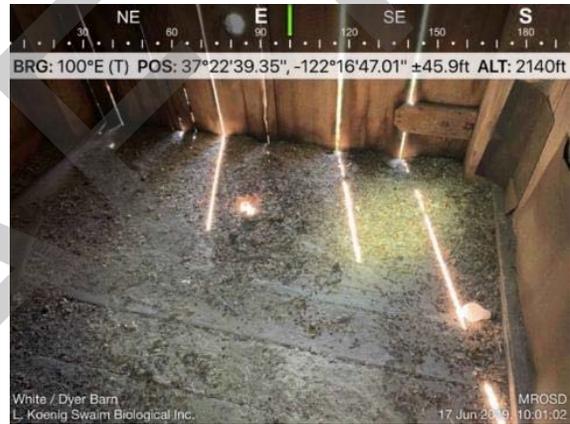
Photo 12. Rodent droppings and destroyed food caches observed within the barn.

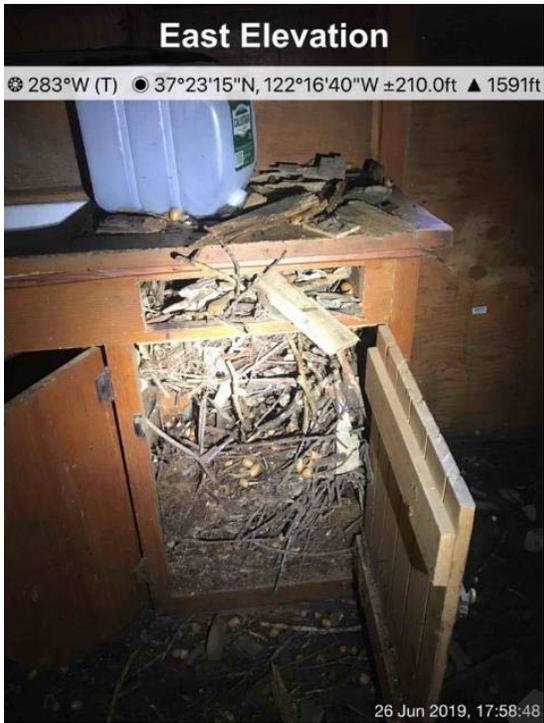
Signs of woodrats were present throughout the cabin including a large number of fecal pellets in all rooms of the cabin. One woodrat nest structure was built into a cabinet in the kitchen (Photo 15), twigs around and behind the oven, twigs on ceiling beams in between rooms (Photo 16), and two nest structures built on top of sinks in two rooms (possibly connected behind the wall) (Photo 17 – 18).

Photo 15. Woodrat nest built into kitchen cabinet of redwood cabin.

- Preconstruction surveys for bats and woodrats prior to stabilization activities.
- Follow the general bat avoidance and minimization measures presented in Section 4.1.
- Development of bat roost deterrent plan for approval by the California Department of Fish and Wildlife (CDFW) prior to structure stabilization activities.
- Follow general woodrat avoidance measures presented in Section 4.2.

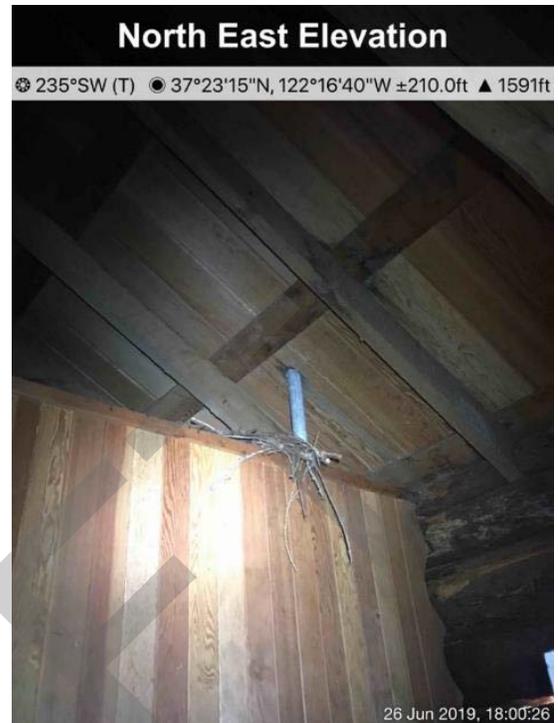
Photo 16. Woodrat nest on ceiling beams of redwood cabin.

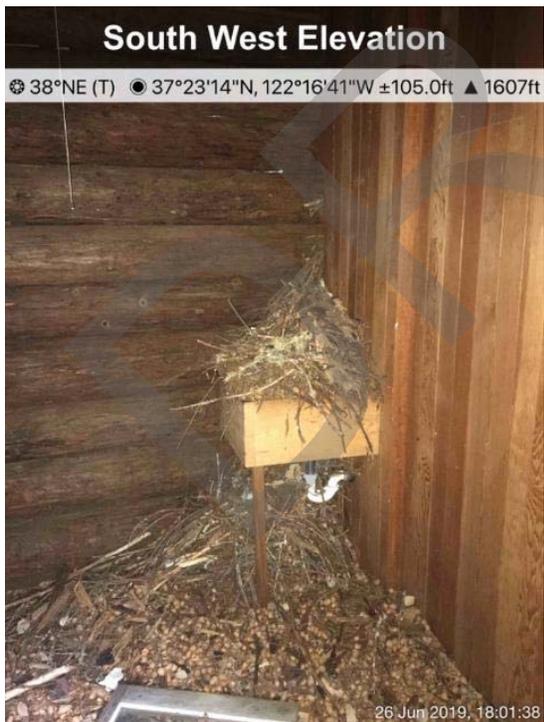
Photo 17. Woodrat nest on sink in Room A of redwood cabin.

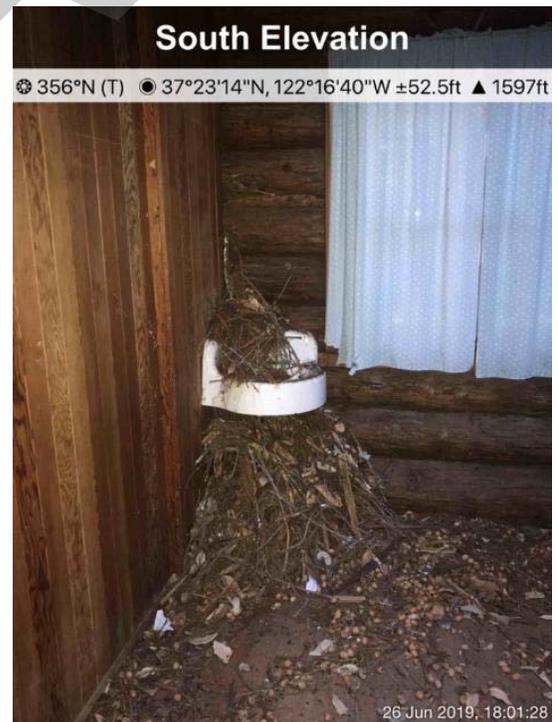
Photo 18. Woodrat nest on sink in a Room B of redwood cabin.

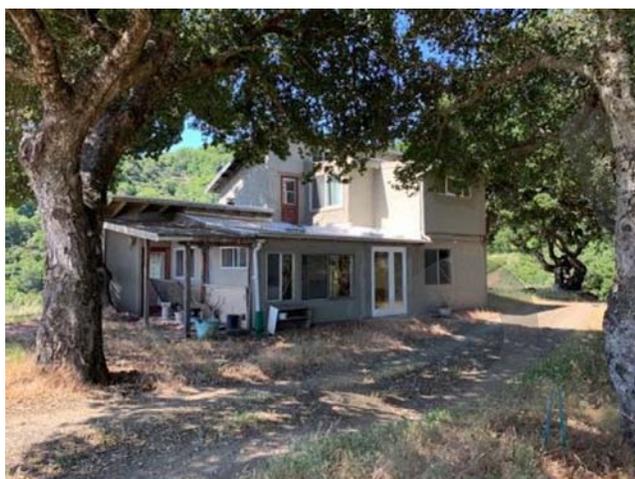
Structure A is a two-level house that is set to be demolished (Photo 19 and 20). Structure A is well shaded on the north and west sides of the house by oak trees and is unshaded on the east and south sides of the house. Structure B is the one-level studio apartment that will not be demolished (Photo 25). The structure is mostly unshaded with a flat-topped roof. There is a garage with an open-air shed space attached. Structure C is a shed that will also remain and not be demolished (Photo 26). In general, moderately – highly suitable bat maternity habitat is found adjacent to the structures listed above and within the structures scheduled to remain.

Photo 19. Structure A is partially shaded by oak trees.

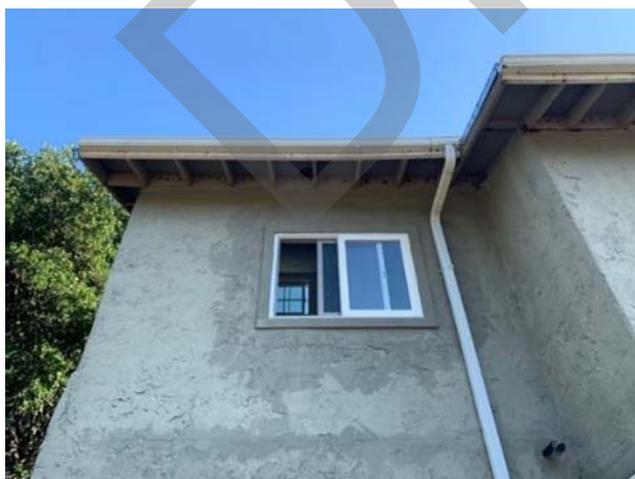
Photo 21. Ventilation holes under the eave of Structure A.

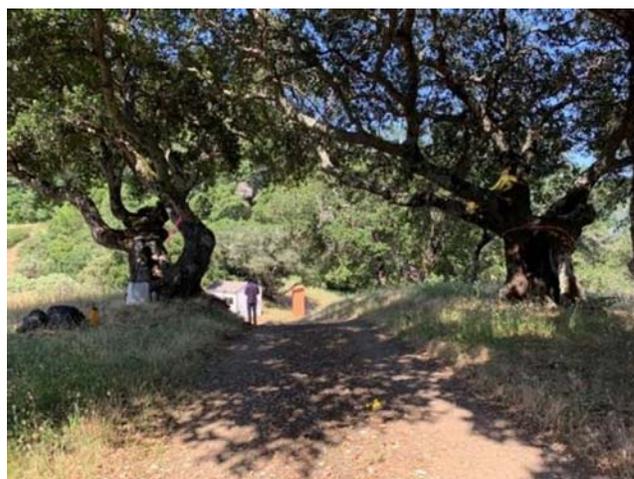
Two woodrat nests were located approximately 25-feet from Structure A in the hollowed-out trunks of two large coast live oaks (*Quercus agrifolia*) (Photo 22). A black phoebe (*Sayornis nigricans*) nest was observed under the eave of Structure A.

Photo 22. Woodrat middens in hollows of oak trees west of Structure A.

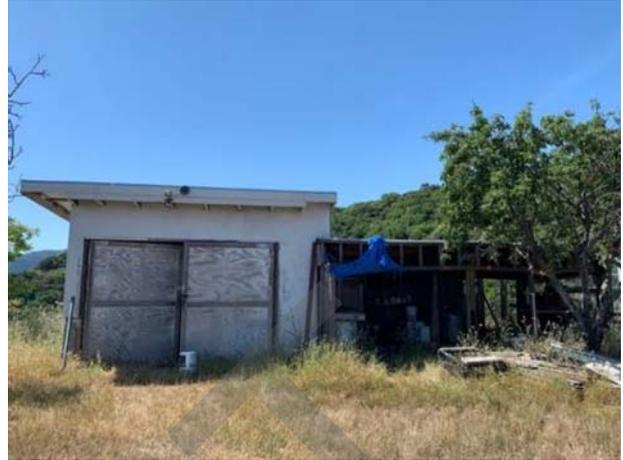
Structure C: The open structure has suitable bat maternity and night roosting habitat within (Photo 24). A potential woodrat midden is located outside of the shed on an upper shelf (Photo 25).

Photo 24. Structure C – shed west of Structure A.

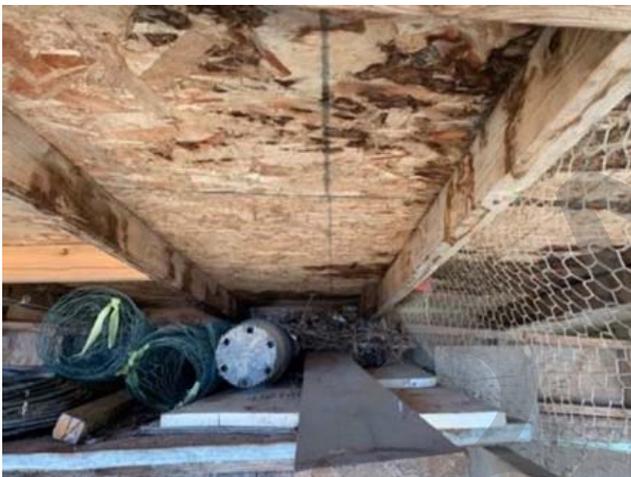
Photo 25. Possible woodrat midden on shelf in Structure C.

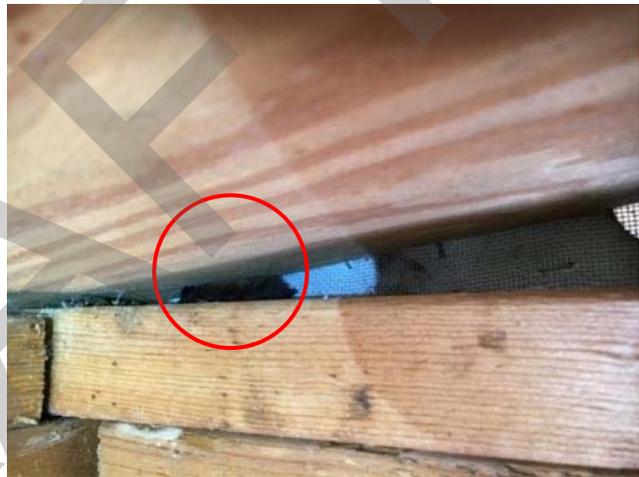
Shed: There is a shed to the west of the structures that were to be surveyed where a day roosting *Myotis* sp. was observed on June 11 (Photo 26). No roosting bats were observed on June 25.

Photo 26. *Myotis sp.* (circled in red) observed roosting in crevice in nearby shed to the west of the structure to be removed.

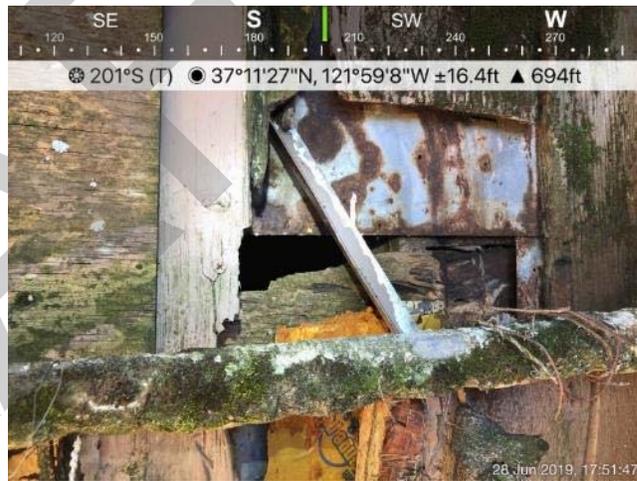
Photo 32. Hole on wall that could provide bat access.

- Preconstruction surveys for bats and woodrats prior to removal activities.
- Follow the general bat avoidance and minimization measures presented in Section 4.1.
- Development of bat roost deterrent plan for approval by the California Department of Fish and Wildlife (CDFW) prior to structure stabilization activities.
- Provide replacement bat maternity roost habitat as part of the deterrent plan for approval by CDFW.
- Follow general woodrat avoidance measures presented in Section 4.2.

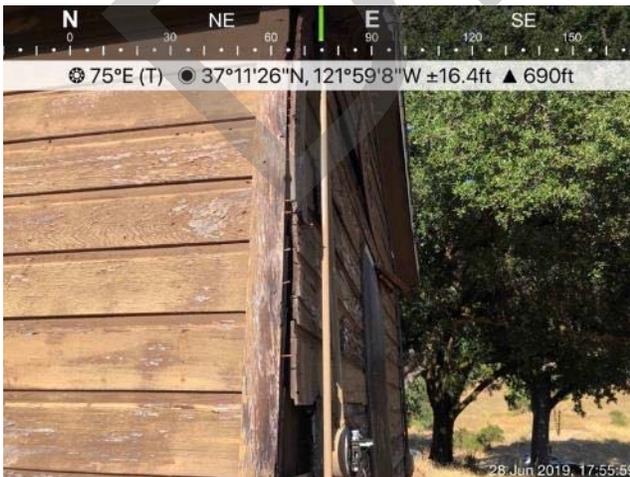
Photo 33. Wooden slats peeling away from the wall.

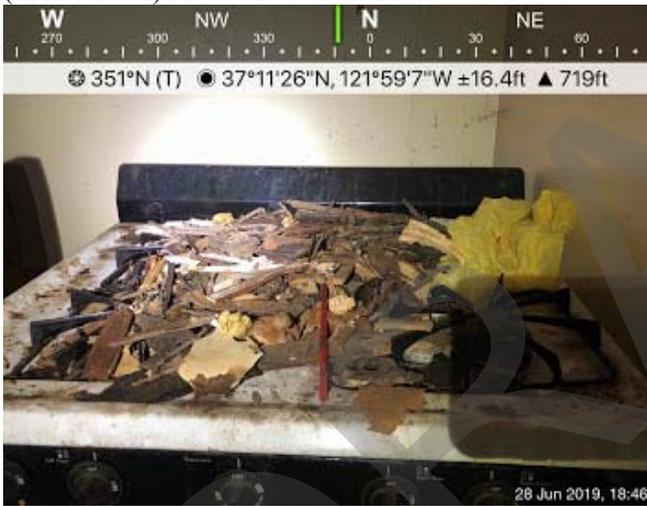
Upon entry to the house, large amounts of woodrat sign (e.g., fecal pellets) were observed throughout the entire house (Photo 37 and 38). Lots of debris on the floor of the house and two stick piles observed, one on top of the stove in the kitchen and one on top of the sink in the bathroom (Photos 37 - 42). No substantial woodrat nests were observed inside the structure, but there are numerous woodrat access points to the crawl space and area between ceiling and roof that were not surveyed. Three woodrat nests were observed within the 50 feet of the Beatty house structure (Photos 39 – 41).

Photo 37. Stick pile on top of stove in kitchen.

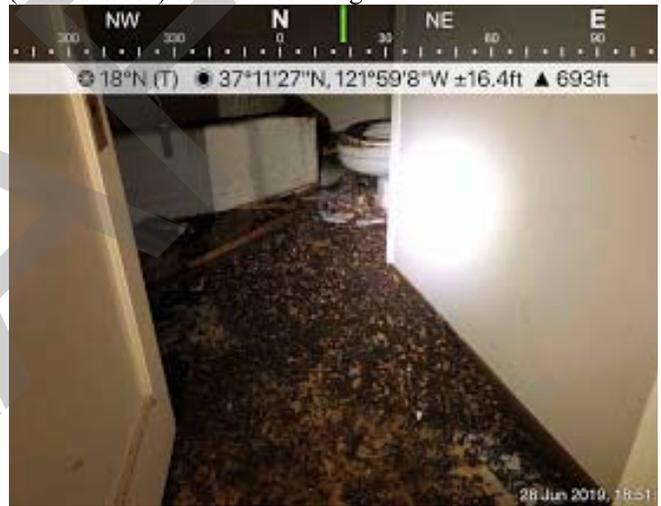
Photo 38. Large amount of woodrat feces on floor.

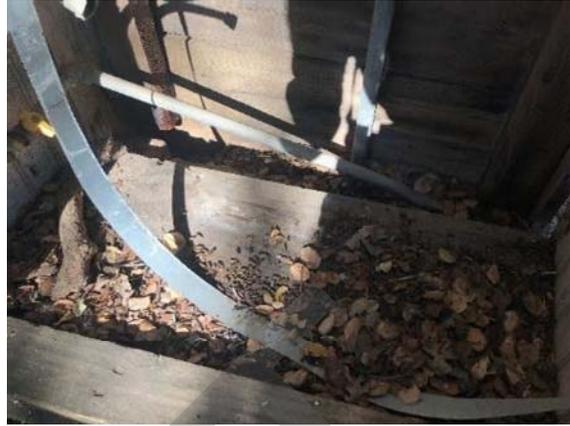
Photo 42. Woodrat A large amount of woodrat feces was observed in one location along the exterior of the structure.
