Midpeninsula Regional
Open Space District

R-20-35
Meeting 20-08
April 8, 2020

Select a design alternative for the La Honda Creek Redwood Cabin, La Honda Creek White Barn, and Sierra Azul Beatty House

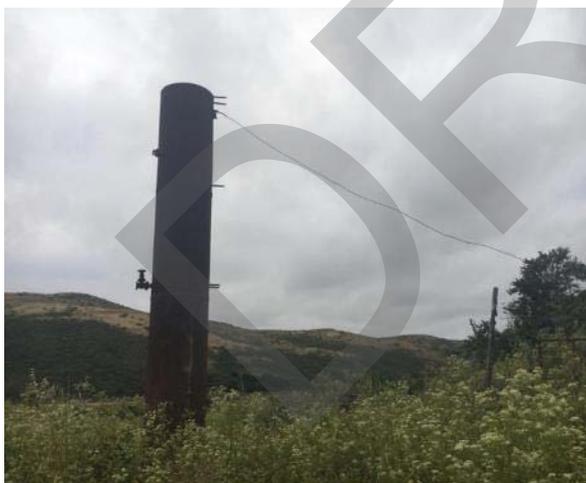
Photo 43. Area B – the distillation column was sealed on top but appeared to have a small opening on the left-hand side near the valve connection.

- Preconstruction surveys for bats and woodrats prior to demolition and debris removal activities.
- Follow the general bat avoidance and minimization measures presented in Section 4.1.
- Development of bat roost deterrent plan for approval by the California Department of Fish and Wildlife (CDFW) prior to structure demolition activities at the Area E Hunting Cabin.
- Provide replacement bat maternity roost habitat for impacts to removal of maternity roost habitat at Area E Hunting Cabin as part of the deterrent plan for approval by CDFW. This replacement habitat will serve as replacement habitat for all bat roost habitat removed or disturbed during removal activities.
- Follow general woodrat avoidance measures presented in Section 4.2.

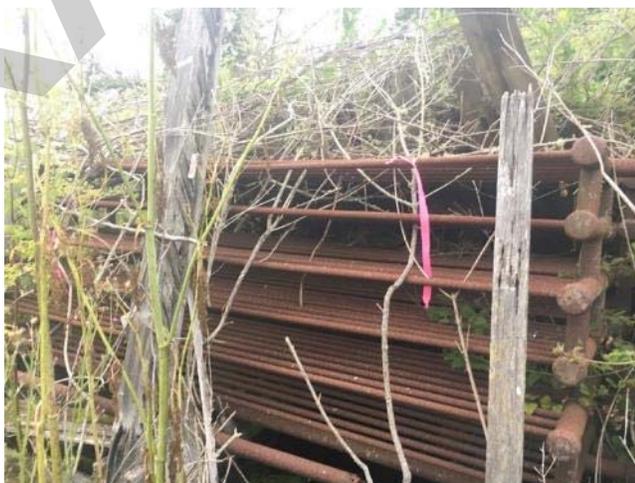
Photo 44. Area B – woodrat nest structure inside the series of iron grates. This structure sits over a concrete spring box filled with water.

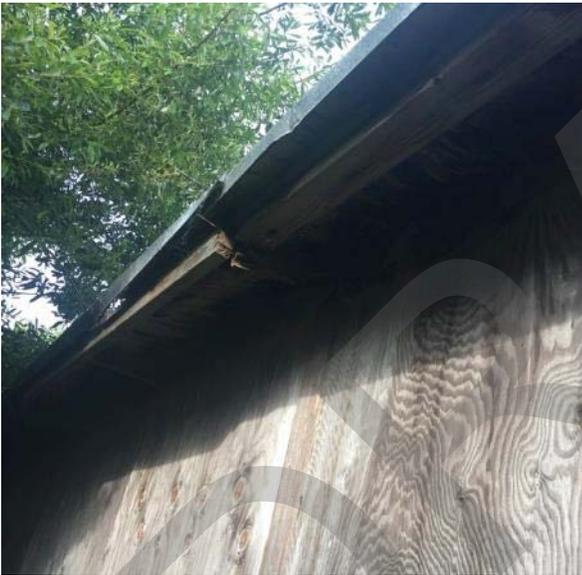
AREA E: The exterior of the hunting cabin had rotted and loose wood paneling, especially near the roofline, that could be suitable for roosting bats (Photo 47 and 48). A search of the structure's exterior found no sign of bats, however, many holes and crevices that led to the space between the roof and the structure's interior could not be fully observed. A search of the interior of the structure revealed that the previous owners had used the cabin recently. Maternity colony day-roosting habitat was observed inside the structure and no guano pellets or urine staining were observed. Additionally, no sign of woodrats were observed inside the cabin, however small mammals droppings (likely *Peromyscus* sp.) were present throughout the cabin. One large woodrat nest structure was observed behind the cabin.

Photo 47. Area E – additional openings and interstitial spaces underneath the roofline.

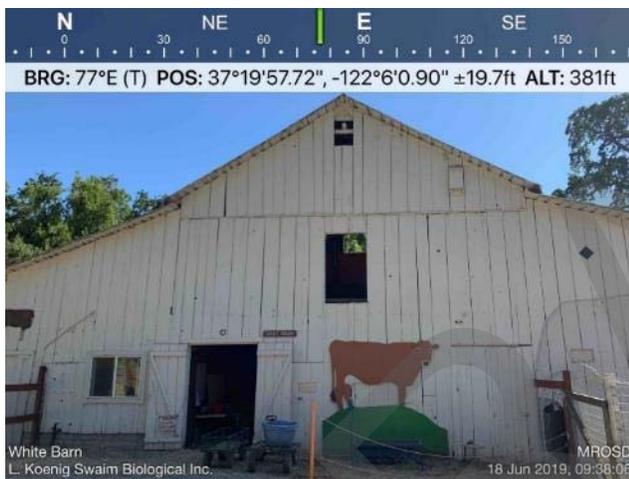
Photo 49. White Barn exterior showing hayloft doors and open access points.

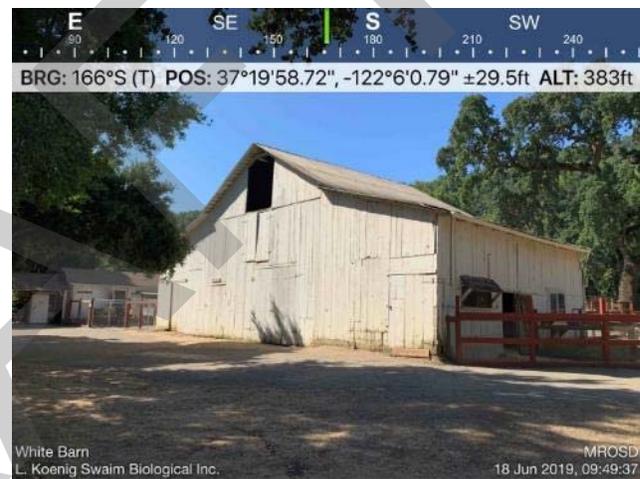
Photo 50. White Barn exterior showing hayloft doors and open access points.

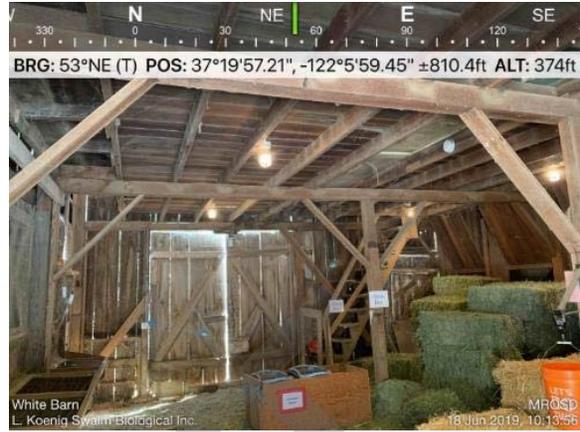
Rodent sign is present throughout the structure with rodent droppings observed (Photo 54). No woodrat nests were observed on the premises or within the 50-foot buffer. While no woodrat nests were observed, the riparian habitat near the structure provides suitable habitat and absence of woodrats should not be assumed.

Photo 54. Lower level with hay storage and milk barn
