R-20-39
Meeting 20-09
April 22, 2020

Select a design alternative for the La Honda Creek White Barn and Sierra Azul Beatty House

La Honda Creek White Barn

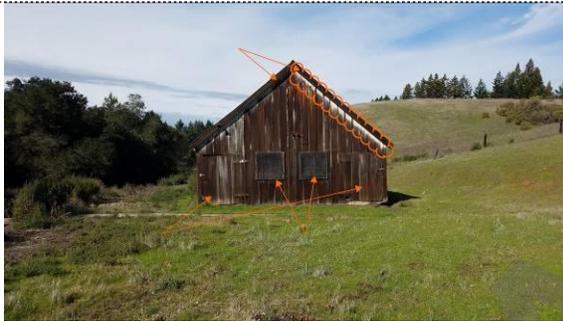
Figure 1

East façade has symmetric doors and windows. Traces of whitewash at the top part of the cladding. Skip sheathing boards covered by another that follows the roof line of the gable end. Roof at 45 degree angle

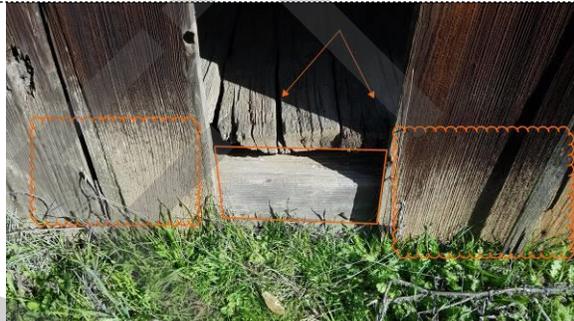
Figure 2

Foundation beam. Deterioration along lower section of boards conforming all façades. Heavy use and weathering deterioration of floor boards.

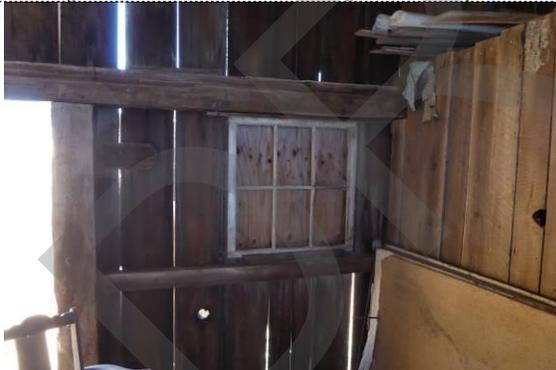
Figure 11

Boarded window of the east façade. Interior partitions added and modified as required by use needs

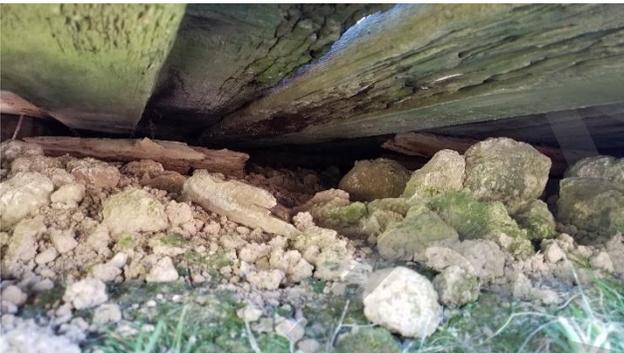
Photo 3. Existing condition at foundation

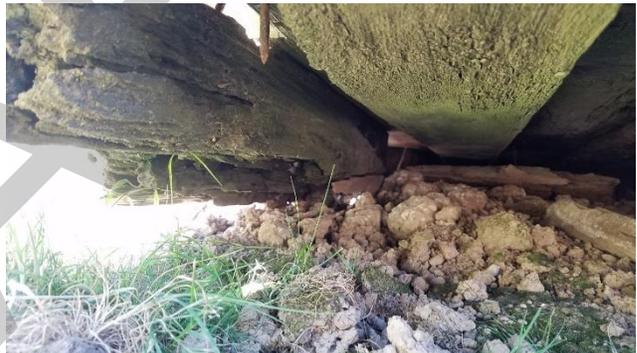
Photo 4. Existing condition at foundation

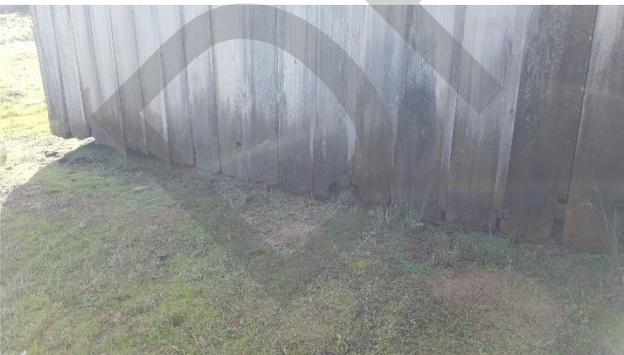
Photo 5. Deterioration of exterior siding

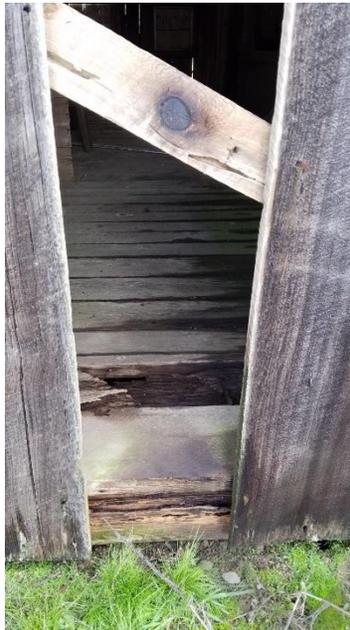
Photo 7. Deterioration at base of exterior wall

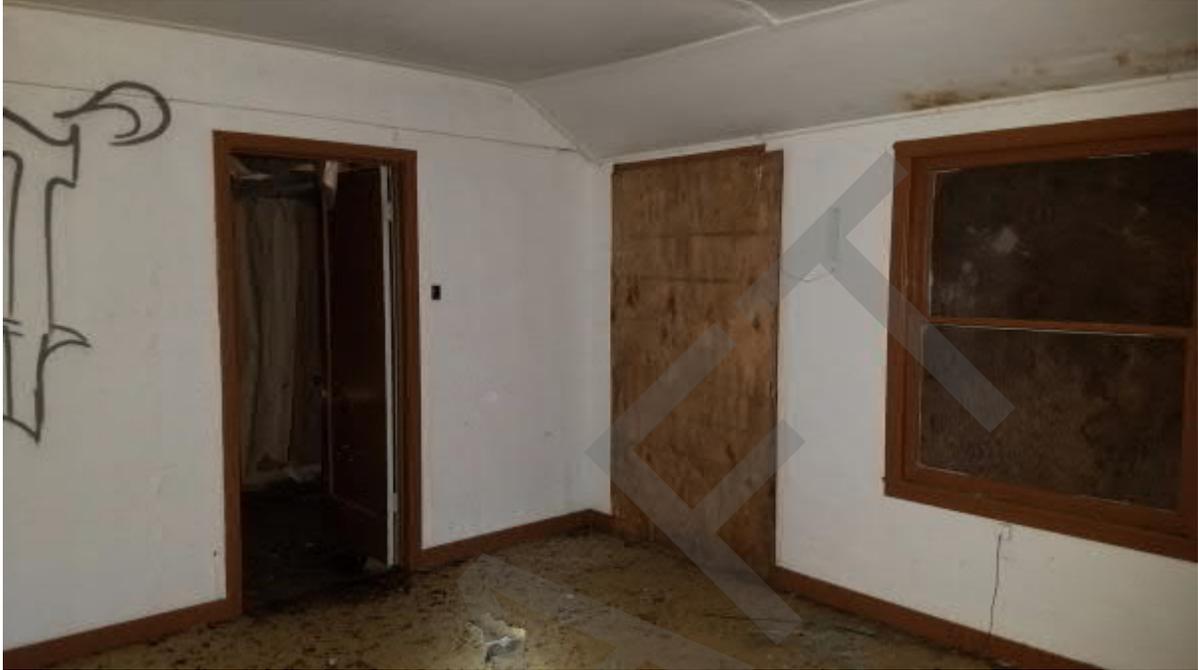
Photo 5 Material 201 ACM vinyl sheet flooring in the Beatty House

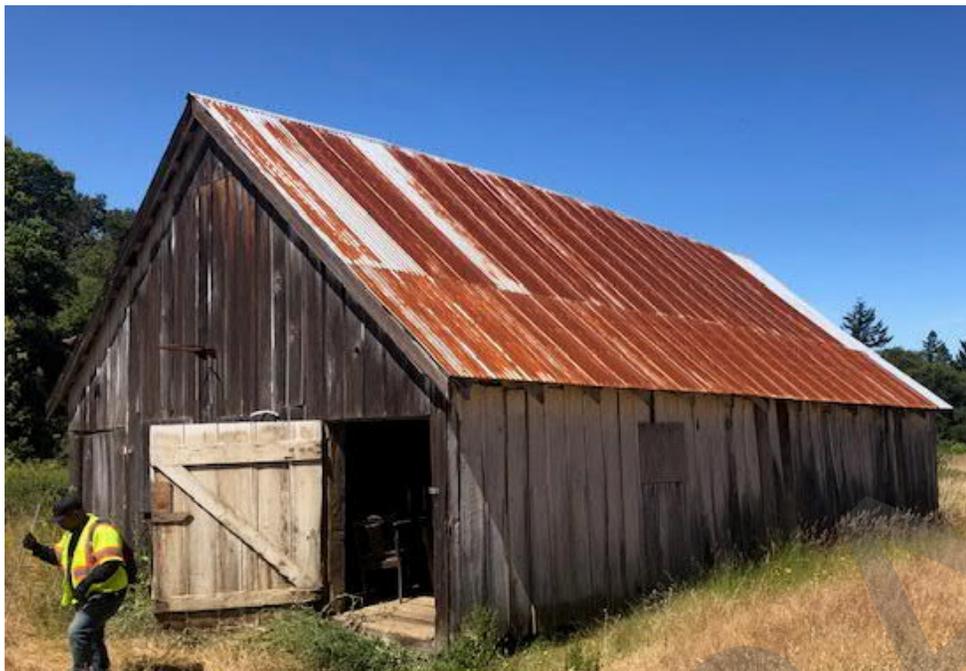
Sample L-3 white paint on wood siding collected from exterior of barn

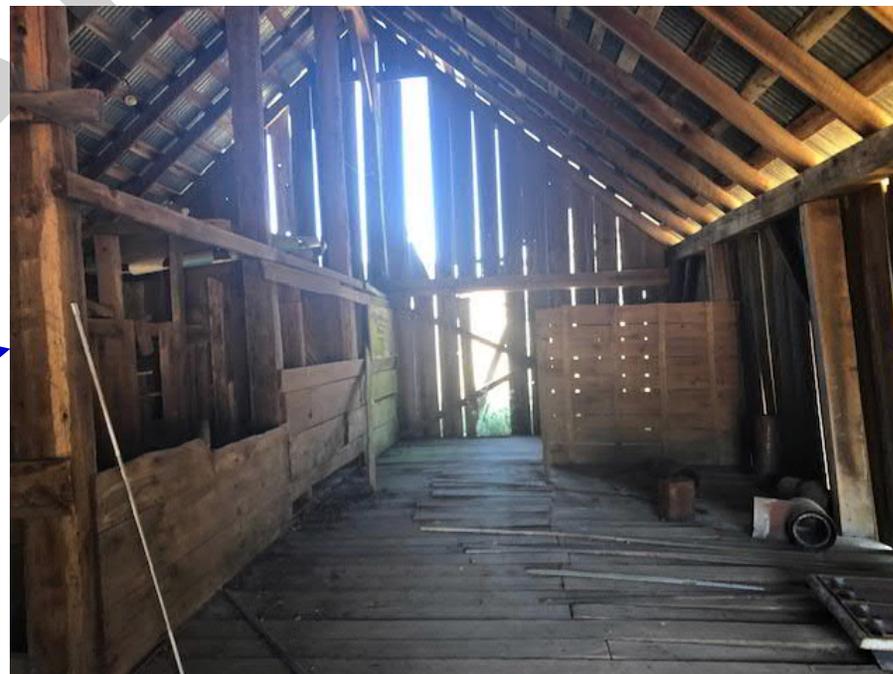
Samples 100A, 100B, and 100C Black 1/8" wiring collected from interior of barn

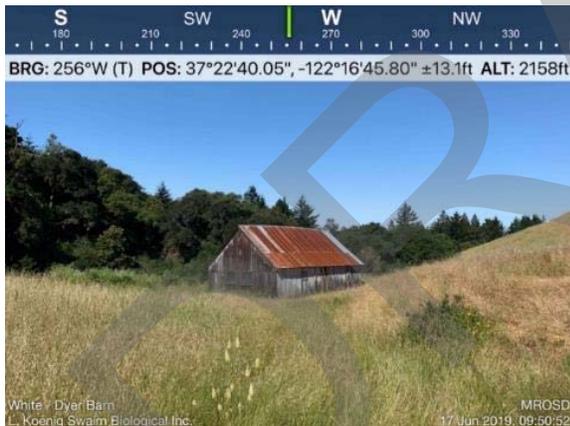
Photo 1. White Barn exterior.

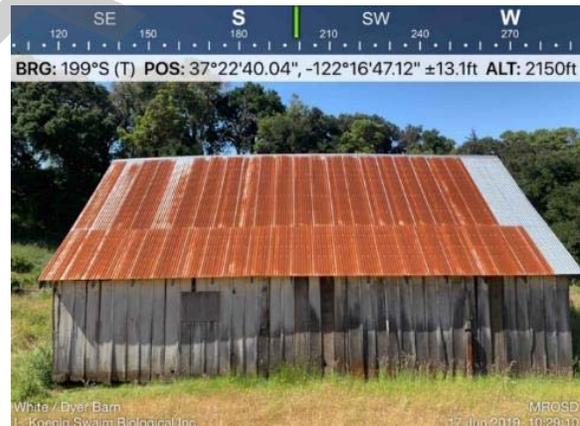
Photo 2. White Barn exterior.

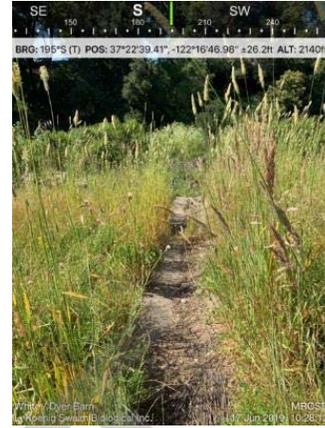
Photo 4. Concrete drainage to the east of White Barn that feeds into the riparian corridor.

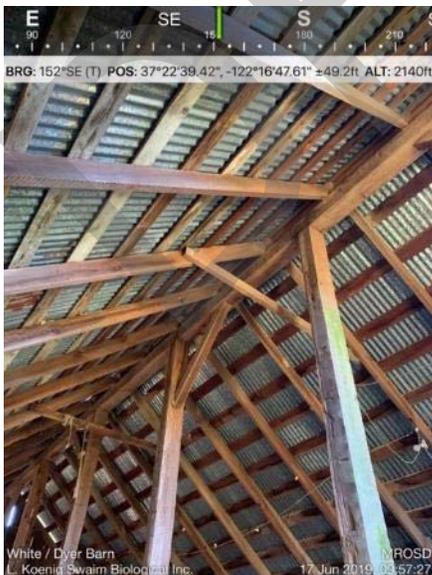
The barn surveyed receives partial shade from the riparian corridor to the west (Photo 3). Surrounding the barn is signs of wetland / wet meadow as demonstrated by the presence of (giant plantago (*Plantago major*), sedges (*Scirpus spp.*), elderberry (*Sambucus nigra spp. Caerulea.*), and willows (*Salix sp*). A concrete drainage adjacent to the east side of the barn appears to drain overland flow into the adjacent drainage (Photo 4). The barn itself is in a flat that leads to a downstream ravine and riparian corridor. The interior of the barn (Photo 5 and 6) is comprised of one area subdivided into sections by feeding stalls, an interior enclosed chicken coop, and an open space area. The barn has a pitched roof with corrugated metal sheets held up in regular intervals by rafters (Photo 7).

Photo 7. Corrugated roof slats and rafters provide suitable bat roosting habitat.

- Preconstruction surveys for bats and woodrats prior to stabilization activities.
- Follow the general bat avoidance and minimization measures presented in Section 4.1.
- Development of bat roost deterrent plan for approval by the California Department of Fish and Wildlife (CDFW) prior to structure stabilization activities.
- The need for replacement habitat due to impacts on the maternity roost per District guidelines is dependent upon whether the planned stabilization activities will eliminate roosting habitat. Determination of the need for replacement habitat plan should coincide with the development of the deterrent plan.

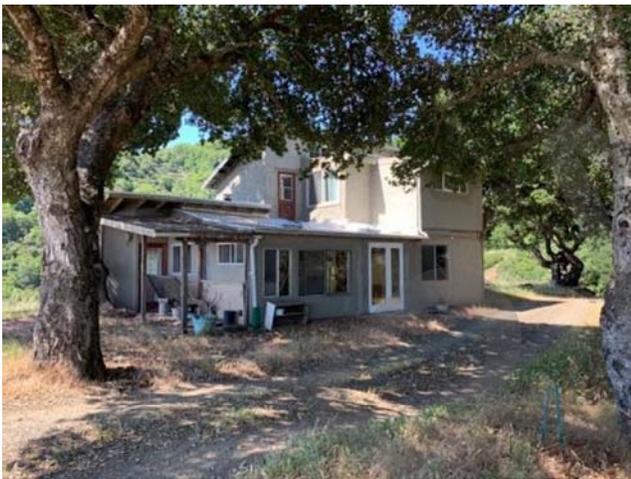
Structure A is a two-level house that is set to be demolished (Photo 19 and 20). Structure A is well shaded on the north and west sides of the house by oak trees and is unshaded on the east and south sides of the house. Structure B is the one-level studio apartment that will not be demolished (Photo 25). The structure is mostly unshaded with a flat-topped roof. There is a garage with an open-air shed space attached. Structure C is a shed that will also remain and not be demolished (Photo 26). In general, moderately – highly suitable bat maternity habitat is found adjacent to the structures listed above and within the structures scheduled to remain.

Photo 19. Structure A is partially shaded by oak trees.

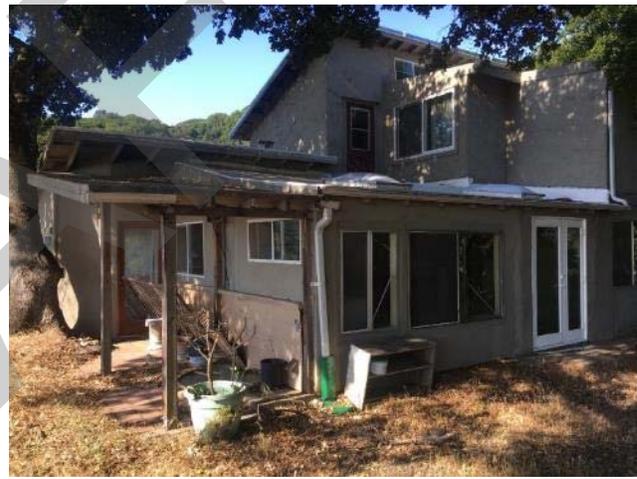
Photo 20. Structure A

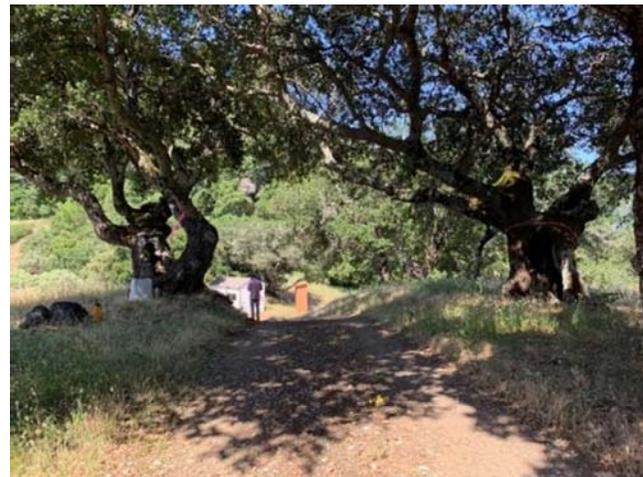
Two woodrat nests were located approximately 25-feet from Structure A in the hollowed-out trunks of two large coast live oaks (*Quercus agrifolia*) (Photo 22). A black phoebe (*Sayornis nigricans*) nest was observed under the eave of Structure A.

Photo 22. Woodrat middens in hollows of oak trees west of Structure A.

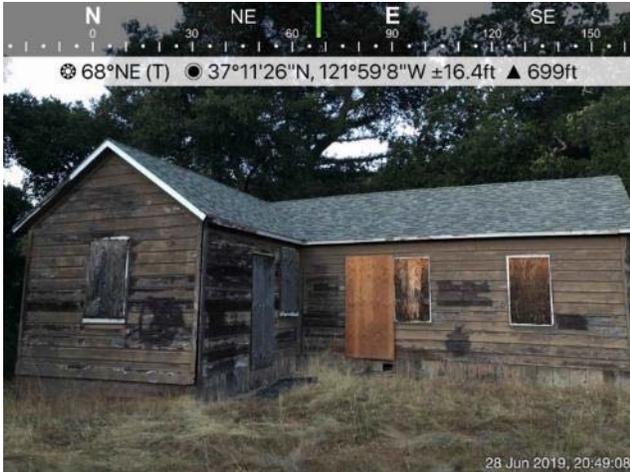
The structure is a one-story house with crawl space and is situated in oak woodland with nearby grassland and Lexington Reservoir within 500 feet of the property (Photo 27). There was a total of nine rooms in the house, including a kitchen, laundry room, and bathroom. The house is shaded on the north, east, and south sides and has full sun exposure on the west side.

Photo 27. Beatty property.

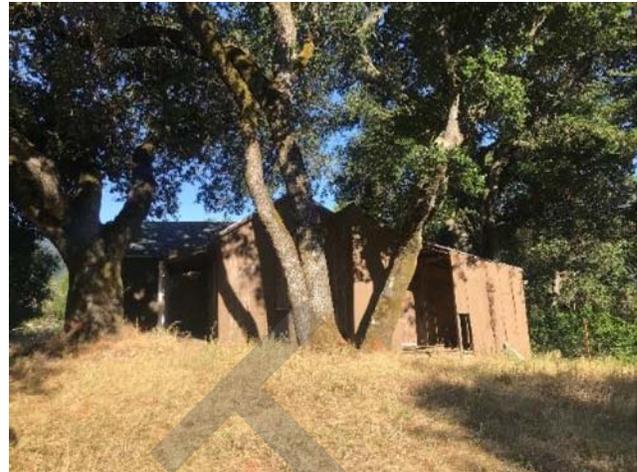
Biologists fully surveyed around the exterior of the house and found multiple potential bat and woodrat entry and exit points on all sides of the house (Photo 27 and 28). Several large oaks surrounding the structure could support roosting bat habitat; two snags on the west side with 5 – 10% exfoliating bark with full sun exposure, one snag of the east side with 5% exfoliating bark with full sun exposure (Photo 29). The house is in disrepair with many decaying eaves around the roofline that bats could be obtaining access through. There is space between many of the boarded-up windows and doors, and some wooden slats of the house are broken that could also provide bat entry points (Photos 30 – 35). There are various holes and broken wooden slats along the bottom of the house that could provide bat or woodrat entry.

Photo 28. The housing structure is located beneath a canopy of coast live oaks (photo facing west).

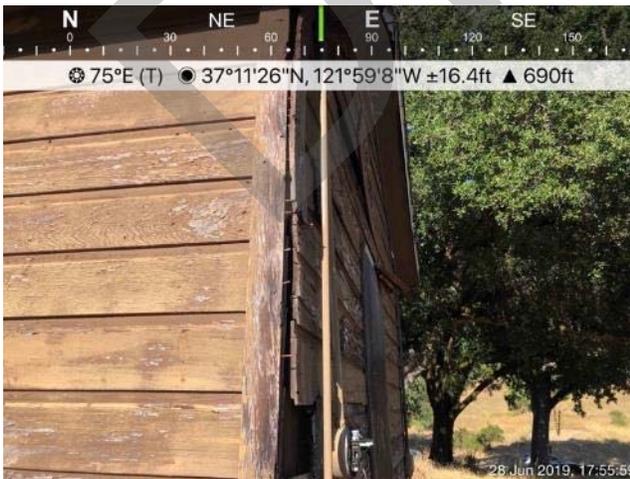
Photo 33. Wooden slats peeling away from the wall.

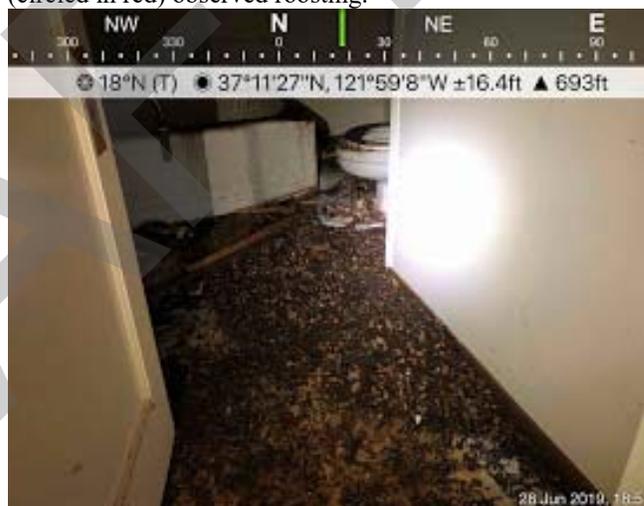
Upon entry to the house, large amounts of woodrat sign (e.g., fecal pellets) were observed throughout the entire house (Photo 37 and 38). Lots of debris on the floor of the house and two stick piles observed, one on top of the stove in the kitchen and one on top of the sink in the bathroom (Photos 37 - 42). No substantial woodrat nests were observed inside the structure, but there are numerous woodrat access points to the crawl space and area between ceiling and roof that were not surveyed. Three woodrat nests were observed within the 50 feet of the Beatty house structure (Photos 39 – 41).

Photo 38. Large amount of woodrat feces on floor.

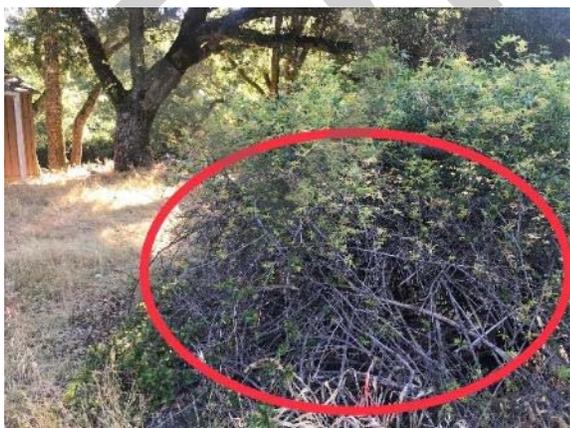
Photo 39. Woodrat nest number 1 is located under an ornamental bush 9 meters south of the structure

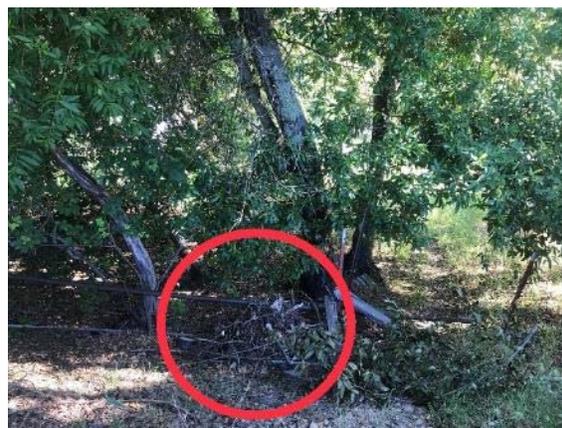
Photo 40. Woodrat nest number 2 is located along a fence 10 meters northeast of the structure.

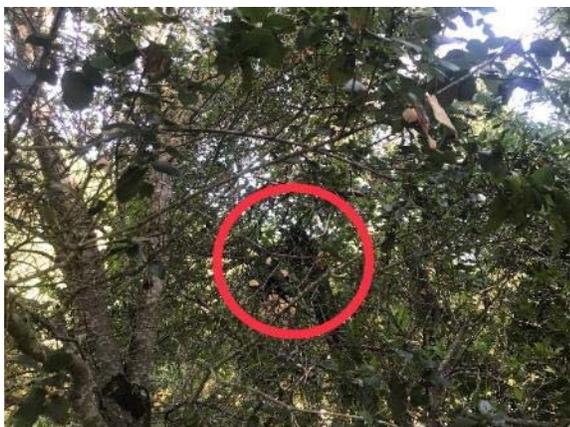
Photo 41. Woodrat nest number 3 is located in a tree, northwest of the structure.

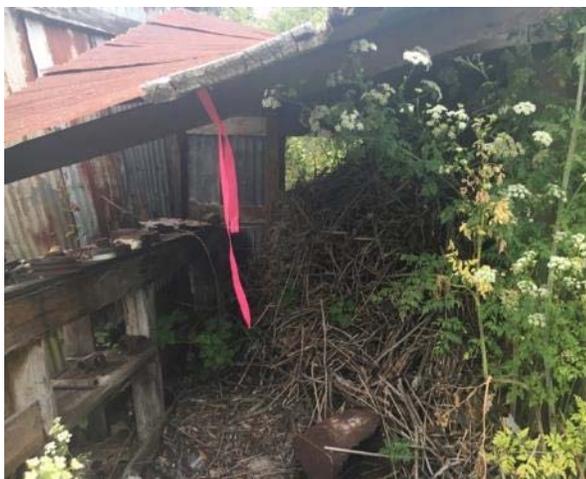
AREA B: The inside of Tanks 1-2 could not be observed due to their height, but both tanks appeared to be single-walled and open on the top. These tanks are likely unsuitable for day roosting bats due to exposure to the elements and the lack of additional surfaces that could create crevices. The distillation column was capped on the top but appeared to have a small opening on its side about 15 feet off the ground that could potentially be used by roosting bats (Photo 43). The structure on the east side of Area B included a series of iron grates over a concrete box filled with water as well as a dilapidated shed with a corrugated tin roof. The shed contained pieces of wood attached to corrugated tin that created small crevices that could be suitable for bats, but no signs of bats were observed. Large woodrat nest structures were observed inside the series of iron grates and inside the dilapidated shed, as well as behind the shed (Photo 44 and 45).

Photo 45. Area B – woodrat nest structure inside the dilapidated building.

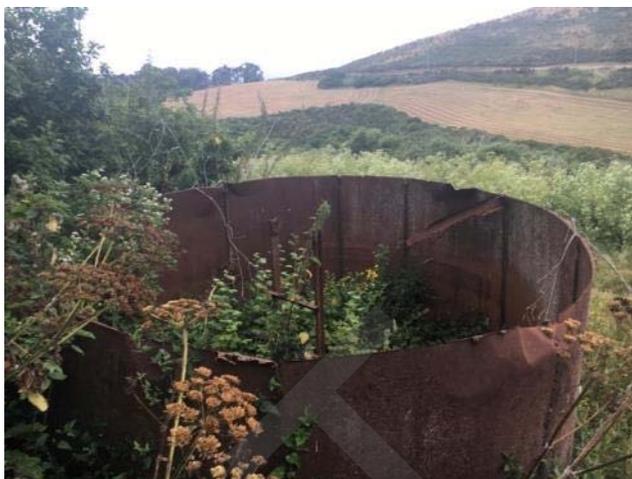
the elements that may preclude these structures from being used by bats (Photo 46). A large woodrat nest was observed inside Tank 11, and two smaller satellite nests were observed surrounding the tank.

Photo 46. Area D – most tanks were single-walled without any small crevice space for roosting bats.

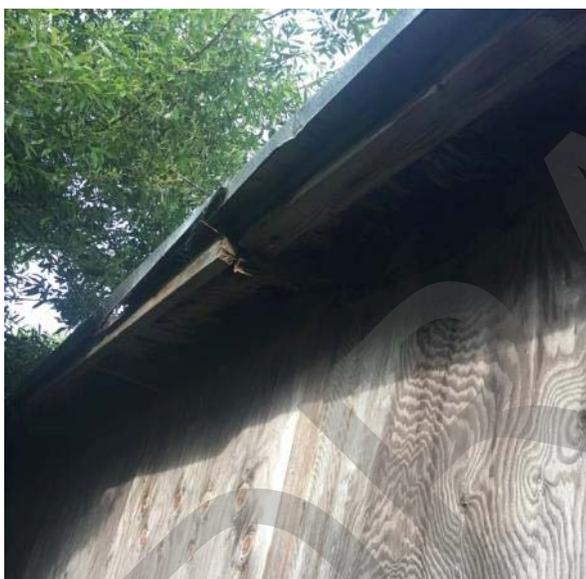
AREA E: The exterior of the hunting cabin had rotted and loose wood paneling, especially near the roofline, that could be suitable for roosting bats (Photo 47 and 48). A search of the structure's exterior found no sign of bats, however, many holes and crevices that led to the space between the roof and the structure's interior could not be fully observed. A search of the interior of the structure revealed that the previous owners had used the cabin recently. Maternity colony day-roosting habitat was observed inside the structure and no guano pellets or urine staining were observed. Additionally, no sign of woodrats were observed inside the cabin, however small mammals droppings (likely *Peromyscus* sp.) were present throughout the cabin. One large woodrat nest structure was observed behind the cabin.

Photo 47. Area E – additional openings and interstitial spaces underneath the roofline.

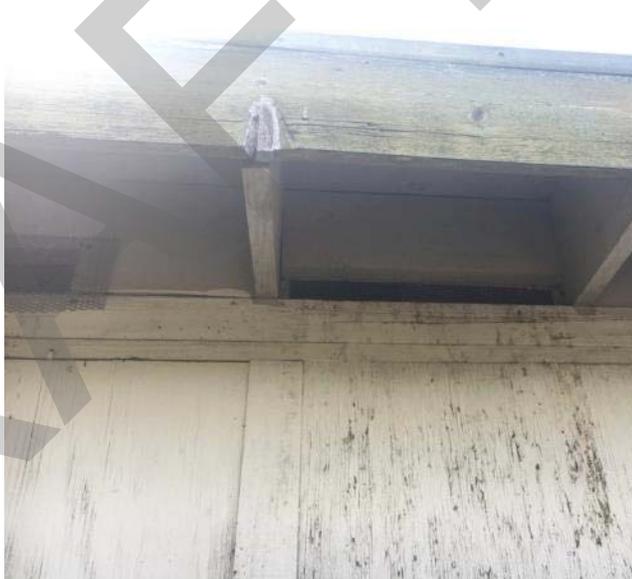
Photo 48. Area E – openings underneath the roofline of the hunting cabin.

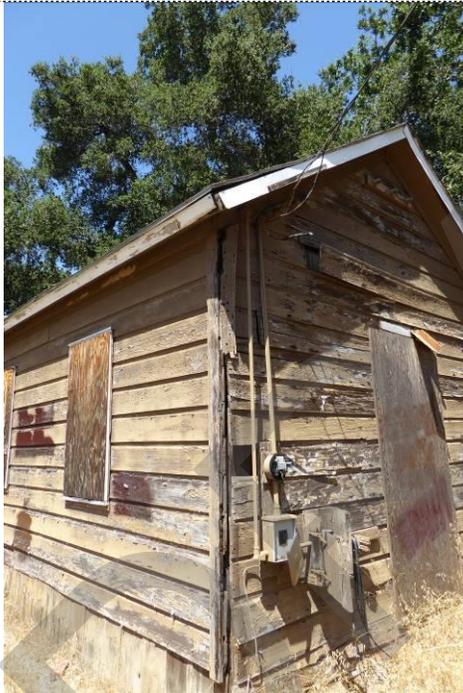
Figure 3

South and west façades of the ca. 1870 addition. Second cladding horizontal layer heavily weathered due to lack of protective treatment and care. Electric connections and meter are in this corner.

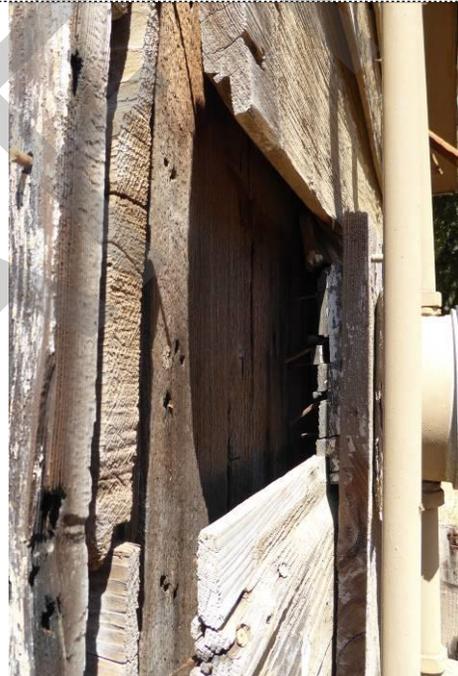
Figure 4

Close-up of lost piece of horizontal cladding where underlying vertical original cladding can be seen, also heavily weathered

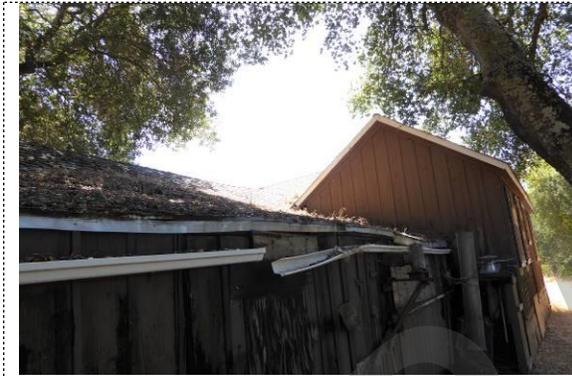
Figure 7

North façade of the kitchen and pantry. Roof has a gentler slope indicating its' belonging of a later addition date. Several elements have been replaced by more modern materials like T-111 siding

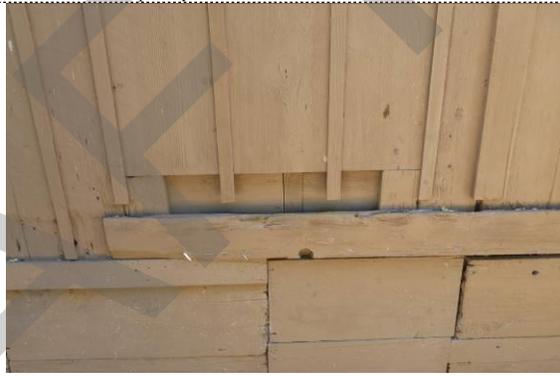
Figure 8

Close-up of cladding under the bathroom window, clearly different from the cladding of the rest insinuating it may have been originally a door opening that was later partially closed to form the current bathroom window

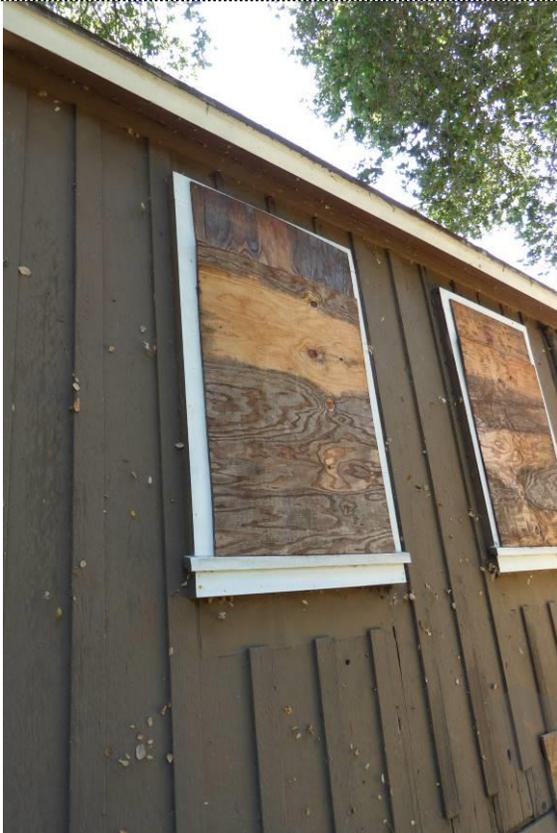
Figure 9

Windows of the north façade of the L-shape addition. The metal pieces under the sills indicates they were moved upwards or reduced in size during modifications to match height of other windows in the building

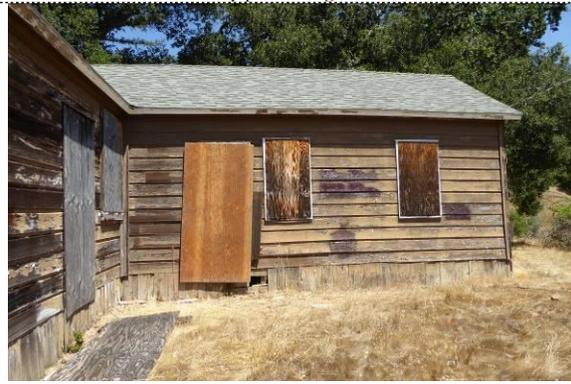
Figure 11

West façade and westernmost section of south façade. Corresponding to the L-shaped addition. All windows except the one in the center, belonging to the hallway, have been moved upwards or modified and reduced in size after the second layer of cladding was installed having a metal piece under the sills to cover up the gap originated during this modification

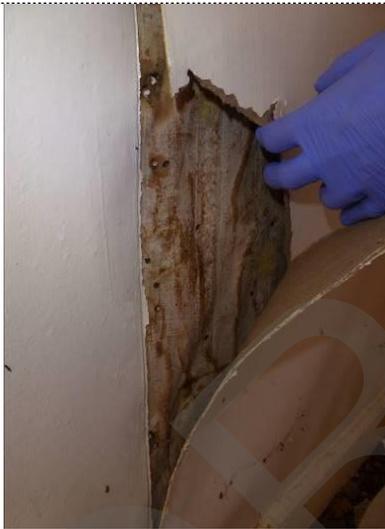
Figure 35

Hanging lower ceiling in the living room as seen through an opening. Clearly the vertical boards could be part of an original façade that was later modified. Evident humidity and rot signs, especially where the different roofing areas merge. Visible the new plywood sheathing directly over the historic one

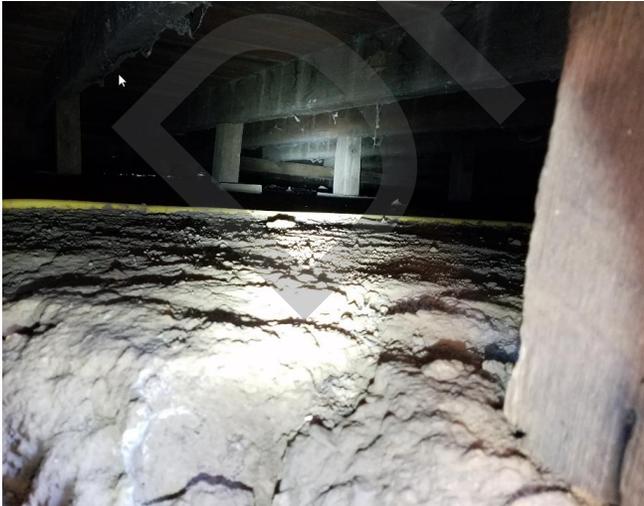
- The structure is founded on wood posts that sit directly on the soil and show evidence of moisture/ rot damage (see Photos 1, 5, and 13). No foundation is present. This condition has likely also contributed to differential settlement across the structure.
- There are holes in the floors, walls, and ceiling where sheathing is missing or damaged (see Photos 6, 7, and 8).
- There is a partially collapsed portion of the shed roof along the south edge of the building (see Photo 9).
- The collar ties between the rafters do not appear to be structurally adequate, and there is no ridge beam present to span between collar ties. (see Photo 8).
- The existing 3x (flat) floor girders do not appear to be structurally adequate (see Photo 13).
- The framed shed on the east side of the home is derelict and not stable (see Photos 2 and 10). This element of the structure should be removed.

The foundations for this structure are limited to wood posts that bear either directly on grade, or on a small wood sleeper on grade. Some posts may be embedded an unknown distance into the ground. Moisture damage was observed at several posts in contact with the ground (see Photos 1, 5, 11, 12 and 13).

Photo 5. Interior crawlspace framing, showing posts bearing on grade or on wood sleepers

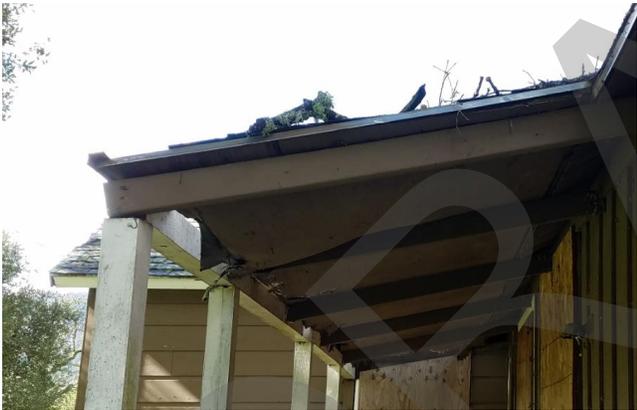
Photo 9. Partially collapsed portion of shed roof

- o Recommendation: Replace in kind all missing siding, planking, and sheathing.
- c) There is a collapsed portion of the shed roof along the south edge of the building (see Photo 9).

- o Recommendation: Replace in kind all damaged roof framing and sheathing, including roofing and waterproofing.
- d) The collar ties between the rafters do not appear to be structurally adequate, and there is no ridge beam present to span between the collar ties. (see Photo 8).

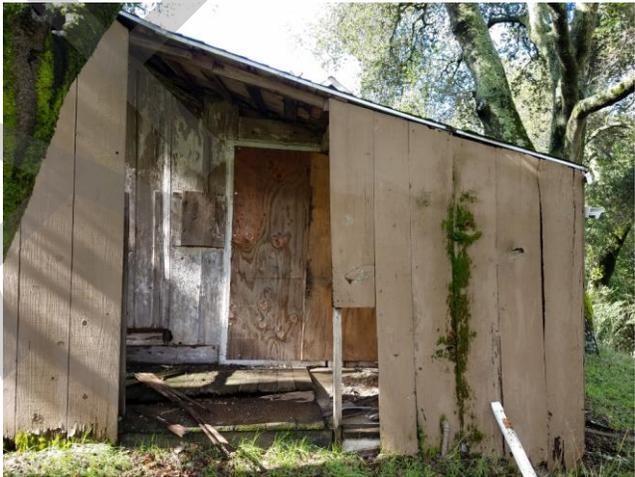
Photo 10. Dilapidated shed

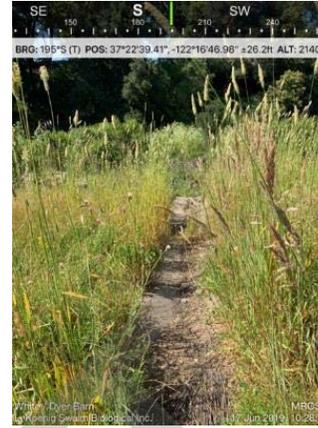
Photo 4. Concrete drainage to the east of White Barn that feeds into the riparian corridor.

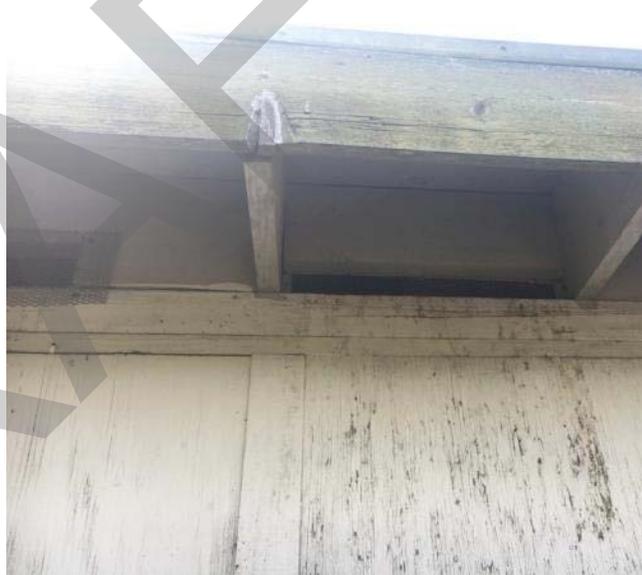
AREA E: The exterior of the hunting cabin had rotted and loose wood paneling, especially near the roofline, that could be suitable for roosting bats (Photo 47 and 48). A search of the structure's exterior found no sign of bats, however, many holes and crevices that led to the space between the roof and the structure's interior could not be fully observed. A search of the interior of the structure revealed that the previous owners had used the cabin recently. Maternity colony day-roosting habitat was observed inside the structure and no guano pellets or urine staining were observed. Additionally, no sign of woodrats were observed inside the cabin, however small mammals droppings (likely *Peromyscus* sp.) were present throughout the cabin. One large woodrat nest structure was observed behind the cabin.

Photo 48. Area E – openings underneath the roofline of the hunting cabin.

- Preconstruction surveys for bats and woodrats prior to demolition and debris removal activities.
- Follow the general bat avoidance and minimization measures presented in Section 4.1.
- Development of bat roost deterrent plan for approval by the California Department of Fish and Wildlife (CDFW) prior to structure demolition activities at the Area E Hunting Cabin.
- Provide replacement bat maternity roost habitat for impacts to removal of maternity roost habitat at Area E Hunting Cabin as part of the deterrent plan for approval by CDFW. This replacement habitat will serve as replacement habitat for all bat roost habitat removed or disturbed during removal activities.
- Follow general woodrat avoidance measures presented in Section 4.2.
