Midpeninsula Regional  
Open Space District

R-21-40  
Meeting 21-10  
March 24, 2021

Review Beatty House Alternatives and Confirm Board Direction

1. Beatty House Basis of Design, Condition Assessment, and Estimate – ZFA December 2019
2. Renderings of Beatty House design alternatives
3. Beatty House Photographs – *Excerpt from Beatty House Basis of Design, Condition Assessment, and Estimate – ZFA December 2019*

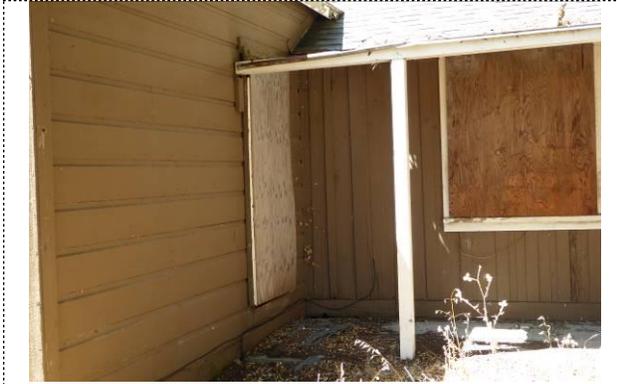
**Figure 5**

East façade (left) of the L-shaped addition. Door is blocked at the top end by the porch. The horizontal second layer of cladding was added before the extra feet connecting the buildings was added as it continues beneath the façade of the connection

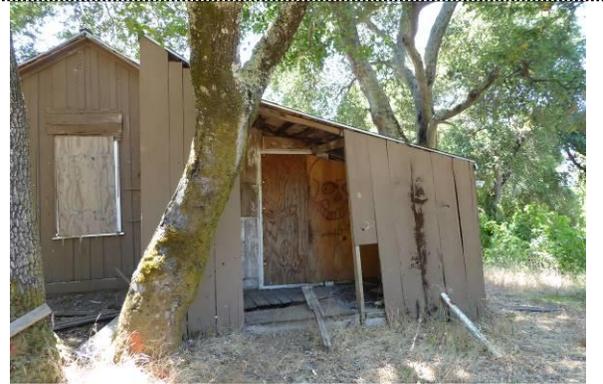
**Figure 6**

Right side of the East façade. Open shed is the latest addition to the building and has direct access to the pantry from the previous addition. The visible change in roof slope corresponds to the original building vs the kitchen and pantry addition

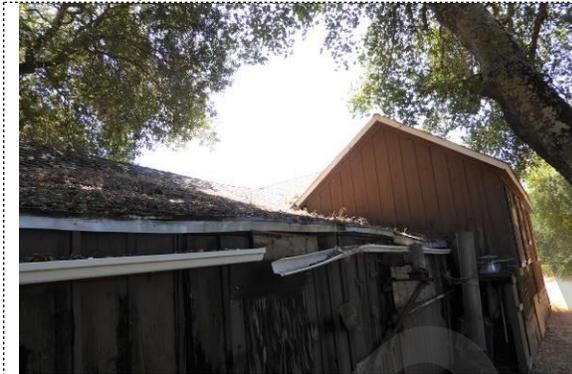
**Figure 7**

North façade of the kitchen and pantry. Roof has a gentler slope indicating its' belonging of a later addition date. Several elements have been replaced by more modern materials like T-111 siding

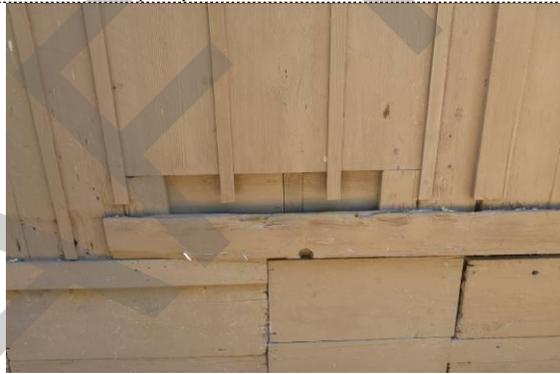
**Figure 8**

Close-up of cladding under the bathroom window, clearly different from the cladding of the rest insinuating it may have been originally a door opening that was later partially closed to form the current bathroom window

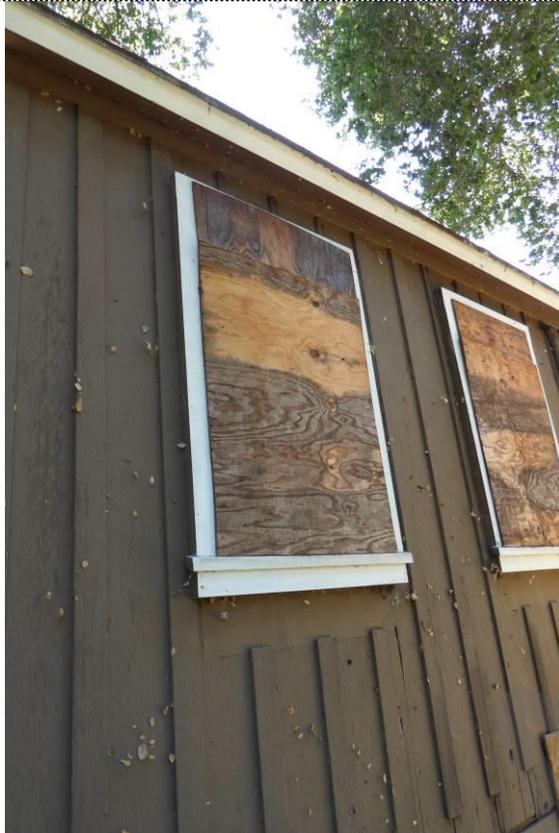
**Figure 9**

Windows of the north façade of the L-shape addition. The metal pieces under the sills indicates they were moved upwards or reduced in size during modifications to match height of other windows in the building

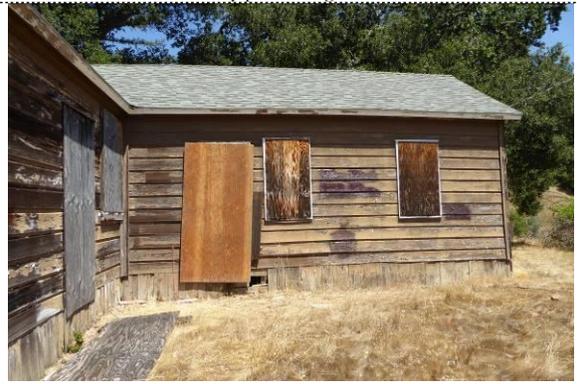
**Figure 12**

West façade of the L-shape, corresponding to the dining room and pantry. The roofs of the entire dwelling are relatively new, consisting of recent plywood sheathing nailed to historic spaced sheathing and covered in asphalt shingles.

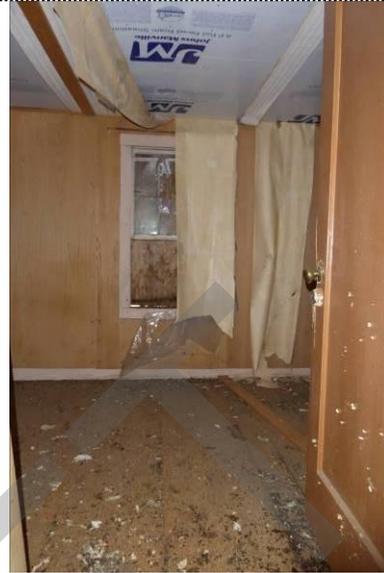
**Figure 18**

Bedroom 2 is accessed descending one step from the living room, insinuating construction at a later phase. Carpeted floor, single flush door, 1/1 window, and isolation on ceiling insinuate a relatively modern build

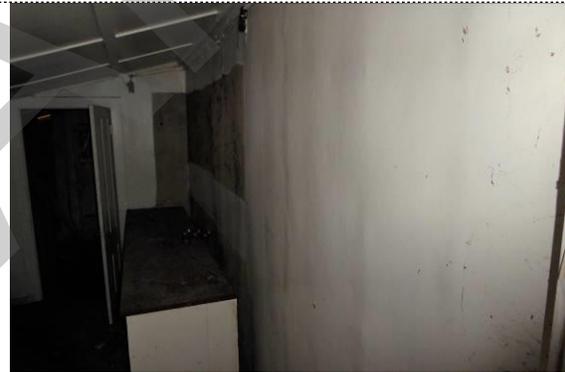
**Figure 20**

Kitchen with access to the pantry on the far side. Several cabinets have been removed. These rooms belong to the latest addition (not counting the shed) and add little value to the historic elements of the dwelling.

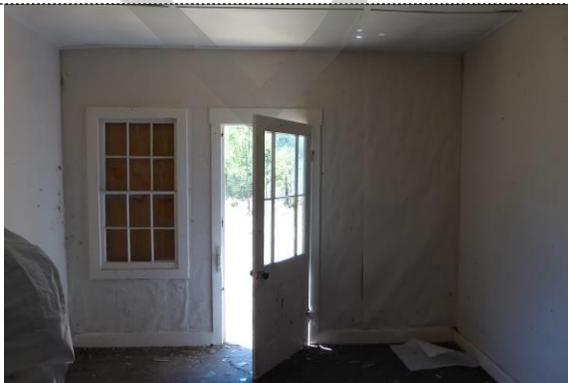
**Figure 21**

Living room, exit door with mid-19th century rim locks, and window to the west façade. Wall finish not properly attached needs reattachment if possible or replacement when not possible to reattach.

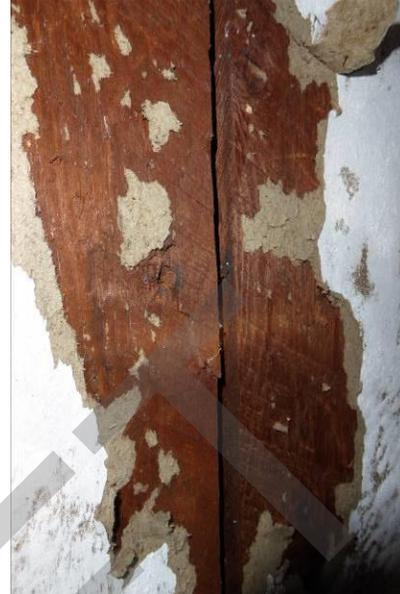
**Figure 24**

Wall boards conforming the façades and partitions are covered directly by the interior finish cardboard with no isolation layers in between

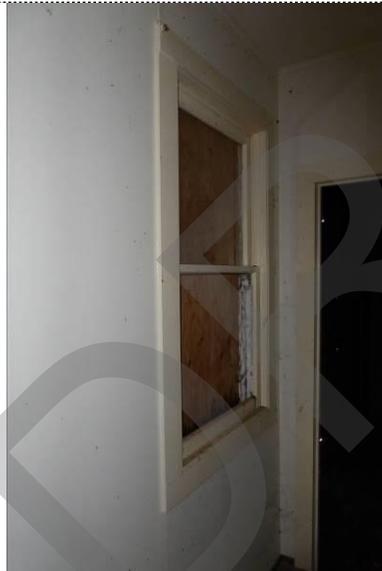
**Figure 25**

Corridor window, design clearly corresponds to a latter period from that of the building of this section. Walls covered in gypsum board

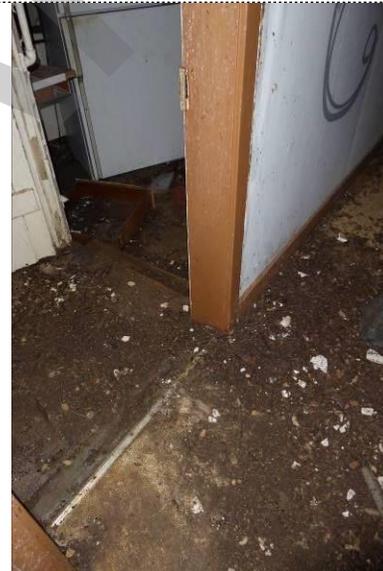
**Figure 26**

Door communicating to the corridor, and steps going down from this to the kitchen. The slight slope downwards into the corridor at the door footer could indicate that this was originally the location of an exit door

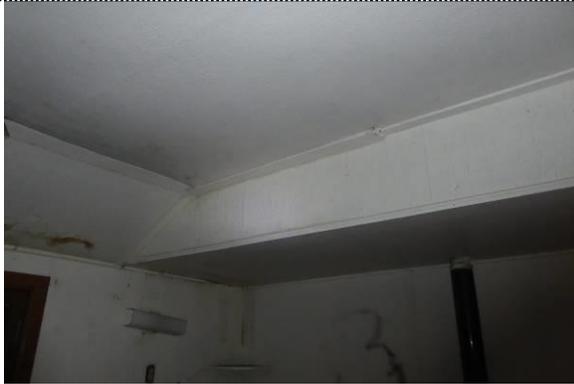
**Figure 34**

Double level ceiling of the living room. The lower section could have been part of the original east façade of the building or a porch covering its eastern side

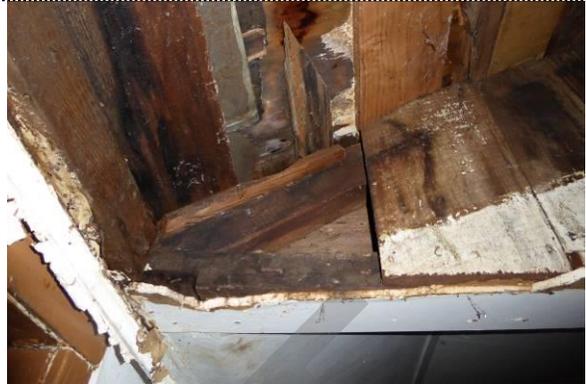
**Figure 35**

Hanging lower ceiling in the living room as seen through an opening. Clearly the vertical boards could be part of an original façade that was later modified. Evident humidity and rot signs, especially where the different roofing areas merge. Visible the new plywood sheathing directly over the historic one

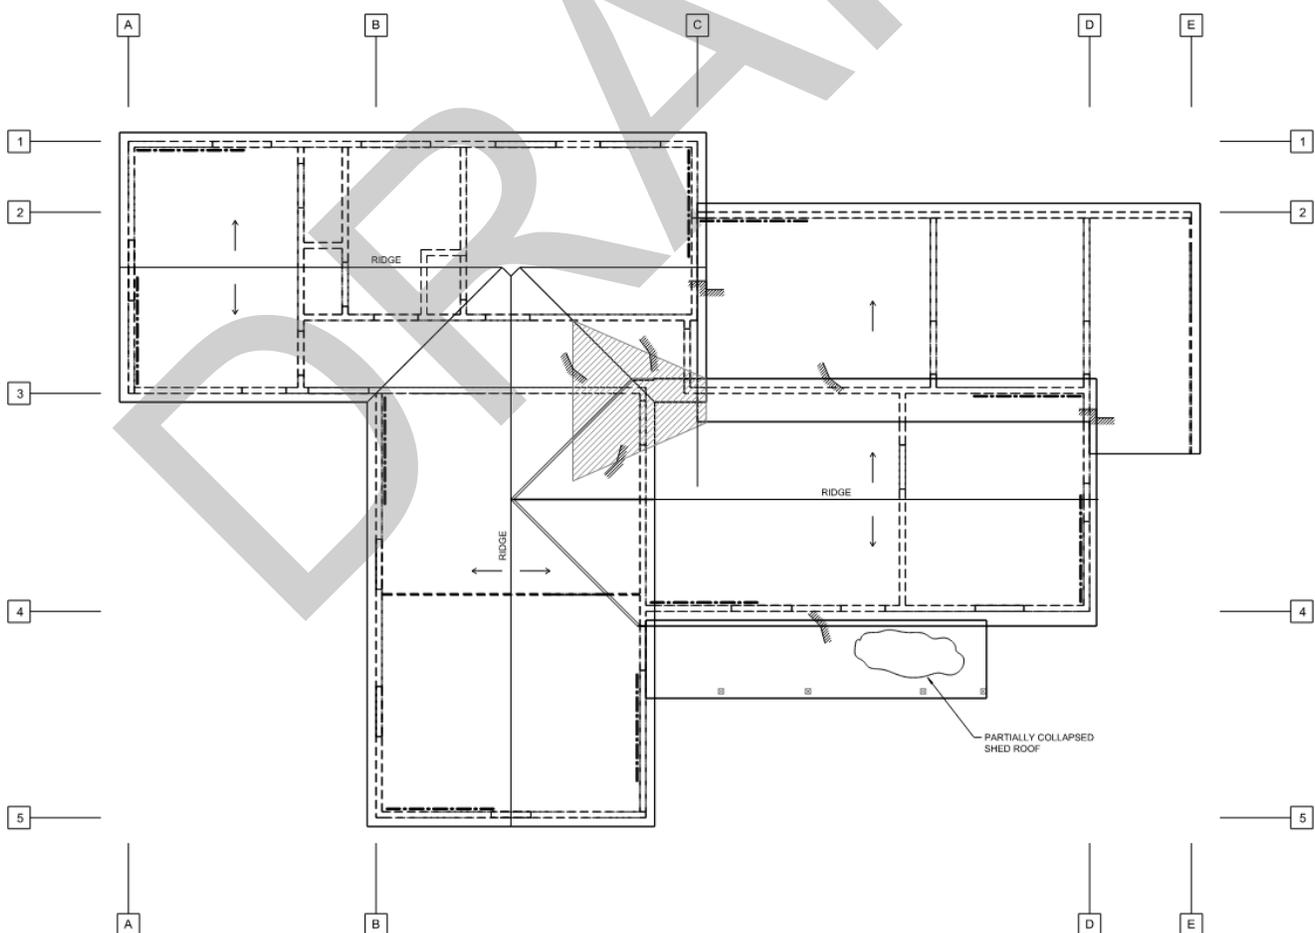
The roofing is composed of asphalt shingles supported directly on 1x horizontal lumber decking oriented up-down slope that forms the roof diaphragm. The 1x decking is supported by 1x framing at approximately 24" on center which spans between the roof rafters. The roof rafters are 2x4 nominal spaced approximately 36" on center and clear span from the ridge to the exterior walls (See photo 8). 1x6 collar ties span between the rafters below the ridge to help resist horizontal thrust and allows the rafters to span between exterior bearing walls. There does not appear to be a ridge beam or ridge board. The existing roof framing plan is shown in Figure 1 below.

Figure 1: Roof Framing Plan from ZFA-prepared Existing Condition Drawings

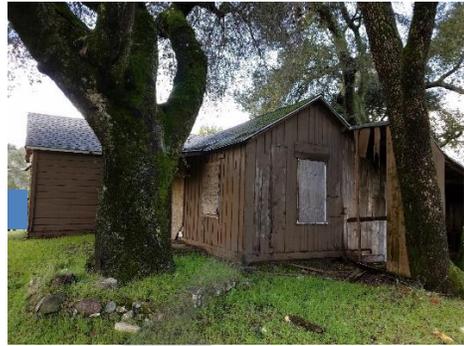
- The structure is founded on wood posts that sit directly on the soil and show evidence of moisture/ rot damage (see Photos 1, 5, and 13). No foundation is present. This condition has likely also contributed to differential settlement across the structure.
- There are holes in the floors, walls, and ceiling where sheathing is missing or damaged (see Photos 6, 7, and 8).
- There is a partially collapsed portion of the shed roof along the south edge of the building (see Photo 9).
- The collar ties between the rafters do not appear to be structurally adequate, and there is no ridge beam present to span between collar ties. (see Photo 8).
- The existing 3x (flat) floor girders do not appear to be structurally adequate (see Photo 13).
- The framed shed on the east side of the home is derelict and not stable (see Photos 2 and 10). This element of the structure should be removed.

Photo 2. East elevation – dilapidated shed shown on the right

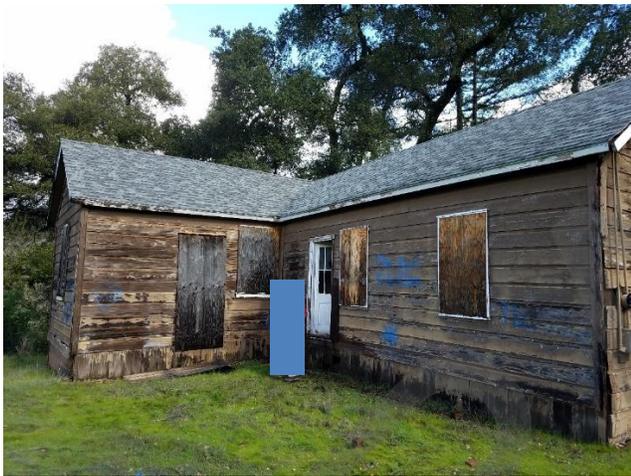
Photo 3. West elevation

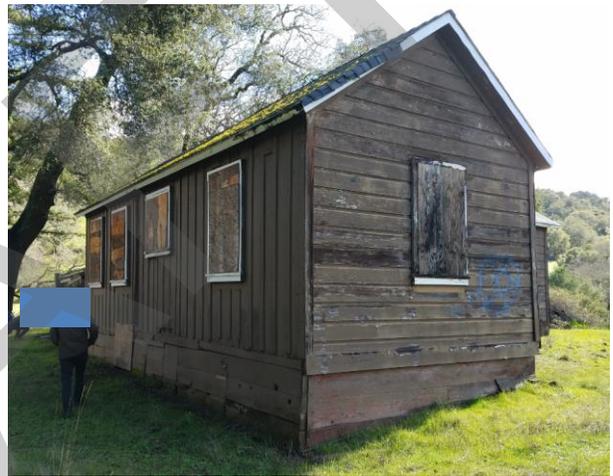
Photo 4. North elevation shown on the left

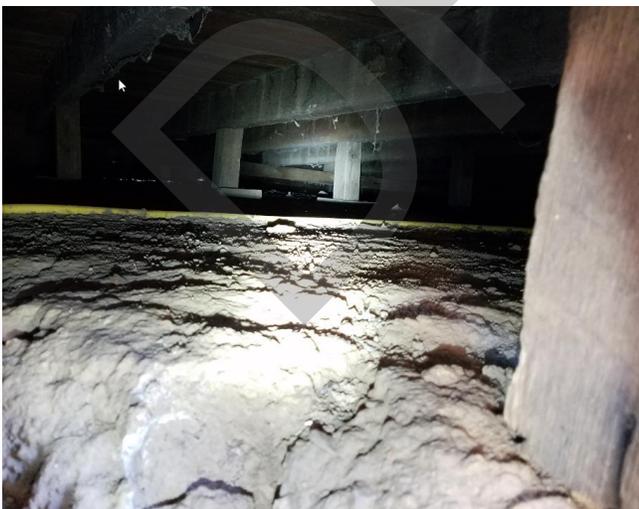
At the ground floor level, the flooring is composed of 1x horizontal wood planking spanning between 2x floor joists spaced at approximately 16" on center. The floor joists span between 3x flat girders that are supported by 3x wood posts. The wood posts are either supported directly on grade or sit on a flat wood sleeper that is directly on grade (see Photos 5, 6 and 13). No blocking, hardware or positive connections were observed between the joists,

Photo 5. Interior crawlspace framing, showing posts bearing on grade or on wood sleepers

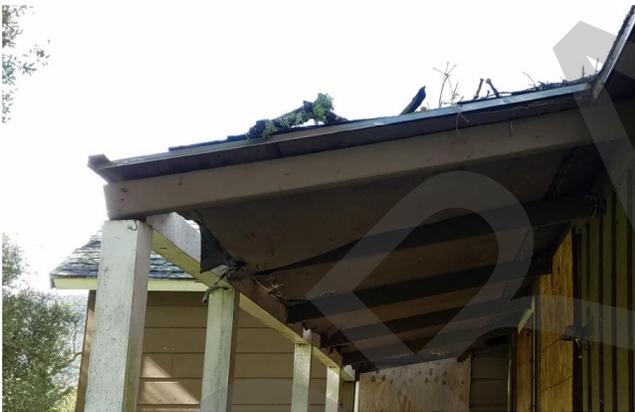
Photo 9. Partially collapsed portion of shed roof

- o Recommendation: Replace in kind all missing siding, planking, and sheathing.
- c) There is a collapsed portion of the shed roof along the south edge of the building (see Photo 9).

- o Recommendation: Replace in kind all damaged roof framing and sheathing, including roofing and waterproofing.
- d) The collar ties between the rafters do not appear to be structurally adequate, and there is no ridge beam present to span between the collar ties. (see Photo 8).

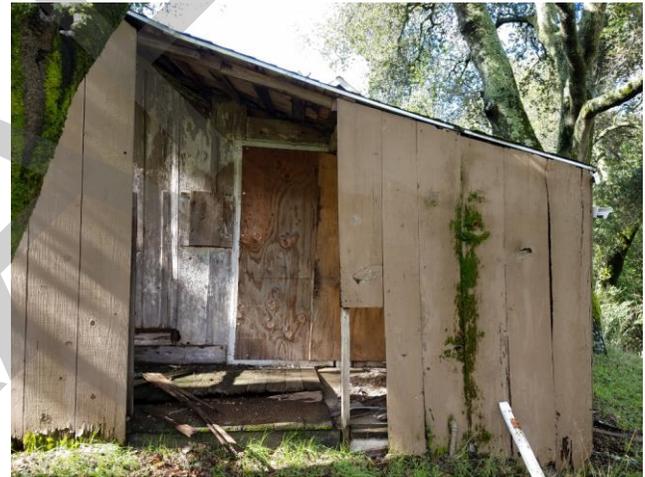
Photo 10. Dilapidated shed

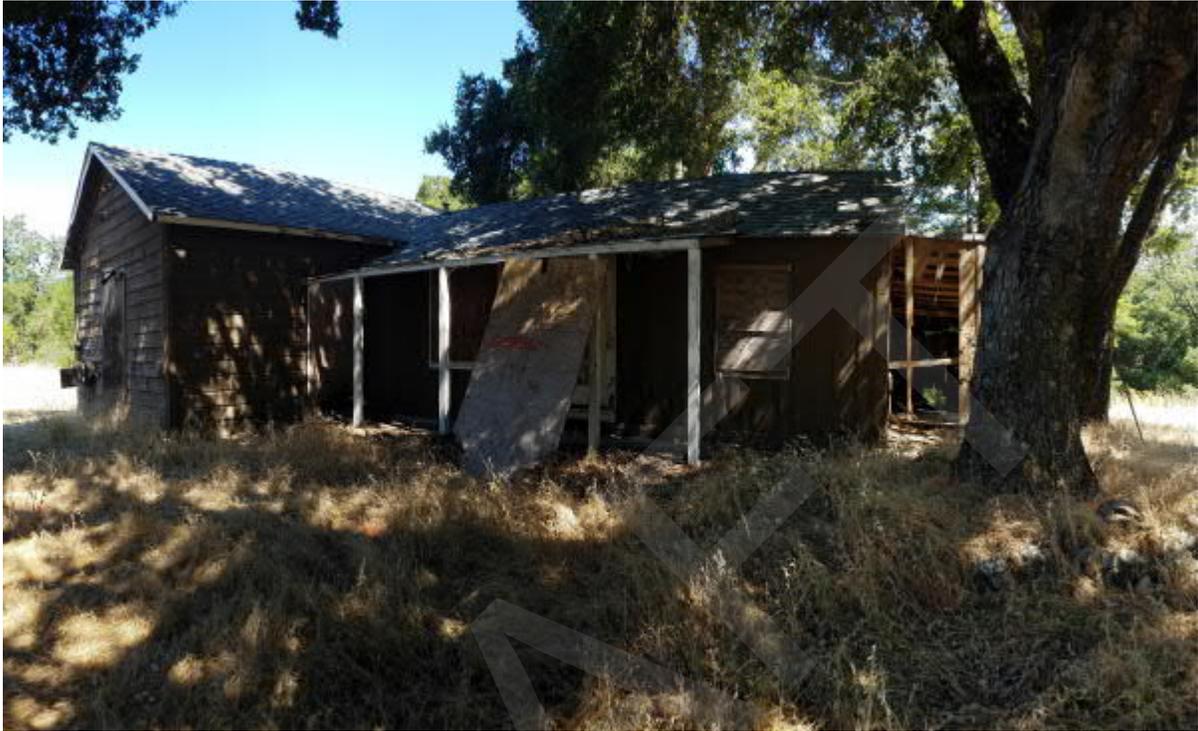
Photo 3 Beatty House

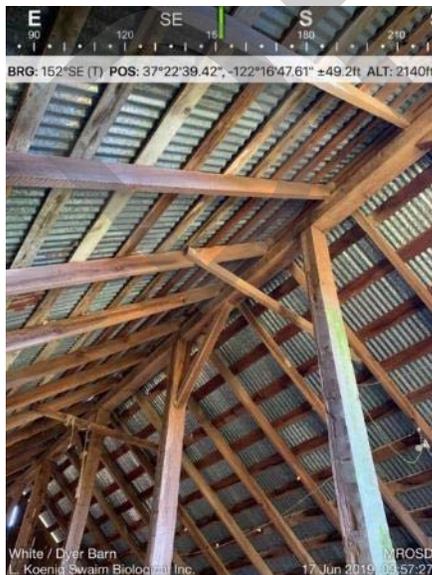
**Photo 7.** Corrugated roof slats and rafters provide suitable bat roosting habitat.

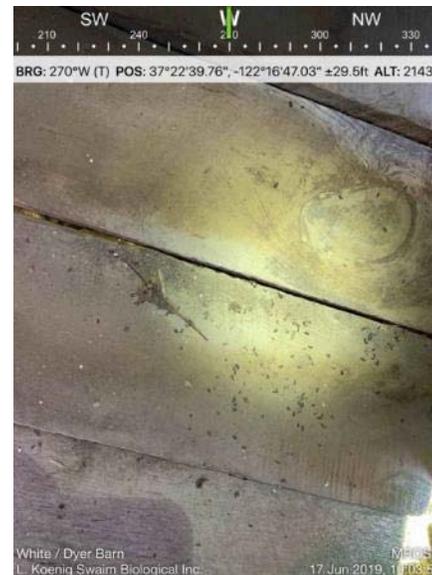
**Photo 8.** Bat guano present on the floor.

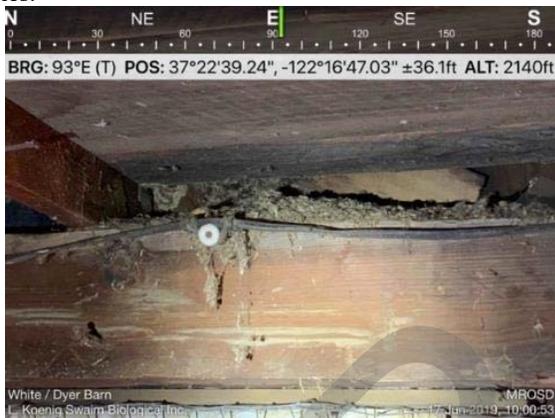
**Photo 11.** Rodent nests observed within the barn. These grass nests are most likely deer mouse (*Peromyscus sp.*) nests.

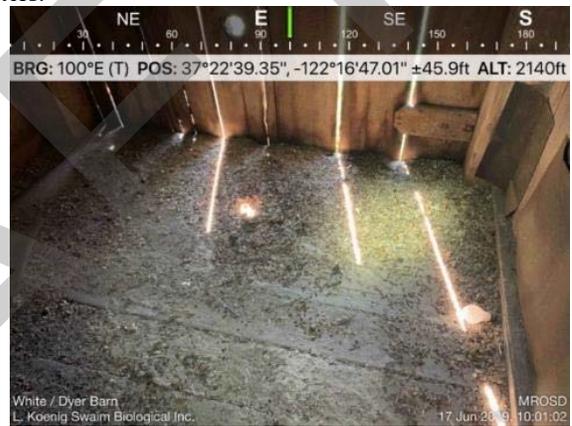
**Photo 12.** Rodent droppings and destroyed food caches observed within the barn.

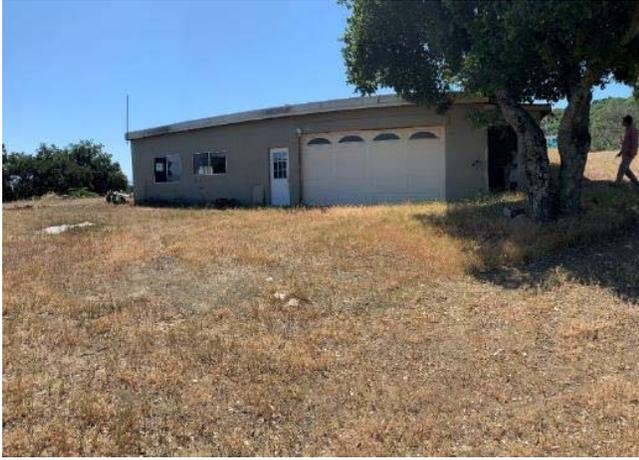
*Structure B:* A seam running under the roof eaves of Structure B was observed that could provide suitable bat roosting habitat although no roosting bats or signs of roosting bats were observed (Photo 23). Inside Structure B large quantities of woodrat fecal pellets were observed scattered throughout the shed.

**Photo 23.** Structure B – north-side view.

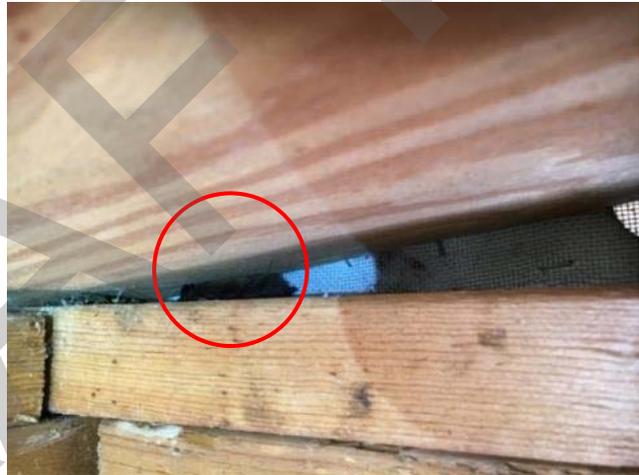
*Shed:* There is a shed to the west of the structures that were to be surveyed where a day roosting *Myotis* sp. was observed on June 11 (Photo 26). No roosting bats were observed on June 25.

**Photo 26.** *Myotis sp.* (circled in red) observed roosting in crevice in nearby shed to the west of the structure to be removed.

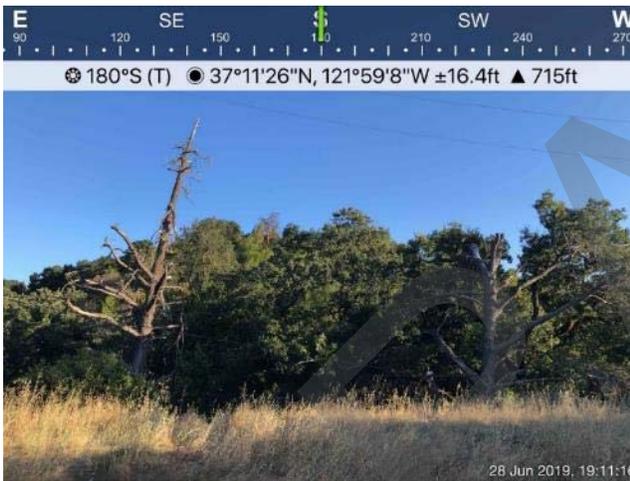
**Photo 29.** Two snags that could support roosting bats on west side of Beatty structure.

- Preconstruction surveys for bats and woodrats prior to removal activities.
- Follow the general bat avoidance and minimization measures presented in Section 4.1.
- Development of bat roost deterrent plan for approval by the California Department of Fish and Wildlife (CDFW) prior to structure stabilization activities.
- Provide replacement bat maternity roost habitat as part of the deterrent plan for approval by CDFW.
- Follow general woodrat avoidance measures presented in Section 4.2.

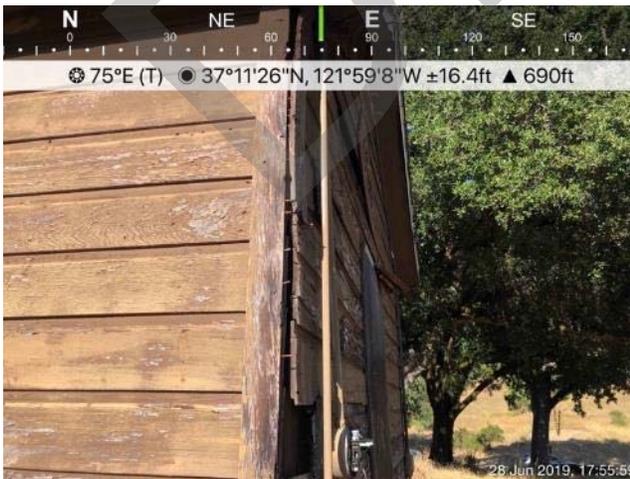
**Photo 33.** Wooden slats peeling away from the wall.

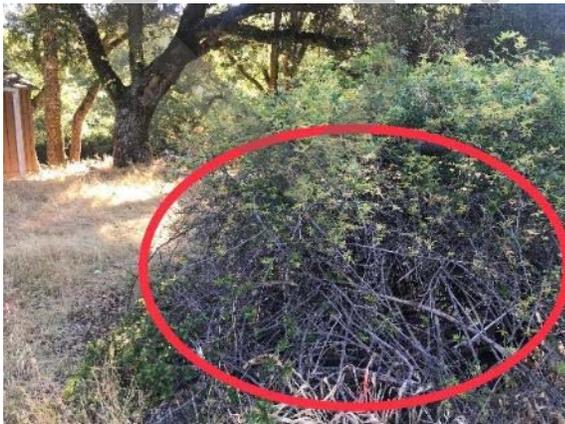
**Photo 39.** Woodrat nest number 1 is located under an ornamental bush 9 meters south of the structure

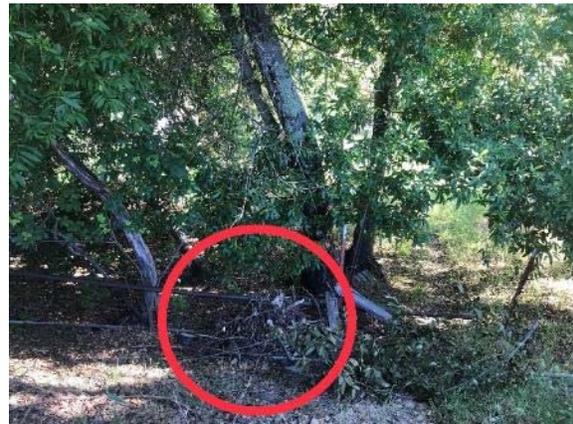
**Photo 40.** Woodrat nest number 2 is located along a fence 10 meters northeast of the structure.

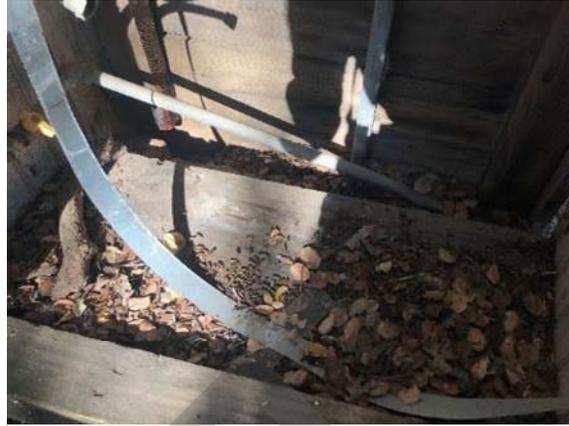
**Photo 42.** Woodrat A large amount of woodrat feces was observed in one location along the exterior of the structure.

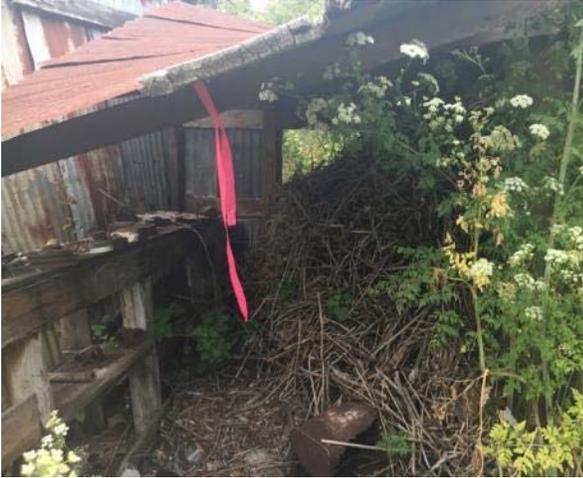
**Photo 45.** Area B – woodrat nest structure inside the dilapidated building.

- Preconstruction surveys for bats and woodrats prior to demolition and debris removal activities.
- Follow the general bat avoidance and minimization measures presented in Section 4.1.
- Development of bat roost deterrent plan for approval by the California Department of Fish and Wildlife (CDFW) prior to structure demolition activities at the Area E Hunting Cabin.
- Provide replacement bat maternity roost habitat for impacts to removal of maternity roost habitat at Area E Hunting Cabin as part of the deterrent plan for approval by CDFW. This replacement habitat will serve as replacement habitat for all bat roost habitat removed or disturbed during removal activities.
- Follow general woodrat avoidance measures presented in Section 4.2.

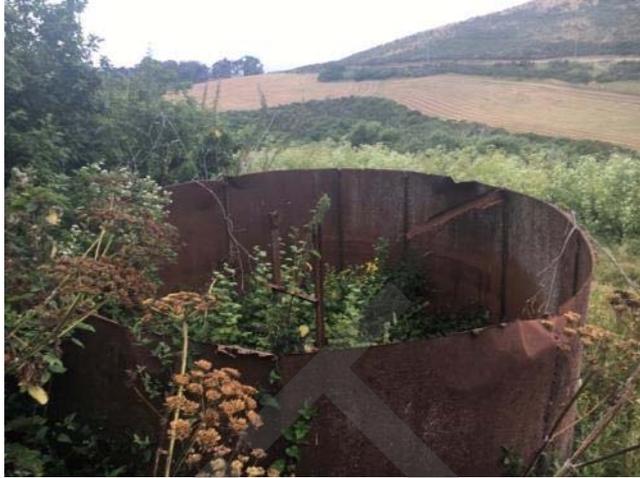
the elements that may preclude these structures from being used by bats (Photo 46). A large woodrat nest was observed inside Tank 11, and two smaller satellite nests were observed surrounding the tank.

**Photo 46.** Area D – most tanks were single-walled without any small crevice space for roosting bats.

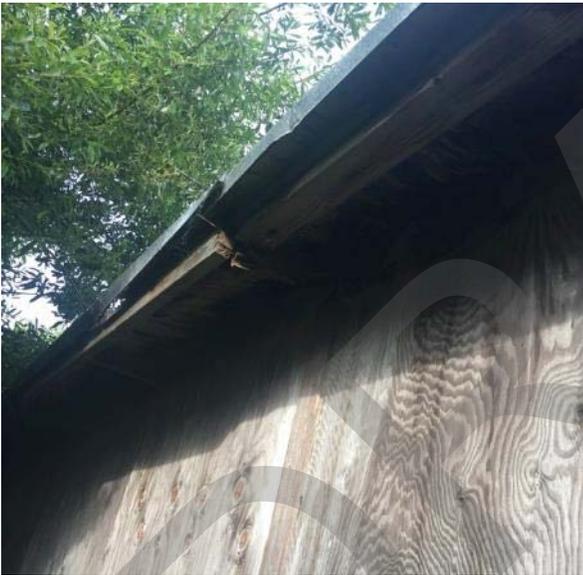
**Photo 47.** Area E – additional openings and interstitial spaces underneath the roofline.

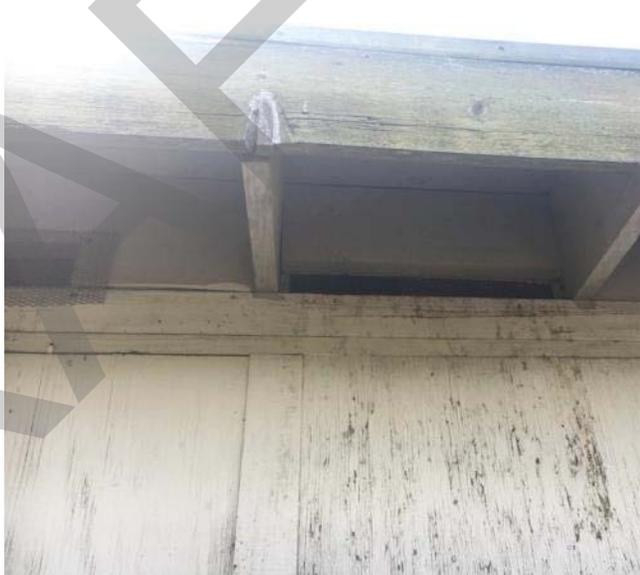
**Photo 48.** Area E – openings underneath the roofline of the hunting cabin.

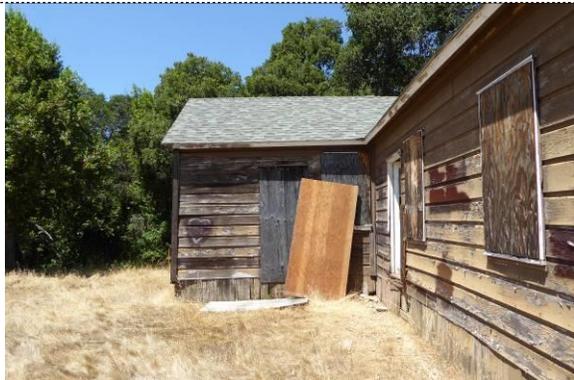
Figure 1

South façade of ca. 1870 addition. Window is addition possibly from the World War II interior modifications as it doesn't have the metal piece under the sill that other windows do on the façades with this cladding

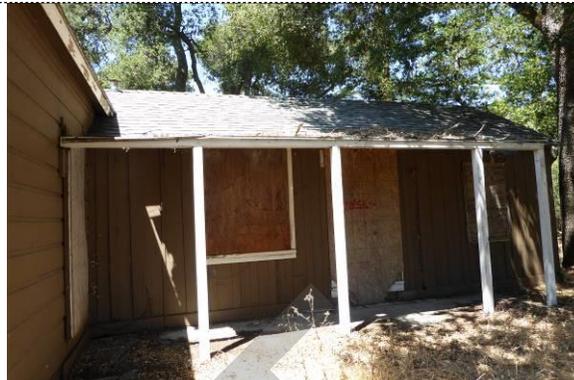
Figure 2

South façade of ca. 1877 addition. Windows and door correspond to the World War II modifications. Porch is addition covering partially the door exiting from the original dwelling.

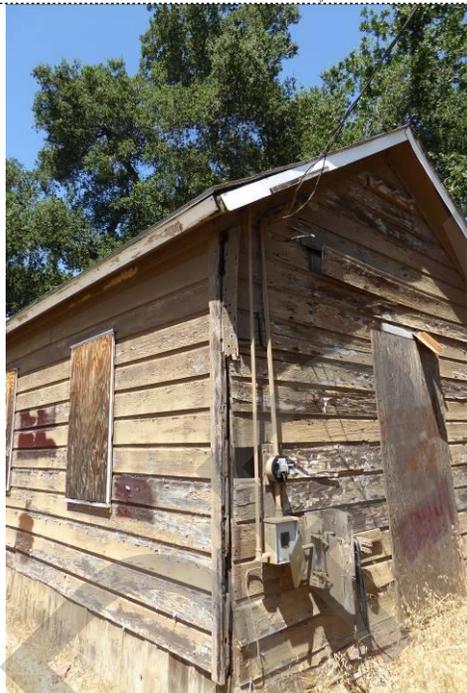
Figure 3

South and west façades of the ca. 1870 addition. Second cladding horizontal layer heavily weathered due to lack of protective treatment and care. Electric connections and meter are in this corner.

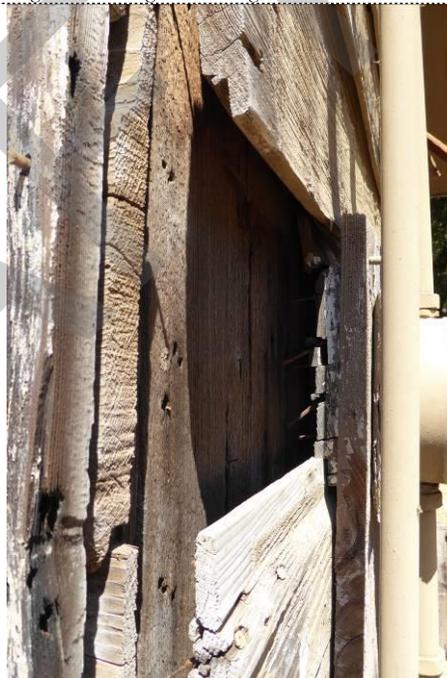
Figure 4

Close-up of lost piece of horizontal cladding where underlying vertical original cladding can be seen, also heavily weathered

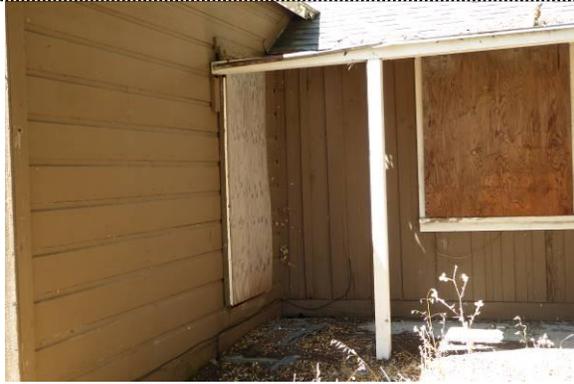
Figure 5

East façade (left) of the L-shaped addition. Door is blocked at the top end by the porch. The horizontal second layer of cladding was added before the extra feet connecting the buildings was added as it continues beneath the façade of the connection

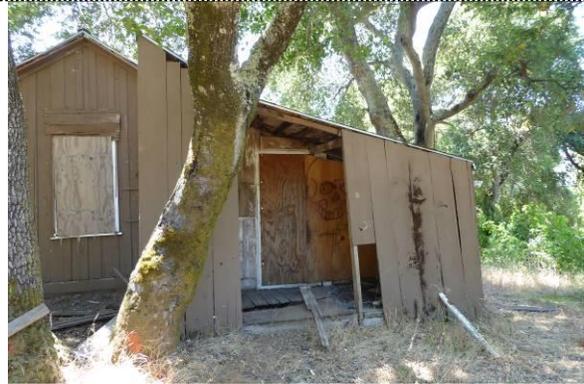
Figure 6

Right side of the East façade. Open shed is the latest addition to the building and has direct access to the pantry from the previous addition. The visible change in roof slope corresponds to the original building vs the kitchen and pantry addition

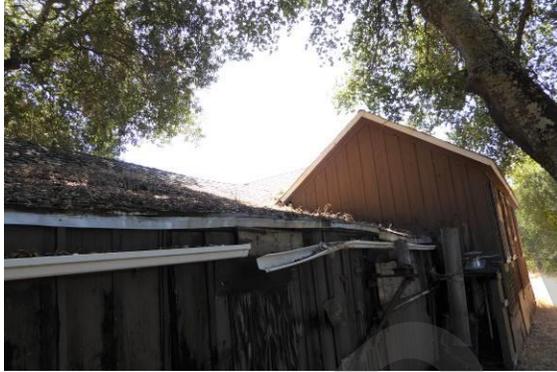
Figure 7

North façade of the kitchen and pantry. Roof has a gentler slope indicating its' belonging of a later addition date. Several elements have been replaced by more modern materials like T-111 siding

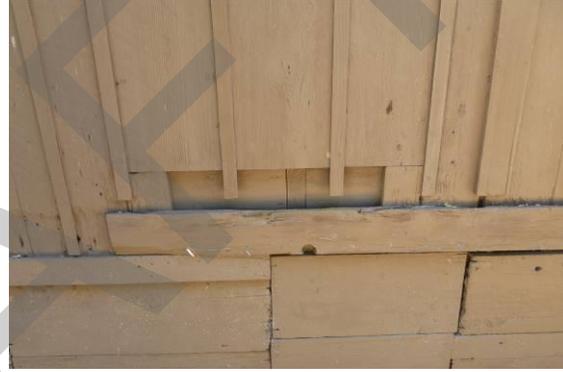
Figure 8

Close-up of cladding under the bathroom window, clearly different from the cladding of the rest insinuating it may have been originally a door opening that was later partially closed to form the current bathroom window

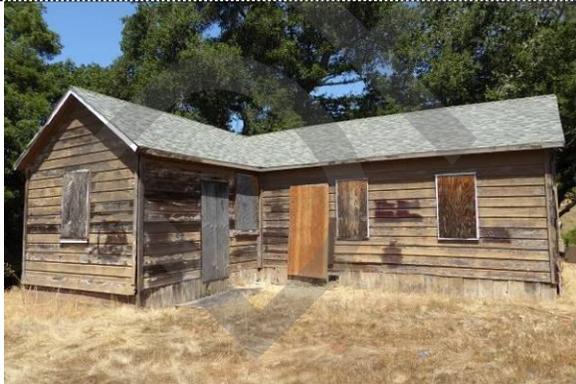
**Figure 11**

West façade and westernmost section of south façade. Corresponding to the L-shaped addition. All windows except the one in the center, belonging to the hallway, have been moved upwards or modified and reduced in size after the second layer of cladding was installed having a metal piece under the sills to cover up the gap originated during this modification

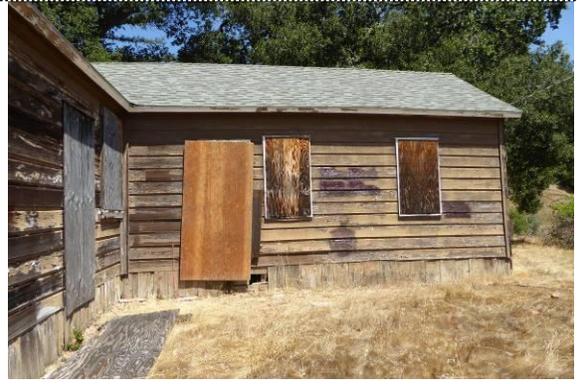
**Figure 12**

West façade of the L-shape, corresponding to the dining room and pantry. The roofs of the entire dwelling are relatively new, consisting of recent plywood sheathing nailed to historic spaced sheathing and covered in asphalt shingles.

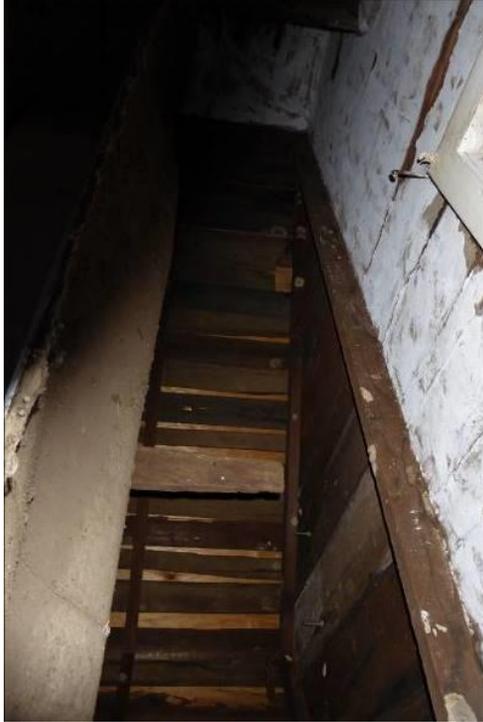
**Figure 13**

Opening in the ceiling to the roof structure in the parlor. Current nesting area for bats, sighting of bats not visible in this photo. Recommend removal by experienced personnel following appropriate directions by biological monitors prior to any repairs in these particular areas

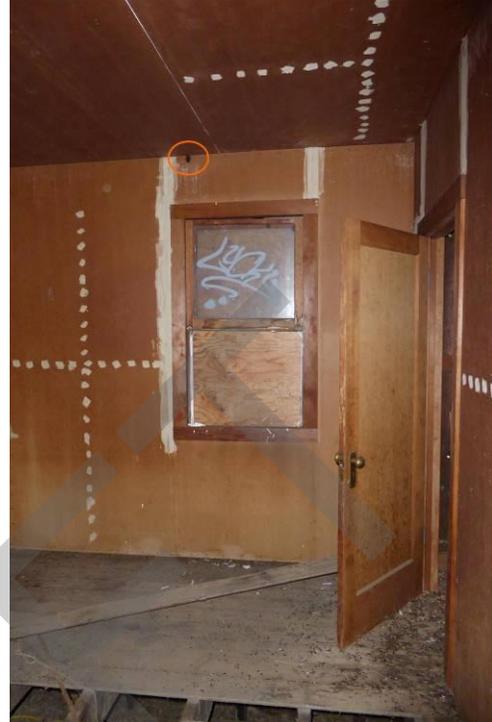
**Figure 14**

Sighting of bat resting above the window in the unfinished room. Other signs throughout the whole building suggest the possibility of several nests in the house

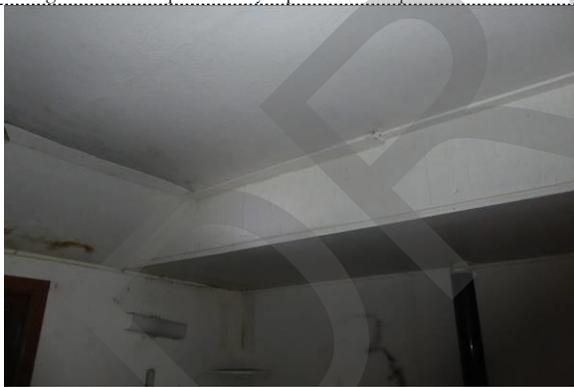
**Figure 15**

Double level ceiling of the living room. The lower section could have been part of the original east façade of the building or a porch covering its eastern side

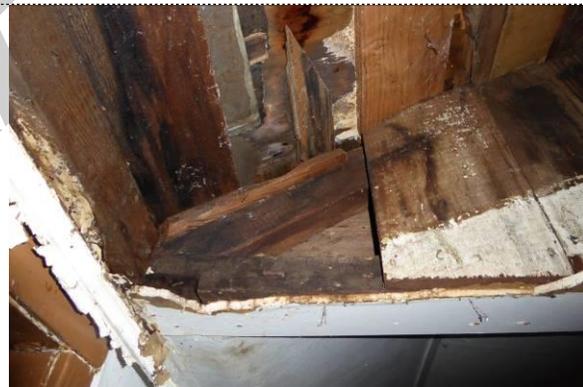
**Figure 16**

Hanging lower ceiling in the living room as seen through an opening. Clearly the vertical boards could be part of an original façade that was later modified. Evident humidity and rot signs, especially where the different roofing areas merge. Visible the new plywood sheathing directly over the historic one

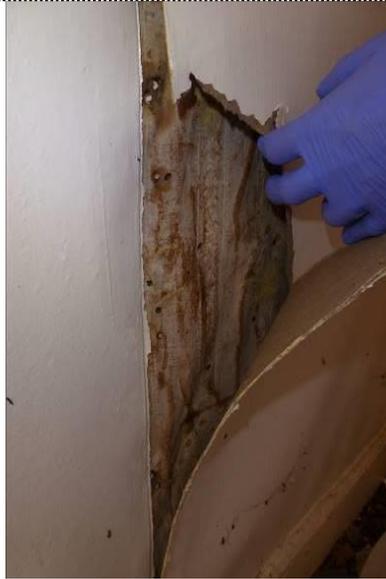
Figure 17

Current gyp board finish nailed over pre-existing floral painting finish board

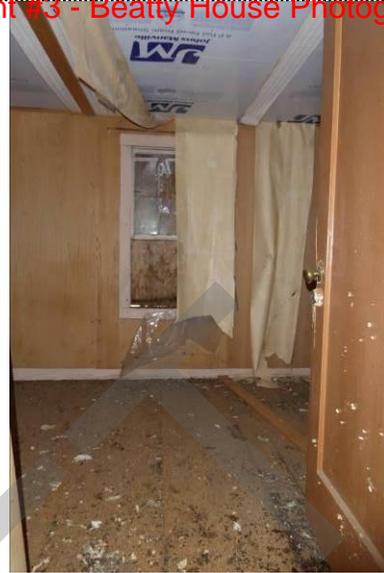
Figure 18

Bedroom 2 is accessed descending one step from the living room, insinuating construction at a later phase. Carpeted floor, single flush door, and isolation on ceiling insinuate a relatively modern build

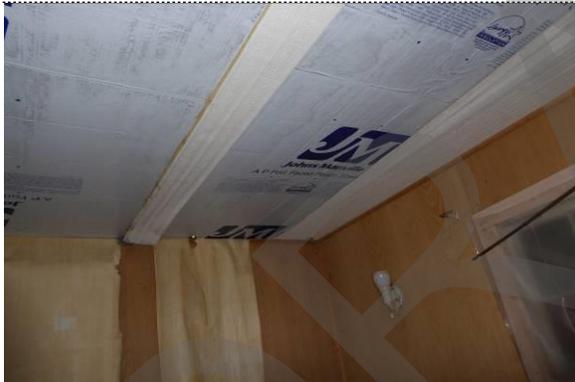
Figure 19

Current ceiling of bedroom 1 include modern materials as fiberglass isolation and others. Walls are covered in faux wood paneling over isolation with fiberglass, indicating it underwent modifications in more recent times.

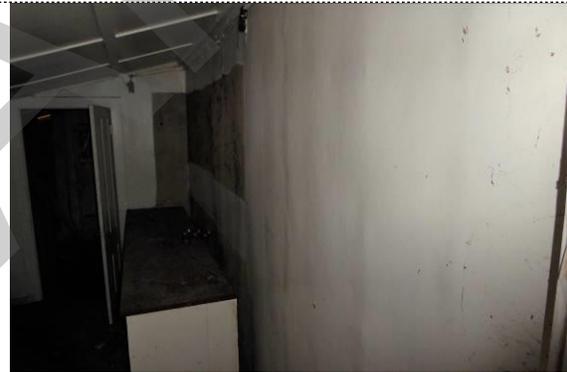
Figure 20

Kitchen with access to the pantry on the far side. Several cabinets have been removed. These rooms belong to the latest addition (not counting the shed) and add little value to the historic elements of the dwelling.

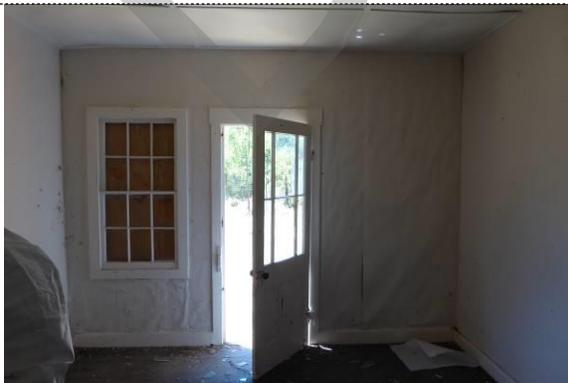
Figure 21

Living room, exit door with mid-19th century rim locks, and window to the west façade. Wall finish not properly attached needs reattachment if possible or replacement when not possible to reattach.

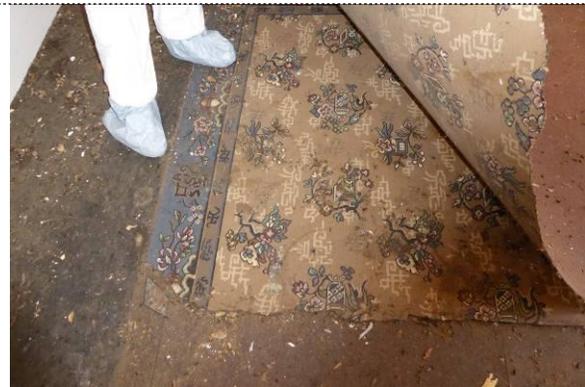
Figure 22

Original floor sheet in rug pattern over tar paper currently folded in half. Would require rehabilitation treatment to rejoin both halves and to bring out the original colors prior to final reinstallation

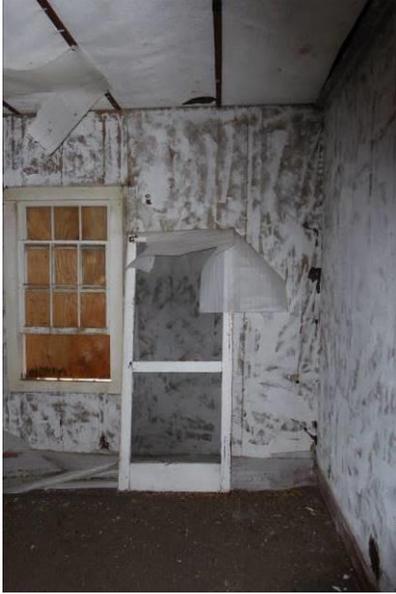
**Figure 23**

Parlor, with carpeted floor and unfinished walls and ceiling insinuate that it was previously used as a bedroom before the final modifications to the house

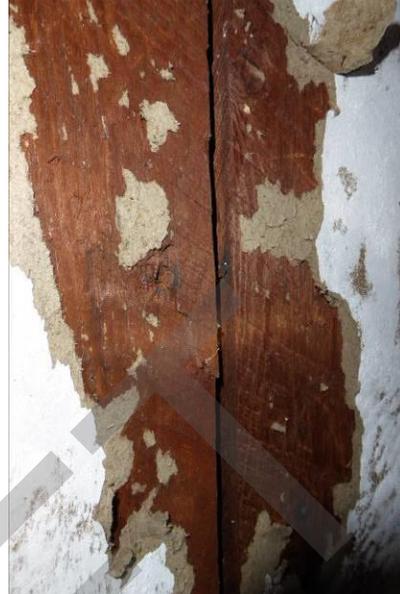
**Figure 24**

Wall boards conforming the façades and partitions are covered directly by the interior finish cardboard with no isolation layers in between

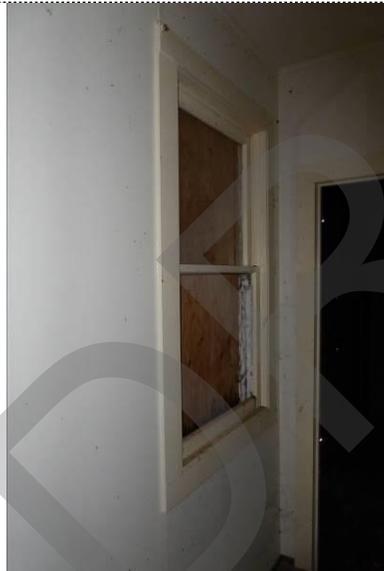
**Figure 25**

Corridor window, design clearly corresponds to a latter period from that of the building of this section. Walls covered in gypsum board

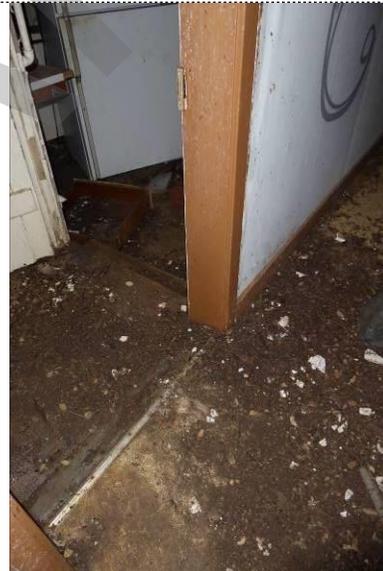
**Figure 26**

Door communicating to the corridor, and steps going down from this to the kitchen. The slight slope downwards into the corridor at the door footer could indicate that this was originally the location of an exit door

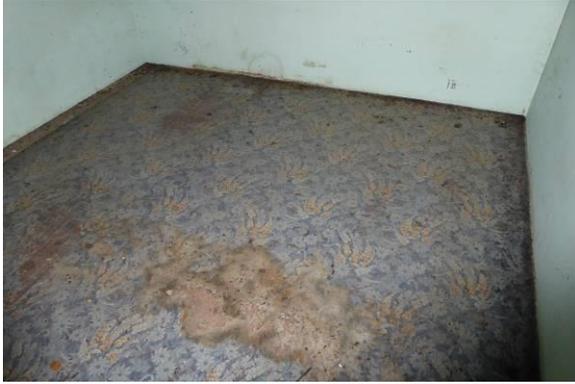
**Figure 27**

Floor of bedroom 1, floor finish is also a sheet in rug pattern over tar paper

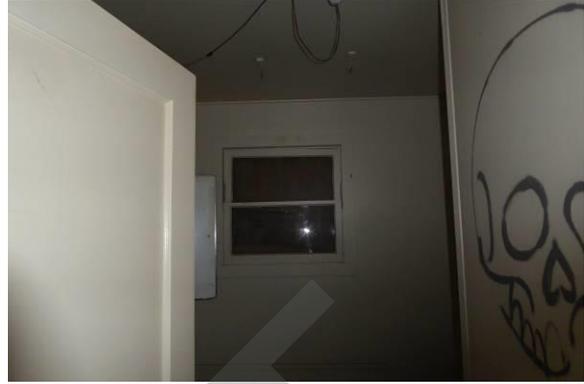
**Figure 28**

Bathroom window where presumably there was originally an exit door

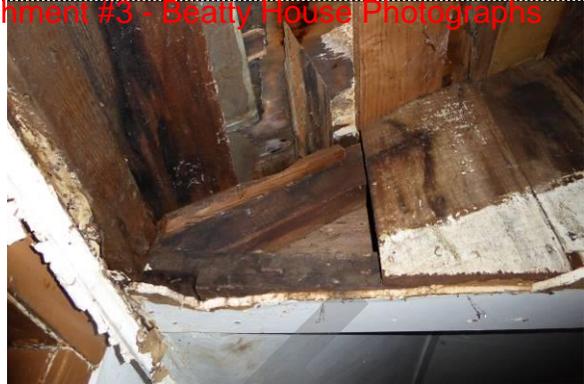
Figure 34

Double level ceiling of the living room. The lower section could have been part of the original east façade of the building or a porch covering its eastern side

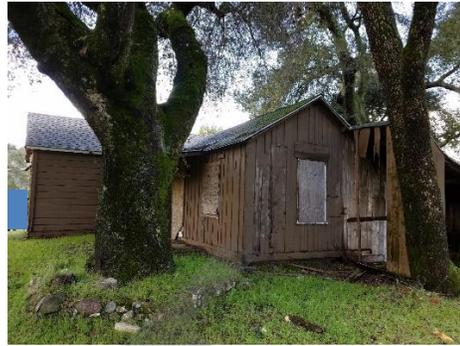
Photo 1. South elevation, showing shed roof support by posts

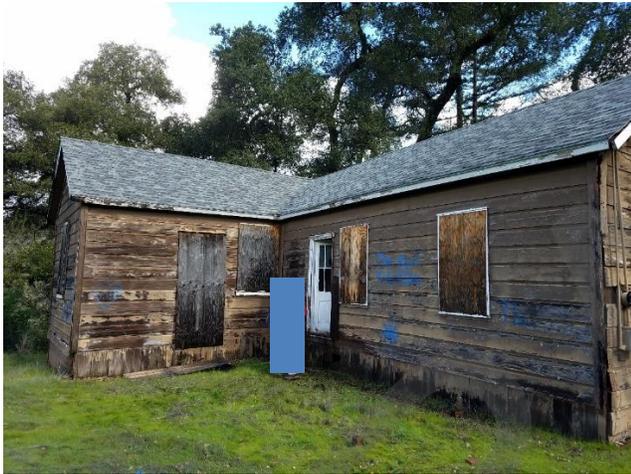
Photo 2. East elevation – dilapidated shed shown on the right

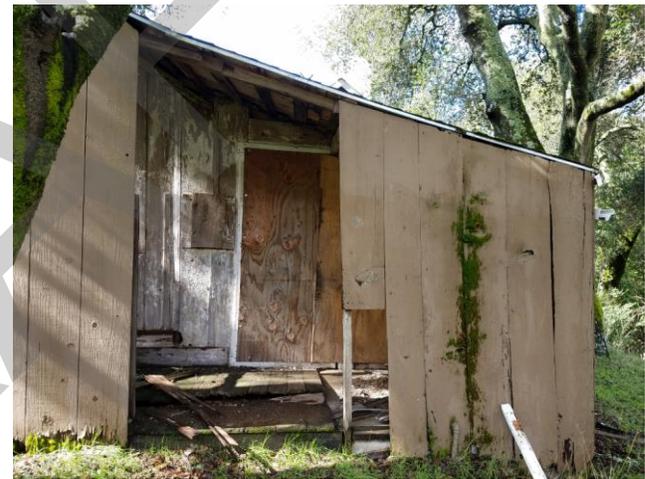
Photo 9. Partially collapsed portion of shed roof
