MOUNT UMUNHUM RADAR TOWER Condition Assessment and Recommendations

Sierra Azul Open Space Preserve
Santa Cruz Mountains, California

Final Report

November 13, 2019
WJE No. 2018.0484

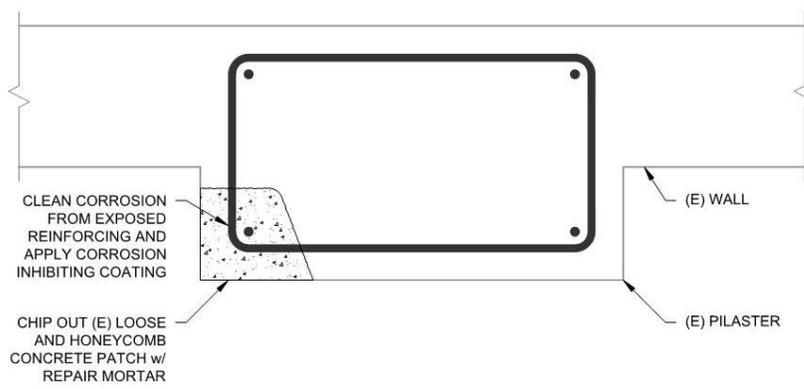
1 PILASTER REPAIR
SCALE: 1 1/2" = 1'-0"

Figure 6. Base concrete pilaster repair.

- Remove loose or delaminated concrete and sawcut the perimeter of the repair area.
- Chip out the concrete to allow access around the exposed reinforcing steel.
- Clean the corrosion and apply a protective coating to the exposed steel.
- Supplement severely corroded or missing reinforcing steel with new reinforcing steel.
- Patch the concrete spalls using an appropriate concrete repair mortar.
- Coat concrete walls and pilasters with an elastomeric coating.
- Re-apply an anti-graffiti coating on the lower portion of the walls, similar to what currently exists at the building.

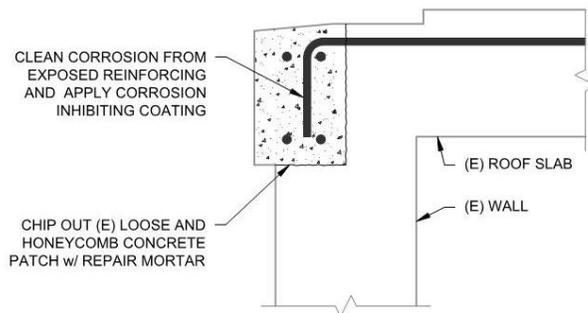
2 ROOF EDGE REPAIR
SCALE: 1 1/2" = 1'-0"

Figure 7. Base perimeter roof edge beam repair.

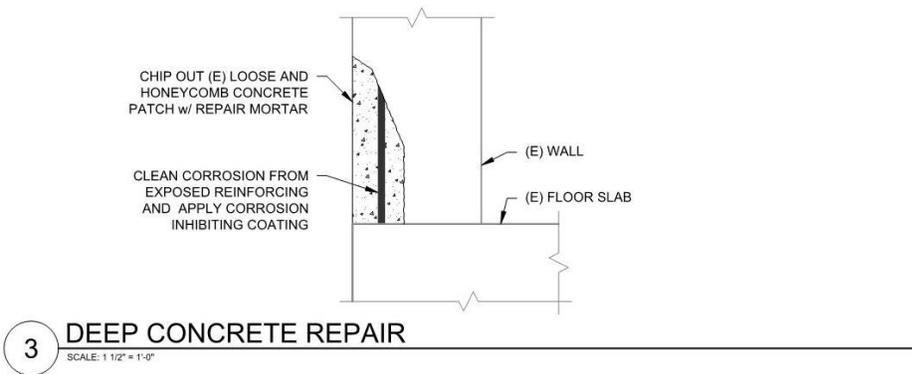
Figure 8. Base deep concrete void or spall repair.

include all locations where the reinforcing steel is exposed and any other location where the depth of the spall or void exceeds 1 inch.

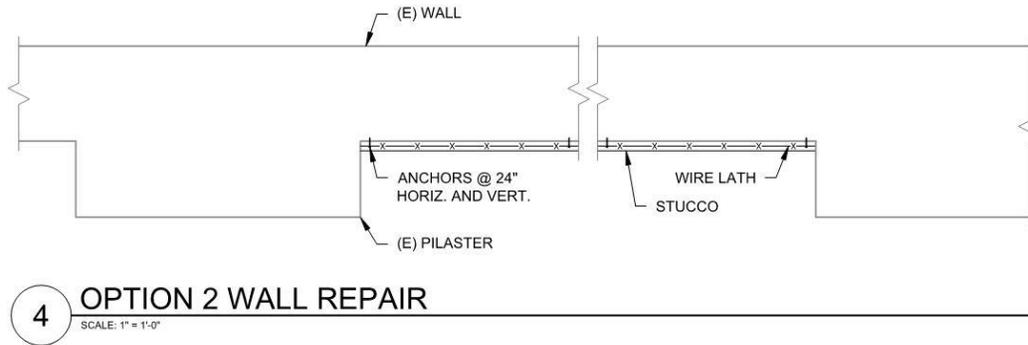
Figure 9. Wall repair option using a mechanically attached stucco system applied to the walls.

This option allows the existing rough surface to remain and installs mechanically attached 3-coat cement plaster (stucco) system (thickness of about 1 inch) on the walls between the concrete pilasters as a substrate for an elastomeric waterproofing coating (Figure 9). The finish of the stucco surface should be smooth to match the texture of a formed concrete surface; however crack control joints needed in the stucco and sealant joints needed between the stucco and the pilasters will be visible deviations from the current appearance. The elastomeric coating would be expected to be overcoated every 5 to 7 years and removed and replaced after about 20 years. The stucco cladding would last at least 40 years as long as the elastomeric coating is maintained, and the sealant would need to be replaced after about 20 years.

- Install mechanically fastened metal lath and 3-coat stucco on the exterior walls between pilasters, and below the perimeter roof edge beam.

- Install horizontal control joints at the bottom of each floor slab level (top of each story wall), and intermediate horizontal control joints at the mid-height of the fourth and fifth floor walls.

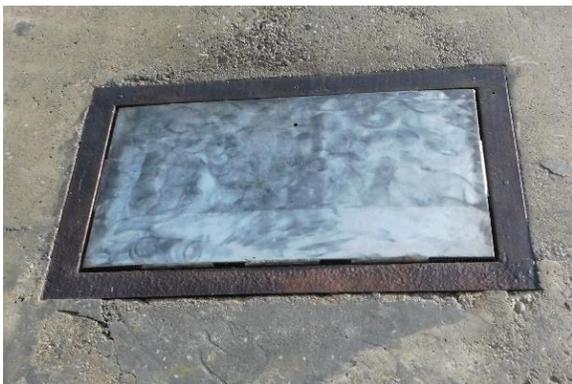
Figure 15. Typical opening in concrete wall, closed with steel plate.

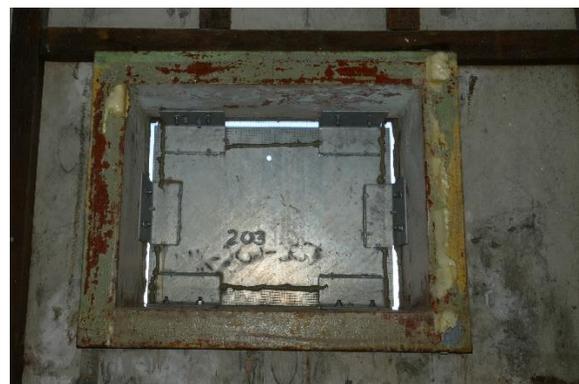
Figure 16. Interior of similar opening in concrete wall with gap around steel plate perimeter.

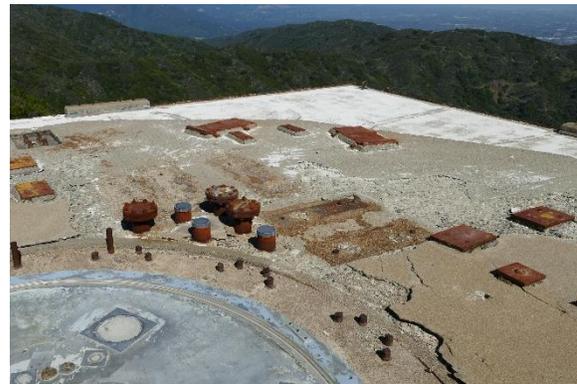
Figure 20. Steel plates, pipes, conduit, and other penetrations at the top of the concrete pedestal.

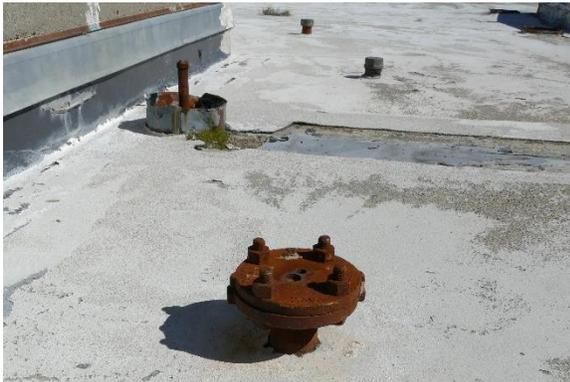
Figure 21. Various pipe penetrations, conduit in a pitch-pocket, and visible sealant repairs at the expansion joint. Photo facing north.

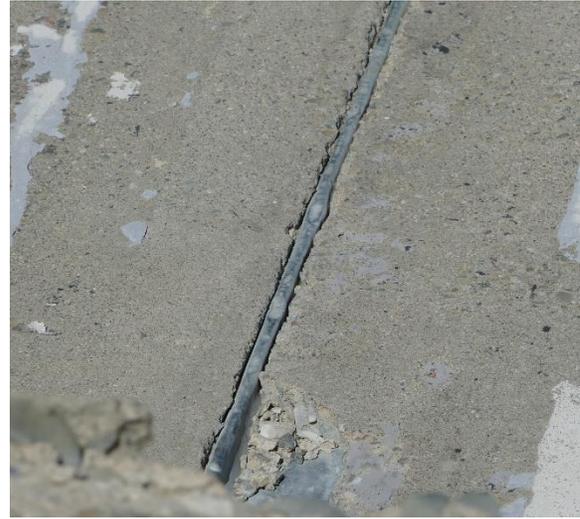
The roof is divided into quadrants by perpendicular expansion joints in the wearing slab (Figure 30) that do not extend through the structural slab (Figure 31). There is a roof drain (Figure 32) in the center of each quadrant, however the drain pipe was reportedly disconnected and sealed with grout to prevent animal intrusion. All four roof drains had plants growing out of them at the time of our observation.

Figure 30. Wearing slab expansion joint formed from folded copper sheet that was originally covered by sealant. Note that the other three joints in the slab were concealed by more modern repair sealant.

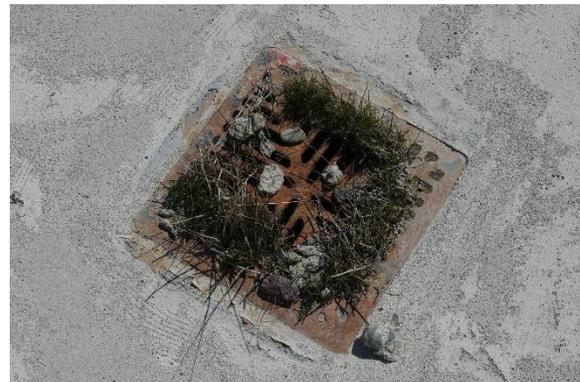
Figure 32. One of four area drains with plants growing out of the drain.

The built-up roofing membrane is concealed beneath the wearing slab and could not be observed. Single-ply membrane flashings have been added around the concrete pedestal and roof hatches (Figure 67), and a fluid-applied waterproofing coating has been applied to the wearing slab over the entire main roof area (Figure 68) and onto these single-ply flashings (Figure 69). There is also evidence of waterproofing repairs at underlying cracks in the concrete wearing slab, and spray foam in many joints and gaps at penetrations and flashings. There are grasses and moss growing along many joints, cracks and gaps at the roof, including plants growing out of all four roof drains (Figure 32).

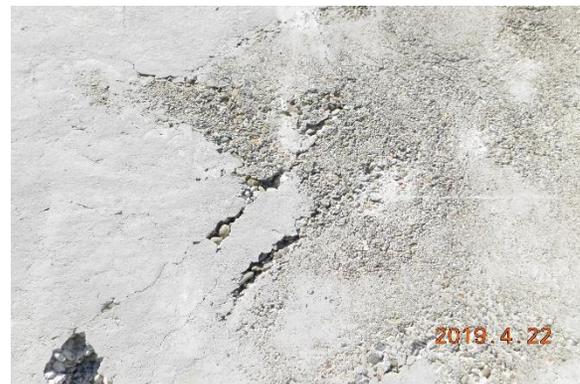
The exterior surface of the concrete walls have an anti-graffiti coating on all four elevations up to a height of approximately 16 feet above the exterior grade. Above this level, the concrete walls are currently uncoated. The surfaces of the concrete are generally rough, weathered, and have numerous areas of poorly consolidated concrete with exposed aggregate, surface voids due to poor consolidation (honeycombing/rock pockets) (Figure 37 and Figure 38). Some areas have little or no concrete cover over reinforcing steel, with corrosion staining and spalls visible at these locations (Figure 39 and Figure 40). Also observed were debris embedded in the concrete from the original construction including pieces of wood and a cigarette lighter (Figure 41 and Figure 42). WJE sounded the surface of the concrete to identify areas of loose concrete. Areas of surface voids and loose concrete are indicated on elevation sketches for each wall, which are provided in Appendix C.

Figure 38. Concrete with a rough surface and areas of poor consolidation.

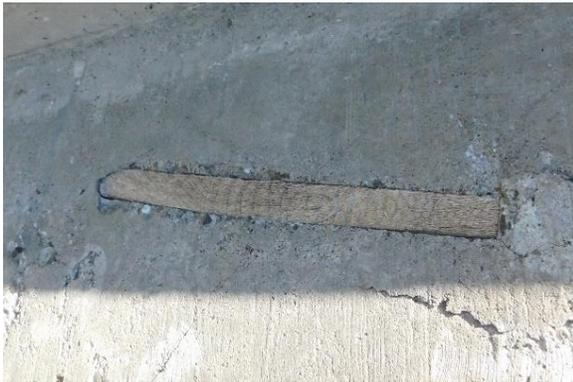
Figure 41. Piece of wood embedded in the concrete wall on the east elevation.

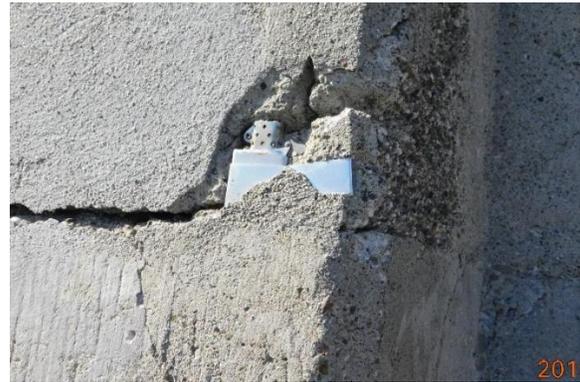
Figure 42. Cigarette lighter embedded in the concrete wall on the south elevation.

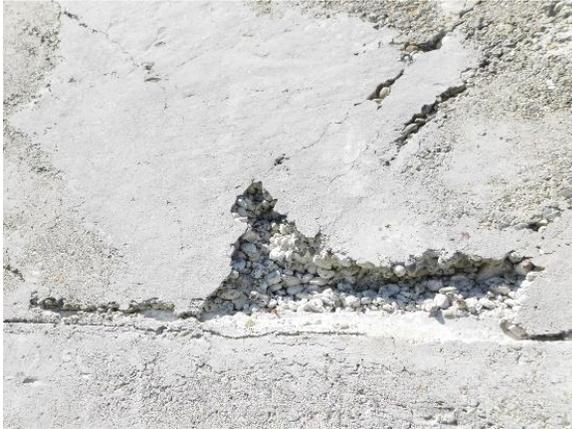
Areas of poor consolidation of the concrete are typically concentrated at the base of the walls immediately above the second through fourth floor slabs (Figure 43 and Figure 44). At these locations horizontal construction joints between the slab and wall concrete placements contain a key (a small formed ridge of concrete along the top of the top of the slab along and within the thickness of the wall to enhance the mechanical bond between the separately-placed slab and wall). At numerous locations, the poorly consolidated concrete extends sufficiently deep into the wall's thickness to expose the reinforcing steel. Acoustic hammer sounding suggested a majority of the concrete adjacent to the visible areas of poorly consolidated concrete with pockets of exposed aggregate are structurally sound, with aggregate well-bonded to the wall, despite their appearance and localized small areas of loose aggregate. Some of these areas of poor consolidation appear to have been modified at some time in the past, by the addition of a trowel applied patch material, possibly following initial concrete placement. These patches were identifiable by their surface finish and coloration, which distinctly differ from the cast-in-place concrete wall (Figure 43). Some of these patches appear to be delaminating from the concrete substrate.

Figure 43. Poorly consolidated concrete above the horizontal construction joint above the floor slab with a smooth patch area above.

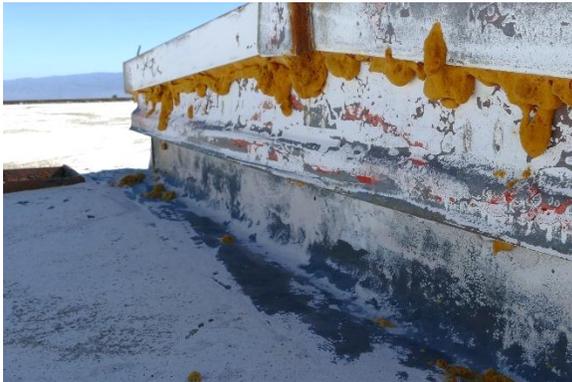
Figure 67. Single-ply membrane flashing (black), spray foam (yellow), and fluid-applied coating (white) at roof equipment hatch.

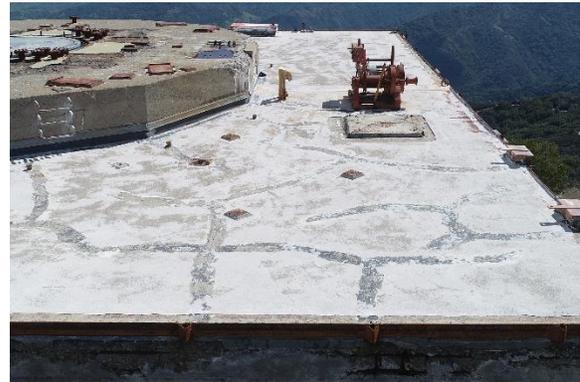
Figure 68. White traffic coating on main roof, facing east. Note the darker stripes where underlying cracks were treated.

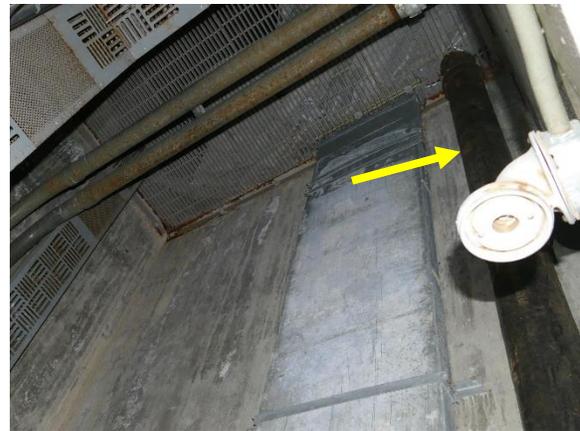
Roof drainage plumbing visible beneath the roof slab (Figure 72) runs from the four original roof drains to the utility shaft at the southeast corner of the building where it descends to the ground floor (Figure 73). The plumbing stack originally exited the building in the utility trench that extends beneath the south end of the east wall, but the pipe was reportedly disconnected and sealed with grout. The drainage plumbing has surface corrosion in many areas.

Figure 73. Cast iron drainage plumbing stack in utility shaft. Photo facing southeast.

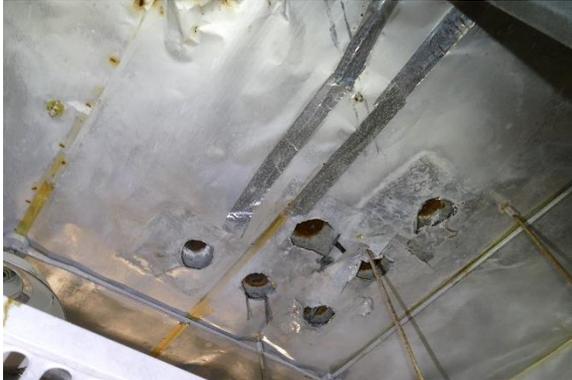
The ceiling beneath the roof is finished with aluminum sheets originally used as shielding (Figure 74), limiting direct observation of the underside of the structural slab. These aluminum sheets are generally oxidized, indicating long-term exposure to moisture, and there are signs of leakage at multiple areas throughout the ceiling including staining, heavier corrosion and efflorescence at the aluminum sheeting and adjacent materials (Figure 75). Several steel beams which serve to anchor steel rods extending through the roof slab that are visible at the underside of the roof have surface corrosion (Figure 76). Although the aluminum sheets prevent direct observation of the roof slab, the presence of staining of the aluminum sheets

indicates water leakage through the roof slab and some degree of corrosion of the reinforcing steel within the roof slab is likely.

Figure 74. Aluminum sheets installed beneath the roof slab are noted as radar shielding in the construction drawings.

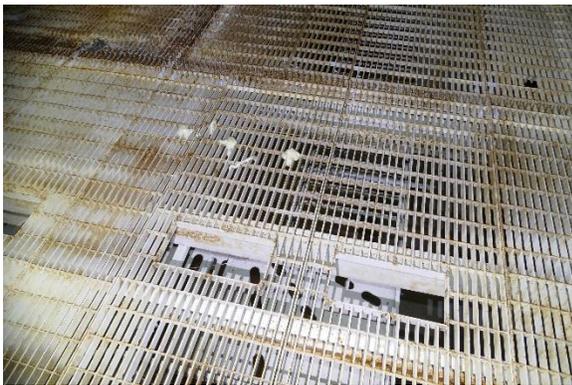
Several abandoned openings (former mechanical penetrations) in the floor slabs are covered with metal plates which may date to the building's decommissioning, but most floor openings are covered with plywood fastened to the floor, reportedly installed in 2016. The metal plates typically have surface corrosion (Figure 82), and the wood covers are generally in fair condition (Figure 83), though ongoing deterioration of these wood covers should be expected given the indications of moisture intrusion throughout the building. The metal grate floor of the fifth-floor mezzanine has a number of rectangular holes (Figure 84) that someone could be injured by stepping into, and generally has surface corrosion (Figure 85).

Figure 84. Rectangular holes in the mezzanine floor grating are large enough to accidentally step through.

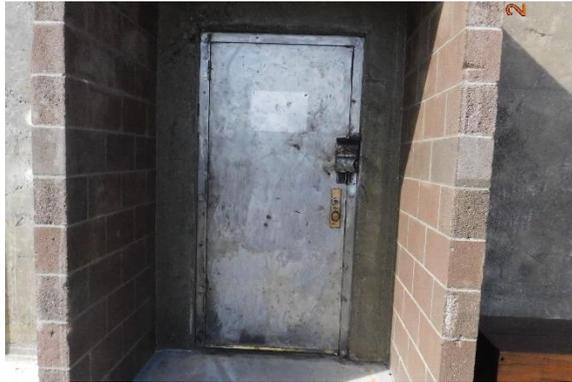
The paint has been removed from the two remaining exterior doors, exposing bare steel. Based on the absence of surface corrosion, the doors are assumed to be constructed of stainless steel. Both doors appear to be relatively secure and resistant to tampering, and have key-operated locks.

Figure 86. Steel door at south of east wall.

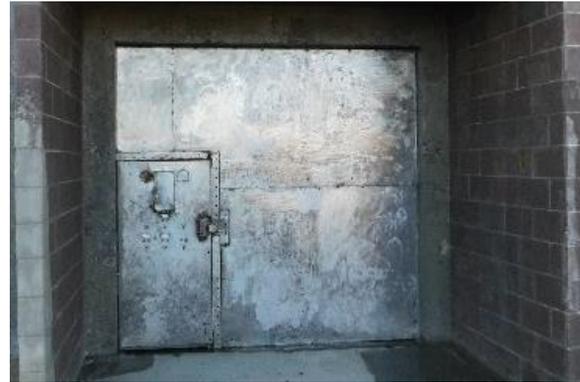
Originally, there were three exterior single-leaf metal outswing doors in the east wall of the building, and a larger double-leaf outswing door opening in the center of the west wall. The two northern doors in the east wall have been removed and the openings filled with concrete. The southern door at the east wall remains (Figure 86). The door at the west is shown as a double-leaf outswing door in the original construction drawings, but currently consists of fixed metal plates that close the opening, with a single access door at the northern side (Figure 87). We are not aware of the date for this modification.

Figure 87. The west door was originally a double-leaf door, but appears to have been modified and has only a small access door in a larger metal plate.

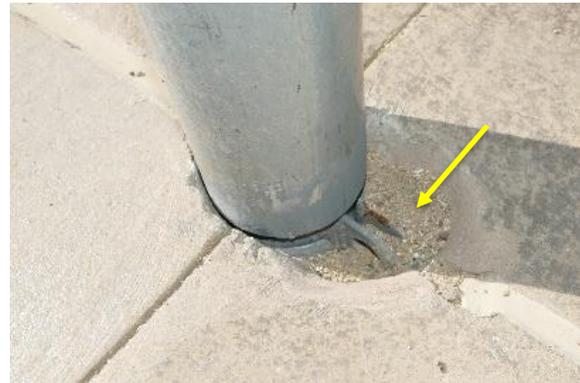
the concrete sidewalk and can be removed (Figure 88 and Figure 89). Removing these bollards can be difficult due to sand and debris that collects between the bollard and the sleeve.

Figure 89. Base of removable bollard. Note sand in the recess adjacent to the bollard sleeve (arrow).

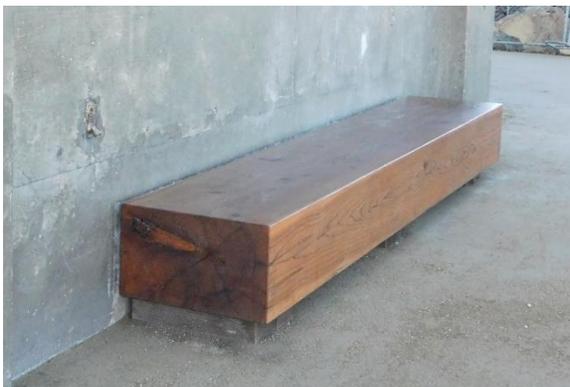
The wood benches adjacent to the building are constructed of a single large timber that is in close proximity to the building wall and the ground (Figure 90). Most of the benches are located with a gap of about 1 inch between the bench and the exterior wall of the tower. The timber benches are supported by wood bases that are reportedly well anchored to a concrete foundation below, and may be difficult or impossible to remove without damaging the benches.

Figure 90. Wood benches are very close to the concrete walls.
