Midpeninsula Regional
Open Space District

Alma College Site Cultural Landscape Rehabilitation Plan

Report for Landscape
Architecture Services

March 24, 2017

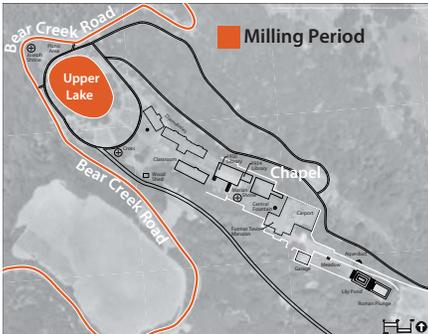
Figure 1: Milling Period elements overlaid on the existing Alma College Site Plan

Logging and milling was recorded in the early 1850s when a man named Webb, attracted by dense groves of redwoods and madrones, operated a sawmill on the ridge. In the mid 1850s, James Howe developed a mill pond by damming Webb Creek to provide water for his waterwheel to power a sawmill³. Wilbur Wilcox, the superintendent of the San Jose Water Company, owned the land during this period, and the pond and Bear Creek Road date to this period, as well (see Figure 1⁴).

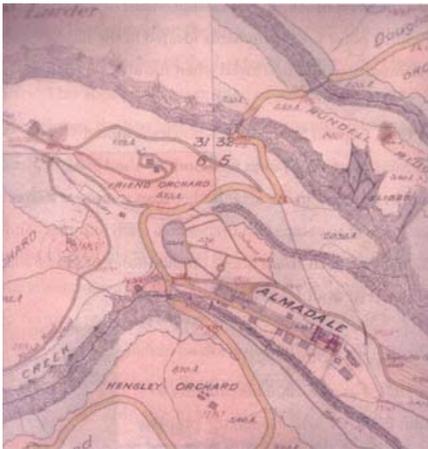
Figure 2: Site Plan of the flood estate (Page & Turnbull, page 6)

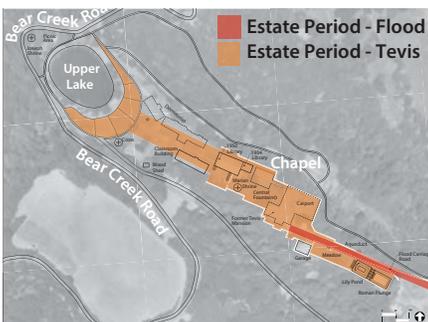
Figure 3: Estate Period elements overlaid on the existing Alma College Site Plan

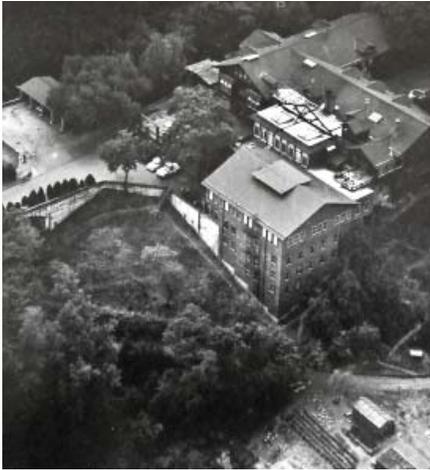
Figure 4: Tevis Mansion and North retaining wall with aqueduct

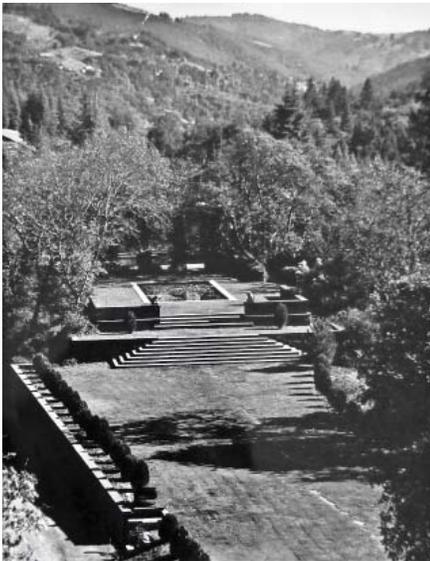
Figure 5: Almadale meadow with lily pond and Roman plunge beyond

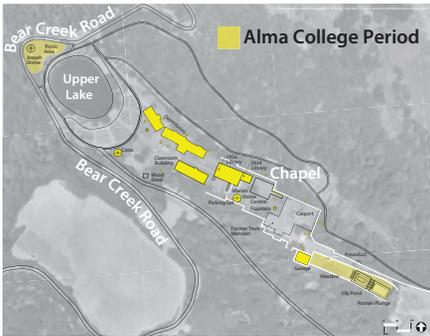
Figure 7: Alma College Site and Jesuit period elements overlaid on the existing site plan

becoming the faculty house and Tevis' library becoming the Chapel. The Jesuits built the 1934 Library, two Dormitory buildings (1934-1937), the Classroom building (1935), and the garage in the early Jesuit Alma College period, and the large 1950 Library addition in the late Jesuit period (see Figures 7 to 9). Several shrines were added to the landscape of Alma College as were introduced tree species, adding to those likely planted by Flood and Tevis. The Jesuits utilized the Tevis gardens and circulation system, expanding them when the dormitories and Classroom buildings were built (as seen in Figure 10). They also utilized the Tevis-era terraces, the Roman plunge and a number of other structures, vineyards and the orchard. Features remaining from the Jesuit period include the 1950 Library, 1934 Library, the Classroom and garage, remnants of the Dormitory basements, the Marion and St. Joseph shrines, paths, grapevines, and evidence of piping that appears to have been part of the Jesuit's local fire hydrant system.

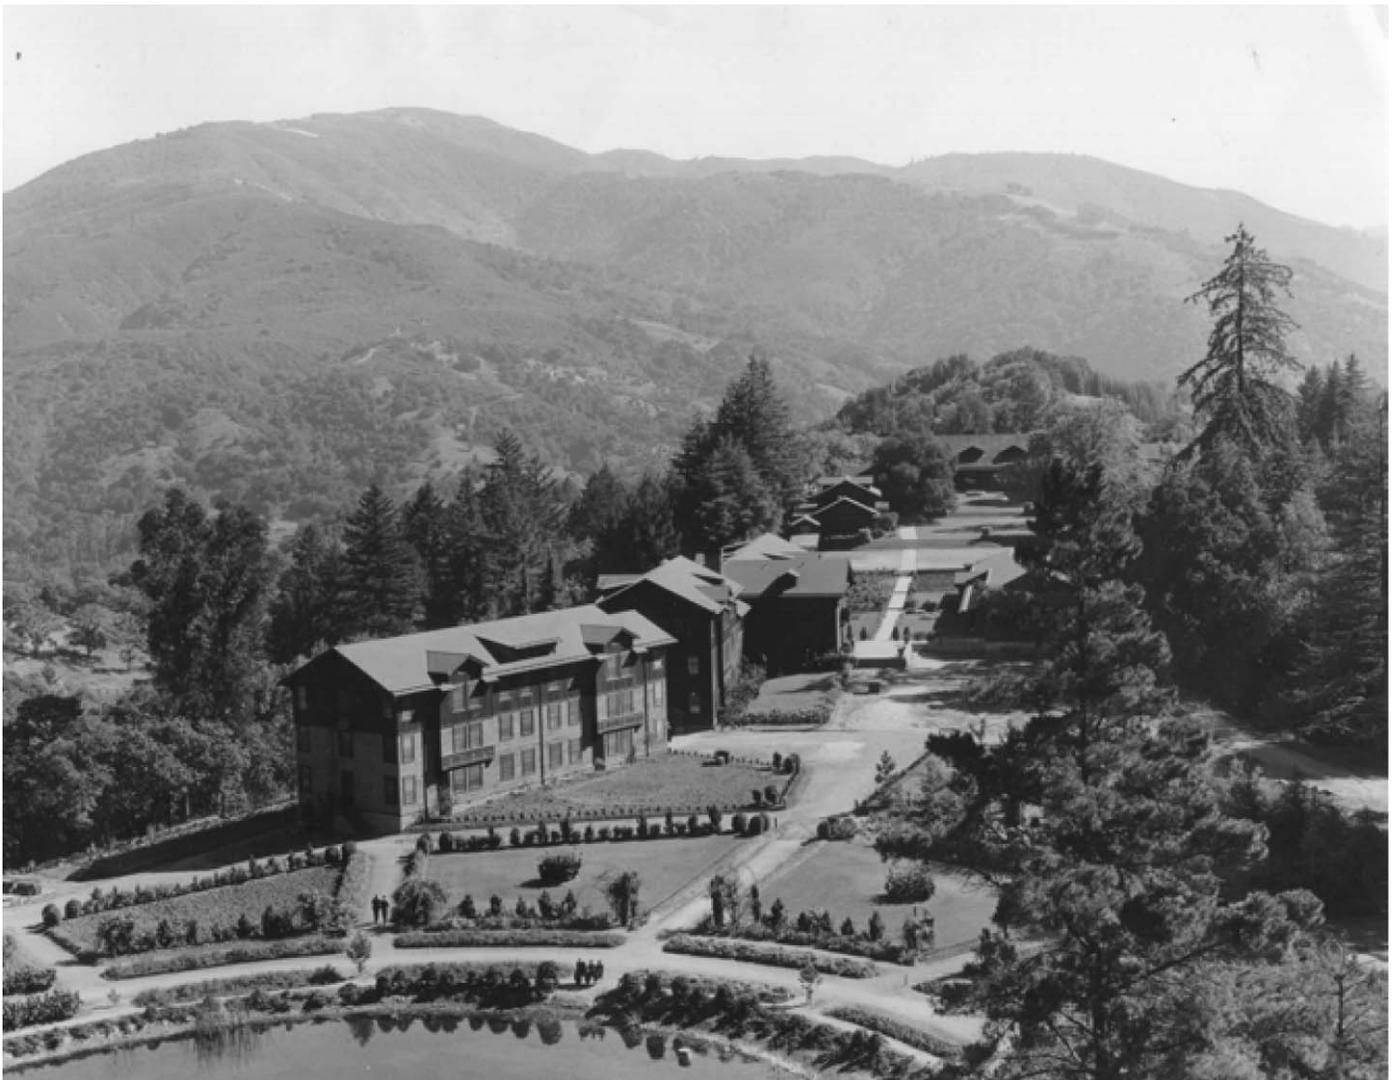
Figure 8: Jesuit-era Alma College Site before the 1950 Library was constructed

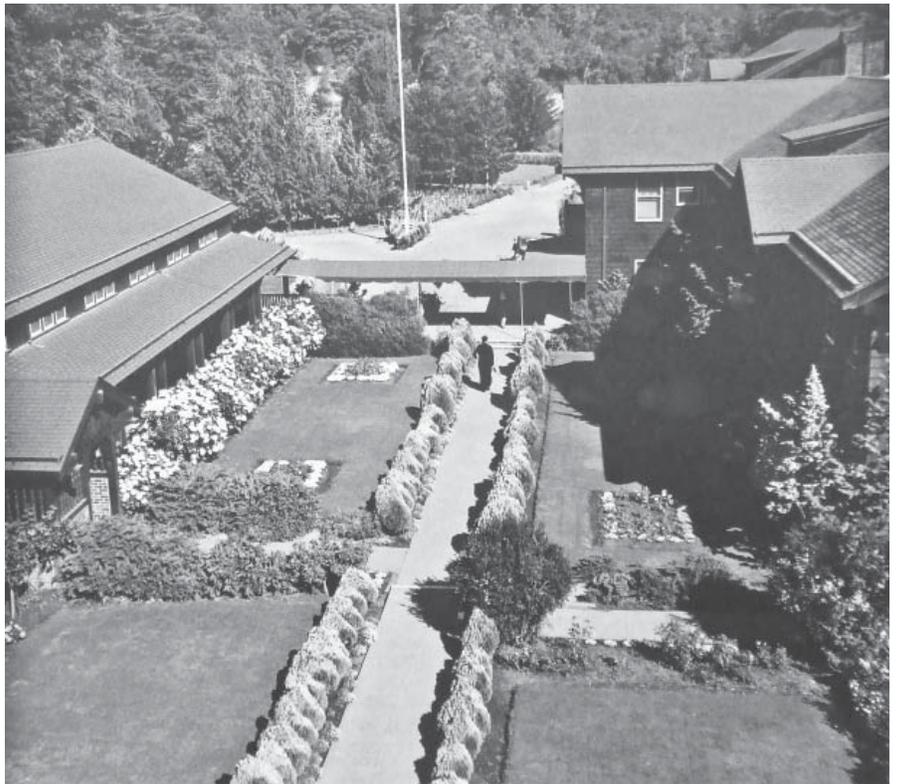
Figure 9: Jesuit Classroom (left) and dormitories (right) with gardens between

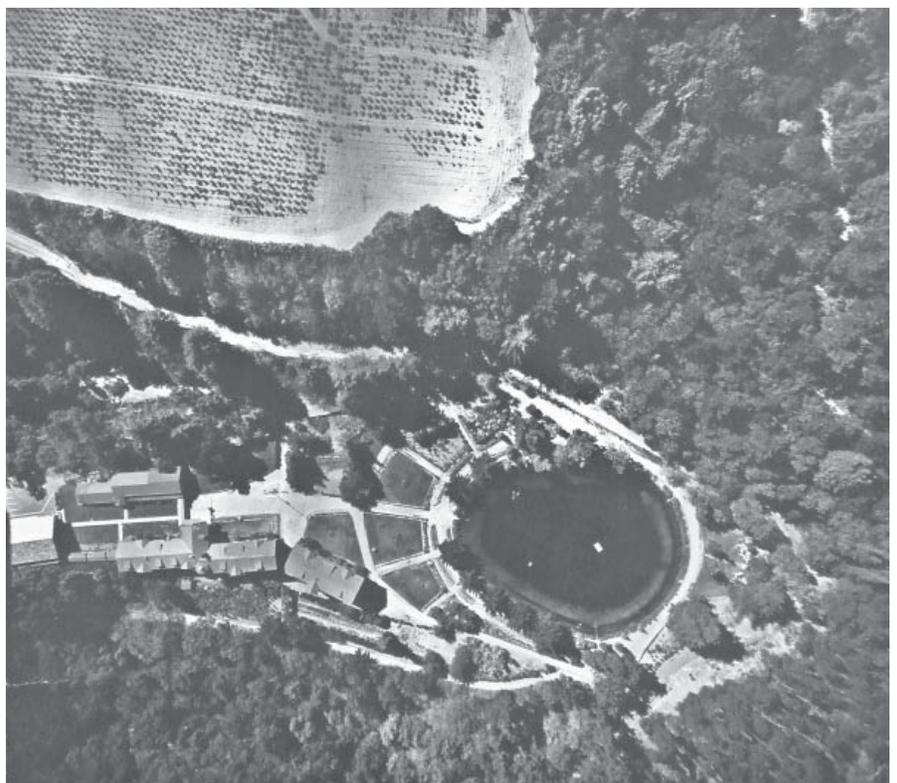
Figure 10: Upper lake and paths, gardens, and Jesuit-era buildings after 1950

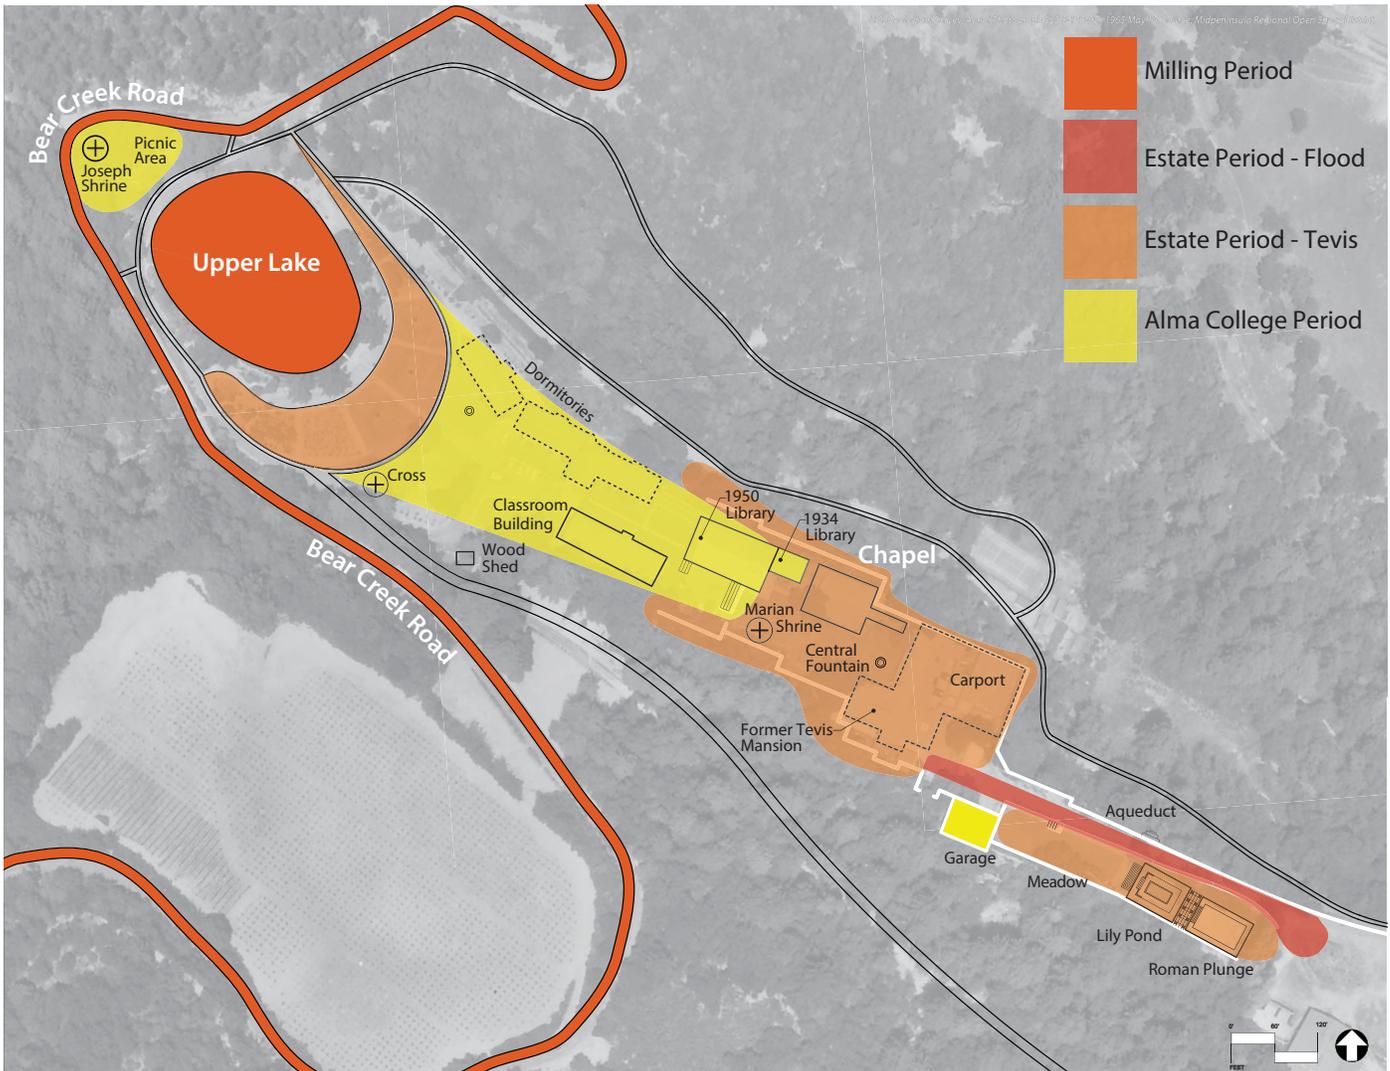
Figure 11: Accumulated periods plan overlaid on the existing Alma College Site Plan

In 1999, MROSD purchased the property. A master plan for Bear Creek Redwoods Preserve is underway. Figure 11 shows extant features and the periods from which they date.

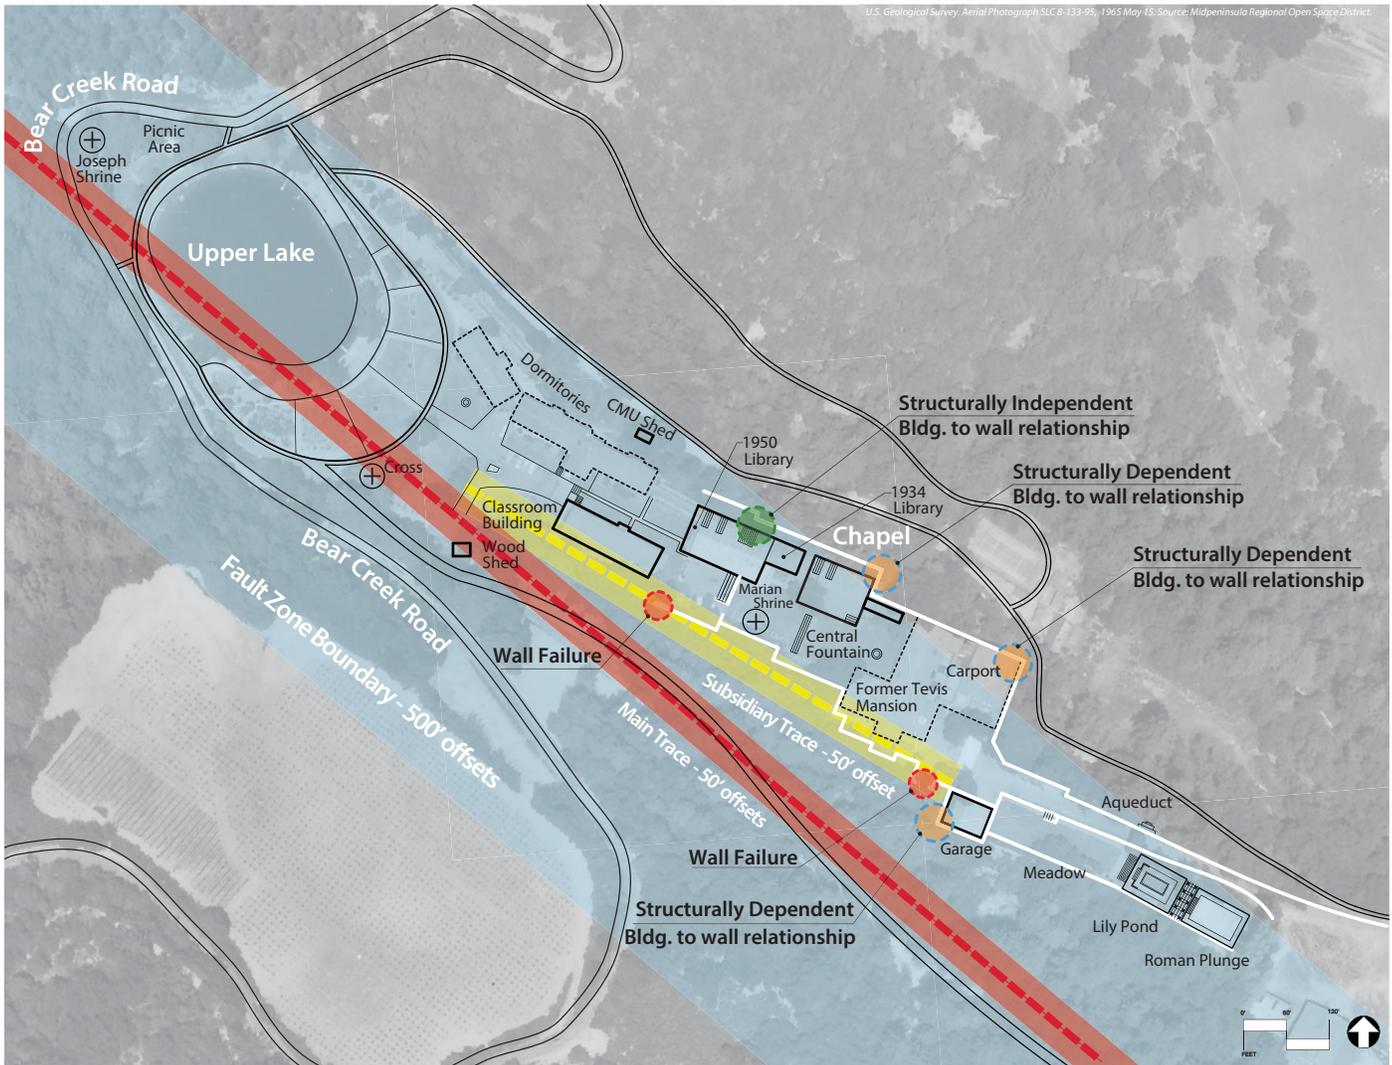
Figure 12: Alma College Site Site Analysis

There are two broad components that must be addressed when considering the project parameters. The first includes the physical site issues, as illustrated in the site analysis, Figure 12. The second relates to management and uses of the property. Together, these define what are sometimes referred to as “bookends,” in that they contain the full extent of the information and limitations at the site. Figures 13 through 20 illustrate existing conditions of the cultural landscape.

- In most places, there appears to be structural independence of the buildings from the retaining walls. However, as identified in Figure 12, possible loading of the retaining wall from the adjacent structure is likely at these three locations:

- The San Andreas fault runs through the south side of the Alma College ridge. Additionally, a subsidiary fault trace lies along the general alignment of the south retaining wall and other subsidiary traces may also underlie the site. As identified in Figure 12 from each side of both the fault and the trace, the Alquist Priolo Earthquake Fault Zone Act requires that a 50’ offset is measured. Within this zone, no new building can be built and extant buildings cannot be occupied by people unless further geotechnical study demonstrates it is safe.*

- A broader Fault Zone Boundary straddles the fault line with a required 500’ offset each side as shown in Figure 12. This zone has limitations that include occupying extant buildings no more than 2,000 hours per year (see Appendix A Geotechnical Analysis in for more information). A Fault Rupture Evaluation is required prior to humans occupying any building to demonstrate that there are no additional fault traces in the immediate vicinity, i.e. within 50 feet of the building.*

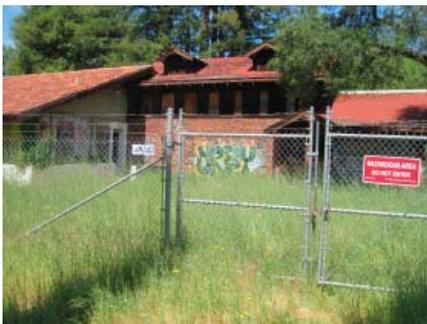
Figure 16: The brick and shingle 1934 Library with larger 1950 Library to the right

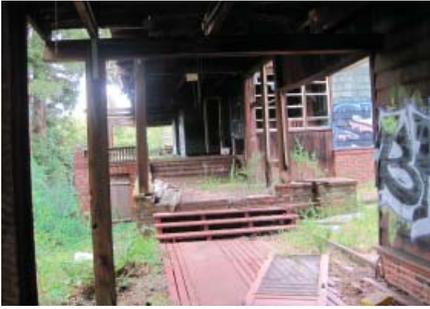
Figure 17: The walkway on the north side of the Chapel and 1934 and 1950 libraries

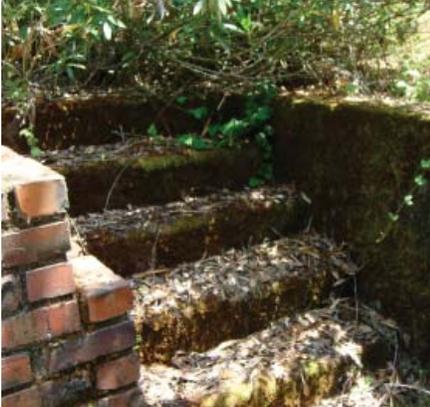
Figure 19: Brick steps leading to the meadow

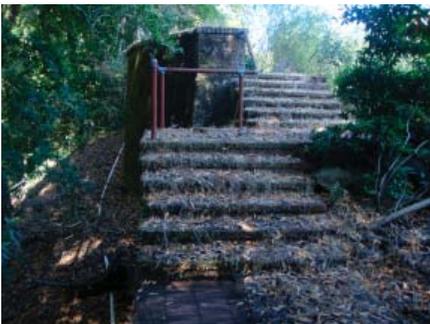
Figure 20: Brick and till steps at the lily pond and Roman plunge

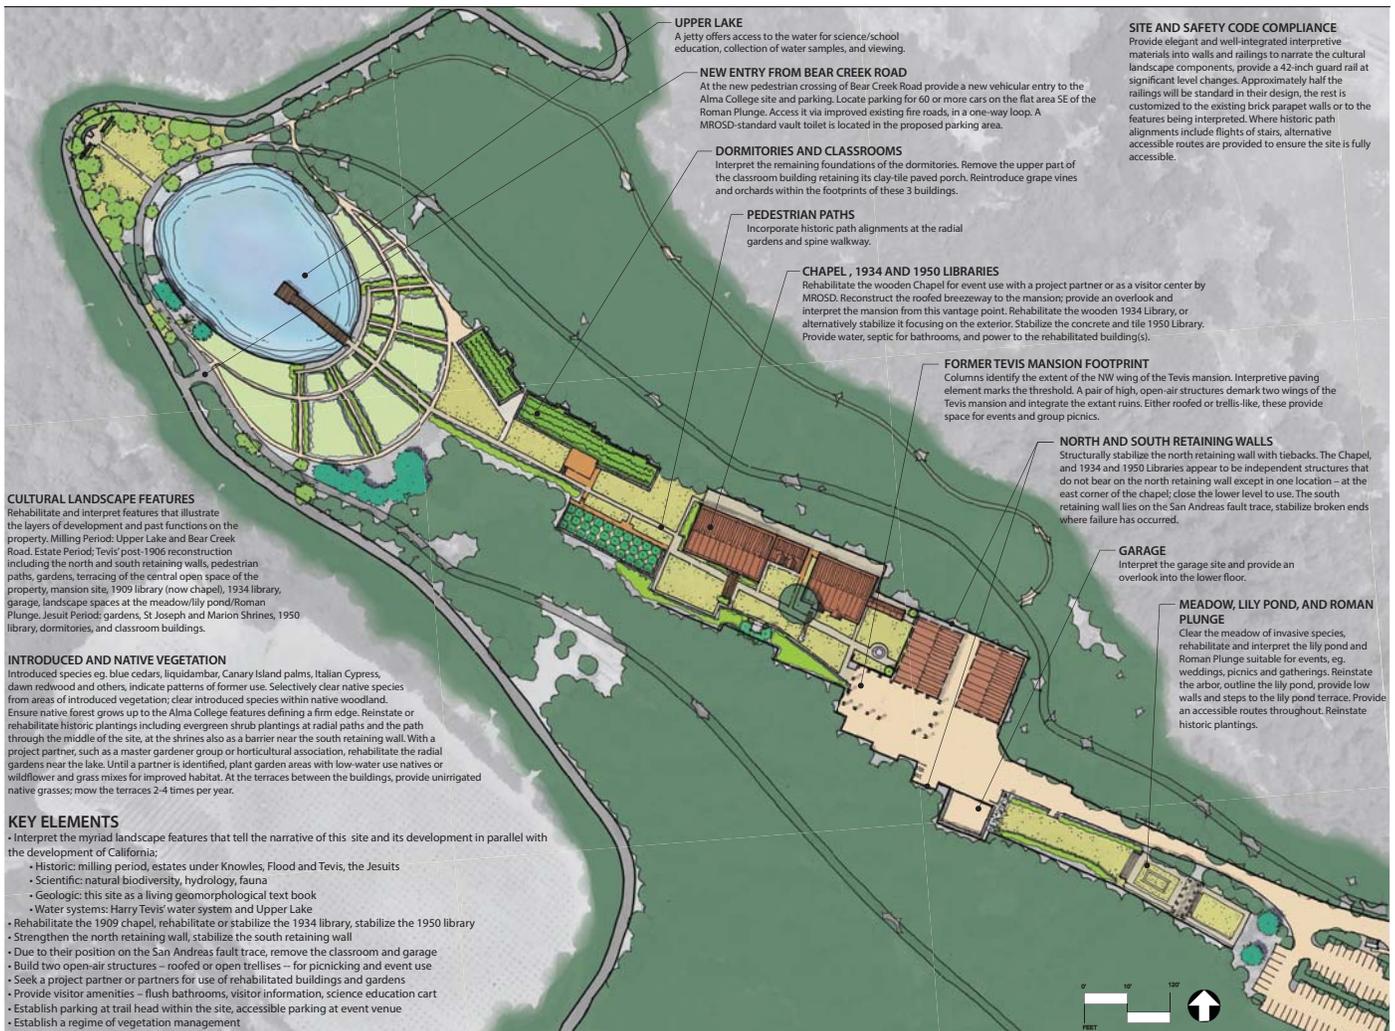
Figure 21: Alma College Site Draft Rehabilitation Plan - Scheme A

(See Figures 21 to 23)

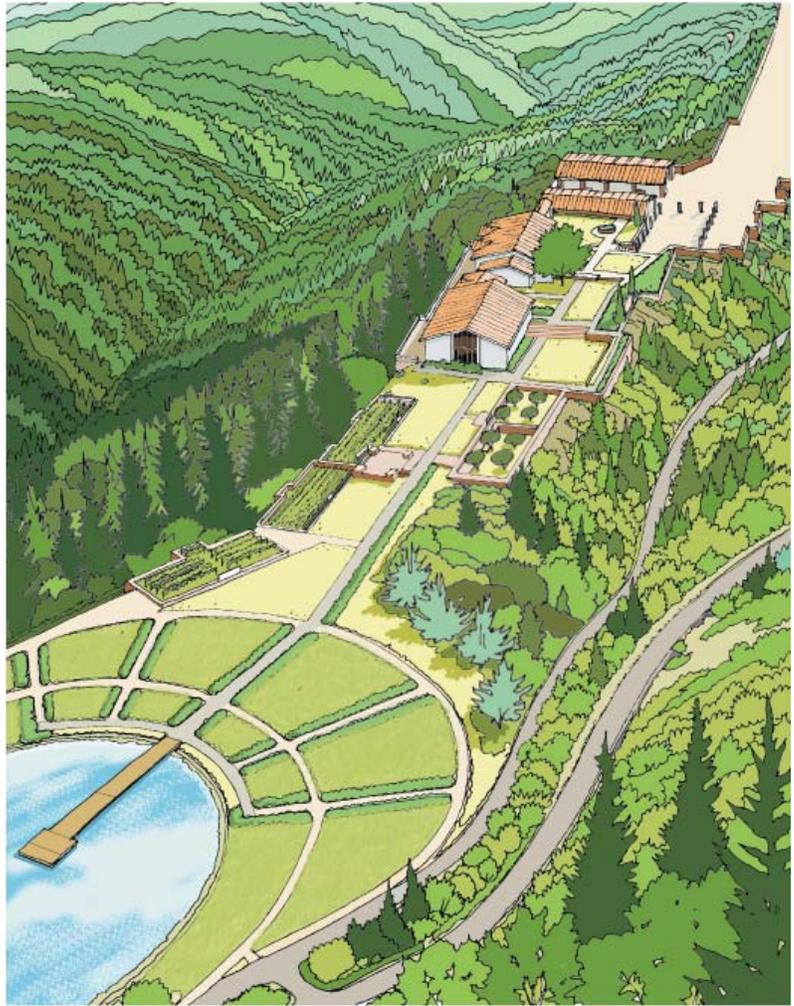
Figure 22: Aerial view of Scheme A

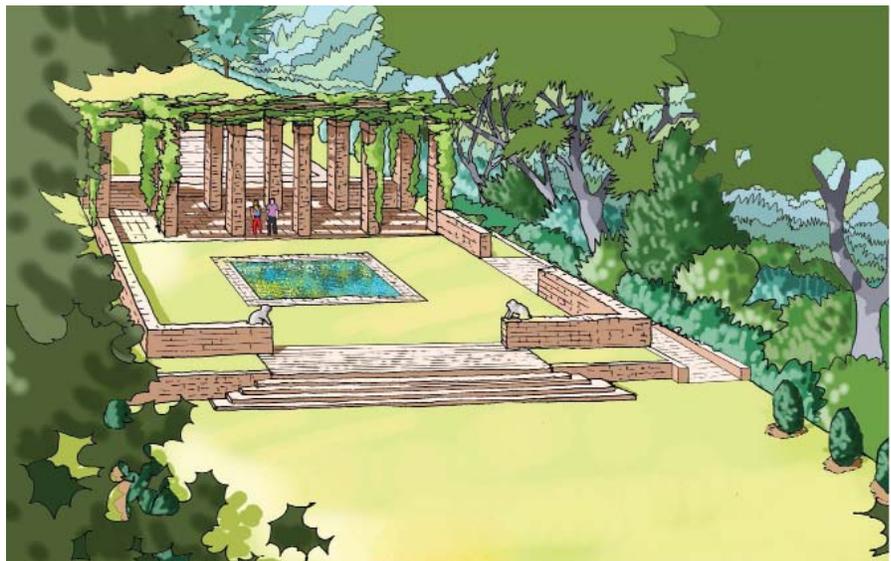
Figure 23: Rehabilitation of the meadow, lily pond, and Roman plunge shown in Scheme A

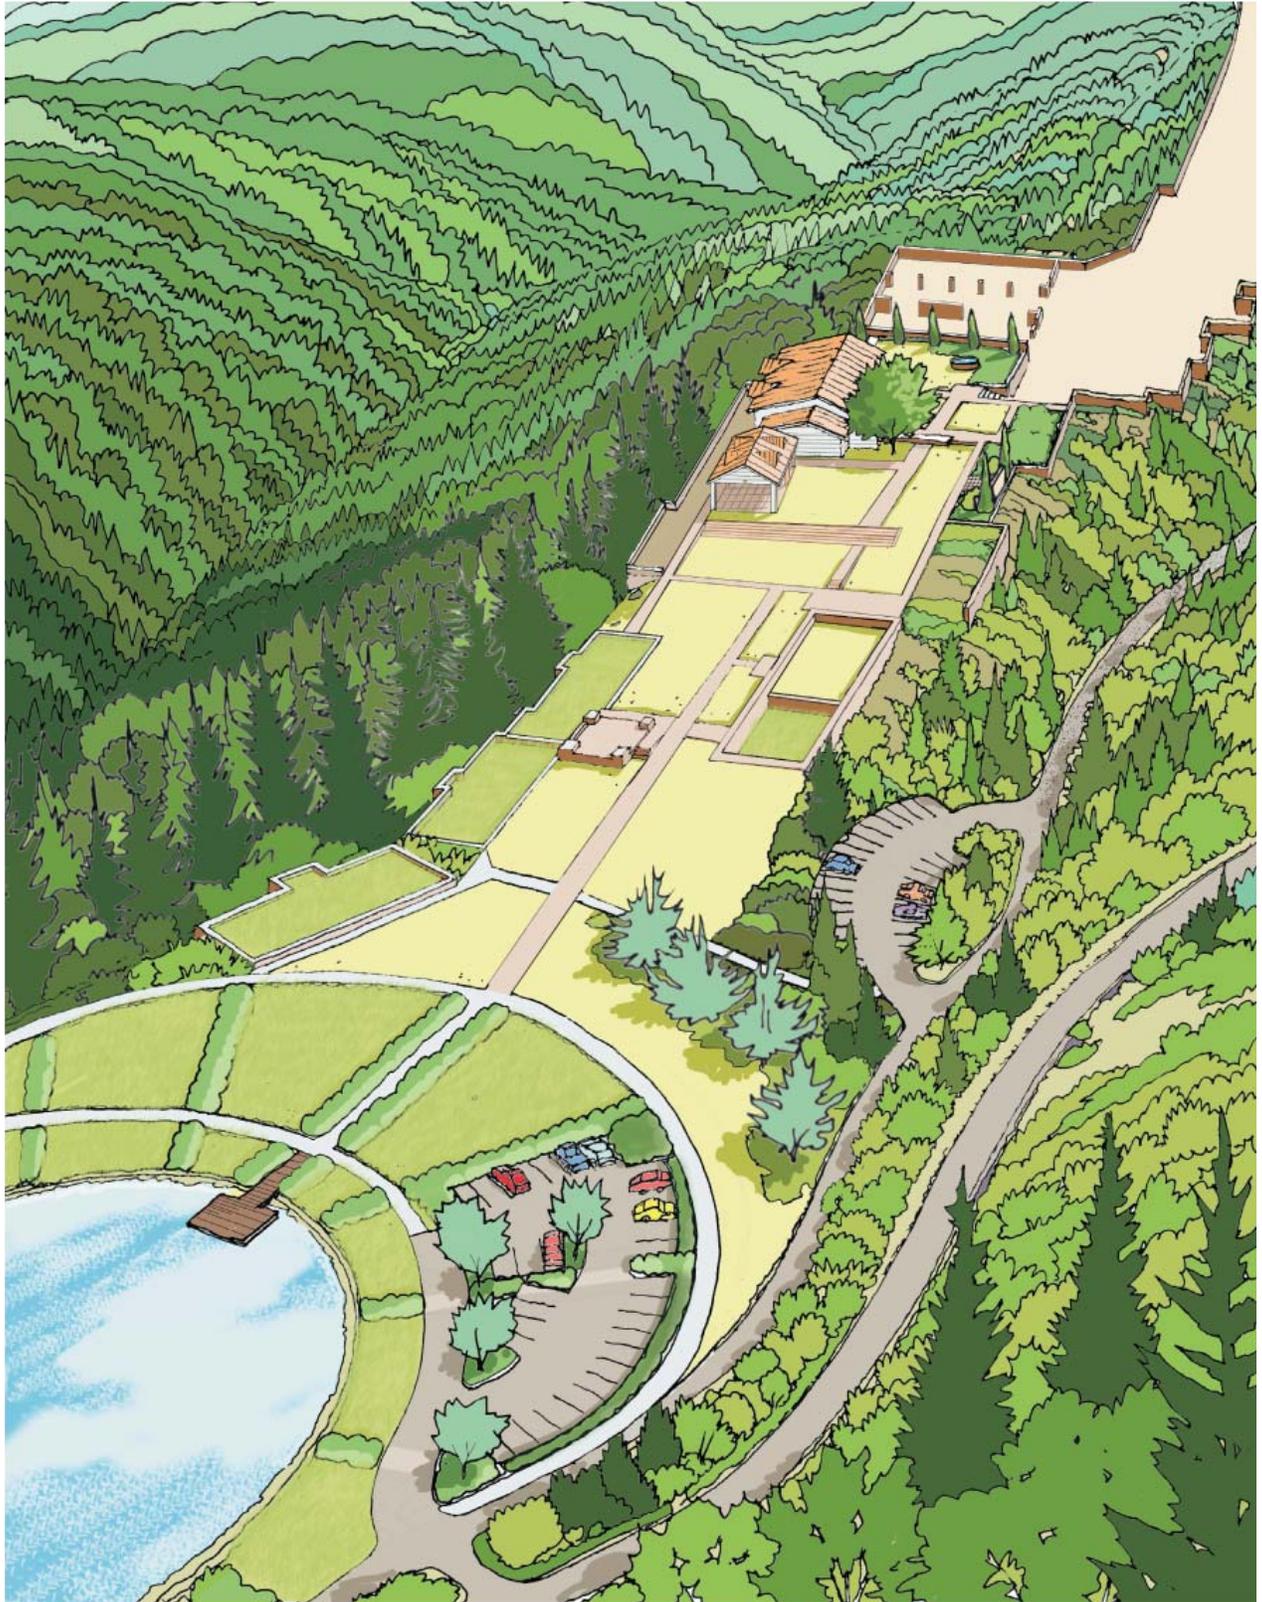
Figure 25: Aerial view of Alma College Site Rehabilitation Plan

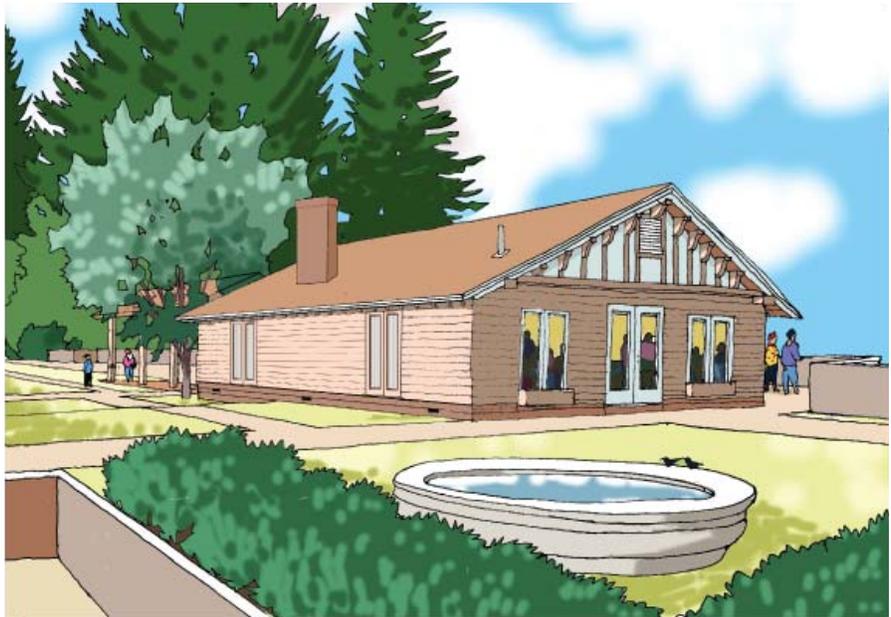
Figure 26: Rehabilitated Chapel / Tevis Library shown in Alma College Site Rehabilitation Plan

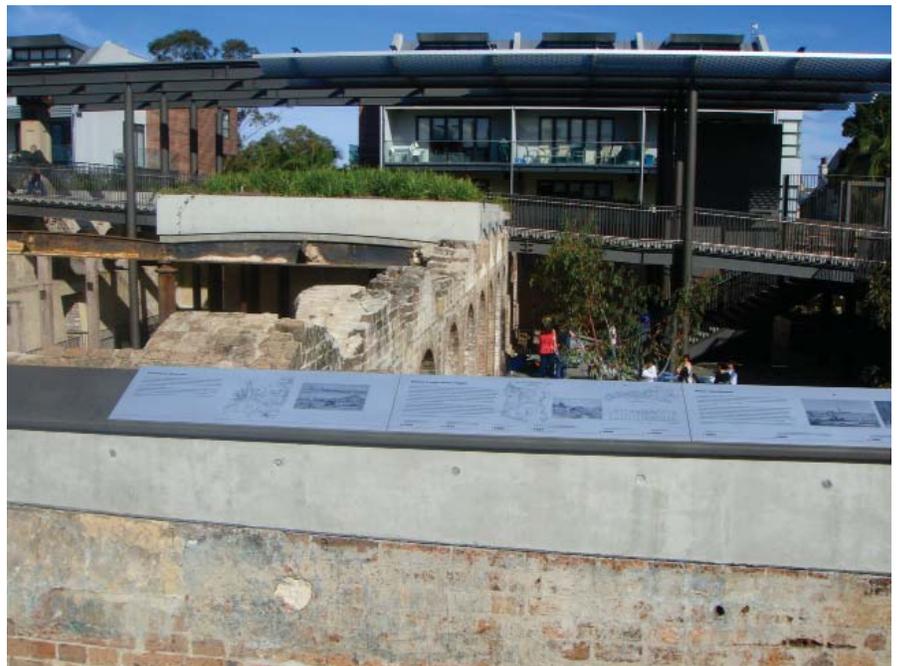
Figure 27: Example of interpretive panels mounted on a historic wall and providing a barrier at a significant level change

there are significant level changes at building foundations (as seen in Figure 27.) The threshold and footprint of the mansion may be marked in the paving to identify its location, while perimeter walls marking wings of the building may serve double duty, offering informal seating areas.

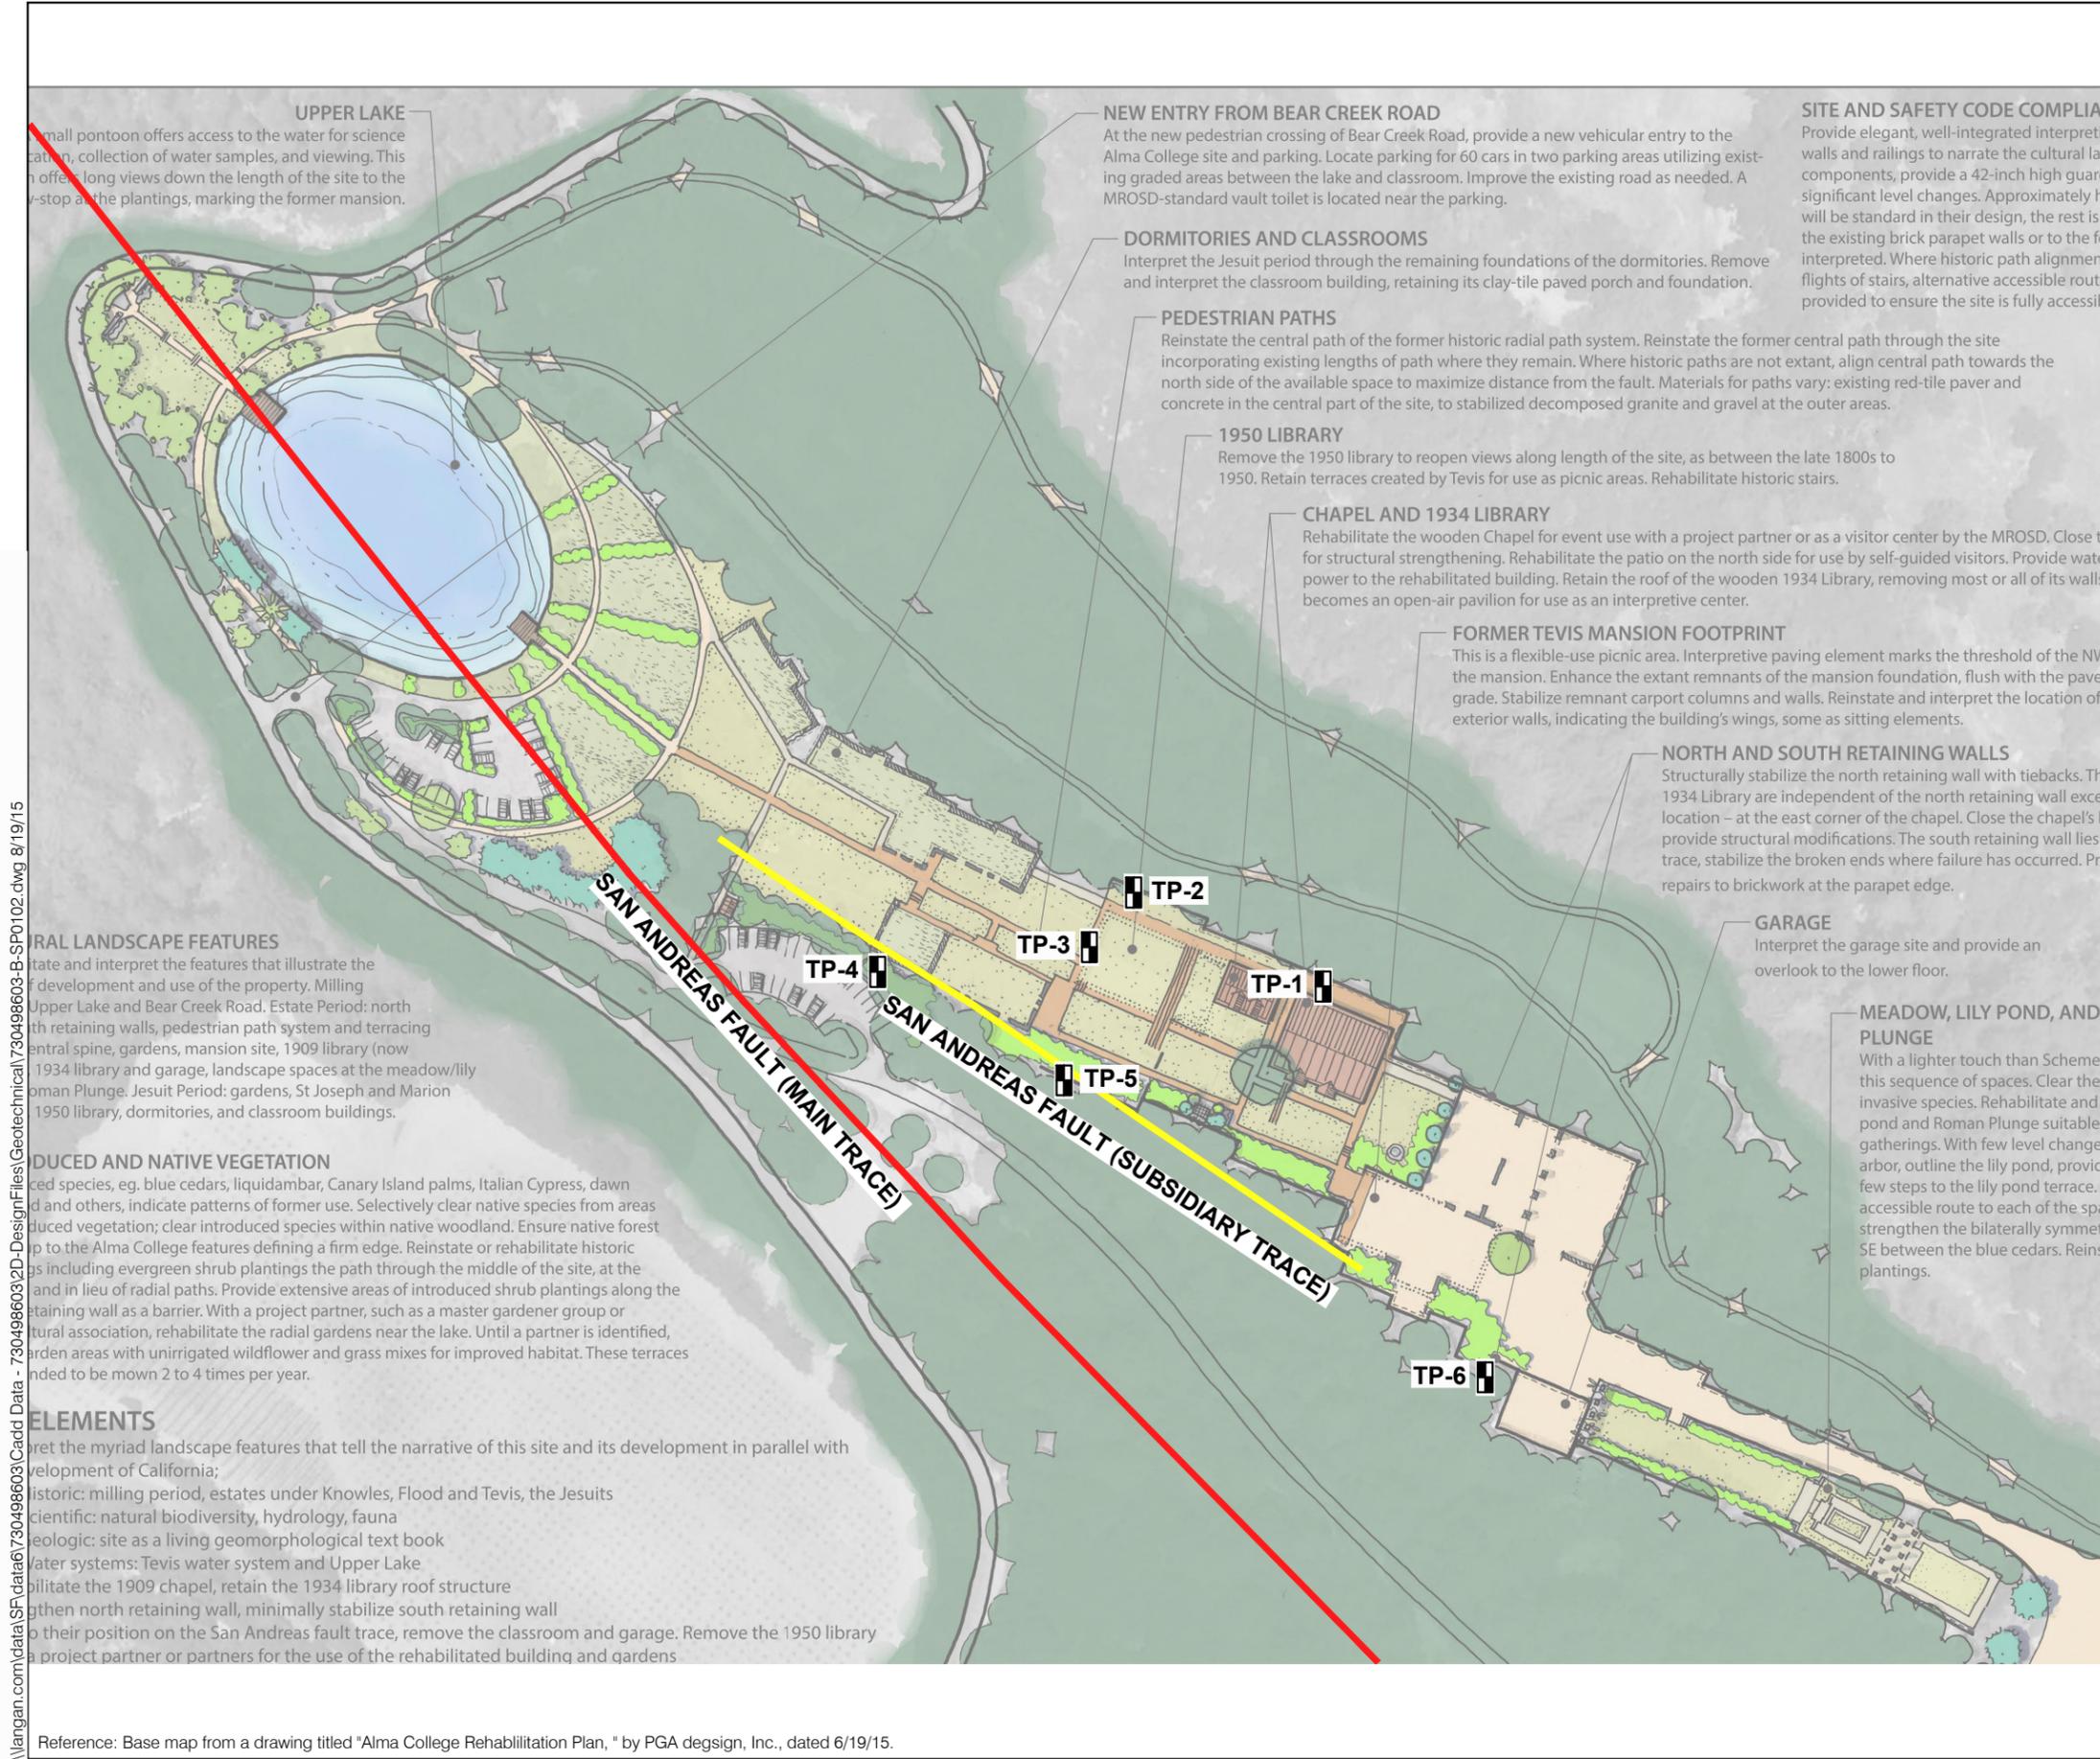
Date 08/18/15 | Project No. 730498603 | Figure 2

UPPER LAKE
A small pontoon offers access to the water for science collection, collection of water samples, and viewing. This offers long views down the length of the site to the west stop at the plantings, marking the former mansion.

NEW ENTRY FROM BEAR CREEK ROAD
At the new pedestrian crossing of Bear Creek Road, provide a new vehicular entry to the Alma College site and parking. Locate parking for 60 cars in two parking areas utilizing existing graded areas between the lake and classroom. Improve the existing road as needed. A MROSD-standard vault toilet is located near the parking.

In 2009, T&R excavated and logged six test pits, designated TP-1 through TP-6. The approximate locations of T&R's test pits are shown on Figure 2. One test pit was excavated at each of the three main structures to evaluate the foundation of each structure, and three test pits were excavated adjacent to site retaining walls to expose the bottom of the foundation for the walls. Logs of the test pits are presented in Appendix A.

The classroom building is a one- and two-story, wood-framed structure constructed in 1935. The structure is supported on a brick and concrete foundation and is at the western end of the ridge, as shown on Figure 2. Test pit TP-4 was excavated adjacent to the foundation on the southwest side of the building. Based on observations in the test pit, it appears that the structure is founded on a continuous, concrete, perimeter spread footing embedded 18 inches below the ground surface, gaining support in the underlying sandstone bedrock (see Figure A-4).

Geologic maps by the California Geological Survey (CGS) and the USGS indicate that traces of the active San Andreas Fault cross the site and large portions of the property area are within an Alquist-Priolo Special Studies fault rupture hazard zone. The main trace of the San Andreas fault is located between about 100 and 260 feet southwest of the subject buildings, as shown on Figure 2. A subsidiary fault trace identified in the JCA report is located about 45 feet from the two library buildings and crosses beneath the southwestern side of the classroom building as shown on Figure 2.

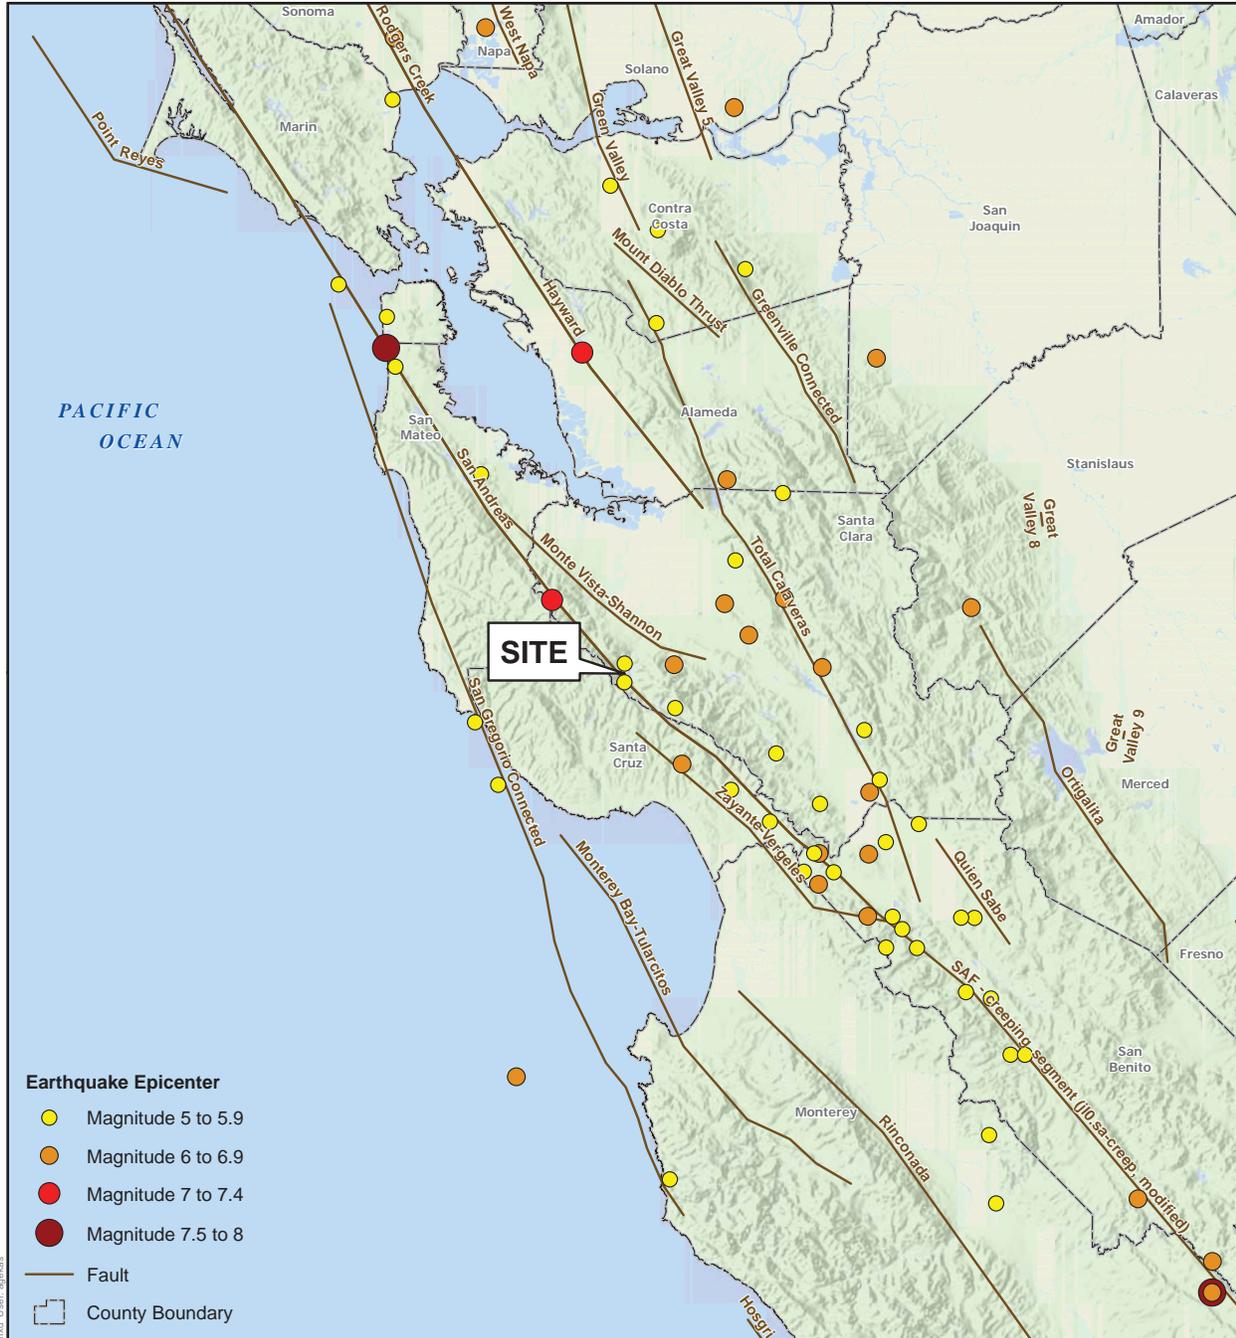
<p>ALMA COLLEGE SITE REHABILITATION PLAN Santa Clara County, California</p>	<p>MAP OF MAJOR FAULTS AND EARTHQUAKE EPICENTERS IN THE SAN FRANCISCO BAY AREA</p>		
<p>LANGAN TREADWELL ROLLO</p>	<p>Date 8/19/2015</p>	<p>Project No. 730498603</p>	<p>Figure 4</p>

The greater San Francisco Bay Area is recognized by geologists and seismologists as one of the most active seismic regions in the United States. The three major faults that pass through the Bay Area in a northwest direction have produced approximately 12 earthquakes per century strong enough to cause structural damage. The faults causing such earthquakes are part of the San Andreas fault system, a major rift in the earth's crust that extends for at least 700 miles along the California Coast, which includes the San Andreas, Hayward, and Calaveras fault zones. These and other faults of the region are shown on Figure 4. For each of the active faults

Figure 4 also shows the earthquake epicenters for events with magnitude greater than 5.0 from January 1800 through August 2014. Since 1800, four major earthquakes have been recorded on the San Andreas Fault. In 1836, an earthquake with an estimated maximum intensity of VII on the Modified Mercalli (MM) scale (Figure 5) occurred east of Monterey Bay on the San Andreas Fault (Topozada and Borchardt 1998). The estimated Moment magnitude, M_w , for this earthquake is about 6.25. In 1838, an earthquake occurred with an estimated intensity of about VIII-IX (MM), corresponding to an M_w of about 7.5. The San Francisco Earthquake of 1906 caused the most significant damage in the history of the Bay Area in terms of loss of lives and property damage. This earthquake created a surface rupture along the San Andreas Fault from Shelter Cove to San Juan Bautista approximately 430 kilometers in length. It had a maximum intensity of XI (MM), a M_w of about 7.9, and was felt 560 kilometers away in Oregon, Nevada, and Los Angeles. The most recent earthquake to affect the Bay Area was the Loma Prieta Earthquake of 17 October 1989 with an M_w of 6.9. The epicenter of the earthquake was in the Santa Cruz Mountains approximately 19 km from the site.

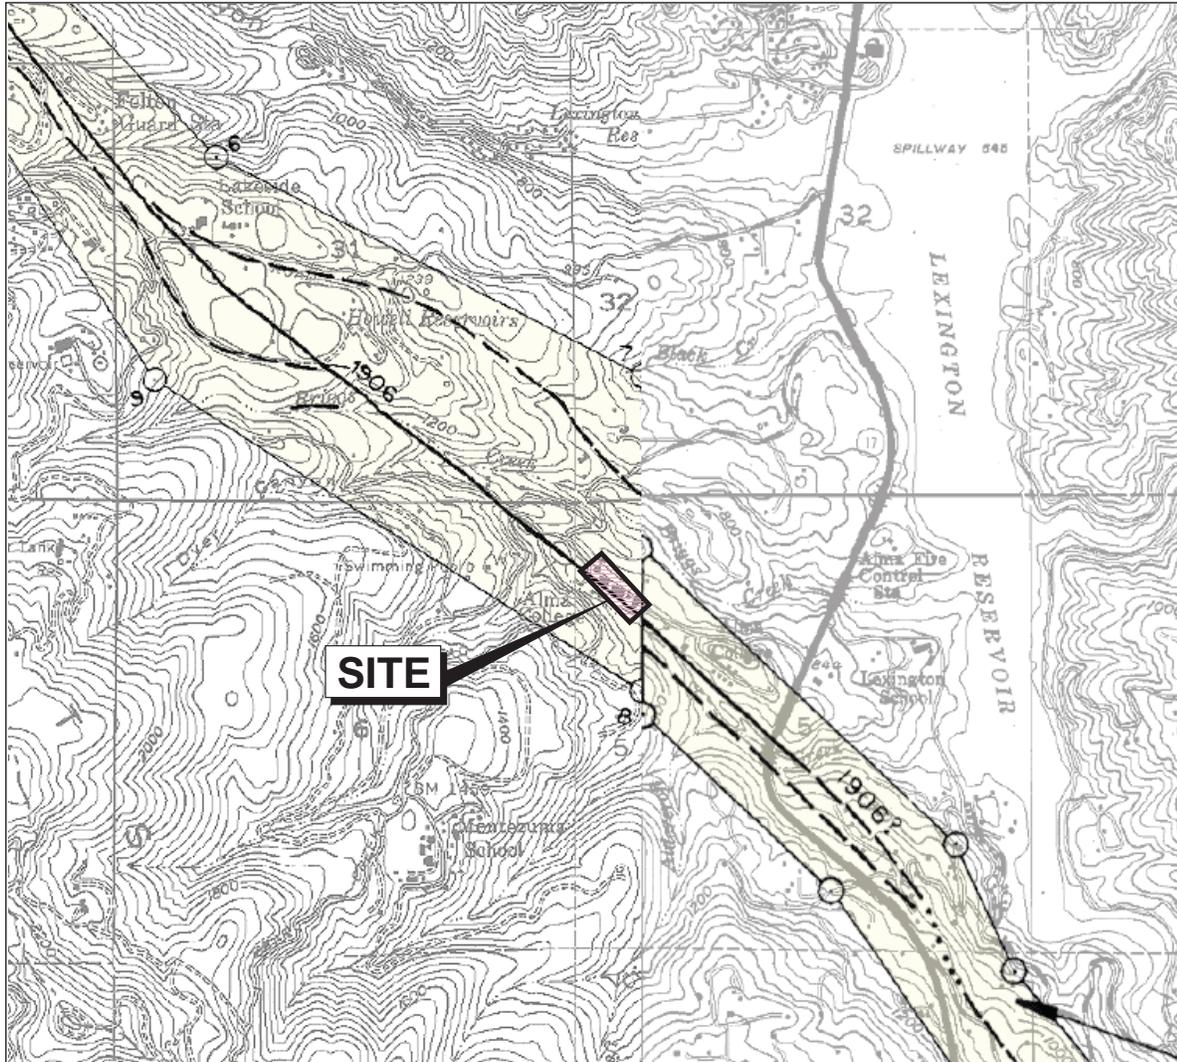
Date 08/18/15 | Project No. 730498603 | Figure 6

Potentially Active Faults
