Midpeninsula Regional
Open Space District

Alma College Site Cultural Landscape Rehabilitation Plan

Report for Landscape
Architecture Services

March 24, 2017

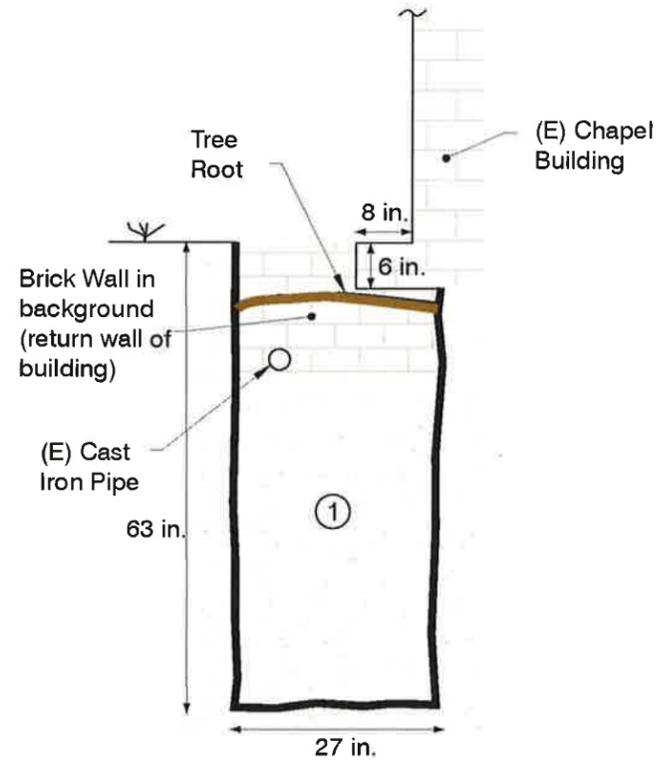
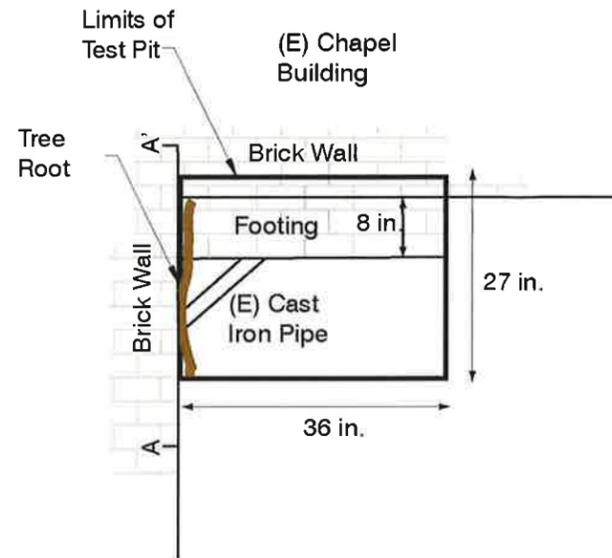
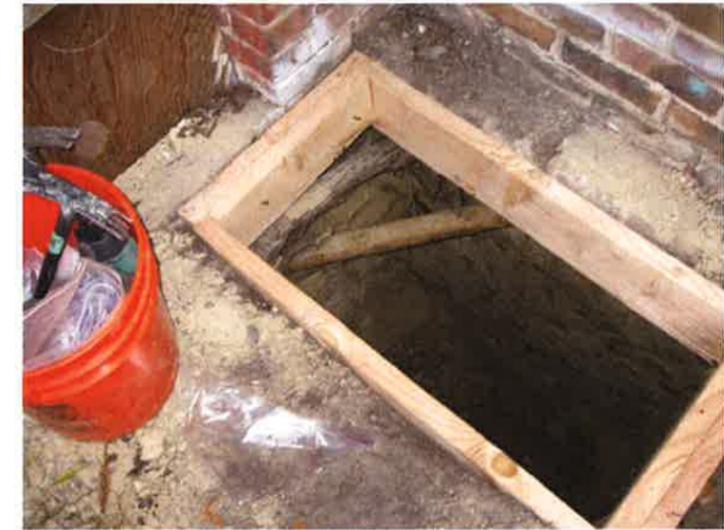
Date 08/19/09 | Project No. 4986.01 | Figure 3

SECTION A-A'

- ① SANDSTONE
yellowish brown (10YR 5/6) and
grayish brown (10YR 5/2),
homogeneous, dense, friable,
well-sorted, fine- to very fine-
grained, subrounded, slightly
moist
[BEDROCK]

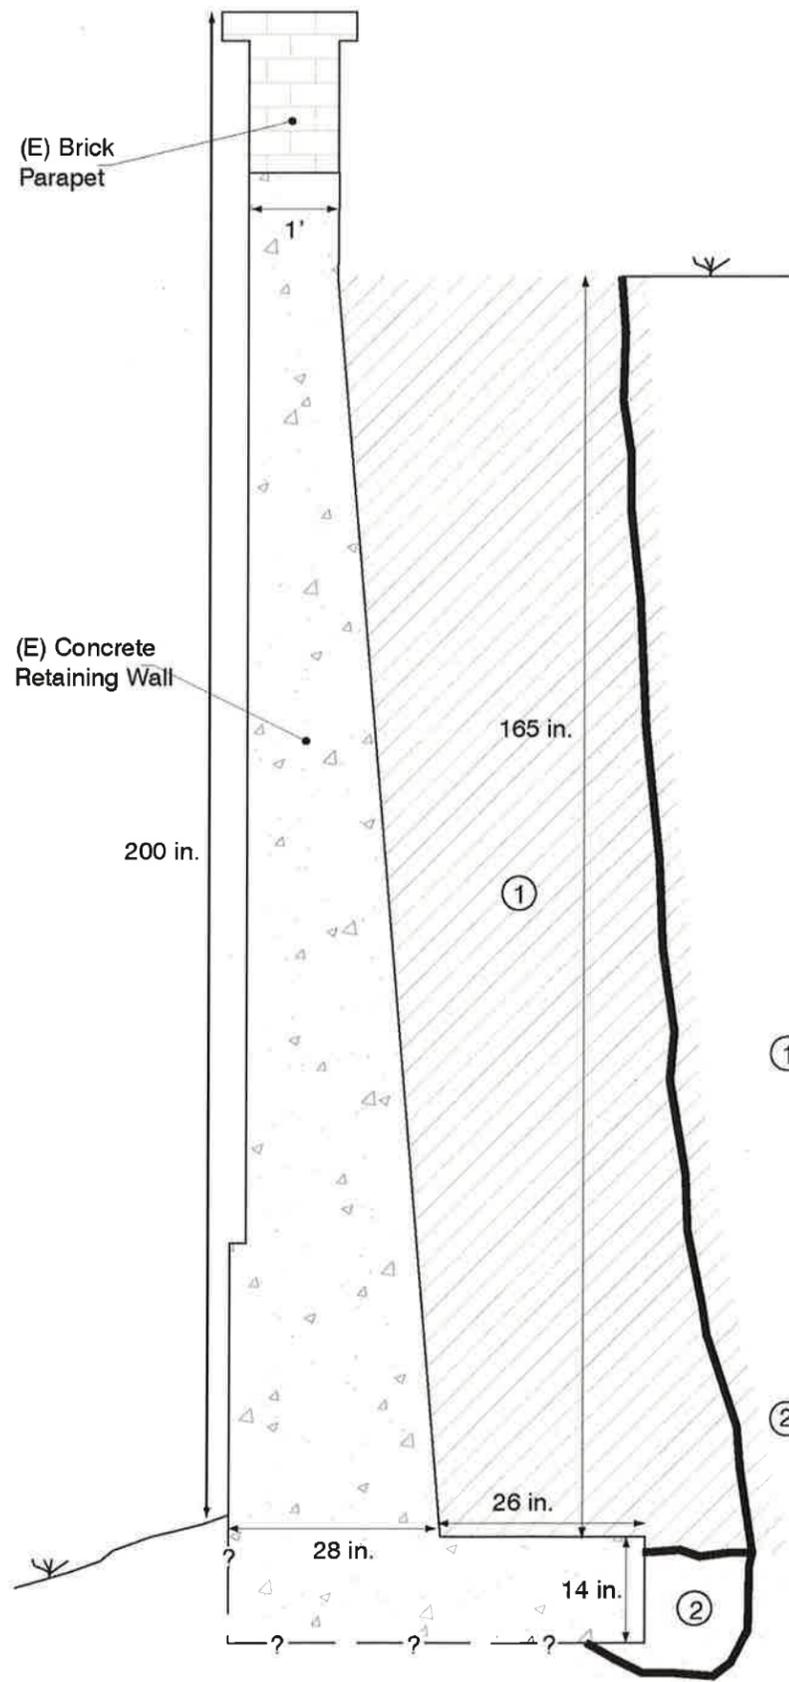
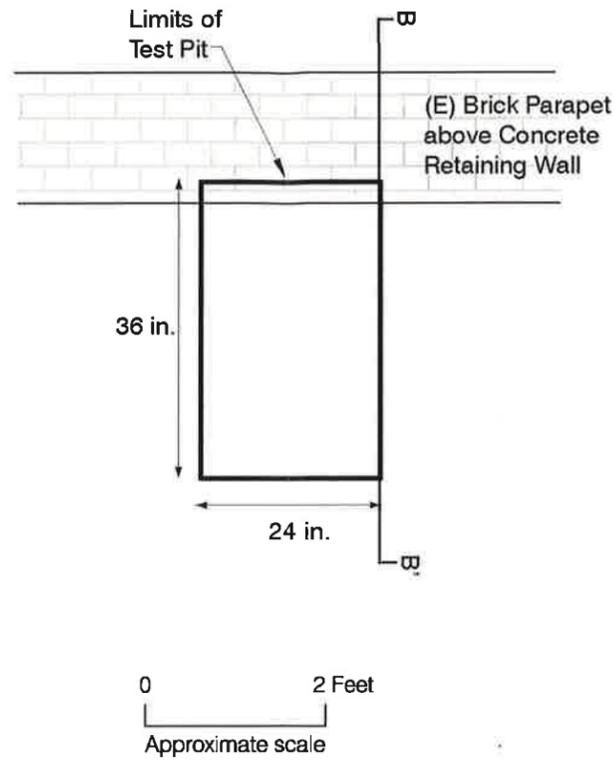
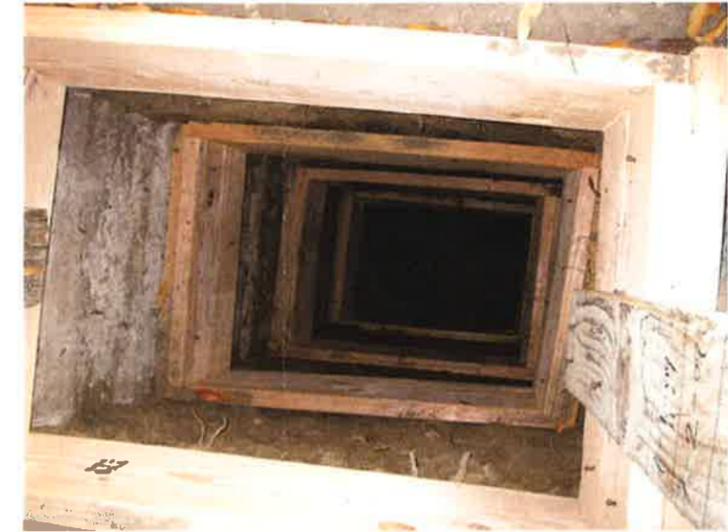
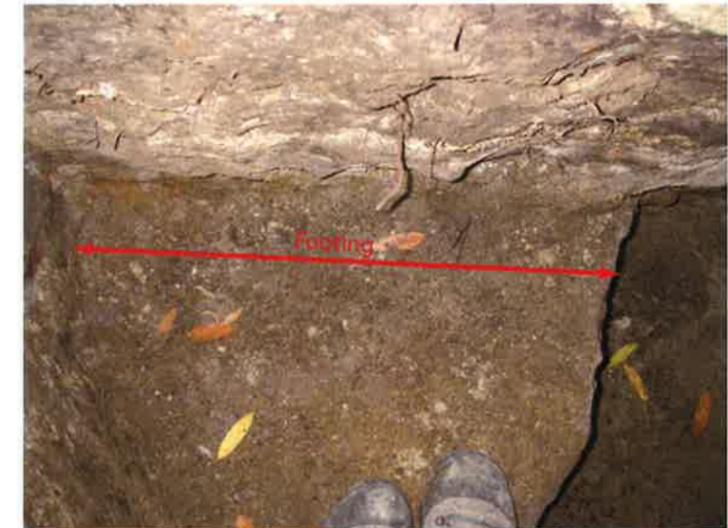
Date 08/19/09 | Project No. 4986.01 | Figure 4

SECTION B-B'

- ① SANDY CLAY (CL)
brown (10YR 4/3) to dark brown (10YR 3/3), stiff, slightly moist, low to moderately plastic, heterogeneous with brick, concrete, and glass fragments scattered throughout, 10-20% fine- to medium-grained sand and 5-10% gravel [RETAINING WALL BACKFILL]
- ② SANDSTONE
yellowish brown (10YR 5/6) and grayish brown (10YR 5/2), homogeneous, dense, friable, well-sorted, fine- to very fine-grained, subrounded, slightly moist [BEDROCK]

The classroom building is a one- and two-story, wood-framed structure constructed in 1935. The structure is supported on a brick and concrete foundation and is at the western end of the ridge, as shown on Figure 2. Test pit TP-4 was excavated adjacent to the foundation on the southwest side of the building. Based on observations in the test pit, it appears that the structure is founded on a continuous, concrete, perimeter spread footing embedded 18 inches below the ground surface, gaining support in the underlying sandstone bedrock (see Figure A-4).

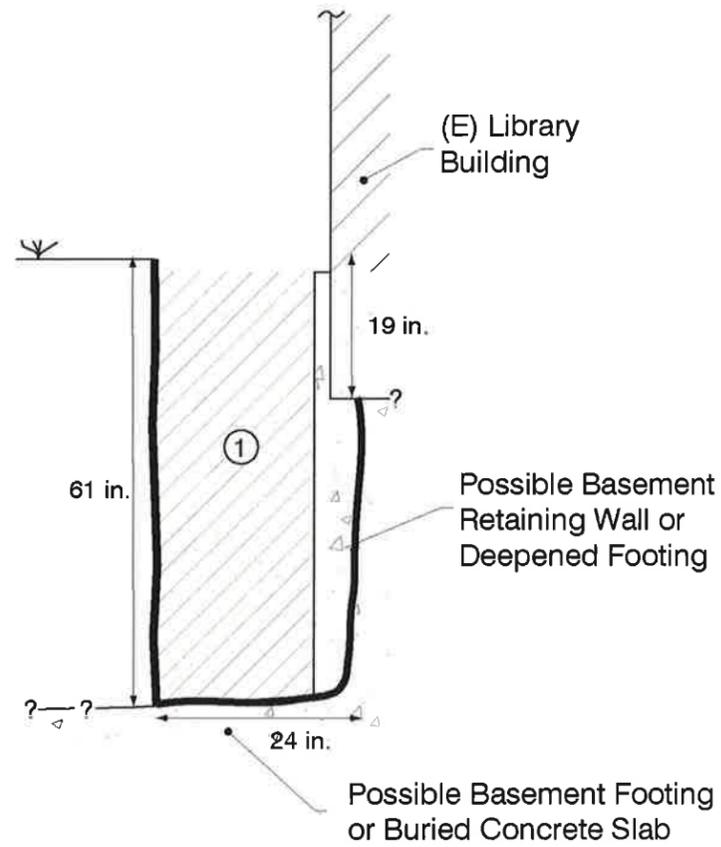
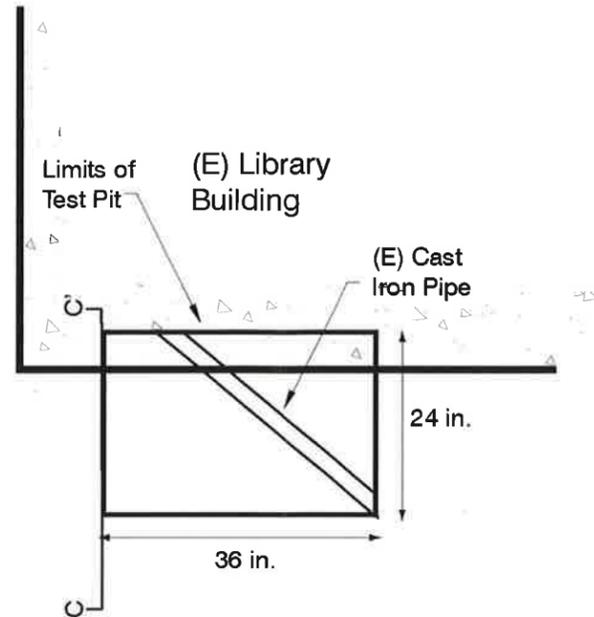
SECTION C-C'

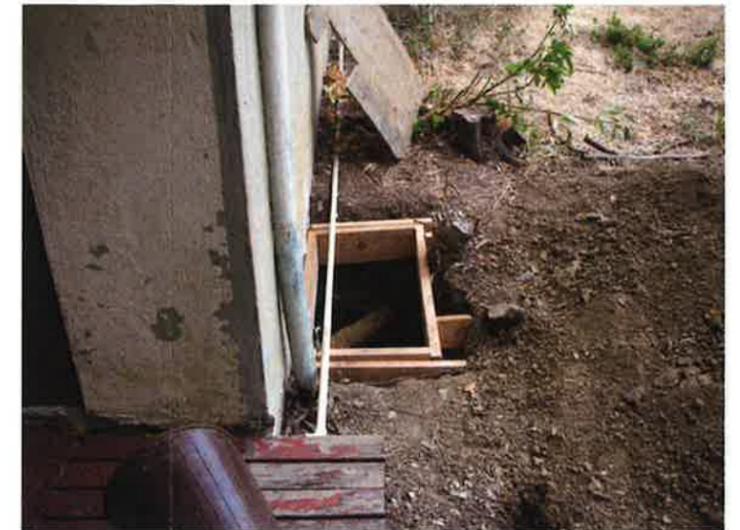
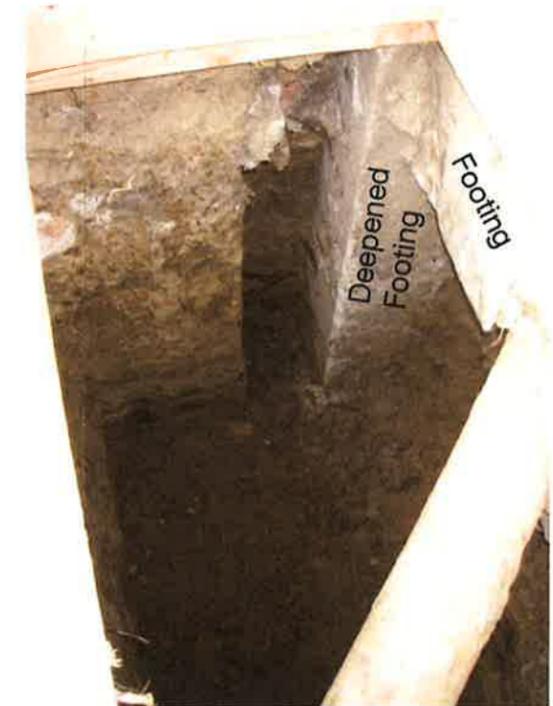
PHOTOS

- ① SILTY SAND (SM) to CLAYEY SAND (SC) very dark grayish brown (10YR 3/2) with variegated colored sand and rock fragments, medium dense, poorly sorted, very fine- to coarse-grained, scattered brick and concrete fragments, moist, low plasticity, abundant roots and rootlets
[FILL]

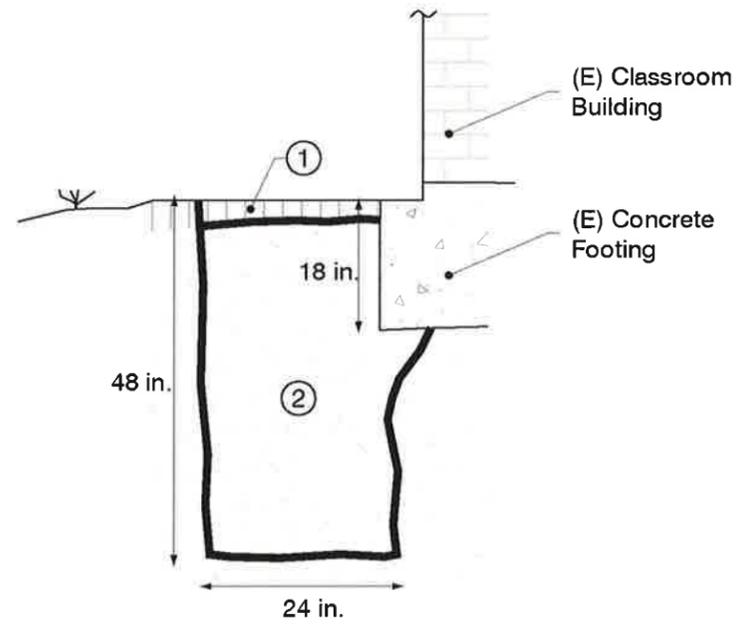
SECTION D-D'

- ① SANDY SILT (ML)
dark grayish brown (10YR 4/2),
stiff, homogeneous, dry, poorly
sorted, fine- to coarse grained,
dry, abundant roots and organics
[TOPSOIL]
- ② SANDSTONE
yellowish brown (10YR 5/6) to
grayish brown (10YR 5/2),
very dense, homogeneous, well-
sorted, very fine- to fine-grained,
subrounded to subangular,
slightly moist
[BEDROCK]

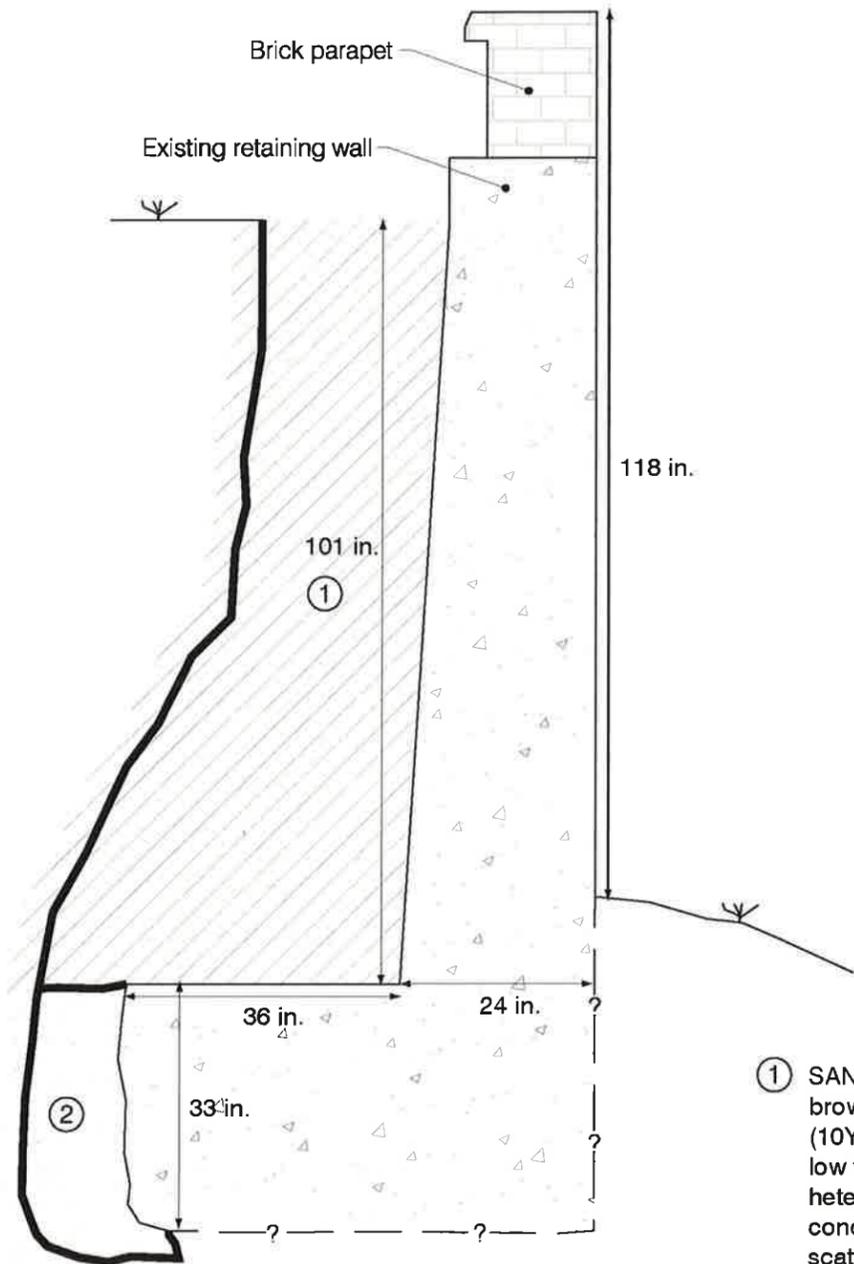
SECTION E-E'

- ① SANDY CLAY (CL)
brown (10YR 4/3) to dark brown (10YR 3/3), stiff, slightly moist, low to moderately plastic, heterogeneous with brick, concrete, and glass fragments scattered throughout, 10-20% fine- to medium-grained sand and 5-10% gravel [RETAINING WALL BACKFILL]
- ② SANDSTONE
yellowish brown (10YR 5/6) and grayish brown (10YR 5/2), homogeneous, dense, friable, well-sorted, fine- to very fine-grained, subrounded, slightly moist [BEDROCK]

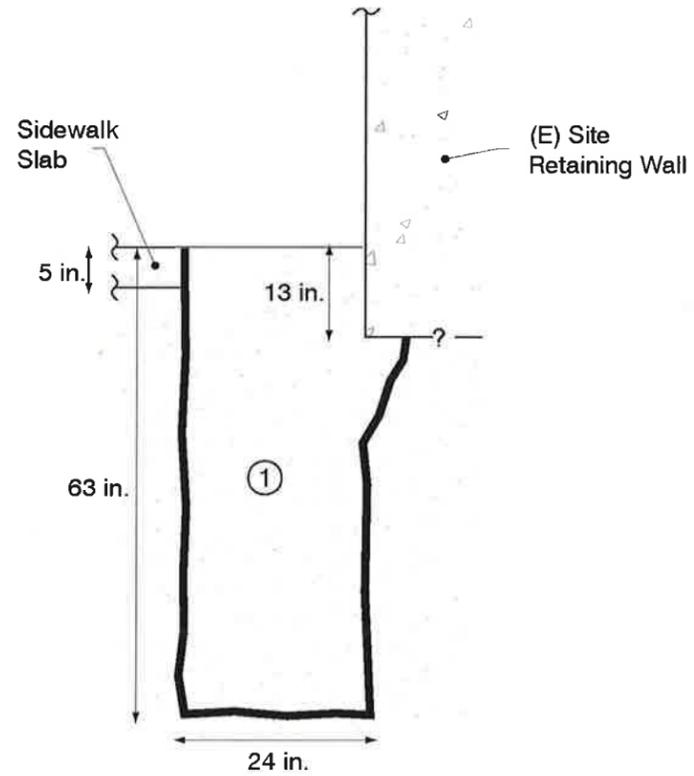
SECTION F-F'

- ① SANDSTONE
yellowish brown (10YR 5/6) and
grayish brown (10YR 5/2),
homogeneous, dense, friable,
well-sorted, fine- to very fine-
grained, subrounded, slightly
moist
[BEDROCK]

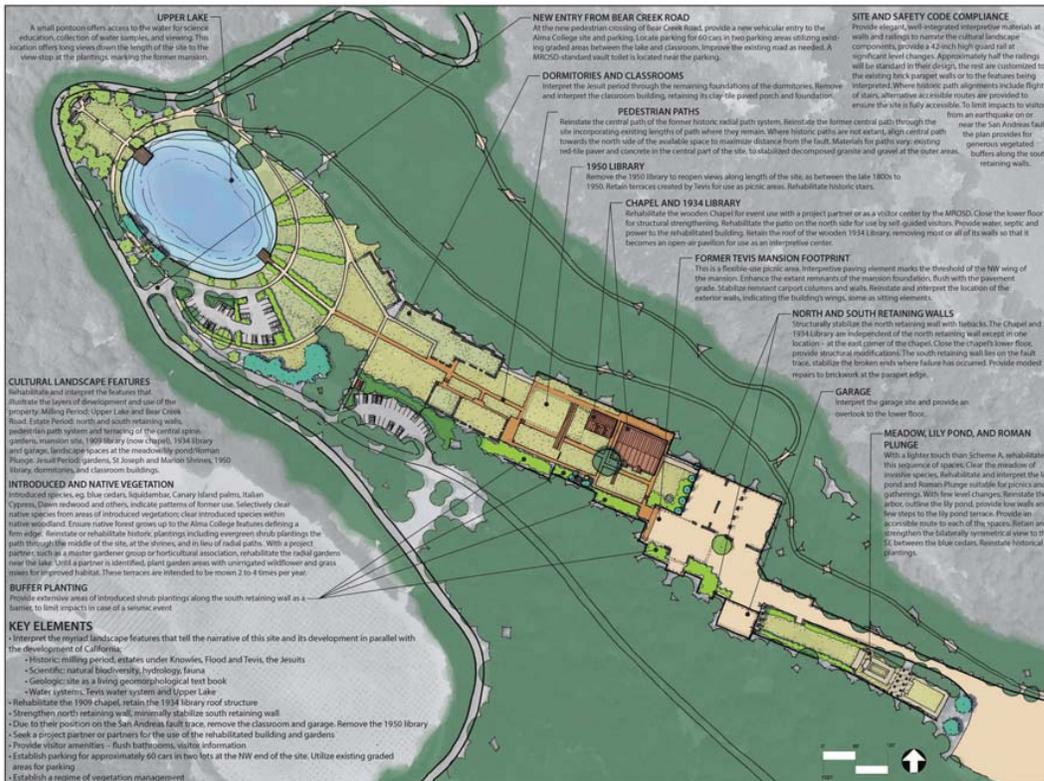
Figure C.1 – Rehabilitation Plan Base Option

- 1.1. Strengthen full length of the existing north retaining wall with structural tiebacks.
- 1.2. Repair and strengthen portions of the existing south retaining wall adjacent to previous wall failures.

Overall Rehabilitation Option (Figure C.1) PLEASE USE THE CURRENT ALMA COLLEGE SITE REHABILITATION PLAN DRAWING

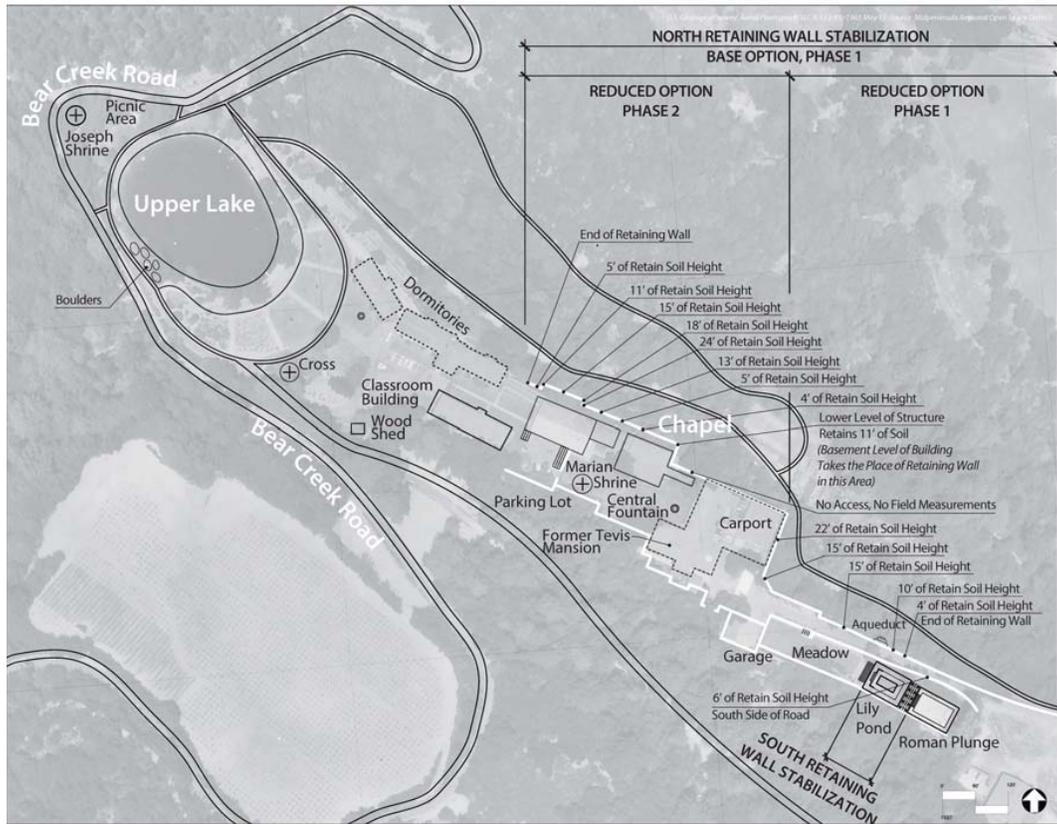
The existing site retaining walls delineate the edges of the relatively flat-topped ridgeline that defines the core of the Alma College site. The walls are concrete with non-structural red brick veneer on the exposed faces. No independent field testing of the concrete was possible within the scope of this report. Therefore, thicknesses and strength of the concrete as well as the extent of existing reinforcing steel in the retaining walls could not be determined. No existing building documents for the site retaining walls were available for review.

At various locations, sections of the existing wall have failed. These failure types vary from minor to complete. Minor failures have been defined as walls leaning towards the downhill side and separating from perpendicular retaining walls creating wide cracks through the thickness of concrete wall. Complete failures have been defined as sections of the wall collapsing down the hillside.

Figure C.3 – Retaining Wall Information

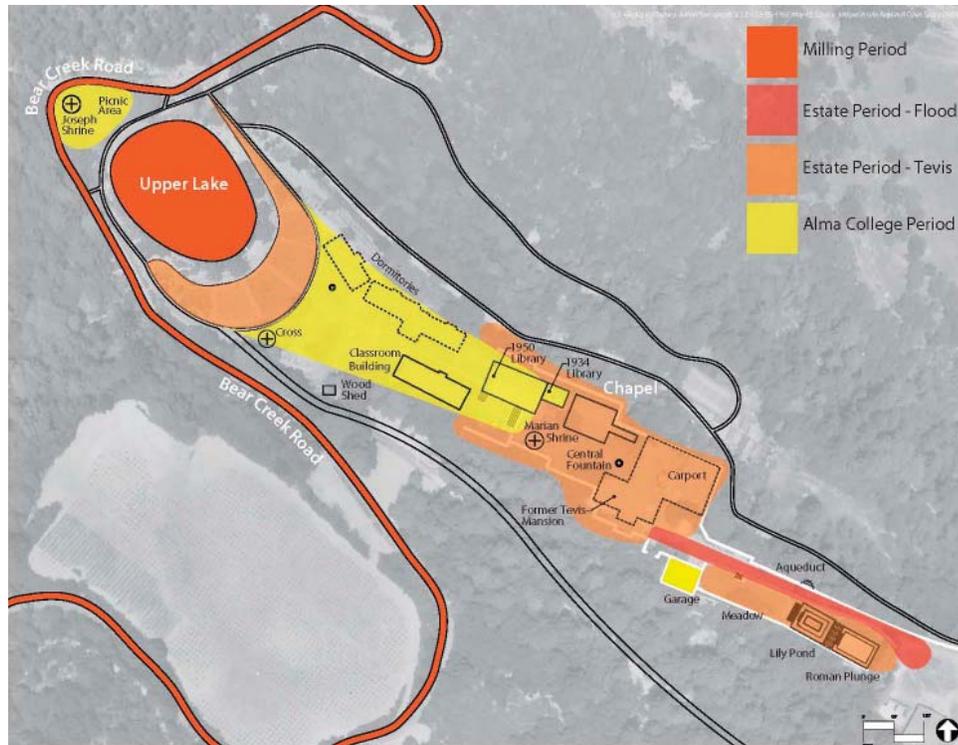
Figure 1. Site plan illustrating various historical periods at the former Alma College site, as described in Knapp Architects' 2010 report. Source: PGA Design, Alma College Cultural Landscape Rehabilitation Plan (August 2015): 13.

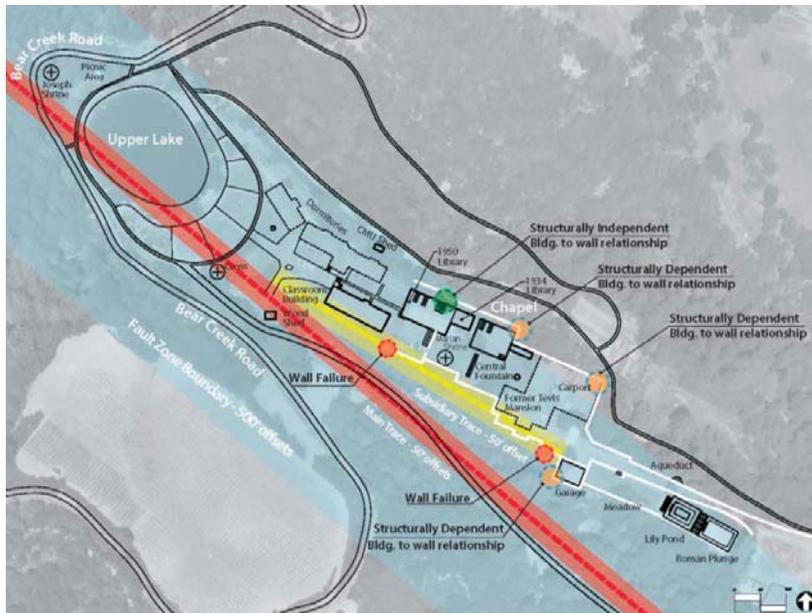
Figure 2. Site plan roughly illustrating the fault lines and zones at the former Alma College site. The red line illustrates the San Andreas Fault plus 50 ft buffer, the yellow line represents a trace plus 50 ft buffer, and the blue zone shows the 500 ft buffer zone Source: PGA Design, Alma College Cultural Landscape Rehabilitation Plan (August 2015): 19.
