**ALMA COLLEGE**  
**HISTORIC RESOURCE STUDY**  
Revised Draft – Subject to Revision

**BEAR CREEK ROAD**  
**LOS GATOS, CALIFORNIA**

Page & Turnbull, Inc.  
San Francisco, California  
November 2005

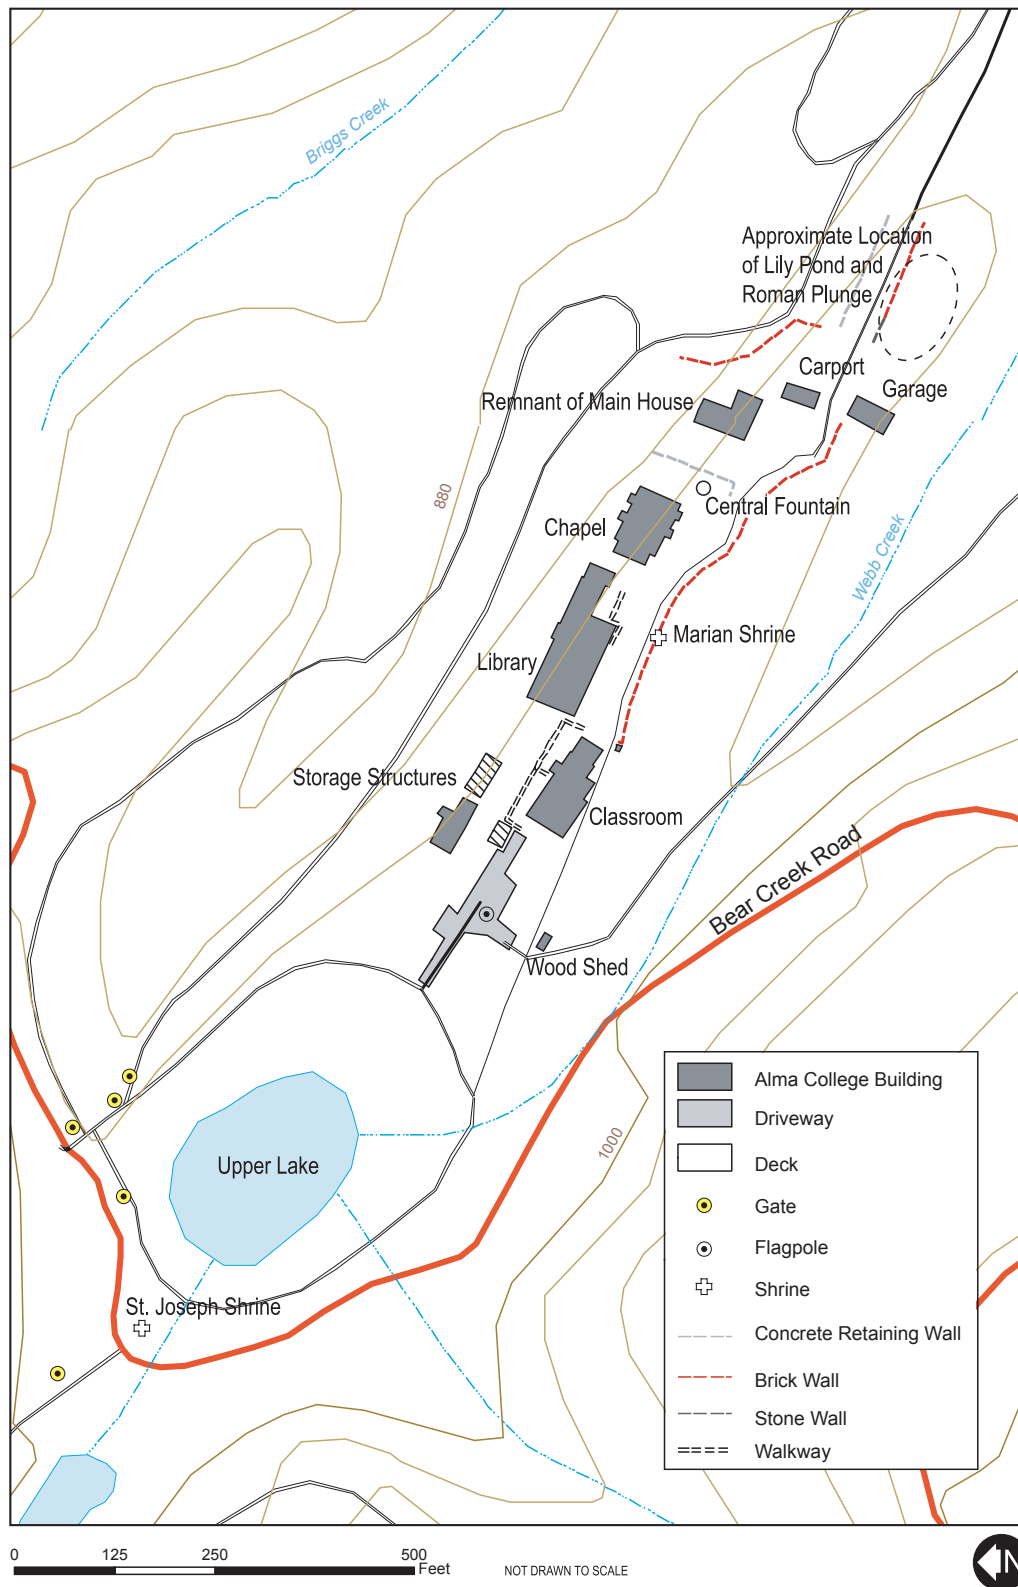
Santa Cruz Mountains rise to the north and west while the Lexington Reservoir, which was an open valley until the 1950s, lies to the east. As indicated on the schematic site plan, which is attached as Figure 20, the primary approach to the site is from Bear Creek Road, which winds southwest from SR 17, passing along the north side of the college site. Turning left off Bear Creek Road, one passes through a series of modern gates. A main road leads around the north and east sides of Upper Lake, which began its life in the 1850s as the Howe millpond. Over the next century, the body of water was regularized and used as the primary gateway to the property and a critical organizing element for all three estates as well as the seminary that succeeded them. Beyond Upper Lake, the road bends to the south and east and rises

Figure 20: Site Map of Former Alma College, Bear Creek Redwoods Open Space Preserve (Midpeninsula Regional Open Space District map; modified by Page & Turnbull, August 2005).

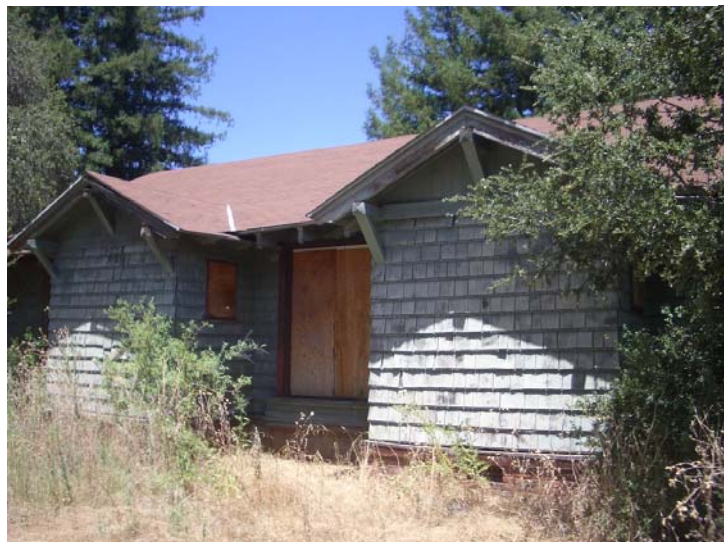
In 1934, the Jesuits converted the Library to serve as the Chapel. On the exterior, two small side chapels were added on both the north and south façades of the building. The large stone fireplace along the south wall was removed, pews were installed and a raised altar was built at the west end of the main room. In later years, the building fell into disrepair, the pews were removed and the french doors broken and boarded over. Carpet now covers the wood floors, and the building has a significant vermin problem.

**Figure 23: South Façade, Alma College Chapel, former Tevis Library, 2005 (Page & Turnbull).**

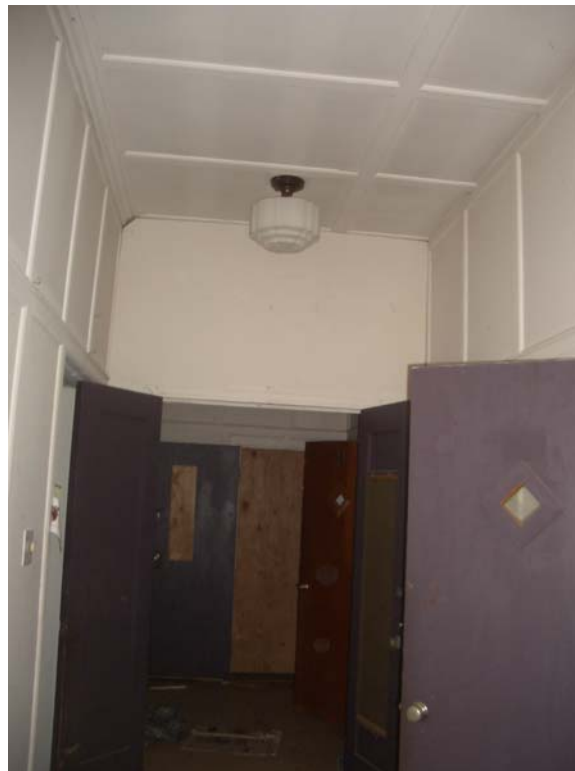
Figure 27: Entry Hall, Alma College Library, 2005 (Page & Turnbull).

largely historic, with painted wood paneled walls and ceilings, a wood floor and an original light fixture. To the right of the entry hall, two small rooms retain their original wood paneled walls and wood floors, with the addition of a suspended acoustic tile ceiling. To the left of the entry hall, within the two-story portion of the building, the second floor has been partially removed, creating a double-height space with a kitchen along the west wall and a loft above. The windows, significantly damaged, are the only historic elements remaining in this area. New gypsum board walls and ceilings, carpeted floors and new fixtures finish the space. Today, there is no connection between this area and the 1949 library addition. It was not possible to survey the interior of the 1949 addition in 2005, and it is unknown what kind of changes the Jesuits and later tenants made over time.

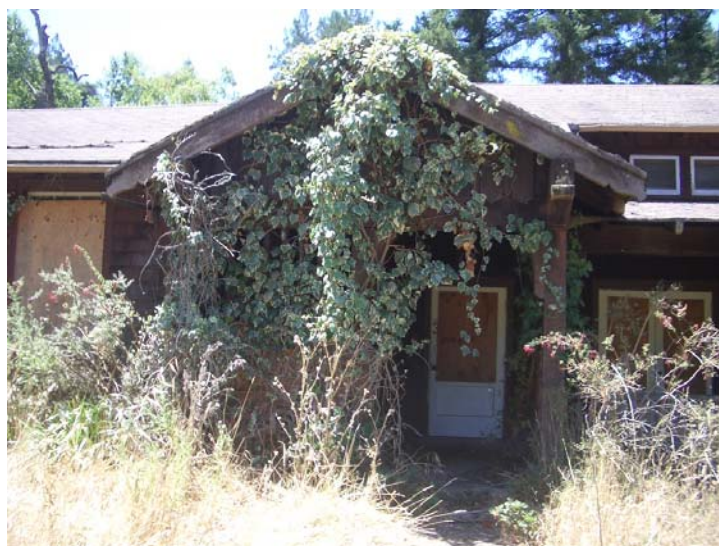
The Classroom Building stands on a site that slopes gently to the southwest, one story high at the northeastern corner, with a full story brick basement exposed at the southwestern corner. The long narrow building consists of two attached sections. To the west, an exterior arcade runs along the north side of the building, connecting a series of classrooms and looking out at what was once the mall for the campus. At the eastern end of the building, an enclosed space occupies the full footprint of the building. A brick vestibule with spindle screen openings serves as the main

Figure 29: North Facade, Classroom Building, 2005 (Page & Turnbull).

entrance at the center of the building. On brick foundations, the wood frame walls are finished with shingle siding, and the asphalt shingle gable roof covers the exterior. Within the arcade, the walls are finished in flush vertical wood siding, and brick tiles cover the floor. Much like the covered walkways on the south side of the campus, the arcade has carved heavy timber capitals. Some original doors remain boarded-up on the exterior, and at least one historic light fixture survives within the arcade. Over time, changes were made to the Classroom Building. On the exterior, asphalt shingles replaced the original wood shingles and metal angle braces have been attached to the arcade capitals, suggesting an attempt at seismic reinforcement. Currently the west façade of the building is finished only with building paper and vertical wood battens, although it seems probable that this façade was originally finished with wood shingles similar to the other three sides of the building. The interior of the building has been more significantly altered. Partition walls have been demolished and finishes removed. The interior at the east side was not accessible, but beyond original doors and windows, nothing survives on the west end of the building.

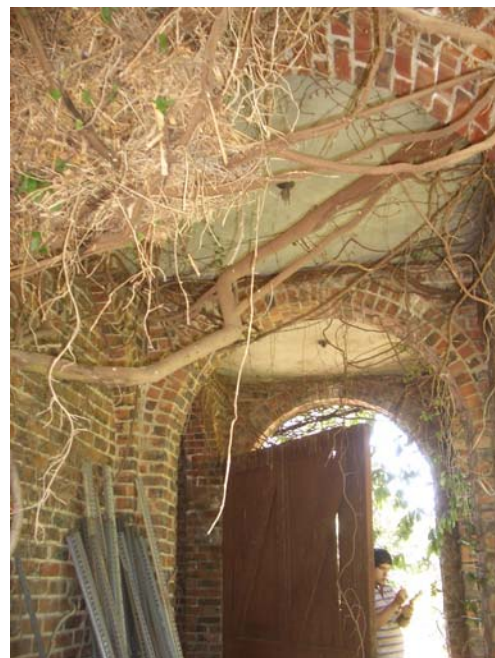
The surviving remnant was actually an addition to the east side of Tevis' original house, designed in 1920 by George Kelham and then altered in 1923. The 1920 addition consisted of a two-story brick guest wing, built into the steep hill, and a single-story area above ground accommodating service and entertaining spaces. The roof of the new addition served as a wide deck for the entertaining areas on the main floor of the house, offering a dramatic view of the Santa Clara Valley to the north and east. Built around a large, jagged rock that served as a landmark for Tevis, a grand brick stair led from the ground level up to the deck, while two stairways led down to the guest rooms built into the hill. In 1923, the stair leading up to the deck was eliminated, replaced with a hallway with arched openings.<sup>35</sup> No windows, doors or finishes survived the fire, and although a concrete stair leads down into the guest room area, the original wood floor within the space has collapsed. Burned timbers attached to concrete beams on the above-ground level of the remnant attest to the high finishes of the original interior as well as the severity of the 1970 fire.

Figure 33: 1923 East Façade Addition to the Main House, 2005 (Page & Turnbull).

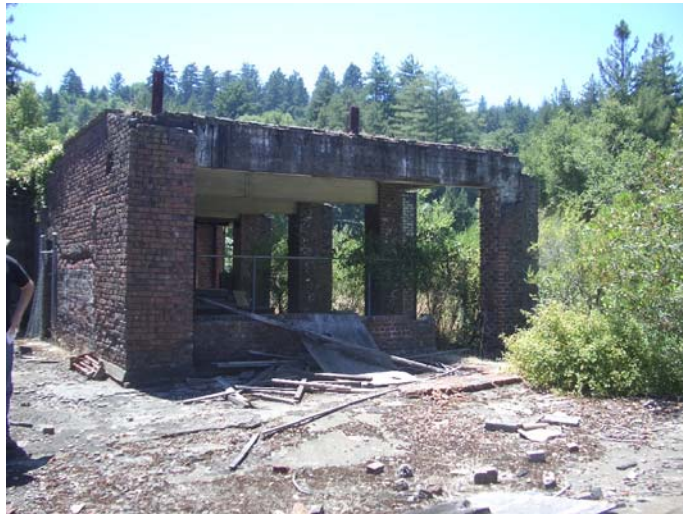
The Main House burned down on Christmas Eve 1970, and today only the northeastern corner of the building survives. Constructed of brick, the remnant consists of one floor above grade and a two-story section that extends into the hillside

**Figure 34: Remnant of the Main House, 2005 (Page & Turnbull).**

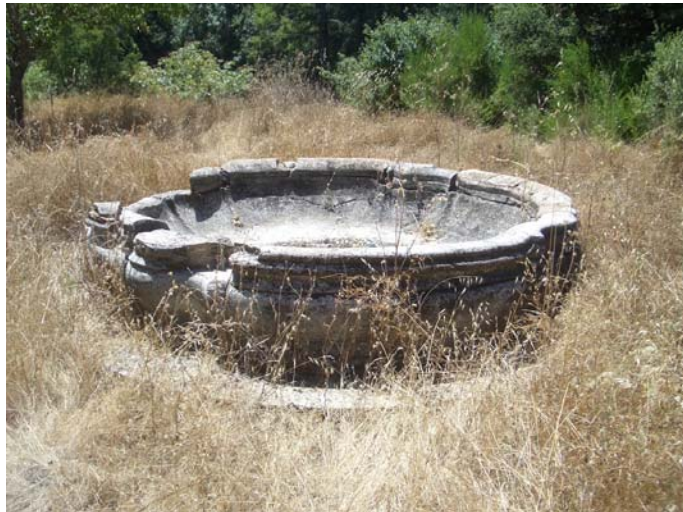
In 1909, Dr. Tevis installed a circular sunken pool within the courtyard of the main, west façade of the building. Sometime during his occupancy, he replaced this sunken pool with a raised, stone pool in the same location. That stone pool survives today, in a somewhat dilapidated condition, south of the chapel.

**Figure 35: Central Fountain, 2005 (Page & Turnbull).**

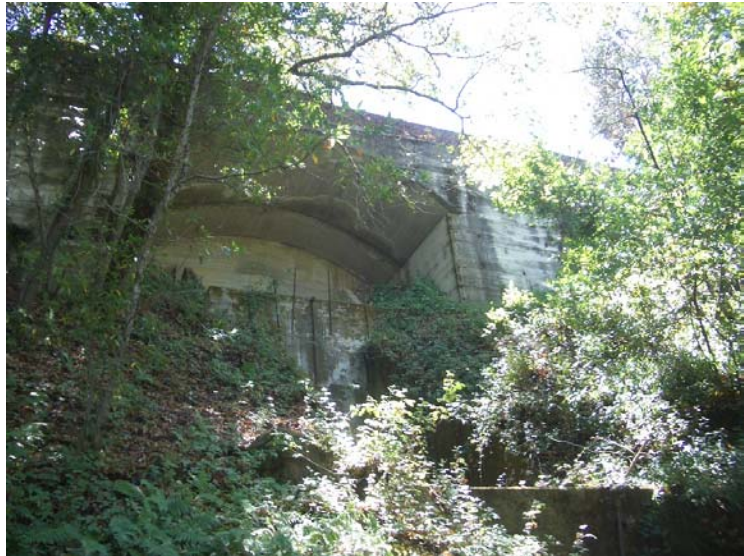
Throughout the site, retaining walls attest to the once cultivated nature of Alma College. A significant concrete and brick retaining wall lies to the north of the campus, spanning its entire length and supporting the steep decline in this direction. Seismic activity and years of deterioration and plant growth have created large cracks in this wall. Poured concrete walls mark the original foundations of the east wall of the Main House. Moving further east, beyond the house, along the private road the Floods constructed to Alma, a significant rough stone retaining wall rises to the north. Beyond the late-era garage building, the Floods' road passes across a narrow ridge. The north side of this ridge is supported by a massive, reinforced-concrete wall that

features an arched center panel and a series of descending concrete pools, apparently used to move water from the south to the north side of the estate. Brick retaining walls and a brick retention pond stand south of this massive wall, across the road and below the level of the adjacent lawn. These retaining walls represent a massive construction effort and illustrate how extensive and intensively developed this property has been in the past. These examples are visible in 2005, and it is a virtual certainty that many more survive, hidden by years of plant growth.

**Figure 38: Retaining Wall and Water System at North Side of Complex, 2005 (Page & Turnbull).**

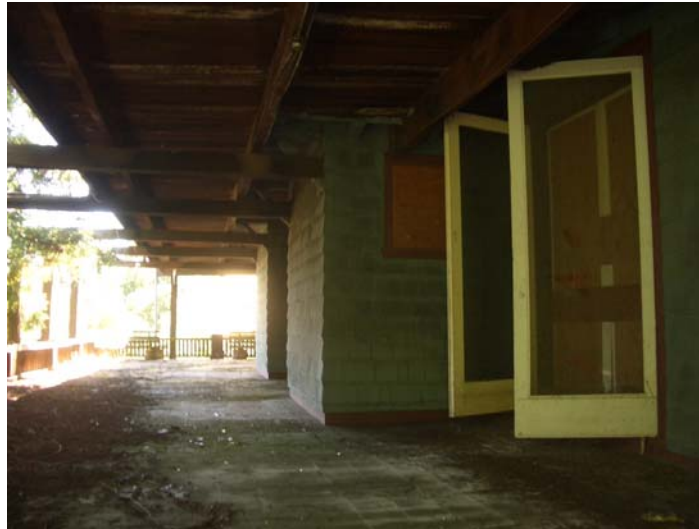
**Figure 40: North facade, Alma College Chapel, former Tevis Library, 2005 (Page & Turnbull).**

diminished. On the interior, the building remains largely a single, expansive, open space. The alteration of the north and south façades has caused the loss of the Chapel's design integrity.
